Your Home Inspection

1010 USA Drive Fort Wayne, IN 01010

Prepared for: Mr. Mrs. John Doe

Prepared by: PTI Home Inspections 407 North Main Street Churubusco, Indiana 46723 License #HI00500182 License #F212917

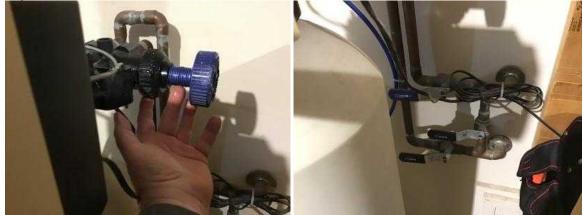
1. Water Softener: Culligan water softener - Re generated at the inspection-service as regular maintenance

The unit started leaking about 45 minutes into the RE generation, PTI contacted the sellers agent to inform of bypassing the unit and unplugging to stop further leaking and or damage, review and repair as needed

- 6. Water PSI High: 59 psi
- 7. Gallons Per Minute: 8-10 gallons per minute
- 8. Satisfactory Functional Flow: Average water flow
- 9. Major Defect
 Water Softener: Culligan water softener Re generated at the inspection-service as regular maintenance
 The unit started leaking about 45 minutes into the RE generation, PTI contacted the sellers agent to inform of bypassing the unit and unplugging to stop further leaking and or damage, review and repair as needed
