INFORMATION TRANSMITTED: March 3, 2006 Leachate Release

Re: March 3, 2006 Leachate Release
North Country Environmental Services, Inc. (NCES) Landfill
581 Trudeau Road
Bethlehem, New Hampshire

This letter was prepared to document our observations of the leachate release that occurred at the NCES site on Friday March 3, 2006.

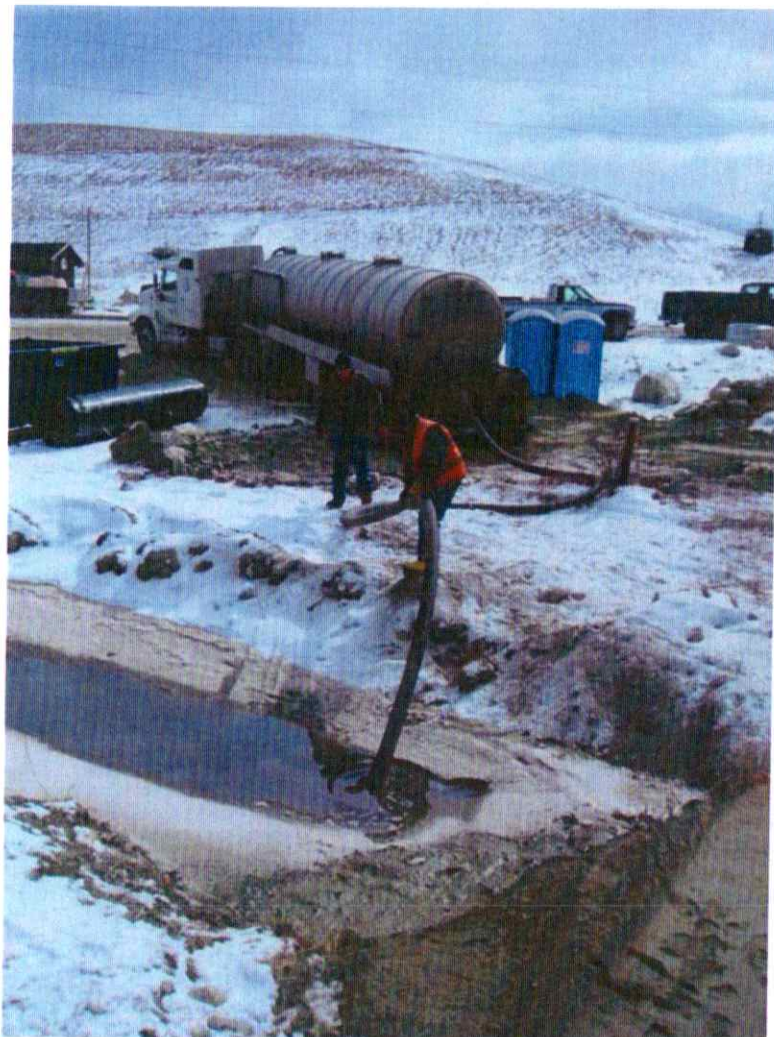
Loading tanker from contained leachate.

The vacuum truck was filled before all the leachate that had pooled in the swale was collected. The additional leachate in the swale was soaked up with sand, excavated, and transported to the active portion of the landfill for disposal. CCI excavated the banks and bottom of the swale where the leachate collected, as well as the layer of the soil where the leachate flowed across the road. It appeared that CCI removed the soil that was impacted by the leachate release.

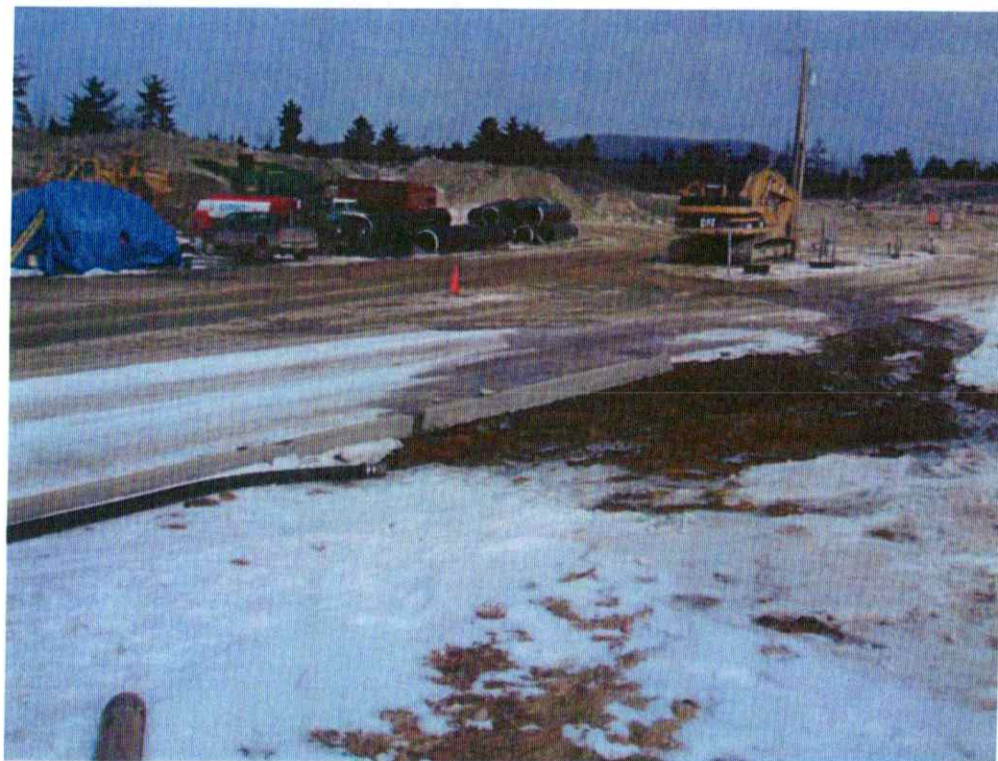
Sean Moran of NCES was overseeing the clean up. Sean explained that an NCES employee had attempted to fill a leachate transport truck from the Consolidation Building, but was unable to pump leachate due to an ice blockage in the pipe that extended from the building to the truck. Sean indicated that the NCES employee had the truck move to a different leachate pump station to be filled, and had accidentally forgotten to turn off the key switch that prevents the leachate pump from operating. Sean speculated that while the truck was being filled at the other location, the ice blockage released and the system pumped 5,036 gallons of leachate onto the ground in front of the leachate consolidation building. The leachate volume was obtained from the flow meter for the truck loadout pump.

Source of leachate release (hose in foreground).

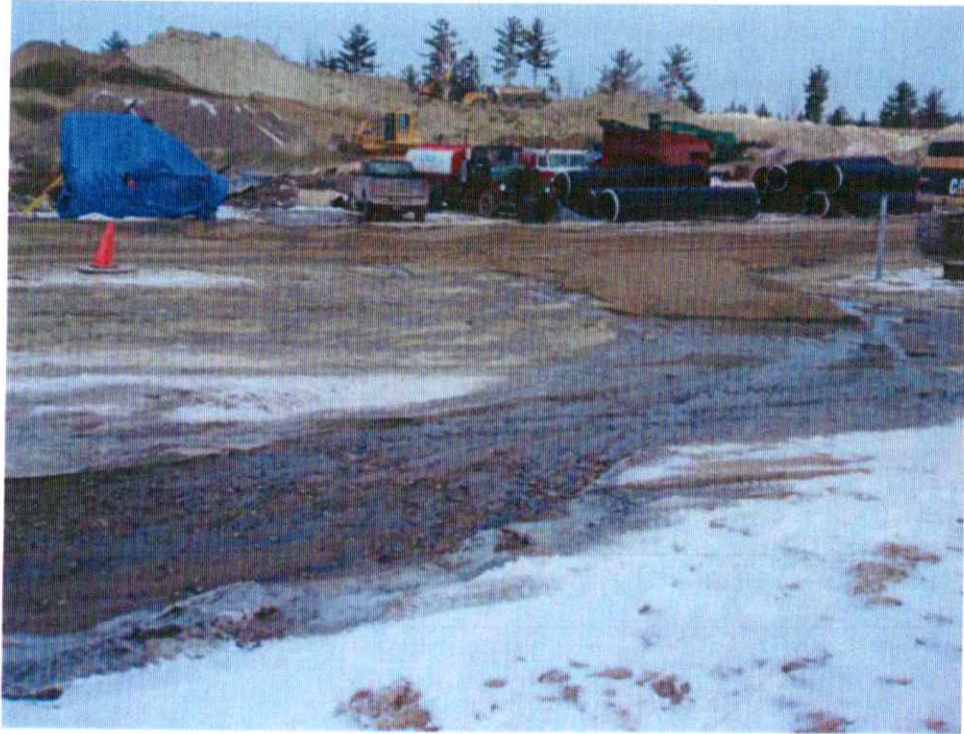
The leachate flowed across the perimeter road and collected in a storm water swale north of the CCI temporary construction field trailer. The swale normally conveys the discharge from Detention Pond No. 3. Spencer observed that CCI had dammed the swale with soil near the low end of the swale to confine the leachate while the truck vacuumed it out. CCI had also spread soil on the perimeter road to help absorb leachate. Sean indicated that approximately 30 gallons of leachate flowed to the portion of the swale downstream from where the soil dam was constructed. Spencer photographed the containment and collection efforts. Refer to the attached photos of the release area.

Stormwater swale where leachate was contained as excavation was being completed.
