**RE: North Country Environmental Services, Inc.
Landfill Facility - Bethlehem, NH
Leachate Release**

Re: May 12, 2006 Leachate Release
North Country Environmental Services, Inc. (NCES) Landfill
581 Trudeau Road
Bethlehem, New Hampshire

This letter was prepared at your request to document Sanborn, Head & Associates, Inc.'s (SHA's) observations of a leachate release that occurred at the NCES site on Friday May 12, 2006.

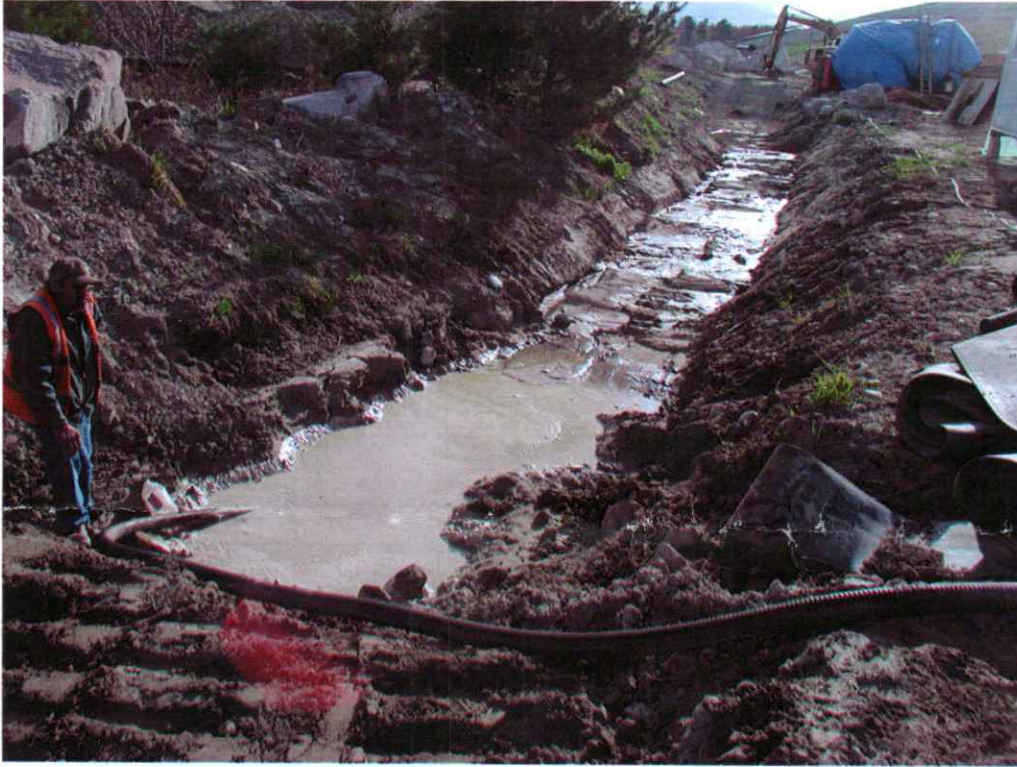
Loading tanker from contained leachate.

The storm water swale conveys the storm water flow from Detention Pond No. 3 to the long treatment swale from Detention Pond No. 2. Dennis observed that CCI had constructed a soil dam in the swale near the down stream junction with the long treatment swale to confine the leachate while the truck vacuumed it out. CCI also spread sand on the perimeter road to help absorb leachate. Dennis photographed the containment and collection efforts. Refer to the attached photos of the release area.

The totalizing flow meter at the load out pump control panel indicated that 1,049-gallons had been pumped through the leachate consolidation building. The vacuum truck driver estimated that 550-gallons of leachate was collected in the vacuum truck from the swale. An on-site contractor excavated the banks and bottom of the swale where the leachate collected, as well as the layer of the soil where the leachate flowed across the road. The soils were transported to the active portion of the landfill for disposal. It appeared that the on-site contractor removed the soil that was impacted by the leachate release.

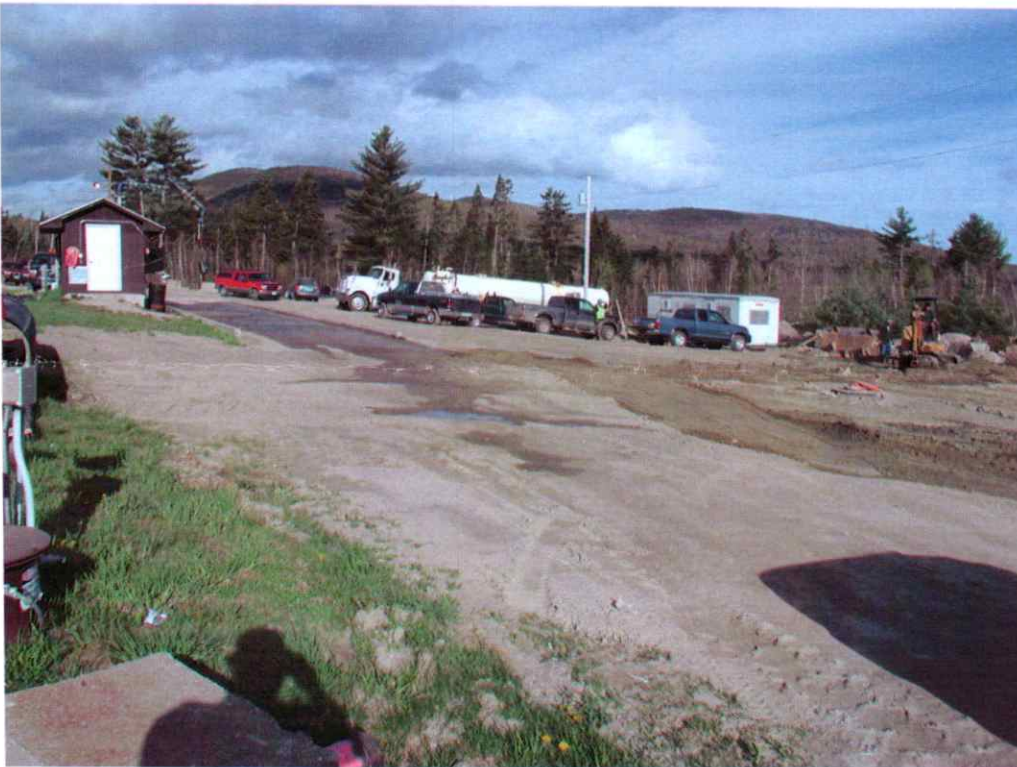
Dennis observed that the release occurred from the loadout arm of the Leachate Consolidation Building between the landfill perimeter road and the toe of the northern Stage I slope. The leachate spilled onto the concrete loadout pad and flowed off the east end on the pad, across the perimeter road to the north, and into the storm water swale north of the perimeter road. Refer to the attached Figure No. 1 for the approximate location of the release.

Source of leachate release (Truck loadout arm shown in the background).

Sean Moran of NCES observed the clean up. Sean explained that the Leachate Loadout pump had unexpectedly turned on sometime around 0715 hours. The pump was not manually turned on. It was determined that an electric relay switch failed, which unexpectedly energized the pump. Sean indicated that he would be in contact with personnel from EOS Research, Ltd., the provider of the pump control system, to try to determine the cause of the problem and would turn the electric circuit breaker for the pump to the "off" position in the meantime.

NCES has instituted a standard operating procedure that mandates all that valves on the Leachate Loadout discharge pipes be manually closed when the loadout is not in use.

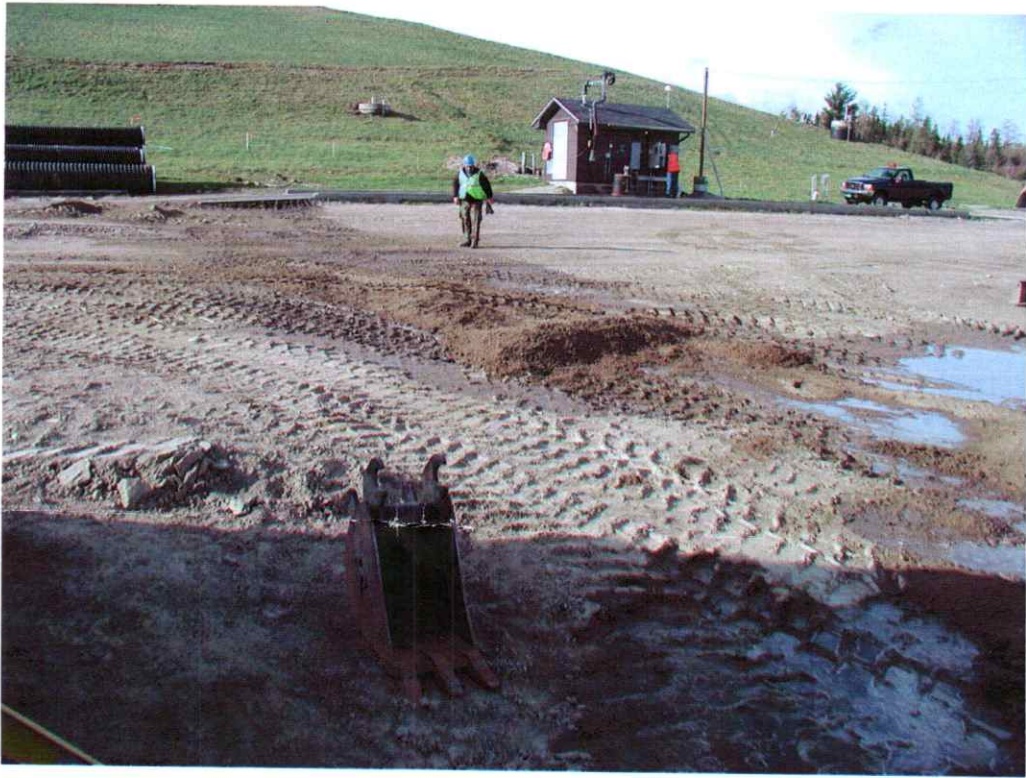
Leachate flow path across the perimeter road.

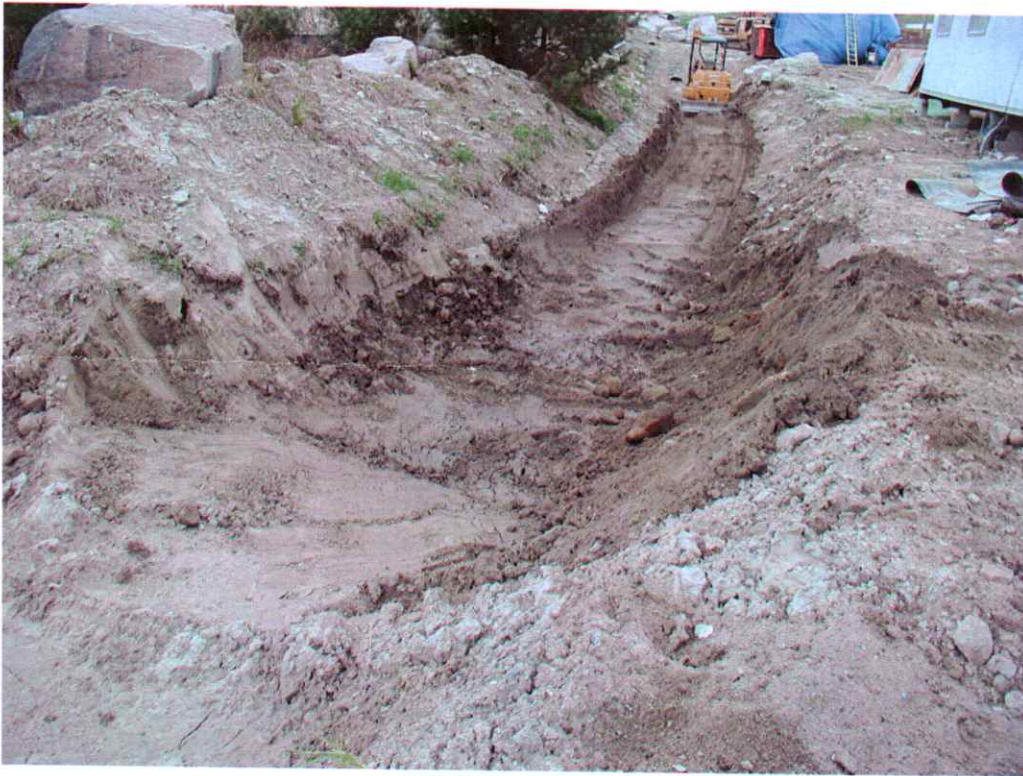
Storm water swale where leachate was contained as excavation was being completed.
