# Data collection and Analysis on the Cosumnes Flood-MAR Vineyard

OHWD Board Meeting  
October 18, 2022

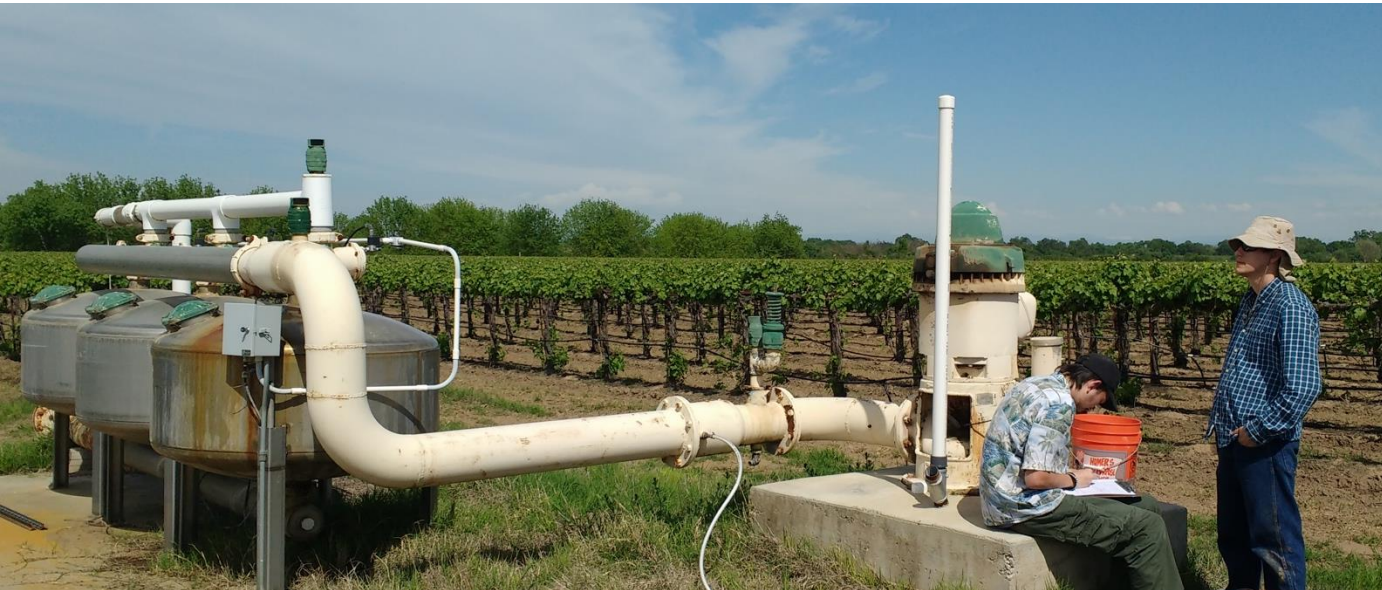
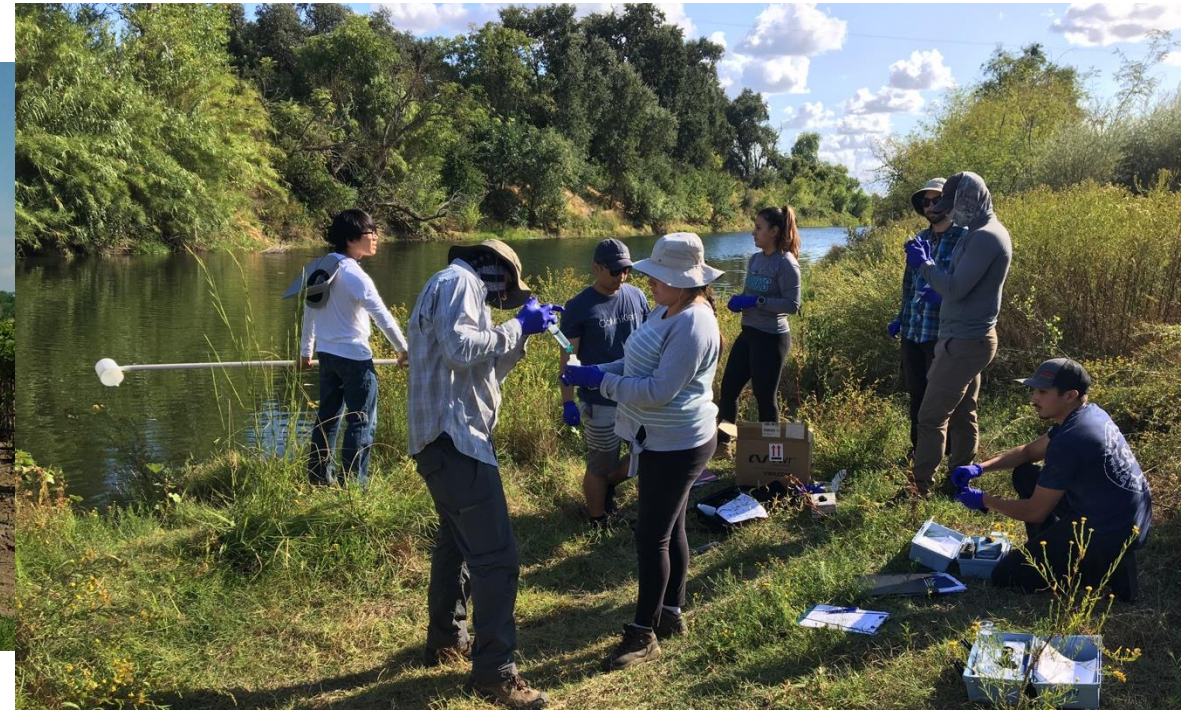
# Water quality monitoring

- Baseline groundwater and surface water sampling campaigns in 2019
- Water sampling during and after flooding in 2021

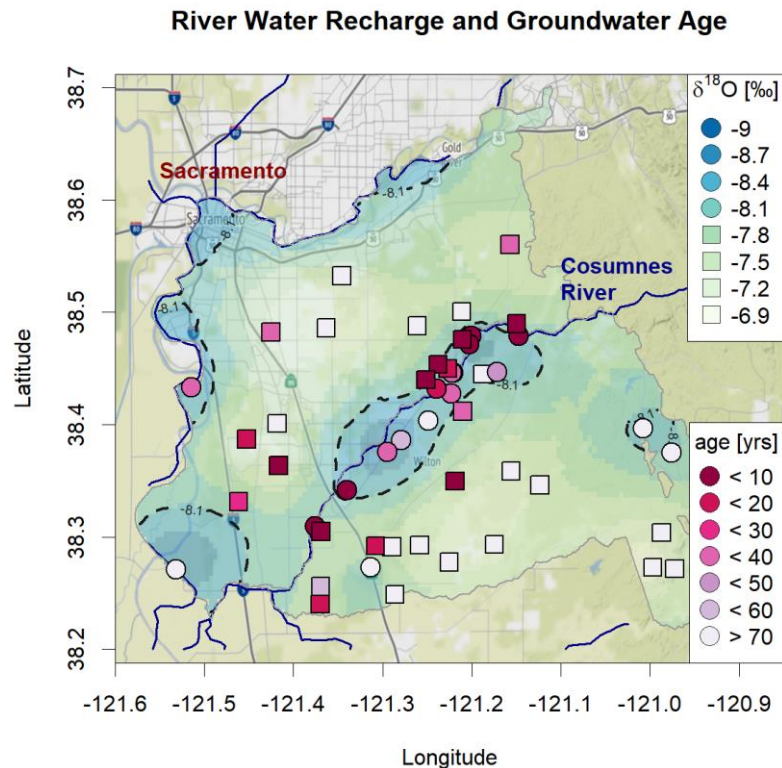
# Regional groundwater isotope analyses

- Most young groundwater close to Cosumnes River and Deer Creek  
→ active recharge
- Older fossil water in regional groundwater basin  
→ no recharge

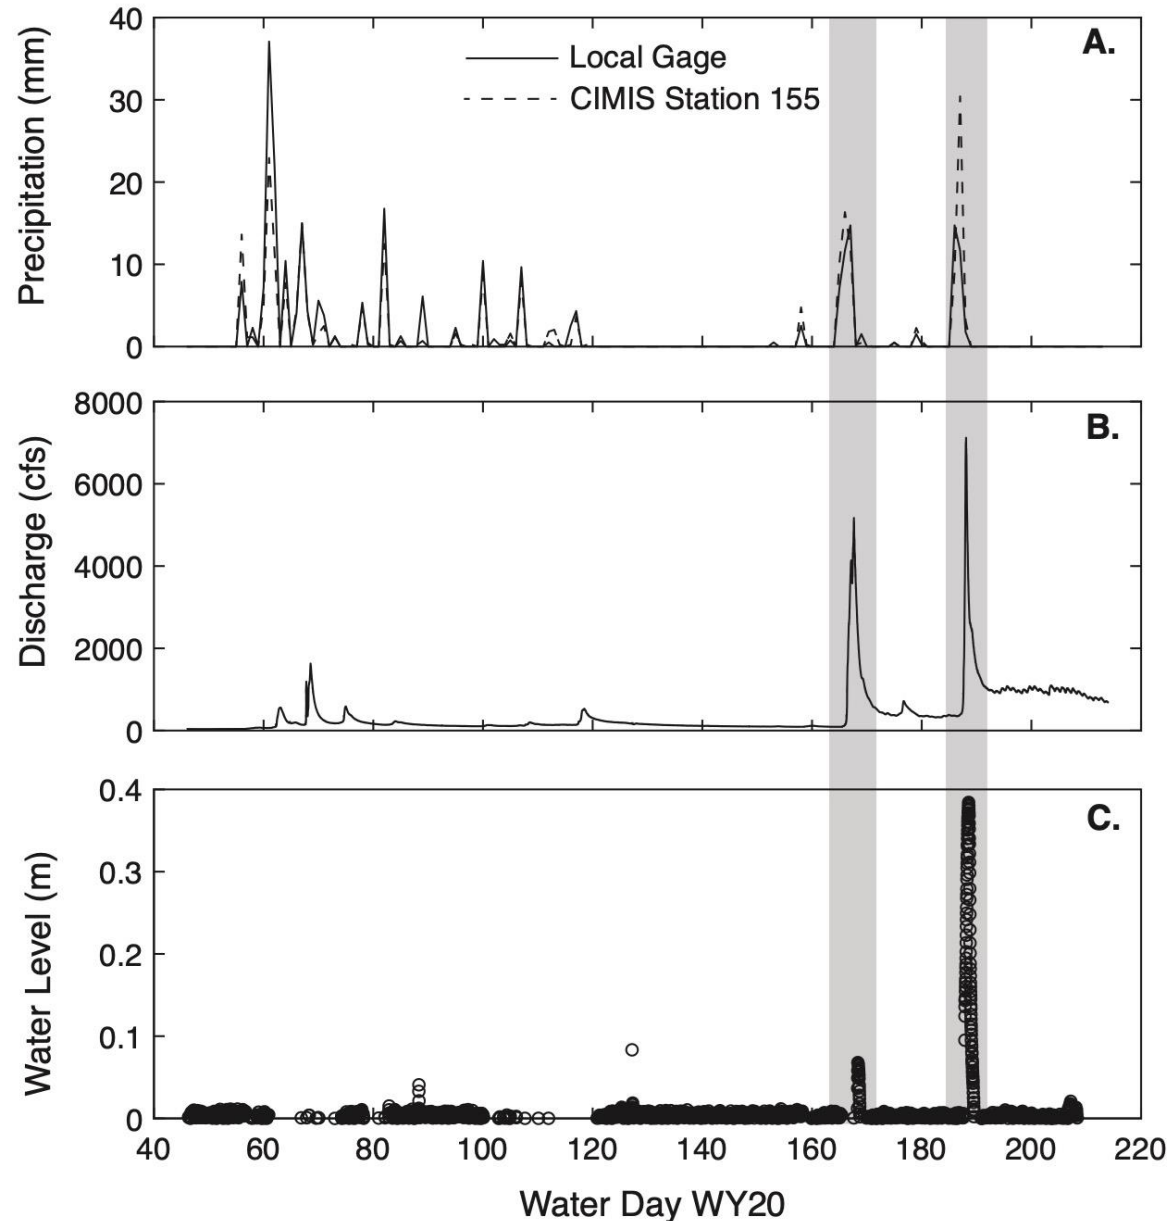
# Infiltration rates ranged between 0.5- 8 in/day

## Infiltration rates:

**Day 168:** 19 cm/day

**Day 169:** 11 cm/day

**Day 188:** 8 cm/day

**Day 189:** 1 cm/day

- Infiltration rates were higher during the first rain event, likely decreased due to sedimentation
- Likely a conservative estimate – a large fraction of infiltration occurs through macropores (i.e. plant roots, animal burrows)

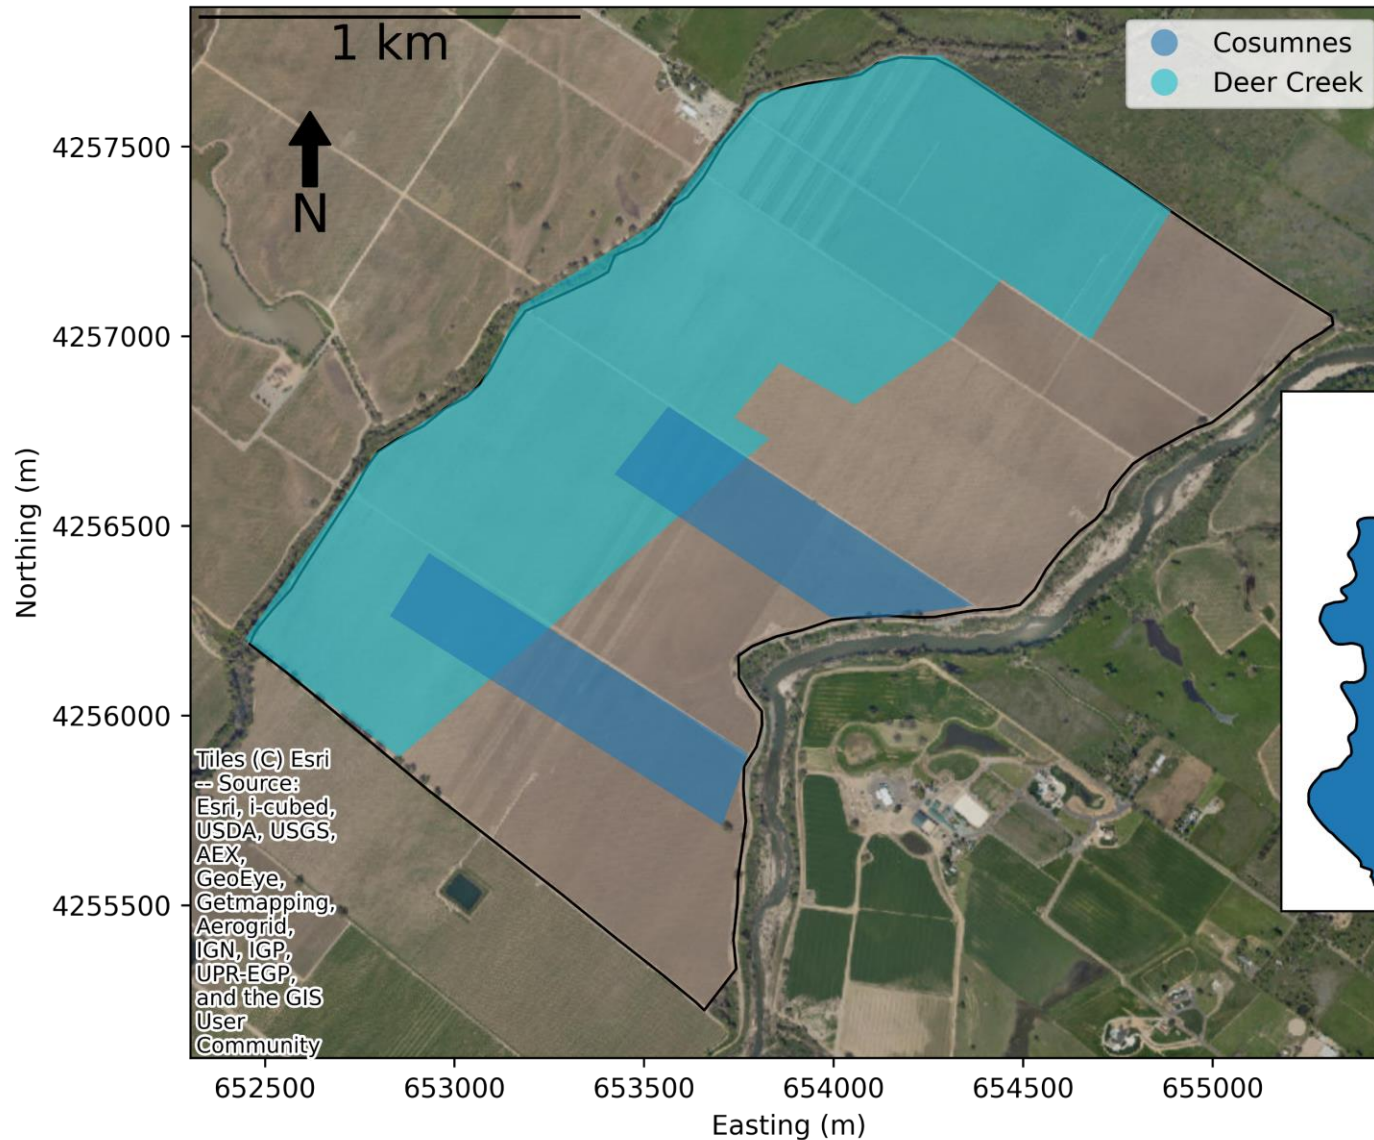
# More details on the actual 2021 flooding

Approximate flooding  
extent

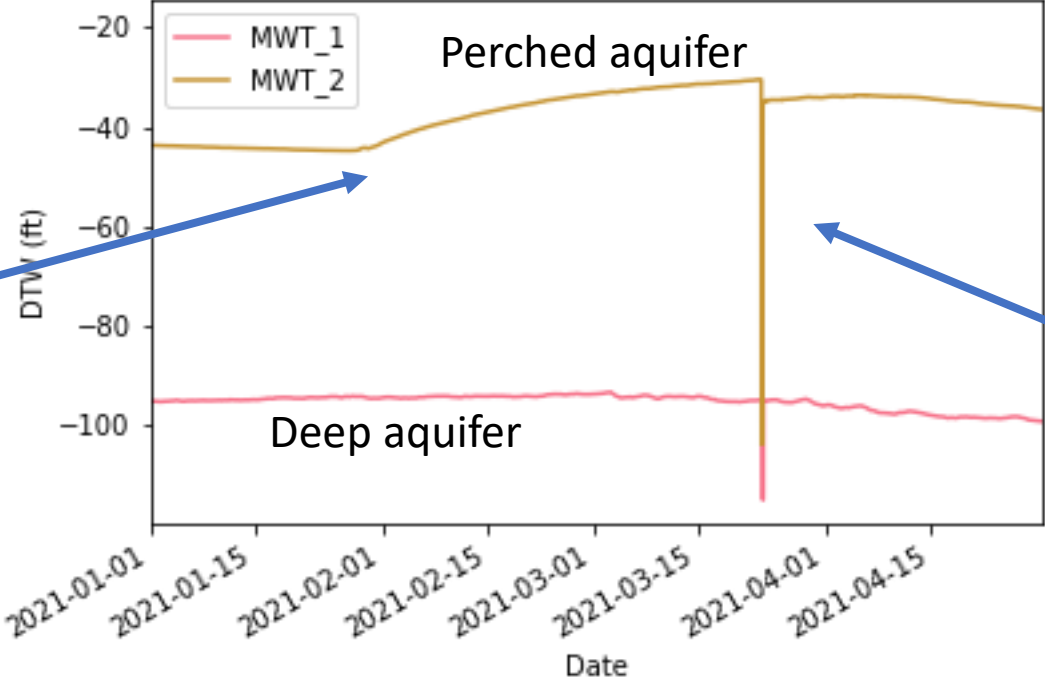
Recharge  
into  
perched  
aquifer

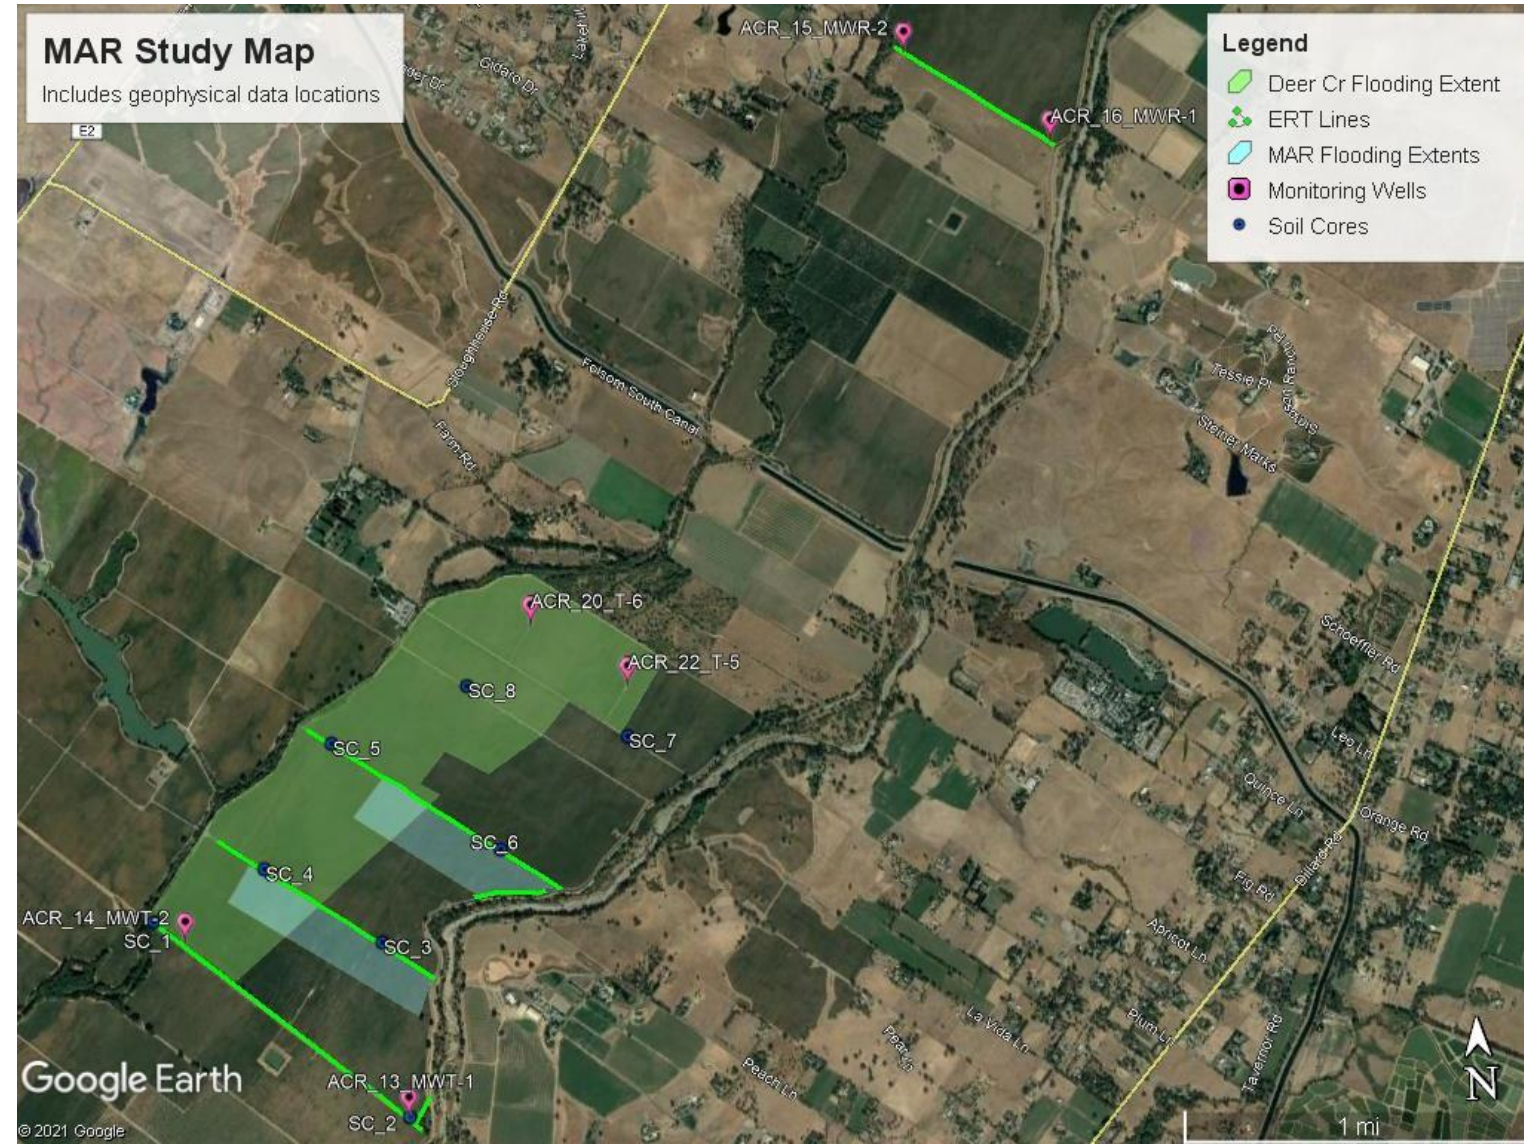
### Site map of recent & continuous data collection locations

- Collected:

- Borehole geophysics (gamma, induction, & NMR)
  - Tells us how sediments change in lithology and water content continuously down depth in a well
- Electrical Resistivity Tomography (ERT) Imaging
  - Provides a 2-D depth scan along a line on the surface that tells us how changes in lithology vary with depth and along a survey path

- Data collected complement our existing knowledge of:

- Surface hydrology
- Groundwater hydrology
- Lithology (aquifer material)

- Helps to understand MAR impacts

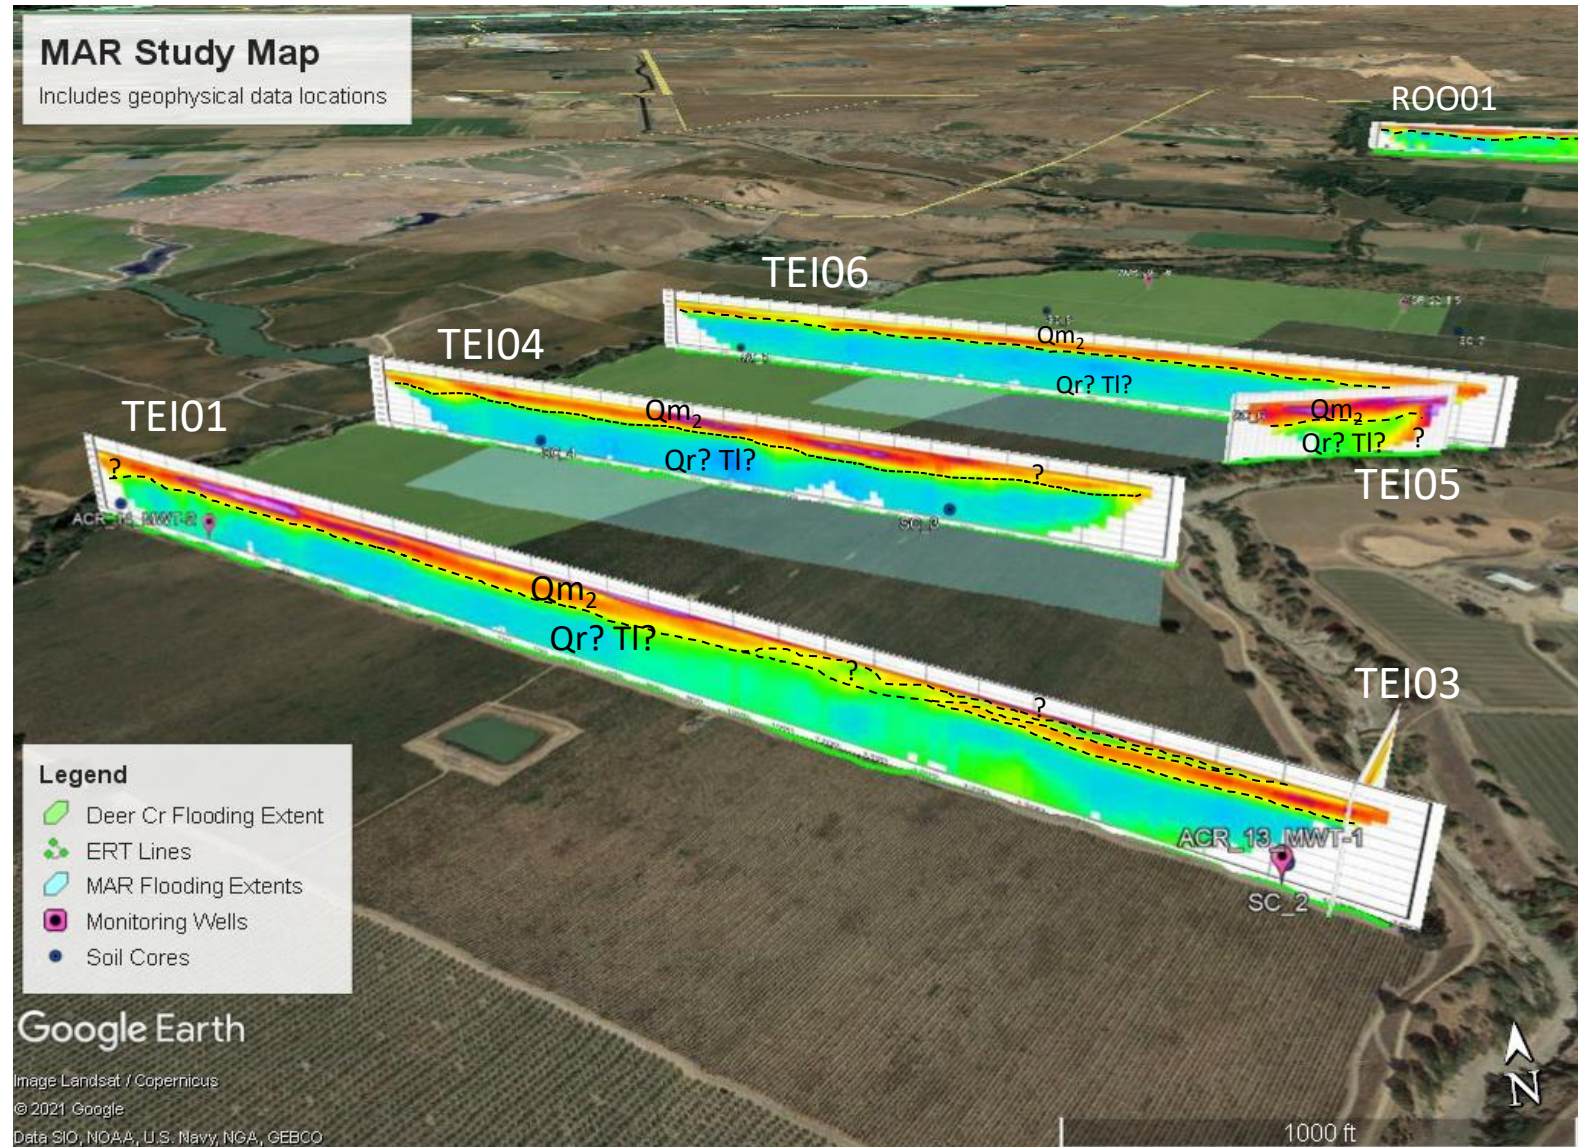
## - Surface geophysics (ERT imaging)

- Paleochannels of higher concentrations of sand/gravel present throughout  $Qm_2$
- Natural & artificial flooding, irrigation, and **large paleochannel intersection with modern Cosumnes R. bed** all contribute to recharge throughout different times of the year
- $Qm_2$  hosts perched aquifer that recharges regional aquifer (Qr/TI)
- MWT-2 effectively records perched aquifer (dynamic response to flooding)
