CALIFORNIA COASTAL COMMISSION

REMAND

5-18-0930 (GRAHAM PROPERTY MANAGEMENT, LLC)

FEBRUARY 8, 2024

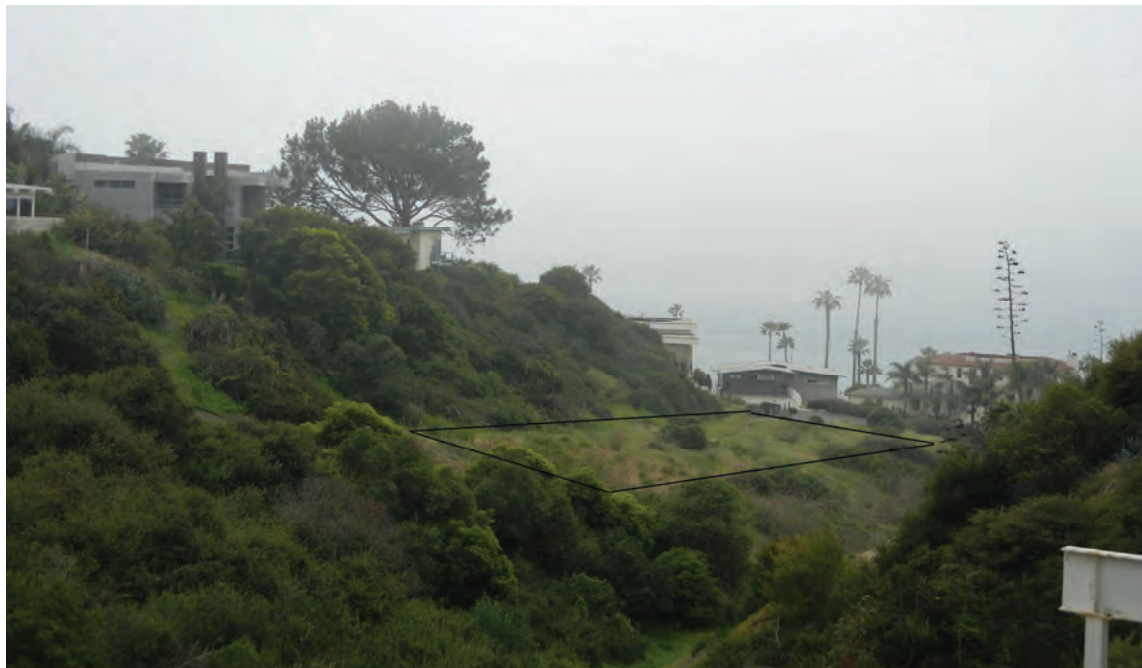
Figure 1a. Photo showing the topography and vegetation of the area and the portion of the site cleared annually by the black rectangle.

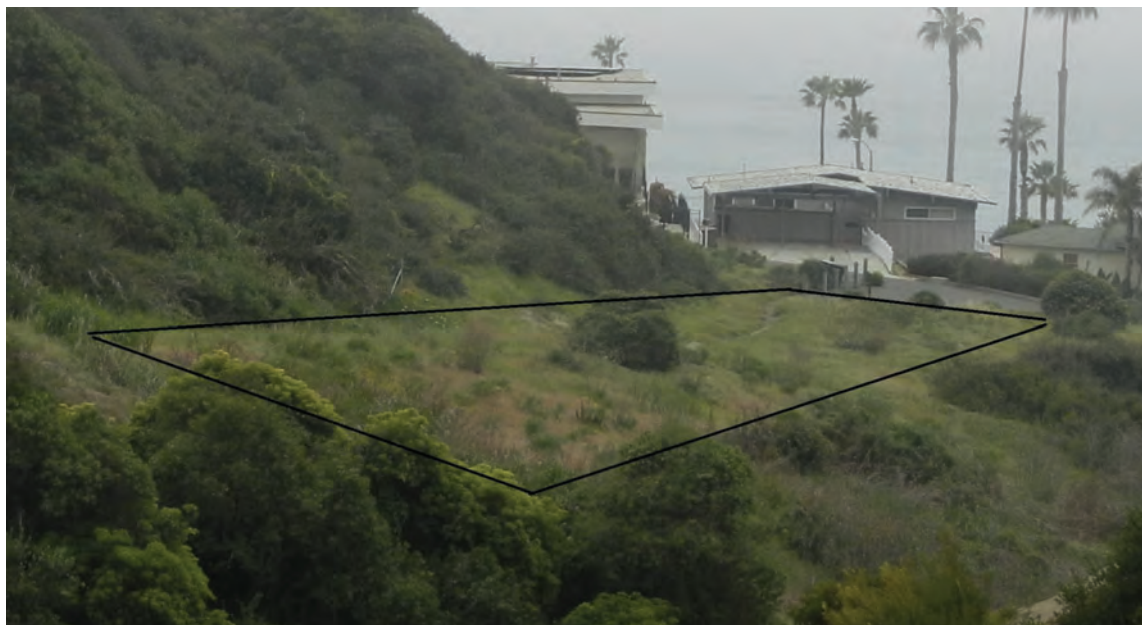
Figure 1b. Close up of the cleared area showing giant wild rye along the northern edge of the property (along edge of black rectangle) and into the canyon and a myoporum bush along the center of the east side of the black rectangle.

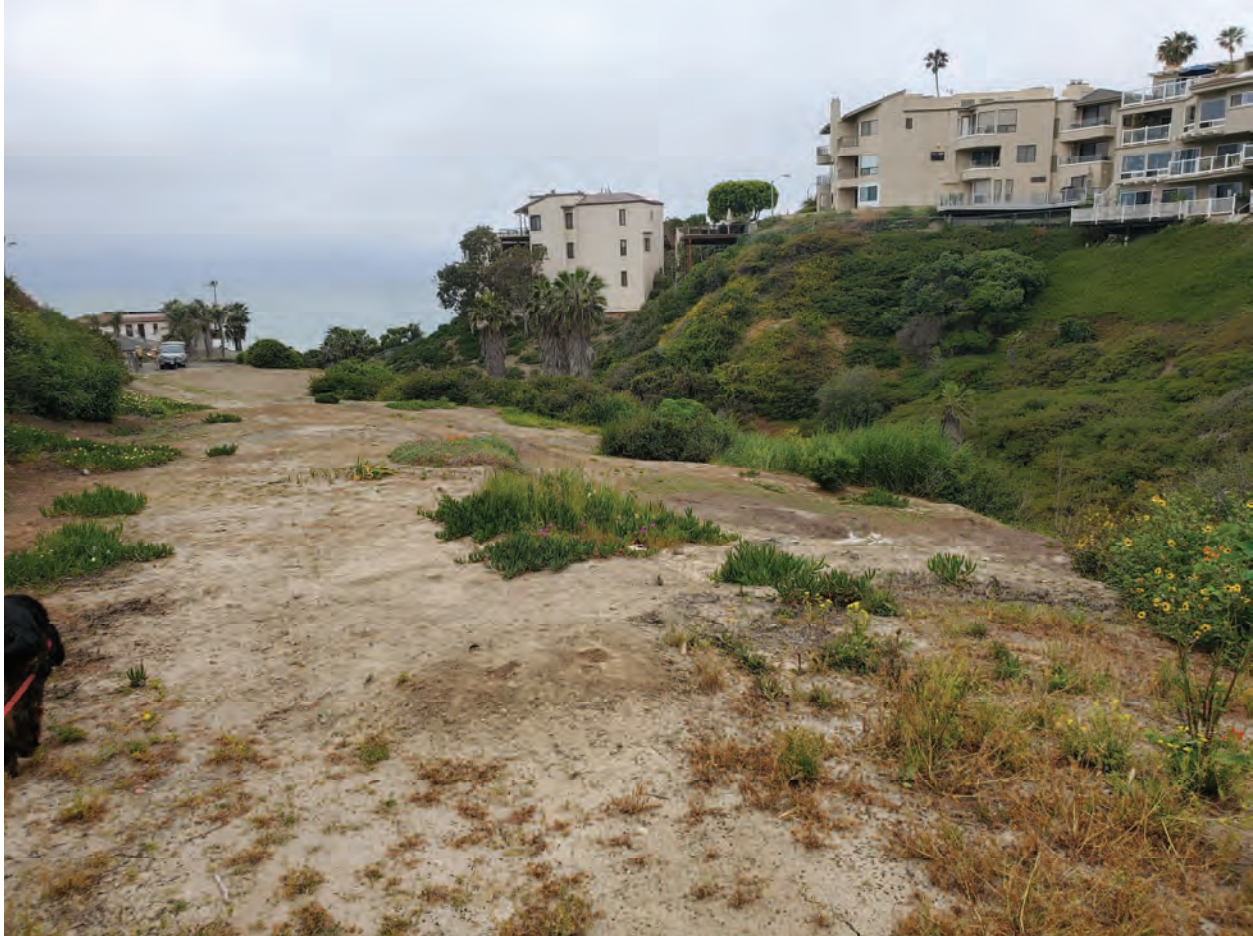
Figure 1d. Photo of the cleared area of the site with a California sunflower bush (*Encelia californica*) in the bottom left of the photo and giant wild rye grass growing out of the patch of iceplant in the center of the photo.

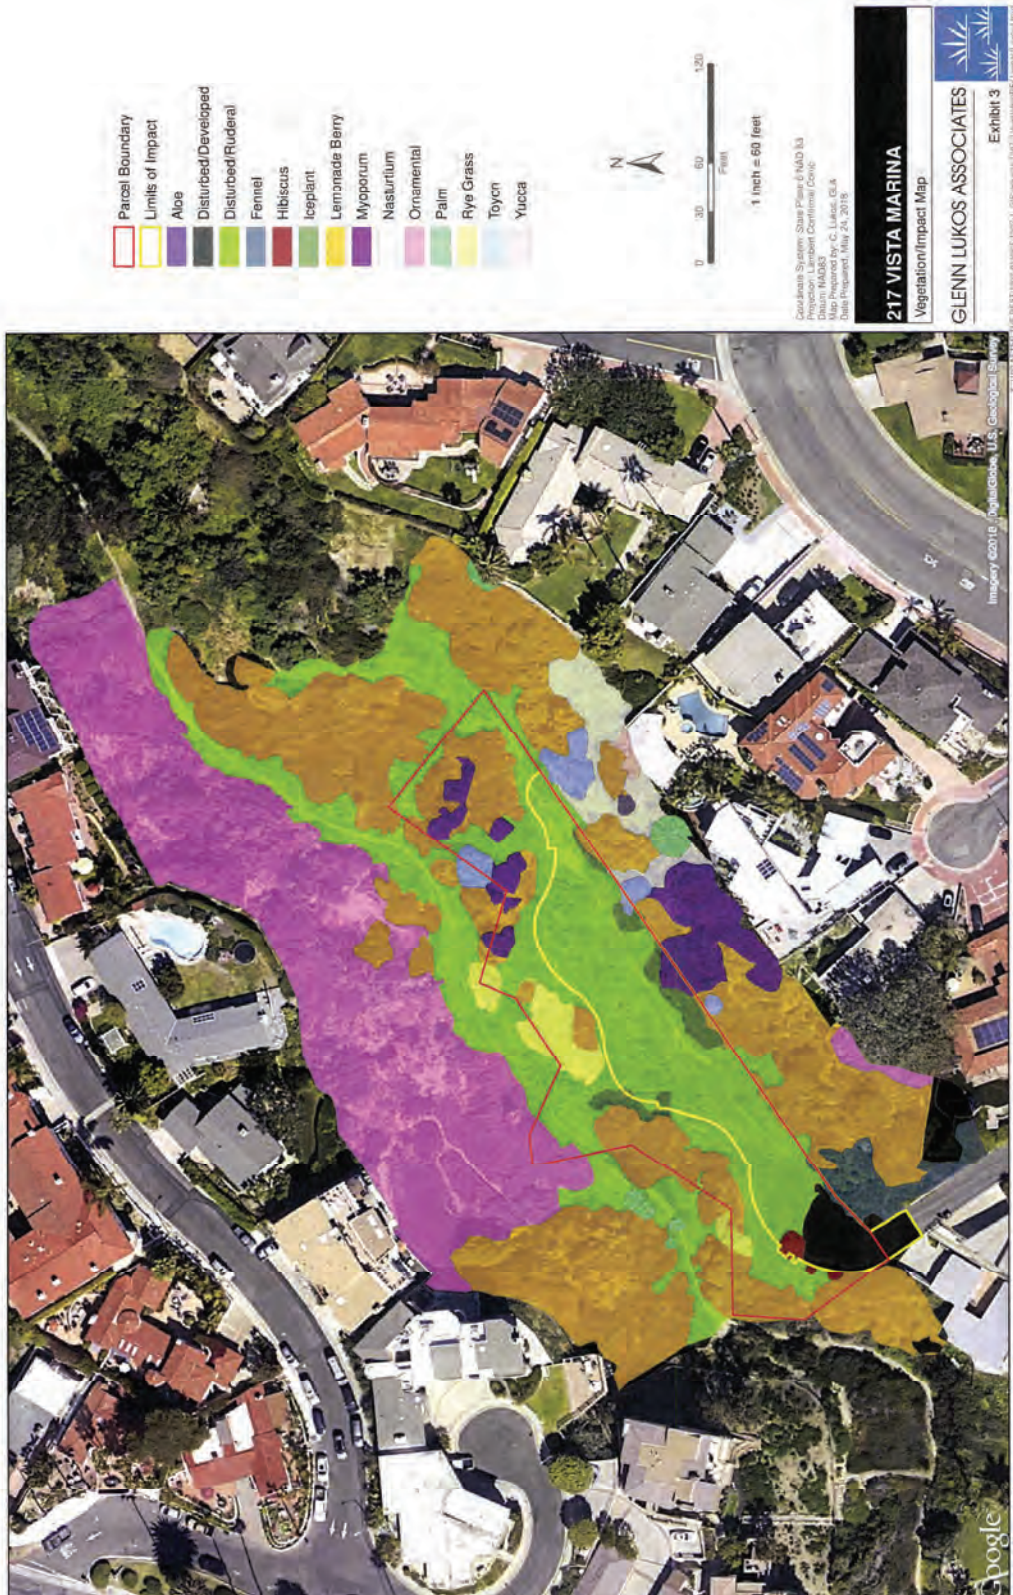
Figure 2. Exhibit 3, "Vegetation/Impact Map" from GLA's 2018 'Biological Technical Report, 217 Vista Marina, City of San Clemente, Orange County, California'.

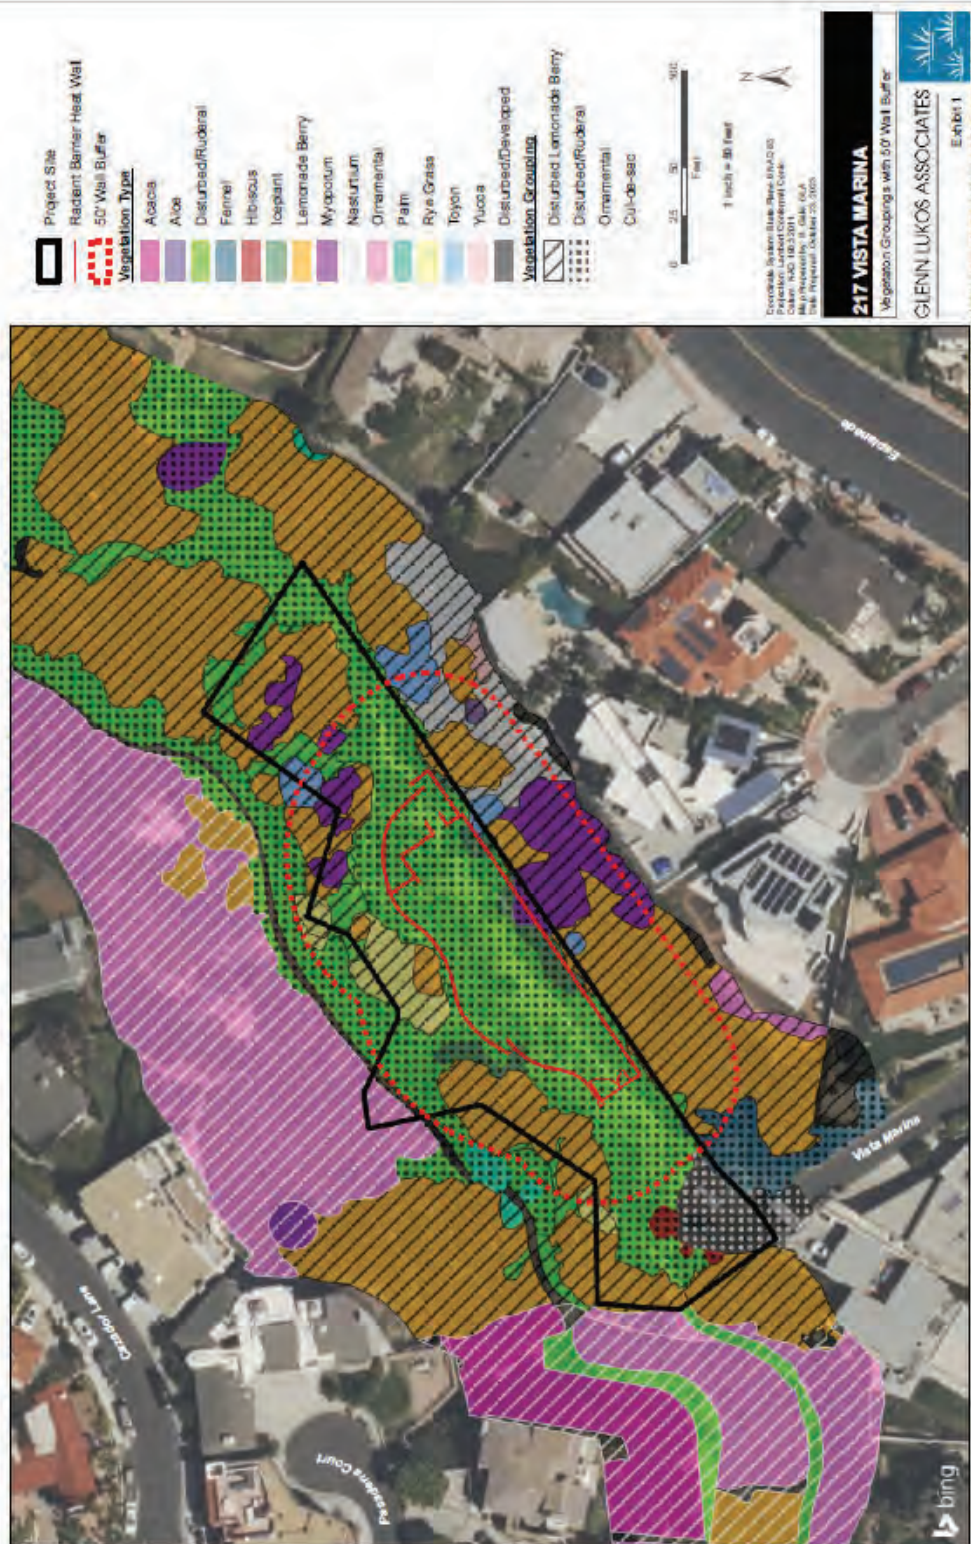
Figure 3. Exhibit 1, "Vegetation Groupings with 50' Wall Buffer" from GLA's 2023 Technical Memorandum 'Additional Considerations Regarding Vegetation Alliances at 217 Vista Marina, San Clemente'.

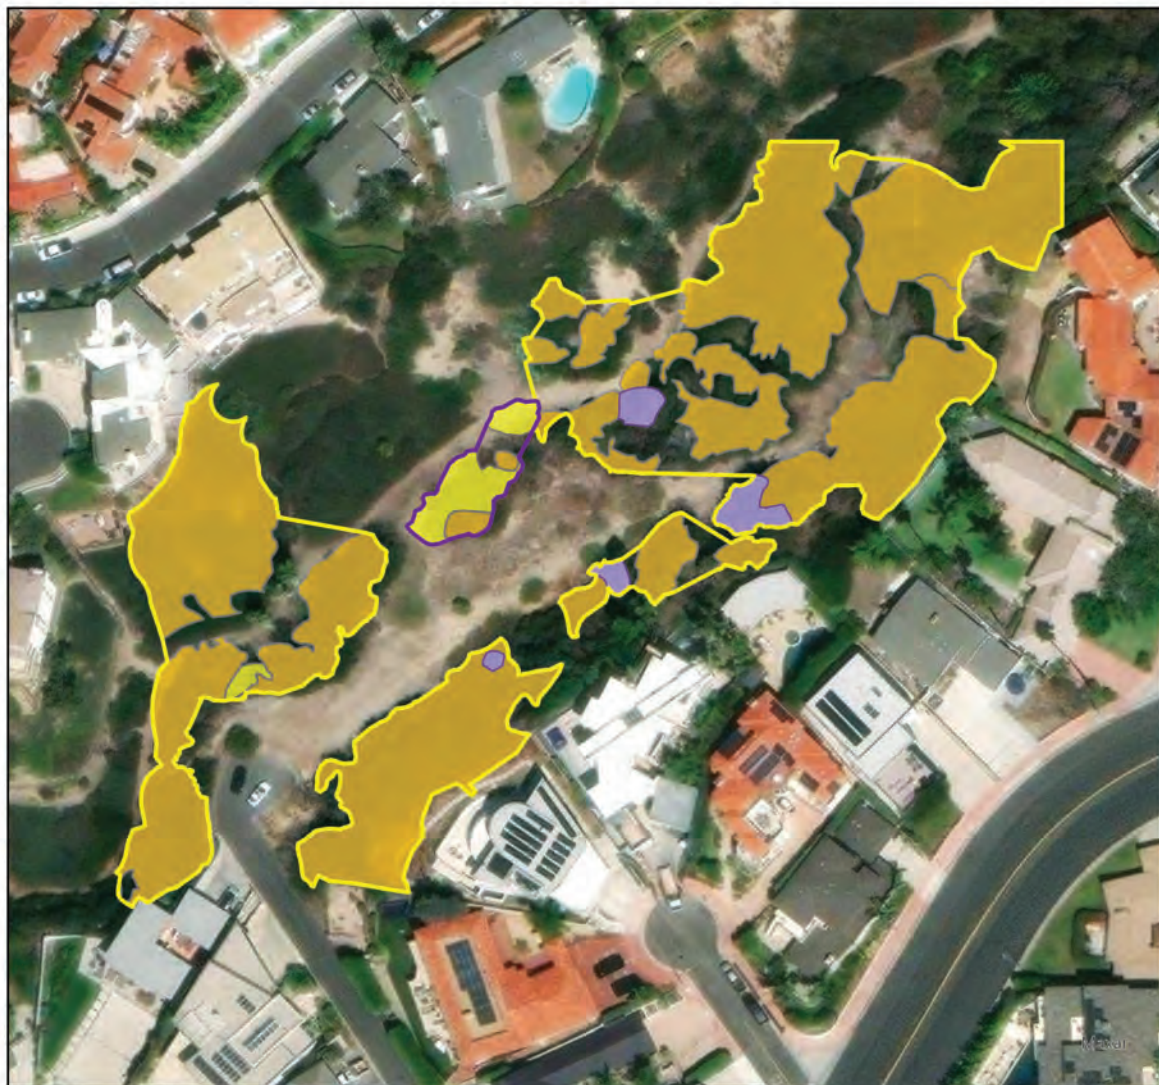
ESHA On and Surrounding 217 Vista Marina, San Clemente

- Giant Wild Rye Grassland ESHA
- Lemonade Berry Scrub ESHA Stand
- Toyon
- Giant Wild Rye Grass
- Lemonade Berry Scrub

Figure 4. *Rhus integrifolia* Shrubland Alliance (Lemonade berry scrub) and *Leymus condensatus* Herbaceous Alliance (Giant wild rye grassland) ESHA stands.

The *Leymus condensatus* Herbaceous Alliance, commonly known as Giant Wild Rye Grassland, also has a rarity ranking of G3 S3. The Commission's Enforcement Unit found that patches of giant wild rye grass were cleared as part of the City's annual vegetation maintenance on the relatively flat pad but other patches occurred on the slopes and amongst the scrub vegetation. The one remaining patch of Giant Wild Rye Grassland I delineated meets the CDFW/CNPS definition and characteristics of a stand (Figure 4).

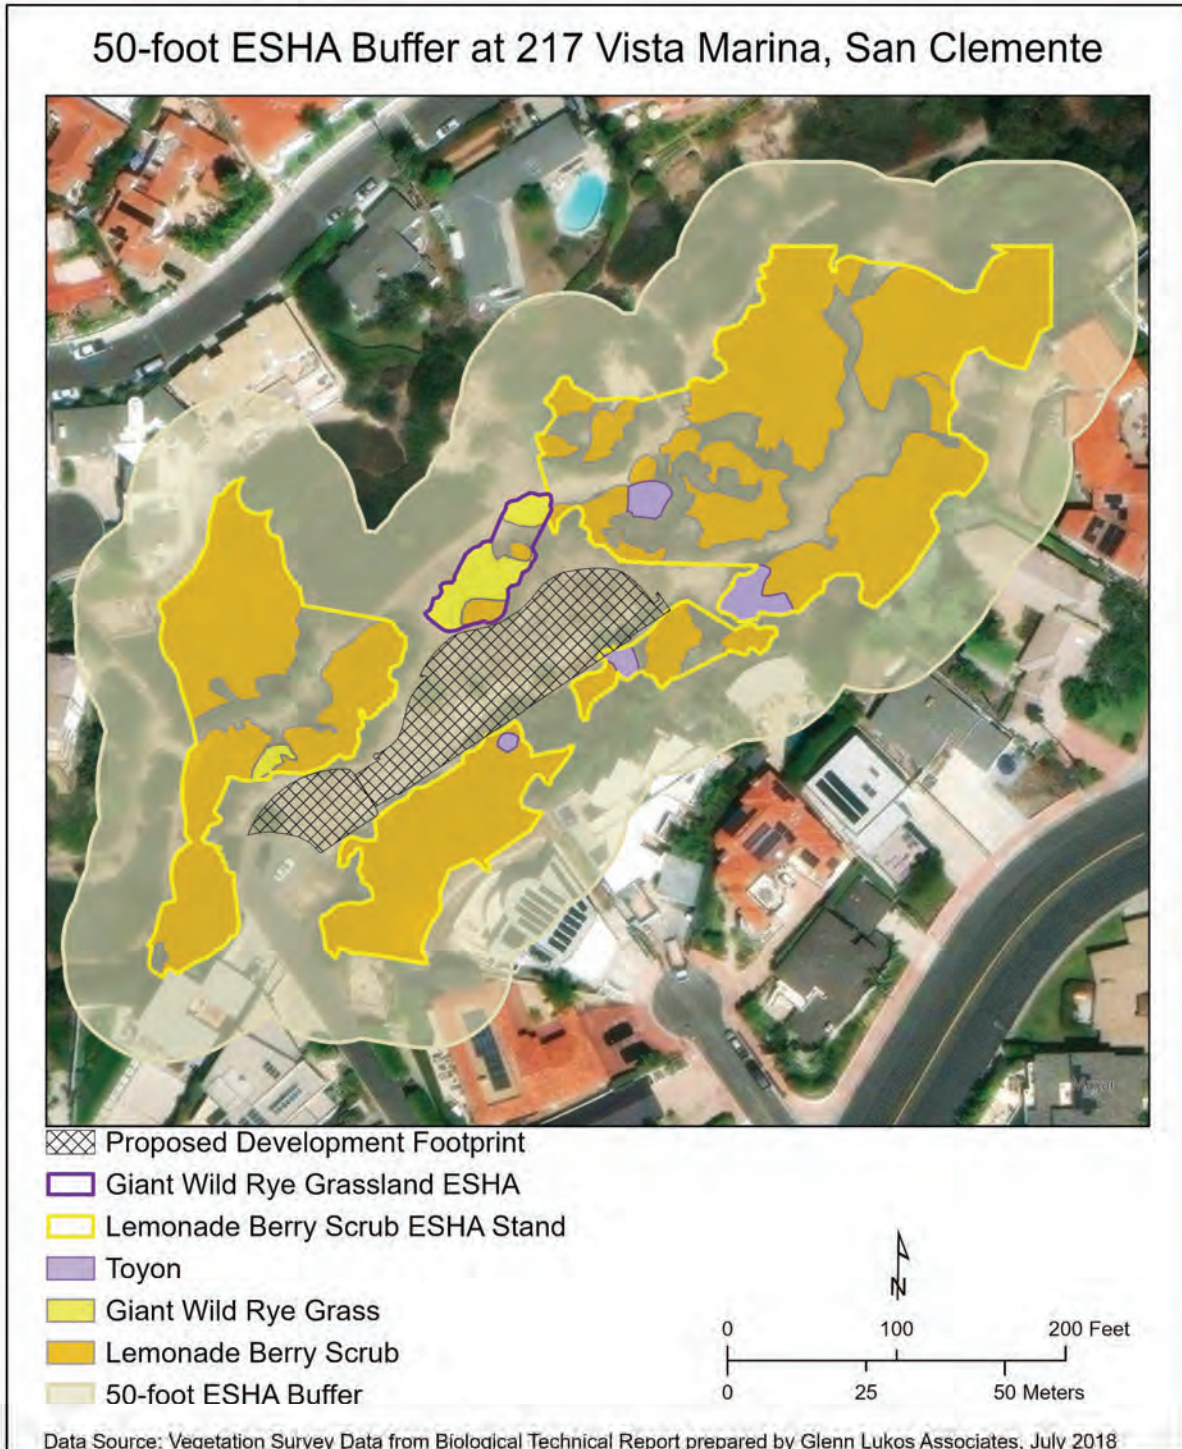
Figure 5. *Rhus integrifolia* Shrubland Alliance (Lemonade berry scrub) and *Leymus condensatus* Herbaceous Alliance (Giant wild rye grassland) ESHA stands protected by 50-foot buffers.

While the San Clemente LUP buffer policy calls for a 100-foot buffer, I find that a 50-foot buffer, along with a 6-foot fire wall surrounding the development, would prevent impacts that would significantly degrade or disrupt the biological integrity and habitat values of the ESHA on this site. In the discussion above I lay out the rationale for buffers between ESHA and development and all the potential adverse activities they provide protection against. Although the wall provides some additional buffering, it is limited by the fact that the development towers over the wall, allowing some of the impacts of typical residential development, such as light and noise, to flow freely beyond the wall. Thus, the buffer should not be reduced dramatically from 100 feet. It is my professional opinion, given the subject site characteristics, that the 50-foot buffer I am recommending, in combination with a 6-foot wall, will provide a sufficient distance between proposed development and ESHA for “business as usual” activities such as native vegetation reproduction and growth, insect pollination, and other animal activities such as nesting, foraging, dispersing, and mating (Figure 5).

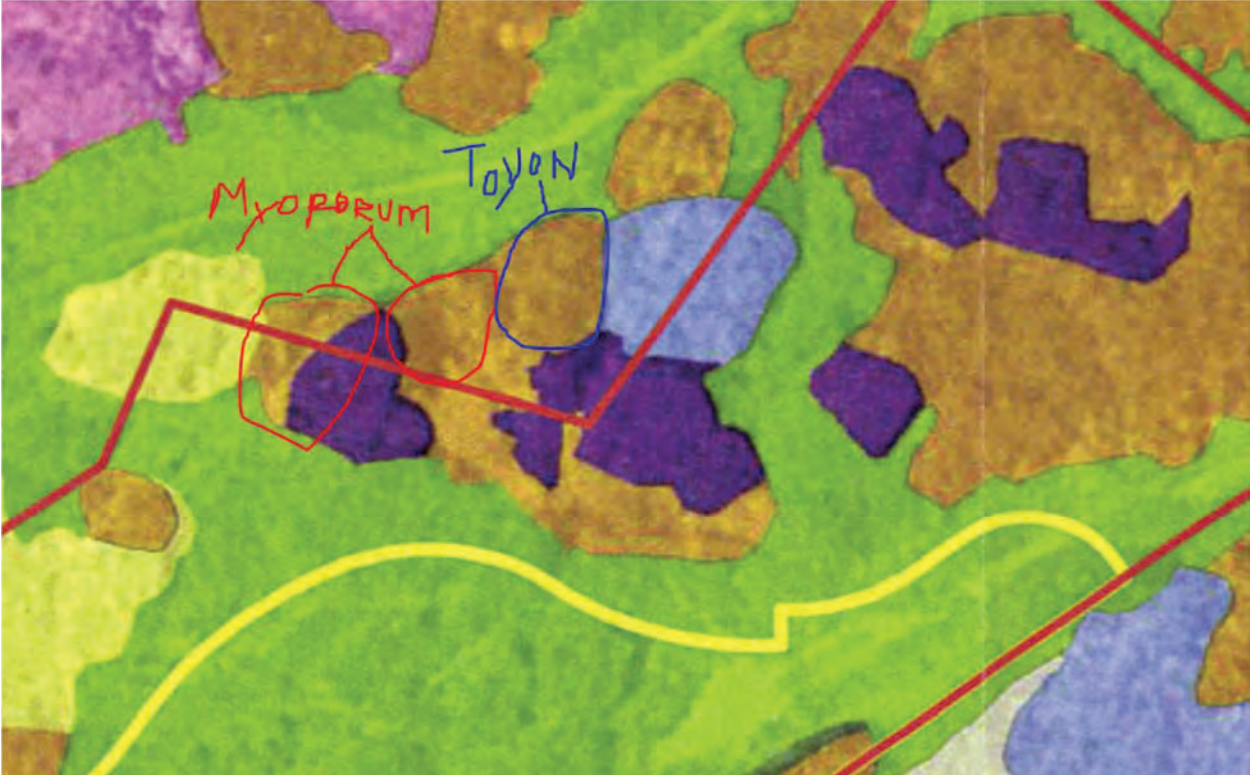
Figure 6. Image from Mr. Bomkamp's Dec. 20, 2023 letter report identifying myoporum within the lemonade berry scrub originally identified as lemonade berry.

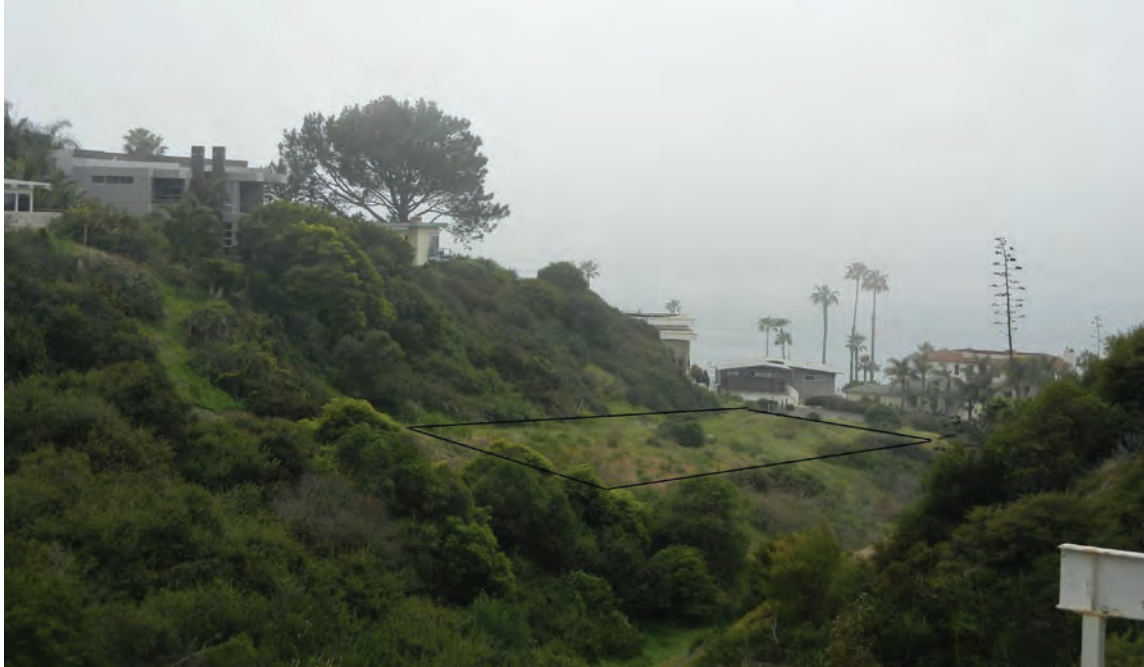
Figure 1a. Photo showing the topography and vegetation of the area and the portion of the site cleared annually by the black rectangle.

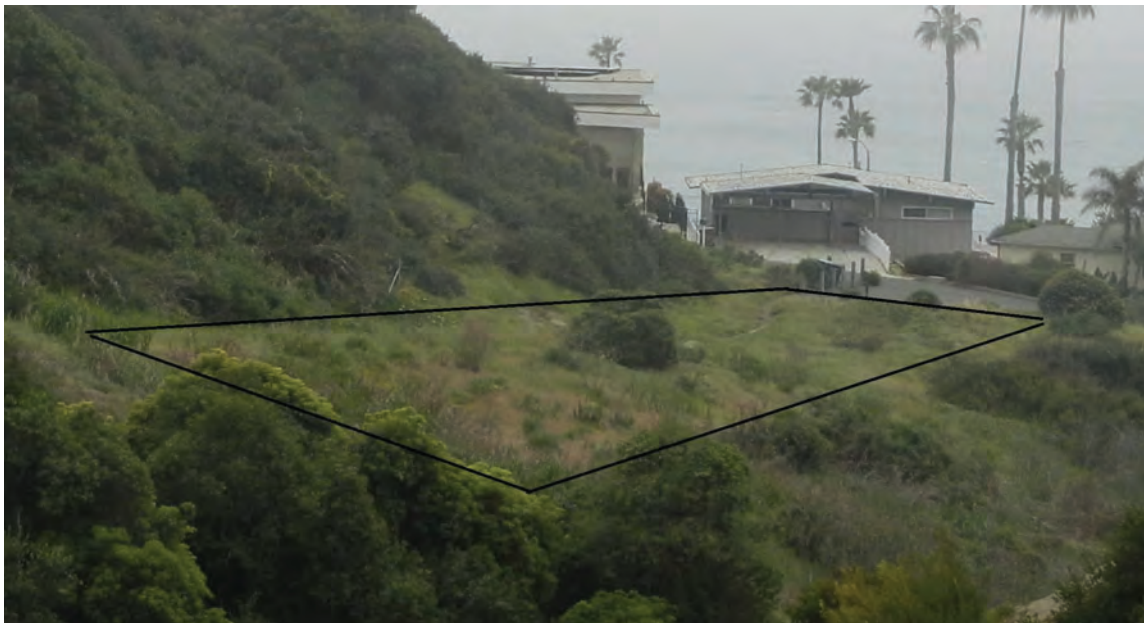
Figure 1b. Close up of the cleared area showing giant wild rye along the northern edge of the property (along edge of black rectangle) and into the canyon and a myoporum bush along the center of the east side of the black rectangle.

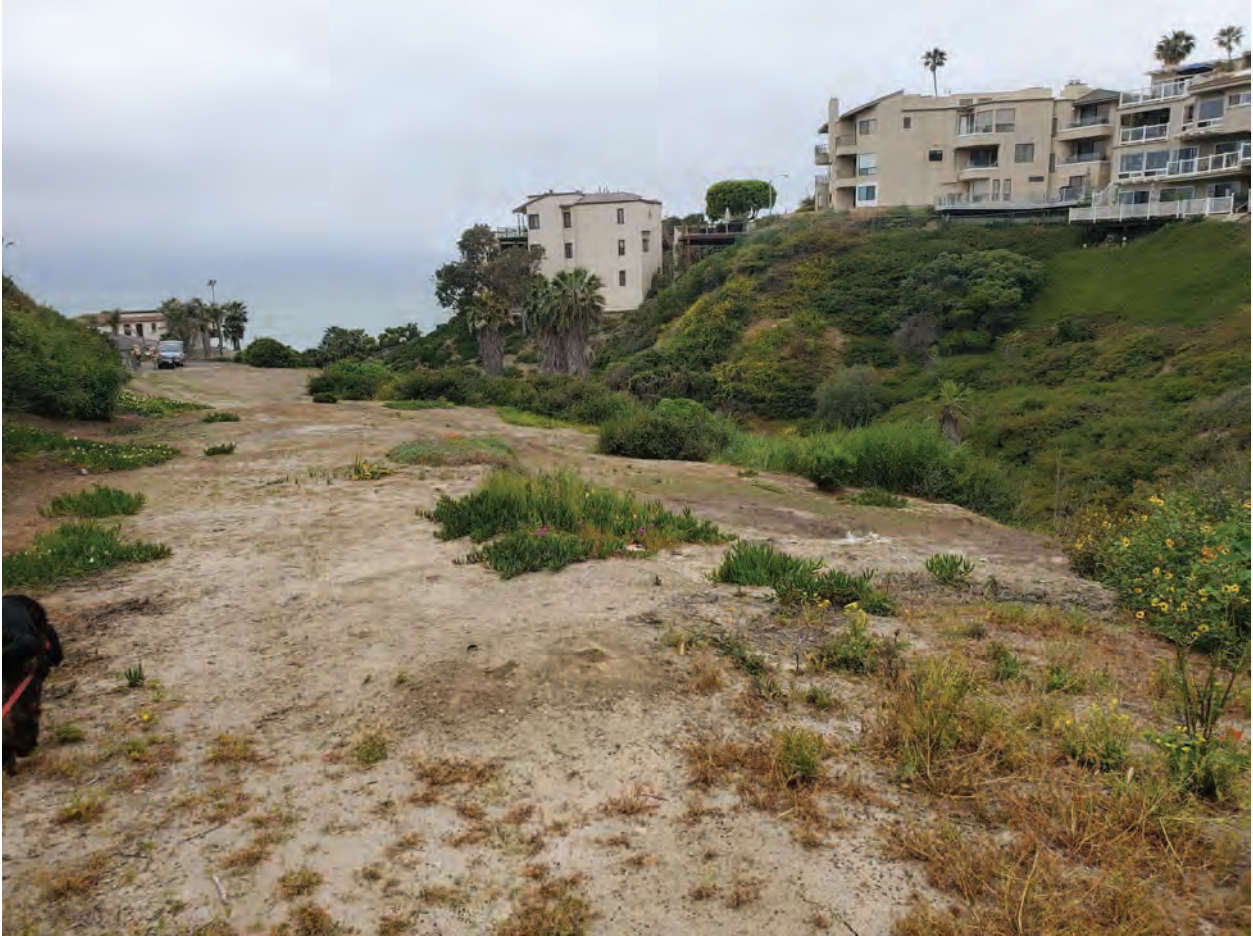
Figure 1d. Photo of the cleared area of the site with a California sunflower bush (*Encelia californica*) in the bottom left of the photo and giant wild rye grass growing out of the patch of iceplant in the center of the photo.

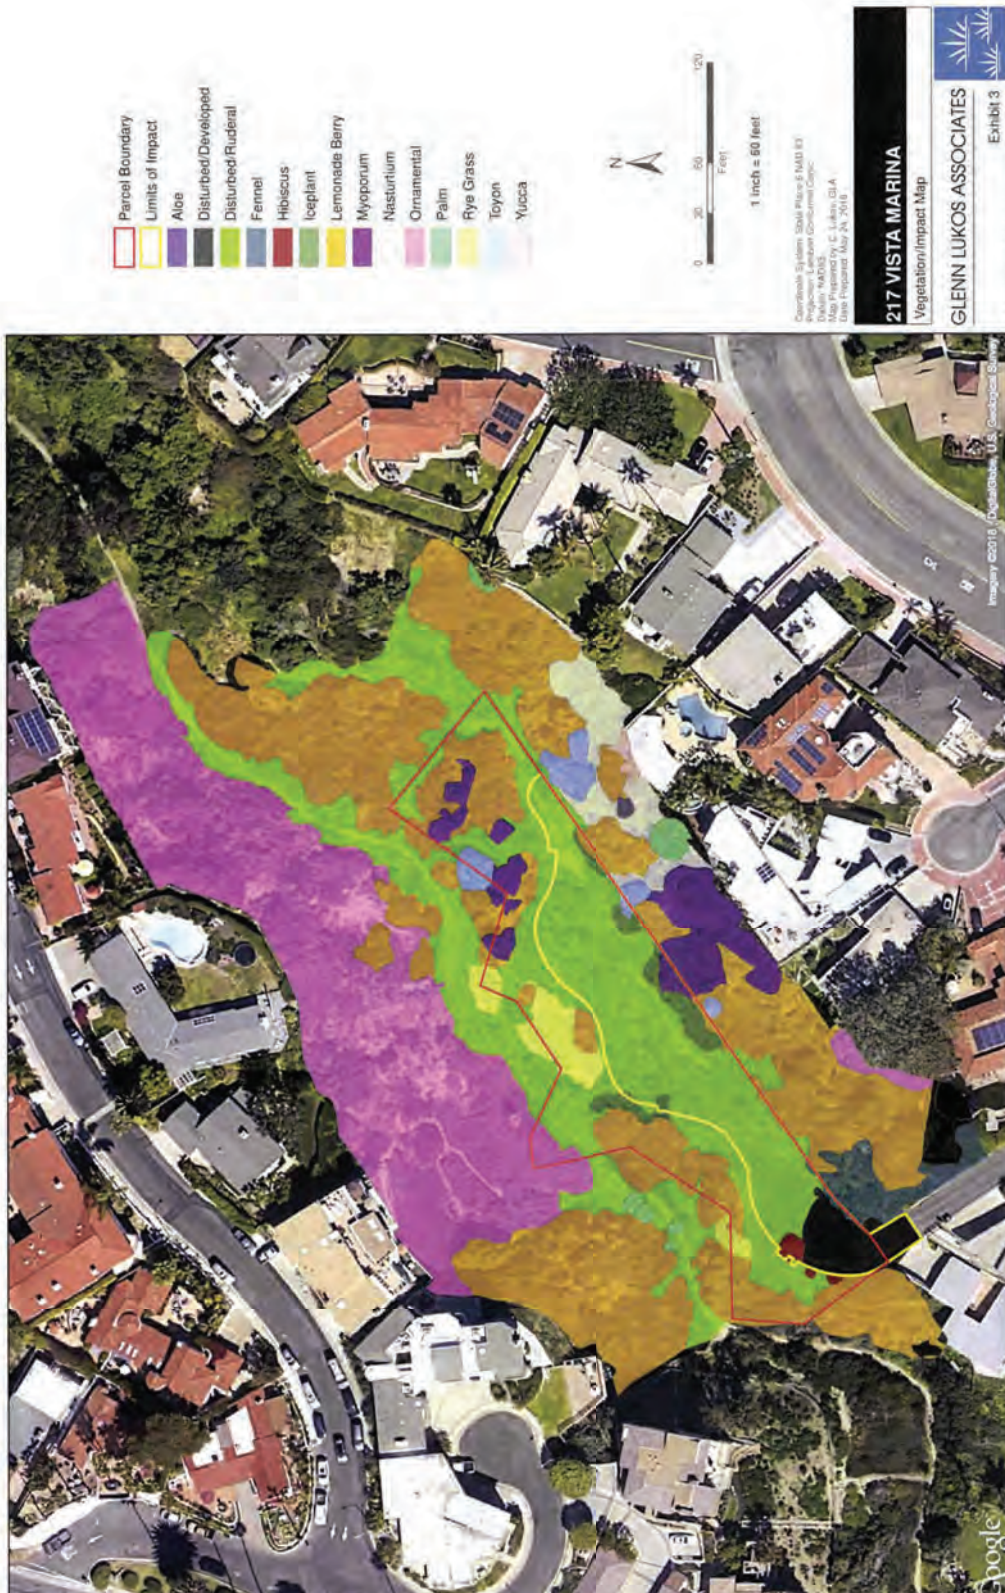
Figure 2. Exhibit 3, "Vegetation/Impact Map" from GLA's 2018 'Biological Technical Report, 217 Vista Marina, City of San Clemente, Orange County, California'.

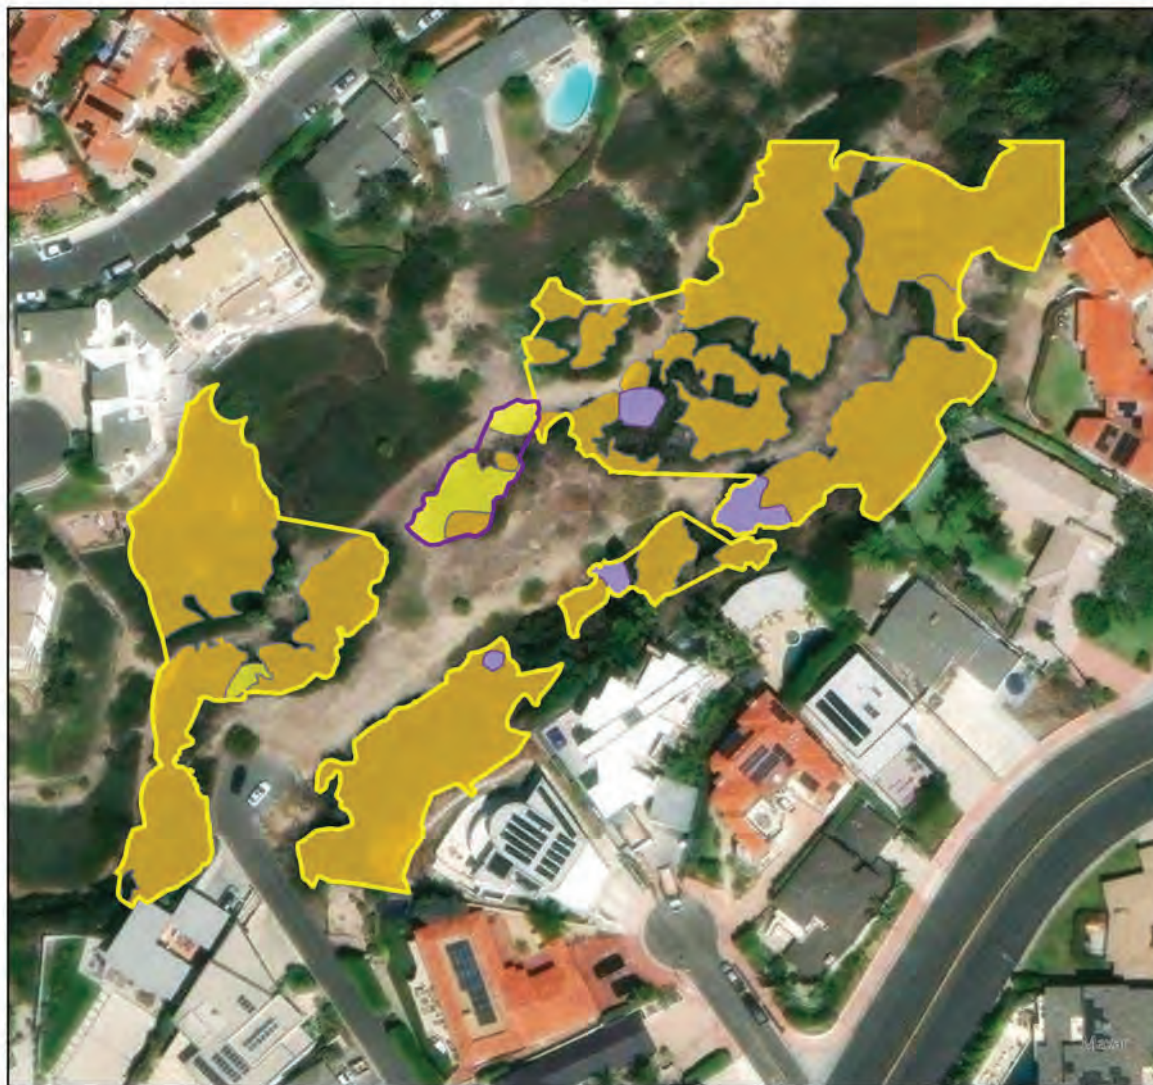
ESHA On and Surrounding 217 Vista Marina, San Clemente

Figure 4. *Rhus integrifolia* Shrubland Alliance (Lemonade berry scrub) and *Leymus condensatus* Herbaceous Alliance (Giant wild rye grassland) ESHA stands.

The *Leymus condensatus* Herbaceous Alliance, commonly known as giant wild rye grassland, also has a rarity ranking of G3 S3. The Commission's enforcement group found that giant wild rye grassland patches were cleared as part of the City's annual vegetation maintenance on the relatively flat pad but other patches occurred on the slopes and amongst the scrub vegetation. The one remaining patch of giant wild rye grassland I delineated meets the CDFW/CNPS definition and characteristics of a stand (Figure 4).

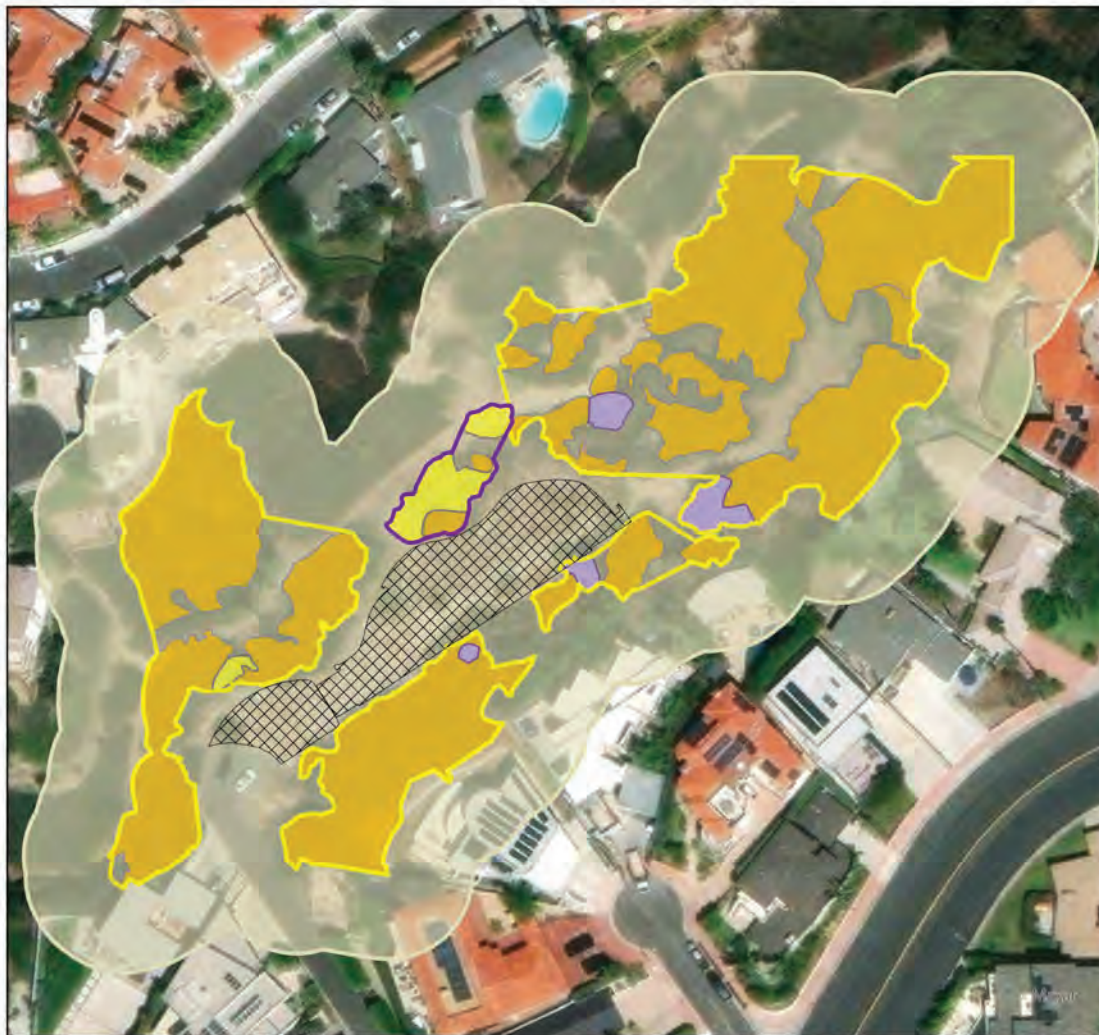
50-foot ESHA Buffer at 217 Vista Marina, San Clemente

- ▨ Proposed Development Footprint
- ▭ Giant Wild Rye Grassland ESHA
- ▭ Lemonade Berry Scrub ESHA Stand
- ▭ Toyon
- ▭ Giant Wild Rye Grass
- ▭ Lemonade Berry Scrub
- ▭ 50-foot ESHA Buffer

While the San Clemente LUP buffer policy calls for a 100-foot buffer, I find that a 50-foot buffer, along with a 6-foot fire wall surrounding the development, would prevent impacts that would significantly degrade or disrupt the biological integrity and habitat values of the ESHA on this site. In the discussion above I lay out the rationale for buffers between ESHA and development and all the potential adverse activities they provide protection against. Although the wall provides some additional buffering, it is limited by the fact that the development towers over the wall, allowing some of the impacts of typical residential development, such as light and noise, to flow freely beyond the wall. Thus, the buffer should not be reduced dramatically from 100 feet. It is my professional opinion, given the subject site characteristics, that the 50-foot buffer I am recommending, in combination with a 6-foot wall, will provide a sufficient distance between proposed development and ESHA for "business as usual" activities such as native vegetation reproduction and growth, insect pollination, and other animal activities such as nesting, foraging, dispersing, and mating (Figure 5).

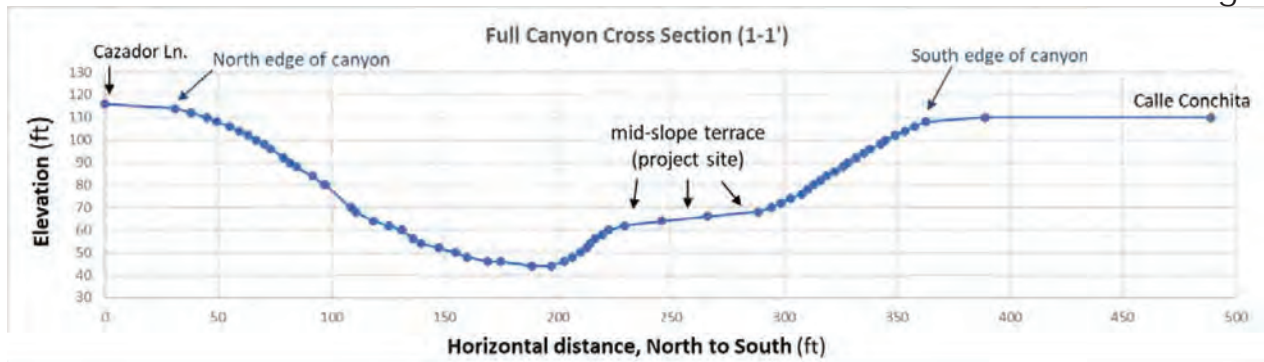
Figure A: Canyon cross-section (see **Fig. 2** for location)

As can be seen in cross-section (**Fig. A**, above; also Fig. 1), moving northward from the top of the canyon (i.e., near Calle Conchita) the gradient increases quickly and ‘more or less continuously’ until it reaches the gradient of the upper slope, which matches or exceeds the general gradient of the canyon. Obviously, the gradient of the terrace on which the project would be located is much less, but I view this as a temporary hiatus or variation in the “general gradient of the canyon” rather than an indication that the terrace somehow lies outside the boundaries of the canyon. The terrace could be considered a “step” or “riser” under the LUP and Commission definitions, but it is located closer to the bottom of the canyon slope than the “top of the canyon face”, and my recommended canyon edge determination is not dependent on this part of the definition language.

In each of these representations of the site, the geomorphic canyon edge, and the “canyon edge” that best fits the definition contained in the City LUP, is located at the top of the 30- to 40-foot-high slope immediately behind and to the south of the proposed building site, at elevations of approximately 100 to 110 feet (**Figs. A, 1-2**). This is the “upper termination” of the canyon landform, and to the extent that this top of slope is “rounded away from the canyon face”, it is still “the point nearest the canyon beyond which the downward gradient of the surface increases more or less continuously until it reaches the general gradient of the canyon.” Measured from top-to-bottom, the average gradient of the southern slope of the canyon is approximately 2.5:1 (horizontal to vertical; h:v); excluding the mid-slope terrace, the slopes both above (south of) and below (north of) the terrace have gradients of 2:1 or greater.
