## COAL MINING EQUIPMENT VIBRATION ANALYSIS RESULTS OF ELEVEN YEARS SHOP TESTING

**Ken Singleton**

**KSC Consulting LLC, Bristol VA**

**Abstract:** Rotating equipment used in underground coal mining such as stage loaders, crushers and conveyer power units are exposed to severe operating conditions. The conditions for the equipment are much different than for rotating equipment used in above ground plants such as petro-chemical, refineries, power houses, paper mills, etc. Above ground, critical rotating equipment is typically mounted on thick sole plates grouted to concrete foundations. Equipment may also be mounted on building structural steel using isolated inertial bases or vibration isolators. Underground, stage loaders, crushers, motors, gearboxes and fluid couplings of conveyer power units are mounted in steel frames which are sitting on the floor of the mine. In some mines, the equipment may even operate partially submerged in mud.

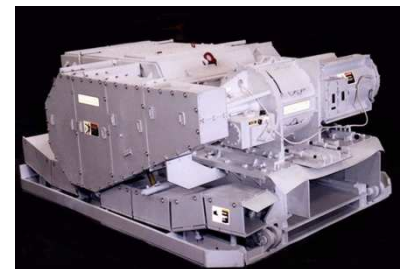
Figure 3. Coal Crusher, Belt Driven.

**Crusher:** High speed crushers, see **Figure 3**, typically have two hammers in four rows. The crusher frame is fabricated from heavy steel plate. The crushers handle lump coal and oversize rock, crushing the material into small particles for easier conveying and improves system productivity. The crushers are typically of two designs, 1)

crusher shaft belt driven or 2) crusher shaft driven by a right angle gearbox, fluid coupling and motor. Motor size is typically 300 HP.

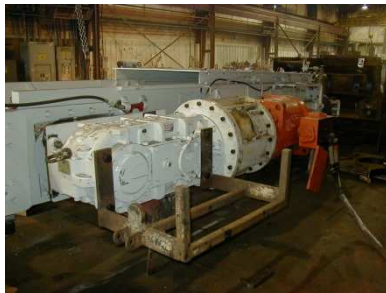
Figure 5. Stageloader.

**Stageloader:** A stage loader or beam stage loader (BSL) is a chain conveyor that transports coal cut by the shearer from the shearer's armored face conveyor (AFC) to a main belt conveyor, see **Figure 4**. The crusher is incorporated into the stage loader's design.

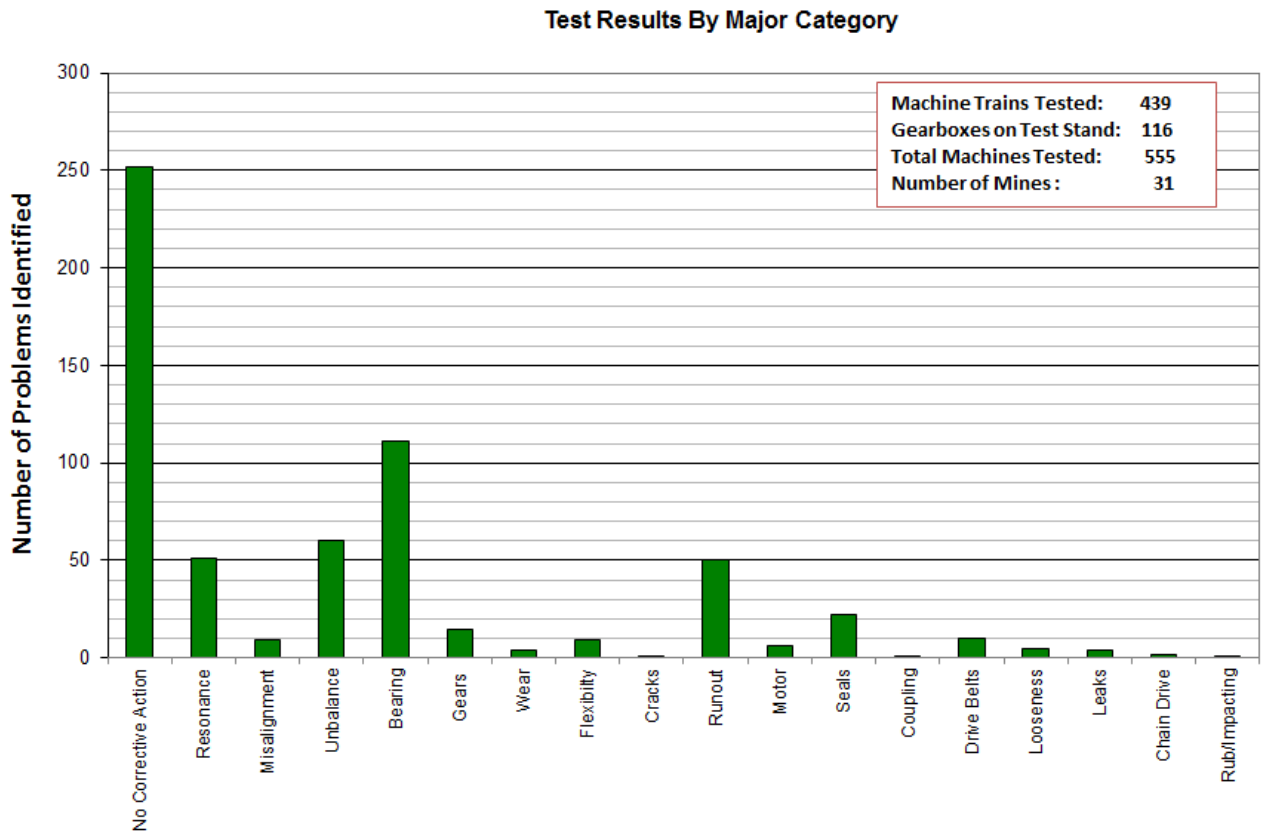
Figure 6. Chart of Problem Major Category.

The problems identified during the equipment test runs were grouped in major categories such as No Corrective Action, Bearings, Unbalance, Resonance, Seals, etc., see chart in **Figure 6**. The major categories were then sub-divided, for example, the Unbalance Category was sub-divided into unbalance resulting from:

**1. No Corrective Actions:** Of the 555 machines tested, no recommendations for corrective actions were made for 45%. This does not mean vibration amplitudes were always in the acceptable range. Some of the equipment, especially crushers, had motor mounting design issues which resulted in very high amplitude vibration. However, the scope of work for the repair facility may be weld repair of the hammers, replacement of bearings and seals but no work on the motor mounting design. In this situation, based on the information provided by the client no recommendations would be made for corrective actions.

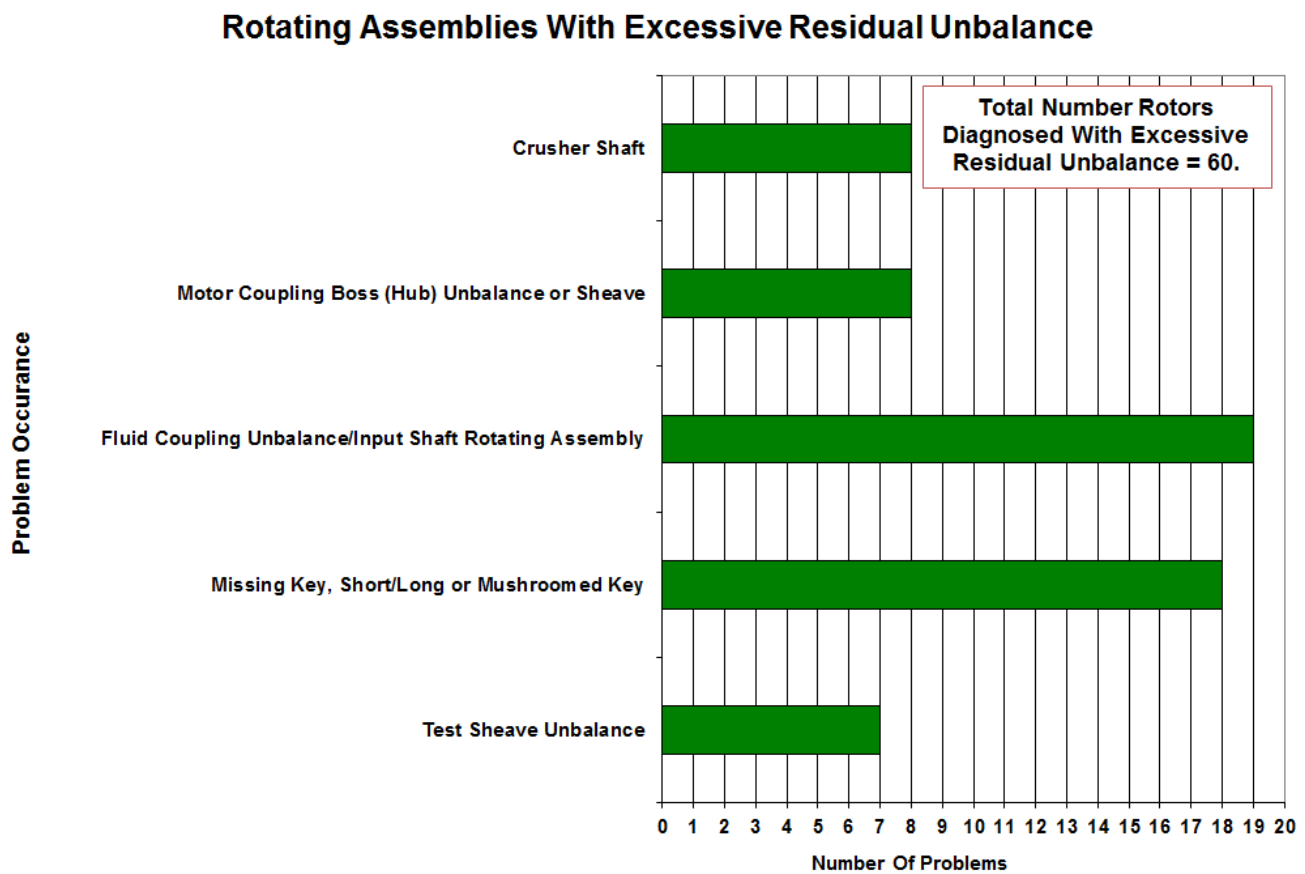
**Figure 8. Unbalance Category Distribution.**

**3. Unbalance:** Excessive residual unbalance was the 2<sup>nd</sup> most frequently identified problem with 60 occurrences documented. The distribution of unbalance is shown in **Figure 8**. Fluid coupling and gearbox input shaft rotating assembly unbalance was the most common. The gearbox input shaft rotating assembly includes the input shaft and the output section of the fluid coupling. Excessive vibration at 1X the gearbox input shaft rotating assembly can result from unbalance of the fluid coupling, coupling eccentricity to the shaft fit, bent input shaft, fluid coupling cocked on the shaft fit, coupling hub eccentricity, long/short keys, etc.

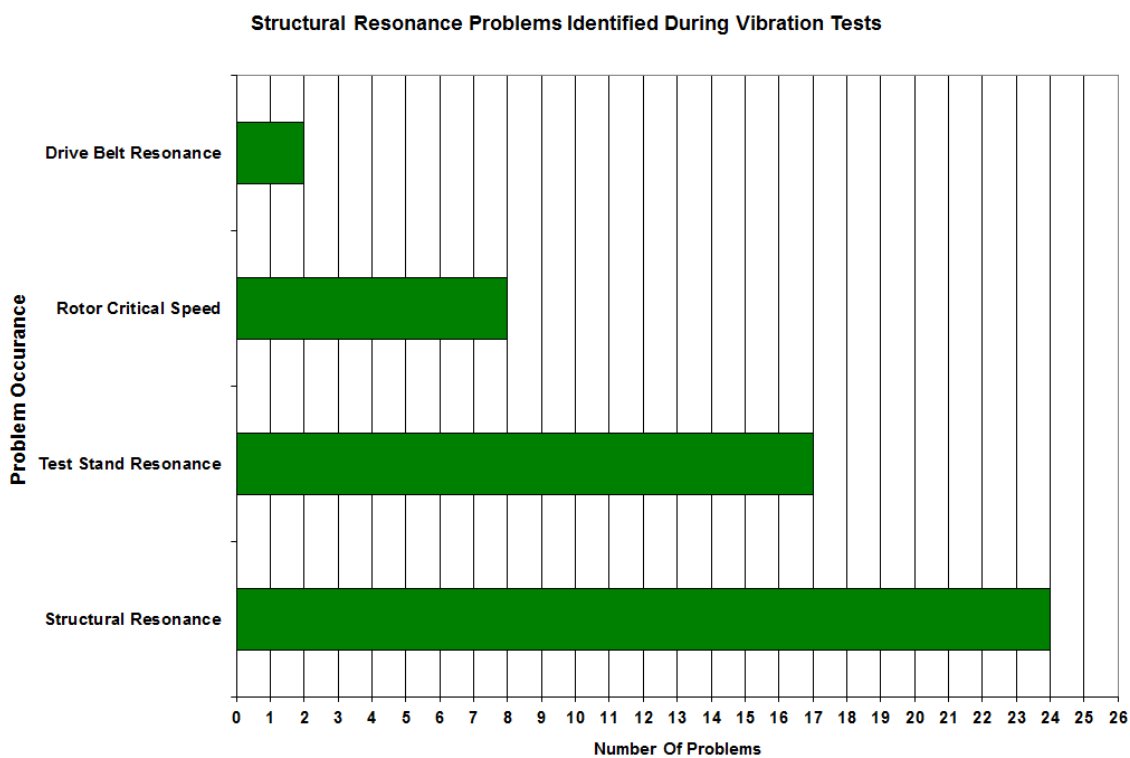
**Figure 9. Resonance Category.**

**4. Resonance:** Resonance (excited natural frequency) was the 3<sup>rd</sup> most commonly identified problem with 51 occurrences, see distribution in **Figure 9**. Structural resonance was the most common and included motor mounting resonance on crushers, crusher motor support plate resonance, power unit (motor-fluid coupling housing-gearbox) flexural mode resonance, etc. The test stand resonance at gearbox input shaft speed was documented for certain size gearboxes.

The Rotor Critical Speed category was a very interesting problem area. The gearbox input shaft rotating assembly of several manufactures gearboxes operated near the 1<sup>st</sup> critical speed. Rotor modeling and modal analysis were used to investigate this problem. A case study is provided in this article.

Crusher drive belt resonance was only documented twice. The belt 2X RPM aligned with 1X the crusher shaft sheave rotational frequency exciting the belt resonance.

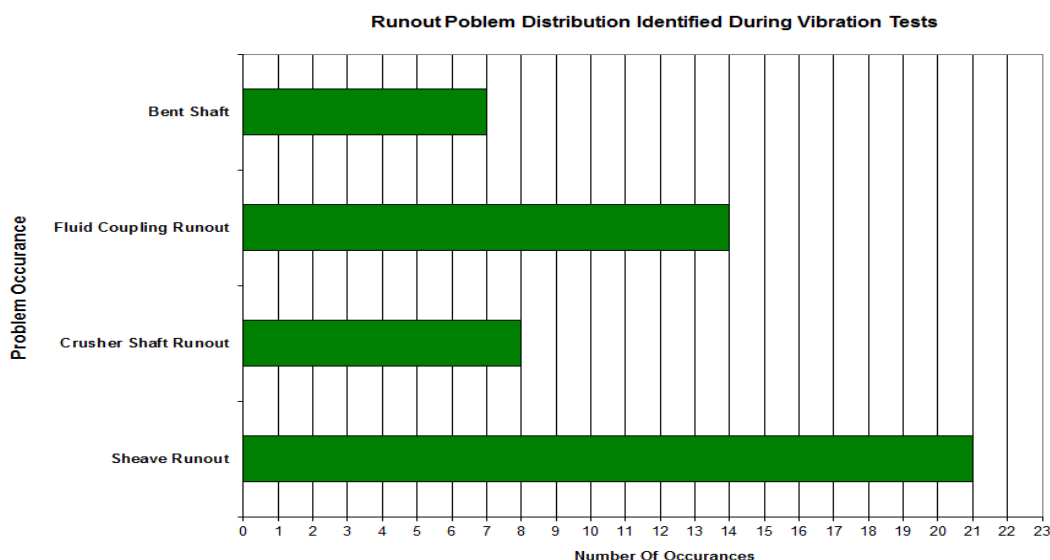
**Figure 11. Runout Category.**

**5. Runout:** Excessive runout was the 4<sup>th</sup> most identified problem as show by the chart in **Figure 11**. The most frequently identified component with excessive runout was belt sheaves on either the motors or crusher shafts. Crusher sheave runout is indicated by the vibration data when motor vibration is primarily at the rotational frequency of the crusher shaft. Vibration at 1X the crusher shaft rotational frequency was elevated especially if the shaft was bent. Due to the environment in the mines, damage to the crusher sheave belt grooves frequently occurs; see the example in **Figure 10**. Since the sheaves, which also act as fly wheels) are at the edge of the crusher frame, the crusher shaft may be bent during movement in the mine if the crusher sheaves contacts the mine wall.

Excessive fluid coupling runout can generate vibration either at the drive end (motor rotational frequency) or output end (gearbox input shaft rotational frequency). The process of dial indicating the motor-fluid coupling rotating assembly and the gearbox input-shaft rotating assembly is described in this article in the case study – Fluid Coupling In-Situ Balancing. Since the fluid coupling input/output sections rotate at different RPM on their internal bearings, several problems can cause excessive fluid coupling runout and vibration as follows:

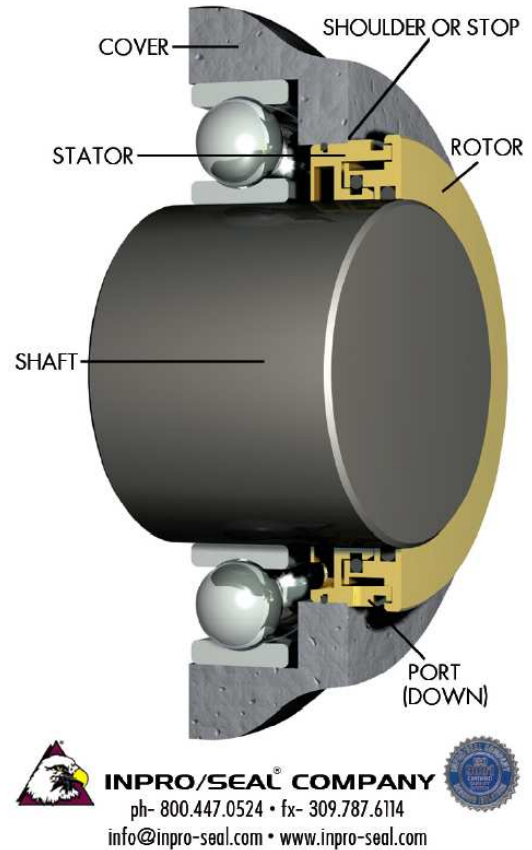
**Figure 12. Inpro-Seal Illustration.**<sup>Ref 7</sup>

**6. Seals:** Seal rubs were the 5<sup>th</sup> most identified problem, documented 22 times. Rubs were identified by vibration data (Peakvue is very sensitive to rubbing), as well as audible squealing. Inpro-Seals are typically used in Reliance motors and some crusher bearing housings. The motor belt-drive setup on crushers requires belt tension over 2000 lb<sub>f</sub>. This high load on the end of the motor shaft causes deflection and can result in the seal rubbing if there is not adequate clearance between the seal rotor and seal stator, see **Figure 12**. Although the seals are advertised as non-contacting, internal clearances are small. Reliance was responsive in increasing clearance of the Inpro-Seals used in their motors for crusher application to reduce or eliminate the rubbing problem.

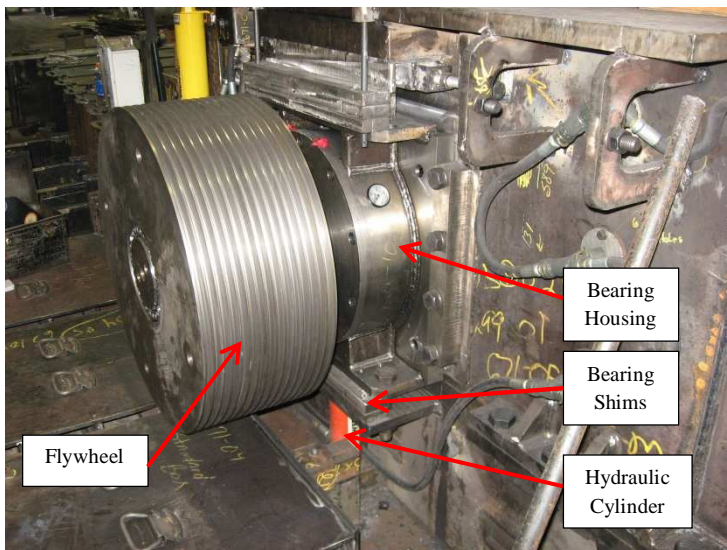
**Figure 13. Crusher Drive End Bearing Showing Hydraulic Cylinder and Bearing Vertical Height Adjustment Shims.**

The crusher bearing housings are adjustable vertically using hydraulic cylinders and steel shims, see **Figure 13**. If the bearing housing guides are not perpendicular, an axial force on the seal can result in rubbing. If the crusher bearing housings are not accurately aligned in the horizontal plane so that the shaft is perpendicular to the bearing housings this can also result in the seal stator and seal rotor rubbing. The rubbing produces audible squealing and sometimes smoke. This is not necessarily a seal problem but a shaft to bearing housing alignment issue.

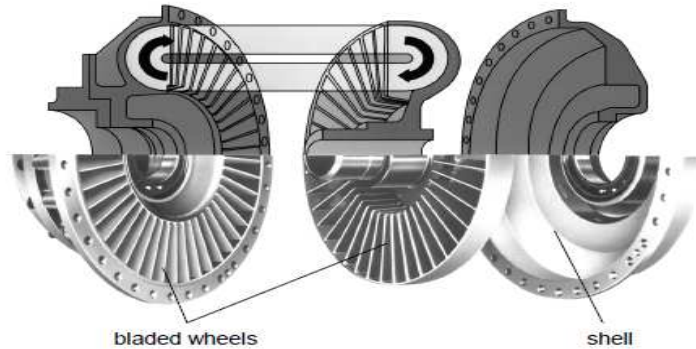
**Figure 16. Voith Fluid Coupling Showing Pump Section and Turbine Section.** <sup>Ref 4</sup>

The Voith turbo coupling<sup>Ref 4</sup> is a hydrodynamic coupling that works on the Föttinger principle. The main components consist of two bladed wheels, the pump impeller and turbine wheel, which are enclosed by a shell, see **Figure 15**. Both wheels are supported on bearings relative to each other. Power is transmitted virtually without wear since there is no mechanical contact between the power-transmitting parts. A constant amount of fluid is in the coupling. Mechanical energy provided by the drive motor is converted to kinetic energy of the operating fluid in the connected pump impeller. In the turbine wheel this kinetic energy is converted back to mechanical energy.

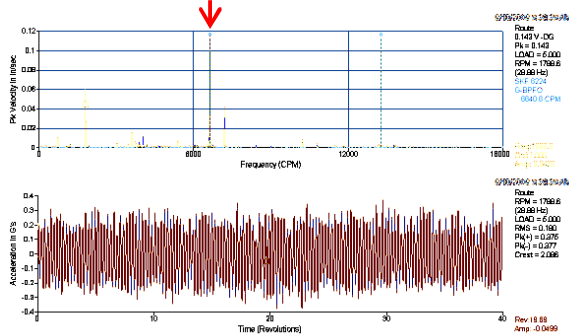
**Figure 19. Motor Opposite Drive End Bearing, SKF 6224 BPFO 0.117 in/sec pk.**

**Case Study: Motor with SKF 6224 Opposite Drive End Bearing False Brinelling.** A motor bearing problem was identified from vibration data measured during an unloaded run test of a Gob Side Tail Drive power unit. The motor was 233/700 HP with ball bearings OB 6224 and IB 6226. Vibration data on the motor OB end showed Brg 6224 BPFO frequency 0.117 in/sec pk, see **Figure 19**. The 6224 BPFO was not present in Peakvue data, see **Figure 20**. Autocorrelation of the vibration time domain data showed the 6224 BPFO, see **Figure 21**. The motor is shown in **Figure 22** during one test supported on rubber belting. The motor shop advised that bearing frequencies were low amplitude before shipment and suspected shipping damage causing either brinelling or false brinelling. The motor was returned to the motor shop, the opposite drive end bearing inspected, confirmed damaged and a new bearing installed. The motor was shipped by truck back to the assembly shop.

The motor shop requested that the motor be tested as received on the shipping crate. The opposite drive end bearing again showed 6224 BPFO in the standard vibration data with amplitude 0.030 in/sec pk. This procedure (returning the motor to OEM) was repeated three times with each test showing BPFO of the outboard bearing in the vibration data. The conclusion was that false brinelling to the outboard bearing was occurring during transport by truck. The inability to lockdown the outboard bearing was allowing the bearing to move axially. Images of the damaged bearings are shown in **Figures 23-27**.

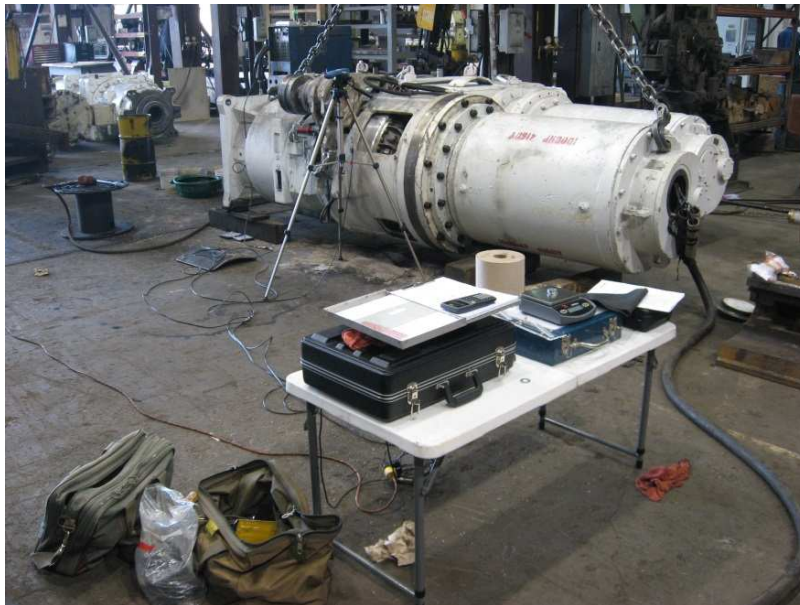
**Figure 28. A Power Unit Setup to Trim Balance The Fluid Coupling In-Situ.**

A power unit consisting of the motor, fluid coupling and 2-stage planetary gearbox is shown in **Figure 27**. A laser tachometer senses reflective tape on the coupling input section, **Figure 28**. The power unit was supported on rubber and wood beams to lower the mounting resonance well below running speed, see **Figure 30**.

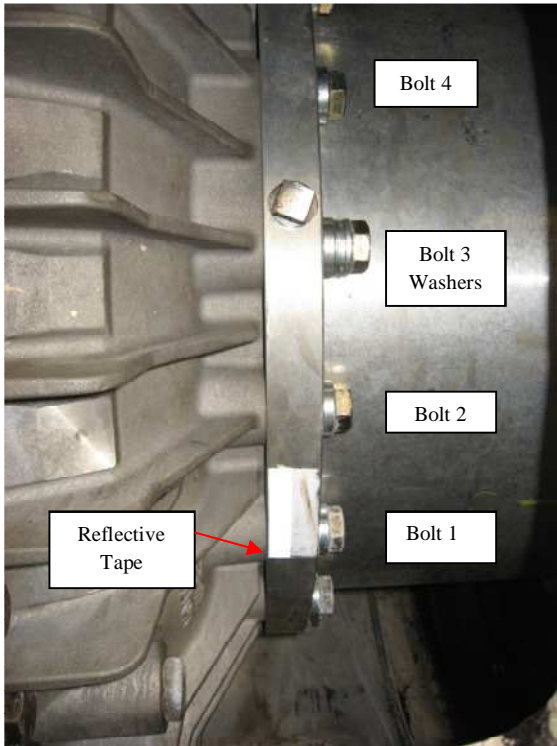
**Photo 29. Reflective Tape Used as Laser Tachometer Trigger. Balance Weights at Bolt #3 (20 Bolts Total).**

Washers were used as balance weights and inserted under the coupling bolt heads #3, #5 and #6 as shown in **Figures 28 & 29**.

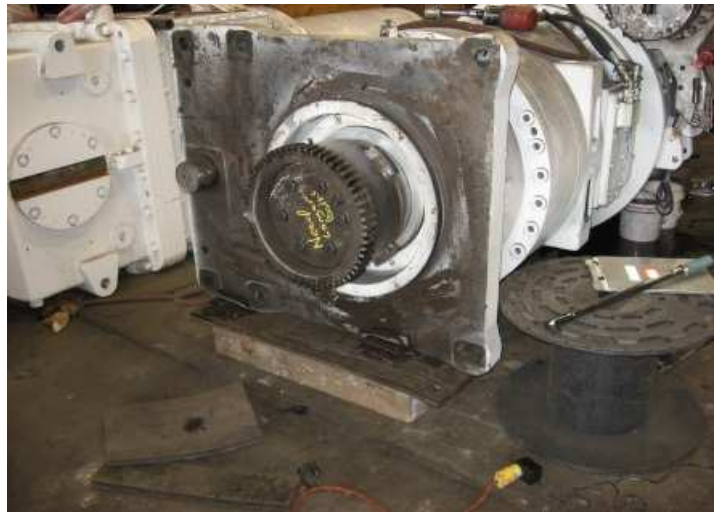
**Figure 31. Two-Stage Planetary Gearbox Supported On Rubber Sheets and Wood Beams to Lower the Mounting Frequency for Balancing.**

- a. Drain about 75% of the fluid from the coupling to achieve at least 40 RPM slip.
- b. Mount the power unit on very soft support so that the mounting natural frequency is very low and does not act to amplify vibration at running speed.
- c. Install reflective tape adjacent to a bolt on the 21.65 inch bolt circle.
- d. Number the bolts against rotation beginning at the reflective tape with #1.
- e. Run the power unit and allow vibration to stabilize. This may require 10 to 15 minutes. Record the initial vibration amplitude and phase lag angle.
- f. Shut the unit down and install a trial weight (one to three washers under one bolt).

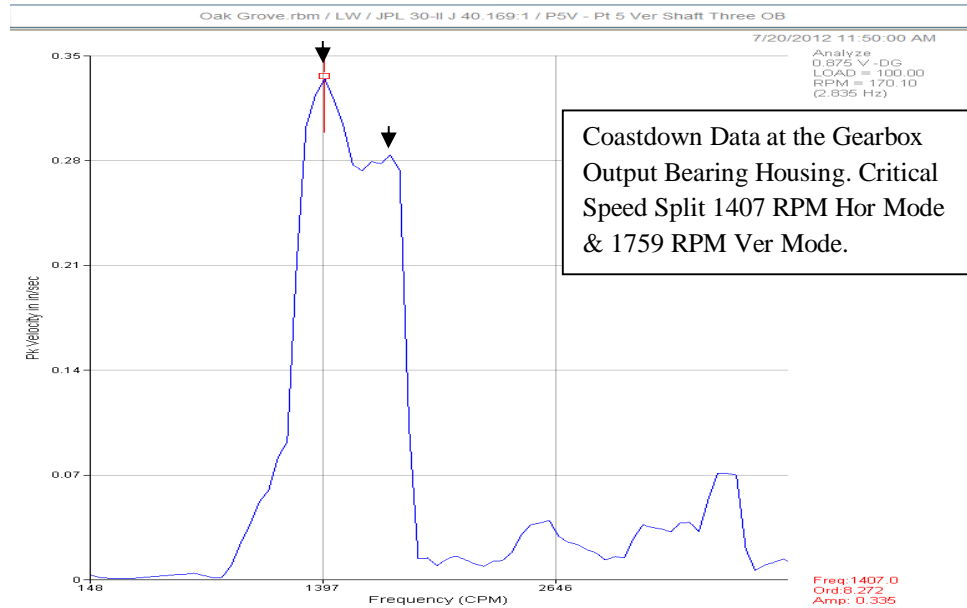
**Figure 32. Frequency Spectrum During Coastdown Showing Two Modes of the 1<sup>st</sup> Critical Speed of Gearbox Input Shaft/Fluid Coupling Rotating Assembly.**

Peak-hold data was measured during coast down to identify the input shaft critical speeds as shown in **Figure 32**. The 1<sup>st</sup> critical vertical mode was about 1759 RPM and the horizontal mode 1407 RPM. Split critical speeds are relatively common and are caused by asymmetry of the rotor support stiffness.

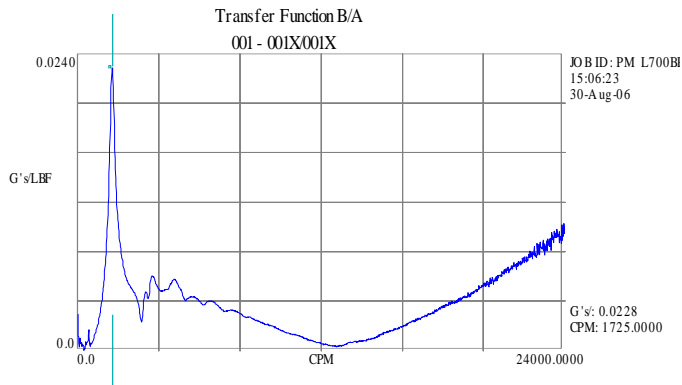
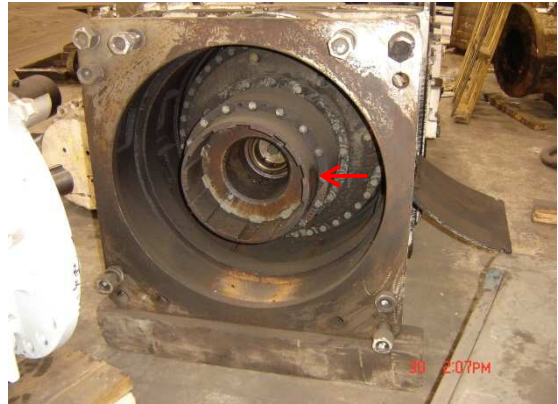
**Figure 35: Modal Test Point at End Of Fluid Coupling, Input End, Horizontal Direction.**

The modal frequency response function (FRF), shown in **Figure 35**, for a L700BP Gearbox measured the 1<sup>st</sup> critical at 1725 RPM. The FRF, see **Figure 36**, on this double planetary gearbox coupling measured 1500 RPM. This unit would operate super critical.

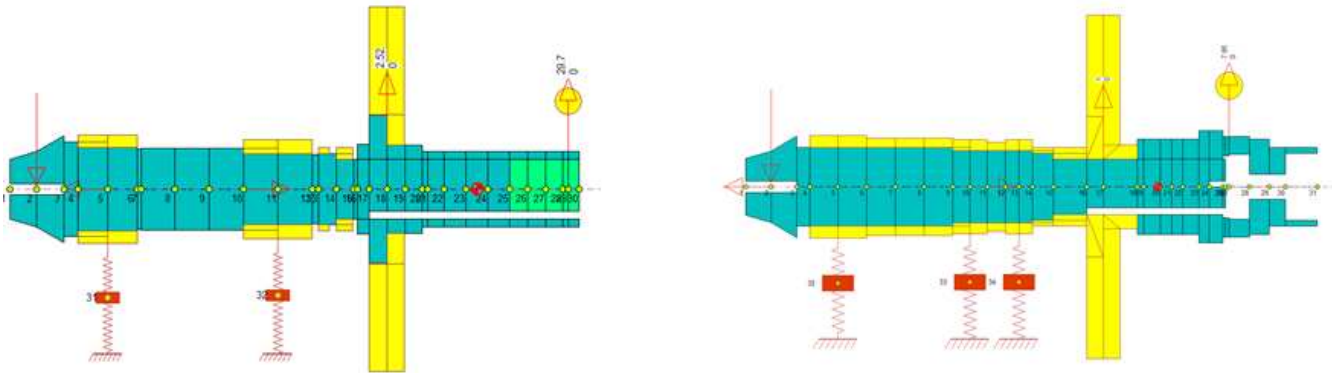
**Figure 37. Model On Left – Original Design, Model on Right – Modified Shaft and Bearing Design.**

Rotor dynamic analysis was conducted using DyRoBeS FE software. Two models were developed as shown in **Figure 37**. The original shaft design used a shaft extension and two spherical roller bearings. The fluid coupling has much greater overhang with this design than the improved design shown in **Figure 37** right side. The undamped critical speed map is shown in **Figure 38** for the original and modified shaft design.

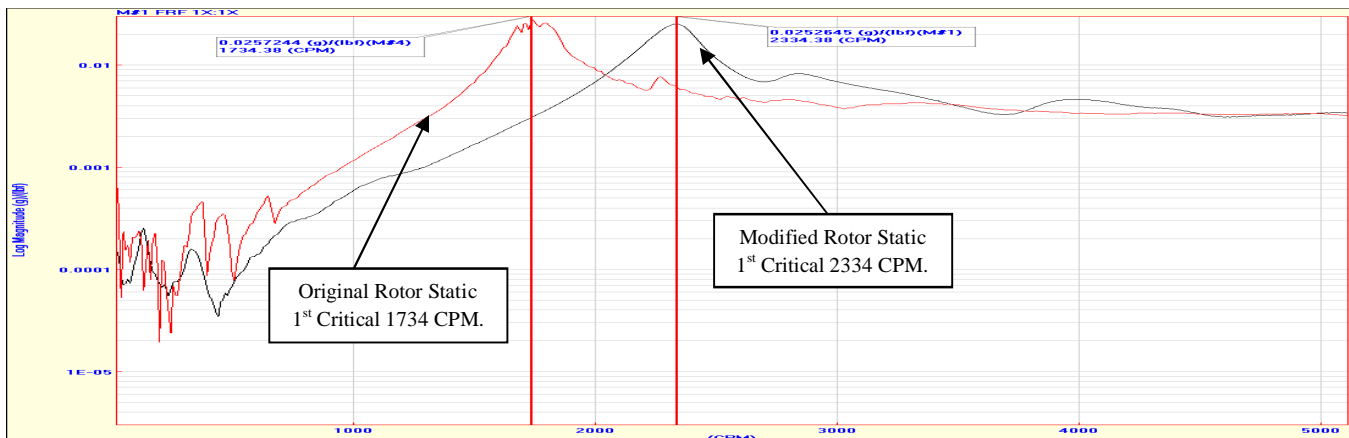
**Figure 41. Modal Test Data Plotted Overlaid Original Rotor and Modified Rotor Design.**

Comparison of modal FRF's measured on the fluid coupling of each rotor are shown in **Figure 41**. The static 1<sup>st</sup> natural frequency of the original rotor design measured 1734 CPM and 2334 CPM for the improved rotor design.

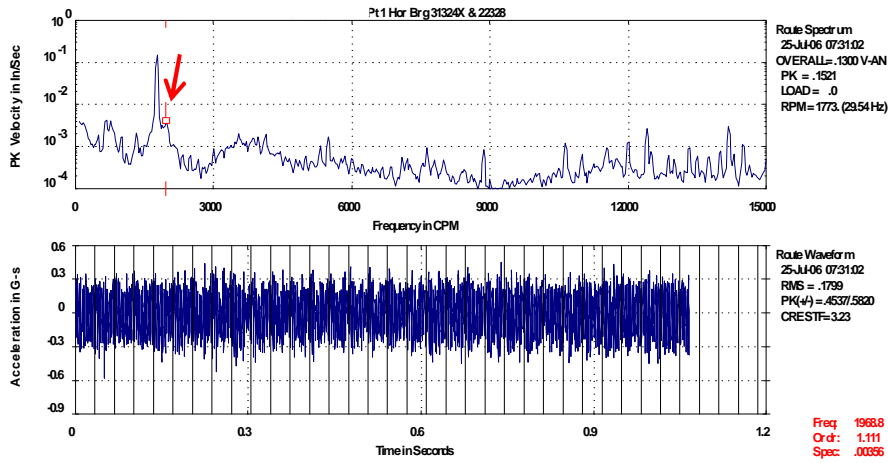
**Figure 42. Original Gearbox Shaft Design, Input Shaft Brg Housing Horizontal. 1<sup>st</sup> Critical Indicated at 1969 RPM. Rotor 1X = 1795 RPM**

Comparison vibration data is shown in **Figure 42**, original shaft design and **Figure 43**, modified shaft design. The plots are log magnitude to enhance the ability to display the rotor 1<sup>st</sup> critical frequency.

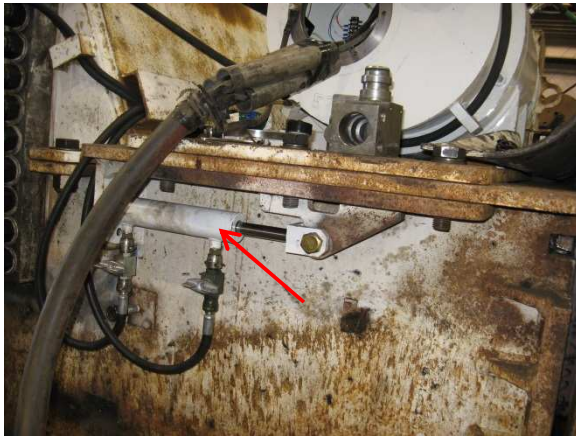
**Figure 44. Crusher Motor Belt Tension Adjustment Using Hydraulic Cylinder.**

A motor face mounted to a cradle which is bolted to the crusher frame is shown in **Figure 46**. The base plate is moved by hydraulic cylinders to tension the belt, see **Figure 43**, then hold-down bolts tightened. This design has relatively low motor vibration even though face mounted. Mines often require crusher motors be face mounted rather than foot mounted so that the motor can be also be used on stage loader power units.

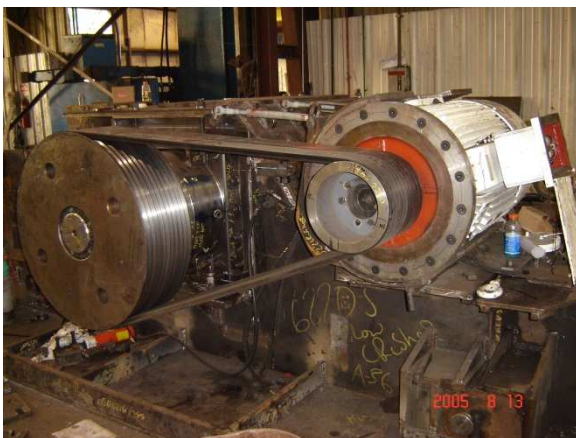
**Figure 46. Motor Face Mounted to Hinged Cradle.**

**Crusher Motor Mounting Designs:** There are a variety of motor mounting designs for coal crushers. The most flexible motor mounting is face mounted to a cradle which is hinged, as shown in **Figure 46**. Sections of pipe are welded to the crusher frame and motor cradle with a piece of shafting inserted to provide a hinge. The drive belts are tensioned by a hydraulic cylinder and turn buckles. Very high amplitude motor vibration often exceeding 1.0 in/sec pk is common.

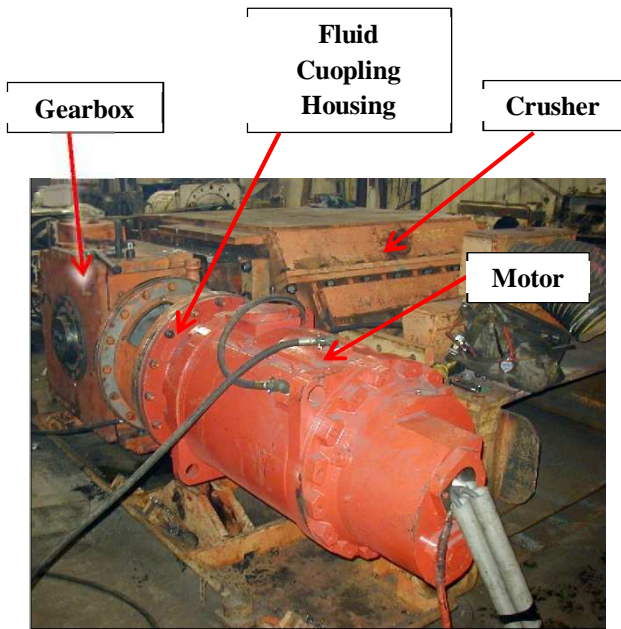
**Figure 48. Crusher With Motor-Coupling Housing & Gearbox Supported on End of Crusher Shaft.**

A less commonly seen crusher design supports the motor-coupling-gearbox on the end of the crusher shaft. The crusher shaft is splined and inserted into the hollow gearbox output shaft, see **Figures 48-50**.

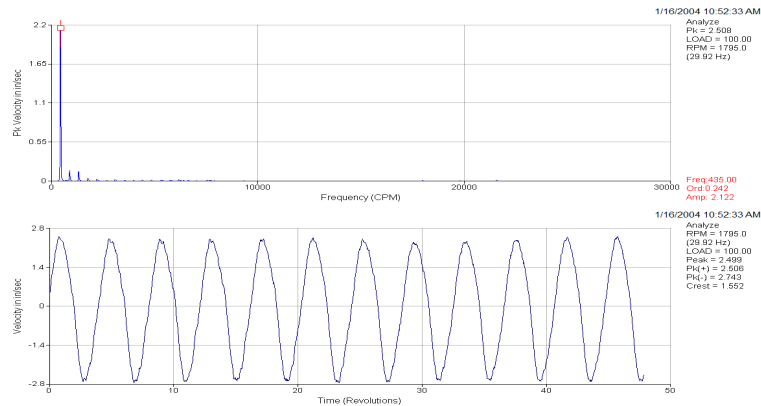
Figure 53. Motor OB Horizontal. Most Vibration at 1X=450 RPM, 89.90 mils or 2.122 in/sec pk.

The crusher had very high amplitude vibration on test measuring 2.122 in/sec pk at 1X on the motor OB Horizontal. Motor OB End vertical measured 0.755 in/sec pk overall, see spectrum and waveforms in **Figures 53 & 54**.

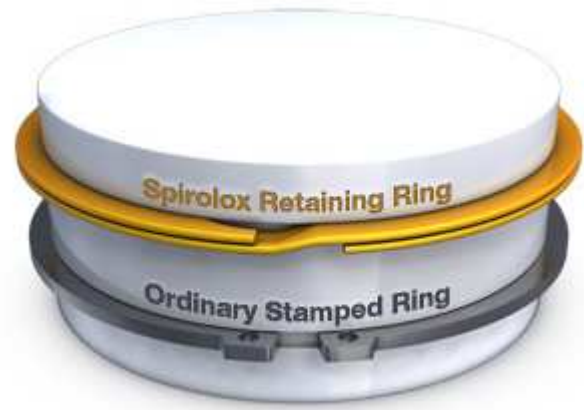
**Figure 56. Spirolox Retaining Ring (www.smalliey.com)**

**Cast Study: Spirolox Retaining Ring Rub:** During a run test of a coal crusher, a clicking sound was audible at the crusher opposite drive end bearing. The design used a Spirolox Retaining Ring, see **Figure 56**. The Peakvue data measured on the crusher opposite drive end bearing housing, see **Figure 57**, indicated impacting each revolution of the shaft. There was a primary impact once each revolution and a weaker impact twice each revolution. As discussed with the design engineer, the source was the Spirolox Retaining Ring impacting the split line of the bearing housing. The circular plot shown in **Figure 58**, indicates the once per revolution impact occurs about the same place each revolution. The secondary impact location occurring twice per revolutions does not appear to be as consistent in location.
