DIFFICULT AND UNUSUAL BALANCE CASE HISTORIES

Nelson L. Baxter

ABM TECHNICAL SERVICES

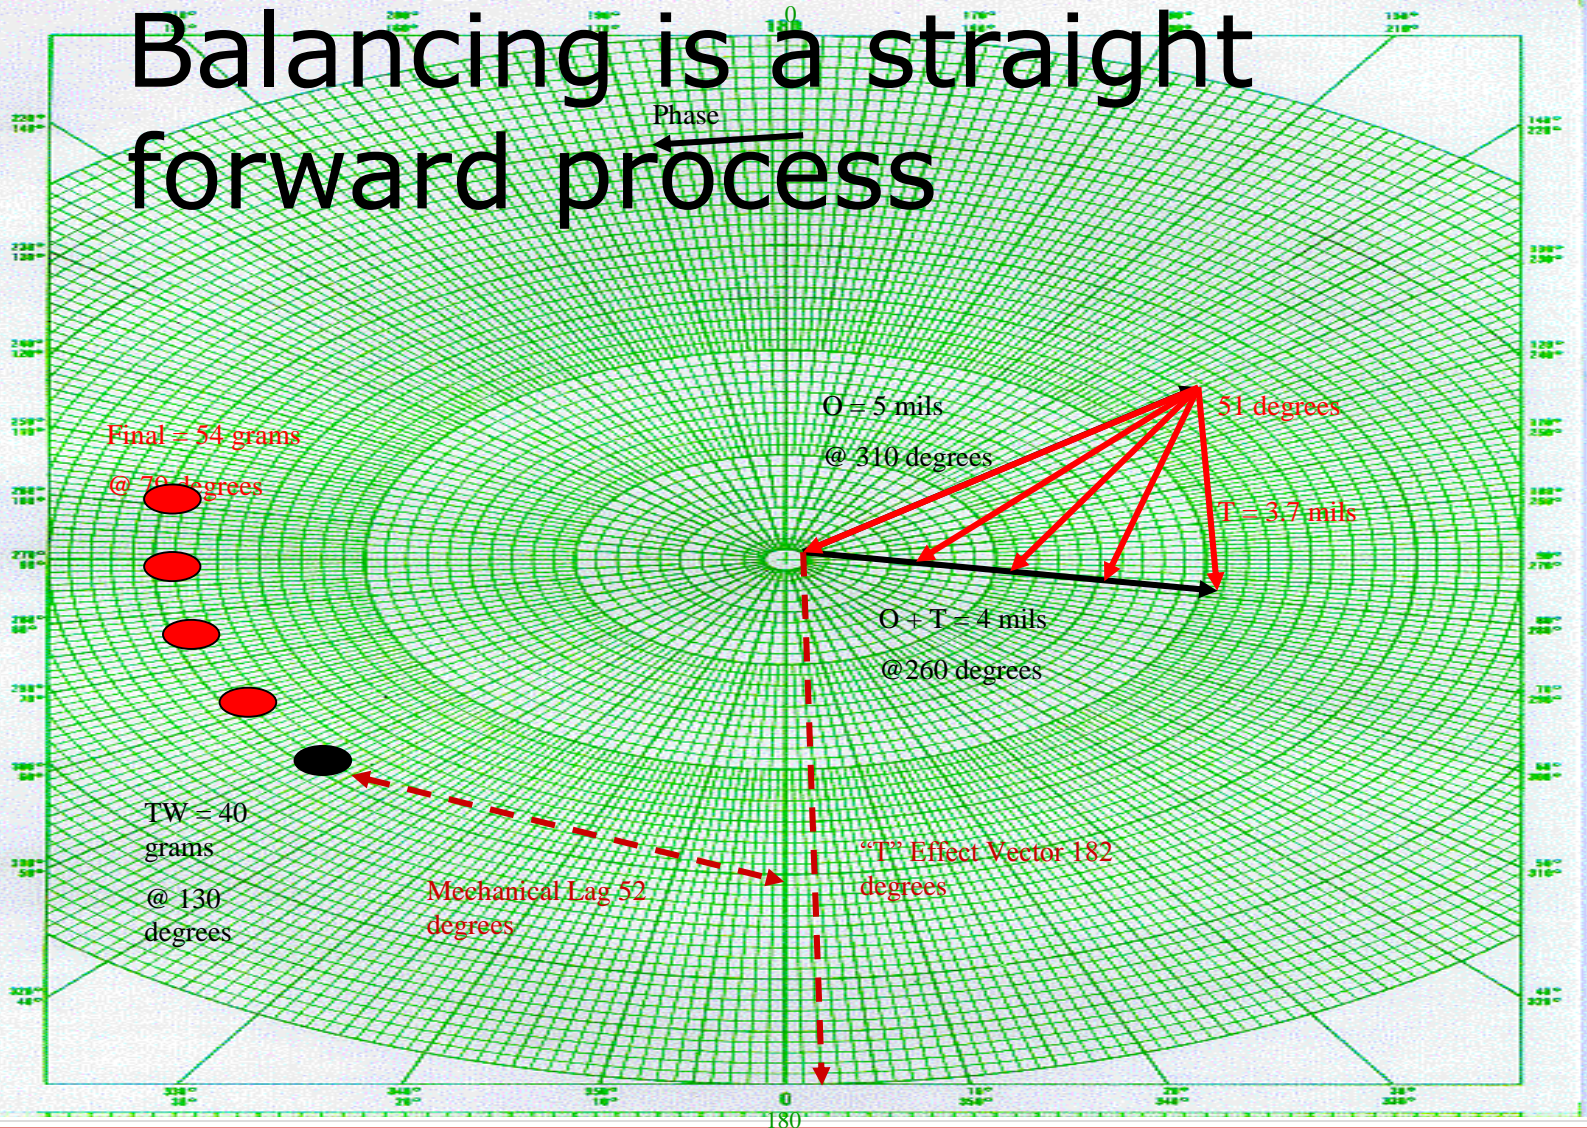
3: Based upon the results of the trial weight, a final solution weight is installed. The solution can be obtained by a graphical approach or by using a math based vector solution program.

Balancing is a straight forward process

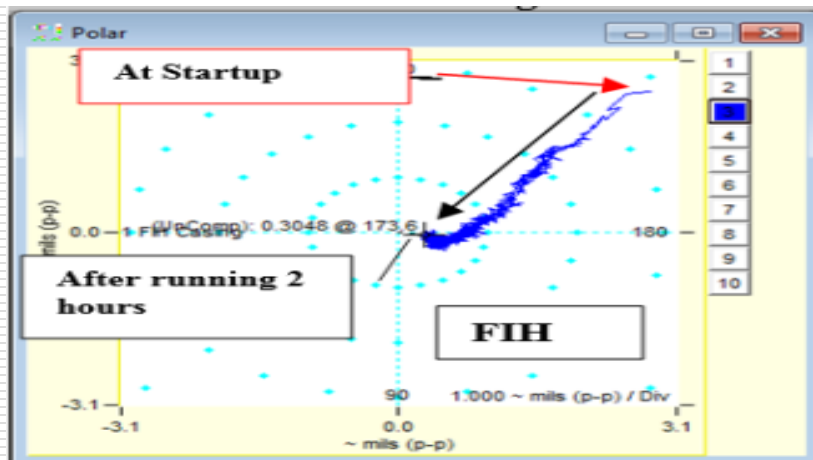
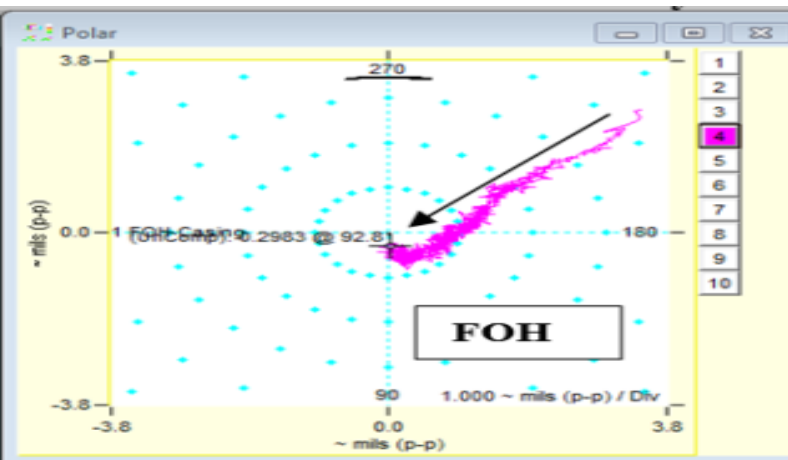
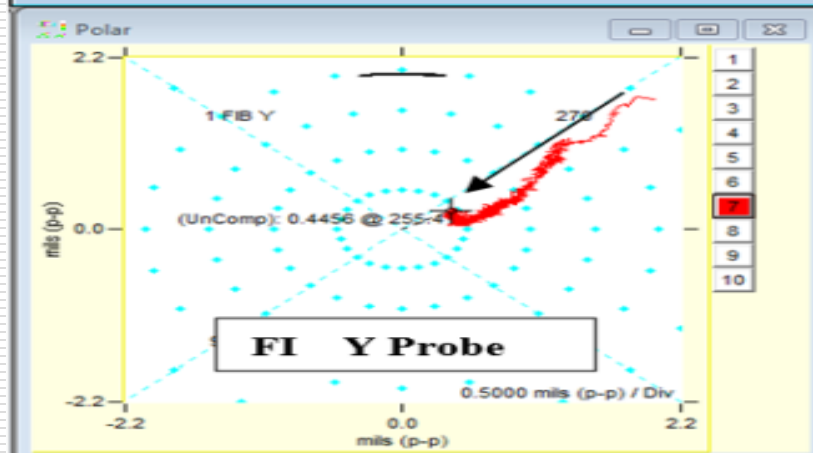
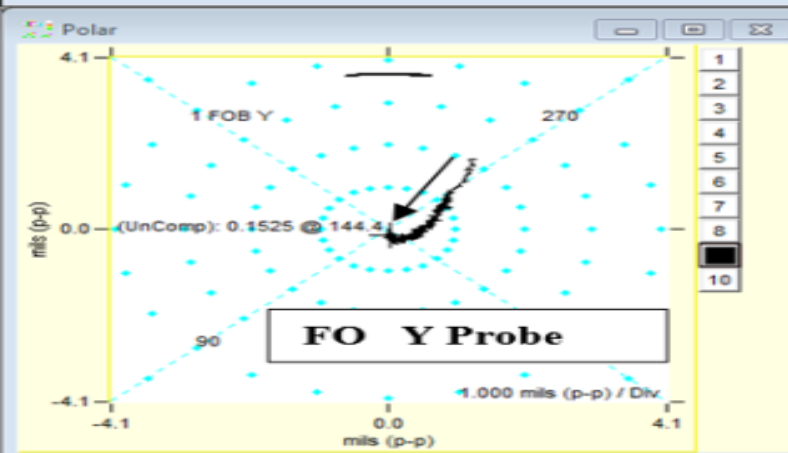
Diagnosis of Problem:
Vibration would slowly change for up to eight hours.

-
- The change in the vibration was so slow that the balancing personnel did not notice it and assumed that the fan was at steady state.
 - This caused the original unbalance vector to be in error as well as any effects of the trial weights to be wrong.
-

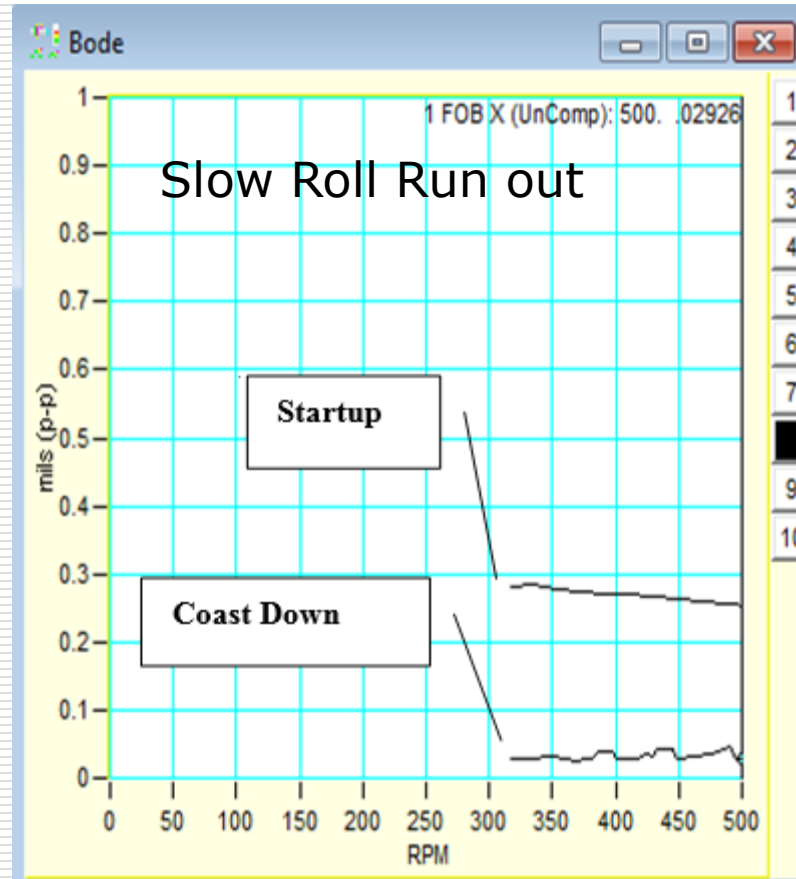
Root Cause- Rotors were bowing, Figure below shows a comparison between startup & coast down runout. Solution- Be very patient when taking balance data.

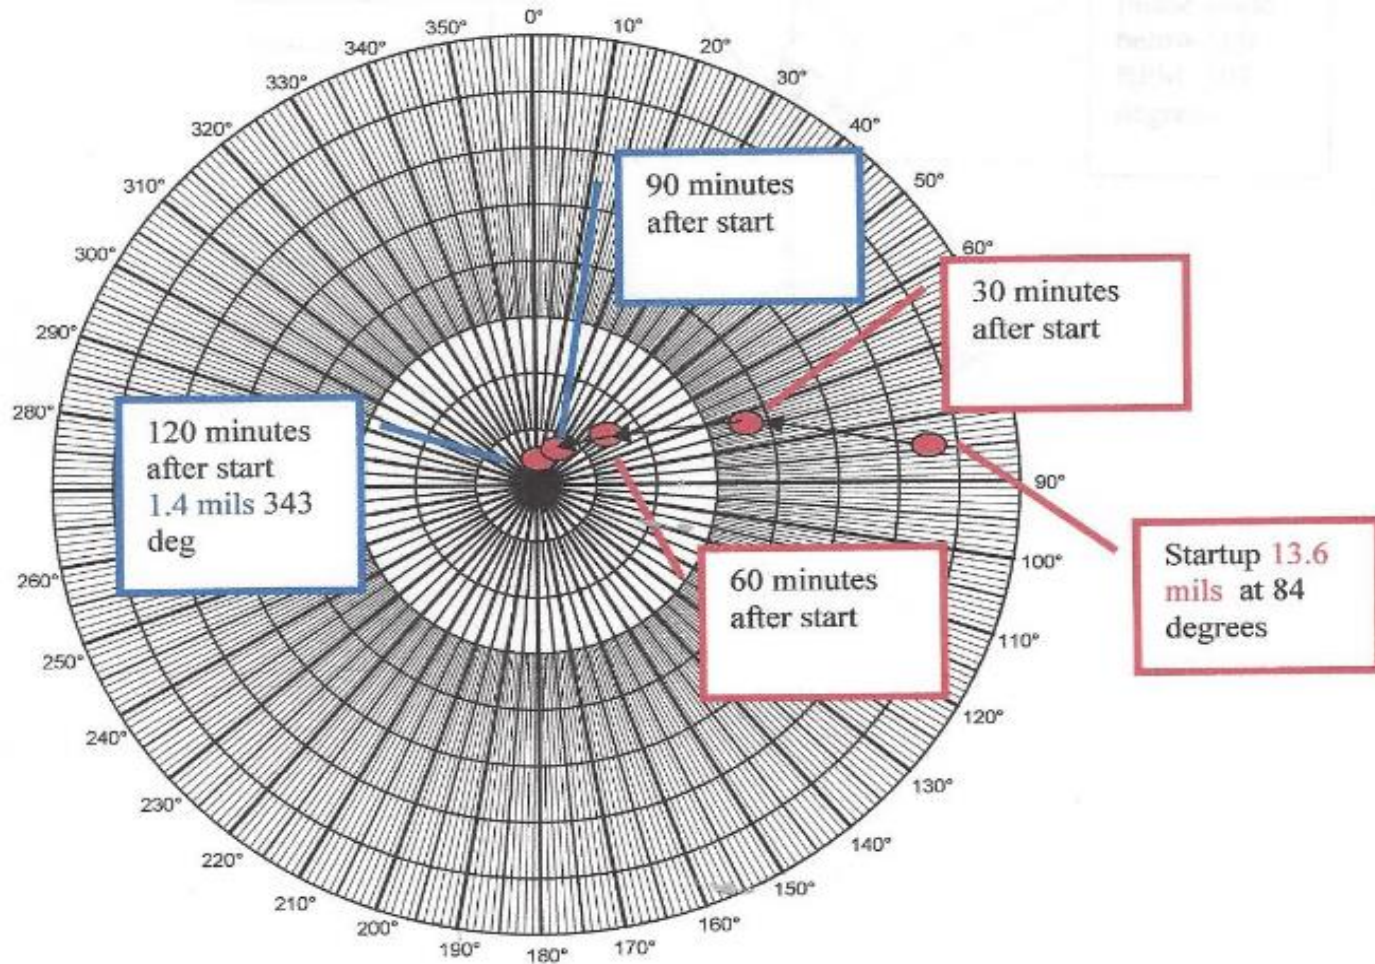
Final Balance shot response change as bow cleared.

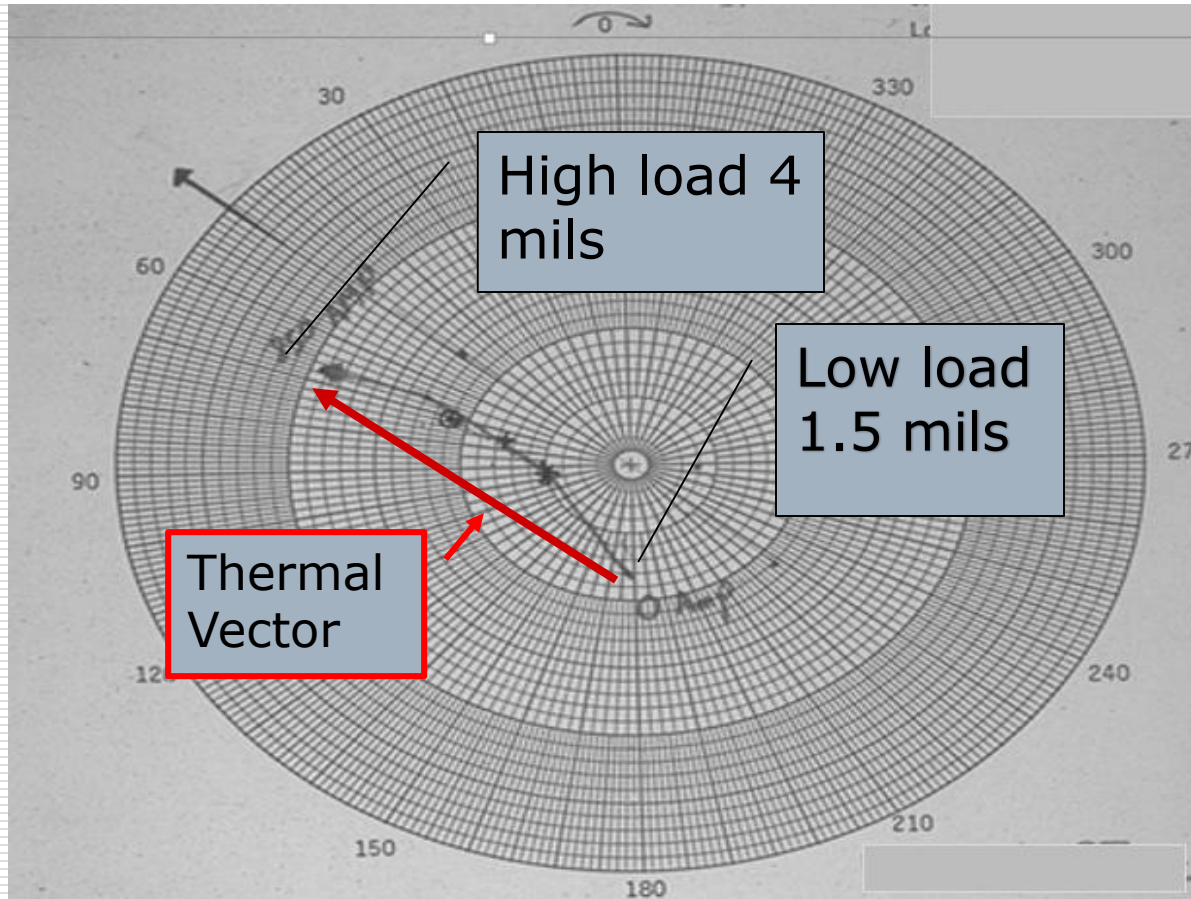
Tape recorded data was sent to US and ran through a Bently Adre system

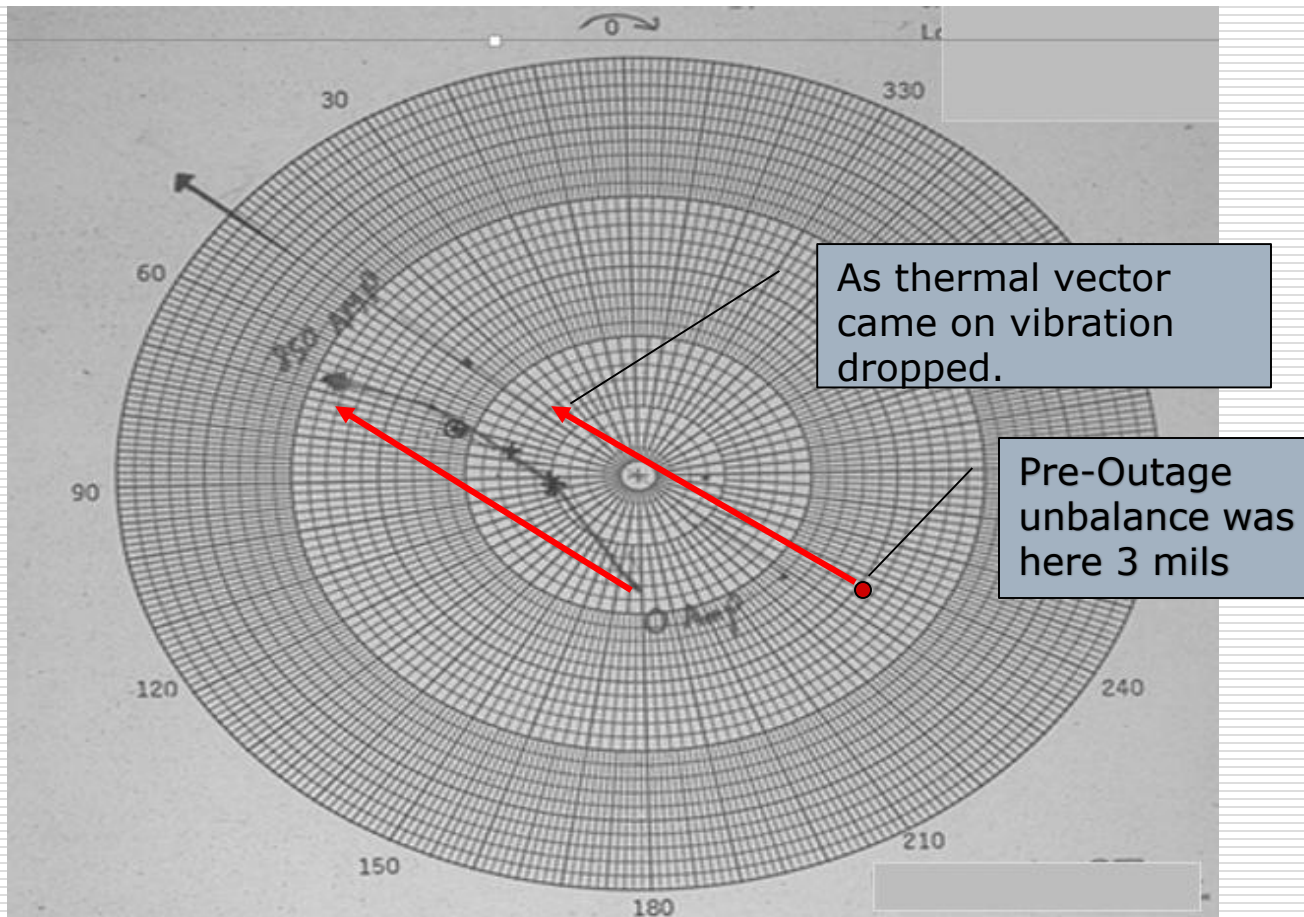
Field balance made vibration higher at full load.

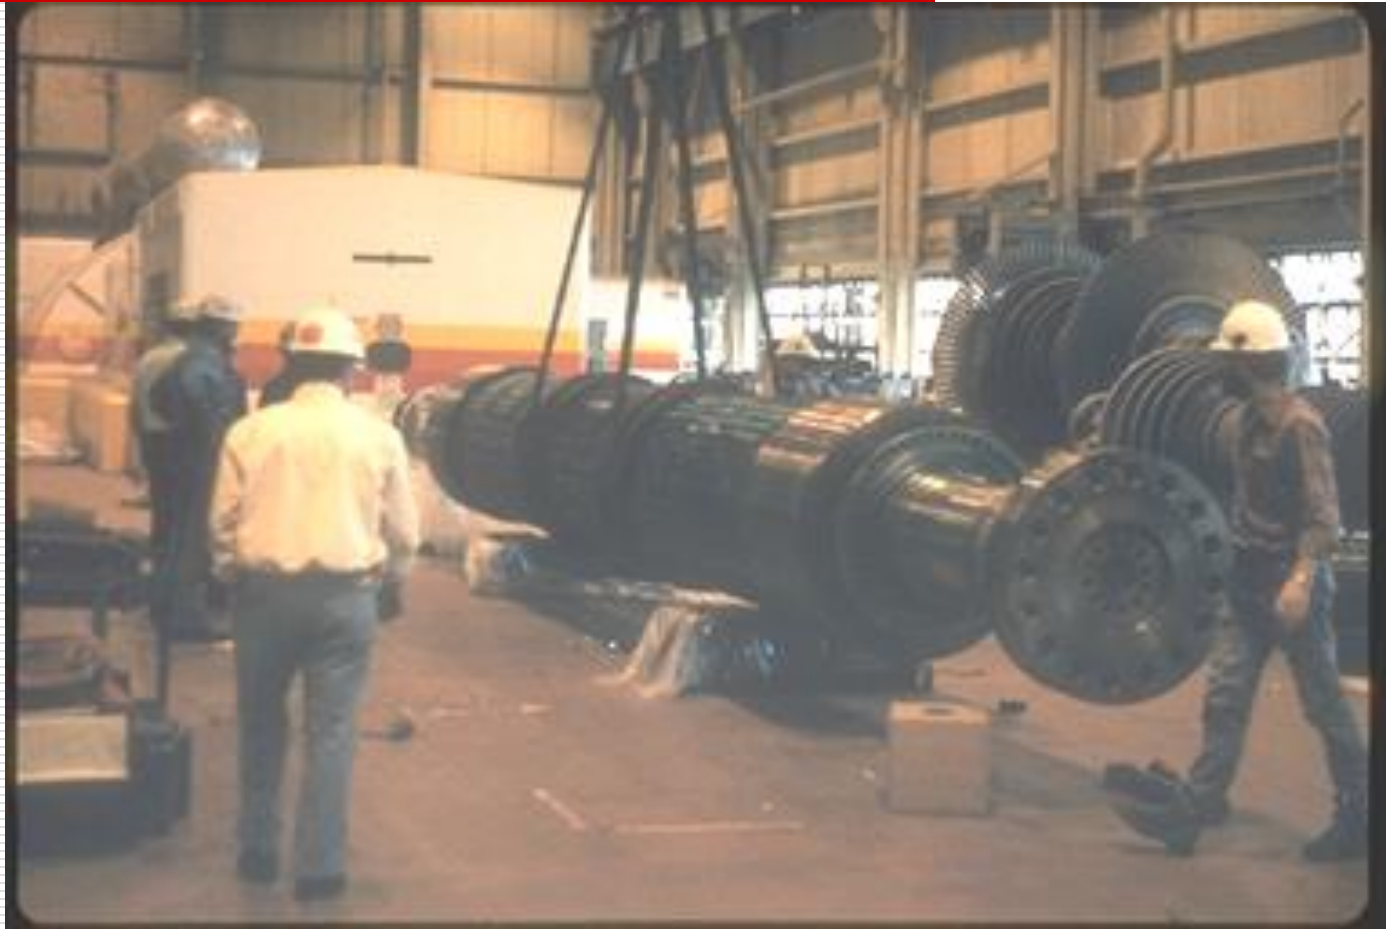
Case 4-650 MW Generator with 11 mil thermal vector

Problem- As Megawatt and var load increased, so did vibration

Problem Shorted coil as seen in flux probe plot below

Solution-Several compromise balance shots until rotor could be repaired.

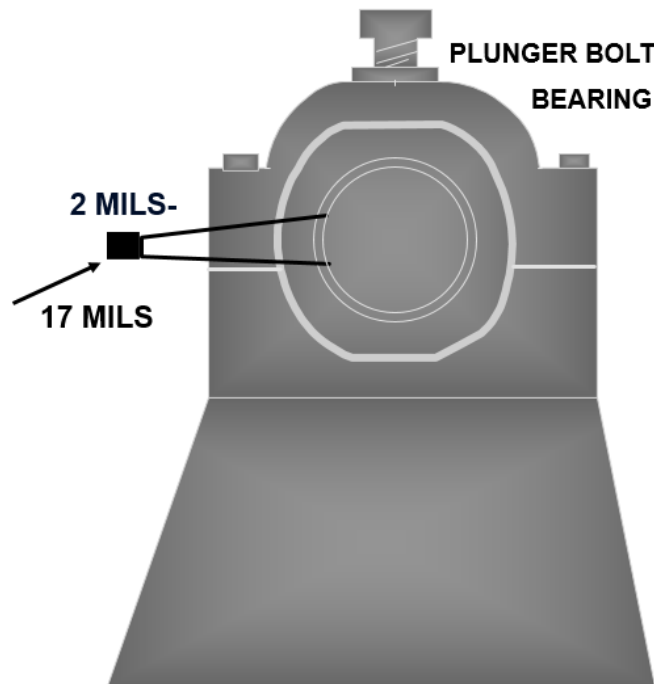
LOOSE BEARING IN HOUSING COMPLICATES BALANCING

IF A BEARING IS LOOSE IN ITS HOUSING, A NONLINEAR SYSTEM IS CREATED AND BALANCING IS ALMOST IMPOSSIBLE

A LARGE ID FAN COULD NOT BE BALANCED. THE CASING LEVELS WERE SLIGHTLY OVER 2 MILS, HOWEVER, WHEN SHAFT STICK LEVELS WERE MEASURED, THE AMPLITUDE WAS GREATER THAN 17 MILS. SINCE THE SHAFT TO INNER BEARING CLEARANCE WAS ONLY 8 MILS, THIS MEANT THAT THE BEARING HAD TO BE MOVING IN THE HOUSING. WHEN THE PLUNGER BOLT WAS TIGHTENED, THE CASING LEVEL ROSE TO 21.5 MILS. AFTER THE TIGHTENING, THE FAN WAS EASILY BALANCED.

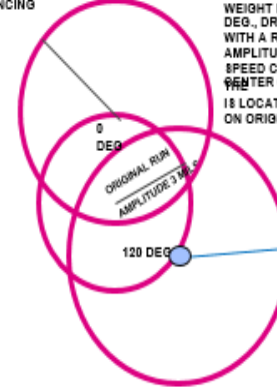
TRIAL WT. AT 120 DEG
4 RUN NO PHASE METHOD OF BALANCING

STEP 3- WITH THE TRIAL WEIGHT LOCATED AT 120 DEG., DRAW A CIRCLE WITH A RADIUS EQUAL AMPLITUDE OF RUNNING SPEED COMPONENT. CENTER OF THE CIRCLE IS LOCATED AT 120 DEG. ON ORIGINAL CIRCLE.

- ❑ Add weight at 120 degrees. Measure amplitude at running speed. Draw a third circle with its center at 120 degrees on first circle and with a radius equal to amplitude with weight at 120 degrees

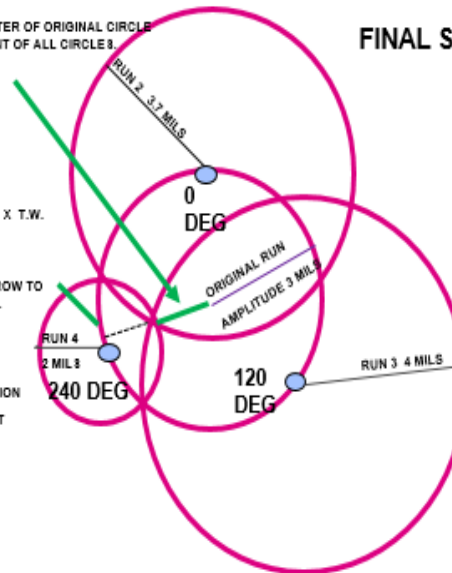
DRAW LINE FROM CENTER OF ORIGINAL CIRCLE TO INTERSECTION POINT OF ALL CIRCLES. EFFECT 1 MIL

SOLUTION:
CORRECT WEIGHT EQUALS
 $\frac{\text{ORIGINAL AMPLITUDE}}{\text{EFFECT}} \times \text{T.W.}$

PROJECT EFFECT ARROW TO INTERSECTION POINT ON ORIGINAL CIRCLE TO FIND CORRECT LOCATION FOR SOLUTION WEIGHT

SOLUTION
ADD 3
TIMES THE
TRIAL WT
AT 250
DEGREES

- ❑ Angle is determined by drawing effect line out to edge of circle 1.
-

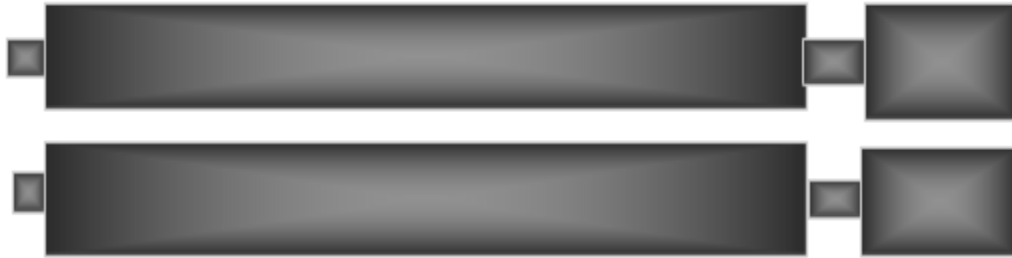
REWINDER AT PAPER MILL

**2 ROLLS ELECTRICALLY
LOCKED TOGETHER
OPERATING AT NEARLY
THE SAME SPEED OF 975
RPM.**

The problem was that the rolls were beating with one another.

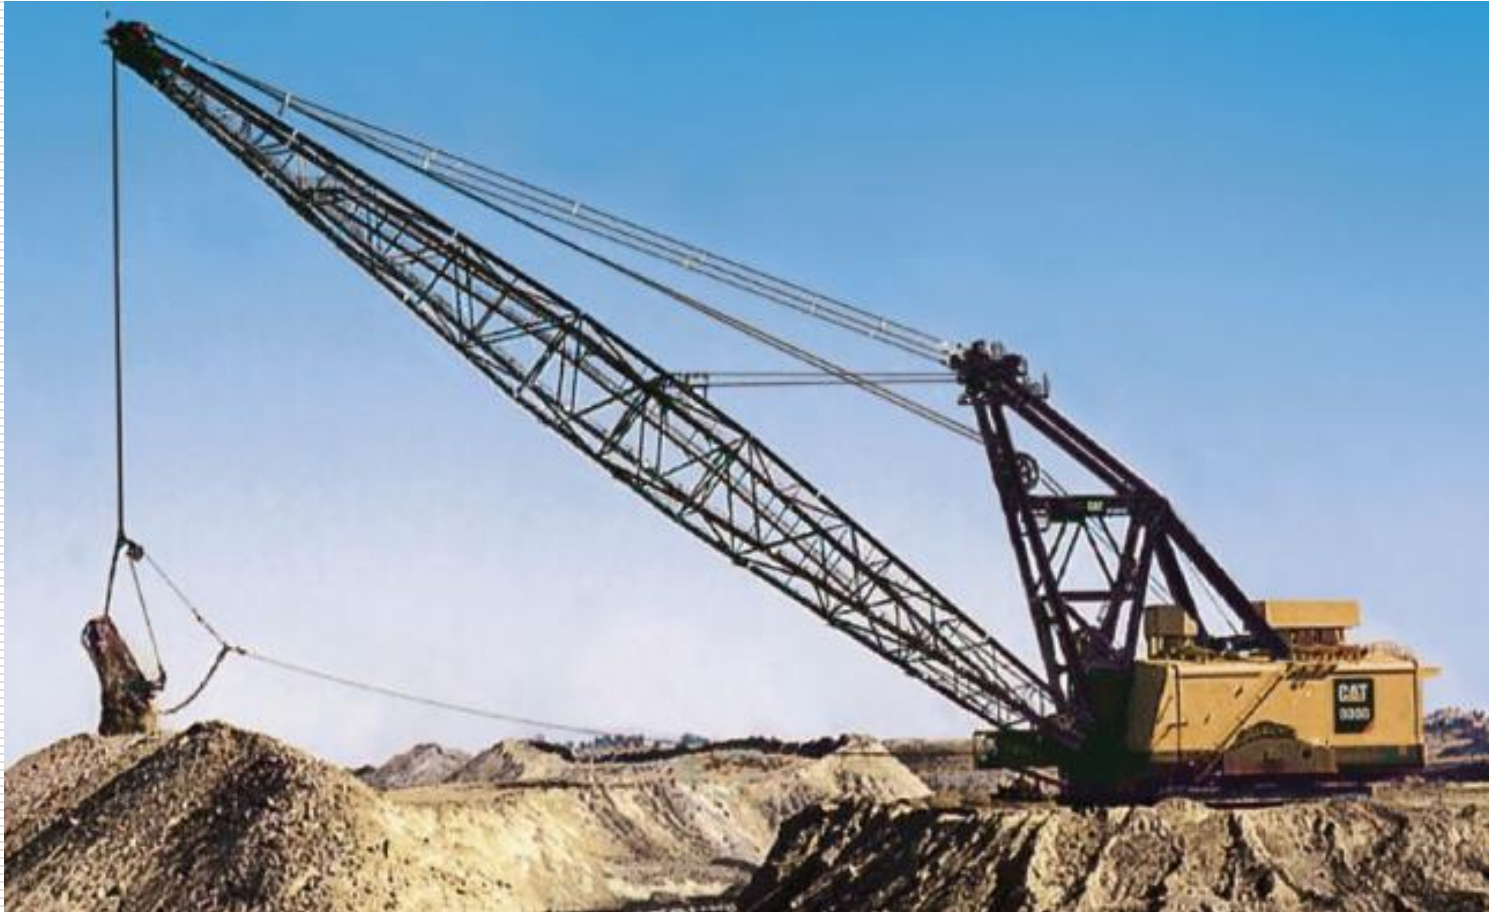
Case 13- Cross effect in a drag line MG set

Drag line MG Sets consist of 6 rotors and 7 bearings.

MOTOR GENERATOR SET ON DRAG LINE

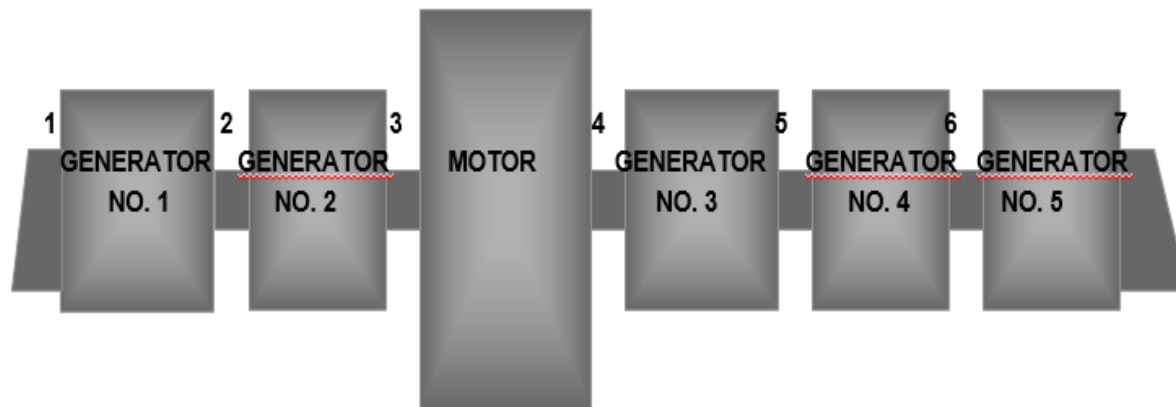
SIX ROTORS WITH SEVEN SHARED BEARINGS SOLIDLY COUPLED ON A METAL DECK.

- ❑ A typical MG train consists of a synchronous motor and 5 DC generators. These supply DC power to the hoists.
 - ❑ There may be up to 5 MG trains on a large drag line.
 - ❑ They are mounted on the same metal deck.
 - ❑ They all run the same speed of 1200 RPM so synchronous time averaging does not help.
 - ❑ Therefore up to 30 rotating elements turning the exact same speed on a common metal deck with each group of six rotors being supported by only seven bearings.
 - ❑ The entire drag line including the 300 ft boom was shaking at 1200 cpm.
-

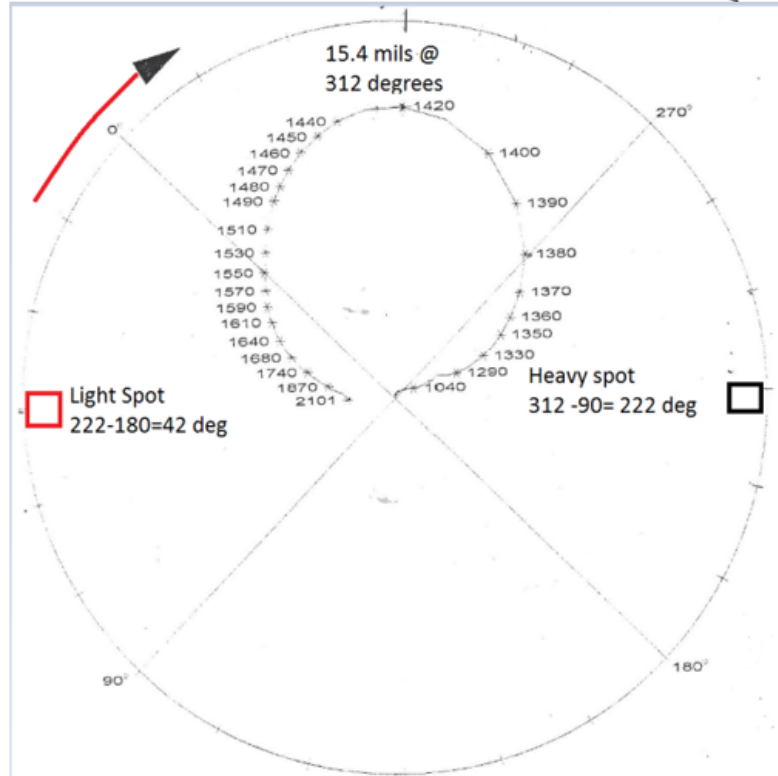
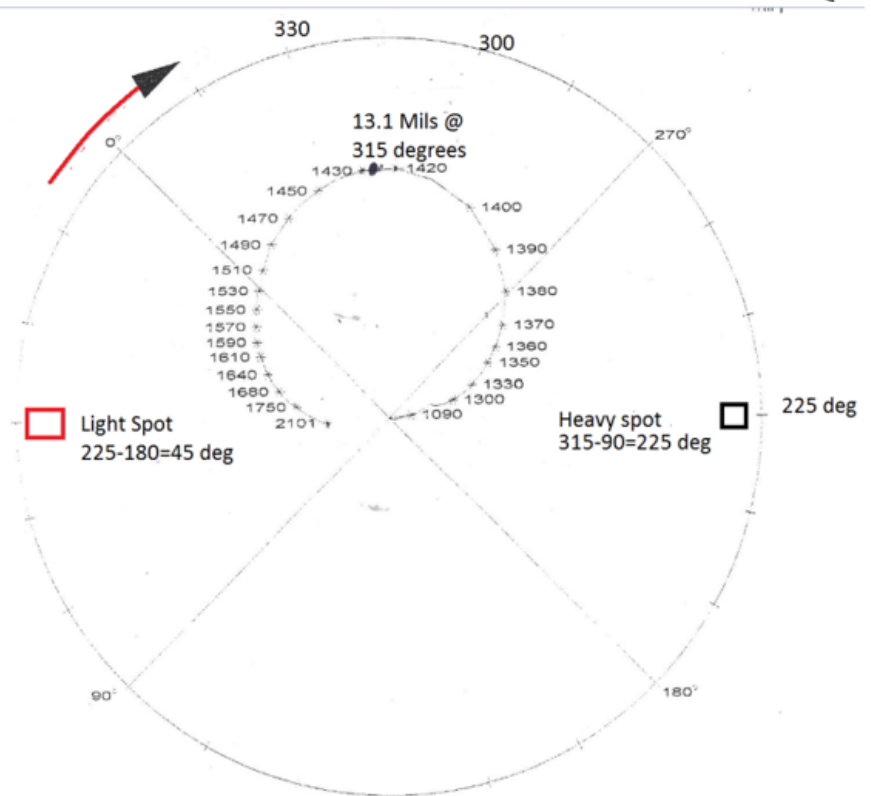
Figure 20 Nyquist plots showing 1st critical speed response

1st Critical Speed Response both bearings in phase 13 & 15 mils

BEARING 1 RUNOUT COMPENSATE NYQUIST

BEARING 2 RUNOUT COMPENSATED NYQUIST

- Vibration response was static in nature (phase angles were nearly identical) as would be expected at the 1st critical.
 - Past experience with this rotor design showed that the cause was a bow in the rotor. Since the rotor was bowed, the weight had to be installed in the mid rotor balance plane rather than in the end planes.
 - A 90 degree lag at the critical speed was used to estimate the angle.
-
