LOW SPEED BEARING ANALYSIS

Bruce Weathersby
KOSA
P.O. Box 4, Mail Drop 1.6
Highway 70 W
Salisbury, NC 281144

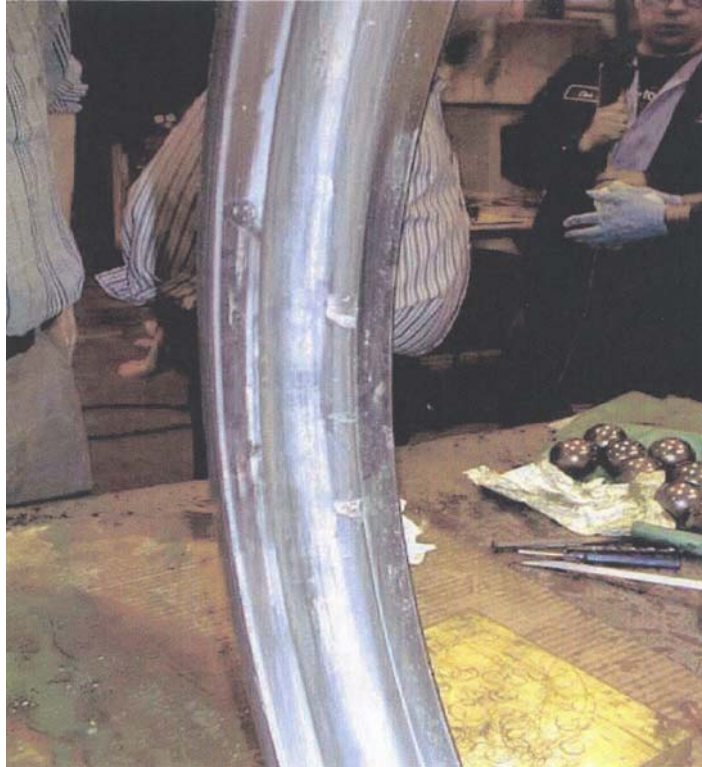
After being able to detect bearing damage with conventional vibration techniques we have been able to spot the original onset of spalling. Figure 14 shows the outer race of a bearing from a seal removed in its early stage of spalling. Figure 13 is the spectrum used to make the decision to remove the seal from service. Figure 15 is the last spectrum taken before removal from service. Figure 16 shows a bearing removed with more advanced spalling. Figure 17 showed a significant increase at the 1XBPFO from the previous month and was predicted as the progression from spalling to race cracking. Figure 17 is the last spectrum taken before removing the seal from service. Figure 18 shows the spalling and cracked race of the bearing in the seal analyzed in Figure 17.

Figure 14. Beginning of Spalling of Bearing Described in Figure 13. Spalling Over 5 Degrees of Arc on Outer Race

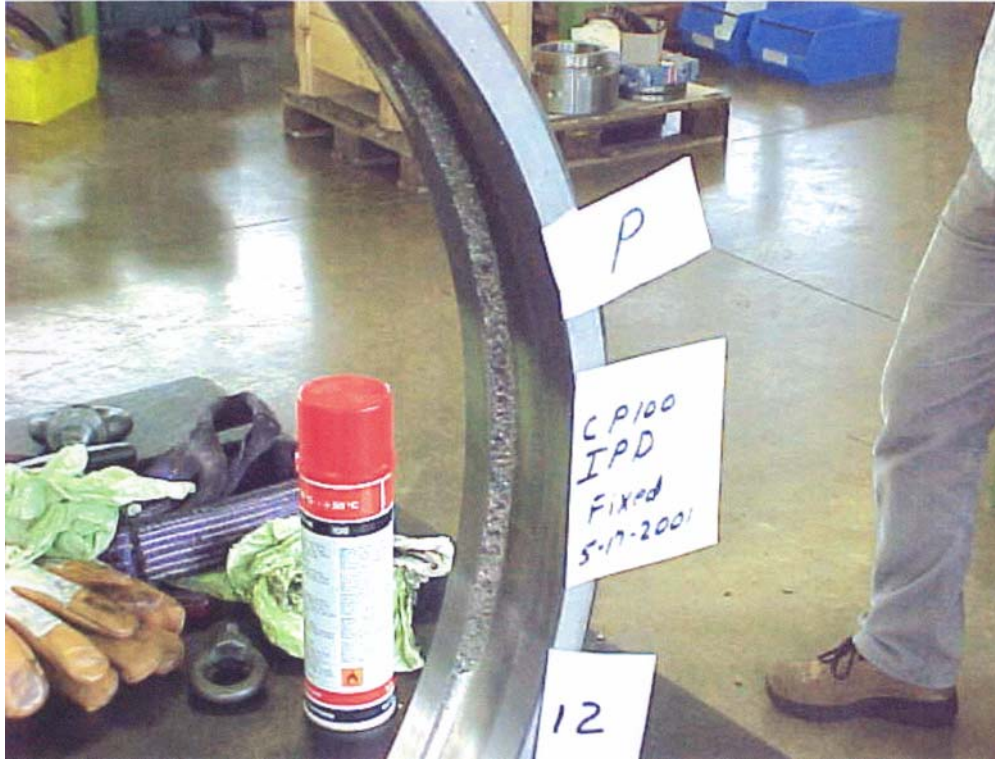
Figure 16. Advanced Spalling of Bearing Described in Figure 15. Spalling Over 45 Degree Arc of Outer Race
