MACHINERY VIBRATION RELATED TO POOR BOLTING PRACTICES

Ken Singleton, Manager
KSC Consulting L.L.C.
Bristol VA
ksingleton@vibrationconsulting.com

Bob McGinnis P.E.
McGinnis Mech Engineering L.L.C
Kingsport TN
mmengineering@charter.net

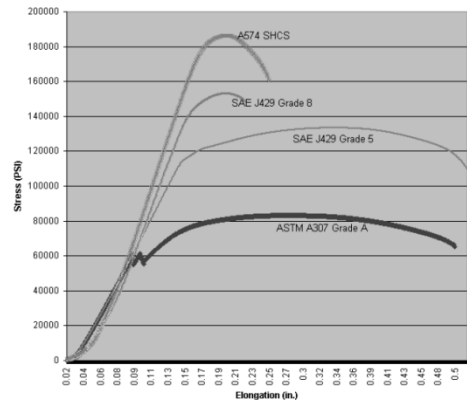
Stress/strain curves for some materials used for bolts are shown in **Figure 11**, [15]. Note that harder, higher tensile strength fasteners such as ASTM A574 Socket Head Cap Screw (SHCS) and SAE J429 Grade 8 are less ductile than lower strength SAE J429 Grade 5 and ASTM A307 Grade A. Although the ASTM A574 and SAE J429 materials have high tensile strength, the overall length of the strain curve is decreased when compared to materials J429 and A307.

Figure 11. Stress/Strain Curve for Different Materials, Reference [15]

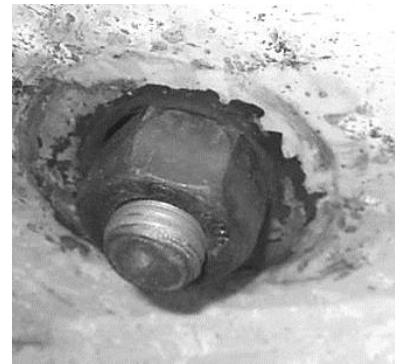
Absence of flat washers where oversize holes exist – Although this may seem improbable, we have found bearing housing and motor hold down bolts installed with no flat washers. In a few instances, only the corners of the nut were actually contacting the base plate as shown in **Figure 18**.

Figure 18. Motor Hold down Bolt, No Washer.

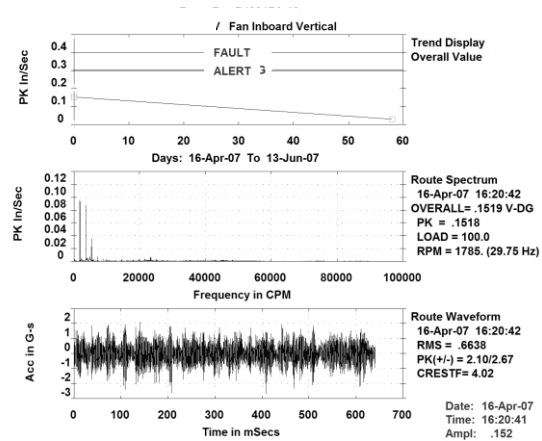
Figure 32 Initial Vibration Data at Fan Inboard Bearing Housing Vertical Direction.

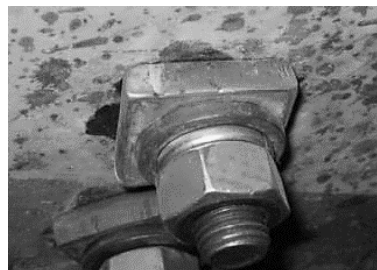
Both fan's bearing housing hold down bolts (under the base plate), see **Figure 34**, had a stack of washers that included a flat washer, split lock washer and square washer burned from bar stock by cutting torch. All bolt assemblies were found loose.

Figure 34. Fan A, Bearing Housing Hold Down Bolts.

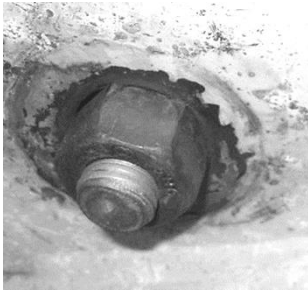
Some of the motor hold down bolts had low carbon steel flat washers which had dished into a large hole. Some bolts had no washer with only the nut corners contacting the support plate, see **Figures 35-37**. The holes in the base plate supporting the motor were much too large.

Figure 35. Motor Hold Down Bolt, Corners of Nut

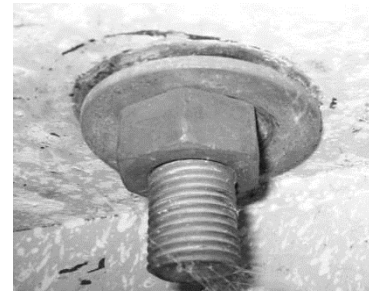
Figure 37. Fan A, Motor Hold Down Bolt With Deformed Flat Washer.

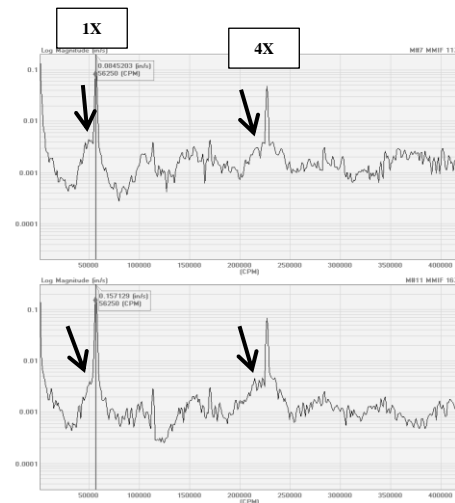
ODS spectra data measured at the motor right-front foot and base vertically are shown in **Figure 47**. The data is plotted with log magnitude scaling to more clearly show the indications of resonance near 1X and 4X run speed (pump vane passing).

Figure 47. Spectrum at Motor IB Right Front Foot and Support, Log Magnitude Scaling Is Better Showing Indication of Resonance.

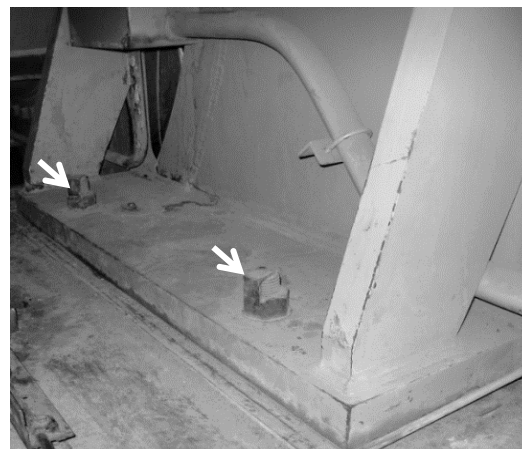
Figure 54. Bearing 5 Pedestal & Soleplate LPB Right Side.

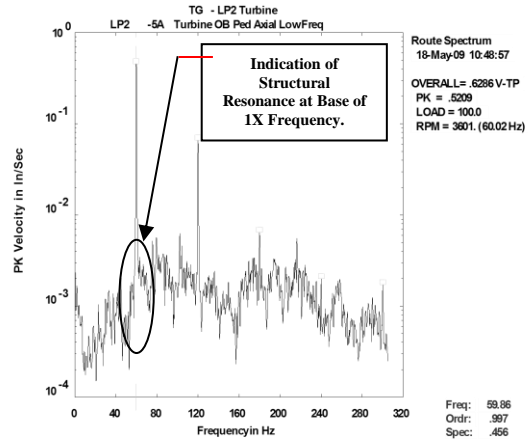
The vibration spectral data showed indication of structural resonance near running speed, see **Figures 55-56**. The spectra are plotted with log magnitude scaling to aid identification of natural frequencies.

Figure 56. Frequency Spectrum at Brg 5 Casing, Axial.

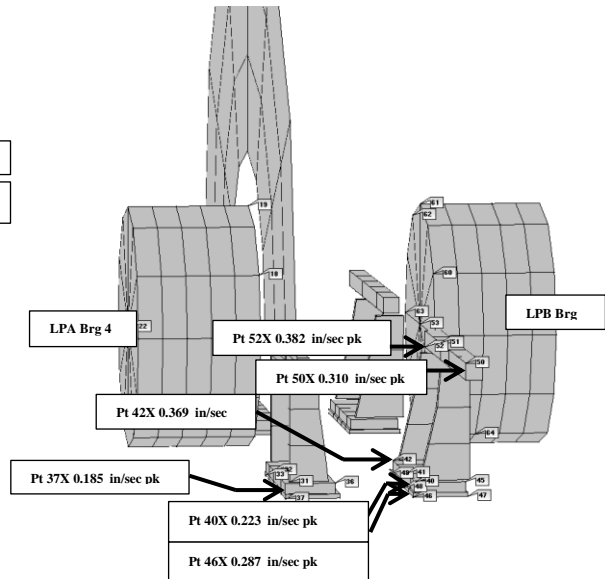
The bearing housings and pedestals of the LP Turbines were modeled using ME'scopeVES, see **Figures 57-58**. ODS data were measured and imported to ME'scopeVES for animation. The ODS data measured on Brg 4 & Brg 5 pedestals showed flexure of the pedestals and relative movement of the pedestal base plates and soleplates. Vibration was highest amplitude near the central points of the casing split lines and bearing housings. Inadequate clamping by the hold down bolts (no bolt pre-load) was indicated.

Figure 58. ME'scopeVES Model, LPA Brg 4, LPB Brg 5 Bearing Housings, Pedestals & Soleplates.

Additional testing to include checking tightness (adequate pre-load) of hold down bolts, modal testing to identify resonance, coastdown data collection from the proximity probes and casing accelerometers was recommended. After these issues and other problems were identified, the client's decision was to bring the outage contractor back on site to resolve the identified problems and collect the recommended vibration data.
