Belt Vibration with Case Histories

Barry T. Cease

Cease Industrial Consulting 2023

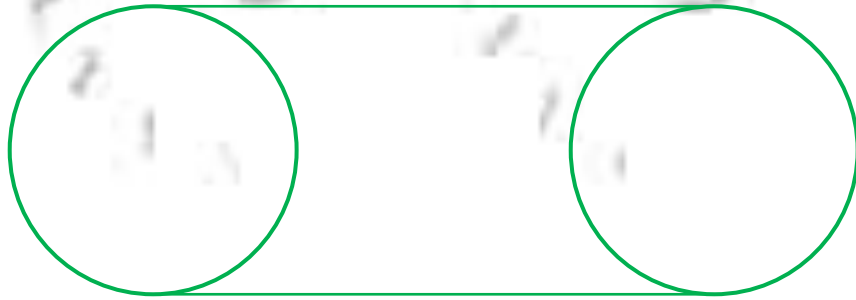
"Ideal" Drive Ratio (1:1)
Same arc of contact at each sheave

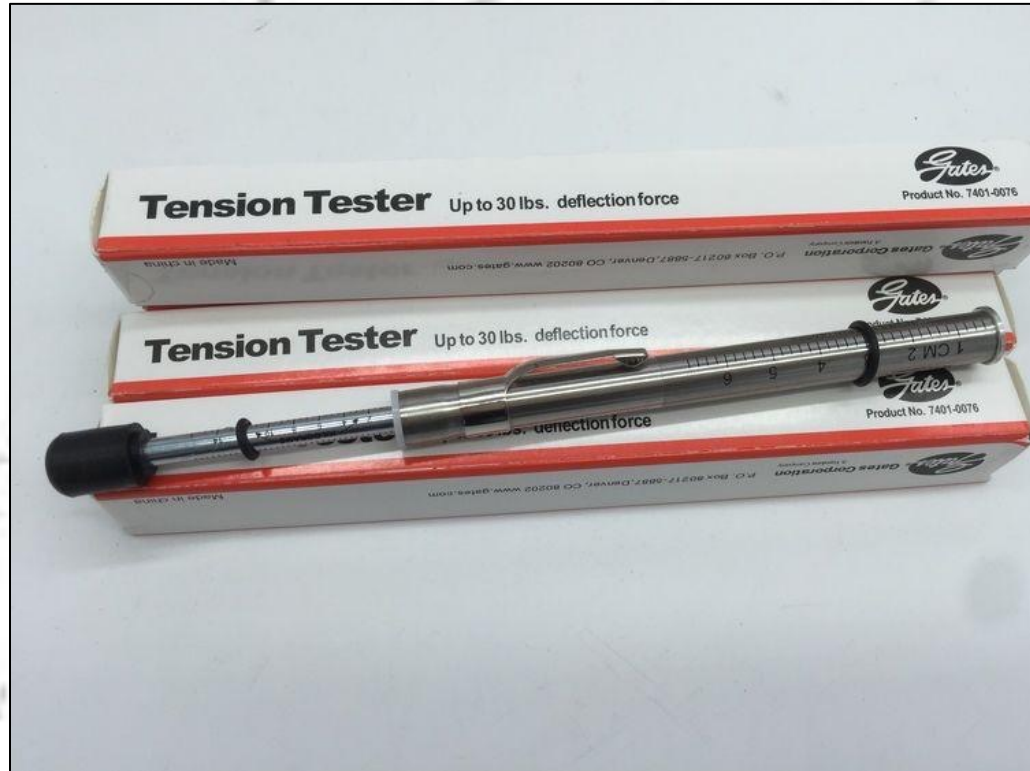
Belt Tension Tester (Spring-Loaded Device)

Belt tension setpoint (lbs)
Lookup in belt OEM table

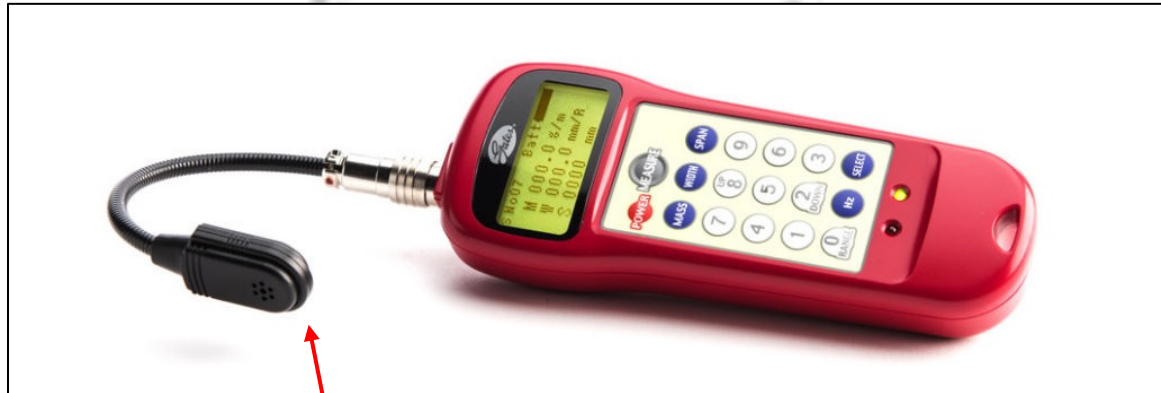
Belt Tension Tester (Sonic Device)

Belt tension sensor (acoustic)
Use table and/or software to
lookup frequency

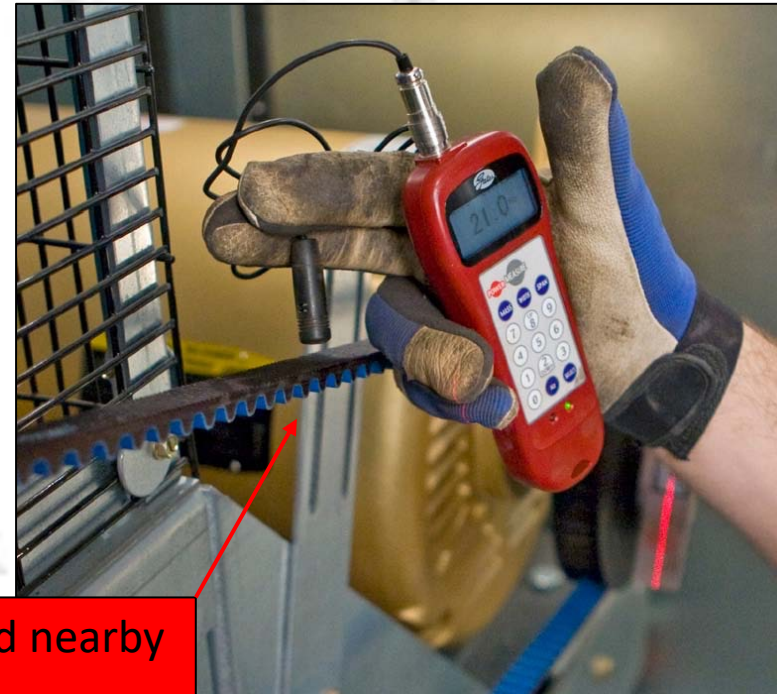
Pluck belt with sensor held nearby
and measure belt strand
frequency. Adjust belt tension
until within recommended range.

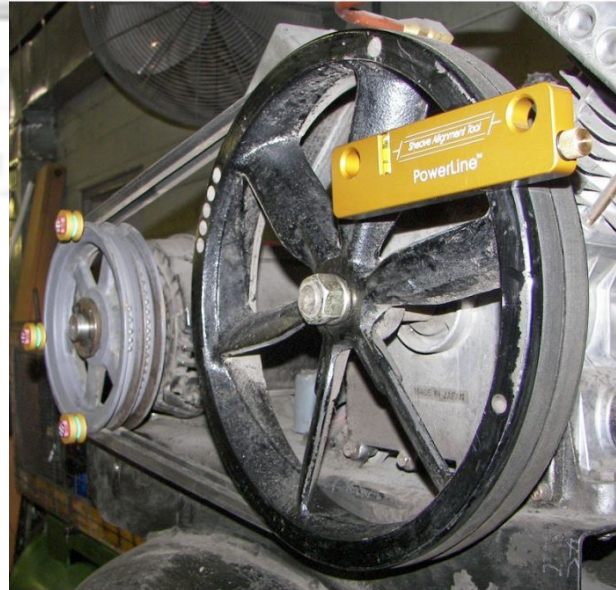
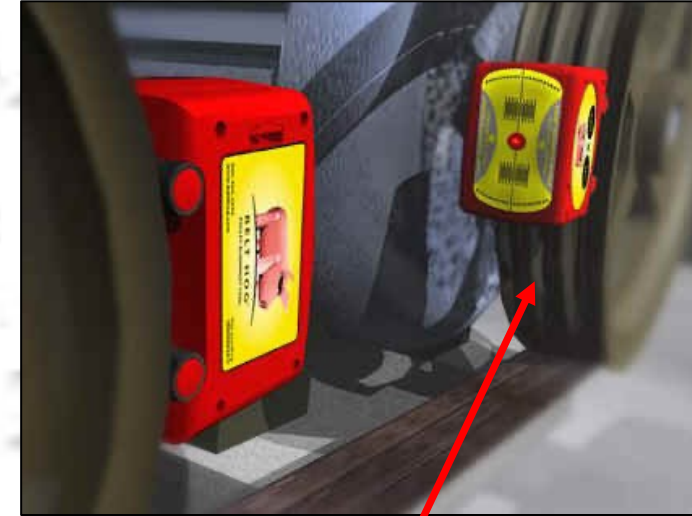
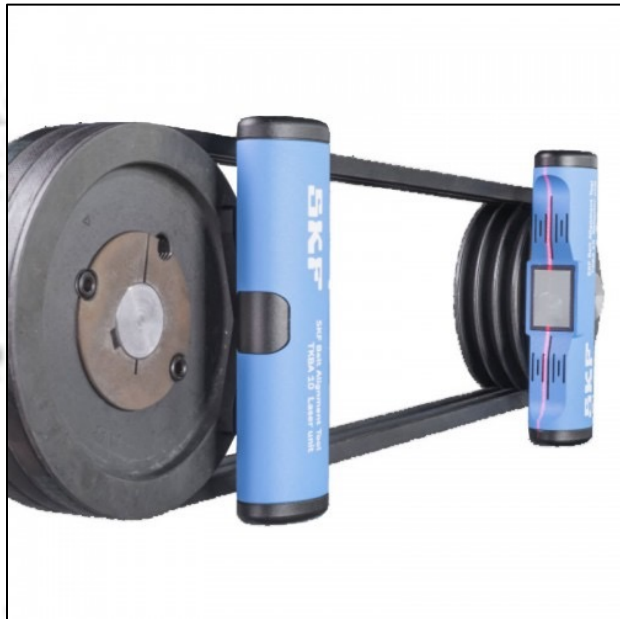
Laser Sheave Alignment Tools

Mounts to outer sheave surface
Must account for potential
differences in sheave thickness.

Mounts inside belt grooves
(where the belts operate)

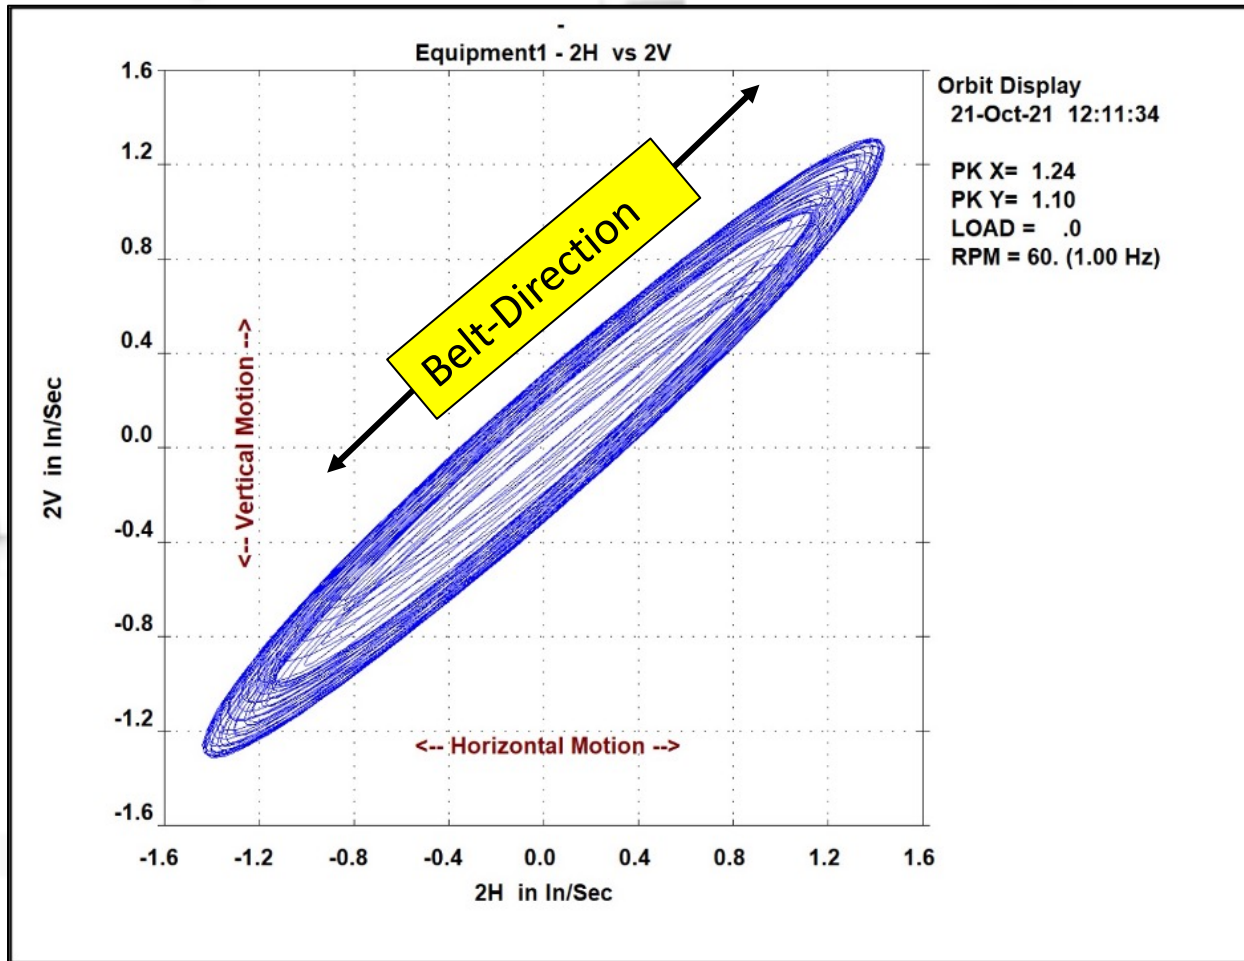
- Highly directional orbit seen at motor, sheave-end bearing.
- Dominant motion in-line with belts.

Point	Description	Motor 1x Pk (ips-pk)	Motor 1x Phase (deg)
2H	Motor, Sheave-End, Horizontal	1.25	254
2V	Motor, Sheave-End, Vertical	1.03	252

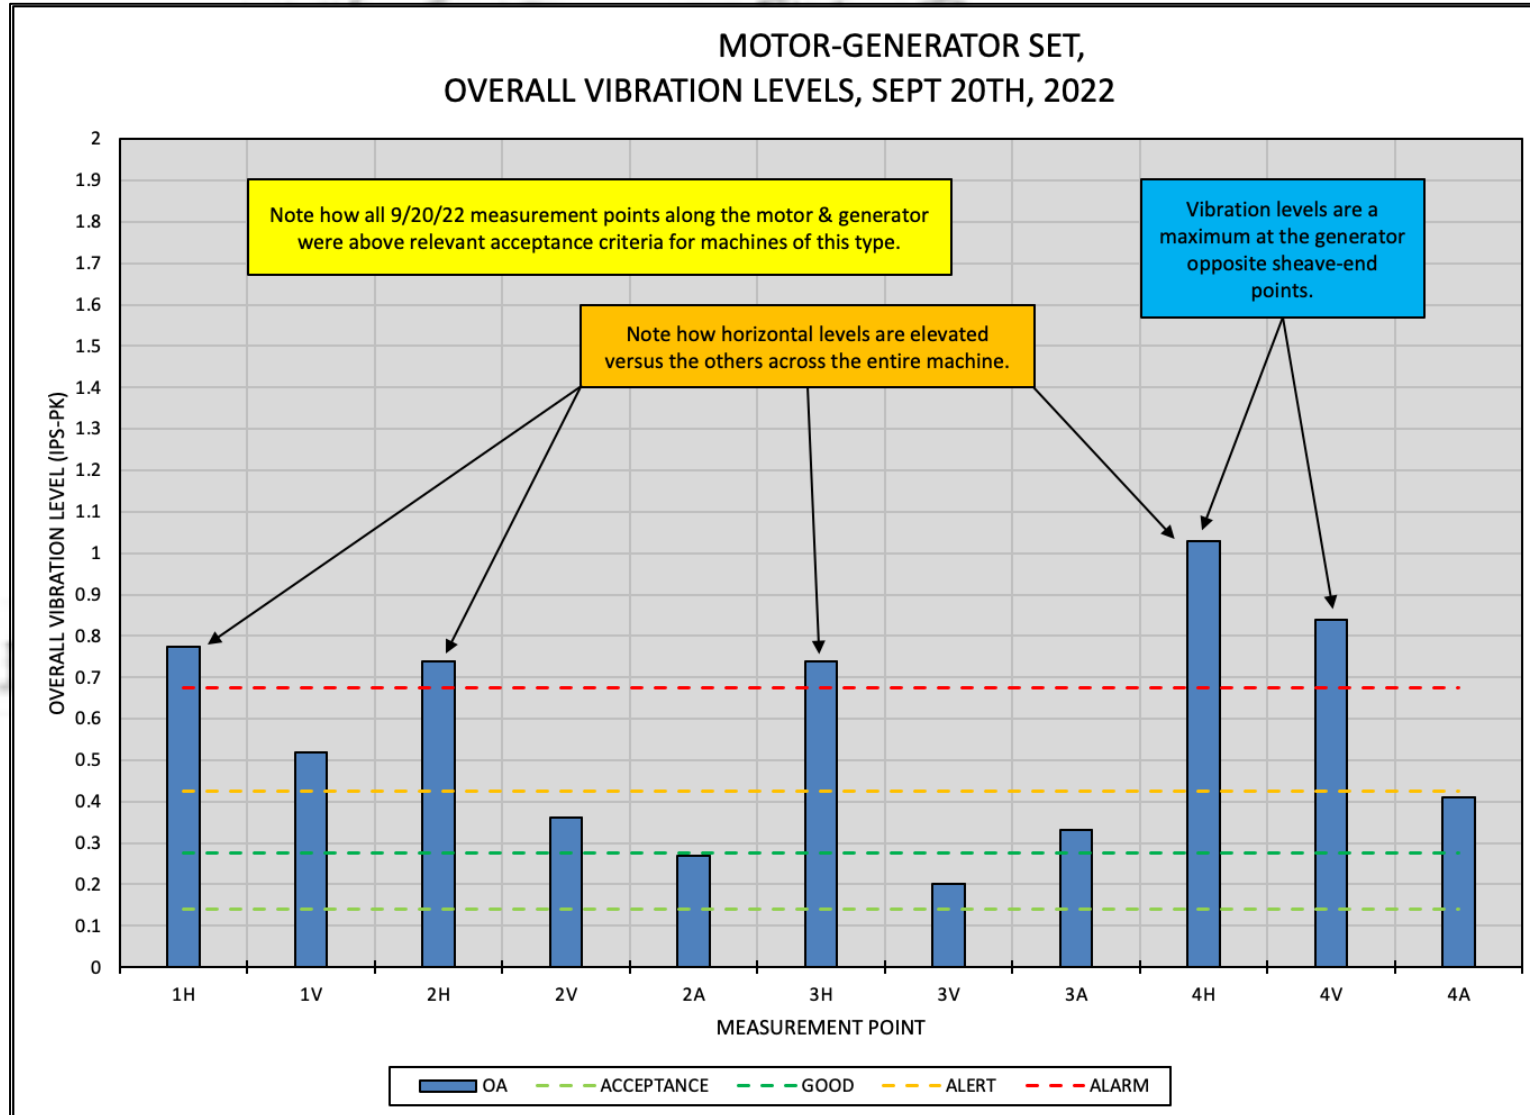
From the overall levels alone we could see our **horizontal** (belt-direction) vibration was highest across both motor & generator.

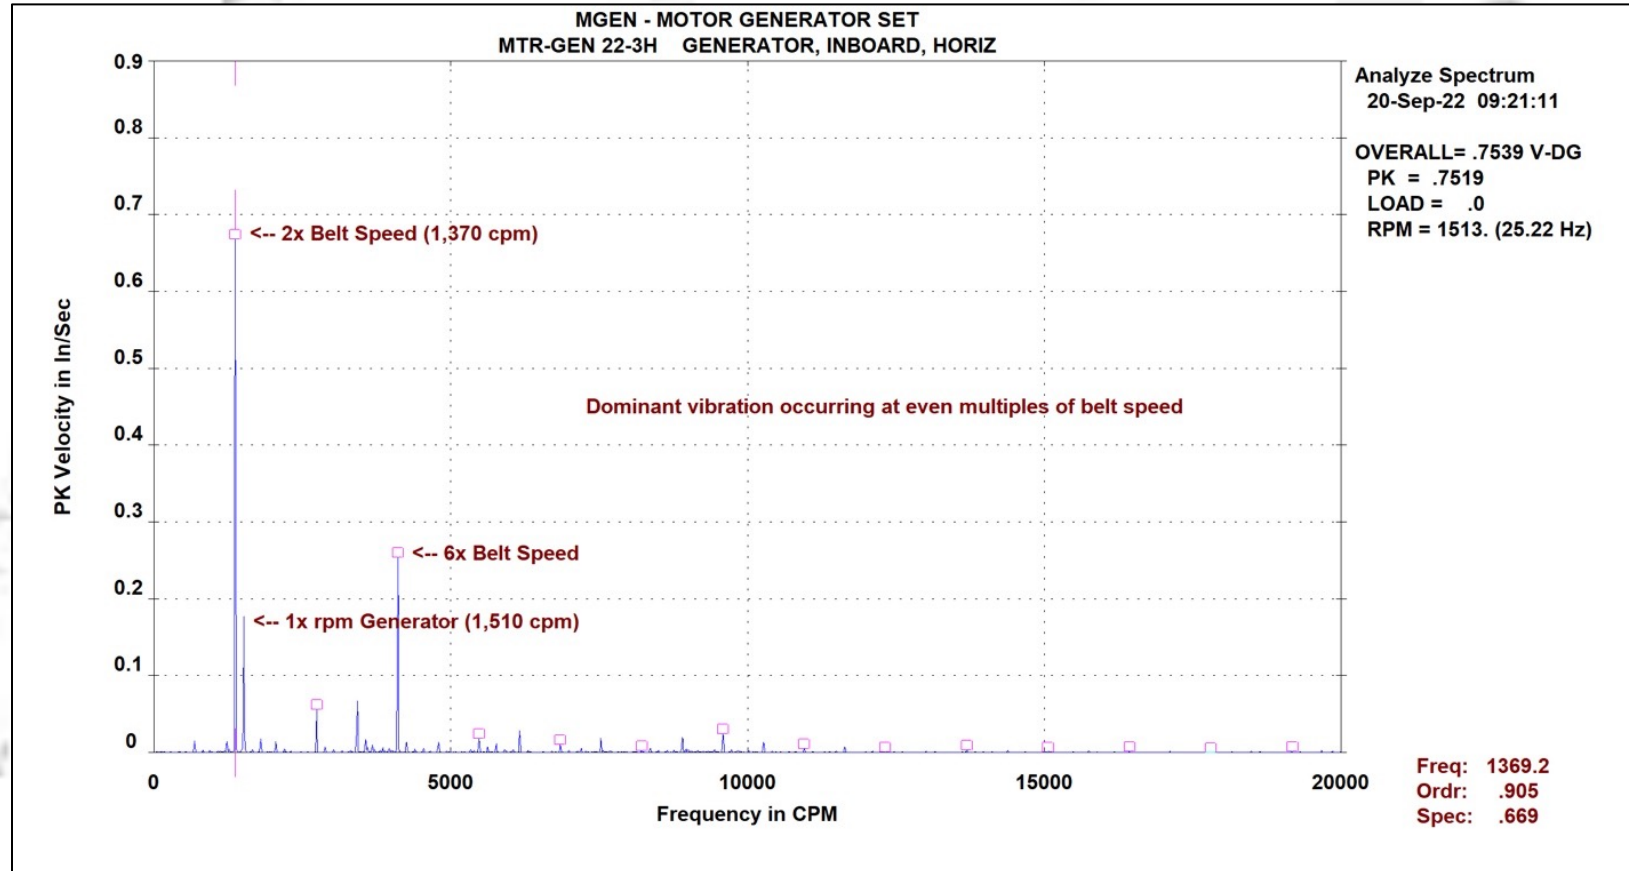
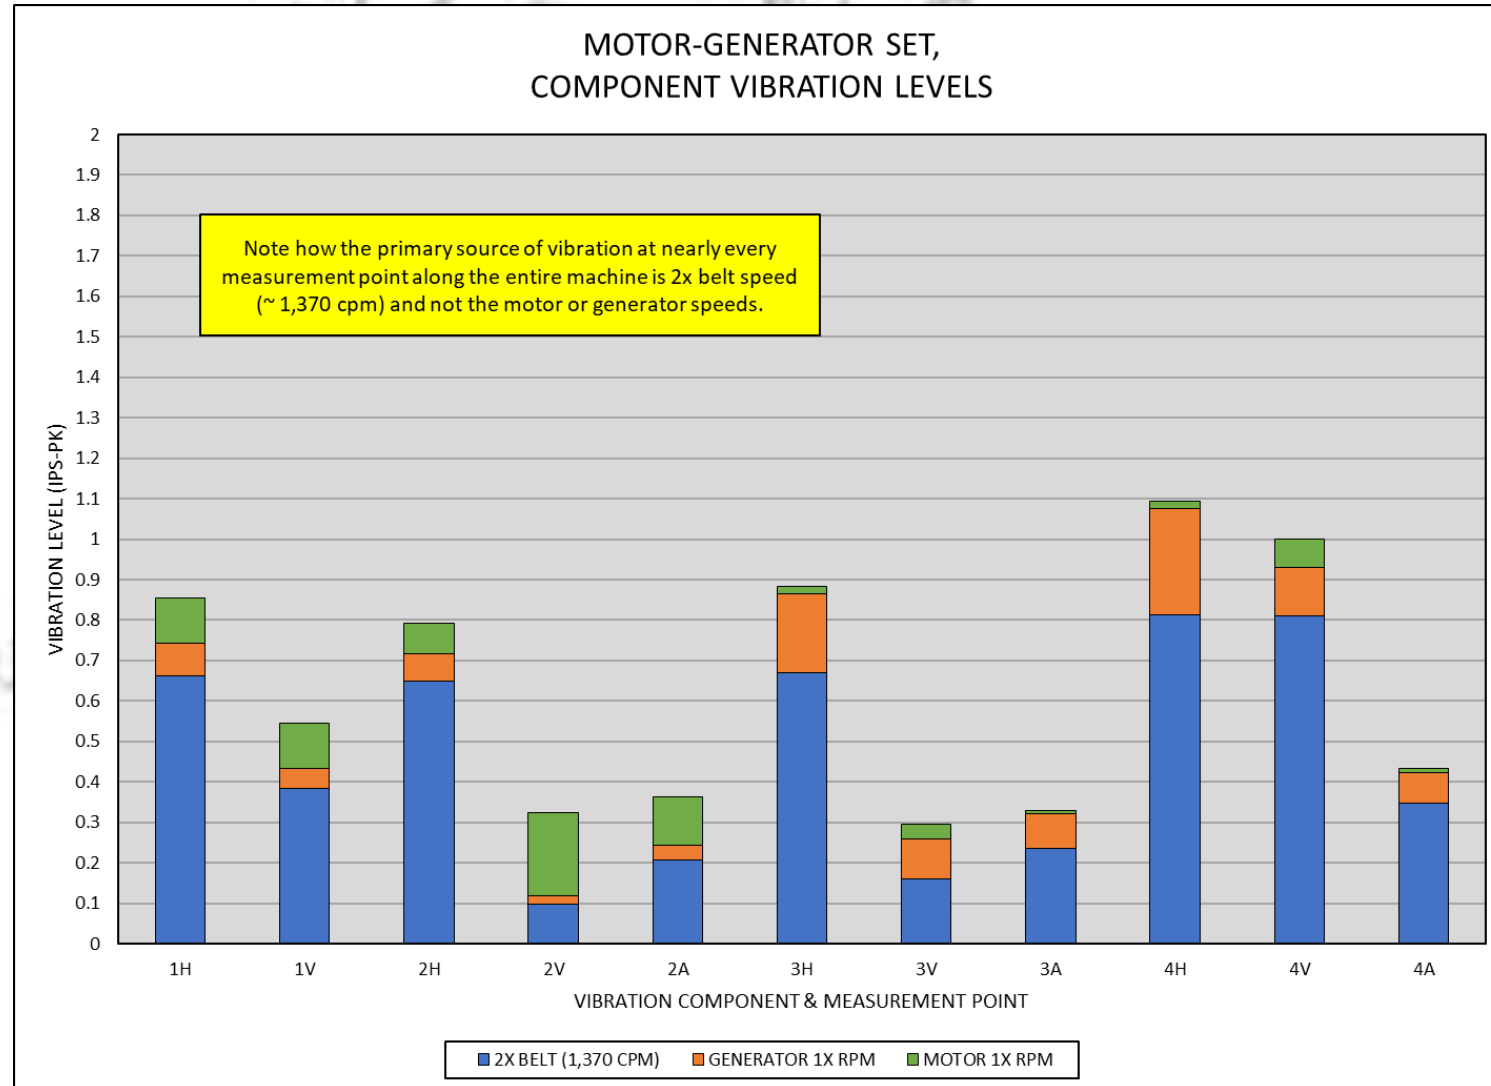
- Vibration spectral data from the points of highest vibration noted dominant vibration occurring not at the motor speed of $\sim 1,800$ cpm or the generator speed of $\sim 1,500$ rpm but instead at $\sim 1,370$ cpm.
- We recalled our belt speed was estimated at 688 rpm giving us 2x belt speed at $\sim 1,376$ cpm which is essentially a perfect match with the dominant vibration frequency seen.
- But why was vibration at 2x belt speed so high especially on a new machine with a new set of belts installed?
