Iris Power MDSP3

Detecting motor rotor cage-winding faults
and air gap eccentricity

A Third Generation On Line Tool to Find Broken Rotor Bars and Rotor Air Gap Eccentricity in Induction Motors

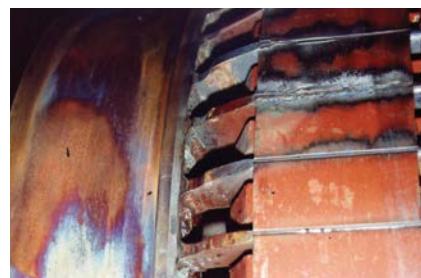
Rotor core damage due to broken bars

Rotor Core damage: Broken bars cause local temperature increases and arcing leading to rotor core damage.

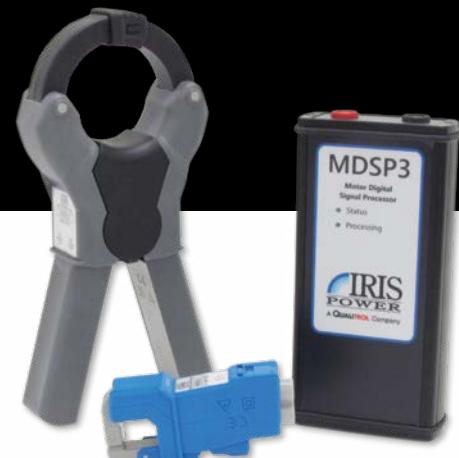
MDSP3 with 2 CTs

Simplicity: Iris Power MDSP3 can detect cage winding faults and eccentricity with the use of a single clamp-on current sensor connected to the secondary side of 50 or 60 Hz motor current transformer; or around one of the phase leads.

Range and accuracy: Iris Power MDSP3 can accurately test motors under varying load conditions where many other test systems give ambiguous results. The Iris Power MDSP3 includes two current probes to cover a wider range of current from 5A to 1000A.

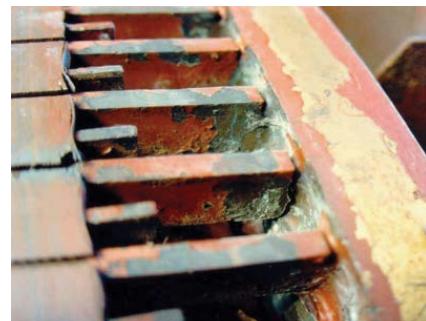
Broken rotor bar

Rotor bar movement and failure: Broken rotor bars can lift out of the rotor slot due to centrifugal force or pieces of them can break off and cause a stator winding failure.

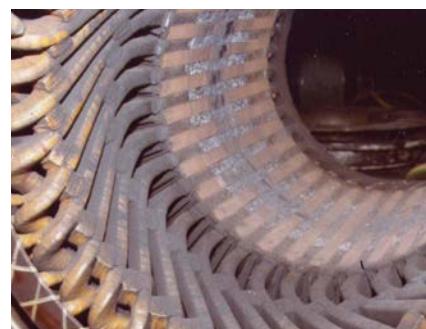
Stator rub due to eccentricity

Rotor eccentricity: For the rotor rotating off center, both static and dynamic eccentricity in conjunction with the resulting unbalanced magnetic pull can lead to: 1) high vibration levels from rotor unbalance, 2) a rotor to rub against the stator bore which can cause a stator winding failure.
