This report has been prepared exclusively for  
**JOE & JANE SAMPLE**

123 Fun Street  
Somewhere, CA 01010  
Inspection Date: 01-10-14

## SUMMARY OF KEY FINDINGS

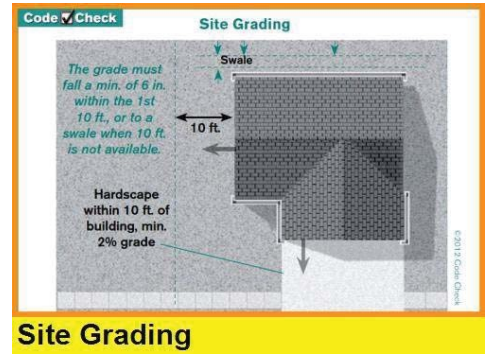
2.A.1-1 SITE GRADING

[CR] A reverse grade was present (sloped towards the structure) at the right side(s) of the building. This means water/moisture will flow towards the building rather than away. This condition is conducive to moisture intrusion and/or deterioration of the building components. The grading should have a positive slope away from the building, dropping at least 6 inches in 10 feet or slope to a drainage system if the building is closer than 10 feet to the property line.

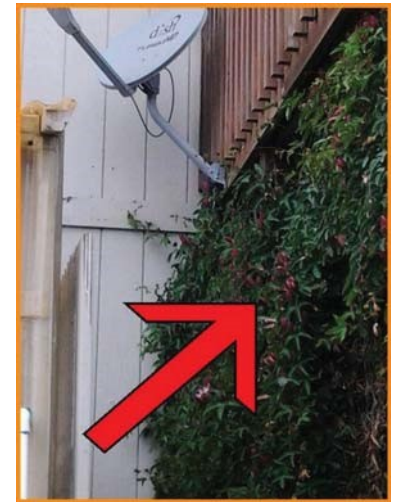
2.A.1-3 LANDSCAPING

[CR] Vegetation was growing on the structure at the left side(s) of the building. This condition limits the inspection, and is conducive to moisture intrusion/deterioration of the building components and provides ready access to rodents and insects.

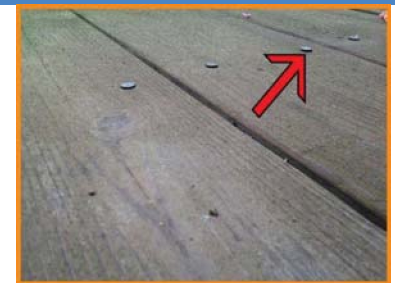
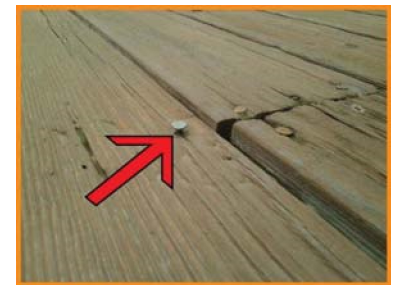
2.A.3-1 ATTACHED DECK(S)

[CR] Wooden structural components were in contact with the soil at the right side deck. Wood in contact with the soil is subject to premature decay and failure.

[SC] Nails were protruding from the decking. This is a laceration or trip hazard that may result in physical injury.

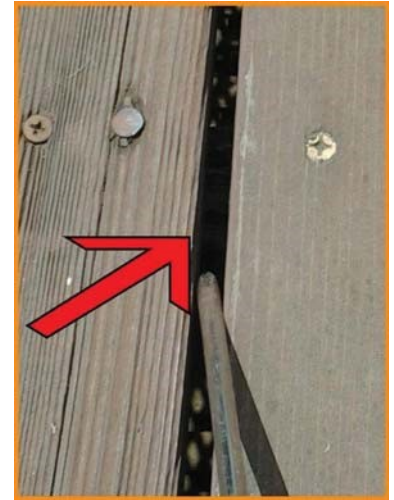
[SC] The deck at the left side(s) of the building had wide spaces between the deck boards. This condition is a trip and fall hazard.

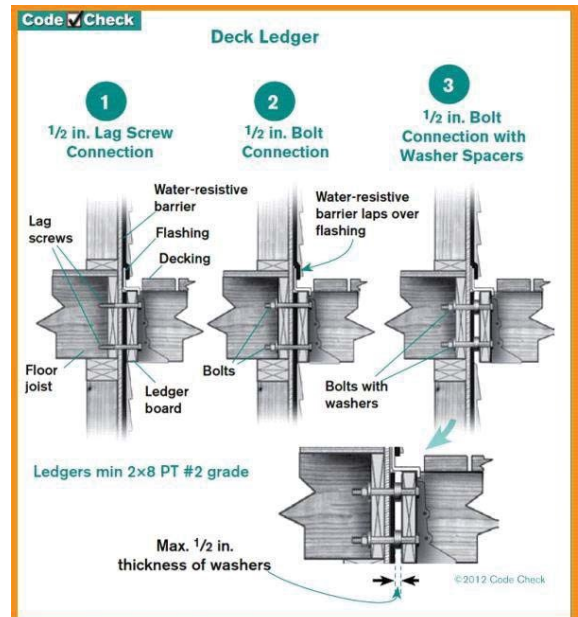
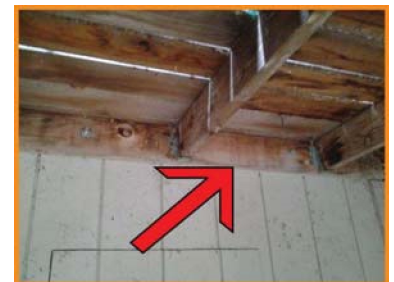
**Lag - Bolt - Flash**

[FE] The ledger was installed over the cladding for the deck at the left side(s) of the building. This condition makes the wall to deck connection difficult to flash and creates shear stress on the connectors.

[CR] There was no flashing at the ledger for the deck at the left side(s) of the building. This condition is conducive to moisture intrusion and damage to the building materials.

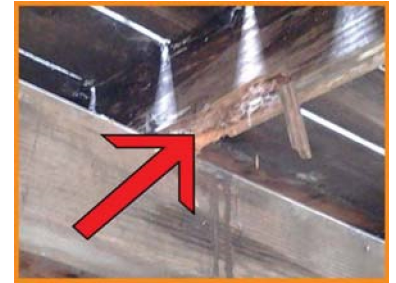
[CR] Moisture damage was noted on the wood deck at the left side(s) of the building. Continued use in this condition may result in premature failure of the deck.

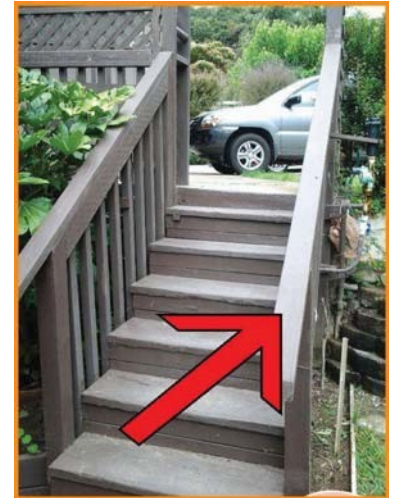
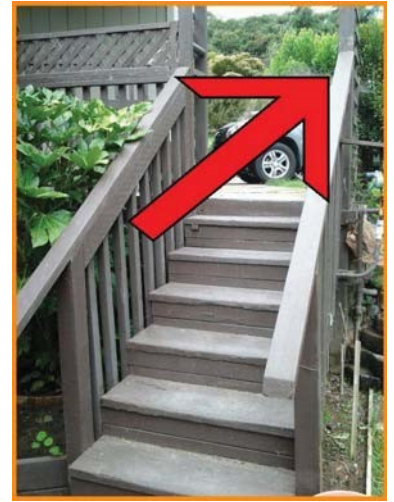
**Grippable / Non Grippable**

[SC] The handrail(s) for the steps/stairs at the front side(s) of the building were loose or not securely fastened in place. The handrail(s) may not be adequately secure to prevent a serious fall should an accident (slip and fall) occur on the steps/stairs.

[SC] The handrail(s) for the steps/stairs at the front side(s) of the building may have met the standards at the time of construction, however they are not considered to be hand grippable by today's standards. Appropriately sized and grippable handrails may be helpful in preventing a serious fall up or down the steps/stairs.

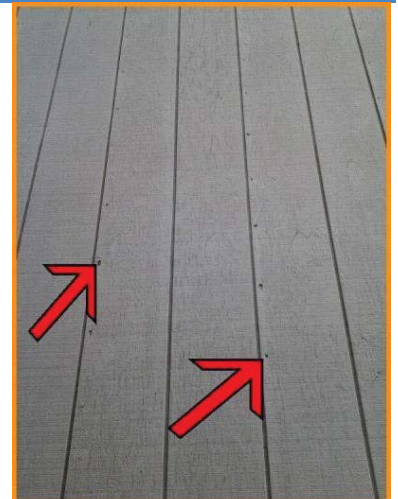
**Fill/Seal**

[CR] The weather seal of the simulated wood cladding was broken at nail penetration points (under and over penetrated). This condition is conducive to moisture intrusion and deterioration of the building materials.

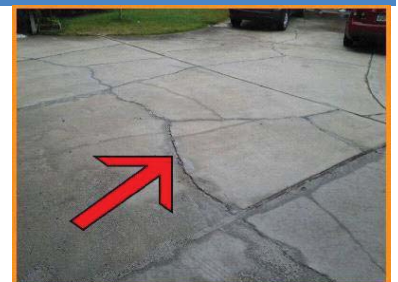
**Keep Filled / Sealed**

[CR] Open cracks were noted in the concrete driveway at the front side(s) of the building. This condition is conducive to moisture intrusion into concealed spaces which promotes deterioration.

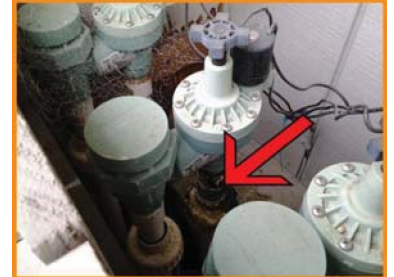
2.B.10 LAWN SPRINKLER SYSTEM(S)

[CR] There were visible leaks at the control valves and anti-siphon devices at the right side of the building. Leaks are a defect in the sprinkler system and are conducive to deterioration of adjacent building materials.

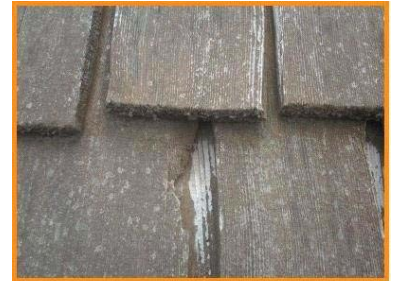
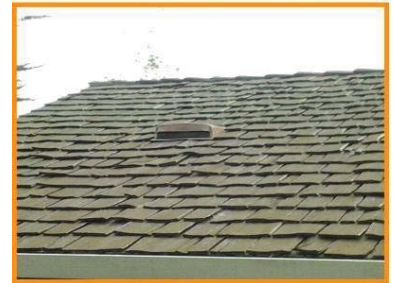
**Open & Lifting**

[NOTE] The roofing material appeared to be in approximately the last quarter of its service life.

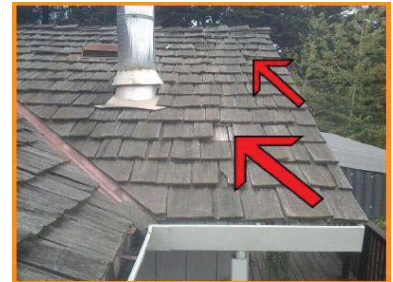
**Missing**

[FE] A number of wood shakes were out of place and missing throughout the roof. This condition is conducive to moisture intrusion and damage to the building components.

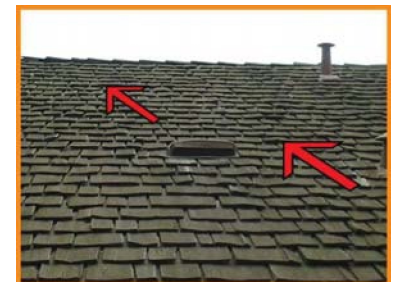
[FE] A number of wood shakes were cupping and lifting throughout the roof. This condition is conducive to moisture intrusion and damage to the building components.

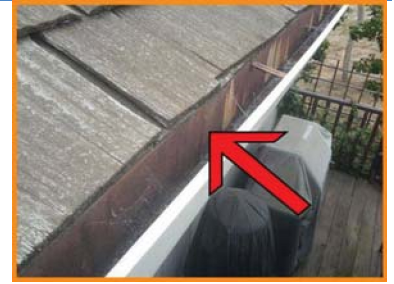
#### 3.A.2-1 DRAINAGE

[CR] The Rain-gutters were rusted/deteriorated at the right side(s) of the building. Continued use in this condition may lead to additional damage.

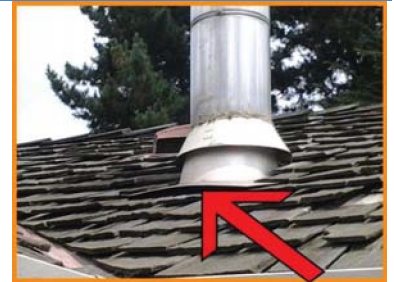
#### 3.A.3 FLASHING(S)

[FE] Roof flashing materials were elevated above the roofing material rather than lying flat. This condition allows for the penetration of driving rain and is conducive to moisture intrusion and damage to the building components.

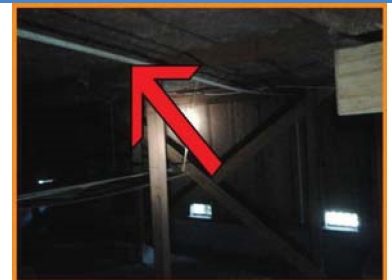
5.A.1-3 **WATER SUPPLY PIPING** [CR] Polyvinyl chloride [PVC] piping used within the building envelope at the crawl space. This type of water piping is generally not rated for use within the building footprint; the most common use for this material is lawn-sprinklers and exterior water-feature piping.

[CR] Polyvinyl chloride [PVC] piping used at the exterior was unprotected and exposed to sunlight. This type of pipe becomes brittle and fails when exposed to sunlight, we recommend painting or some other protection.

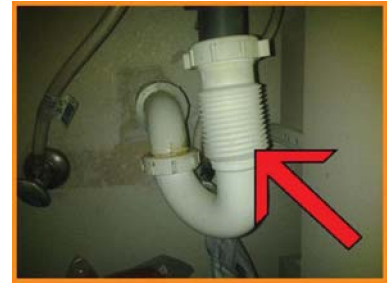
**5.A.2-1 DRAIN PIPING**

[CR] A corrugated plastic product was being used as drain pipe at the master bath and hall bath sink(s). While sold at many "do-it-yourself" stores this material is not approved for this application as the corrugations trap bacteria creating a safety concern. Additionally, these lines are known to result in regular clogging. All drain, waste and vent pipes should have a smooth internal bore and be self-cleaning and self-scouring.

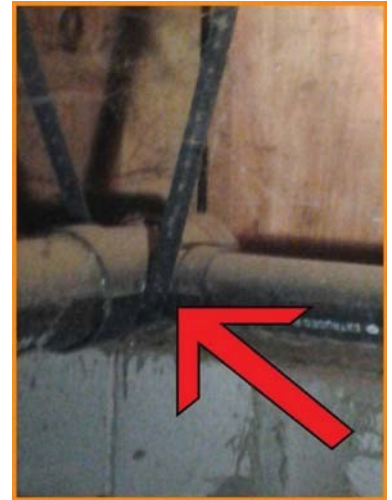
**5.A.2-2 WASTE PIPING**

[CR] A number of the waste pipe fittings in the foundation crawl-space were an improper type or incorrectly installed at the right area(s) of the building. For the waste piping system to function as designed only the appropriate fitting should be installed.

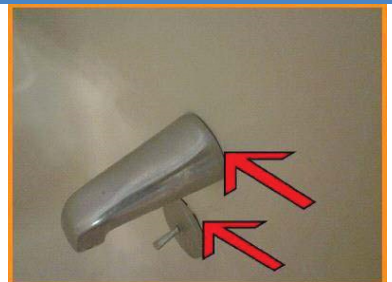
**Caulk/Seal**

[CR] The bath tub faucet/spout were not sealed to the wall/deck in the master bath and hall bath. This condition is conducive to moisture intrusion into concealed spaces and deterioration of the building materials.

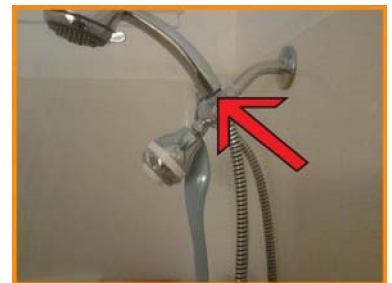
[CR] The shower head was loose/leaking in the hall bath. This condition is conducive to moisture intrusion into concealed spaces.

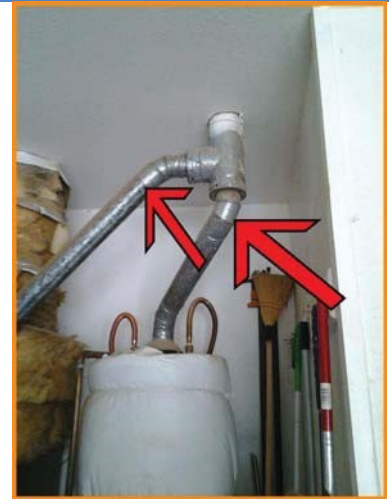
**5.A.5 WATER HEATING UNIT # 1 - CONDITION**

[SC] The water heater vent was connected to the common gas vent prior to the furnace. The largest Btu appliance should be vented first, followed by (higher) the lower Btu unit. This condition may not allow the water heater to vent properly and increases the chances for the its flue to spill carbon monoxide back into the building.

[SC] There was no collar/bucket/thimble to separate the vent pipe from the ceiling or combustible materials. The collar/bucket is needed to provide adequate clearance to minimize heat transfer to combustible materials.

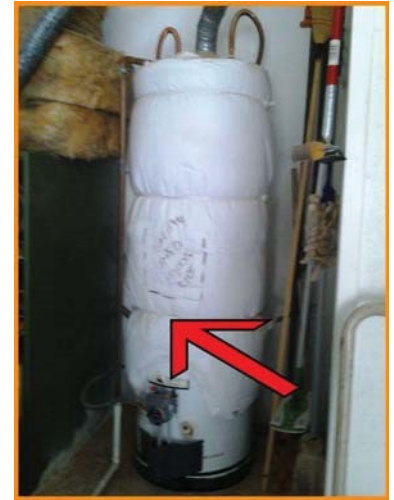
5.A.5-5 SEISMIC BRACING

[SC] The unit did not have two straps securing it in place. Units with fewer than two straps are not properly secured against seismic activity.

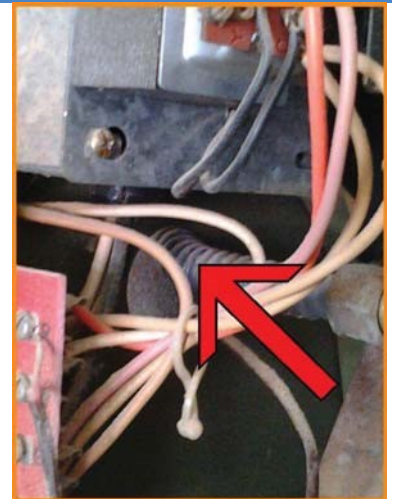
7.A.1-1.6 HEATING ENERGY SOURCE	[SC] The gas flex-connector was in direct contact with the sharp edge of the metal housing where the connector entered the heating equipment. The two components may rub together during system operation and cause a gas leak and creating a fire / explosion hazard. The gas flex-connector should not extend into the machine housing to connect to the equipment.
---------------------------------	---

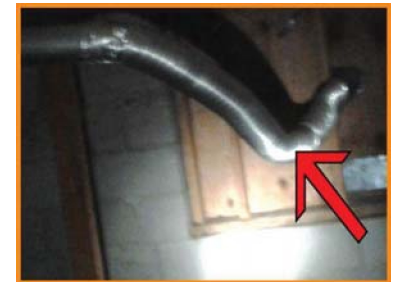
[SC] The dryer vent ducting in the foundation crawl space was plastic. For reasons of fire safety - dryer vent ducting in this location should be a solid, smooth interior, metal ducting.

**Flexible ducting should never go through a wall, in the attic or under the house.** It should only be used between the dryer and the wall.

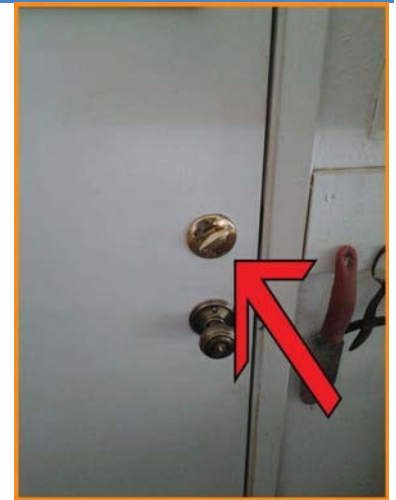
[CR] The entry door(s) had some past damaged in the master bedroom. Continued use in this condition may lead to additional damage.
