Tug Lake Internal Phosphorus Loading Study 2018: Summary Report

Todd Miller

University of Wisconsin – Milwaukee, Joseph J. Zilber School of Health, Milwaukee, WI

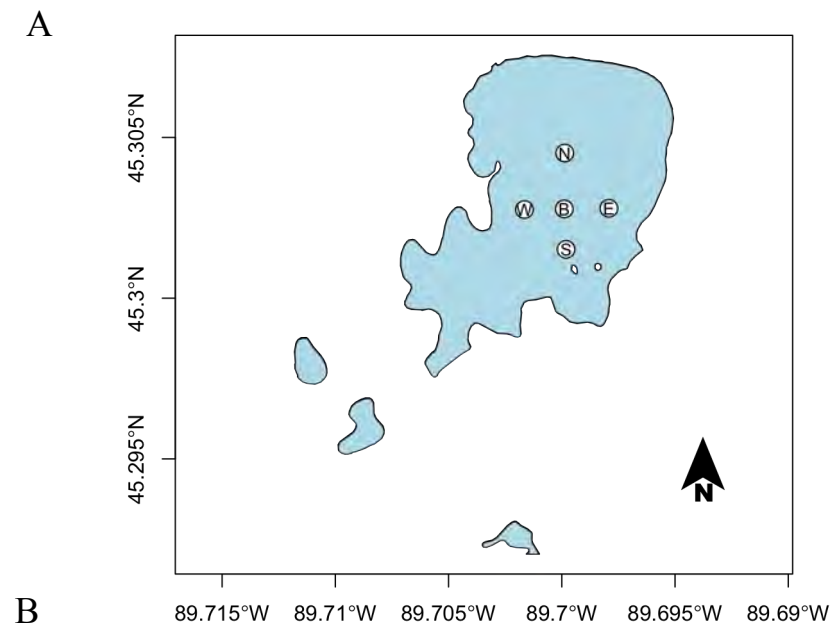
Figure 1. Study site. A). Tug Lake sampling sites. N = north, W = west, S = south, E = east, B = buoy location. B) Water quality monitoring buoy in Tug Lake

Sampling. Water sampling was conducted at four sites within the central basin of the lake (Figure 1, Table 1). Water was collected at discrete depths using a Van Dorn sampler and transferred to certified cleaned amber glass bottles filling the bottle half way, and stored frozen within two hours. Samples were then shipped frozen to the Miller Laboratory at the University of Wisconsin – Milwaukee in batches throughout the summer. At each location and during each sampling event a data sonde (In Situ Aqua Troll 600) was used to measure water temperature, dissolved oxygen, pH, oxidative-reductive potential, and conductivity at multiple depths. A detailed sampling protocol written by the Tug Lake Task Force (Reid Badeau) is provided in Appendix II.

Water Quality Monitoring Buoy. A water quality monitoring buoy (Nexsens CB-450 Data Buoy, Fondriest Environmental) was deployed at site B (Figure 1) on June 28th, 2018 equipped with sensors measuring water temperature every meter from the surface to a depth of 6 m, photosynthetic active radiation (light at wavelengths that can be used by algae) at 0.5 m, algal pigments chlorophyll and phycocyanin at 0.5 m, dissolved oxygen at depths of 0.5 m and 4 m and wind speed approximately 0.5 meters above the lake surface (Table 2). Measurements were made every minute.

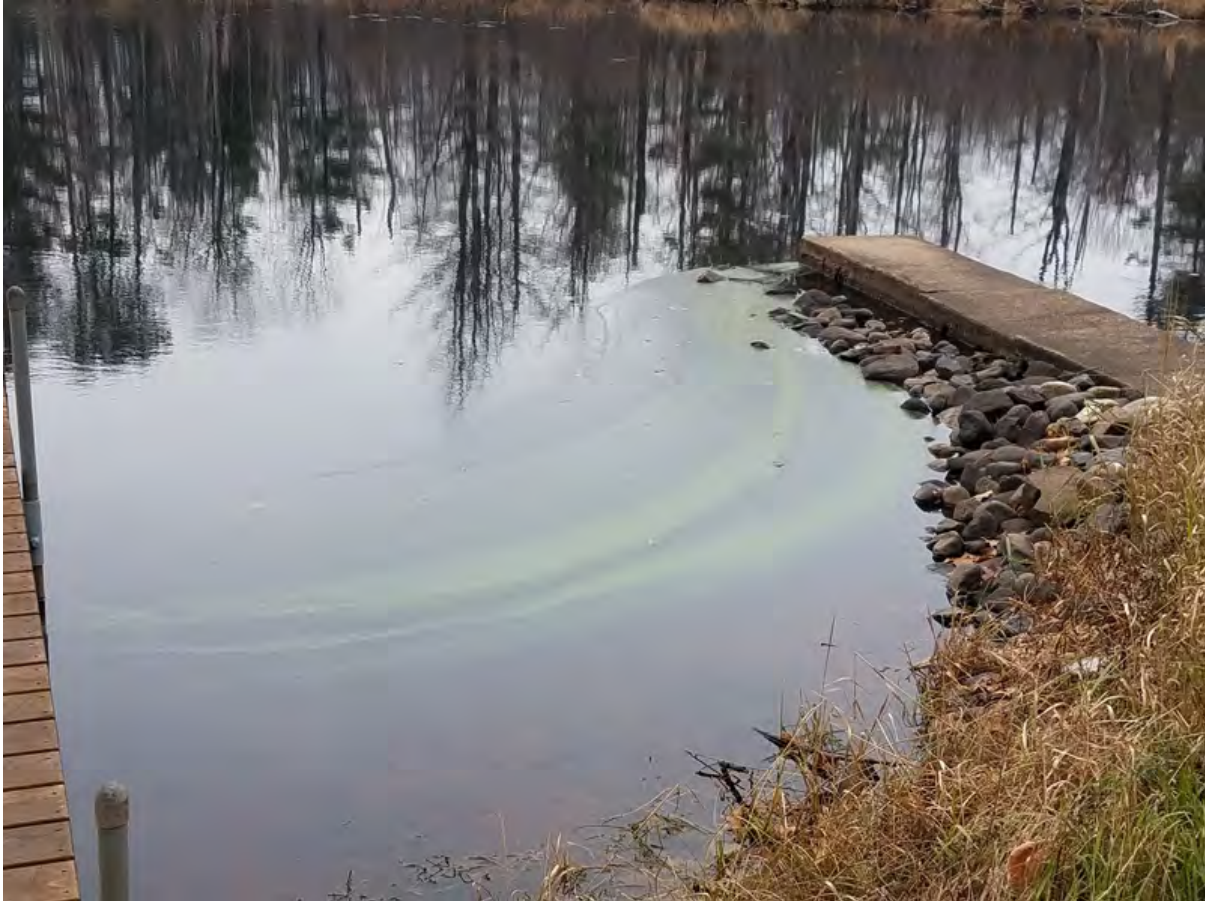
Figure 3. A late October bloom. Near shore bloom late in the season on October 26th (photo credit: Reid Badeau)

Extra samples were taken by Reid Badeau of the near shore bloom in late October. One sample was taken near the shore in heavy bloom conditions, one off the dock 18 feet from shore where very little bloom was showing, and at the beach on the north end where no bloom was showing. Concentrations of MC-LA in the heavy bloom sample was 130 µg/L, over 16 times the safe recreational level. Concentrations of MC-LA was approximately 0.5 µg/L at both of the other sites where little or no bloom was evident.

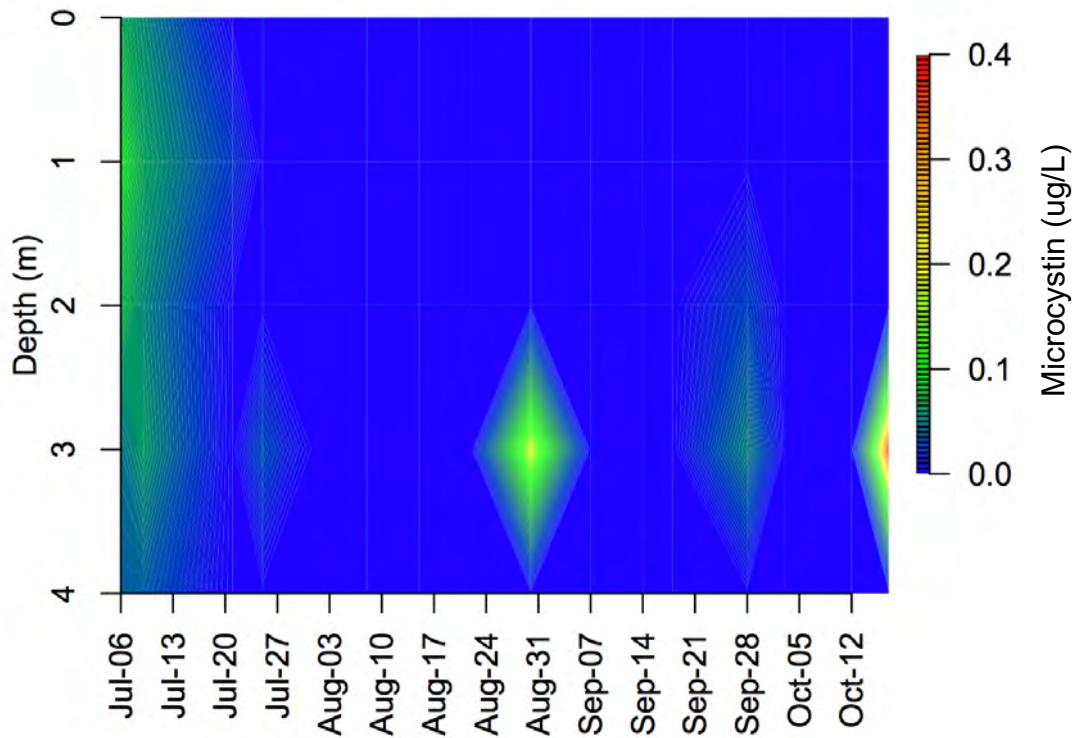
Figure 4. Microcystin toxins at the deep hole. Concentration of microcystins by depth at the deep hole of Tug Lake (location B).

Algal toxins. A total of 195 samples were analyzed for the liver toxin microcystin. The overall average concentration of microcystin in 2018 at all sites (0.7 $\mu\text{g/L}$) was much lower compared with 2017 (7.2 $\mu\text{g/L}$). The only microcystin variant that was detected was microcystin with

leucine and alanine (MC-LA) in the 'X' and 'Y' variable positions of the molecule. Other microcystin variants were detected in 2017, but the MC-LA variant was the most abundant. It is somewhat unusual for MC-LA to be the dominant variant, but other studies in Canadian lakes have made similar observations. Concentrations of MC-LA at all sites was well below the U.S. EPA threshold for recreational environments of 8 µg/L. At the deep hole location concentrations of MC-LA were elevated at the beginning of sampling in early July, as well as on August 30th and at the end of the season in mid- October (Figure 4). In fact, the highest concentration detected at the deep hole was on the last day of sampling on October 17th. Concentrations of MC-LA at the north, south, east, and west sites showed a similar trend with brief increases in MC-LA at the beginning of the sampling period, at the end of August or early September, and at the end of the sampling period in October (Figure 5).

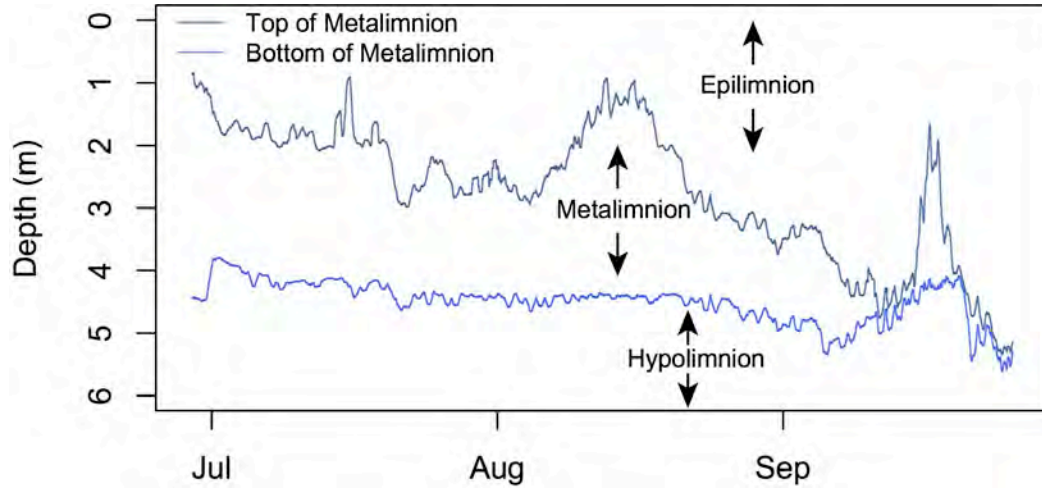
Figure 7. Water layers. Depths of the epilimnion, metalimnion, and hypolimnion in Tug Lake in 2018.

Thermal stratification produces density gradients in lakes that sets up well defined layers in the water column. The epilimnion is the only later that receives sunlight, it is the warmest, and least dense layer. Algal blooms are generally confined to this layer of the lake. In Tug lake the depth of the epilimnion was limited to 2 m for most of the season until September when the lake entered fall mixis (Figure 7). A shallow epilimnion in Tug is partially due to high light attenuation by tannic acids in the lake. The hypolimnion at the bottom of the water column is the most- dense layer where nutrients such as nitrogen and phosphorus are concentrated. The hypolimnion was significantly more dense than the epilimnion in Tug Lake (Figure 8) and they were well separated from each other except for September when the lake entered fall mixis (Figure 7). The metalimnion is a transition zone between the epilimnion and hypolimnion. The metalimnion could be an important source of nutrients feeding algal blooms if even brief, partial mixing events deliver nutrients to the epilimnion. This has been shown to occur in other lakes including Lake Mendota (Stauffer and Lee 1973). In addition, cyanobacteria (blue- green algae) can vertically migrate through the water column using proteinaceous gas vesicles. In some cases they may even migrate to metalimnion depths (Ibelings et al. 1991).

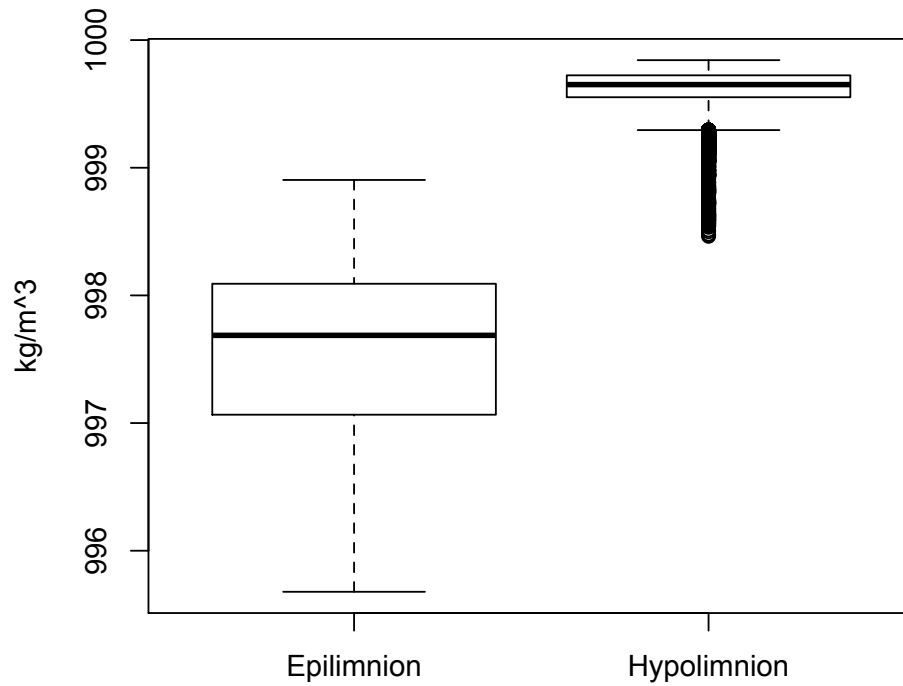
Figure 8. Water density. Box plot of water density of the epilimnion and hypolimnion in Tug Lake in 2018. The dark line in the center of each box is the median, edges of each box are the upper and lower quartiles, the whiskers represent scores above and below the middle 50%. Circles are outliers. The average density in epilimnion and hypolimnion are significantly different at an alpha of $P < 0.01$ based on a rank sum test.

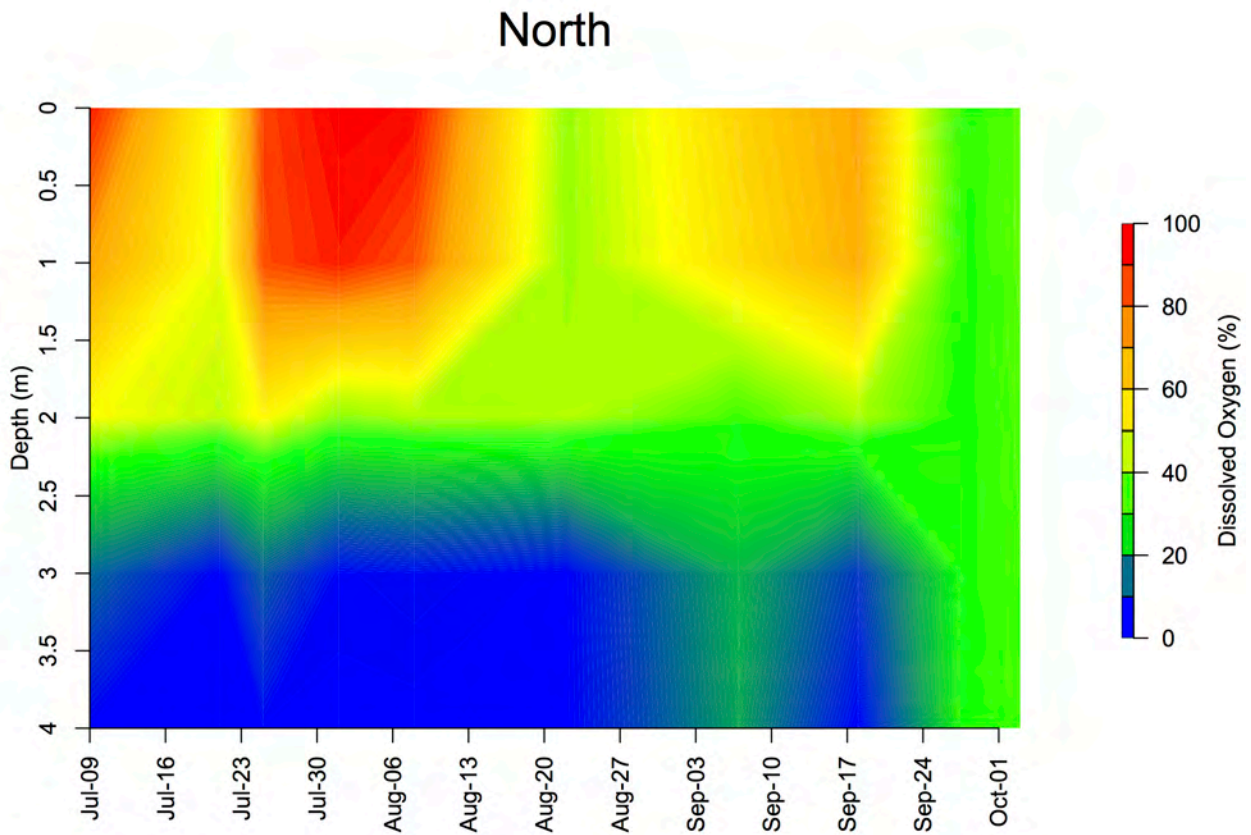
Figure 10. Dissolved oxygen by depth at the north location.

Sonde casts measuring dissolved oxygen at north, south, east, and west locations showed that the water column was anoxic from 3 meters and below for much of the season (Figures 11 – 13) and followed similar trends measured by the buoy dissolved oxygen sensors. Therefore, the anoxic zone below 3 meters was not limited to the deep hole location. This is important since the absence of oxygen can encourage the release of phosphorus from sediments.

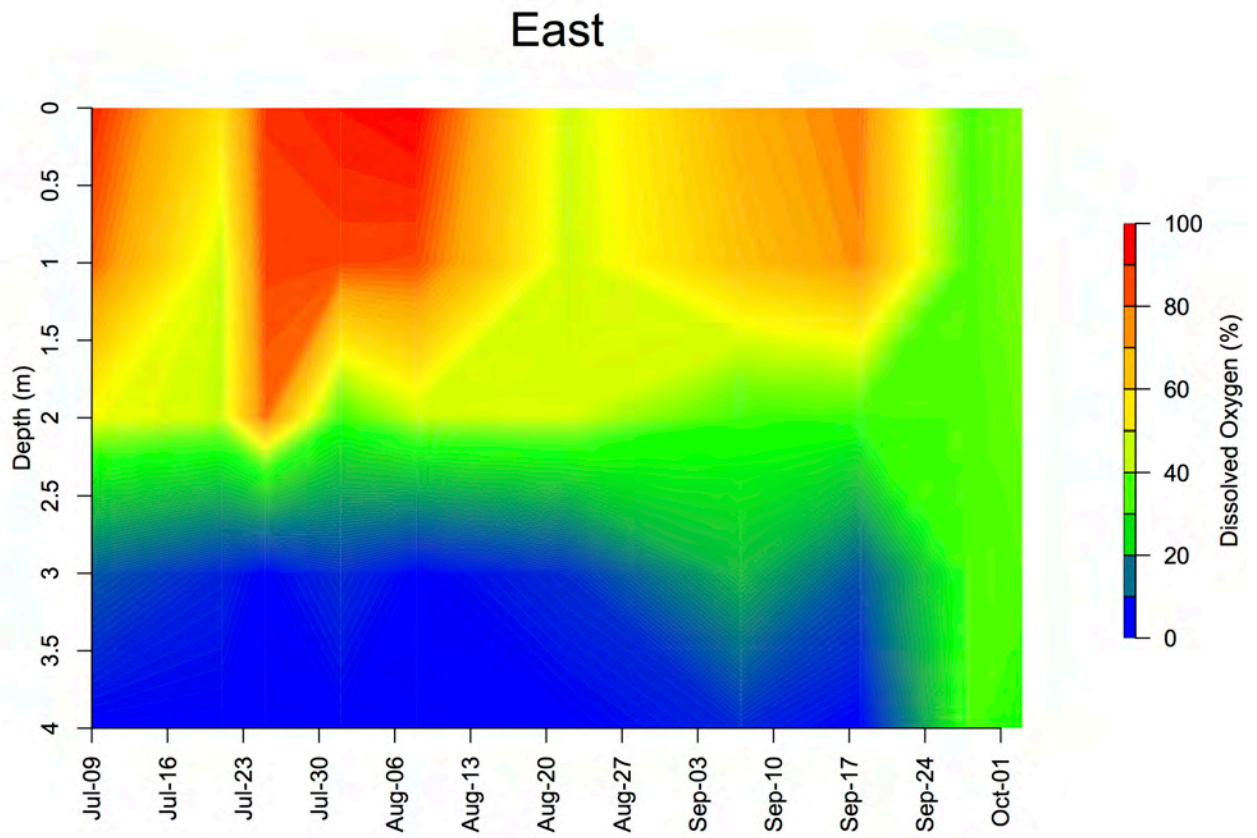
Figure 12. Dissolved oxygen by depth at the east location.

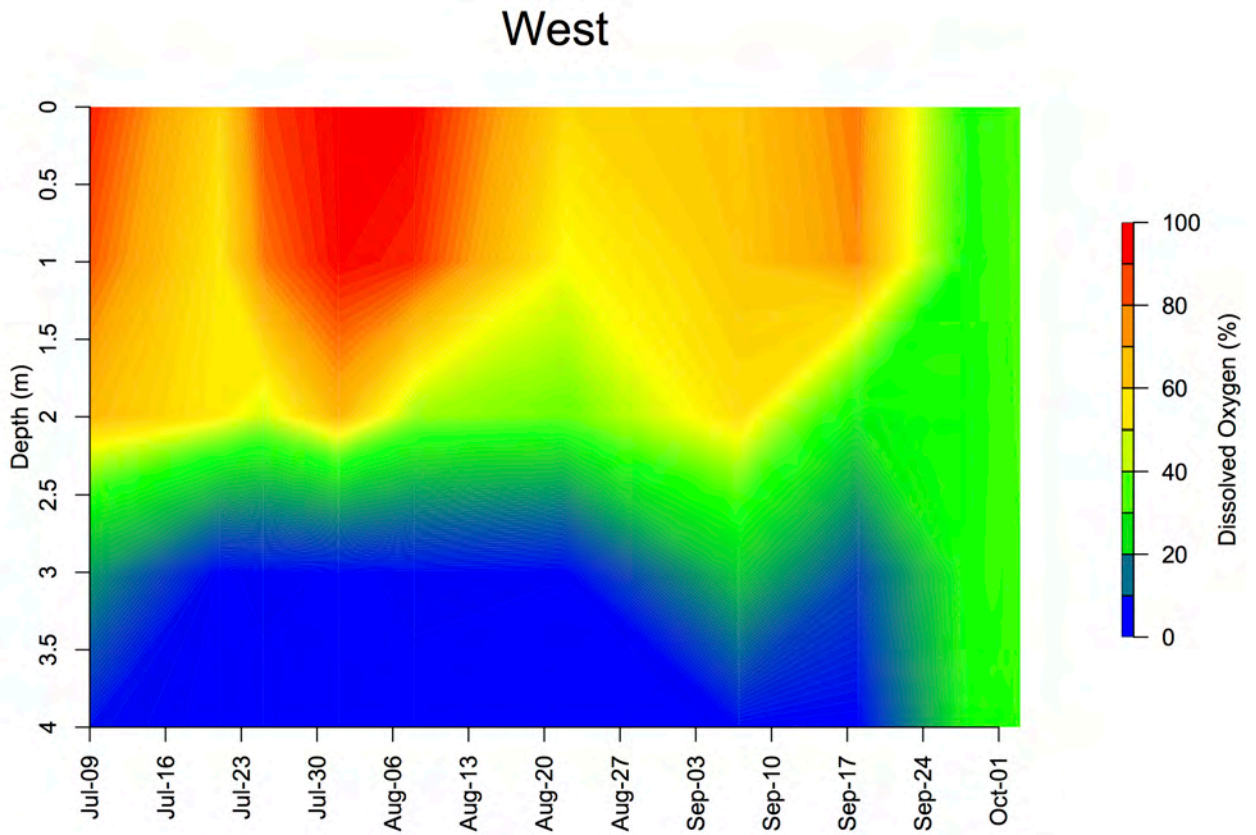
Figure 13. Dissolved oxygen by depth at the west location.

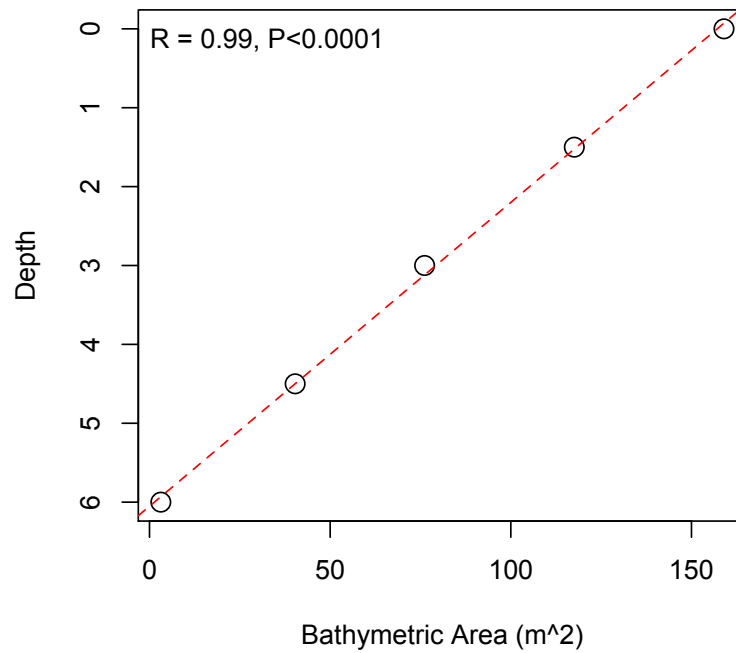
Figure 16. Bathymetry of Tug Lake is cone shaped. Relationship between bathymetric area of Tug Lake and depth in meters is linear.

Estimating Internal Phosphorus Loads. The anoxic zone occurred at 3- 4 meters and deeper at all locations within the central basin of Tug Lake. Using the documented bathymetry of Tug Lake (Figure 15) we estimate the volume of anoxic water in the center basin to be 2.8×10^{10} liters. This assumes the center basin is cone shaped. This is a reasonable assumption given that there is a linear slope in bathymetric area with depth (Figure 16). The average SRP at all locations at 4 meters was 18.7 $\mu\text{g/L}$. Assuming a homogenous distribution at 4 m and below to 6 m then the total mass of SRP in the anoxic bottom waters of Tug averaged an estimated 5.3 kg. At peak SRP in mid- August the total mass of SRP is estimated to be 36 kg in anoxic bottom waters. If all of the mass of SRP in bottom waters was available for growth of *Microcystis* species then it is

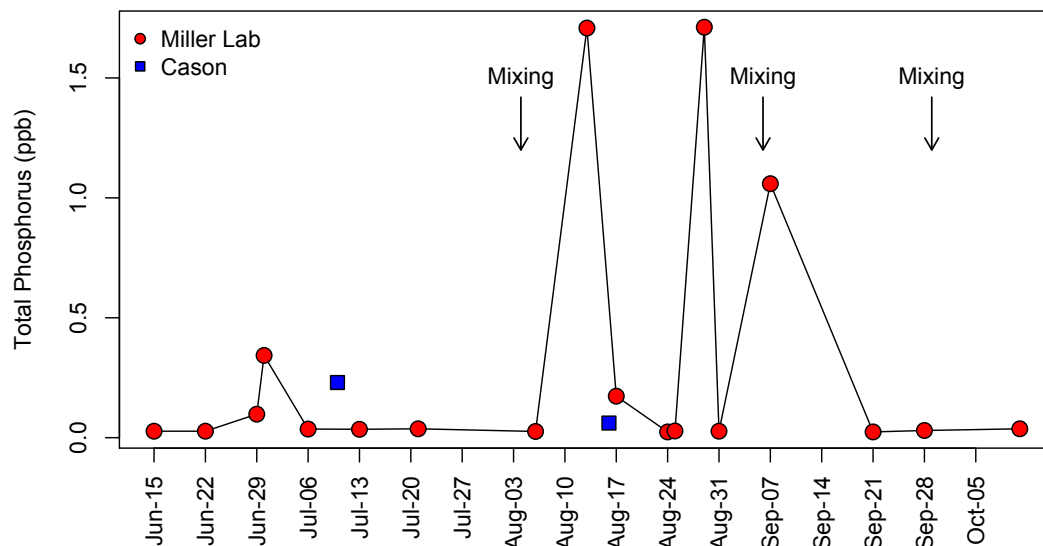
Figure 6. Trends in total phosphorus concentrations at the Deep Hole location.

Total Phosphorus. TP at the DH location was highly variable. For the majority of sampling dates TP was less than 0.1 mg/L. However, on three occasions TP increased to well above 0.5 mg/L on August 13th, August 29th, and September 7th. All three of these occasions occurred after the first mixing event was recorded by the buoy. This may indicate that mixing played a role in delivering phosphorus from bottom waters to the surface waters at the DH location.
