Chico Plant Introduction Garden Forest Service Site #05-08-60-02

*Section 106 Determination of Eligibility
Report #R2020050800025*

Chico Plant Introduction Garden FS Site #05-08-60-02 Mendocino National Forest

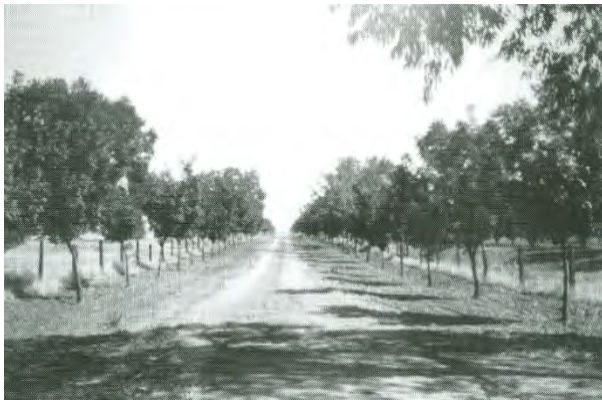
Figure 12: *Pistacia Avenue, Chico Plant Introduction Garden, 1930s. Photograph from Jones & Stokes Associates, Inc., Application for California Point of Historical Interest, 1995.*

Immediately north from Area J, on the west side of today's West Orchard Road, is a row of ornamental pistachio trees, depicted in Figure 191 as Area K. Frank N. Meyer collected cuttings of ornamental pistachios on his first expedition to China from 1905-1906, where they grew around ancient temples in the country's western hills.¹⁹¹ The ornamental pistachios growing on the west side of today's West Orchard Road (formerly Pistacia or Pistache Avenue), are what remains of "a trial avenue a quarter of a mile long, planted at the Chico Garden in 1910." Already by 1916, P.H. Dorsett said of this trial avenue that "the peculiar beauty of the Chinese pistache [sic]... already makes an excellent appearance."¹⁹² Figure 12 shows a view of Pistacia Avenue in the 1930s. Known for their dramatic foliage and propensity to live to an old age, thousands of young ornamental pistachios were distributed to parks throughout the country in the early 20th century.¹⁹³ J. Everett Morrow, superintendent of the garden during two periods from 1911 to 1916 and from 1921 until 1951, said of the ornamental pistachio: "We had one at the entrance of the Plant Garden, and it shone up brilliantly in the Fall, if water was kept off the trees, they would color up brilliantly, red, and purple, and gold, but if you watered them they stayed green and fell without any coloration."¹⁹⁴ Today, ornamental pistachios only occur on the western side of West Orchard Road, though aerial photography from 1975 indicates that the removal of the ornamental pistachios from the eastern side of the road pre-dated transfer of the property to the Forest Service. The eastern side of West Orchard Road is today planted with a genetically improved ponderosa pine seed orchard (see cover page and Figure 211 below). This impacts the avenue trees' integrity of design, feeling, and setting, though its location and association remain intact. At least one large-diameter eucalyptus tree was also planted on the west side of today's West Orchard Road.

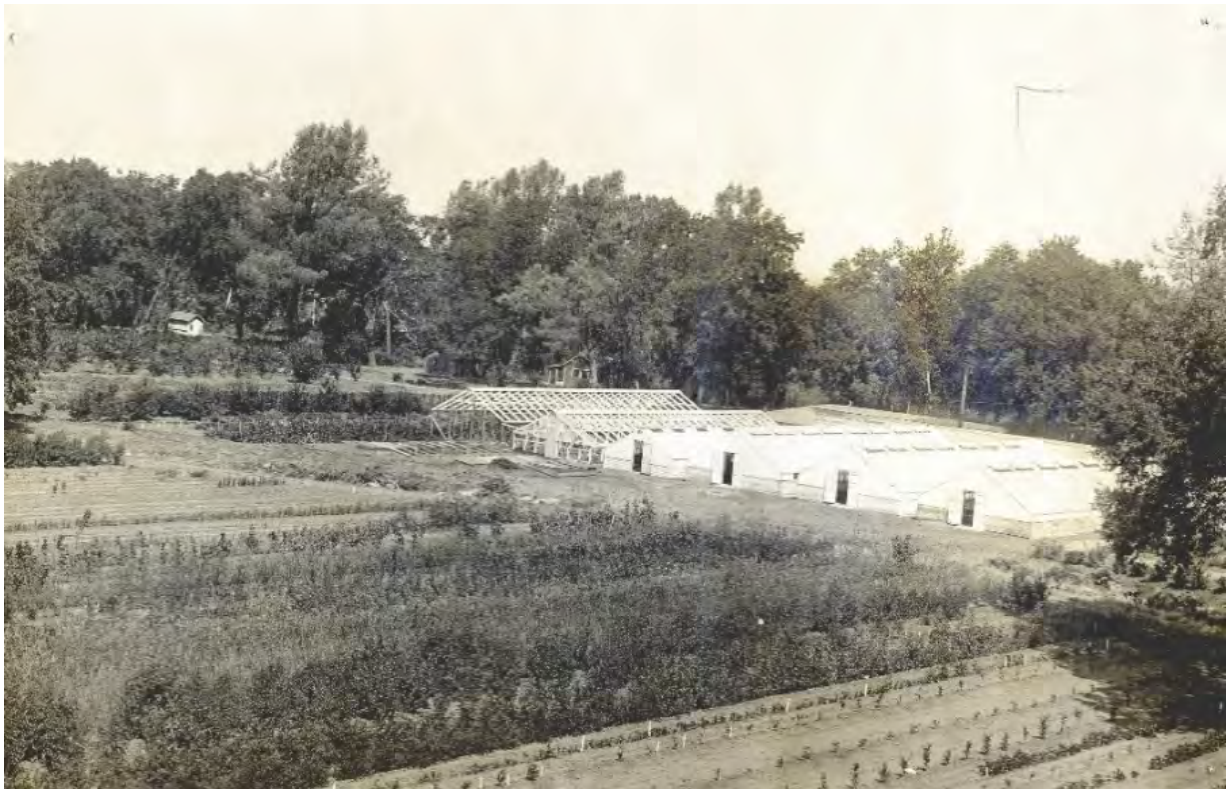
Figure 15: Row of introduced crops, transferred into fields, surround the garden's first set of greenhouses, four of them complete and two still under construction as of 1913. Photograph courtesy of Barbara R. Wilson and the Meriam Library Special Collections of California State University, Chico.

In the immediate area of the present-day greenhouse, other glass-enclosed greenhouse buildings have stood since at least 1905. As of 1908, Chico boasted two greenhouses.¹⁸⁶ As of 1913, four greenhouses had been constructed on site and two more were still under construction (see Figure 15). Six greenhouses are shown on a survey map from December of 1924. Five are shown as of 1936, three of which are directly adjacent, perhaps connected, to the headhouse, a new construction at that time. Four are remaining as of 1942, one having been replaced by two fish ponds. Two are remaining as of 1957. Only one remains as of 1961, the last of the 1920s-era greenhouses. It is in the same location as the present-day 1966 greenhouse directly across from the propagation area/potting room of the headhouse, though it was longer and thinner (76' by 18') than the present-day greenhouse.

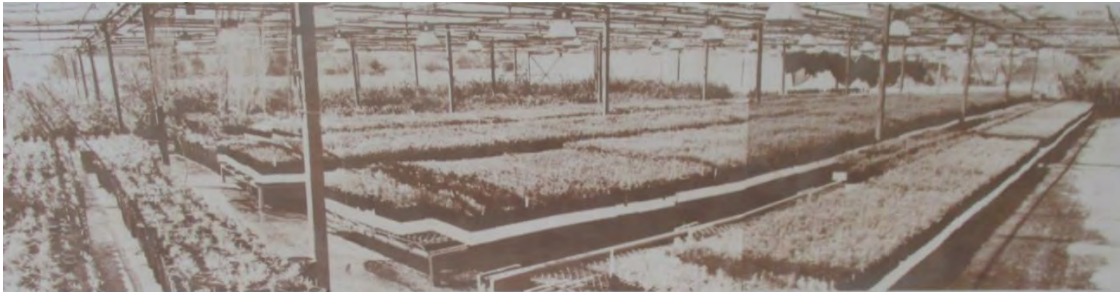
Figure 21: The 1980s-era shadehouse, part of the containerized nursery system of the Chico Tree Improvement Center.

locally grown rootstock. Once established in a greenhouse, the united grafts would be maintained in place for several months before being moved to the shadehouse for hardening until ready for field-planting in one of the center's specific breeding-zone orchards. Cone production under this system is accelerated as a product of the mature scionwood that is utilized. Where it would take a ponderosa pine in a natural forested system approximately 45-60 years to start producing cones, it takes these united grafts only a third of that time once field-planted. The seeds extracted from these cones then become available for genetic evaluation, for reforestation efforts where genetically appropriate, and for use as rootstocks, and the cycle repeats itself. Ultimately the production capacity of the newly established containerized nursery system would approach 59,000 seedlings and 15,000 cuttings at any given time.¹⁶⁹

In 1992, the Chico Tree Improvement Center was renamed the Chico Genetic Resource and Conservation Center, and its mission was re-oriented around management, conservation, and propagation of existing genetic stock on site, as opposed to an active genetic breeding program. The shadehouse was extended in 1992, along with some other infrastructural projects in the area of the Pump/Injector Building and the Shop Road maintenance yard, following the departure of the Butte County Sheriff Department from that area. Interest was renewed in existing *Camptotheca acuminata* stock in support of additional cancer research in the 1990s. Other initiatives were planned or pursued, such as native and riparian plant seed production studies, valley oak provenance studies, a yellow star-thistle predator study, and seed orchard studies for eucalyptus, pacific yew, Chinese maple, and chestnut. During this period, the Chico Genetic Resource and Conservation Center produced trees and plants for purposes of reforestation, wildlife recovery, watershed restoration, riparian habitat projects, oak woodland restoration, mine reclamation, and for campgrounds and interpretive areas.

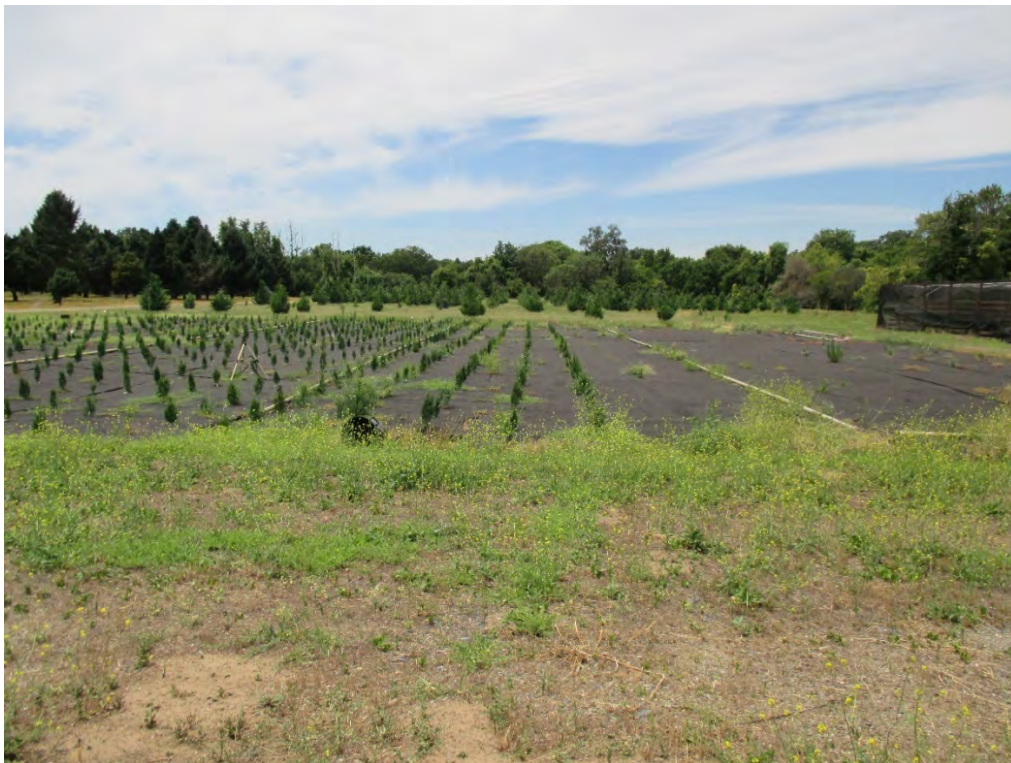
Figure 23: Seedlings recently field-planted at the present-day Chico Seed Orchard Administrative Site, with older transplants in the background. Shadehouse is on the right. Photograph taken 6/25/2019.

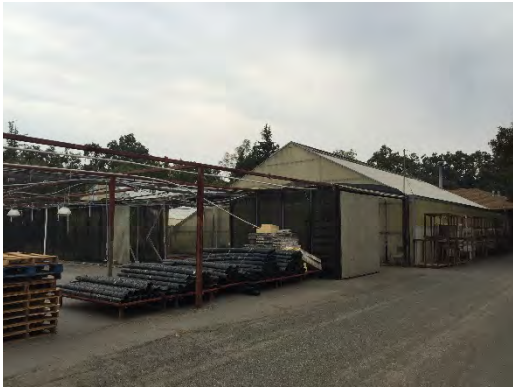
Figure 24: Southern elevation of ca. 1980 greenhouse, removed from site between September and December of 2018. Photograph taken 9/14/2015. Photograph courtesy of Joel Little.

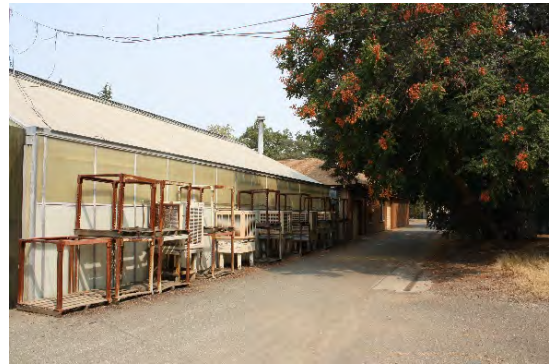
Figure 25: Eastern façade of fiberglass-and-aluminum greenhouse removed from site in late 2018. Photograph taken 8/20/2015. Photograph courtesy of Joel Little.

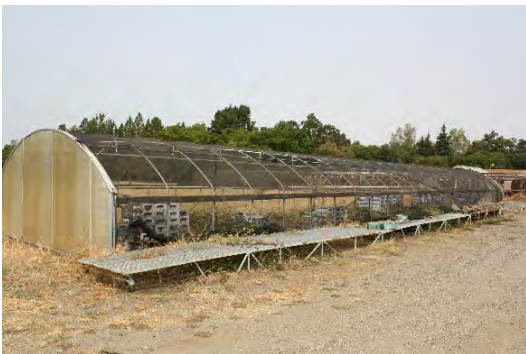
Figure 26: Cold-frame hoophouse, removed between October of 2017 and May of 2018, that was located south of the existing shadehouse. Photograph taken 8/20/2015. Photograph courtesy of Joel Little.

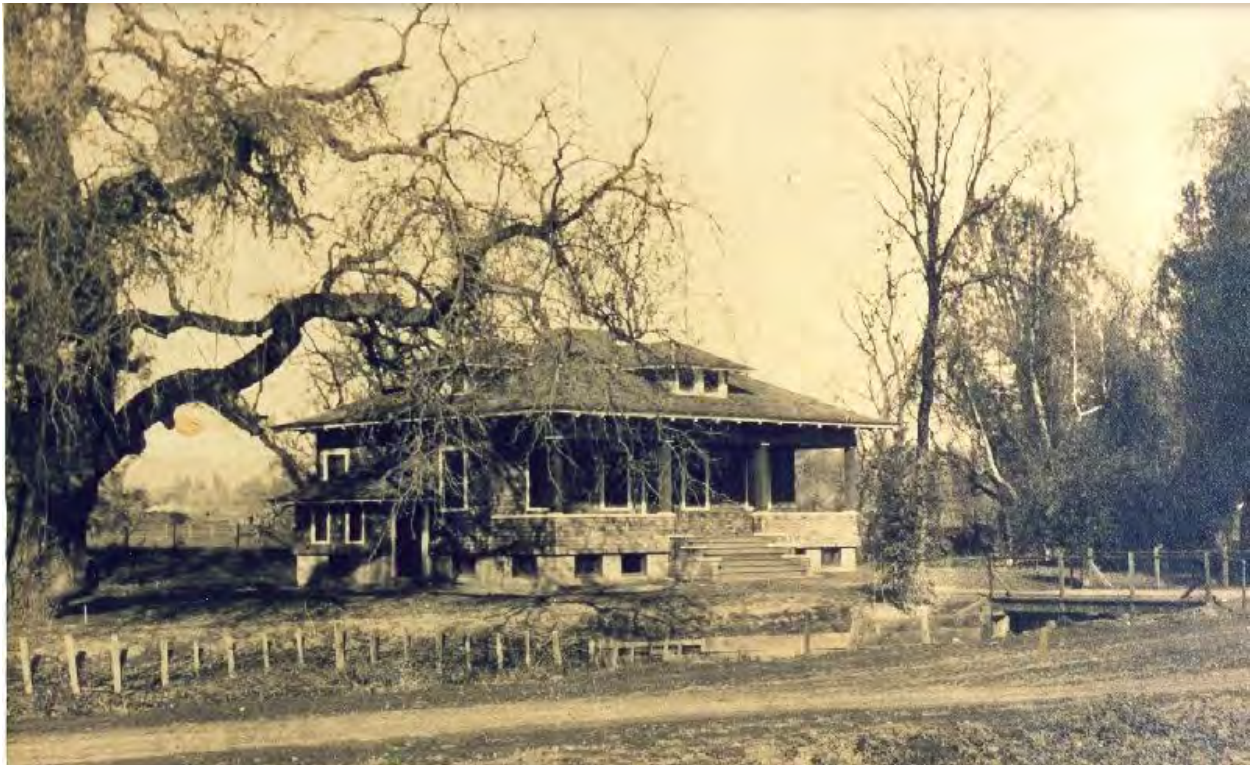
Figure 29: Original design of Office Building (Laboratory), photograph taken between 1907 and 1910, before planting of the linden tree in Figure 32. Note the side channel of Edgar Slough/Comanche Creek in foreground, south of building, prior to full channelization of the creek.

The Office Building (Laboratory) of the Chico Plant Introduction Garden was under construction as of June 1907, according to an article from the *Chico Daily Record*.¹⁷¹ It has been modified a number of times through the course of the 20th century, with different modifications reflecting different architectural styles. In its original 1907 design, this building was characteristic of the craftsman style, hipped-roof form, with certain features indicative of the prairie style, American four-square form, particularly its focalized entryway façade, multi-paneled front door, and original hipped dormers. Despite these prairie features, the building's one-story floor plan, rafters exposed at the eaves, and wood-shingle cladding place it more securely in the craftsman style, less than 10% of which exhibited this hipped-roof form.¹⁷²

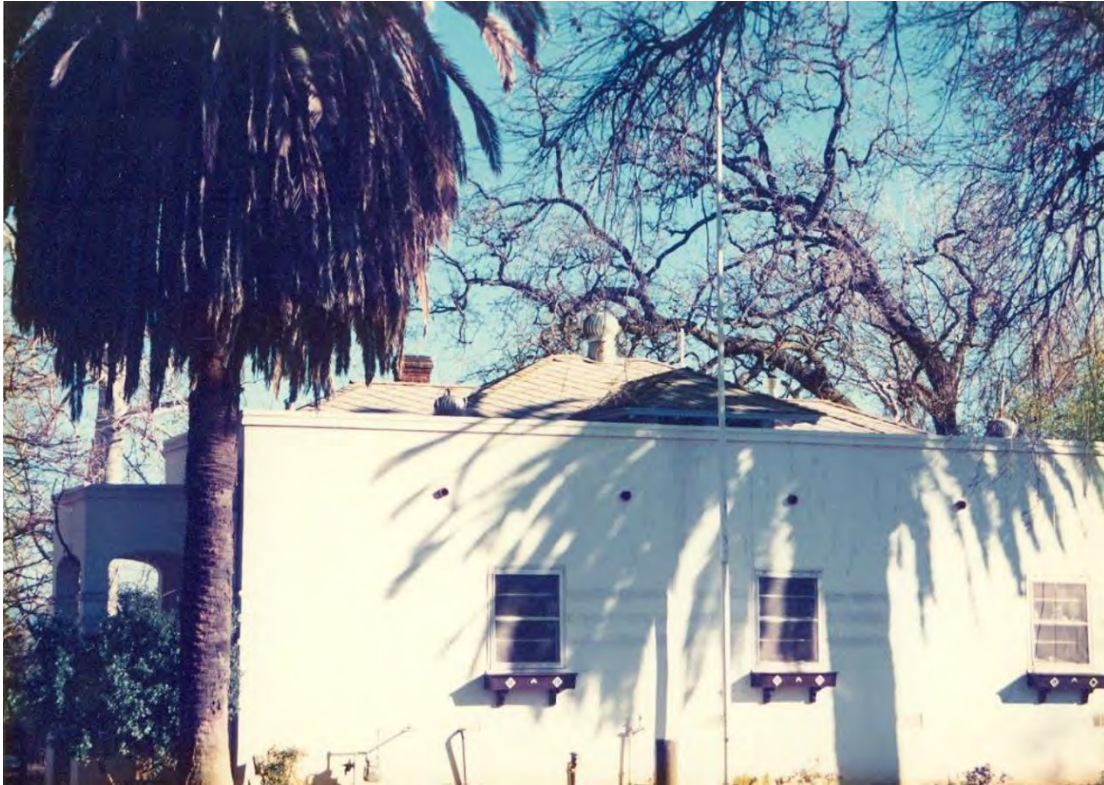
Figure 30: The southern façade of the Office Building (Laboratory) and arched entryway to left. Note coping at the roof line and discoloration left by three embossed horizontal bands (since removed at time of photograph). Also note hipped dormer from original roof, visible above flat roof of addition. Photograph taken March 1, 1990.

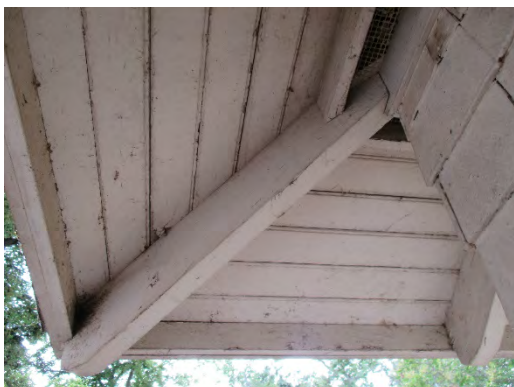
Figure 31: Older tongue-and-groove roof sheathing and rounded rafters under eave projection. Photograph taken 6/24/2019.

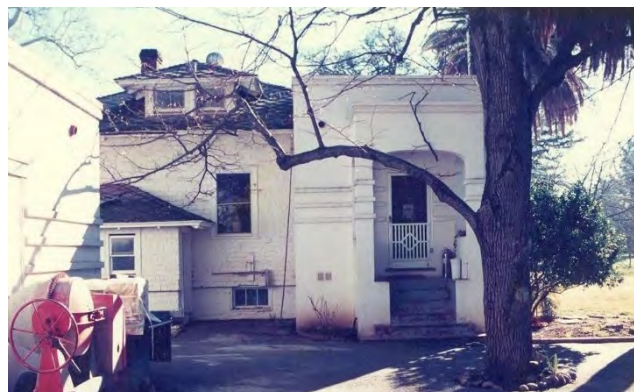
Figure 32: South elevation in March of 1990, showing chimney projection, central dormer, asbestos shingles, and no wooden ramp leading to entryway.

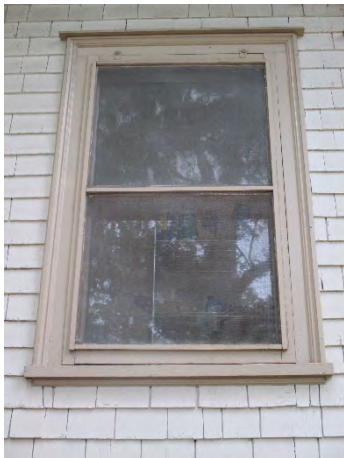
Figure 33: Typical 1st-floor windowframe of original building footprint. Photograph taken 6/24/2019.

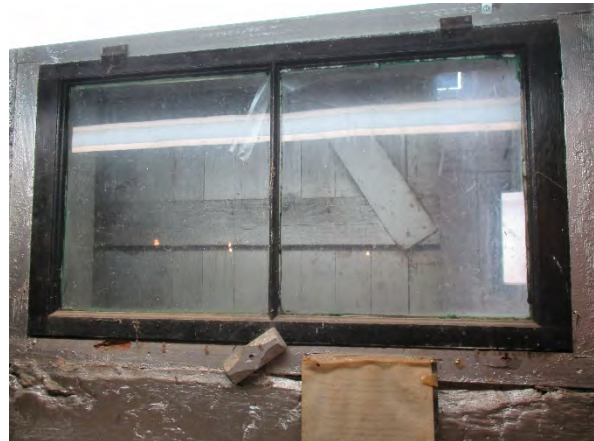
Figure 34: Basement-level window with carved wooden window-stop. Photograph taken 6/24/2019.

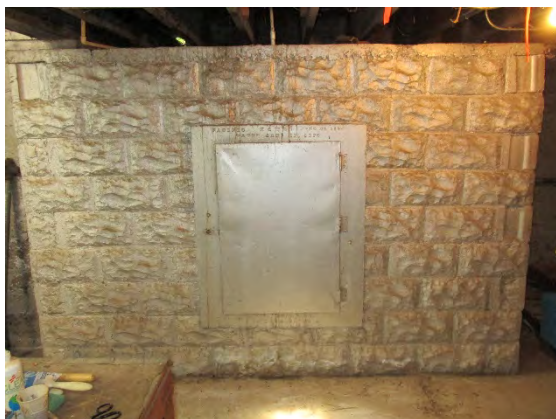
Other features of this building worth mentioning include the storage room located in the basement of the building, and the laboratory-style vertically sliding window in its interior. The door of the storage room is embossed with the following: "PACIFIC HOWE SPEC NO 6504 [line break] PAT^D. JAN. 15 1870." It is rectangular in shape and composed of rough-faced cinder blocks, very similar to those used on construction of the original pumphouse. At various times while administered by the Agricultural Research Service (ARS), this basement housed seed germination experiments and equipment.¹⁷⁵ This utilitarian structure, likely original to the 1907 construction of the building, represents the original function of the building to test and store genetic material of exotic plants, many of which could require a highly controlled environment for short- or long-term storage.

Figure 35: Basement storage room, patented 1870, constructed ca. 1907. Photograph taken 6/24/2019.

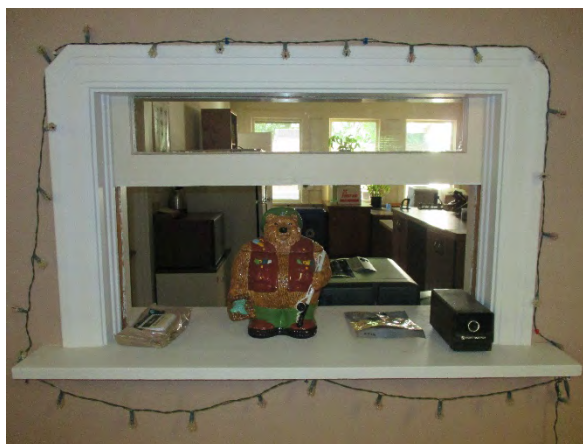
The sliding window in the interior of the Office Building (Laboratory) is located between the office (today's entry room/visitor display room) and the laboratory (today's central common area). It would have been used for passing analytical samples between the office and the laboratory in a controlled fashion. The trim matches other interior doors dating to the 1941 remodeling of the building, and represents an earlier function of the building to investigate samples of exotic plant material for its histological and biochemical properties.

Figure 36: Vertically sliding interior window between office and laboratory. Built in or soon after 1941. Photograph taken 6/24/2019.

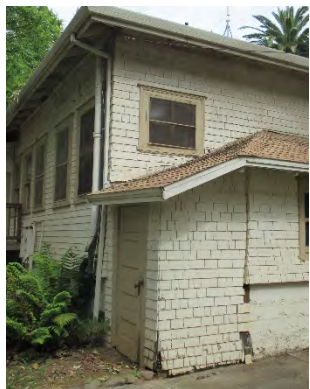
Figure 38: Early one-room addition at northwestern corner of building. Photograph taken 6/24/2019.

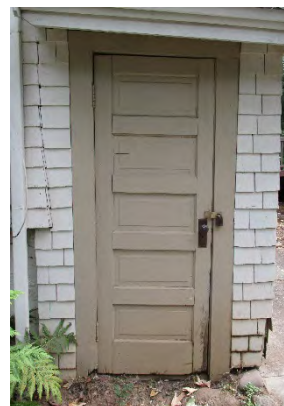
Figure 39: Five-paneled wooden door of one-room addition. Note at left wooden shingles at original northwestern corner of building where they intersect incongruously with wooden shingles of addition. Photograph taken 6/24/2019.

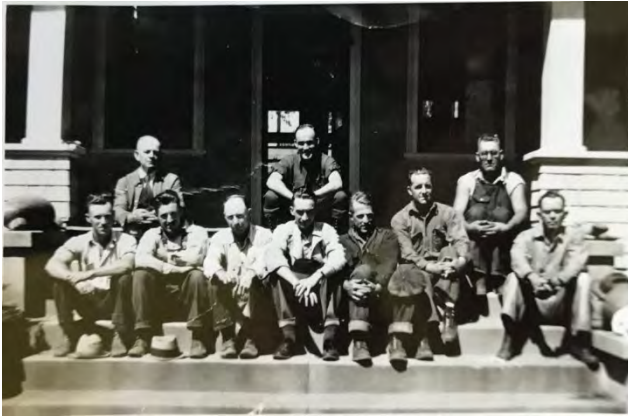
Figure 40: Front steps and focal entry of original craftsman design of Office Building (Laboratory). W.J. Everett Morrow, then Superintendent of the Plant Introduction Garden, at upper left. Photograph taken ca. 1936

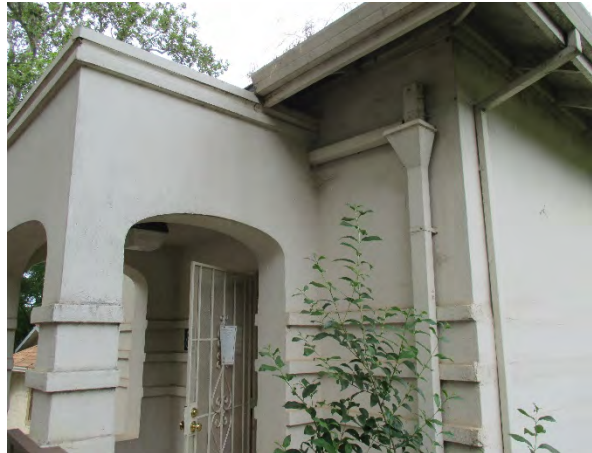
Figure 41: Today's main entryway at southwestern corner of building, where art moderne form of 1941 design is most evident today. Photograph taken 6/24/2019.

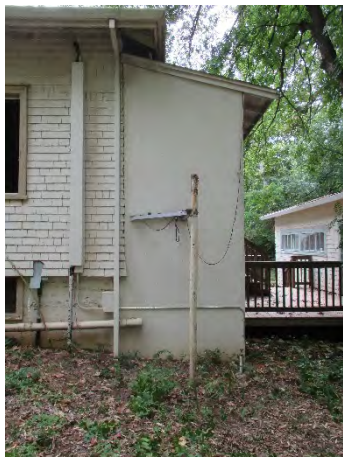
Figure 42: Northeastern corner of the building, showing eastern elevation of stucco-clad restroom/hallway addition. Photograph taken 6/24/2019.

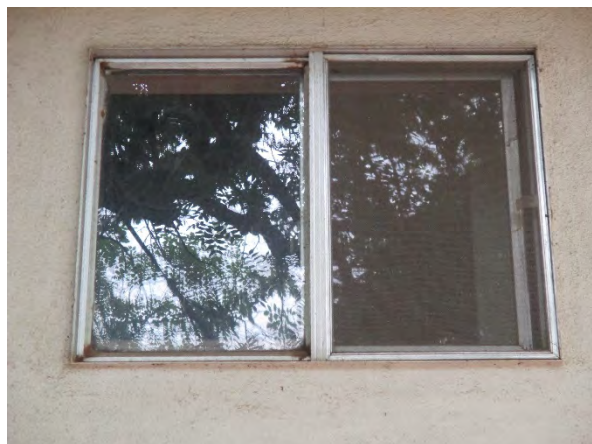
Figure 43: 1960s-era aluminum-framed horizontally sliding window. The only of this post-1950 type on the building. Photograph taken 6/24/2019.

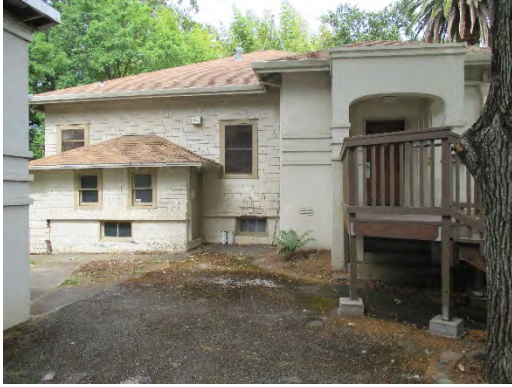
Figure 44: Western elevation, with primary entrance and basement access wing. Corner of utility building on far left. Photograph taken 6/24/2019.

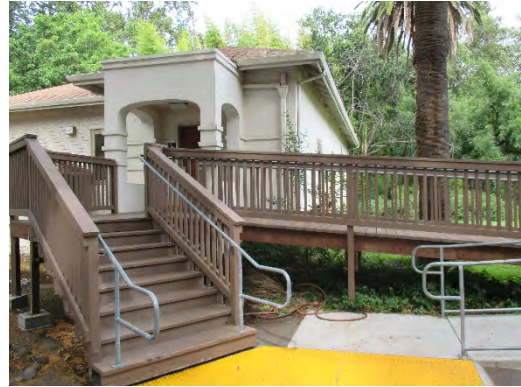
Figure 45: Accessible wooden ramp, built after 1991, leading to the main entrance at southwestern corner of building. Photograph taken 6/24/2019.

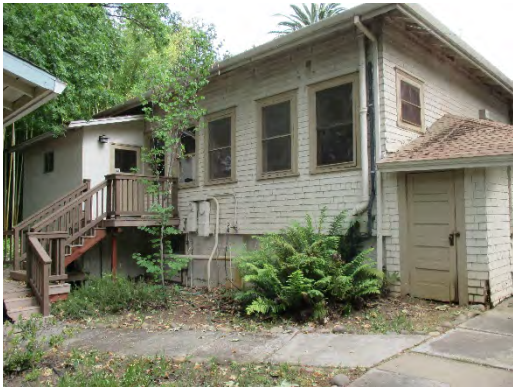
Figure 46: Northern elevation. Photograph taken 6/24/2019.

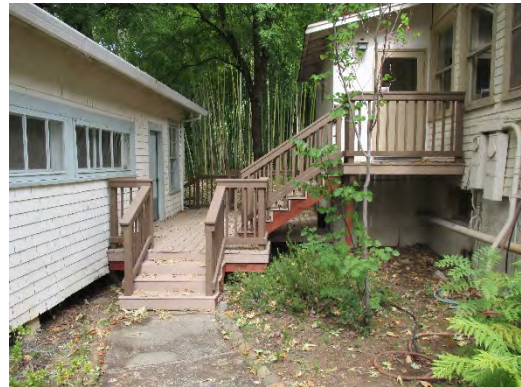
Figure 47: Wooden back porch, north of building, connecting Office Building (Laboratory) on right to Office Annex Building on left. Photograph taken 6/24/2019.

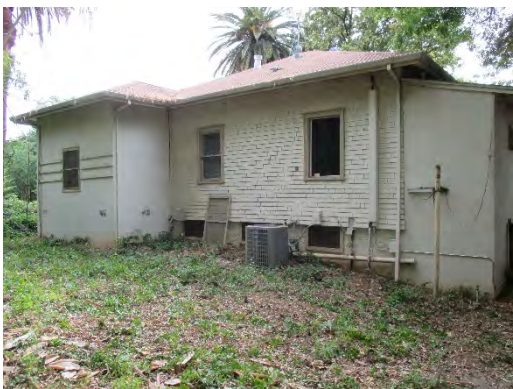
Figure 48: Eastern elevation, with 1941 addition on left and 1962 addition on right. Photograph taken 6/24/2019.

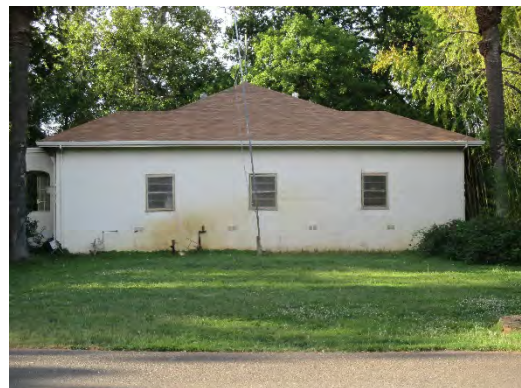
Figure 49: Southern road-side elevation with flagpole at center. Stylistic modification as a product of the 1991 roof re-modeling is most evident from this elevation. Photograph taken 6/24/2019.

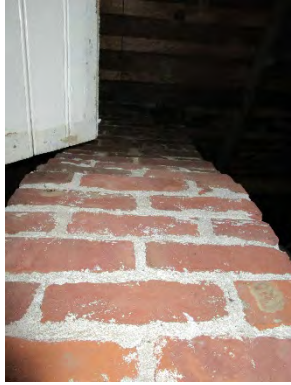
Figure 50: Original brick chimney, now truncated and no longer functional, but still accessible via an access chute in the ceiling of the present-day restroom. Photograph taken 6/24/2019.

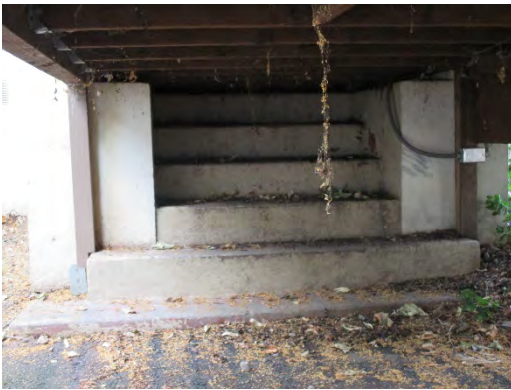
Figure 52: 1941 concrete steps leading to art moderne arched entryway. These steps are now obscured beneath the wooden accessible ramp, installed after 1991. Photograph taken 6/24/2019.

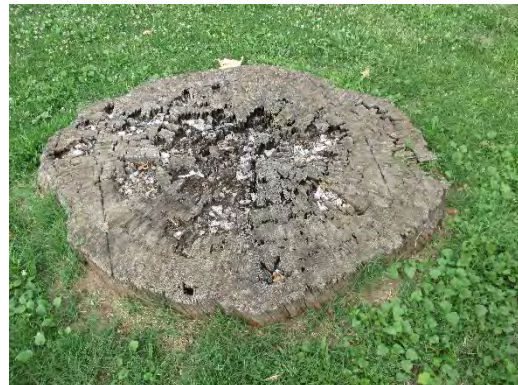
Figure 55: Large flush-cut stump of historic tree in front-yard area of Office Building (Laboratory). Photograph taken 6/24/2019.

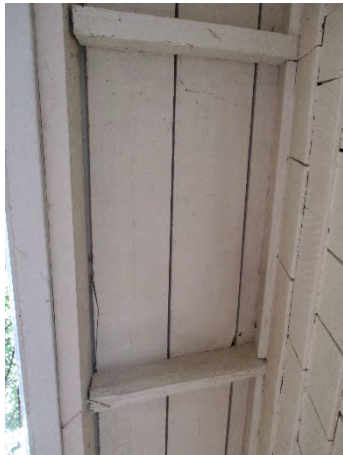
Figure 56: Original tongue-and-groove boards atop exposed rafters under the eave projection of the southern side of the Office Annex Building. Photograph taken 6/24/2019.

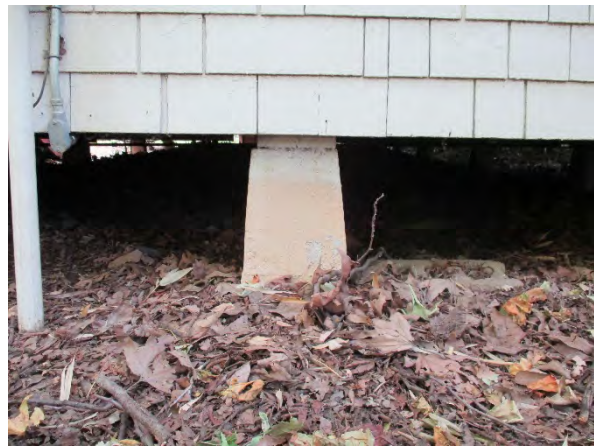
Figure 57: Thick wooden shim atop foundation of concrete pier block. Photograph taken 6/24/2019.

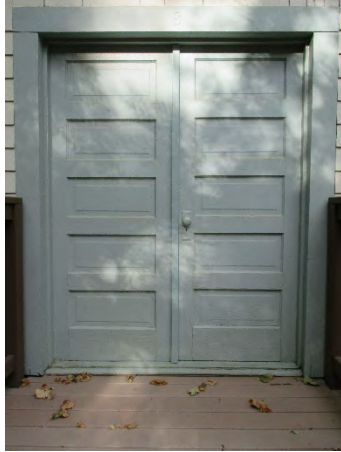
Figure 58: Front entrance to Office Annex Building, consisting of five-paneled wooden double-door. Photograph taken 6/24/2019.

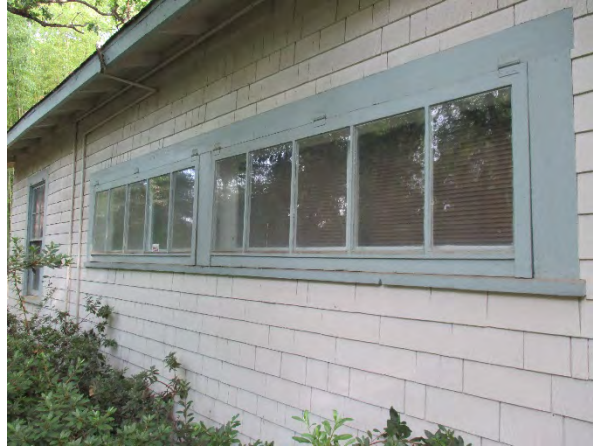
Figure 59: Window ribbons characteristic of the ranch style of domestic architecture, located on the northern elevation of the Office Annex Building. Photograph taken 6/24/2019.

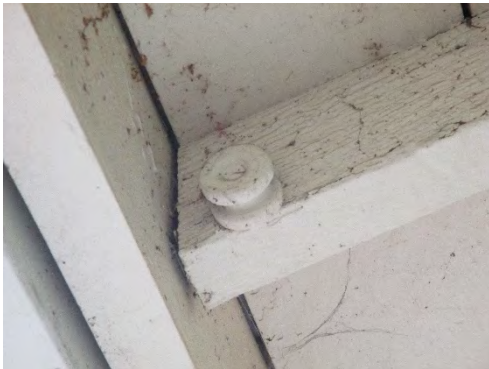
Other features of note that are present on the Office Annex Building include a pre-1940 ceramic insulator for an early electrical line into the Office Annex Building. The insulator is screwed onto an exposed rafter at the southeastern corner of the building. Another feature of note is what appears to be the original hardware that is still affixed to the front door.

Figure 60: Pre-1940 ceramic insulator screwed into exposed rafter of Office Annex Building. Photograph taken 6/24/2019.

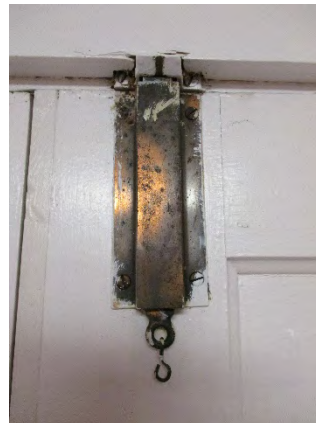
Figure 61: One example of original hardware of front door of Office Annex Building. Photograph taken 6/24/2019.

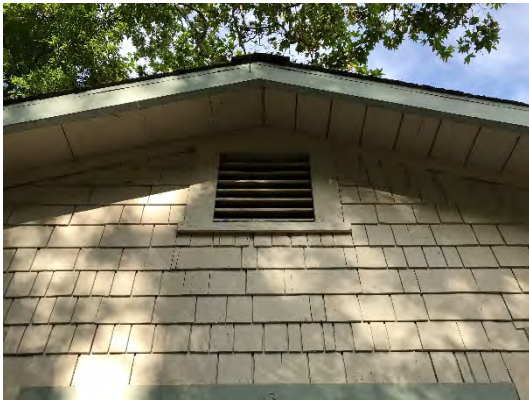
Figure 62: Peak of western (front) gable, showing under-eave tongue-and-groove boarding to the south (right), and plywood boarding to the north (left). Photograph taken 6/24/2019.

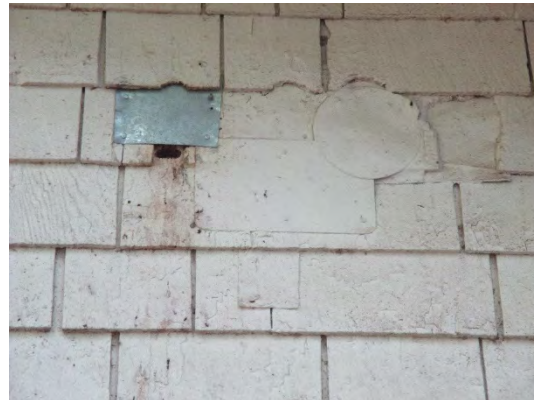
Figure 63: Detail of eastern elevation siding where once may have been an exit for a stovepipe exhaust. Photograph taken 6/24/2019.

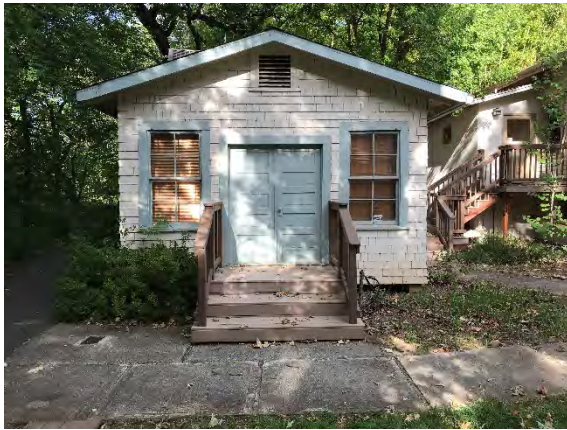
Figure 64: Western elevation and primary entrance of Office Annex Building. Office Building (Laboratory) on the right. Photograph taken 6/24/2019.

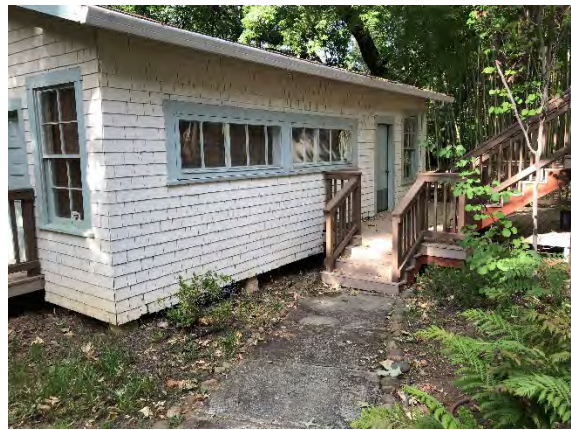
Figure 65: Southern elevation of Office Annex Building with back deck. Photograph taken 6/24/2019.

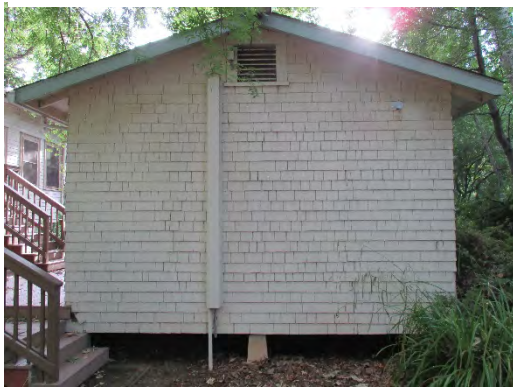
Figure 66: Eastern elevation of Office Annex Building. Photograph taken 6/24/2019.

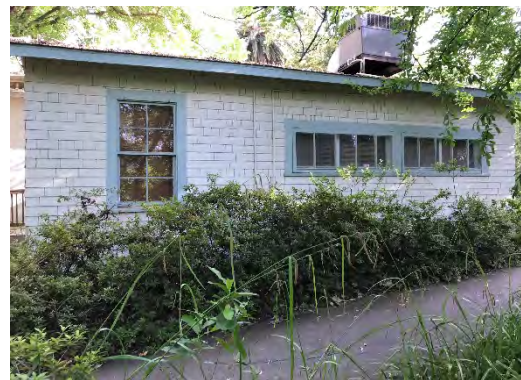
Figure 67: Northern elevation of Office Annex Building with paved walking trail in foreground. This perspective readily reveals the original two-room design of the building. Photograph taken 6/24/2019.

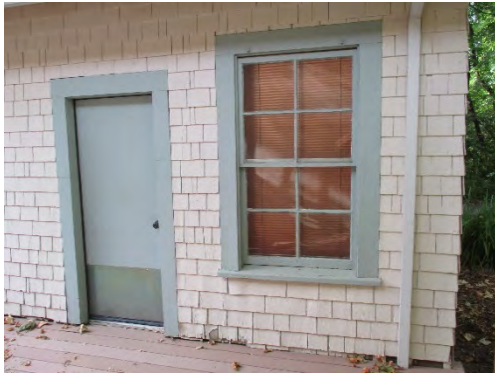
Figure 68: Modern door on southern elevation of Office Annex Building, installed sometime after 1977. Window is original. Photograph taken 6/24/2019.

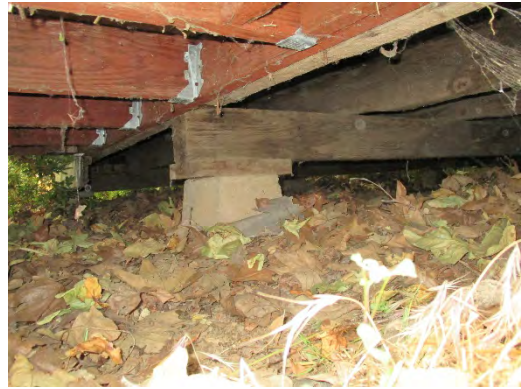
Figure 69: Underside of Office Annex Building, showing wooden beams atop a wooden shim atop a concrete pier foundation. Photograph taken 6/24/2019.

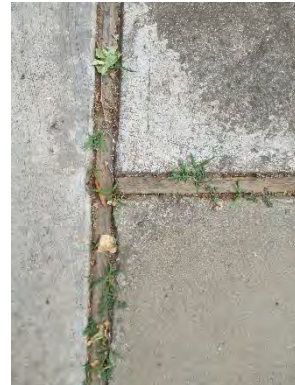
Figure 71: Close-up detail of post-1962 concrete walkway construction. Photograph taken 6/24/2019.

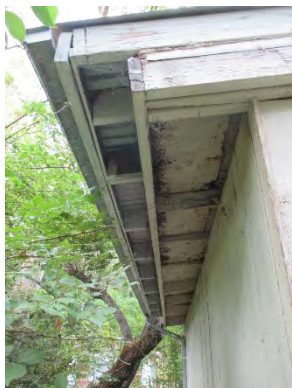
Figure 74: View of two roof construction periods atop exterior shed, built sometime after 1979, on northern side of ROP Classroom (Utility Building/Garage). Photograph taken 6/24/2019.

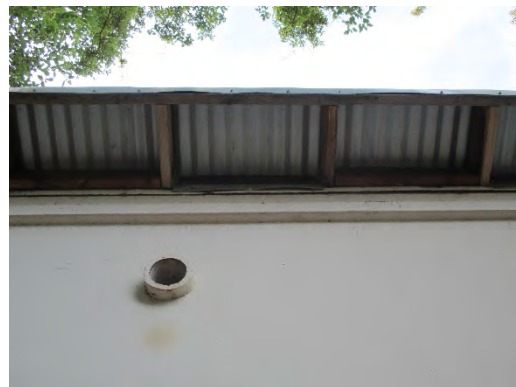
Figure 75: Southern eave projection of ROP Classroom (Utility Building/Garage), with tubular hole below. Photograph taken 6/25/2019.

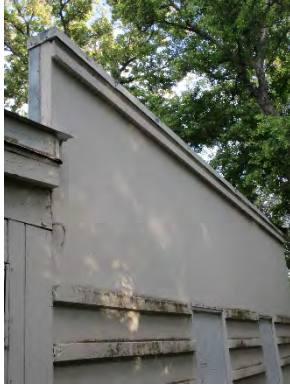
Figure 76: Western elevation of ROP Classroom (Utility Building/Garage), showing original parapet, coping, fascia, and three embossed horizontal bands. Photograph taken 6/24/2019.

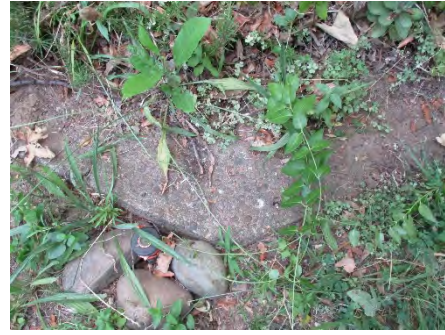
Figure 77: Aggregate concrete slab foundation with pebble inclusions. Photograph taken 6/24/2019.

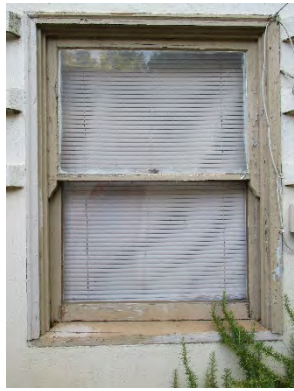
Figure 78: The only remaining functional window on the eastern elevation of the ROP Classroom (Utility Building/Garage). Note curvilinear motif at bottom of upper sash. Photograph taken 6/24/2019.

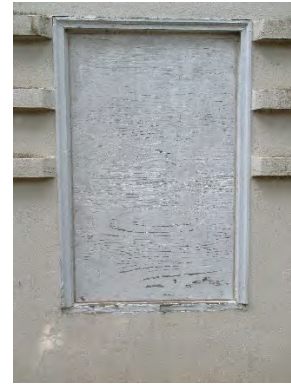
Figure 79: Boarded-up window on the western elevation of the ROP Classroom (Utility Building/Garage). Photograph taken 6/24/2019.

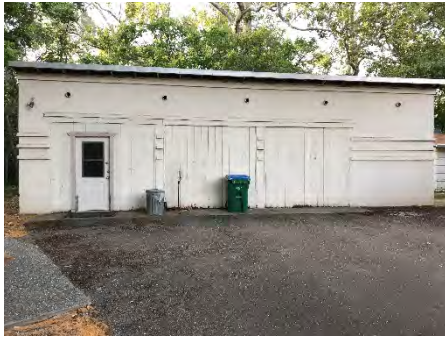
A number of exotic plantings surrounding the building, especially tung trees on its north side, are still present, as is the 1941 re-designed southern addition of the Office Building (Laboratory) with which this building is associated. While the building's generally dilapidated appearance is a detractor, the ROP Classroom (Utility Building/Garage) is nevertheless able to convey an aesthetic and historic feeling of the property in its 1940s form. This feeling is augmented as well by the building's intact association and setting within the property's historic core.

Figure 80: Southern (roadside) elevation of the ROP Classroom (Utility Building/Garage). Photograph taken 6/24/2019.

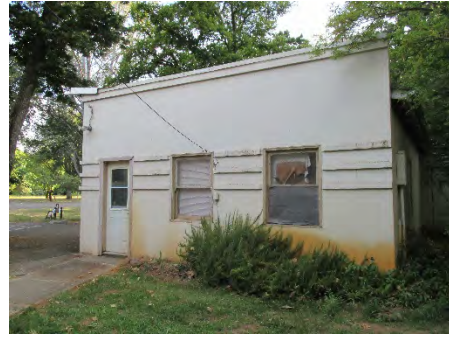
Figure 81: Eastern elevation of the ROP Classroom (Utility Building/Garage), originally the primary pedestrian access. The center window is the only window left on the building with both intact sashes. Photograph taken 6/24/2019.

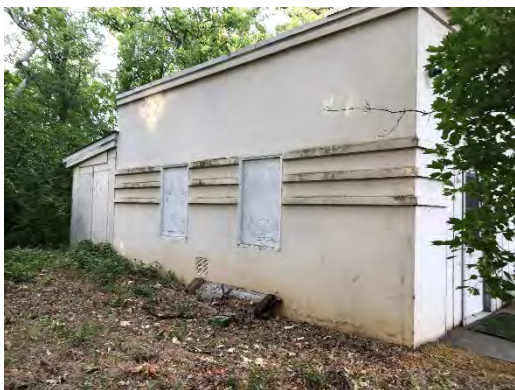
Figure 82: Western elevation of ROP Classroom (Utility Building/Garage) with boarded-up windows and exterior shed at left. Photograph taken 6/24/2019.

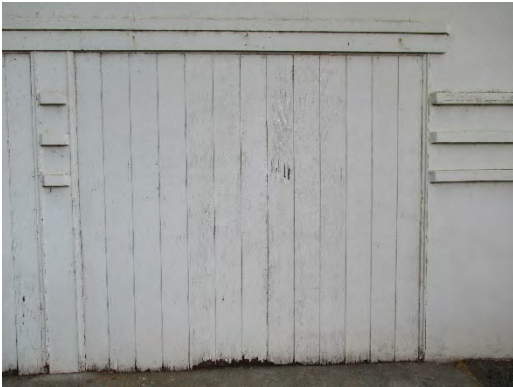
Figure 86: Enclosed vehicle bay door on southern elevation of ROP Classroom (Utility Building/Garage). Note wooden drop-siding used and its similarity to drop-siding on exterior shed. Photograph taken 6/24/2019.

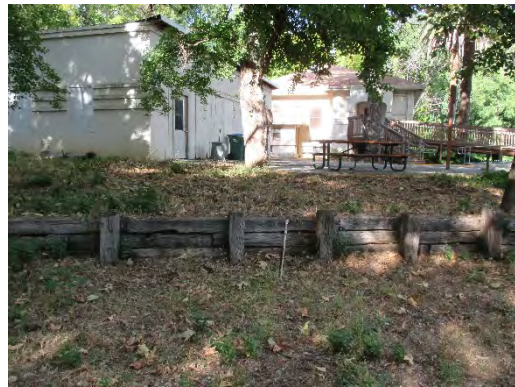
Figure 87: Retaining wall of railroad-tie cribbing. Utility building on left. Office Building (Laboratory) in background. Photograph taken 6/24/2019.

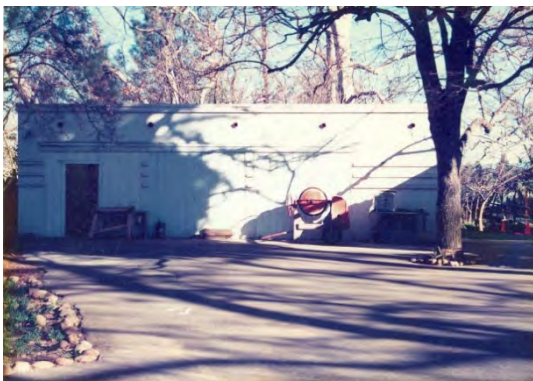
Figure 88: Southern elevation of ROP Classroom (Utility Building/Garage) in 1990, after enclosure of vehicle bay doors and before addition of sheet metal roof. Photograph taken 3/1/1990.

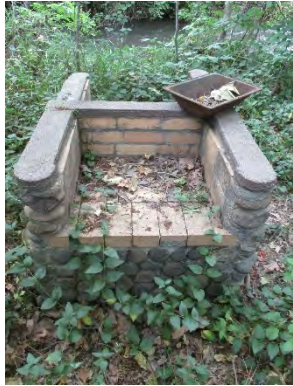
Constructed ca. 1990, and located on the southern bank of Comanche Creek, just west of the present-day footbridge, is a double-sided grill. It is located in the vicinity of the Office Annex Building. The grill's landscape setting is the same as that of the Office Annex Building. It measures 4' 9" by 3' 3". It is composed of a mortared-river-cobble exterior façade and fire-brick interior surfaces. It is capped with concrete. Though in some disrepair, the grill retains integrity of location, design, setting, materials, workmanship, feeling, and association. The grill does not date to the property's period of significance (1904-1973) and is therefore a non-contributing feature to the property's potential historic district.

Figure 90: Two-sided grill with fire-brick interior with Comanche Creek in the background. Photograph taken 6/24/2019.

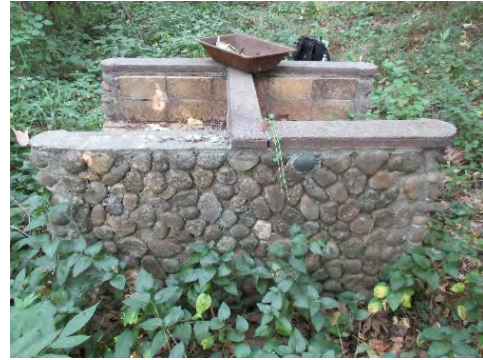
Figure 91: Side view of two-sided grill, showing mortared river-cobble construction. Photograph taken 6/24/2019.

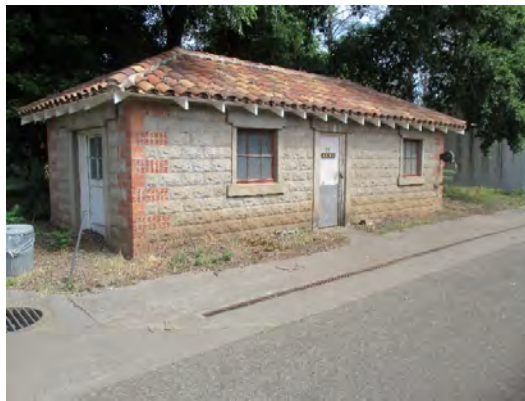
Figure 95: View of Tankhouse (Pumphouse) from the northwest. This building, constructed ca. 1905, is the only existing building on the present-day site of the Chico Plant Introduction Garden that does not markedly display a post Arts-and-Crafts movement modern style of American architecture. Photograph taken 6/25/2019.

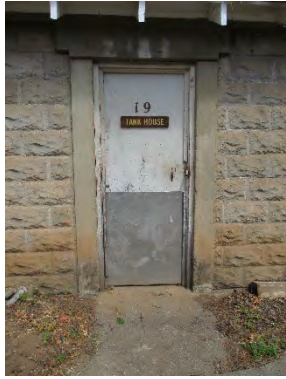
Figure 96: Main door, western elevation of Tankhouse (Pumphouse). Note thick concrete pediment. Photograph taken 6/25/2019.

The Tankhouse (Pumphouse) has two entrances. The main entrance is on the western (road-side) elevation and consists of a solid wood door with simple wooden moulding that has deteriorated over time. The door is framed within thickly set poured concrete, with a simple geometric pediment also of poured concrete. The main entrance on the western elevation is flanked to either side by six-paned, single-frame windows that do not seem to open. The panes are frosted with wire mesh embedded into them. They are separated by muntins and are set in a wooden frame that is itself set in a thick frame of poured concrete with a simple geometric pediment of poured concrete that is identical to that overtopping the main door. These two windows are slightly asymmetrically positioned on the western elevation, likely in order to accommodate the original two-room interior design of the building. The northern elevation contains one large wooden sliding door with six window panes at eye-level separated by wooden muntins. Like those on the western elevation, these window panes are frosted, with wire mesh embedded into them. The door is wooden, with simple wooden moulding and a wooden frame set within a thick frame of poured concrete with a geometric pediment above. This door too is slightly asymmetrical, likely in order to accommodate the hardware associated with a large sliding door. The eastern and southern elevations each have one window apiece, both constructed in an identical fashion as those described above.

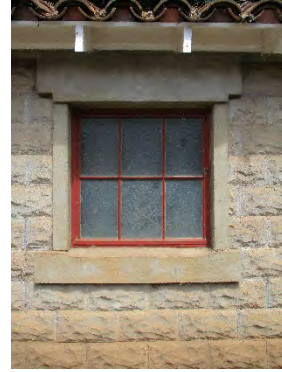
Figure 97: Window from western elevation of Tankhouse (Pumphouse). Note thick concrete pediment. Photograph taken 6/25/2019.

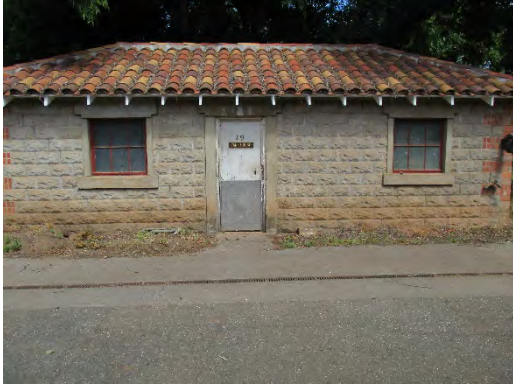
Figure 100: Western elevation of Tankhouse (Pumphouse), with primary entrance. Photograph taken 6/25/2019.

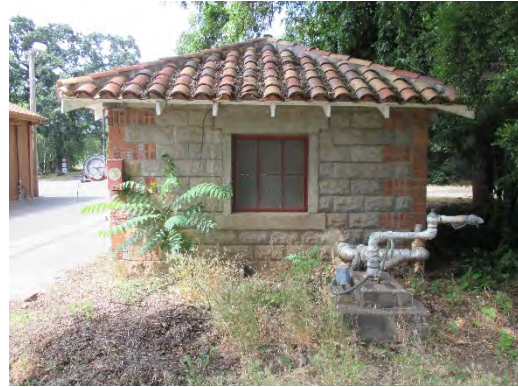
A water hose and an electrical switchboard are mounted onto the building at its southwestern corner. The domestic well infrastructure is located just south of the building on a concrete pad with two large water lines running into the building. Two additional smaller water lines run into the building on its eastern elevation, and an electrical outlet is hung from the eave projection at the building's northeastern corner.

Figure 101: Southern elevation of Tankhouse (Pumphouse), and site of domestic well. Photograph taken 6/25/2019.

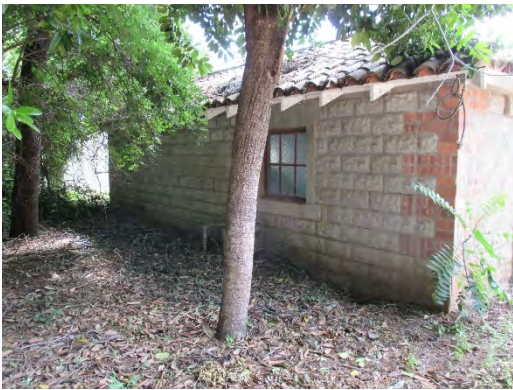
Figure 102: Eastern elevation of Tankhouse (Pumphouse) with exotic plantings in foreground. Photograph taken 6/25/2019.

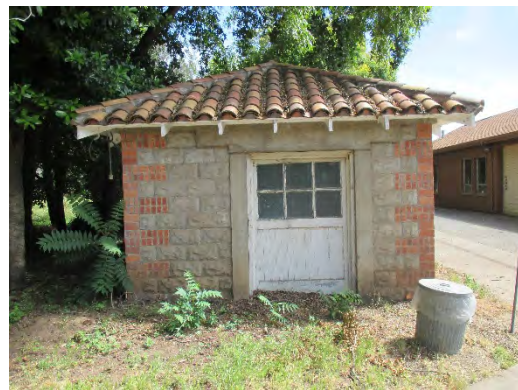
Figure 103: Northern elevation of Tankhouse (Pumphouse) with secondary sliding-door entrance. Photograph taken 6/25/2019.

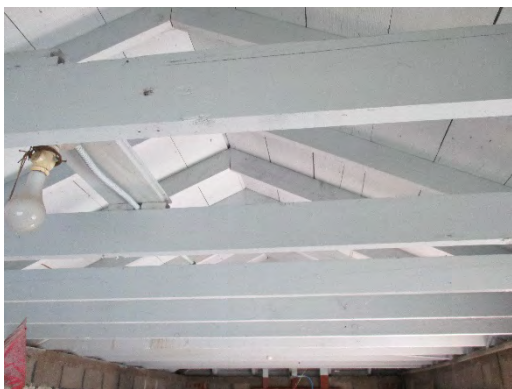
Figure 104: Exposed boards and rafters on interior of Tankhouse (Pumphouse). Photograph taken 6/25/2019.

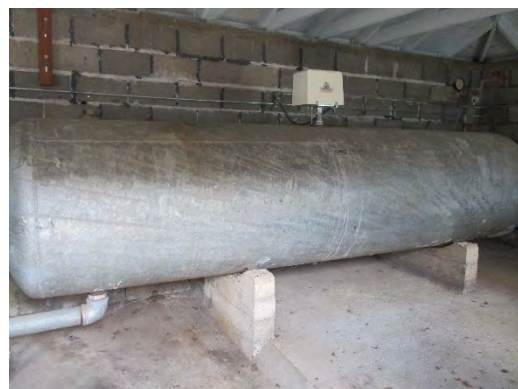
Figure 105: Large water tank located in interior of Tankhouse (Pumphouse). Photograph taken 6/25/2019.

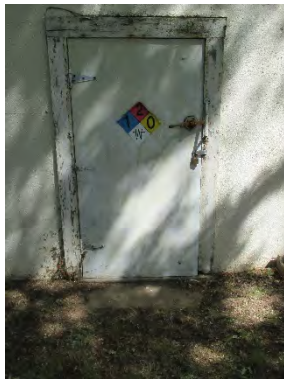
The Saw/Paint Storage Building (Fumigation Storage) has three entrances. The two main entrances are on the southern elevation. The left-hand one is a solid door in a thick wooden frame with what appears to be original hardware, enscribed with "A1 20 83." The right-hand one is a more recent replacement, composed of metal in a metal frame, with hand-applied concrete fitted around the frame. The southern elevation contains a shed door in a wooden frame, composed of vertical wooden boards. It is presently unused and obstructed by materials. The Saw/Paint Storage Building (Fumigation Storage) contains one window on its eastern elevation. It is single-paned with metal casing in a wooden frame with metal bars fitted across it.

Figure 106: Left-hand door of southern (primary) elevation. Photograph taken 6/25/2019.

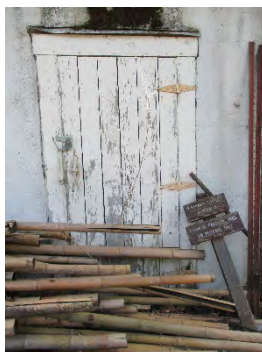
Figure 108: Unused wooden shed door on northern elevation. Photograph taken 6/25/2019.

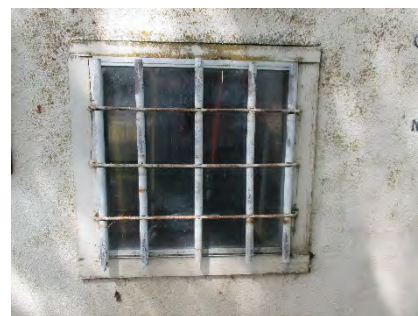
Figure 109: The only window of the Saw/Paint Storage Building (Fumigation Storage), on its eastern elevation. Photograph taken 6/25/2019.

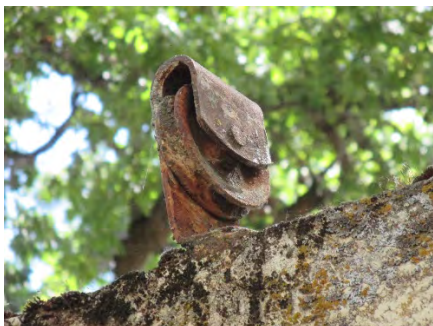
One additional feature of note are the remains of a ring-and-pulley system on the building's western elevation. The ring is almost halfway up the wall and the pulley at the roof-wall junction. Its original purpose was likely for loading either pack animals, horse carts, or vehicles.

Figure 110: Old pulley system at roof-wall junction of western elevation. Photograph taken 6/25/2019.
