Chico Plant Introduction Garden Forest Service Site #05-08-60-02

*Section 106 Determination of Eligibility
Report #R2020050800025*

Chico Plant Introduction Garden FS Site #05-08-60-02 Mendocino National Forest

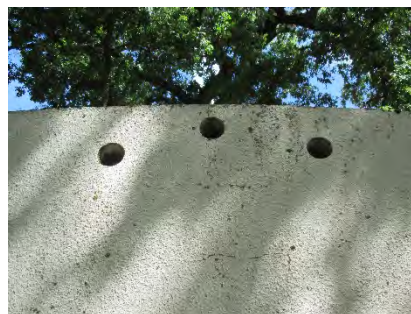
Figure 111: Decorative three-hole motif on southern (primary) elevation. Photograph taken 6/25/2019.

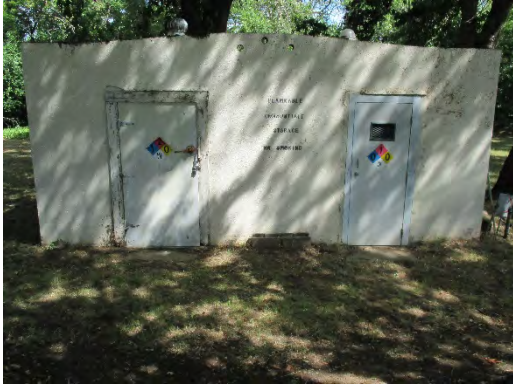
Figure 113: Southern (primary) elevation of Saw/Paint Storage Building (Fumigation Storage) with decorative three-hole motif at center of roofline. Photograph taken 6/25/2019.

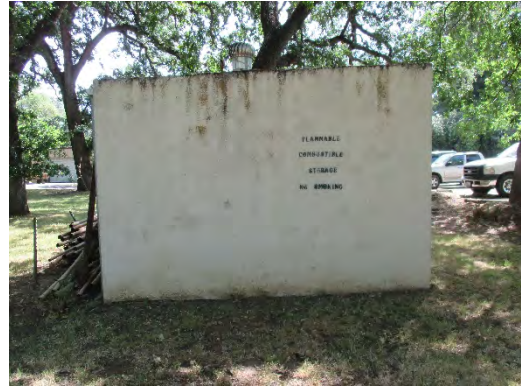
Figure 114: Western elevation of Saw/Paint Storage Building (Fumigation Storage). Photograph taken 6/25/2019.

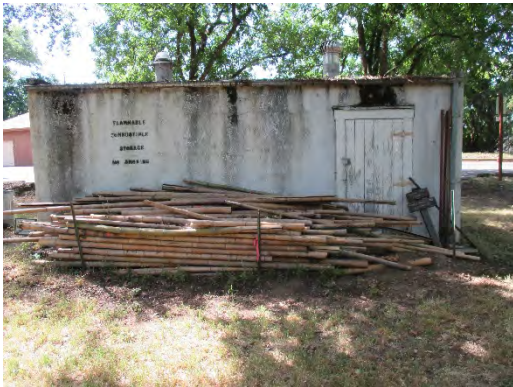
Figure 115: Northern elevation of Saw/Paint Storage Building (Fumigation Storage), with materials storage in foreground. Photograph taken 6/25/2019.

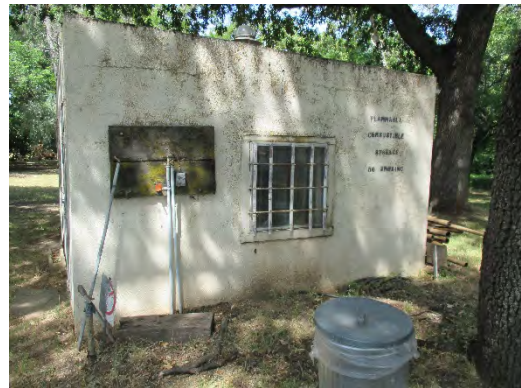
Figure 116: Eastern elevation of Saw/Paint Storage Building (Fumigation Storage), with the building's only window. Photograph taken 6/25/2019.

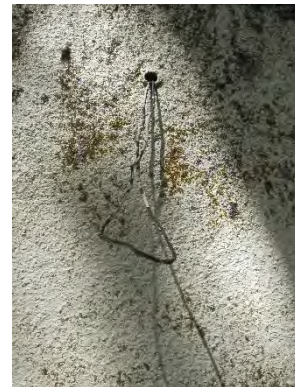
Figure 118: Remains of exterior electrical wiring that once serviced an exterior light on the eastern elevation of the building. Photograph taken 6/25/2019.

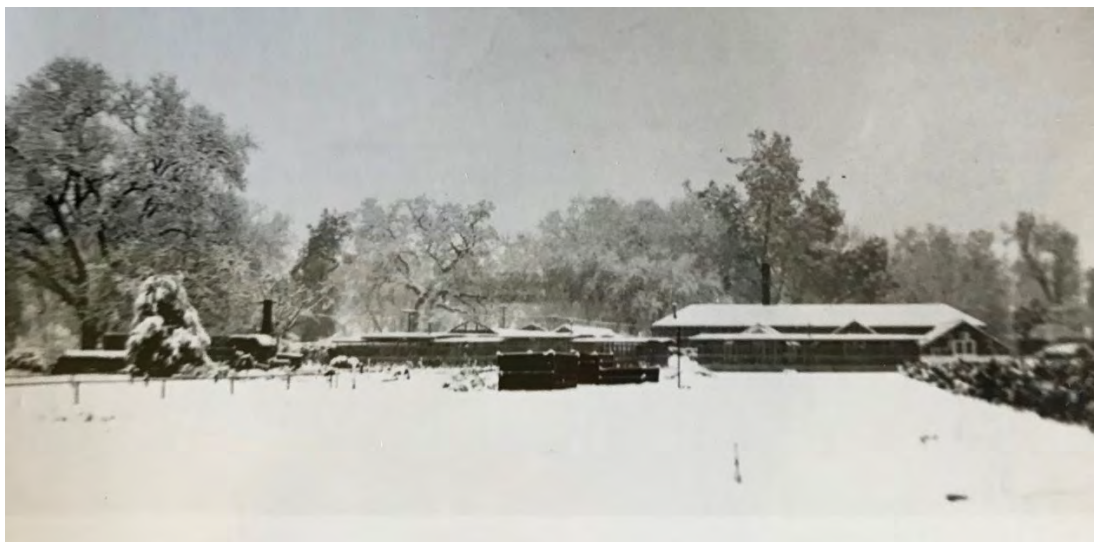
Figure 119: View from the south of headhouse/greenhouse/lathhouse complex in 1937. The headhouse is the building on the right with the hipped roof. Note the tall chimney projection, since removed. Also note the gables of at least five separate greenhouses present at this time. Photograph taken winter, 1937.

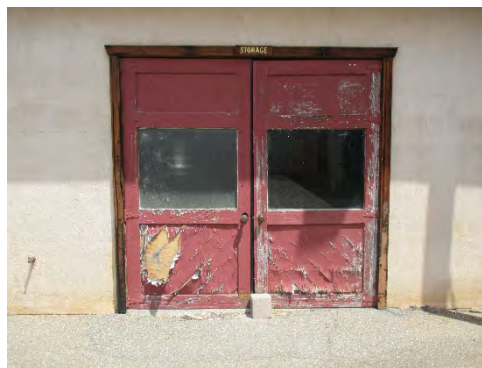
Figure 121: One of four double-doors on interior courtyard of headhouse. Photograph taken 6/25/2019.

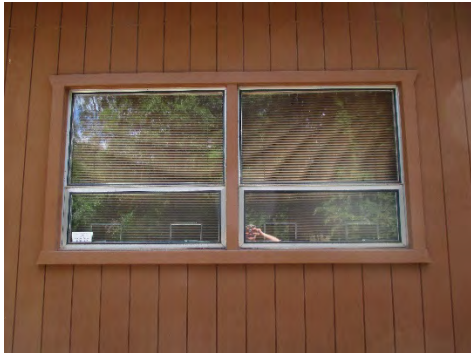
Figure 122: Paired windows on western elevation in post-1950 metal frames. Photograph taken 6/25/2019.

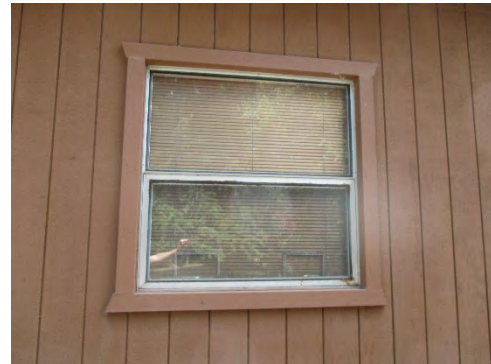
Figure 123: Non-paired window variation on western elevation. Photograph taken 6/25/2019.

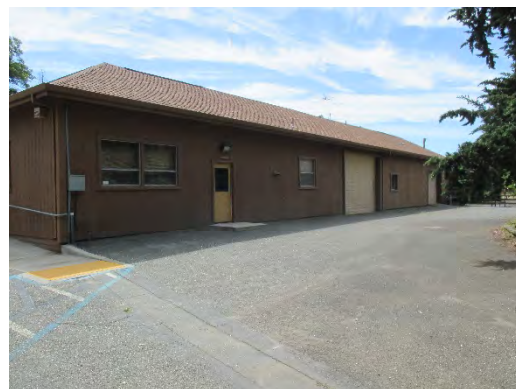
Figure 129: Western elevation of headhouse. Photograph taken 6/25/2019.

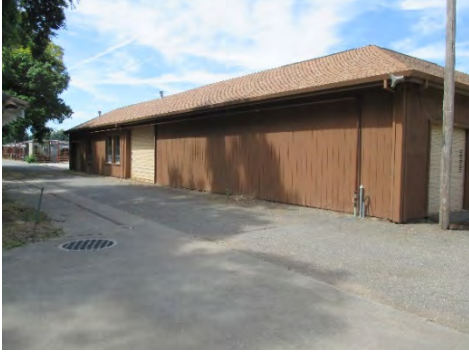
Figure 130: Eastern elevation of headhouse, along what was once referred to as First Avenue. Photograph taken 6/25/2019.

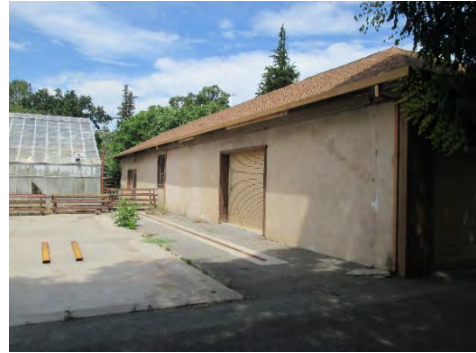
Figure 131: Southern elevation of headhouse. Greenhouse to the left. Photograph taken 6/25/2019.

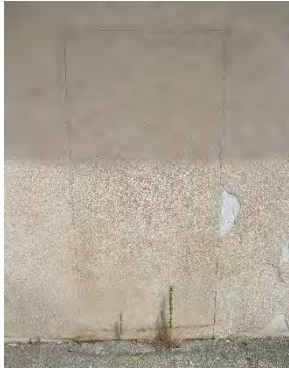
Figure 132: One of three blocked-in doorways on the southern elevation of headhouse. Photograph taken 6/25/2019.

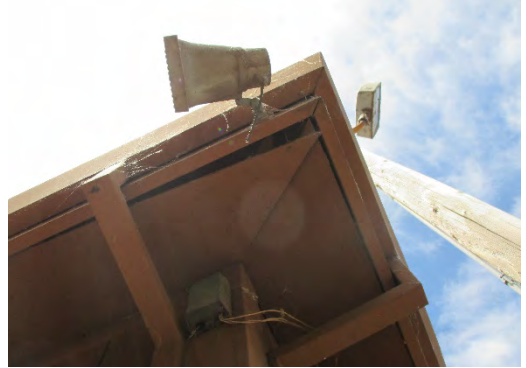
Figure 133: Under-eave projection, boxed in with plywood, showing utility pole and light fixtures at northeast corner of building. Photograph taken 6/25/2019.

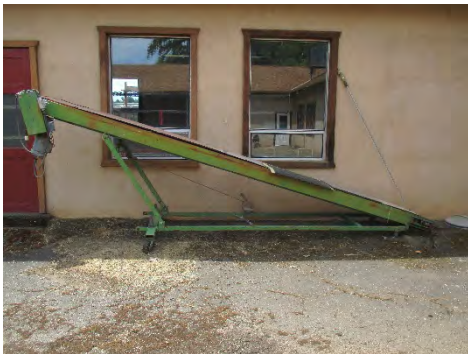
Figure 134: Conveyor machinery located within enclosed courtyard of headhouse. Photograph taken 6/25/2019.

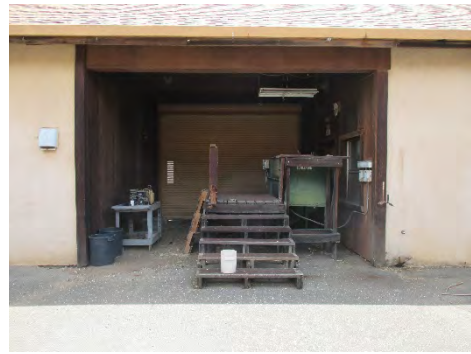
Figure 135: One of three breezeways, as seen from interior of courtyard. Photograph taken 6/25/2019.

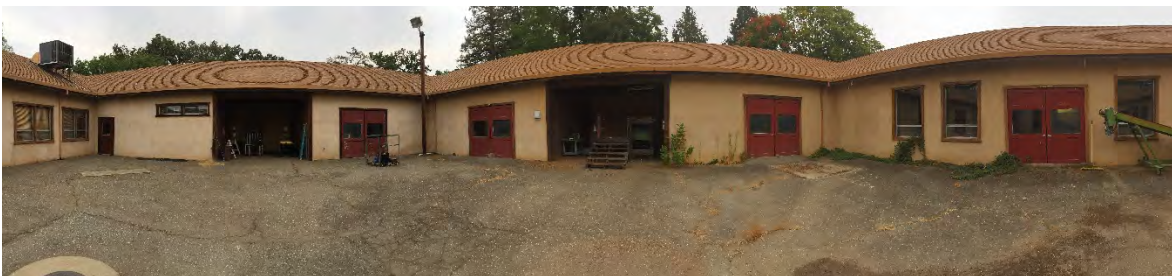
Figure 136: Panoramic view of courtyard interior of headhouse. Photograph courtesy of Joel Little, taken 9/14/2015.

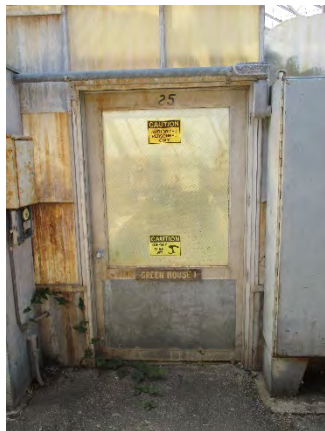
Figure 137: Main door, northern elevation across from the propagation area/potting room of the headhouse. Photograph taken 6/25/2019.

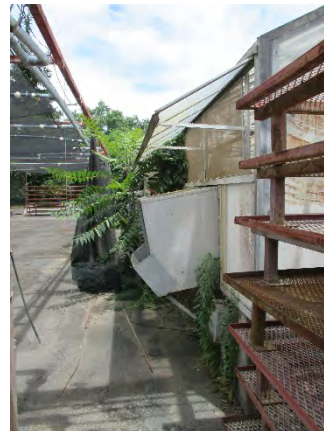
Figure 138: Window panes opened outwards above jet-fan units on western elevation. Photograph taken 6/25/2019.

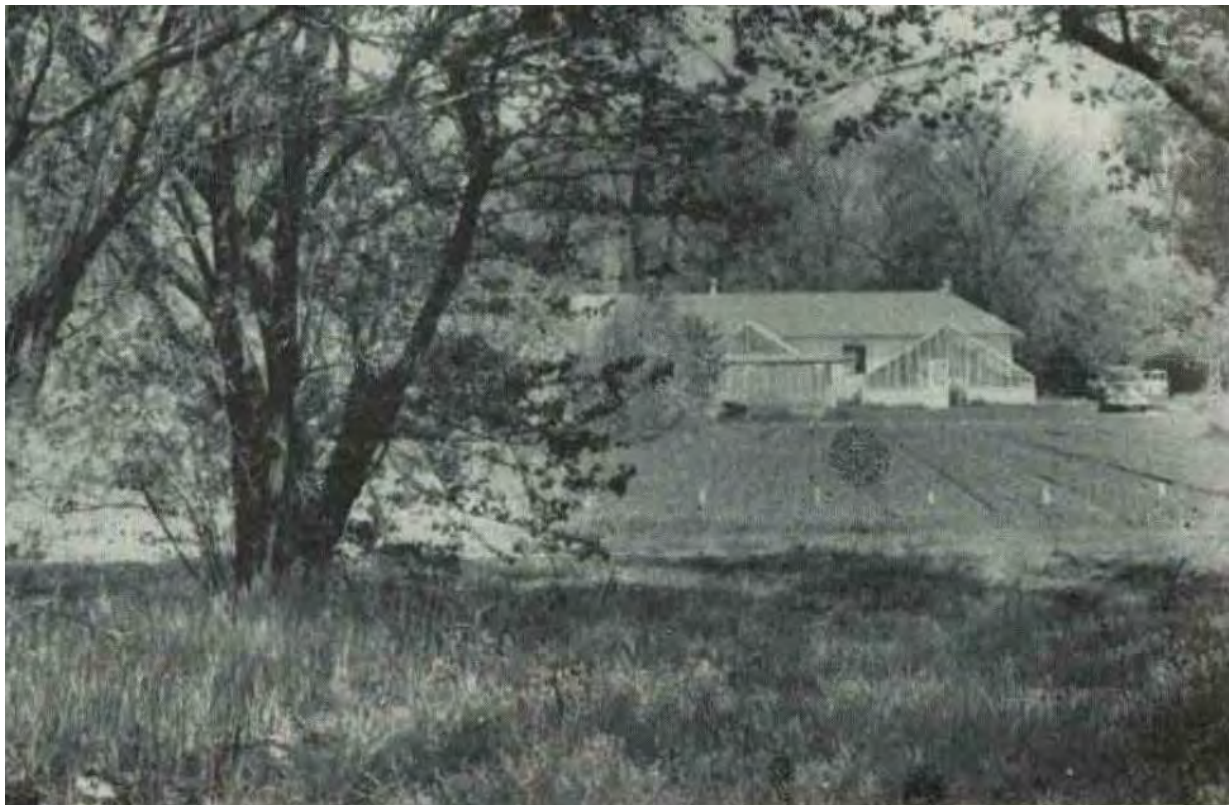
*Figure 139: View of greenhouses and headhouse from the south, ca. 1956.
From Hodge, "Federal Plant Introduction Gardens," 94.*

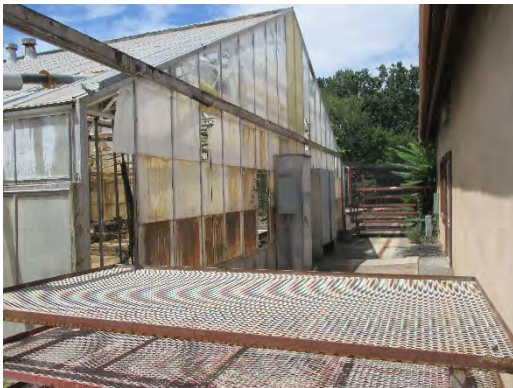
Figure 140: Northern (primary) elevation of greenhouse. Headhouse to the right, and shadehouse in the background. Photograph taken 6/25/2019.

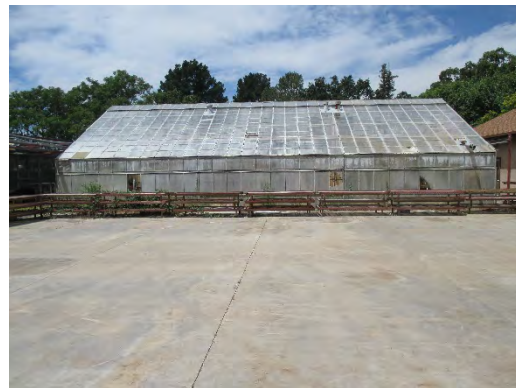
Figure 141: Eastern elevation of greenhouse, with large open concrete slab in foreground where another greenhouse had stood until after September of 2018. Photograph taken 6/25/2019.

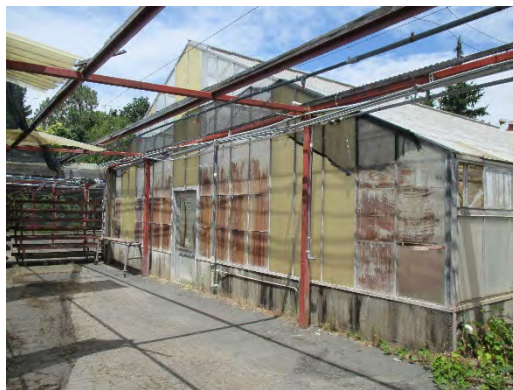
Figure 142: Southern elevation of greenhouse, on which a number of glass panes have been replaced with fiberglass. Shadehouse in foreground. Photograph taken 6/25/2019.

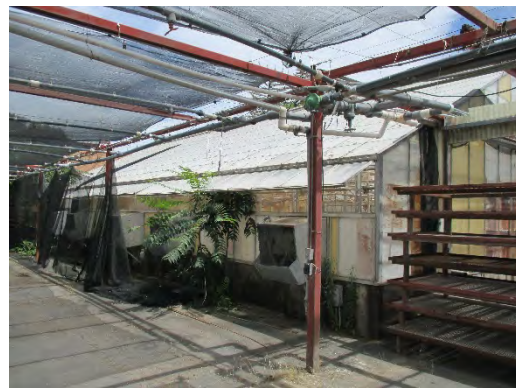
Figure 143: Western elevation of greenhouse, fitted with large jet-fan appliances. Shadehouse in foreground. Photograph taken 6/25/2019.

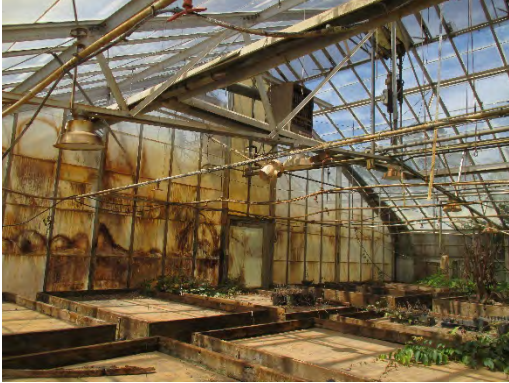
Figure 144: Smaller north room of interior of greenhouse, considerably deteriorated with uncontrolled vegetative growth. Photograph taken 6/25/2019.

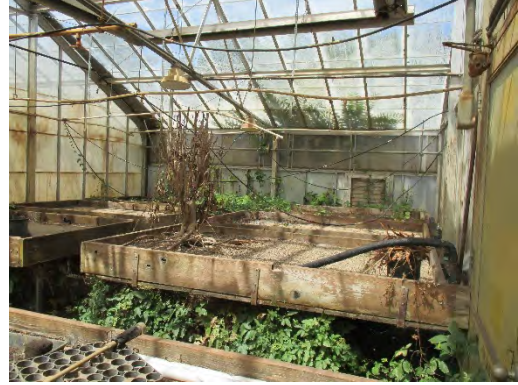
Figure 145: Another view of smaller north room of interior of greenhouse. Photograph taken 6/25/2019.

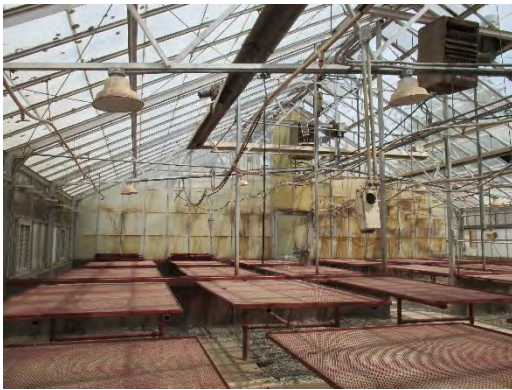
Figure 146: Larger south room of interior of greenhouse. Note concrete walkways interspersed with gravel to allow for water drainage within the building. Photograph taken 6/25/2019.

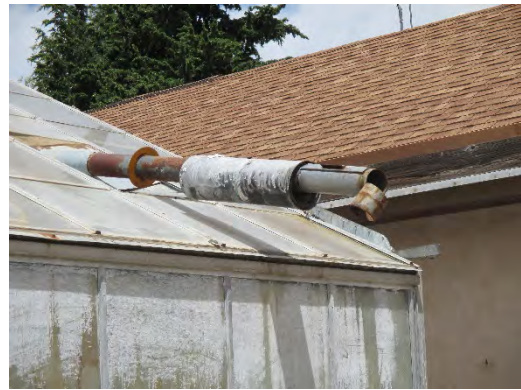
Figure 147: Disconnected water delivery system at northeast corner of greenhouse. Photograph taken 6/25/2019.

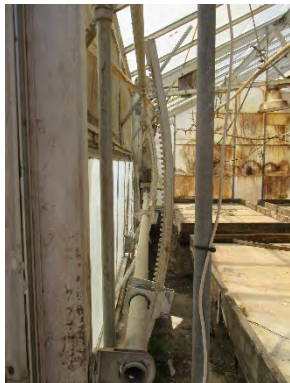
Figure 148: Detail of geared mechanism for opening side-wall windows outwards. Photograph taken 6/25/2019.

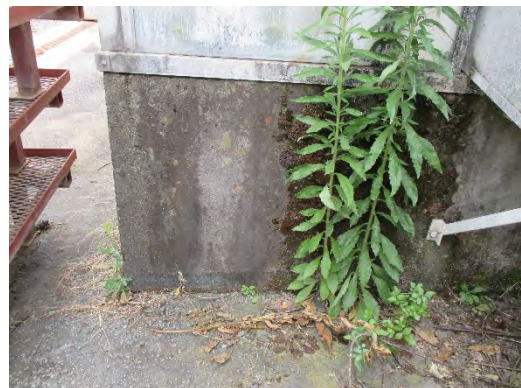
Figure 149: 1-2' poured concrete perimeter foundation. Photograph taken 6/25/2019.

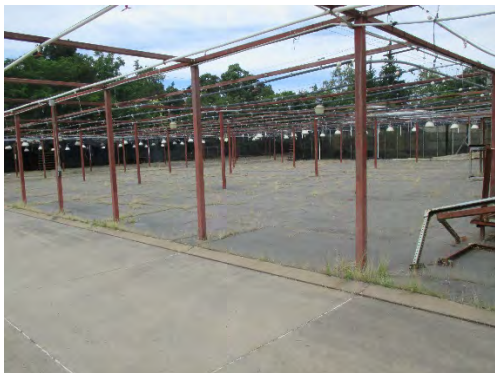
Figure 150: Concrete 'driveway' bordered by asphalt at south end of shadehouse structure. Photograph taken 6/25/2019.

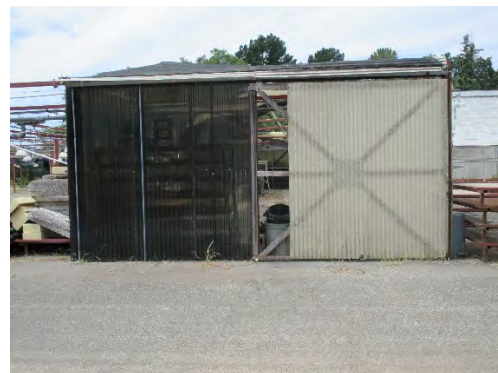
Figure 151: Wood-framed sliding door to 'room' at northeast portion of structure, just south of greenhouse (on right). Photograph taken 6/25/2019.

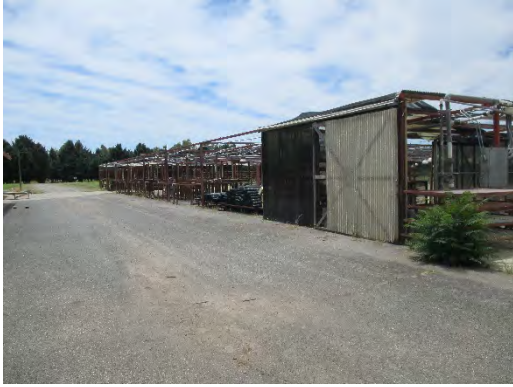
Figure 155: Eastern elevation of shadehouse, along 'First Avenue.' Photograph taken 6/25/2019.

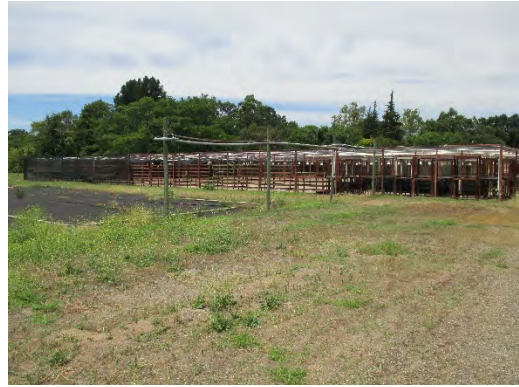
Figure 156: Southern elevation of shadehouse with 'trellis' for defunct water pipe at center. Photograph taken 6/25/2019.

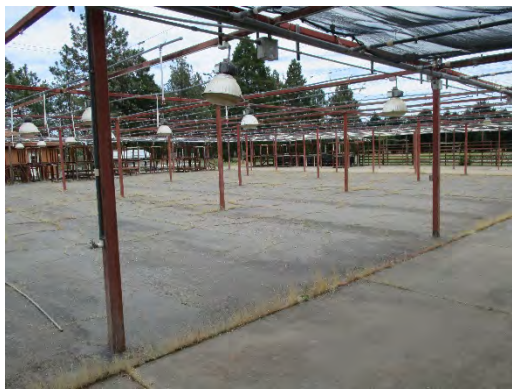
Figure 159: Interior of shadehouse with light fixtures and irrigation sprinklers hanging from overhead steel beams . Photograph taken 6/25/2019.

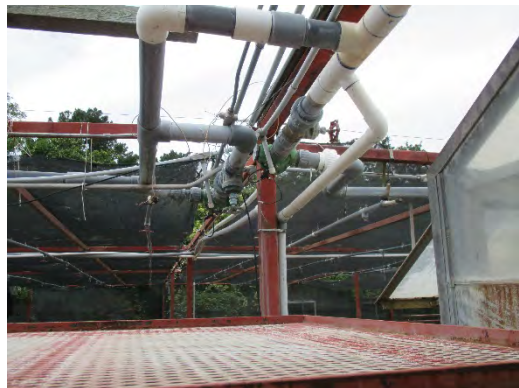
Figure 160: Close-up of valves for water-delivery system on interior of shadehouse. Photograph taken 6/25/2019.

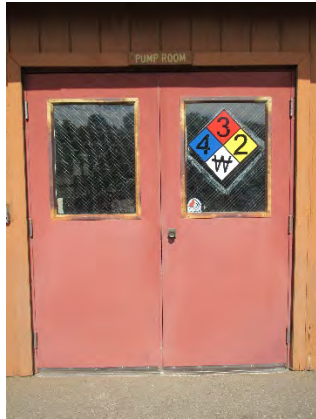
Figure 161: Double-door entrance to pump room on western elevation of Pump/Injector Building. Photograph taken 6/25/2019.

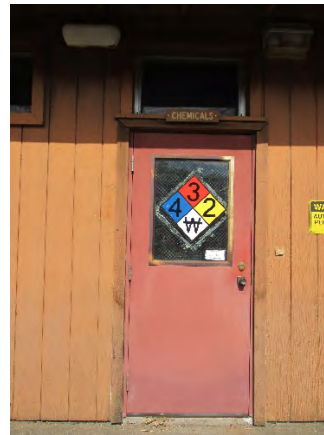
Figure 162: Pedestrian entrance to chemical storage area on western elevation of Pump/Injector Building. Note single-paned window with metal casing directly above door. Photograph taken 6/25/2019.

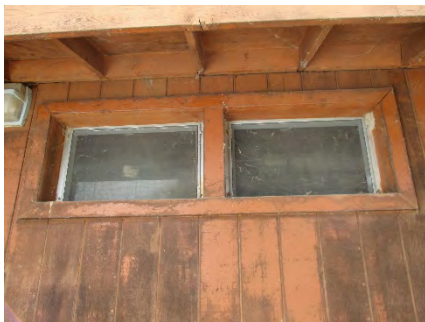
Figure 163: single-paned paired window sets with metal casings and wooden frames and mullions, located just below the eave on the northern elevation. Photograph taken 6/25/2019.

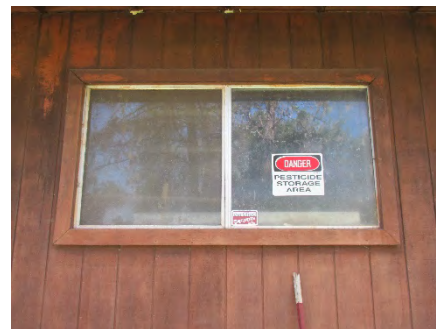
Figure 164: double-paned vertically sliding windows with metal casings and wooden frames, located about one foot below the eave of the eastern elevation. Photograph taken 6/25/2019.

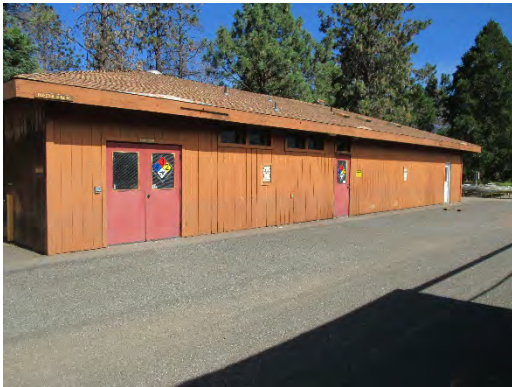
Figure 165: Western (primary) elevation of Pump/Injector Building. Photograph taken 6/25/2019.

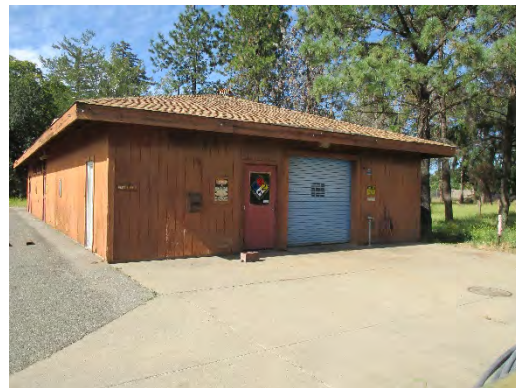
Figure 166: Southern elevation of Pump/Injector Building, with vehicle drive-up bay and grove of mostly exotic trees in background. Photograph taken 6/25/2019.

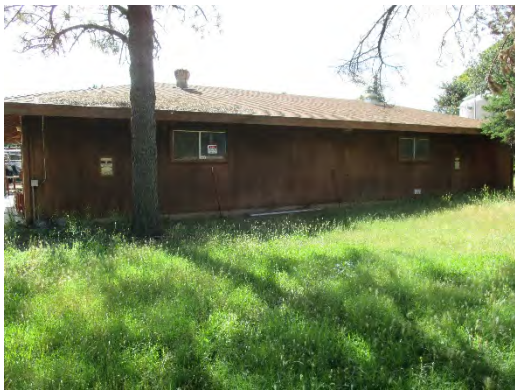
Figure 167: Eastern elevation of Pump/Injector Building. Photograph taken 6/25/2019.

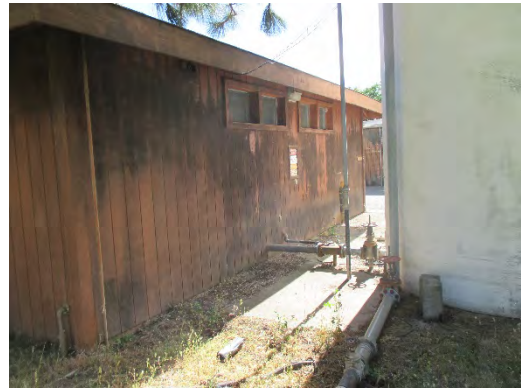
Figure 168: Northern elevation of Pump/Injector Building with 10,000-gallon water tank at right. Photograph taken 6/25/2019.

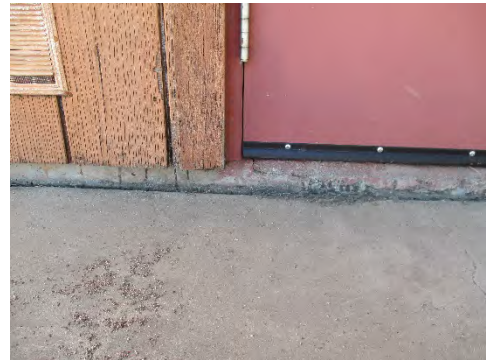
Figure 170: Concrete slab foundation. Photograph taken 6/25/2019.

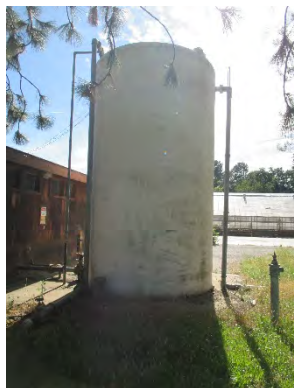
Figure 171: 10,000-gallon water tank. Photograph taken 6/25/2019.

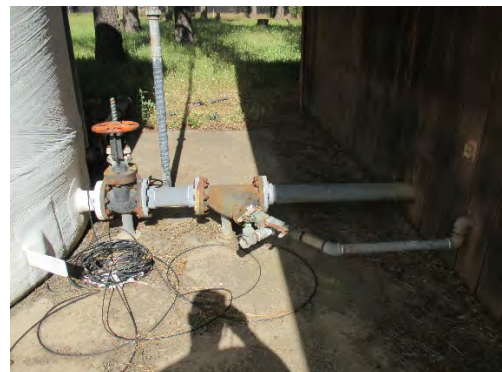
Located approximately 5' north of the Pump/Injector Building is a 10,000-gallon water tank on a concrete slab. It is fitted with pipes that lead directly into the pump room of the Pump/Injector Building, where it is chemically treated and thence delivered to irrigation systems on the property. It once delivered water to the greenhouse and shadehouse, but the connection to the greenhouse has been removed and likely the same for the shadehouse. The Pump/Injector Building today still serves as the location for storage of certain chemicals, such as herbicides, pesticides, insecticides, fungicides, and fertilizer.

Figure 172: Water-delivery connections from water tank into Pump/Injector Building. Photograph taken 6/25/2019.

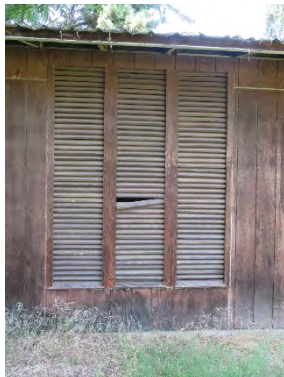
Figure 175: Full-length shuttered feature on southern elevation of shed extension of Tree Cooler 3 of 3 (Willamette Barn). Photograph taken 6/25/2019.

The Tree Cooler 3 of 3 (Willamette Barn) was relocated to its present location ca. 1992-1995. At that time, a new concrete driveway was poured for it. It has seen some deterioration, especially of the shuttered features on its shed extension, but its exterior otherwise does not seem to have been modified since its relocation. Its interior has likely been modified in order to accommodate its new function at the present-day Chico Seed Orchard Administrative Site.

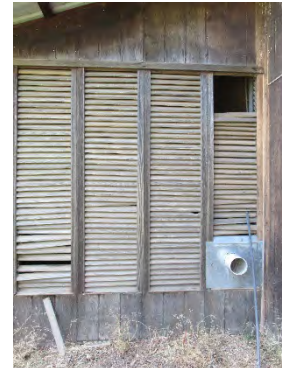
Figure 176: Full-length shuttered feature on eastern elevation of shed extension of Tree Cooler 3 of 3 (Willamette Barn). Photograph taken 6/25/2019.

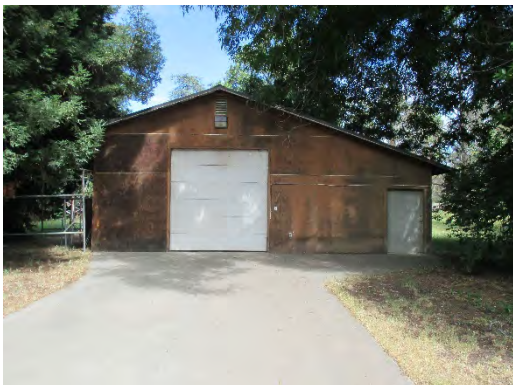
Figure 177: Western (primary) elevation of Tree Cooler 3 of 3 (Willamette Barn), the only elevation on the building with entrances. Note two (not one) horizontal bands of trim. Photograph taken 6/25/2019.

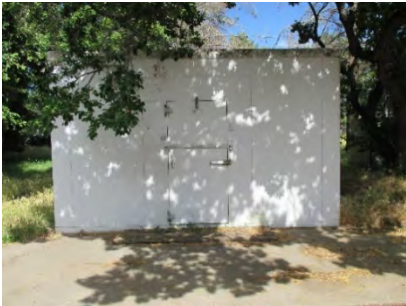
Figure 181: Western elevation of and entrance into the cold-storage shed. Photograph taken 6/25/2019.

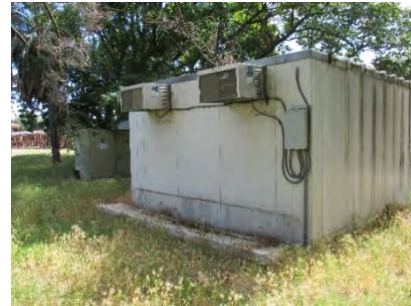
Figure 182: Eastern elevation of cold-storage shed, with two air-conditioning units at roof-wall junction. Photograph taken 6/25/2019.

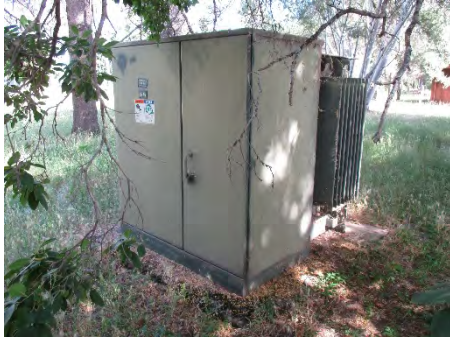
Installed ca. 1980, the large energy control box is set on a concrete slab measuring approximately 5' by 6.' It is located between the Tree Cooler 2 of 3 and the supplemental storage cabinet, and its function is likely related to that of those two adjacent structures.

Figure 185: Front-side of large electric control box. Photograph taken 6/25/2019.

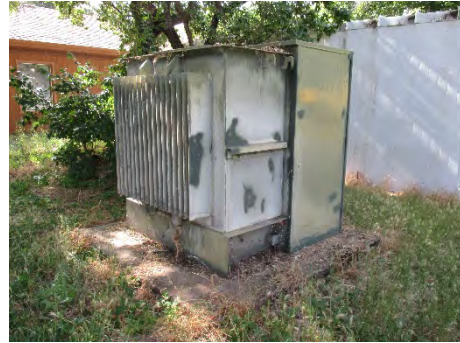
Figure 186: Back-side of large electric control box. Tree Cooler 2 of 3 in background. Photograph taken 6/25/2019.

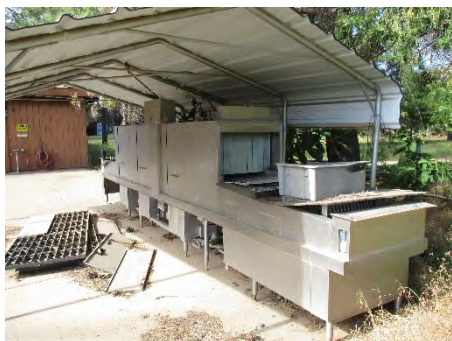
The shade canopy measures approximately 20' by 12.' It is open on all sides and is located above a piece of large machinery with a conveyor that may be a seed-sorting machine. The machine is embossed with the maker's mark 'HOBART.' The shade canopy is located approximately 20' south of the Pump/Injector Building.

Figure 189: Large machinery beneath shade canopy. Photograph taken 6/25/2019.

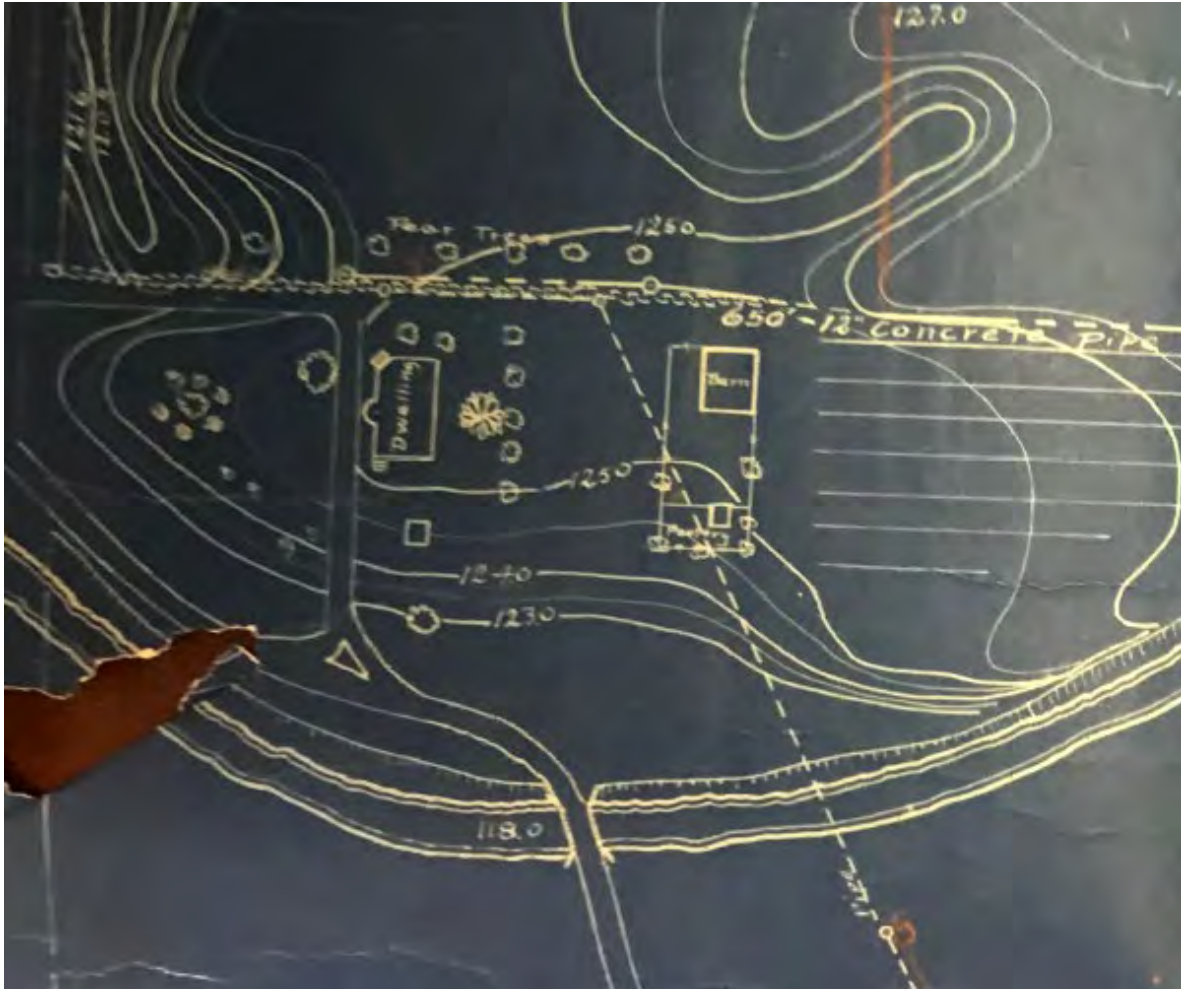
Figure 204: Detail from a 1924 feature map of the property, showing the landscaping plan around the present-day old residence/site host area (Area J). Note barn and poultry shed on site in 1924 as well.

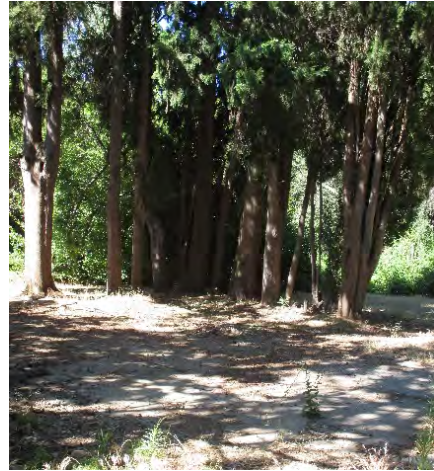
Figure 206: A grove of cedars, planted at the corner of the old residence building, of which the concrete-and-brick foundation can be seen in the foreground. Photograph taken 6/26/2019.

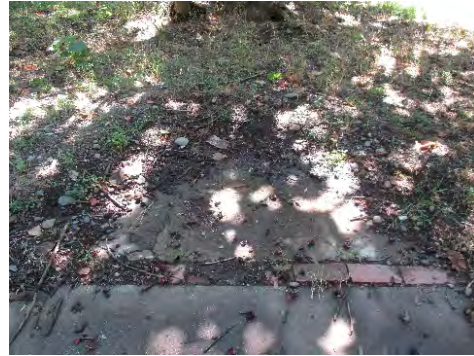
Figure 208: Detail of the concrete-and-brick foundation of the old residence building. Photograph taken 6/26/2019.

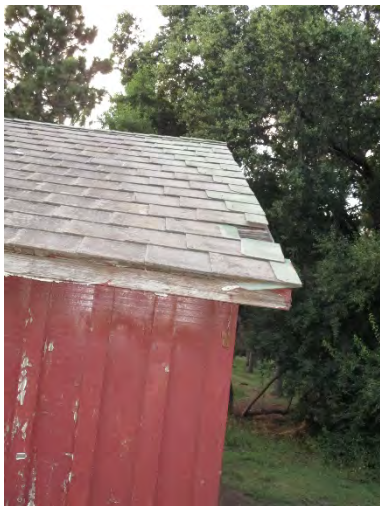
Figure 226: Horizontally overlapping roof shingles. Photograph taken 6/25/2019.

The barn has retained much of its form and feel, despite some modifications. The porch on its northern elevation was added on sometime after 1979. Some roof shingles have been replaced on the southern portion of the roof, and others have fallen off (see Figure 226). The metal door on the eastern elevation is not original, and may have been installed where previously there was no door. Glass panes have been removed from the barn's three windows on its southern elevation, and replaced with plastic fittings, and the one window on the eastern elevation has been boarded up.

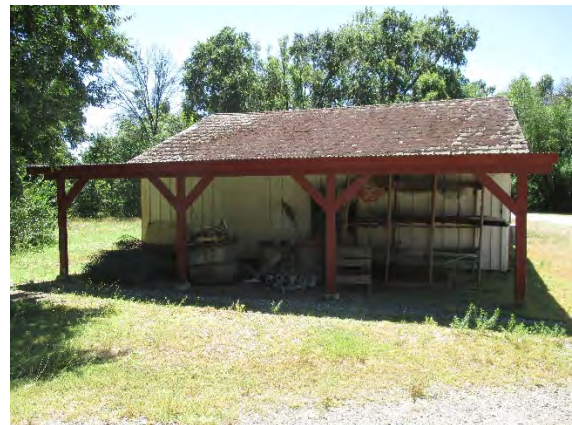
Figure 227: A thick mat of vegetative duff sits atop the northern portion of the Barn's roof. Photograph taken 6/26/2019.

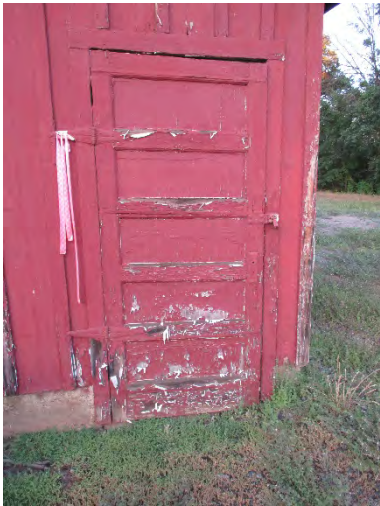
Figure 228: Primary pedestrian entrance door with five horizontal panels. Photograph taken 6/25/2019.

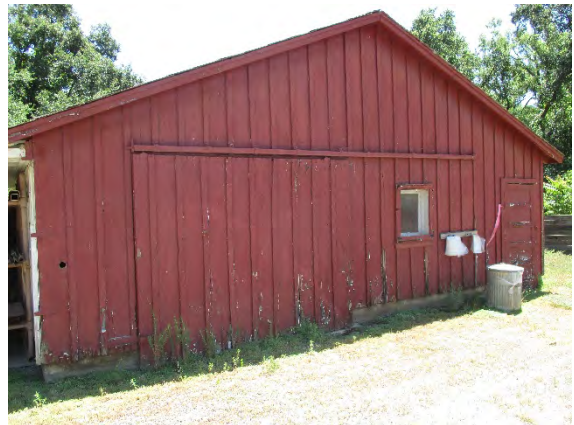
Figure 229: Sliding bay door and single window of western elevation. Note the two brackets and one drilled hole on the left. Photograph taken 6/26/2019.

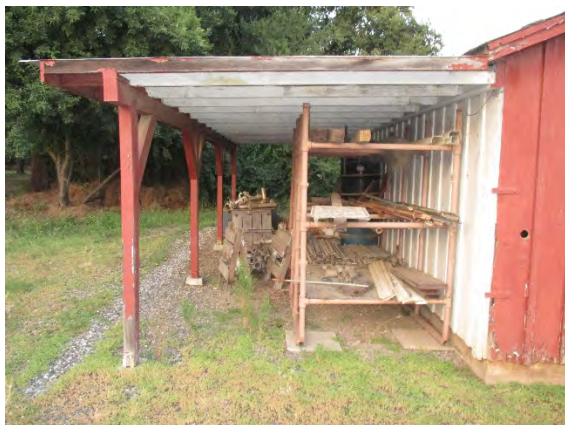
Figure 230: Post-1979 porch addition. Photograph taken 6/25/2019.

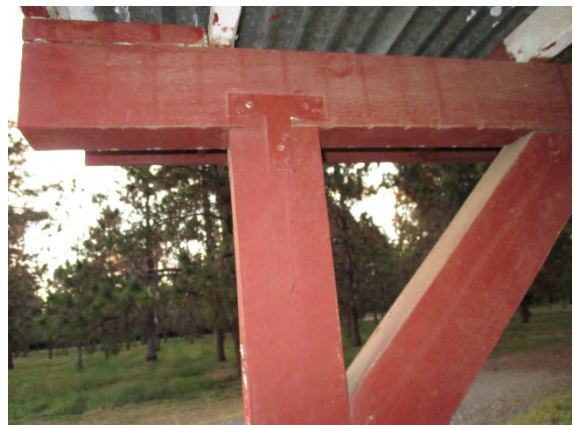
Figure 231: Metal T-brace attaching wooden beams of porch addition. Photograph taken 6/25/2019.

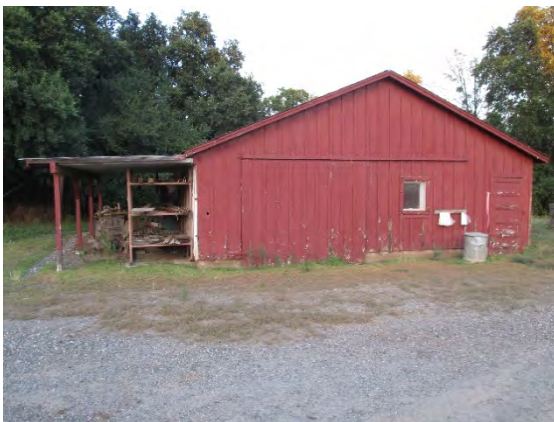
Figure 232: Primary western elevation of Barn, with unenclosed porch addition on the left. Photograph taken 6/25/2019.

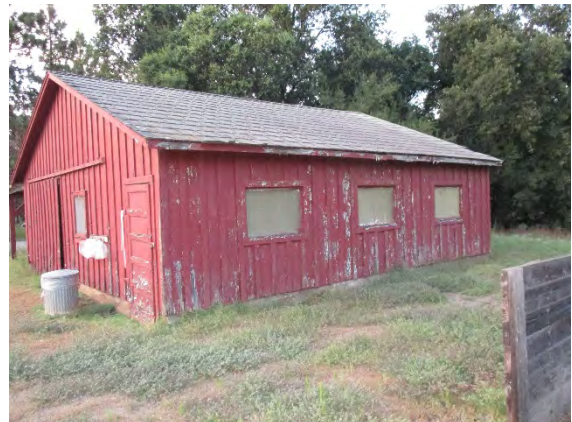
Figure 233: Southern elevation of Barn, with three windows that have been fitted with plastic. Photograph taken 6/25/2019.

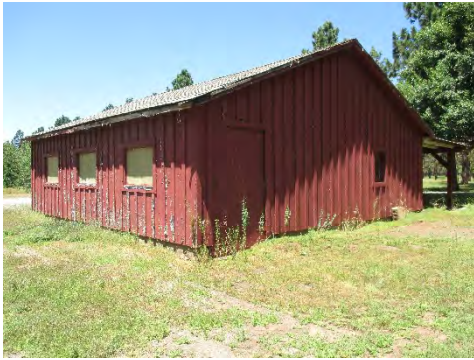
Figure 234: Eastern elevation of Barn with one solid metal door and one boarded-up window. Photograph taken 6/26/2019.

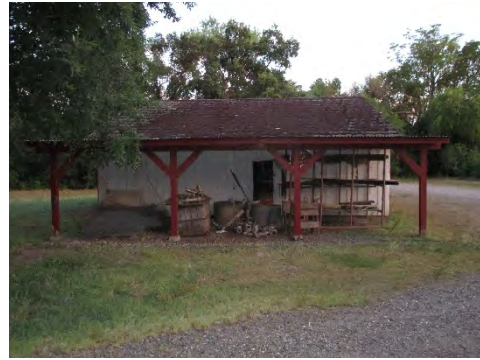
Figure 235: Northern elevation of Barn with unenclosed porch addition. Photograph taken 6/25/2019.

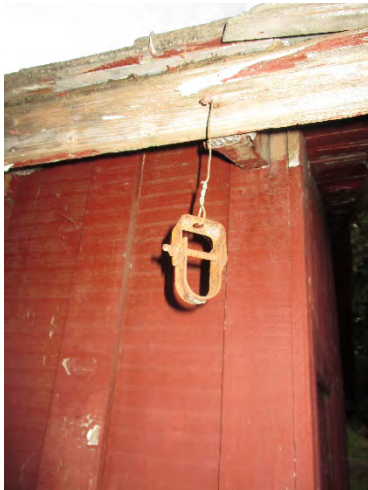
Figure 236: Hardware fixture hanging from wire at the southeastern corner of building. Photograph taken 6/25/2019.

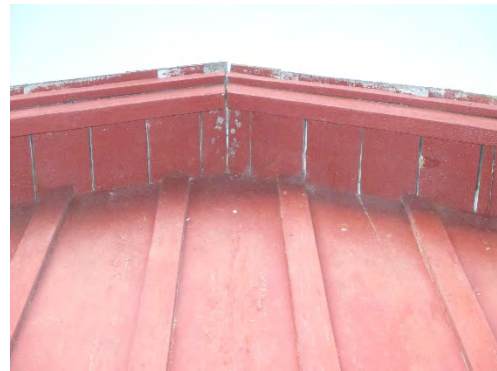
Figure 237: View of board-and-batten siding and tongue-and-groove boards that remain intact below the both sides of the building's roof. Photograph taken 6/25/2019.

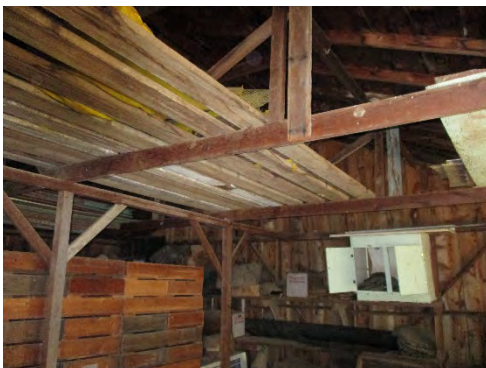
Figure 238: View of interior wood framing of the Barn. Photograph taken 6/26/2019.

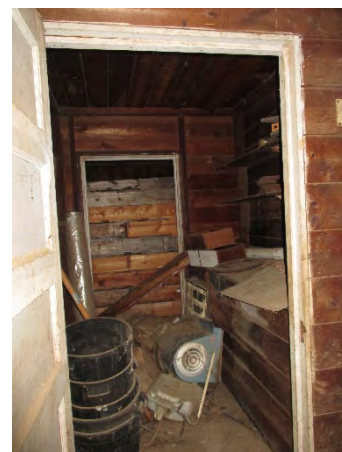
Figure 239: Small front 'office' area of the Barn. Photograph taken 6/25/2019.

The eastern elevation of the barn is fitted with one large solid metal door that does not appear to be original to the building. The eastern elevation also contains one boarded-up window with a wooden frame within wooden casing. The southern elevation contains three windows, whose panes have been replaced with plastic fittings set within wooden casing. The northern elevation contains no windows or doors, but does have an unenclosed porch addition that was added on to the building sometime after 1979. The porch addition has a flat transitional shed roof of corrugated metal set atop wooden braces. It is fitted with modern hardware and set atop concrete footers. Both the porch and the interior of the barn are today used for storage of building materials, pallettes, irrigation pipes and joints, and other goods. The interior of the barn is composed of two rooms: one large storage area and one much smaller front 'office' area (see Figure 239).

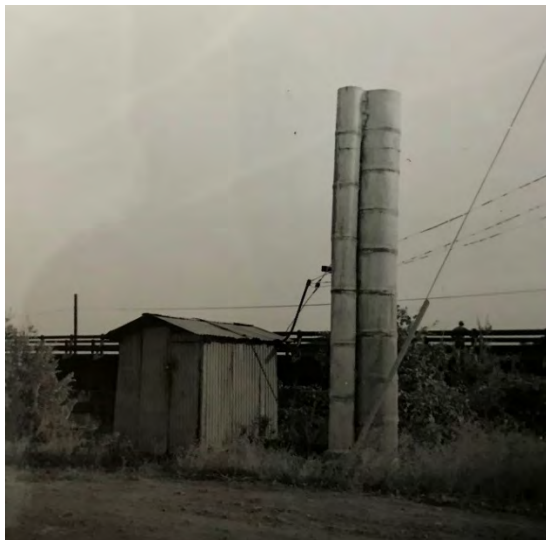
Figure 240: Butte Creek Pumphouse and adjacent irrigation standpipes. Photograph taken on November 16, 1959.

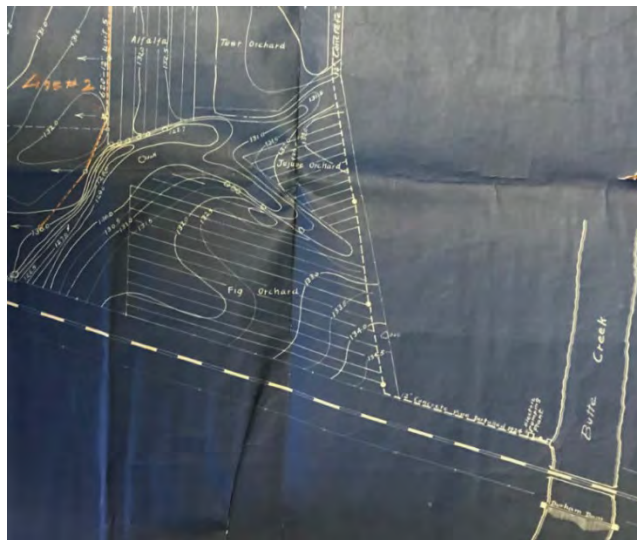
Figure 241: Detail of 1924 Feature Map, showing Durham Dam at bottom right, Butte Creek at right, "electric pumping plant" (i.e. the Butte Creek Pumphouse) just left of Butte Creek, and some of the fig, jujube, and citrus orchards irrigated by this supplementary irrigation system.

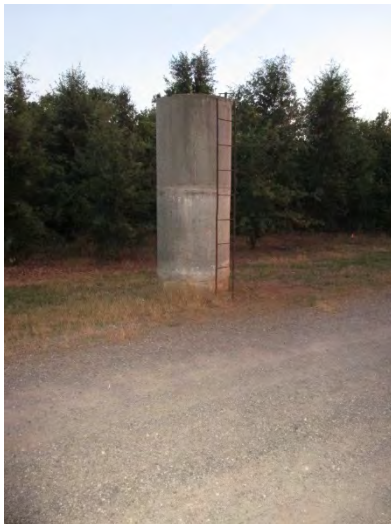
Figure 242: Concrete irrigation standpipe just south of Comanche Road, 300' west of the Barn, with metal rung access ladder. Photograph taken 6/25/2019.

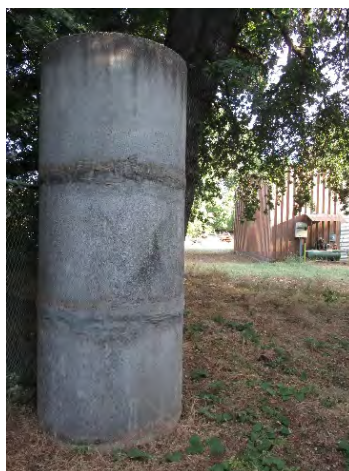
Figure 243: Concrete irrigation standpipe on south bank of Comanche Creek at far eastern boundary of property, with Shop/Storage Building (Old Search-and-Rescue) in back right of photograph. Photograph taken 6/25/2019.

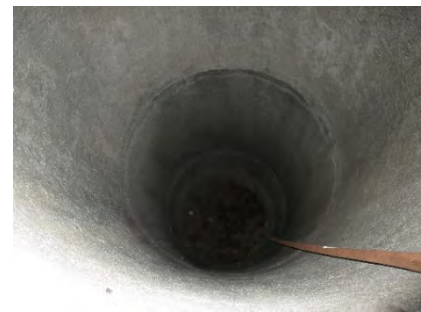
Figure 244: View looking into concrete irrigation standpipe south of Comanche Road, with manual operating mechanism descending into its depth. Photograph taken 6/25/2019.

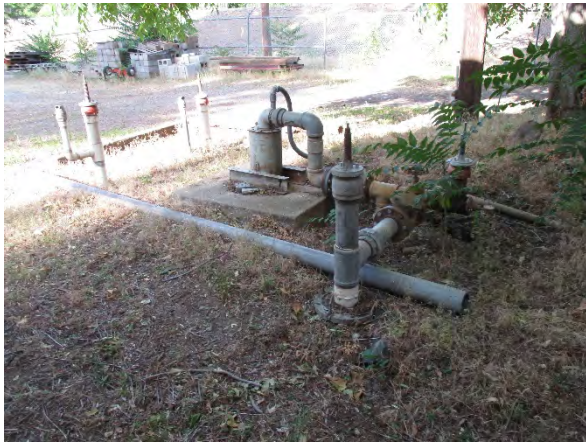
Figure 245: The east well, with Shop Road vehicle loop and chain-link fence of eastern property boundary in the background. Photograph taken 6/25/2019.

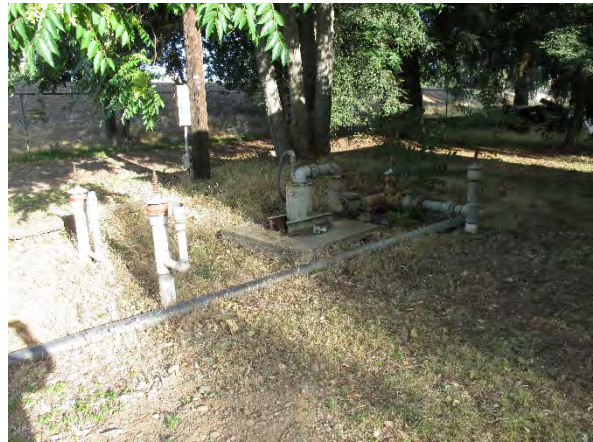
Figure 246: The east well with some ARS-era exotic plantings to its south in the background. Photograph taken 6/25/2019.

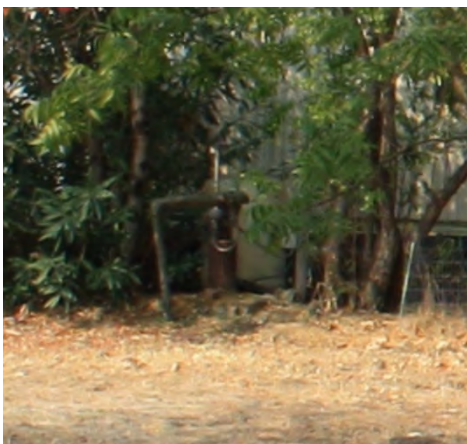
Figure 247: The old residence/site host area well. Photograph taken 8/20/2015. Photograph courtesy of Joel Little.

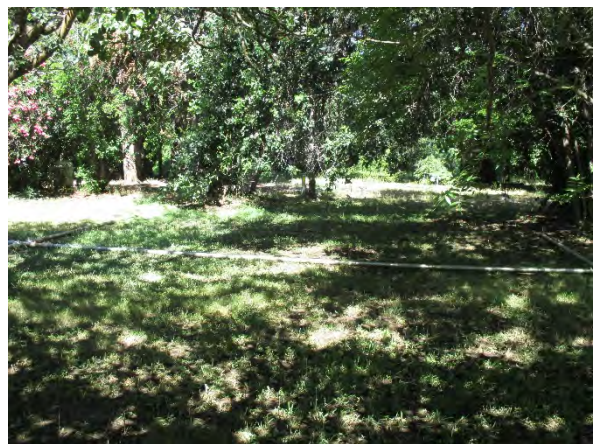
Figure 248: Present-day setting of the old residence/site host area well, with irrigation lines in the mid-ground. The well itself is barely visible at back left. Photograph taken 6/26/2019.

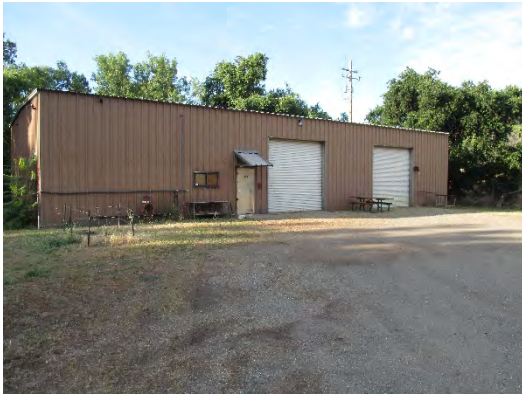
Figure 250: Southern primary elevation of Shop/Storage Building (Old Search-and-Rescue), with primary pedestrian entrance and two roll-up vehicle bay doors. Photograph taken 6/25/2019.

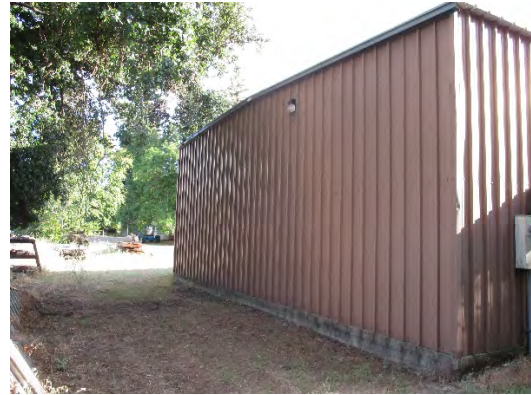
Figure 251: Eastern elevation of Shop/Storage Building (Old Search-and-Rescue) with no windows, doors, or other architectural features. Photograph taken 6/25/2019.

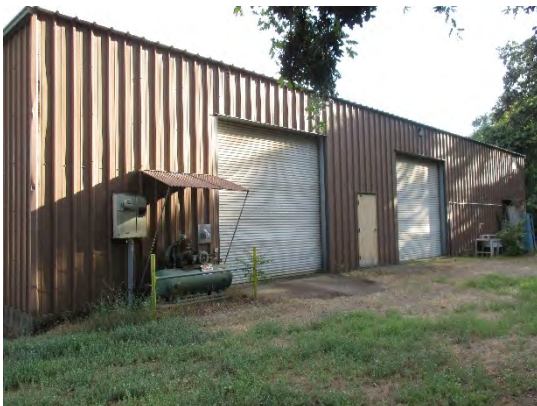
Figure 252: Northern (riverside) elevation of Shop/Storage Building (Old Search-and-Rescue), with pedestrian entrance, two roll-up vehicle bay doors, and two canopy awnings overtopping utilities. Photograph taken 6/26/2019.

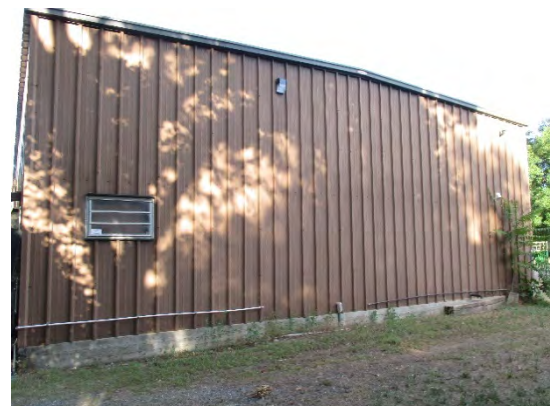
Figure 253: Western elevation of Shop/Storage Building (Old Search-and-Rescue) with one awning-style window of three single horizontal panes. Photograph taken 6/26/2019.

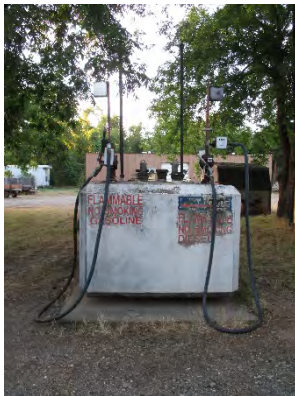
Figure 254: Southeastern primary façade of gasoline dispenser with Shop/Storage Building (Old Search-and-Rescue) in the background. Photograph taken 6/25/2019.

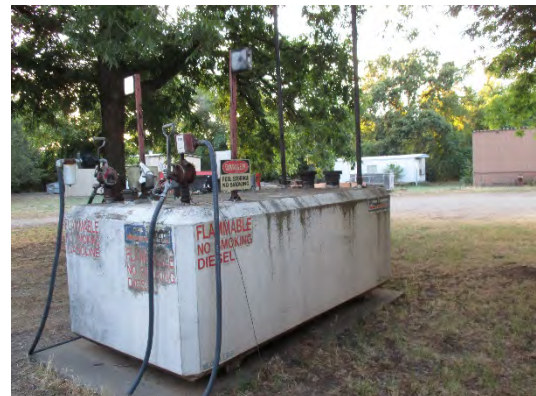
Figure 255: Northeastern façade of gasoline dispenser with mobile office in the background. Photograph taken 6/25/2019.
