Chico Plant Introduction Garden Forest Service Site #05-08-60-02

*Section 106 Determination of Eligibility
Report #R2020050800025*

Chico Plant Introduction Garden FS Site #05-08-60-02 Mendocino National Forest

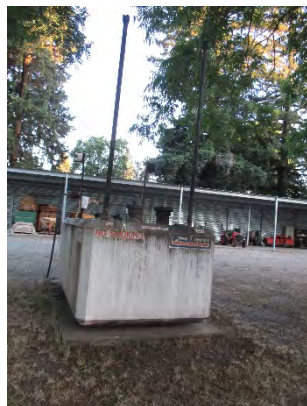
Figure 256: Northwestern façade of gasoline dispenser with Open Garage in the background. Photograph taken 6/25/2019.

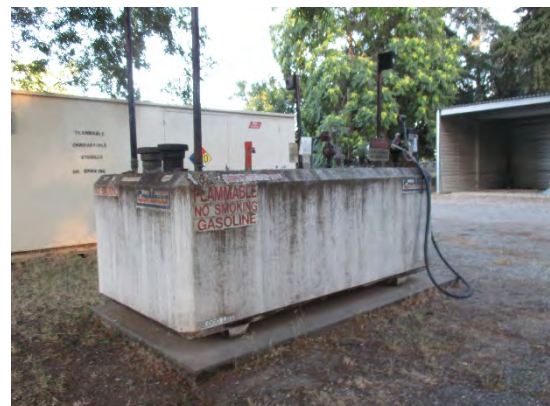
Figure 257: Southwestern façade of gasoline dispenser with flammables and combustibles storage container in the background. Photograph taken 6/25/2019.

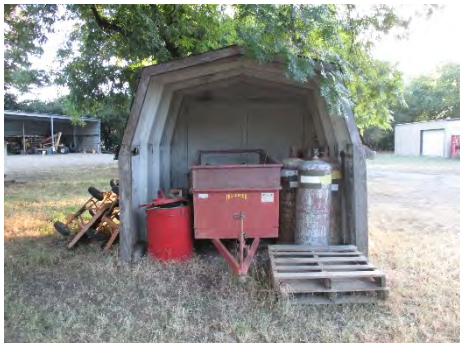
Figure 258: Northeastern primary open façade of the Shop Road small storage shed, with Open Garage at back left and Storage Building (Warehouse) at back right. Photograph taken 6/25/2019.

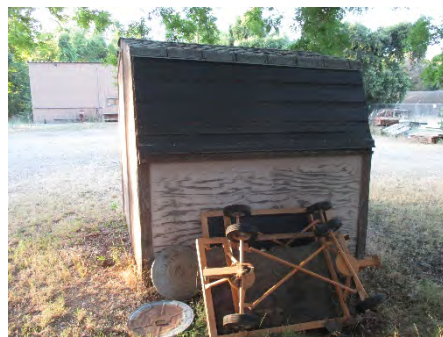
Figure 259: Southeastern façade of Shop Road small storage shed, with Shop/Storage Building (Old Search-and-Rescue) in the background. Photograph taken 6/25/2019.

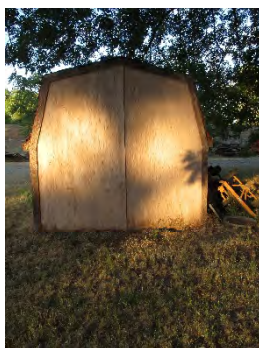
Figure 260: Southwestern façade of Shop Road small storage shed, showing gambrel roof form. Photograph taken 6/25/2019.

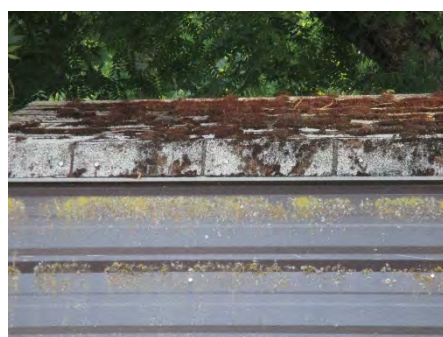
Figure 261: Detail of roofing materials of Shop Road small storage shed, with moss-covered asbestos shingles on upper pitch and corrugated sheet metal on lower pitch. Photograph taken 6/25/2019.

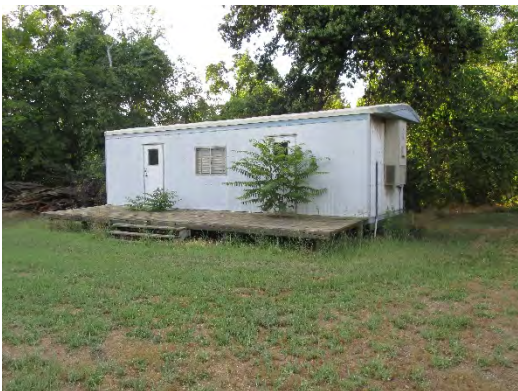
Figure 262: Southern primary elevation of mobile office, with two entrances and one double-paned casement window. Photograph taken 6/25/2019.

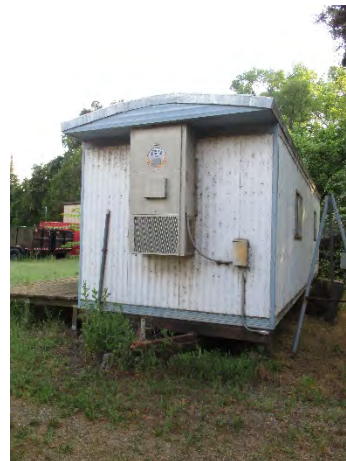
Figure 263: Eastern elevation of mobile office, with roof overhang overtop affixed air-conditioning unit and other utilities. Two double-paned casement windows of northern elevation are visible on the right, and the Storage Building (Warehouse) is visible at back left. Photograph taken 6/25/2019.

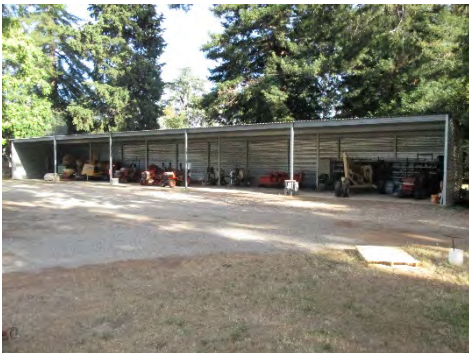
Figure 264: Open northern elevation of Open Garage. Photograph taken 6/25/2019.

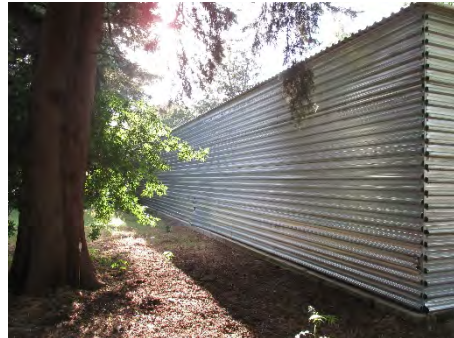
Figure 265: Southern elevation of Open Garage. Though ARS-era exotic plantings are located just south of the structure, they bear no association to each other besides location. Photograph taken 6/25/2019.

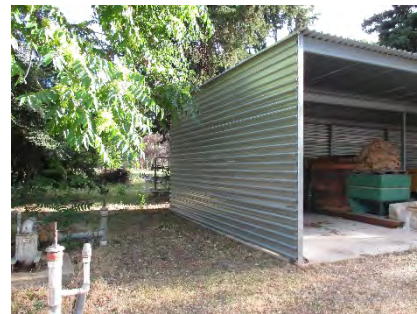
Figure 267: Eastern elevation of structure. Note historic east well at left. Photograph taken 6/25/2019.

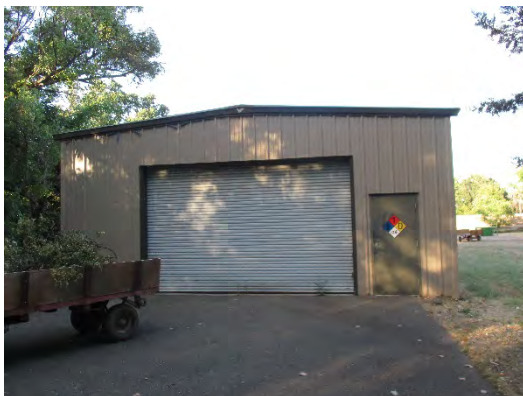
Figure 268: Southwestern primary elevation of Storage Building (Warehouse), with pedestrian entrance and vehicle bay door fronting on asphalt driveway. Photograph taken 6/25/2019.

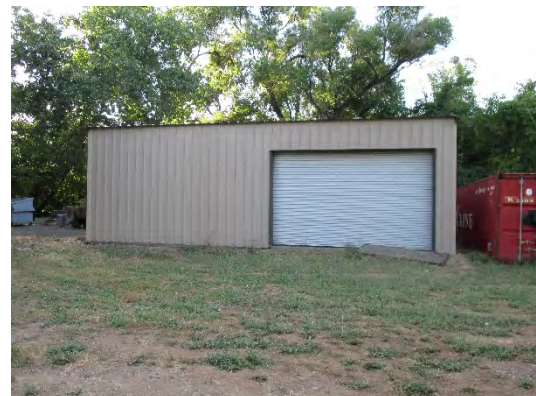
Figure 269: Southeastern elevation of warehouse/storage building with vehicle bay door fronting on the Shop Road maintenance yard. Adjacent 'K-Line' container is located directly northeast of the building. Photograph taken 6/25/2019.

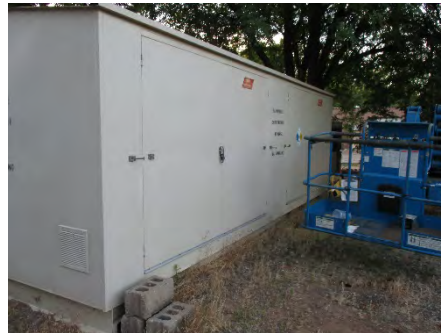
Figure 271: Northeastern façade of gasoline dispenser with mobile office in the background. Photograph taken 6/25/2019.

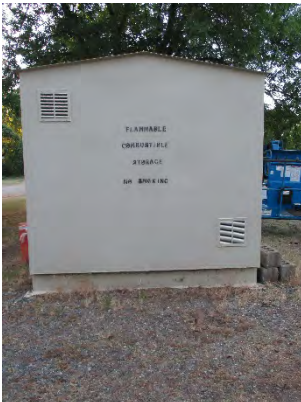
The flammables and combustibles storage container measures 24' by 9' 6," encompassing approximately 228 square feet. The foundation of the flammables and combustibles storage container consists of steel I-beams set atop the ground surface. Its roof is side-gabled with a low pitch, is sheathed with sheet metal and contains no roof projections. The structure's walls are clad in sheet metal. The flammables and combustibles storage container has three entrances and no windows. The primary entrance is located on the southwestern façade, facing the gasoline dispenser, and is accessed by a set of two wooden steps. The other two entrances are located on the northeastern façade. Two of the three entrances are labelled with the hazardous materials symbology. All three entrances consist of metal double doors with modern hardware, set within metal frames. The primary southwestern façade contains one awning-style box vent. The southeastern and northwestern facades each contain two flat grate vents. The structure has no windows.

Figure 272: Southeastern façade of flammables and combustibles storage container, with two flat grate vents. Photograph taken 6/25/2019.

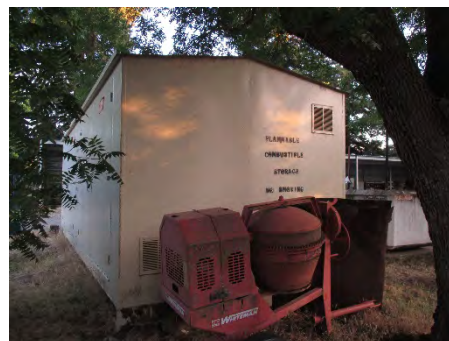
Figure 273: Northwestern façade of flammables and combustibles storage container, with cement mixer stored aside it. Photograph taken 6/25/2019.

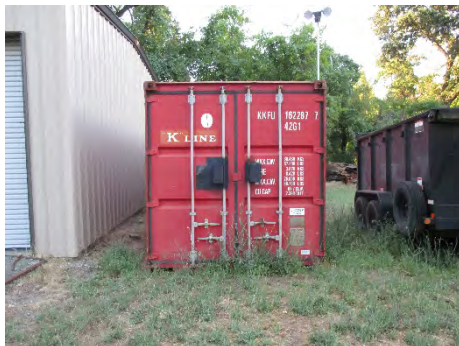
Installed on site between 2017 and 2018, the Shop Road K-line container is a standardized intermodal metal shipping container. It is oriented towards the south. It is located in the Shop Road maintenance yard, directly to the east of the Storage Building (Warehouse) and approximately 80 feet southwest of the Shop/Storage Building (Old Search-and-Rescue). The landscape setting of the Shop Road K-line container is the same as that of the Shop/Storage Building (Old Search-and-Rescue). The container measures 8 feet by 40 feet, encompassing approximately 320 square feet. It has no foundation, but is set directly atop the ground surface. Its roof is flat, and its roof and walls are entirely composed of metal. It is equipped with an electric floodlight fixture. The container has one double-door entrance, encompassing the entirety of its southern façade. This K-line container replaces a previous mobile office that was removed from the site between September 2015 and April 2016.

Figure 274: Southern primary façade of Shop Road K-line container, with Storage Building (Warehouse) to left and staged vehicle trailer to right. Photograph taken 6/25/2019.

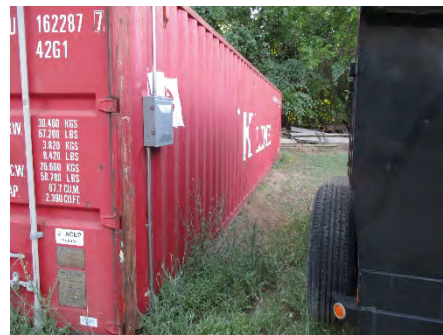
Figure 275: Eastern façade of Shop Road K-line container with utility hook-up for electric floodlight fixture. Photograph taken 6/25/2019.

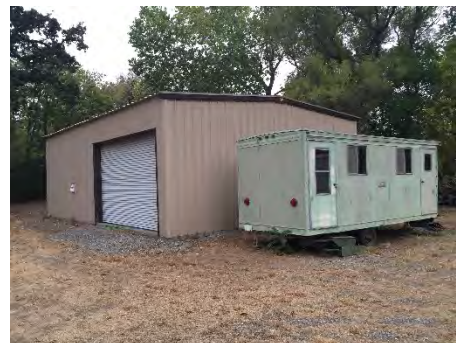
Figure 277: Previous mobile office in location of present-day K-line container. This mobile office was removed from the site between September 2015 and April 2016. Photograph taken 9/14/2015. Photograph courtesy of Joel Little.

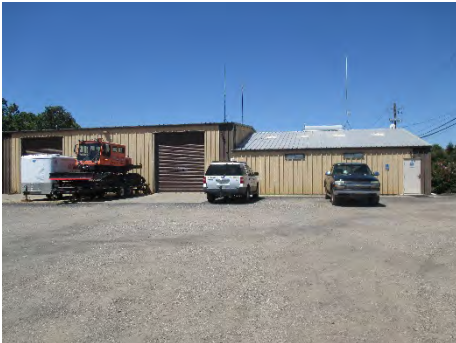
Figure 279: Eastern primary façade of Butte County Sheriff Search and Rescue Headquarters, with primary pedestrian entrance on right. Photograph taken 6/26/2019.

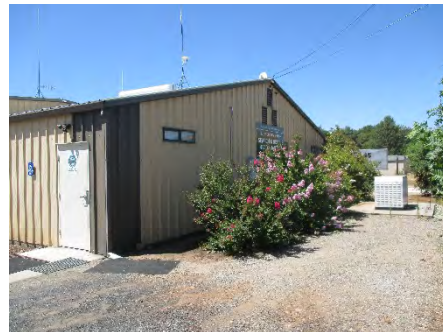
Figure 280: Northern façade of Butte County Sheriff Search and Rescue Headquarters, with flowering shrubs obscuring utilities. Photograph taken 6/26/2019.

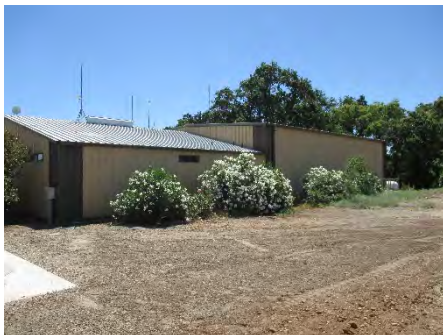
Figure 281: Western façade of Butte County Sheriff Search and Rescue Headquarters. Photograph taken 6/26/2019.

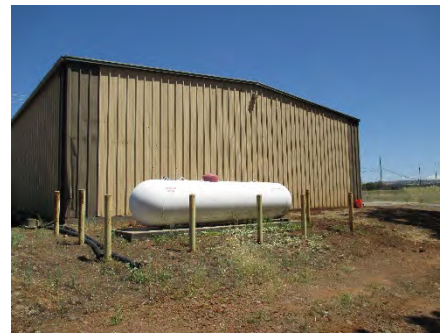
Figure 282: Southern façade of Butte County Sheriff Search and Rescue Headquarters, with Skyway Road at back right. Photograph taken 6/26/2019.

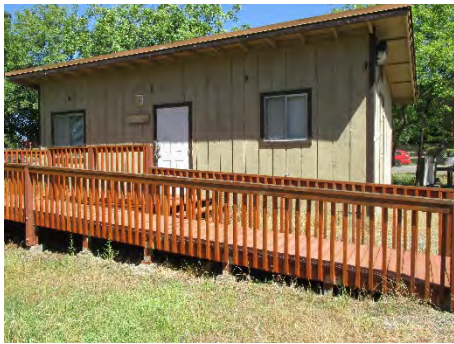
The O.C. Crew Office Building measures 30’ 3” by 12’ 3”, encompassing approximately 370 square feet, not including an open front deck and ramp. This building has a shed-style roof, sloped down toward Morrow Lane. The roof is sheathed in corrugated metal atop plywood sheathing. It features a plywood fascia and an unboxed eave with exposed rafters. Two vent pipes project through the roof along its northern margin. The building’s foundation is obscured by wooden drop siding that extends down to the ground surface. This building is a modified modular office, pre-fabricated, installed on site, and seemingly set directly on grade. The building’s walls are clad in wooden drop-siding in three distinct segments: one segment that extends not more than one foot above ground surface, one segment that encompasses the main body of the building, and one segment that encompasses the slope of the roof.

Figure 283: Primary southern elevation of O.C. Crew Office Building, with open front deck and ramp. Photograph taken 6/26/2019.

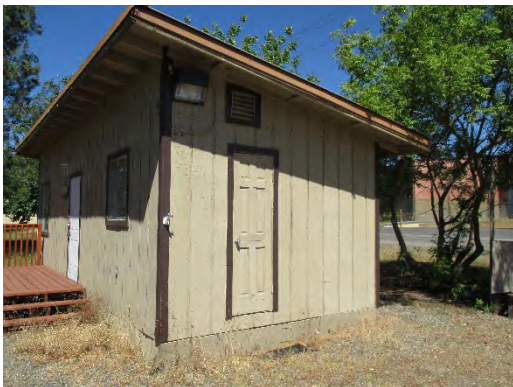
Minor modifications of this building include the metal patches on the western elevation where presumably utilities previously entered or exited the building, as well as the lack of steps for the door that is raised above ground level on the eastern elevation. The front deck and ramp itself are likely to be

Figure 285: Eastern elevation with door raised above ground level. Photograph taken 6/26/2019.

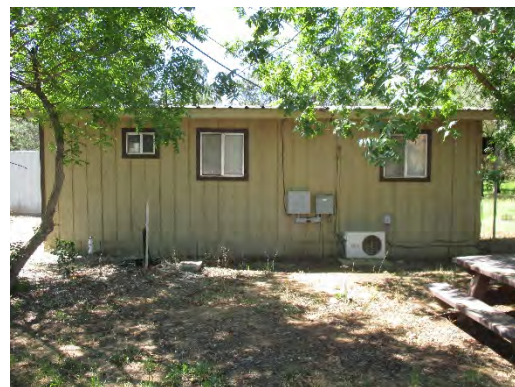
Figure 286: Northern (roadside) elevation with utility connections. Photograph taken 6/26/2019.

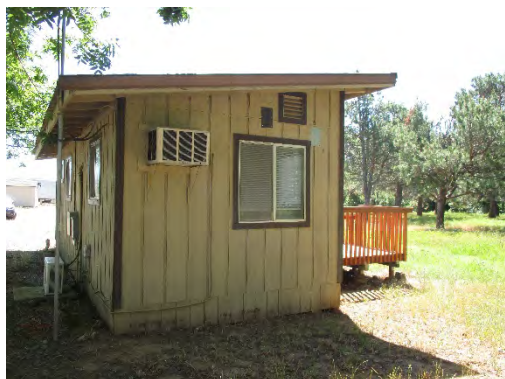
Figure 287: Western elevation with metal patches. Photograph taken 6/26/2019.

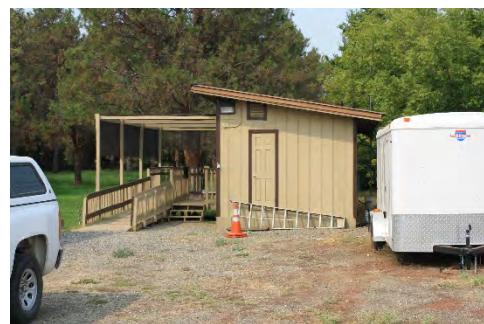
a later additions to the original floor plan. As of 2015, the front deck was equipped with an overhead wooden framework that supported a shadecloth, but both framework and shadecloth have been since removed. Though this building does not date to the property's period of significance, it retains integrity of design, materials, and association with a highly developed commercial area with ease of access to city streets. Its design as a modular unit detracts from any degree of integrity of location, setting, or feeling that would be afforded to a permanent building. Its setting was modified somewhat in 2005 with the construction of a large commercial facility directly across Morrow Lane.

Figure 288: Eastern elevation as seen in 2015, when wooden framework and shadecloth of front deck were still in use. They have since been removed. Photograph taken 8/20/2015. Photograph courtesy of Joel Little.

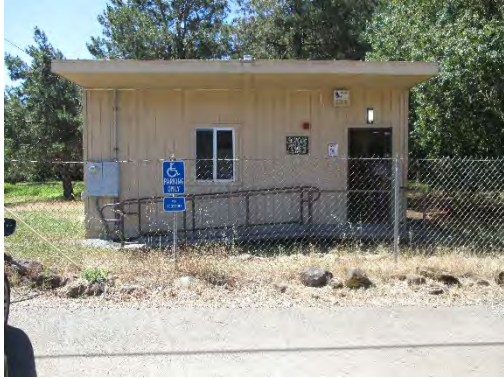
Figure 289: Primary northern (roadside) elevation of Butte County Education Extension Building, with accessible ramp. Photograph taken 6/26/2019.

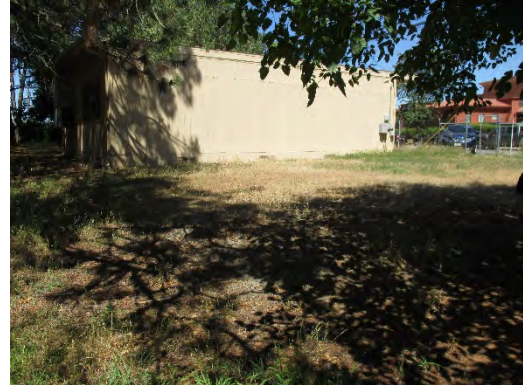
Figure 290: Eastern elevation with adjacent graded area with gravel base. Photograph taken 6/26/2019.

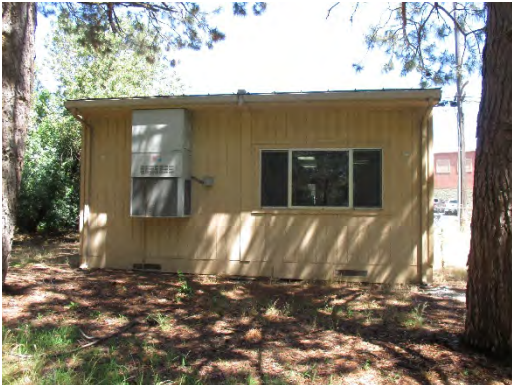
Figure 291: Southern elevation with one casement window and affixed air-conditioning unit. Photograph taken 6/26/2019.

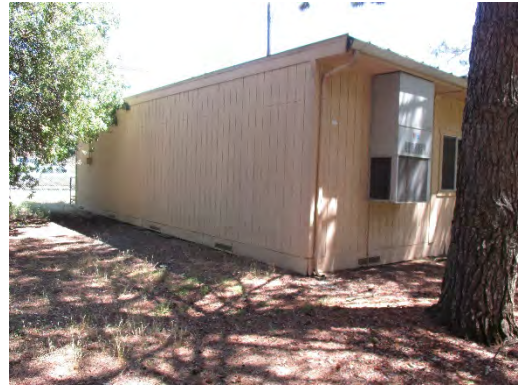
Figure 292: Western elevation with no windows or doors. Photograph taken 6/26/2019.

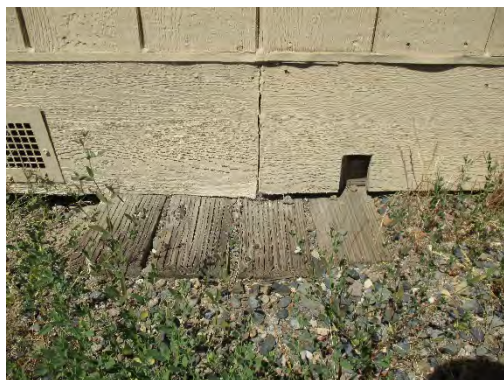
Figure 293: Horizontal baseboards and foundation of wooden boards. Photograph taken 6/26/2019.

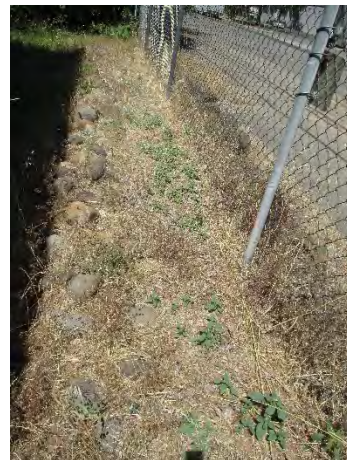
Figure 294: Abandoned rock garden located in front of building, bisected by installation of chain-link fence. Photograph taken 6/26/2019.

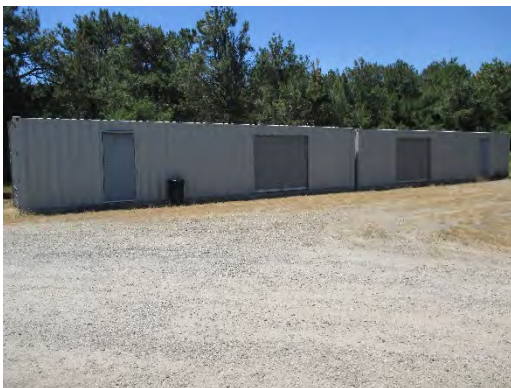
They measure 40' by 9' each, encompassing 360 square feet each. They are metal on all sides, and are set directly atop the ground surface with no foundation. Their pedestrian doors are metal with modern hardware, set within metal frames. Their vehicle bay doors are metal roll-ups set within metal frames. They also contain standard container double-doors, encompassing the entirety of their (outer) eastern and western façades, respectively. They contain no windows. They have undergone no modifications, and retain integrity, though they do not date to the property's period of significance.

Figure 295: Northern (roadside) elevation of two fire cache containers, located within the Search and Rescue Headquarters building cluster. Photograph taken 6/26/2019.

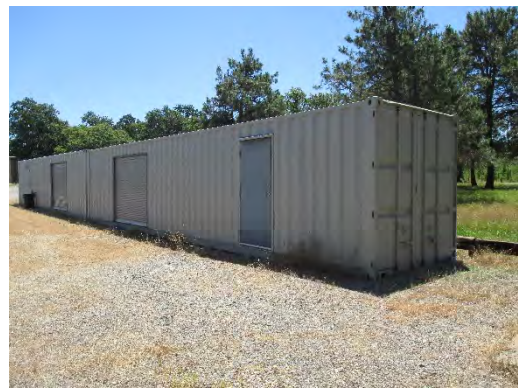
Figure 296: Northern and western elevations. Photograph taken 6/26/2019.

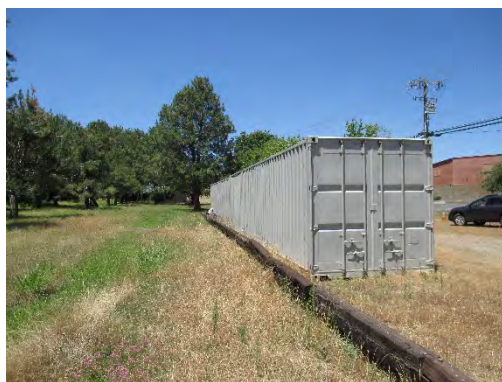
Figure 297: Southern and eastern elevations, with retaining wall over remains of Stone Run. Photograph taken 6/26/2019.

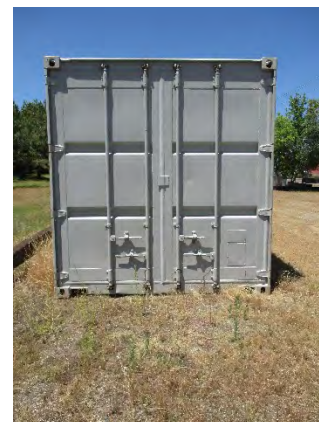
Figure 298: Eastern elevation with standard container double-door. Photograph taken 6/26/2019.

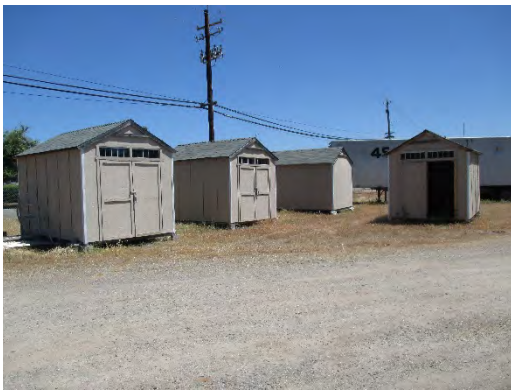
They are utilitarian one-story storage sheds, with front-gabled rooves, set atop foundations of cinder blocks. Their rooves are sheathed with shingles and their walls are of unclad board-and-batten plywood. They have one wooden double-door apiece set within wooden frames. Atop these double doors are two ribbon windows of five panes apiece with metal mullions within wooden frames. They retain integrity, though they do not date to the property's period of significance.

Figure 299: Four of five new search-and-rescue storage sheds, with large vehicle trailer in background. Photograph taken 6/26/2019.

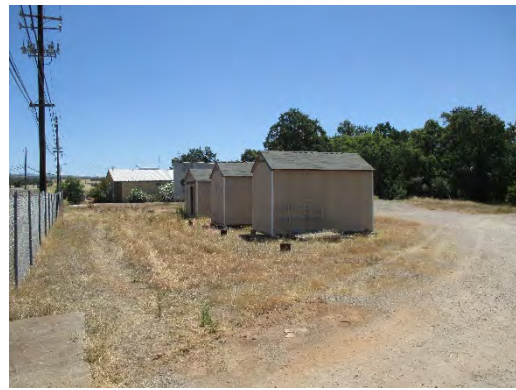
Figure 300: Three of five new search-and-rescue storage sheds with Search and Rescue Headquarters in background. Photograph taken 6/26/2019.

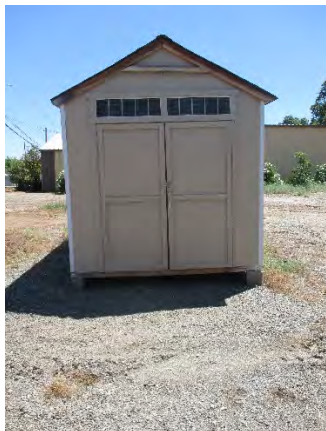
Figure 301: Primary elevation of storage shed, with double-door and ribbon windows. Photograph taken 6/26/2019.

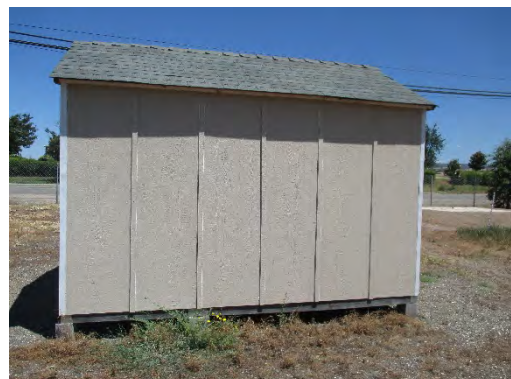
Figure 302: Side elevation of storage sheds with board-and-batten plywood. Photograph taken 6/26/2019.

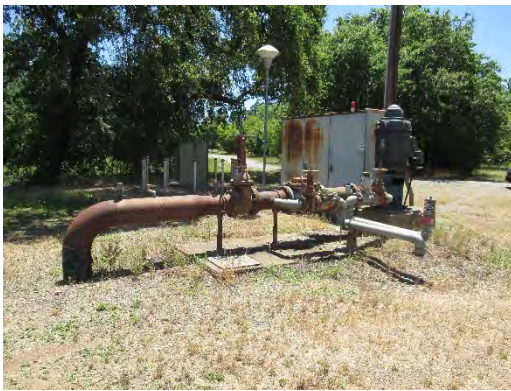
The north well was drilled in 1979, with its industrial-grade pump and electrical fixtures installed in 1980. Irrigation lines that were fed by this well continued to be installed until at least 1983. The north well is composed of large steel pipes and joints, encased within a concrete pad. An adjacent industrial-grade pump is set upon a concrete platform. An electric control box and a storage cabinet are also set atop two separate concrete pads. A wooden light pole rises above the structure. The north well is located just north of Comanche Road, approximately 900 feet west of the Barn and 1,200 feet east of the old residence/site host area. It is at the south end of a rust-resistant sugar pine seed orchard. Its general setting consists of 209 acres of federal land, 131 acres of which host source-identified genetically improved trees for the reforestation program of the Pacific Southwest Region. Species dedicated to this program present on property include ponderosa pine, Douglas-fir, rust-resistant sugar pine, Port Orford cedar, and Afghanistan pine. The storage cabinet and generator may be later additions to the site, and are likely contemporaneous with the storage cabinet and generator at the headhouse building complex, since they are identical. Otherwise, the north well retains integrity, though it does not date to the property's period of significance.

Figure 303: The north well, with storage cabinet and electric control box in the background. Photograph taken 6/26/2019.

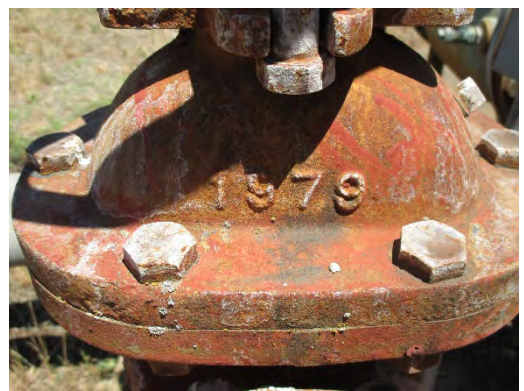
Figure 304: "1979" embossed on one of the well's joints. Photograph taken 6/26/2019.

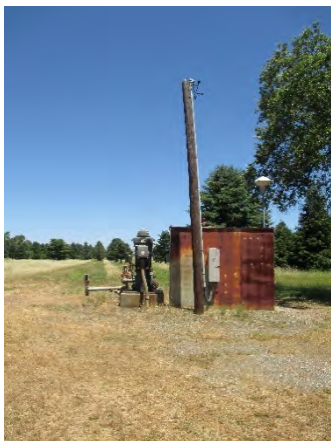
Figure 305: View looking north of the north well, storage cabinet, and light pole, with rust-resistant sugar pine seed orchard in background. Photograph taken 6/26/2019.

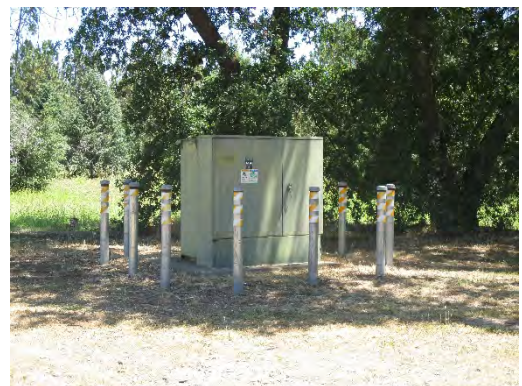
Figure 306: Adjacent electric control box on a concrete pad. Photograph taken 6/26/2019.

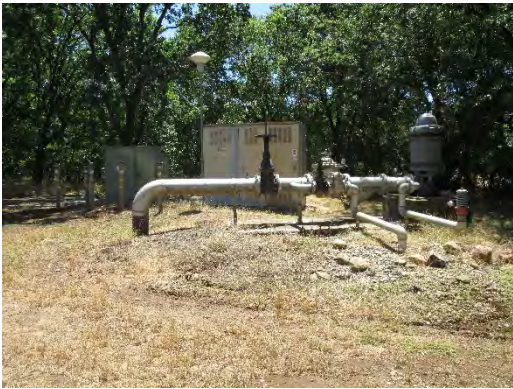
The south well was drilled in 1979 and plans for installation of its pump were drafted in 1980, though actual installation of the pump may not have occurred until 1984, when electrical power was connected to it via underground lines. Different joints on the structure itself are embossed with “1985,” “1986,” and “1988,” at which point the system presumably became operational. The south well is composed of large steel pipes and joints, encased within a concrete pad. An adjacent industrial-grade pump is set upon a raised concrete platform. An electric control box, a storage cabinet, and a metal light pole are also located adjacent. The electric control box is set upon a concrete pad. The south well is located at the end of the improved section of South Well Road, a spur of South Orchard Road. It is located approximately 700 feet southwest from the Office Building (Laboratory), 715 feet south of Comanche Creek, and 460 feet north of the southern boundary of the property. Its general setting consists of source-identified genetically improved trees for the reforestation program of the Pacific Southwest Region to its north and west, and remnant historic exotic plantings, including pistachio trees and grape vines, to its south and east. The south well retains integrity, though it does not date to the property’s period of significance.

Figure 307: The south well, with storage cabinet and electric control box in the background. Photograph taken 6/26/2019.

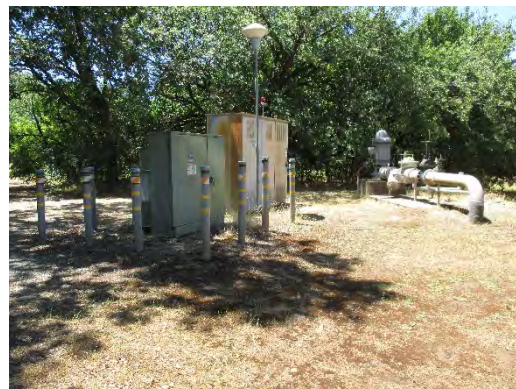
Figure 308: Electric control box and storage cabinet on left, south well on right. Photograph taken 6/26/2019.

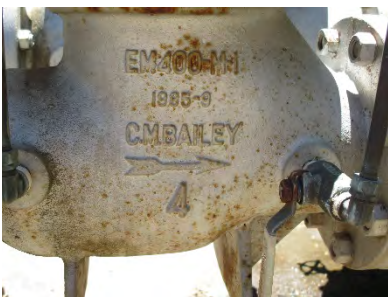
Figure 309: Steel joint of the south well, embossed with “EM400-M-I; 1985-9; C.M.BAILEY; 4.” Photograph taken 6/26/2019.

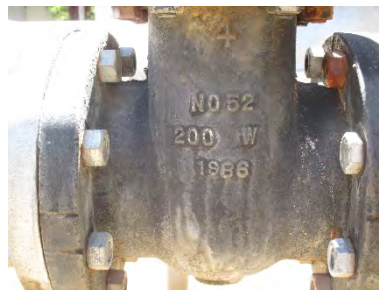
Figure 310: Steel joint of the south well, embossed with “4; NO 52; 200 W; 1986.” Photograph taken 6/26/2019.

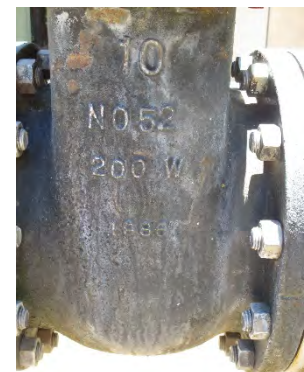
Figure 311: Steel joint of the south well, embossed with “10; NO 52; 200 W; 1988.” Photograph taken 6/26/2019.

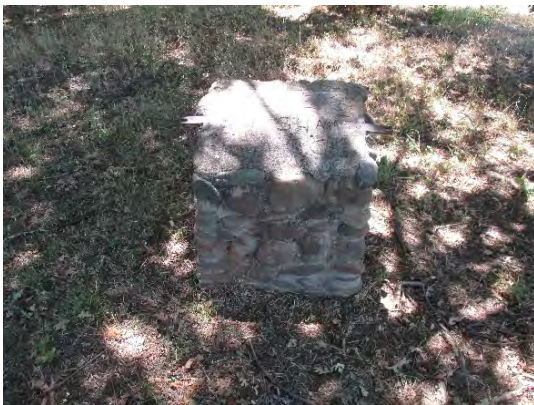
Installed in 1981, the stone monument is located on the south side of Comanche Road under a large shade tree, approximately 95' southeast of the North Well. It is composed of concrete, with a veneer of embedded river cobbles on its sides. A metal bar, which presumably once held a plaque, is embedded into the concrete on its top surface. It is likely that this stone monument was installed to commemorate the discovery of four pre-contact burials on site in 1976. These burials were subsequently nominated to the National Register of Historic Places in 1981.

Figure 312: View of the stone monument from the north. Photograph taken 6/26/2019.

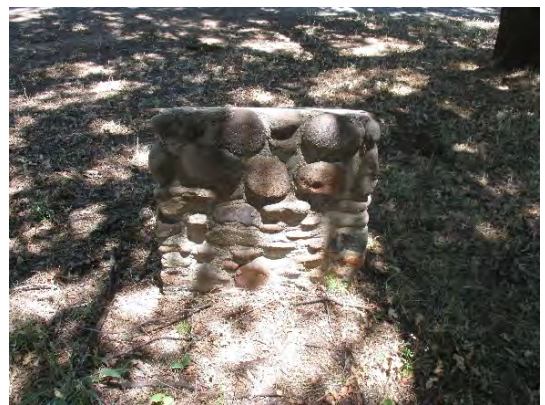
Figure 313: View of the stone monument from the south. Photograph taken 6/26/2019.

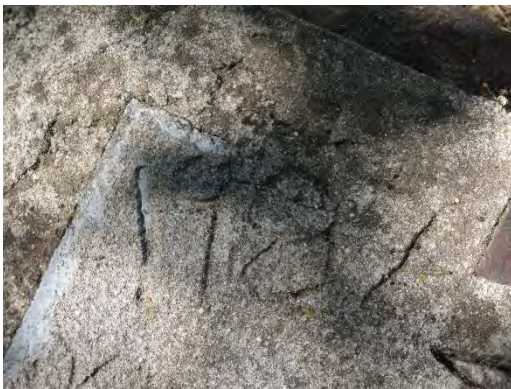
Figure 314: Date '1981' inscribed into the concrete on the top surface of the stone monument. Photograph taken 6/26/2019.

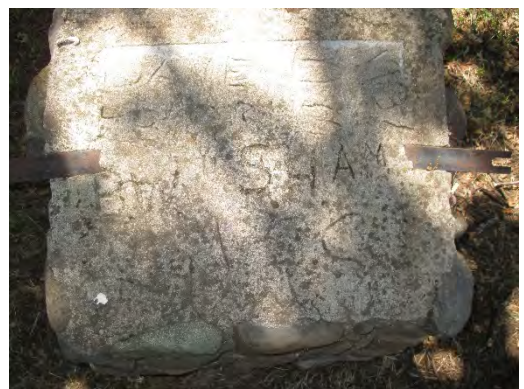
The stone monument has lost its commemorative plaque, but has otherwise not been modified or altered. This structure retains integrity, though it does not date to the property's period of significance.

Figure 315: Various names inscribed into the concrete on the top surface of the stone monument. Note metal bar that presumably once held a plaque. Photograph taken 6/26/2019.

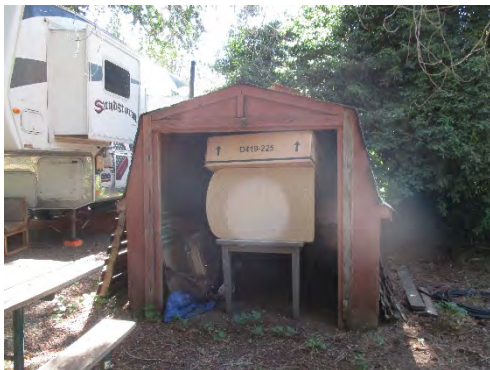
Figure 316: Primary open western façade of storage shed, with recreational vehicle trailer at back left. Photograph taken 6/26/2019.

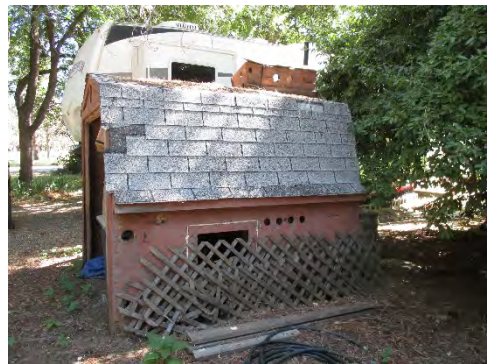
Figure 317: Southern façade of storage shed, showing gambrel roof with bottom flange. Note modifications presumably for use as a doghouse. Photograph taken 6/26/2019.

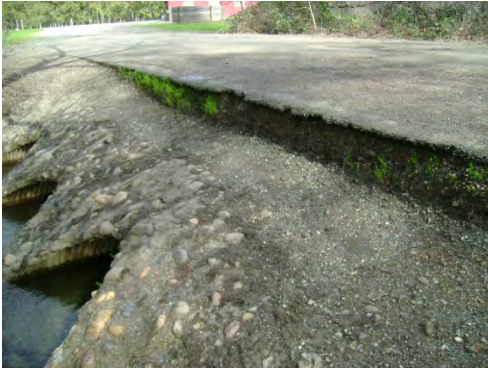
Figure 318: Eastern vehicle bridge looking north toward Barn. Photograph taken 2/9/2009. Photograph courtesy of Lisa Crane.

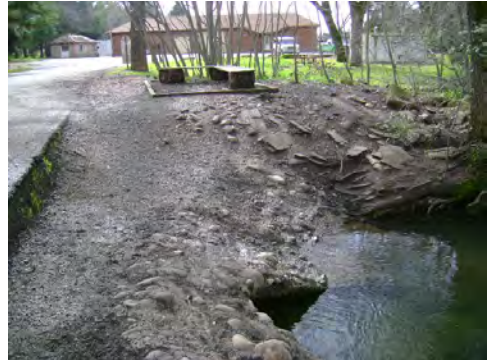
Figure 319: Eastern vehicle bridge looking south toward headhouse. Photograph taken 2/9/2009. Photograph courtesy of Lisa Crane.

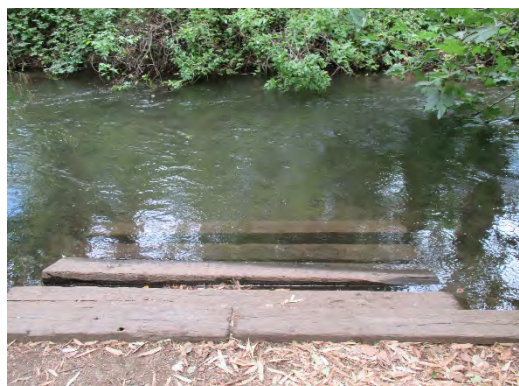
Figure 321: Remains of a previous footbridge, shown on a map from 1961. Photograph taken 6/24/2019.

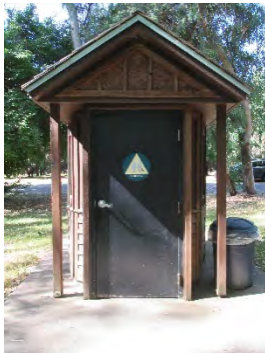
Figure 322: Primary northern façade of Day-use Area Toilet, with geometric wooden motif beneath end-gable. Photograph taken 6/25/2019.

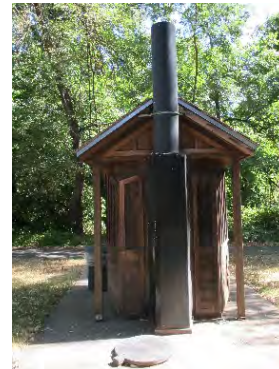
Figure 323: Southern façade with large ventilator. Photograph taken 6/25/2019.
