Inspection Report

Property Address:
4338 E Neverland Dr
Phoenix AZ 85044

Keylight Home Inspections

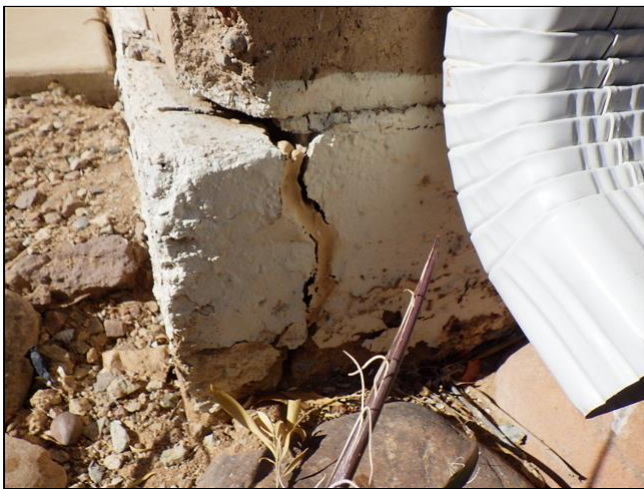
1.0 Item 1(Picture)

(1) Cracking and deterioration observed at multiple locations of the surrounding stem wall foundation including front back and both left/right sides of the house. I recommend professional evaluation and repairs by a licensed contractor.

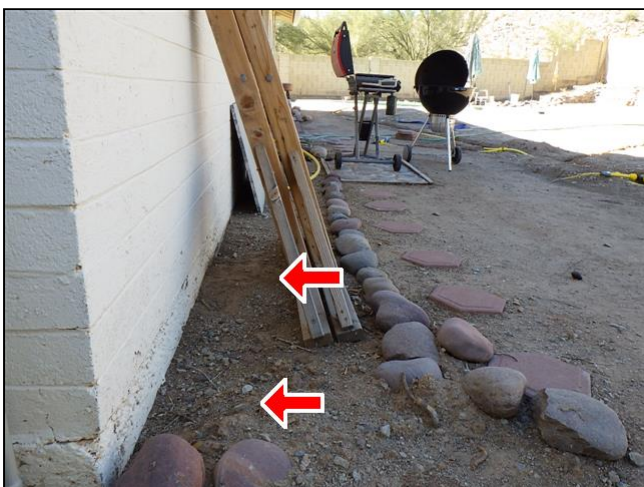
1.0 Item 9(Picture)

(2) There is evidence of water penetration into the rear of the house. This is likely due to the grade in the back yard sloping towards the house. Adjust the grade to direct surface water away from the affected area and keep the soil adjacent to the foundation as dry as possible.

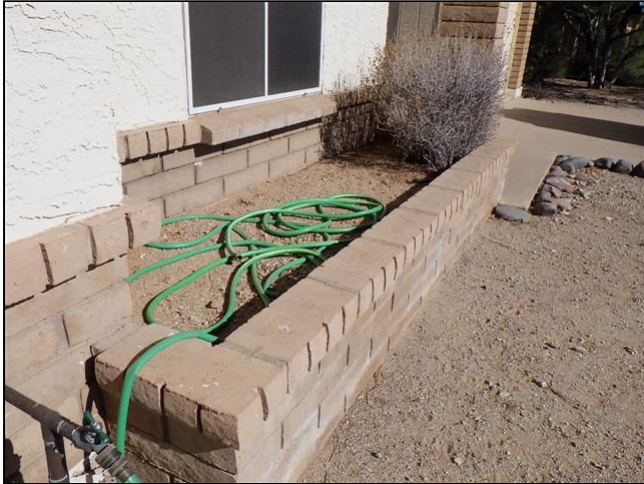
1.0 Item 11(Picture)

(3) The front planter was improperly installed/ designed against the foundation stem wall and/or exterior wall. 4 to 6 inches of foundation is typically recommended to be visible in order to properly identify foundation problems. This

condition not only limits inspection visibility but also creates a potential moisture concern. Recommend separating planter materials from exterior structure and ensuring any damages present are professionally repaired.

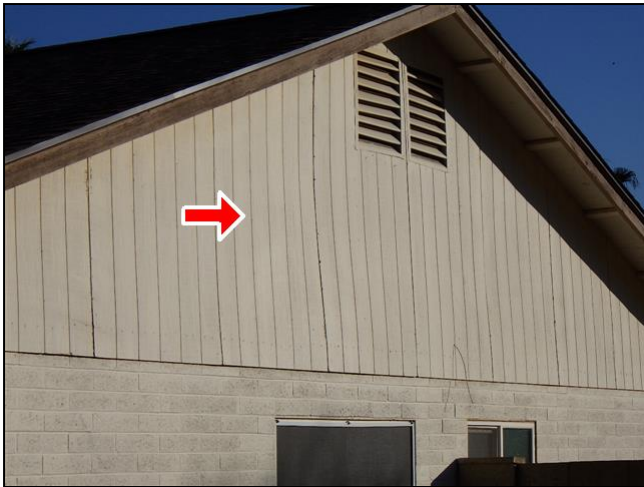
1.2 Item 1(Picture)

(2) The wall is bowed inward on the top left side of the house. I recommend professional evaluation with repairs as necessary.

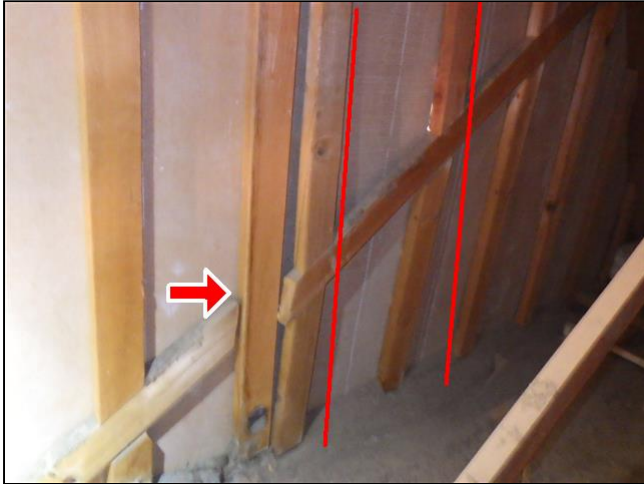
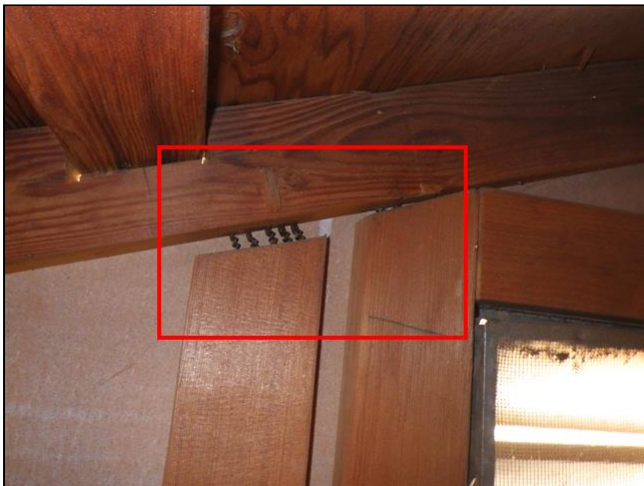
(1) Truss members out of position at the west end of attic and the exterior siding is bowed in at this end. I recommend further evaluation by a licensed professional and repair as necessary.

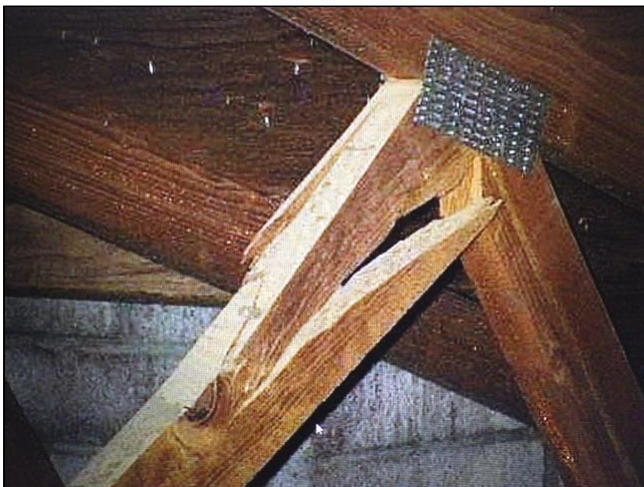
1.4 Item 4(Picture)

(2) There is a cracked/damaged truss member in the middle portion of the attic. I recommend further evaluation by a licensed professional and repair as necessary.

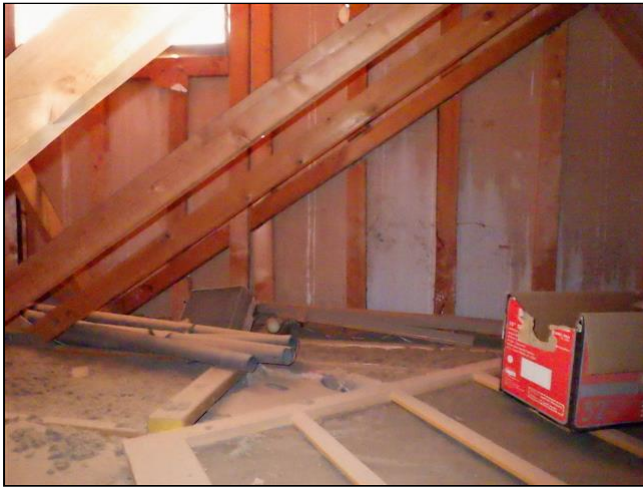
1.8 Item 1(Picture)

I recommend removal of the personal property stored in the attic.

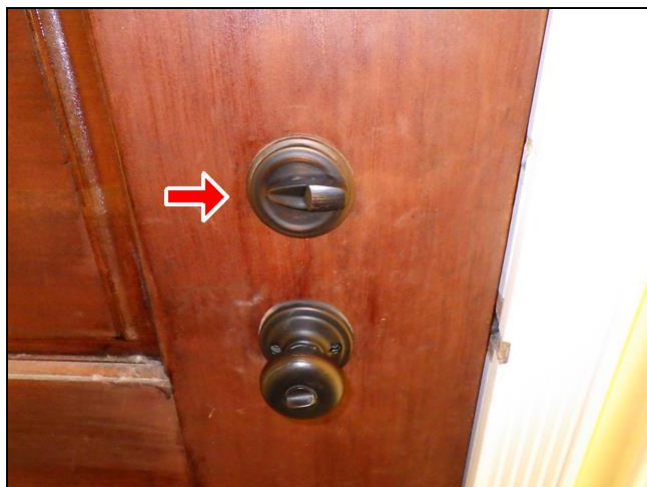
2.2 Item 1(Picture)

- (1) The exterior doors are in satisfactory condition and operational.
- (2) The front door bolt lock is very difficult to lock. Repair or replace as necessary.

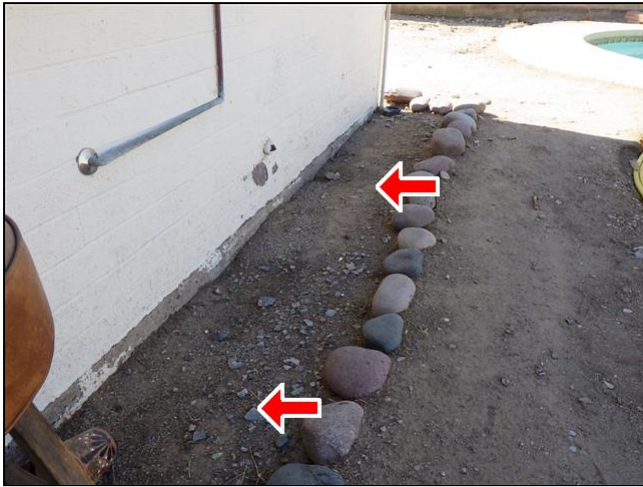
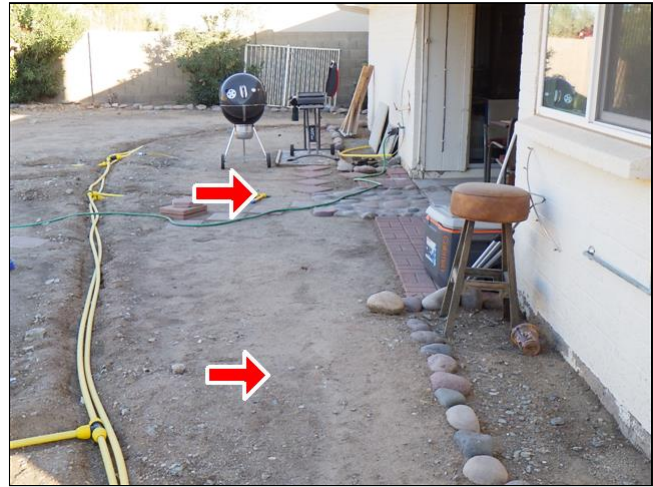
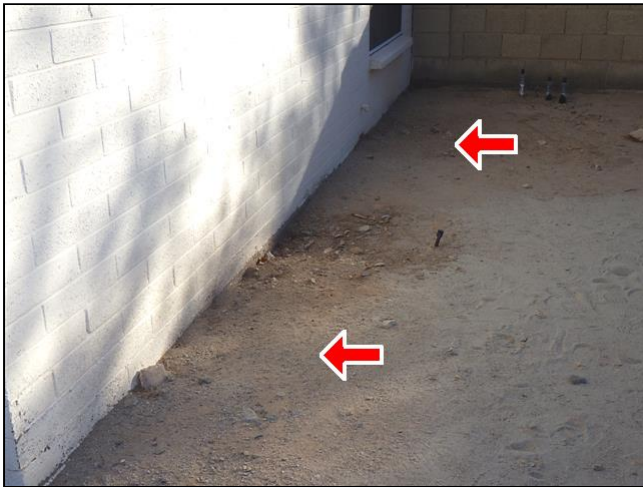
(1) The grade is sloped toward the house in several locations. This will direct surface water into the soil adjacent to the foundation and cause water damage to the foundation concrete. Adjust the grade to direct surface water away from the foundation to prevent water damage.

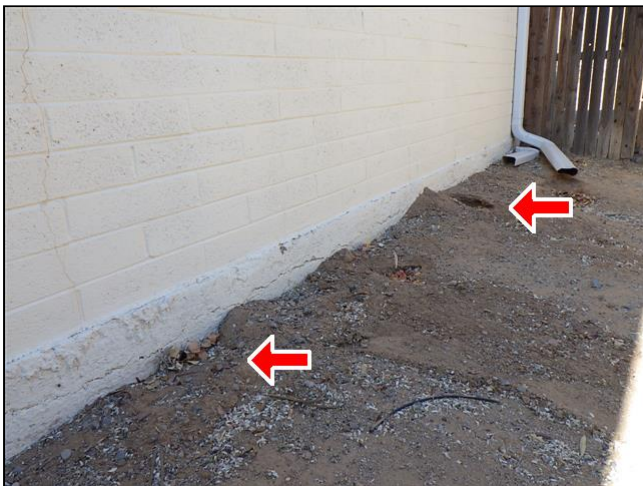
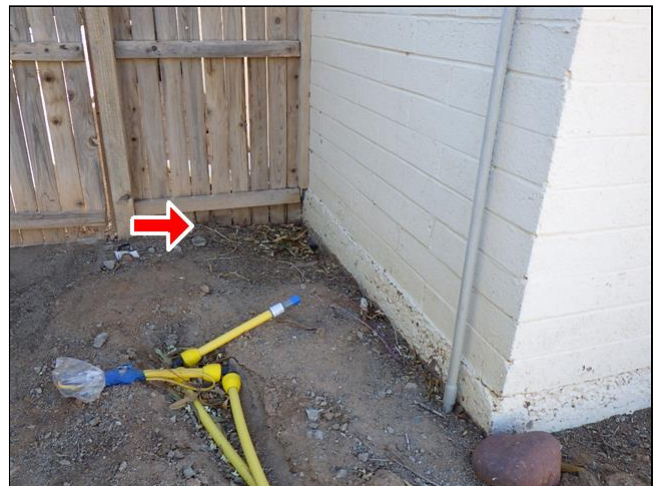
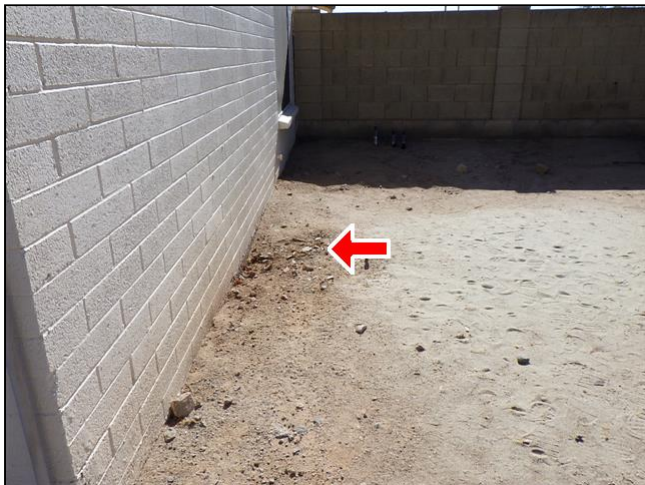
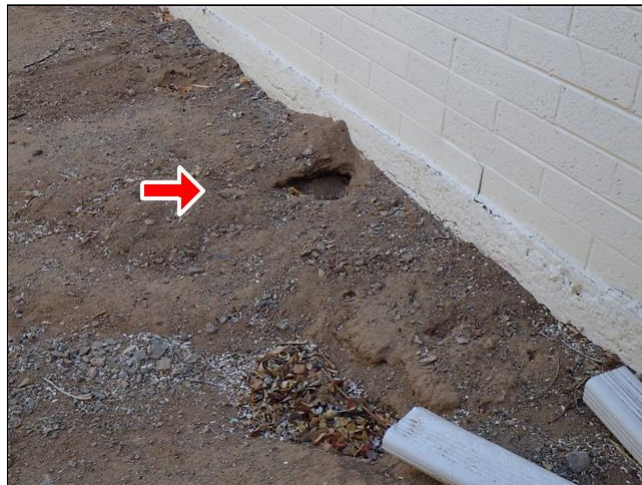
(2) Fill in the holes and adjust the grade to direct water away from the foundation.

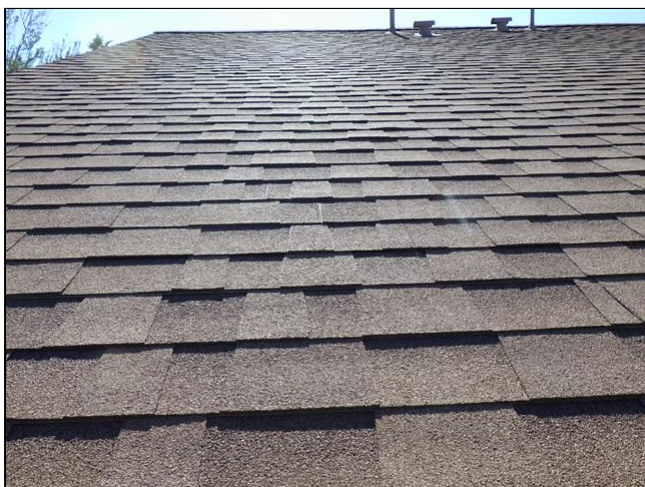
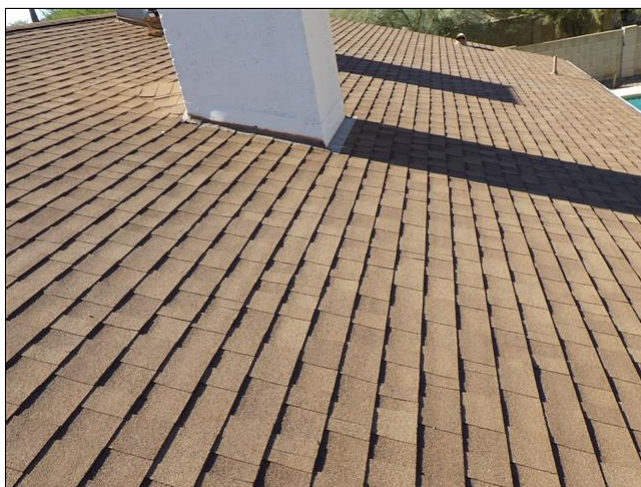
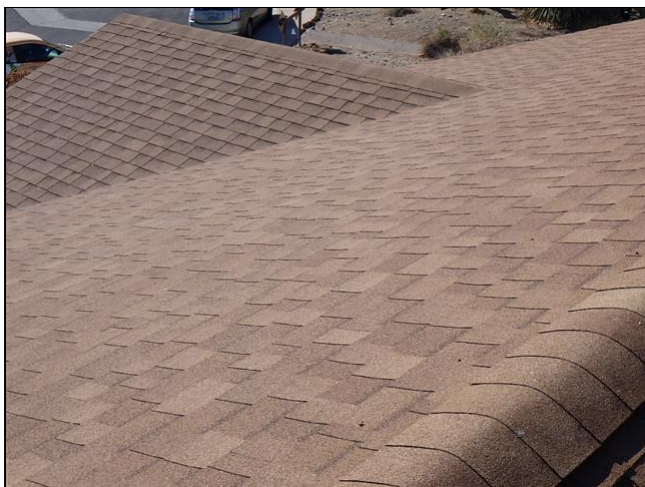
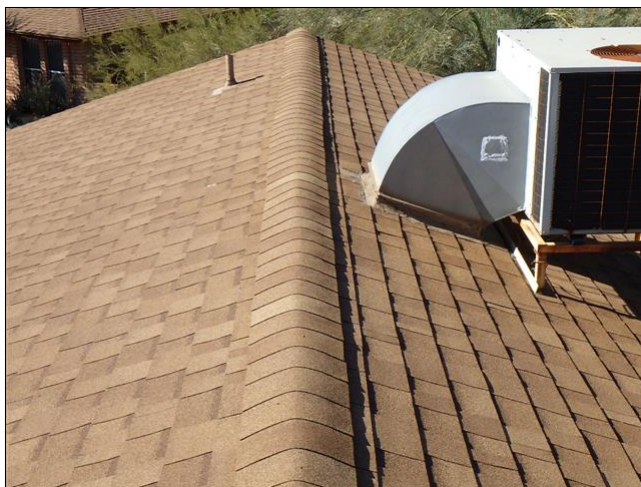
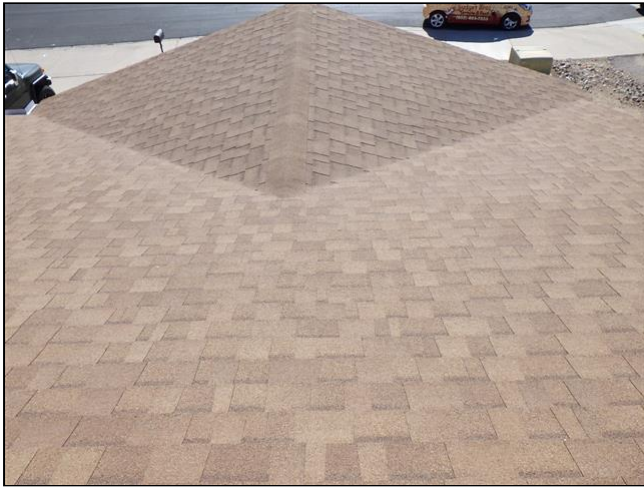
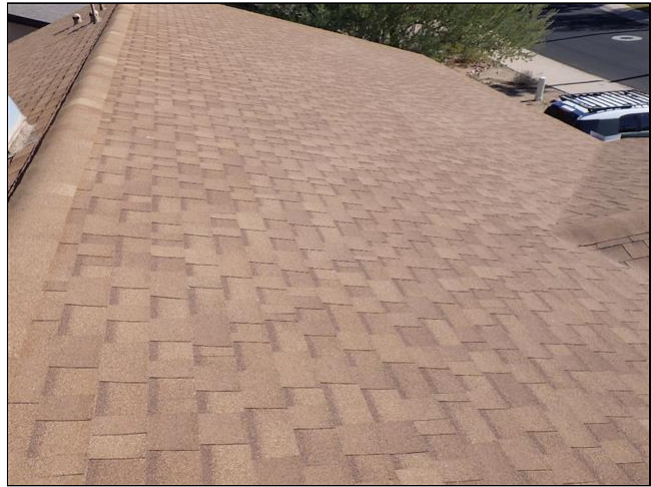
The visible portions of the roof coverings are in satisfactory condition.

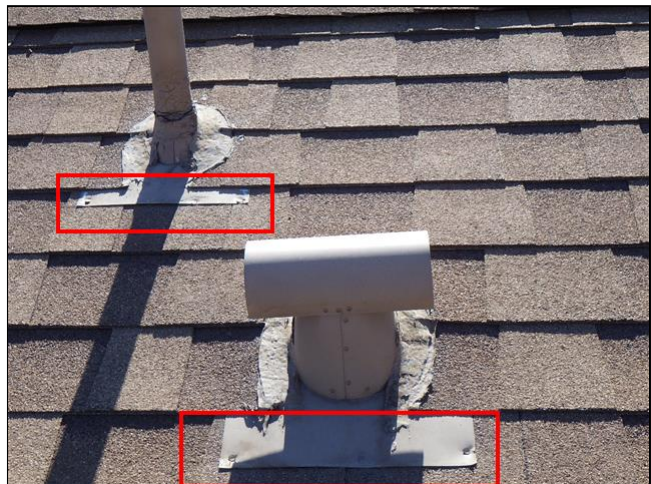
3.2 Item 2(Picture)

(1) Seal the exposed nails and staples at the flashings to prevent leakage.

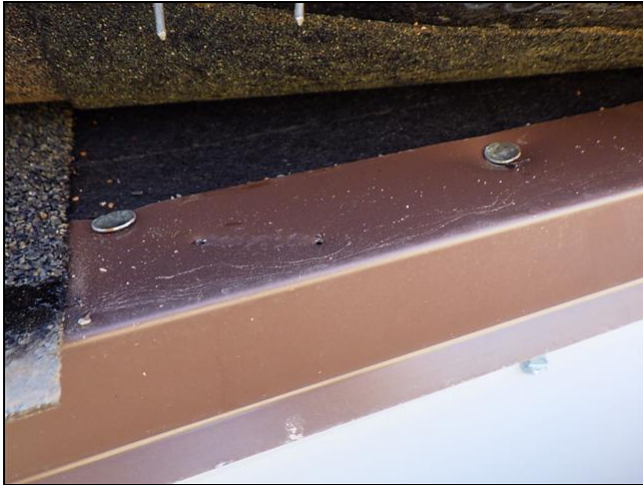
3.2 Item 8(Picture)

(3) The drip edge flashing trim is installed improperly over top of the underlayment. I recommend professional remediation by a licensed roofer.

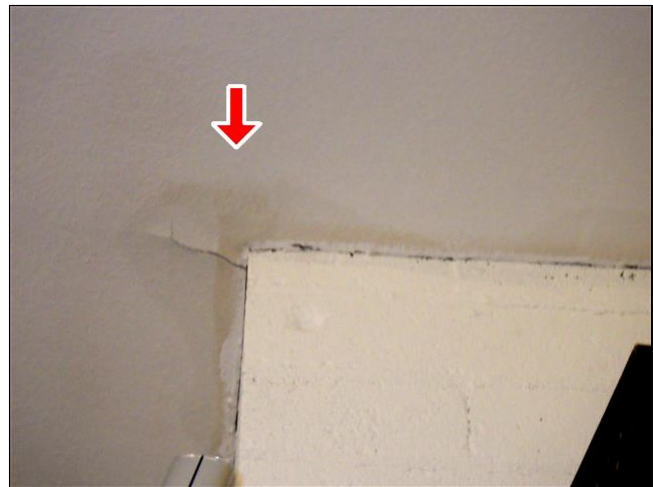
3.3 Item 2(Picture)

(1) There are signs of leakage (water stains) on the living room ceiling above the fireplace. I recommend professional evaluation and repair as necessary.

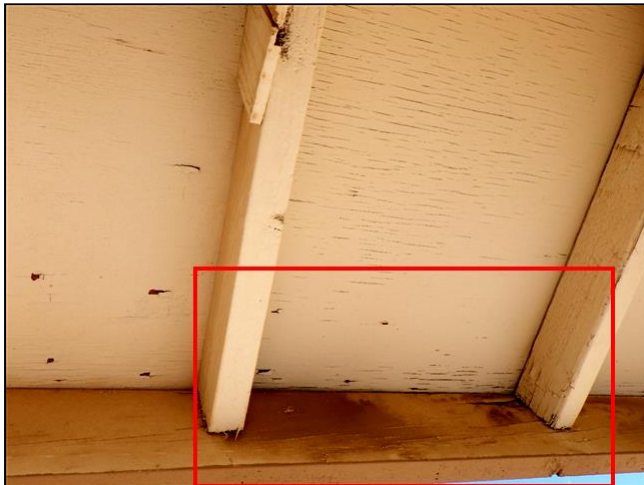
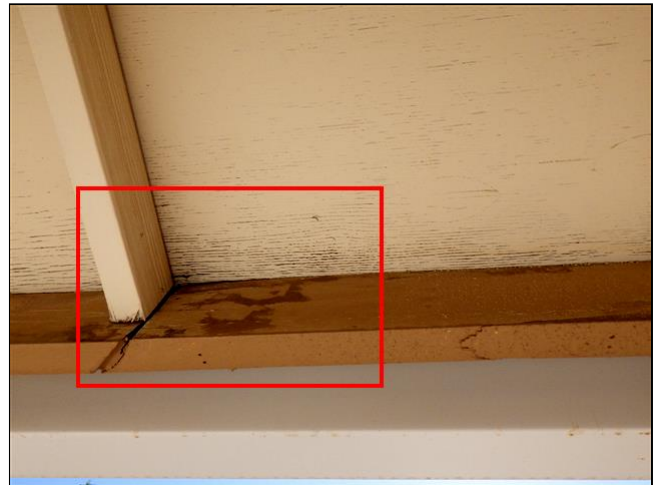
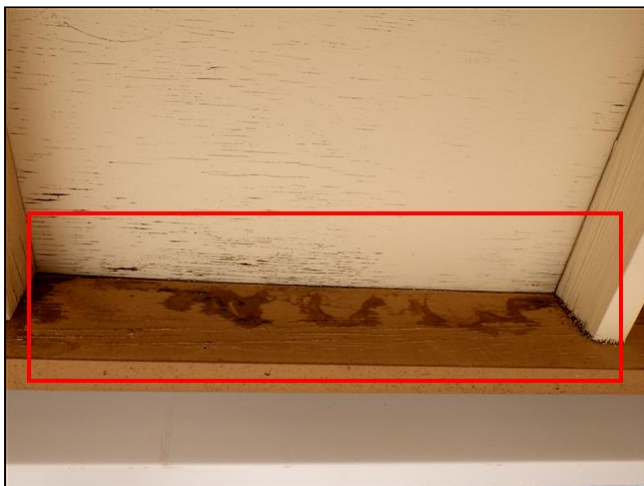
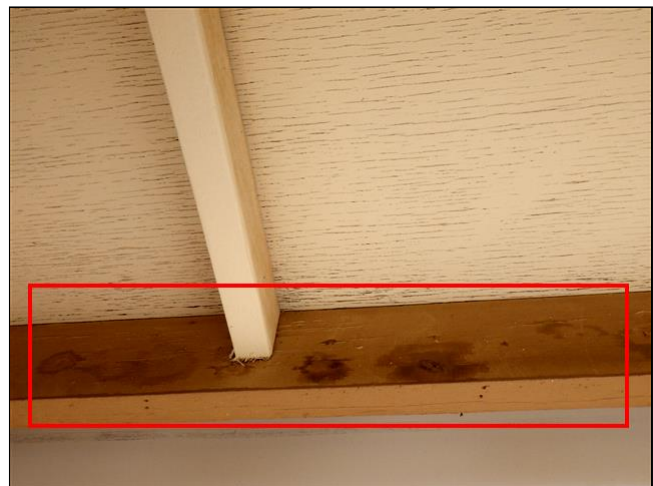
(2) There are signs of leakage (water stains) at the eaves on the front of the house. I recommend professional evaluation and repair as necessary.

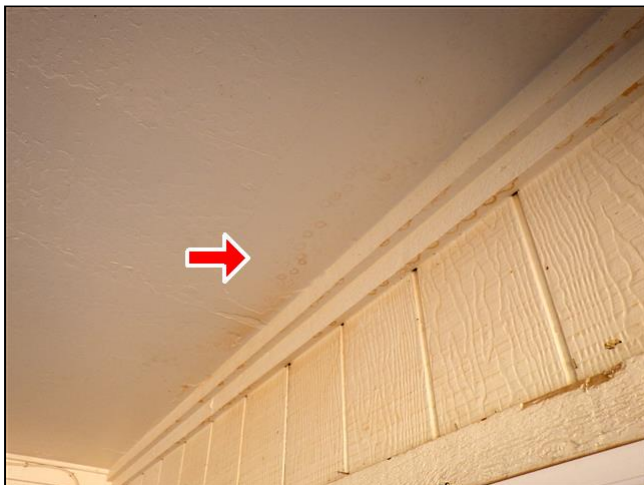
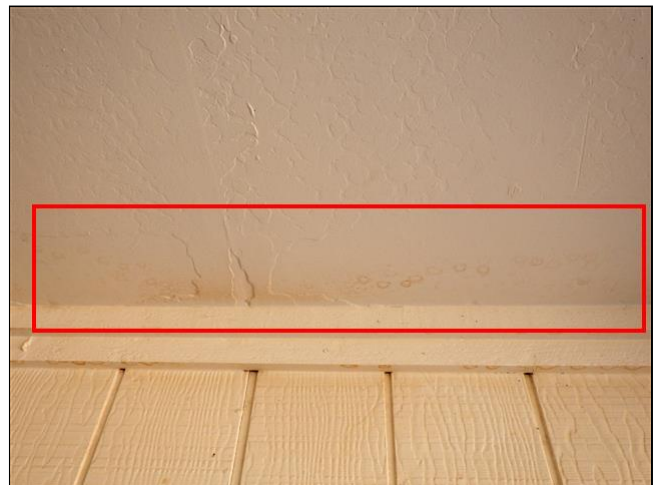
(3) There are signs of previous leakage (water stains) on the rear porch decking. I recommend further evaluation and repairs as necessary.

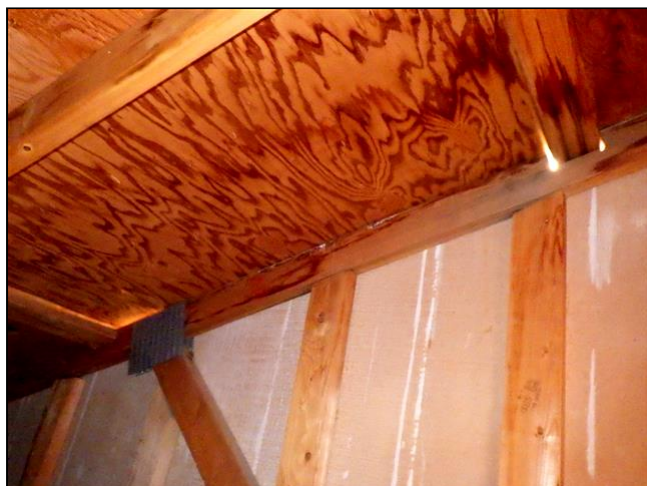
3.3 Item 10(Picture)

(4) There are signs of leakage (water stains) in the attic on the decking and on the trusses. I recommend professional evaluation and repair as necessary.

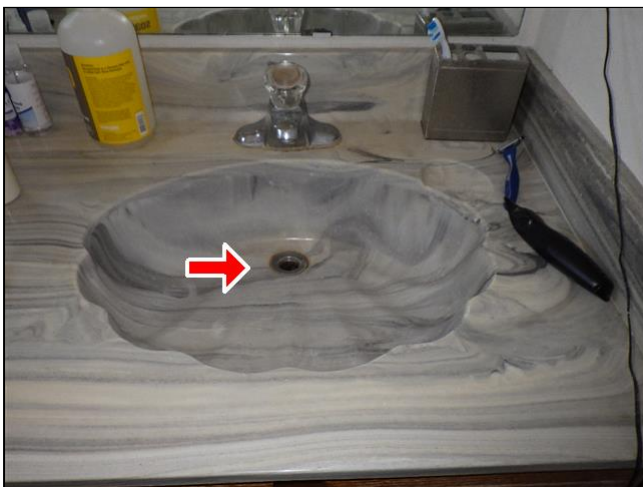
4.3 Item 1(Picture) left and right master sinks

(1) The master bathroom sinks and hallway bathroom sink stops have been removed. I recommend replacement

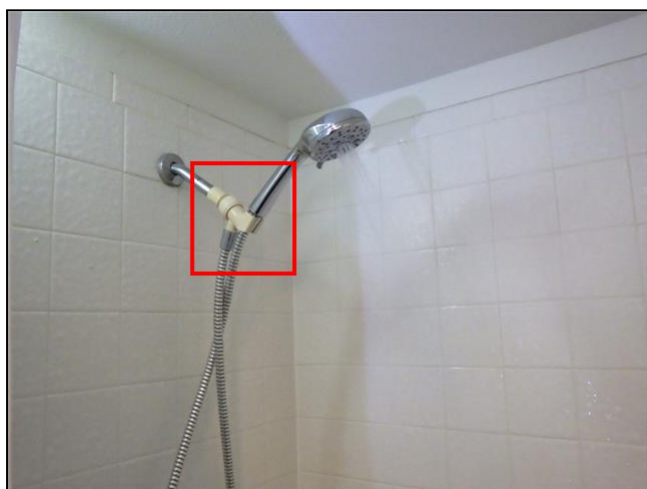
4.3 Item 3(Picture)

(2) The shower heads in the master bathroom and hallway bathroom are leaking. Repair or replace as needed.

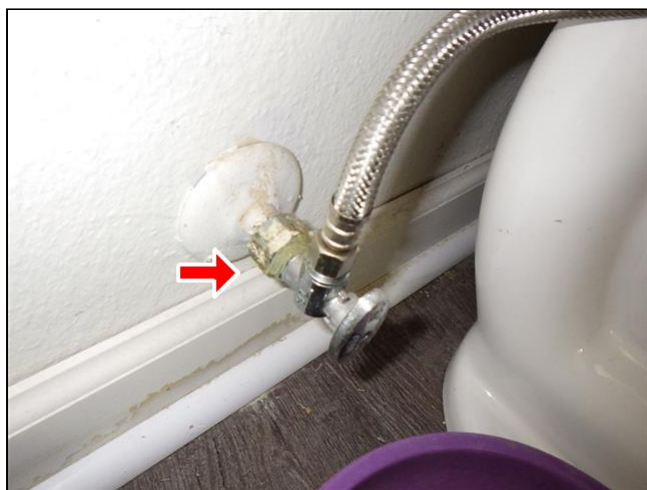
4.3 Item 5(Picture)

(3) There is evidence of leakage at the hall bathroom toilet supply valve. I recommend professional repair/replacement to prevent further leakage.

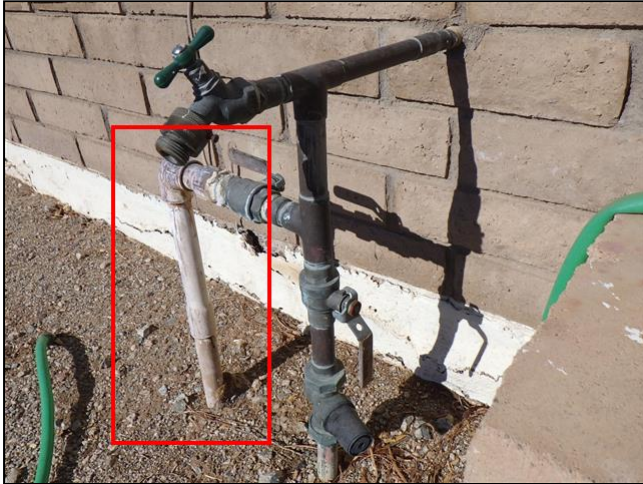
4.6 Item 1(Picture)

Irrigation that taps into the house water supply requires a vacuum breaker to prevent contamination of the potable water supply. I recommend a licensed plumber evaluate and remedy as needed.

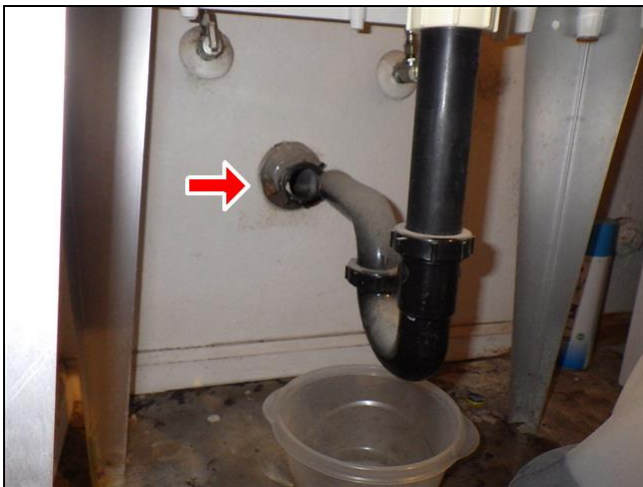
4.8 Item 1(Picture)

The garage laundry sink drain is not connected and leaks out the bottom. Repair as needed

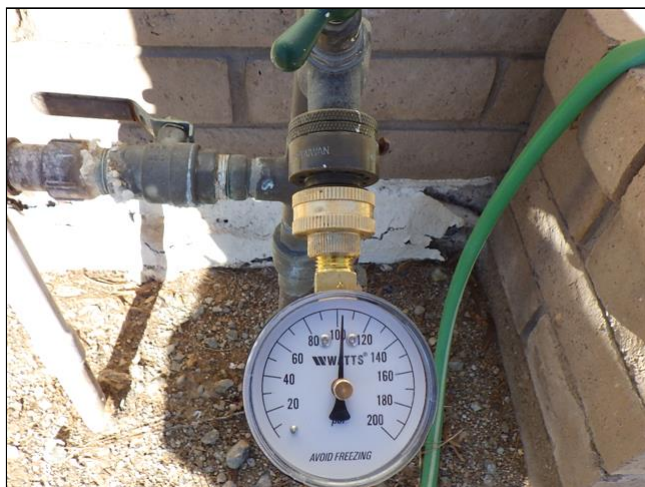
4.14 Item 1(Picture)

Water pressure above 80 psi is considered excessive by industry standards and can cause damage to plumbing fixtures. In addition, many home warranty companies will not honor a plumbing claim if the water pressure is above 80psi. The water pressure on this home is in excess of 80 psi. I recommend lowering the water pressure to within the recommended range. There is a pressure reducing valve installed.

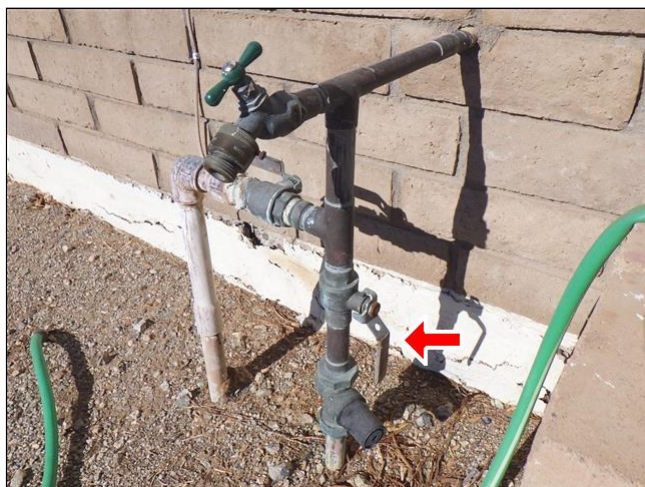
4.15 Item 1(Picture)

The main water shut off valve is located on the front of the house.

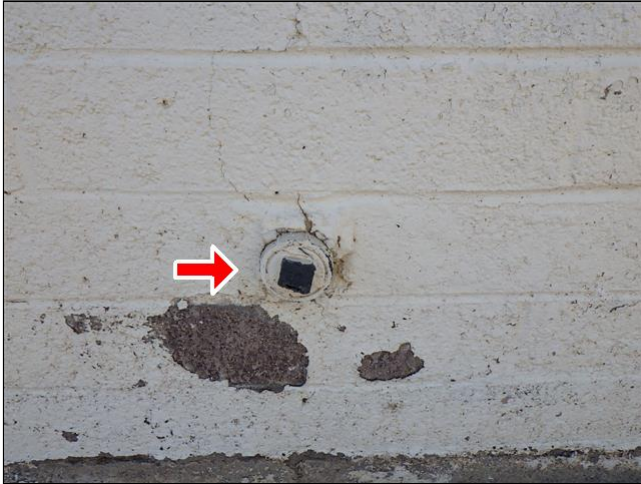
4.19 Item 1(Picture)

The clean out cap is missing from the back wall underneath the kitchen sink window. Recommend replacement or repairs as needed.

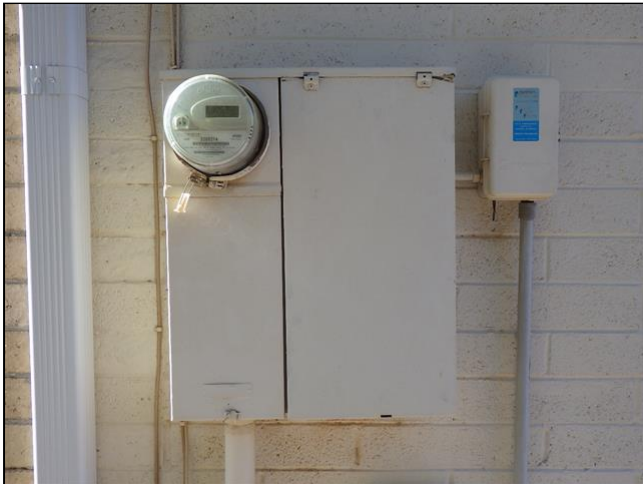
5.0 Item 1(Picture)

(1) The main disconnect and distribution panels are located on the right of the house. The main and distribution panels are in satisfactory condition.

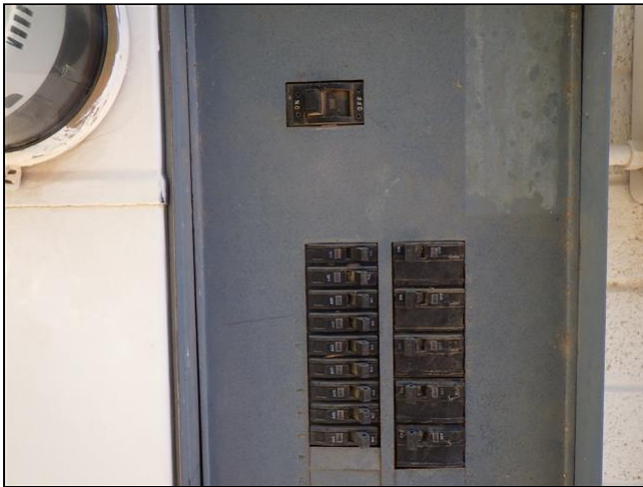
5.0 Item 2(Picture)

(2) Permanently identify the circuits on the dead front panel for future reference.

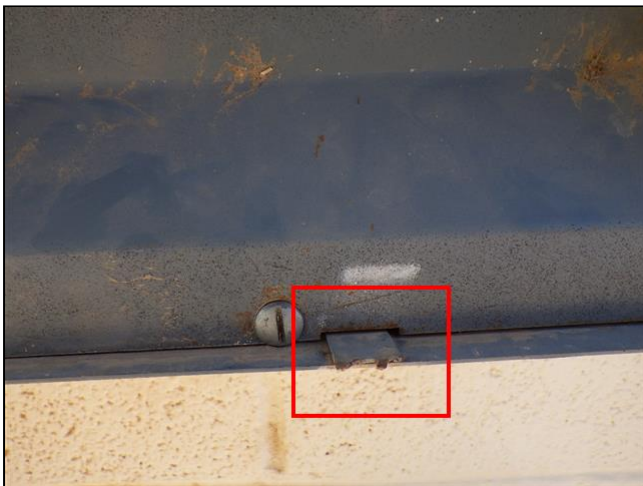
5.0 Item 3(Picture)

(3) The electric panel lock point is damaged/missing, repair as needed.

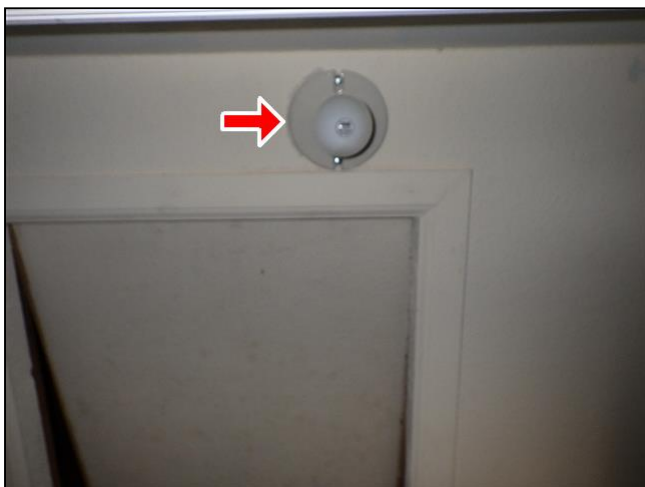
5.6 Item 1(Picture)

(2) Open incandescent bulb fixtures are no longer allowed in closets, fire hazard. A recessed incandescent or surface fluorescent can be installed within 6" of the top shelf or an enclosed incandescent may be installed within 12" of the top shelf or a surface mount fluorescent may be installed on the inside wall over the door. I recommend professional evaluation and remedy as needed.

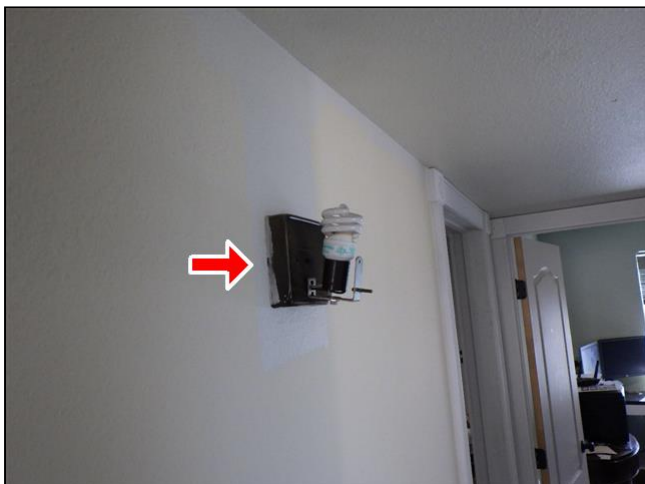
5.6 Item 2(Picture)

(3) The light globe in the hallway has been removed. I recommend replacement.

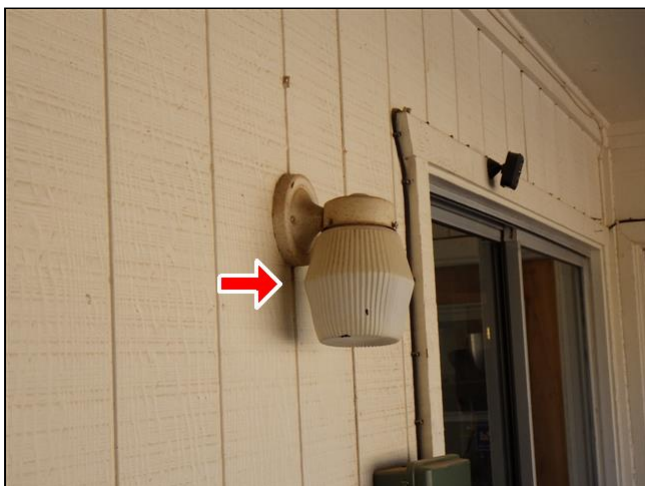
5.6 Item 3(Picture)

(4) The light fixture in the rear patio is inoperable at the switch. Replace the fixtures/bulbs as needed to verify operation or repair as necessary

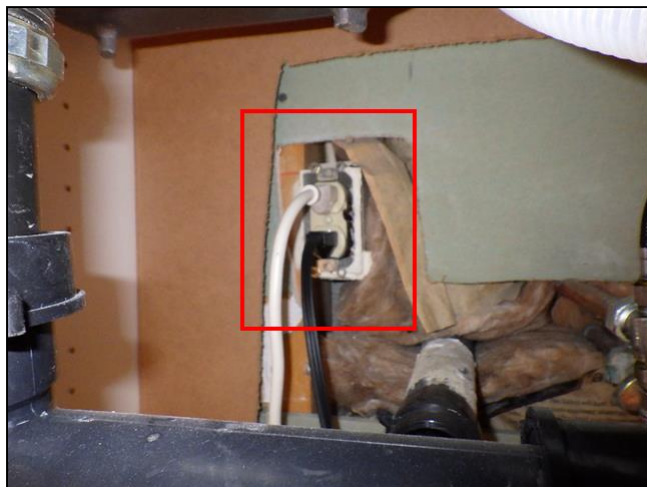
5.7 Item 1(Picture) under kitchen sink

(2) There are several outlet covers that have been removed throughout the house, under the kitchen sink, behind the stove, entry hallway, and both front left and right bedrooms. I recommend replacement.

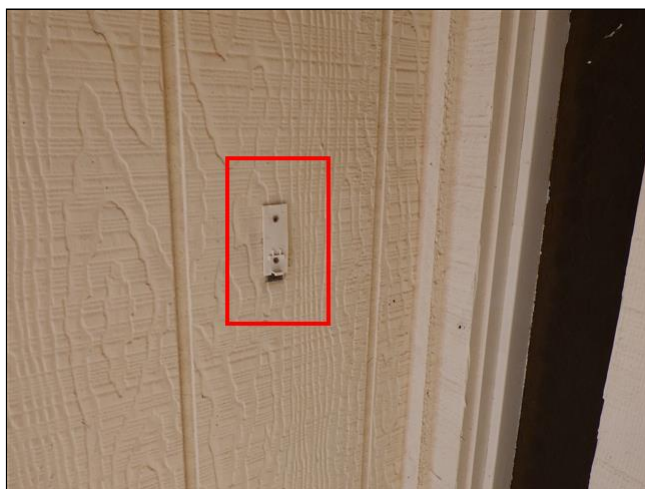
5.10 Item 1(Picture)

(1) The doorbell is inoperable, repair as needed.

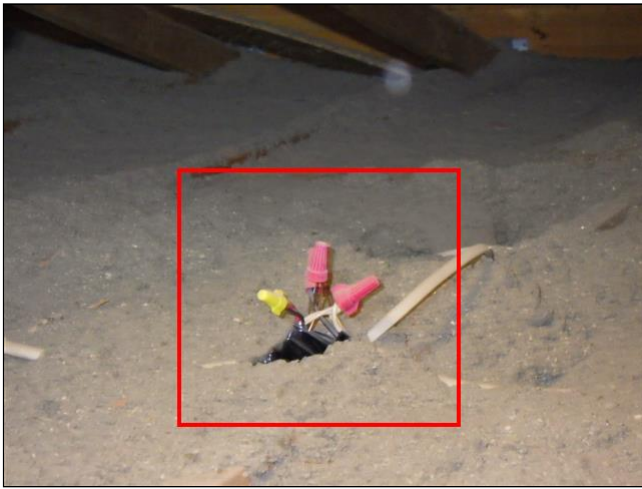
5.10 Item 2(Picture)

(2) There are exposed electric junctions in the attic, remedy as needed.

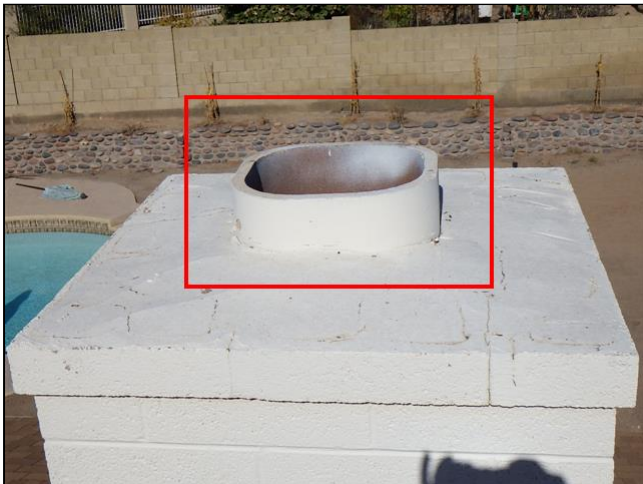
6.2 Item 1(Picture)

(2) Consider the addition of a chimney cap/spark arrestor to keep birds and rain out of the chimney.

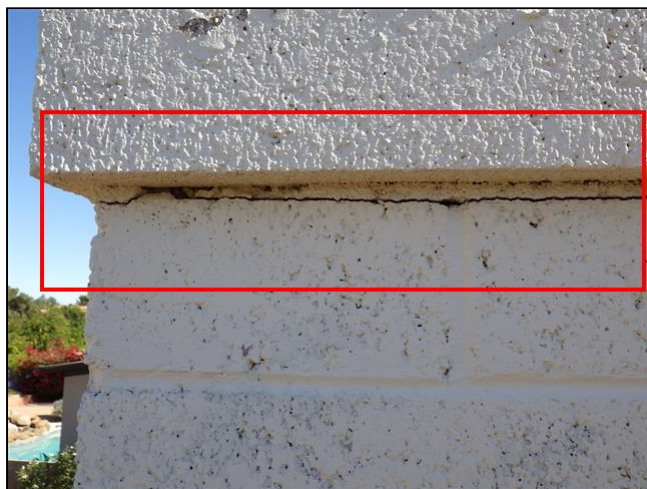
6.2 Item 2(Picture)

(3) Seal up any cracks in the chimney to prevent water intrusion or damage.

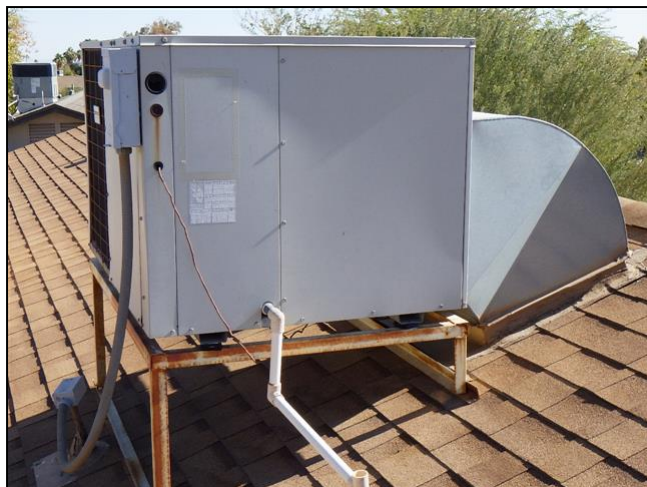
7.0 Item 1(Picture) 2001 3.5ton

(1) The visible portions of the cooling equipment are in satisfactory condition and operational.

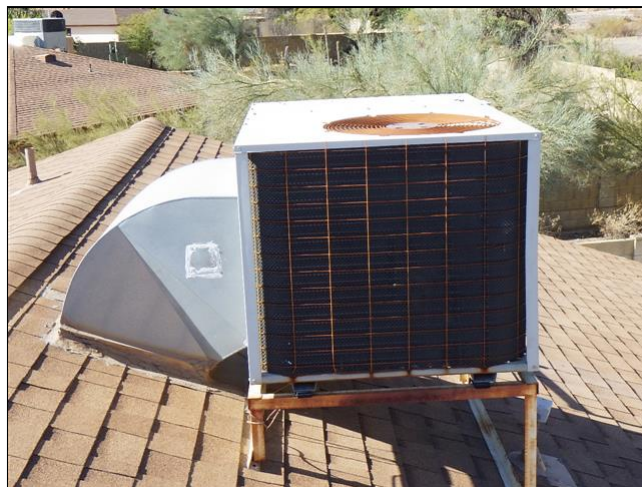
7.0 Item 2(Picture)

(2) Heat pumps typically last 10-15 years in Arizona. This system is a 2001 model and near the end of it's service life. I recommend regular service and maintenance as needed for maximum service life. Budget for replacement soon.

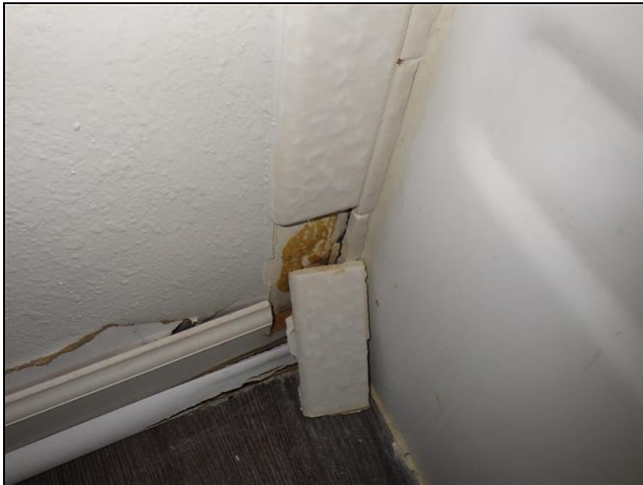
8.0 Item 1(Picture) master bathroom

- (1) The visible portions of the walls, ceilings and floors are in satisfactory condition except for normal wear/age.
- (2) There is damage to the walls and tiles in the master bathroom and hallway bathroom next to the tub/shower. Repair as needed.

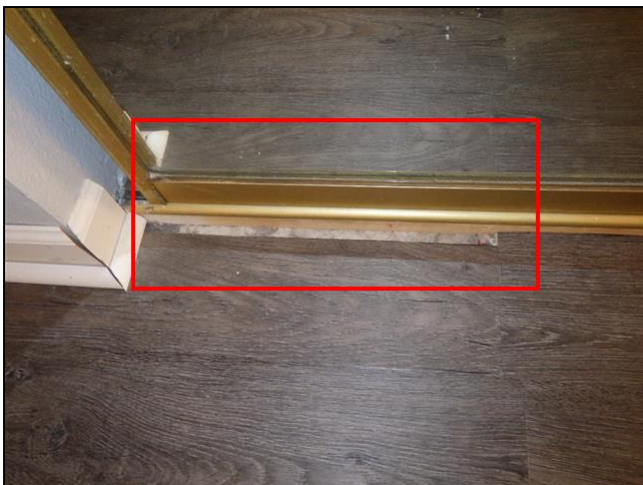
8.0 Item 3(Picture)

- (3) There are baseboard moldings missing/damaged in various areas/sections of the home. I recommend repairs as necessary.
- (4) The wood flooring incomplete at the west hall closet and there are gaps along the edges and missing sections throughout the home. Recommend repairs as necessary.

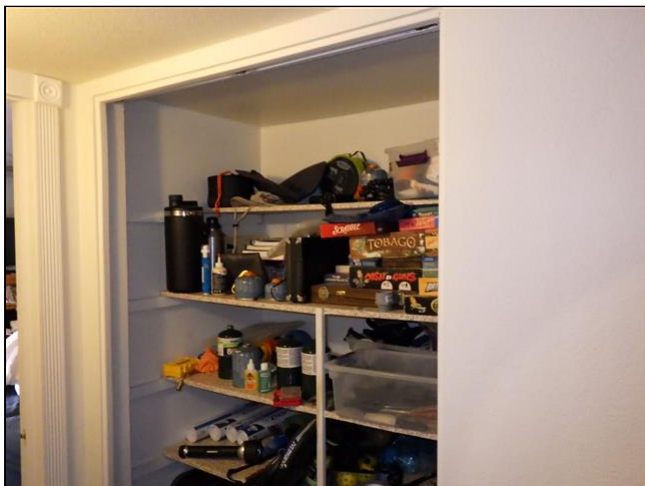
8.4 Item 1(Picture) Hallway closet

(2) The closet doors have been removed in the hallway next to master bedroom and front left bedroom. I recommend replacement.

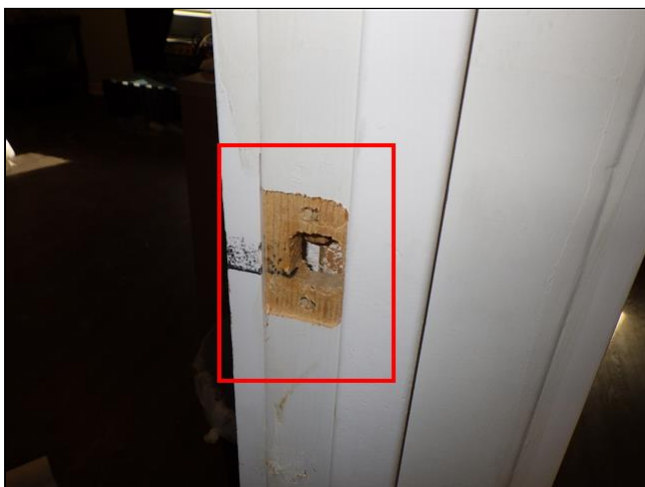
8.4 Item 3(Picture)

(3) The door striker/striker plates are missing at mostly all of the interior doors adjust as needed.

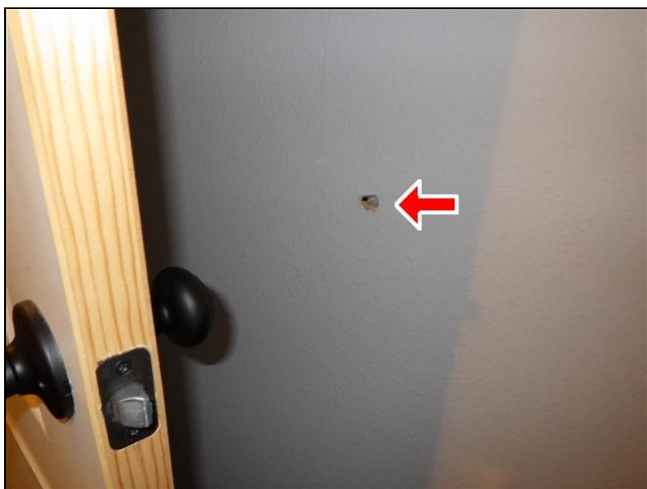
8.4 Item 4(Picture)

(4) The door stops are missing at all interior doors causing dents and holes in the drywall. Remedy as needed.

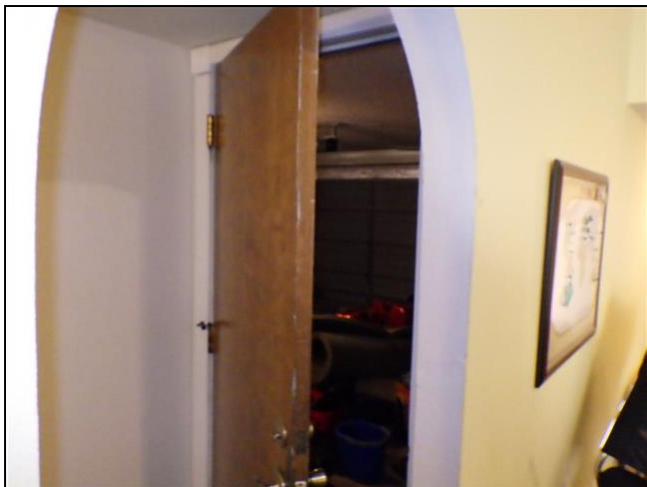
8.6 Item 1(Picture)

(1) The fire separation door between the garage and house is in good condition but does not close, latch and seal automatically. I recommend adjusting the door to close automatically as required.

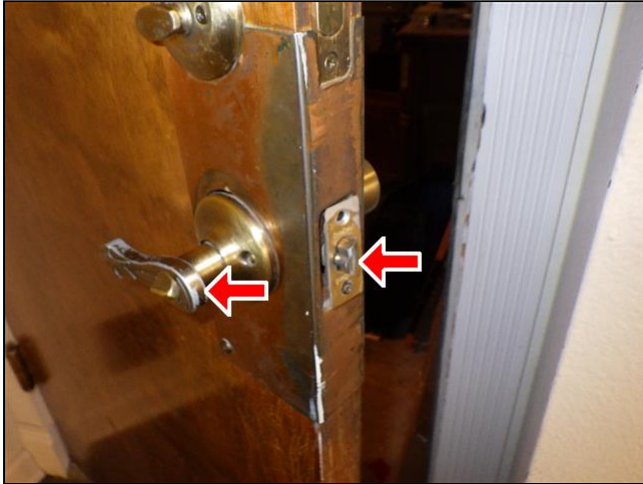
8.6 Item 2(Picture)

(2) The door and jamb is damaged in several areas to the garage, door rubs the jamb and bottom lock is inoperable difficult closing. Recommend repairs as necessary.

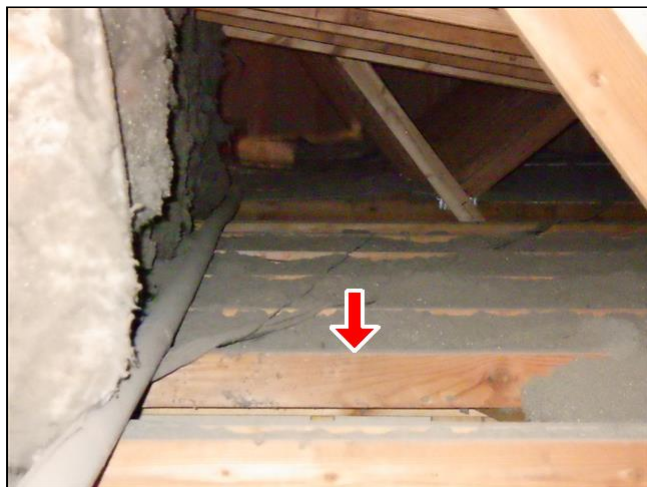
9.0 Item 1(Picture)

- (1) The visible insulation is in satisfactory condition. Attic visibility is limited, portions of the attic are not visible from the attic access.
- (2) The insulation has been displaced at the knee wall in areas and I recommend re-installation to reduce heat transfer.
- (3) The attic insulation is thin in places. Consider additional insulation as needed.

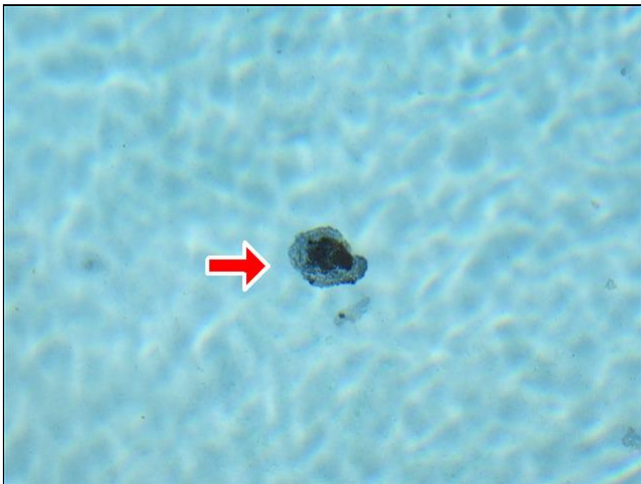
11.1 Item 1(Picture)

(1) The plaster is near the end of its service life. Budget for re-plastering.

(2) The interior finish is in poor condition. Rust spots and wear spots observed. I recommend professional evaluation and repair as necessary.

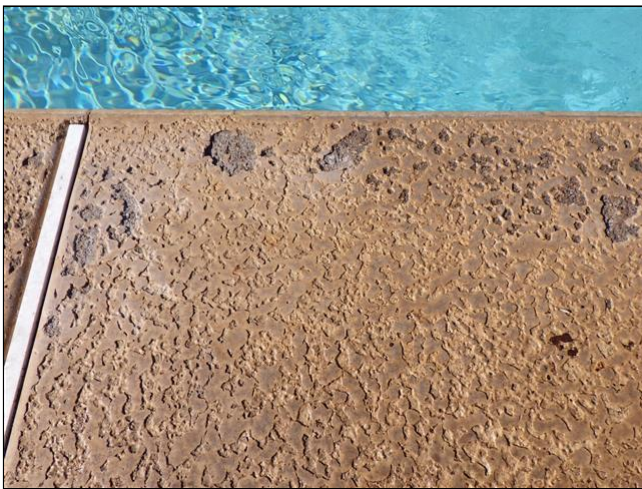
11.2 Item 6(Picture)

(3) The pool deck finish is peeling and chipping. I recommend professional evaluation with repairs as necessary.

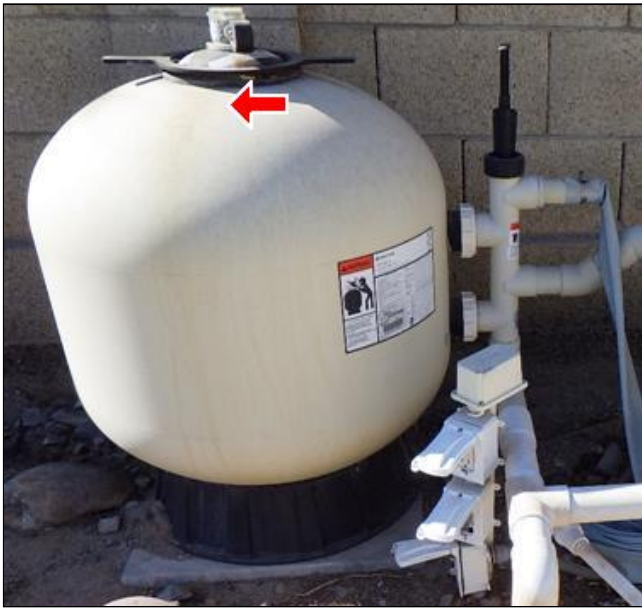
11.3 Item 1(Picture)

(2) The filter has evidence of leaking, I recommend professional evaluation and repair as needed.

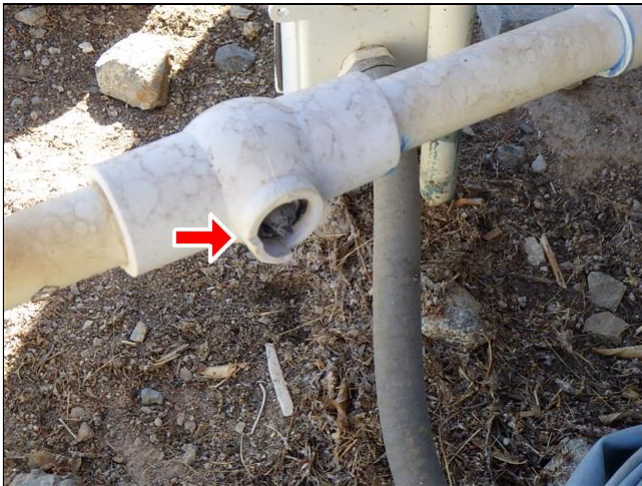
11.5 Item 1(Picture)

Comments: Repair or Replace
(1) The aerator valve handle is broken, I recommend replacement
