Inspection Report

Property Address:
4338 E Neverland Dr
Phoenix AZ 85044

Keylight Home Inspections

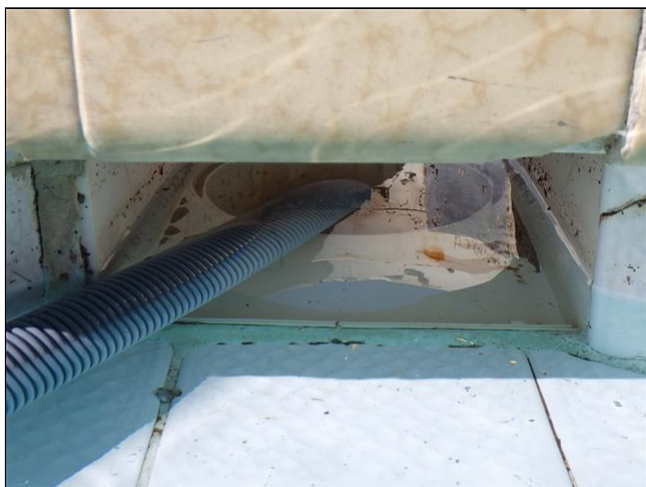
11.5 Item 2(Picture)

(2) The weir door has been removed, I recommend replacement.

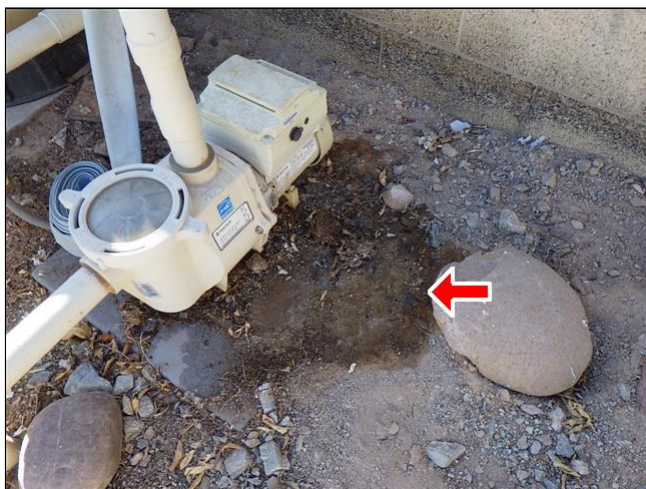
11.5 Item 3(Picture)

(4) The pool filter pump is leaking, repair as necessary.

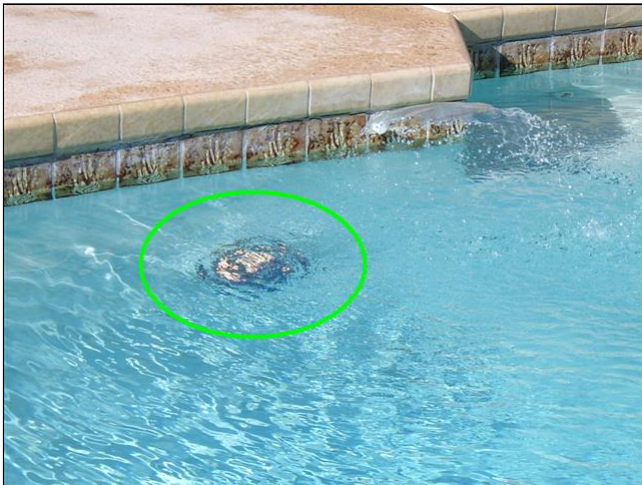
11.6 Item 1(Picture)

(1) The pool light is operational but the GFCI associated does not turn off when tripped at pool. Recommend repairs for proper safety.

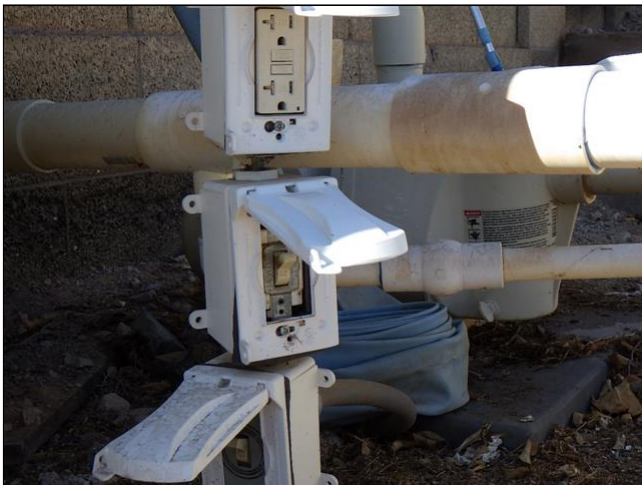
11.6 Item 2(Picture)

(2) The GFCI is present and operational but doesn't turn off the pool light. Recommend further evaluation and repairs for safety.

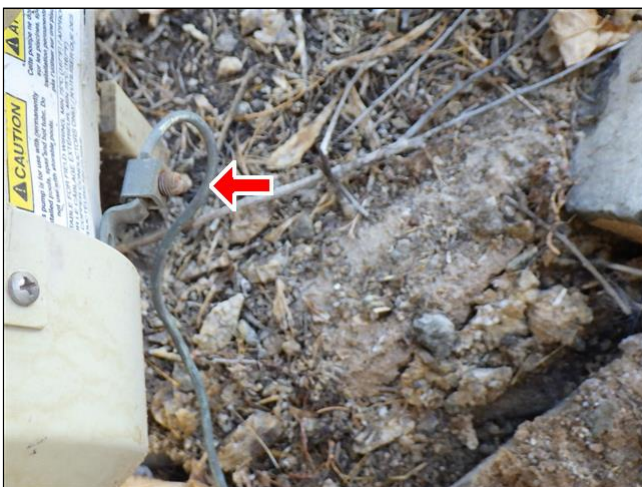
11.6 Item 3(Picture)

(3) The external bonding conductor for the pump motors, blowers and heater is present and in satisfactory condition.

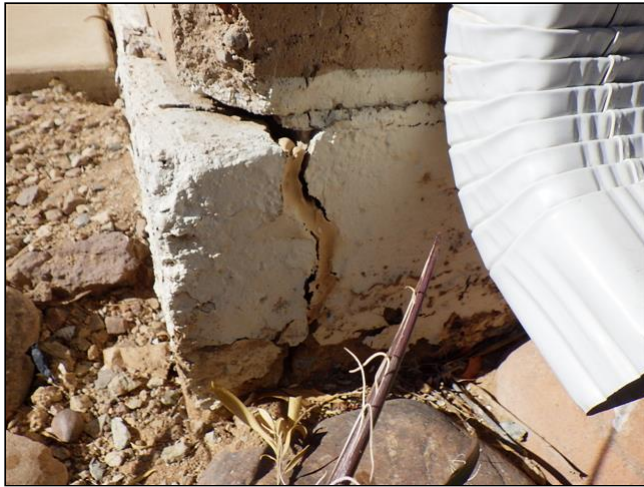
1.0 Item 1(Picture)

(1) Cracking and deterioration observed at multiple locations of the surrounding stem wall foundation including front back and both left/right sides of the house. I recommend professional evaluation and repairs by a licensed contractor.

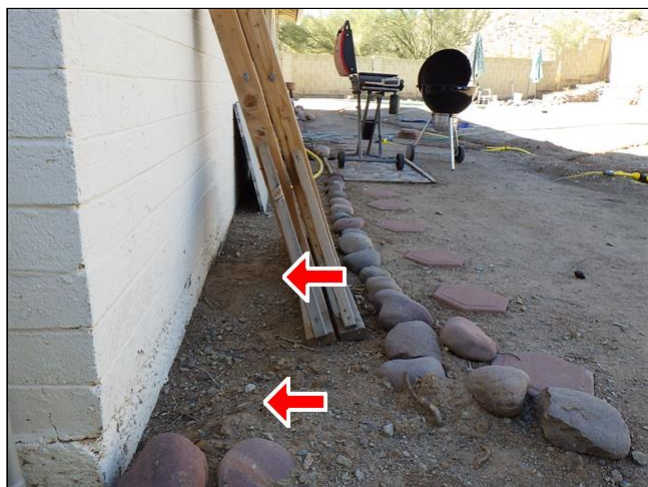
1.0 Item 9(Picture)

(2) There is evidence of water penetration into the rear of the house. This is likely due to the grade in the back yard sloping towards the house. Adjust the grade to direct surface water away from the affected area and keep the soil adjacent to the foundation as dry as possible.

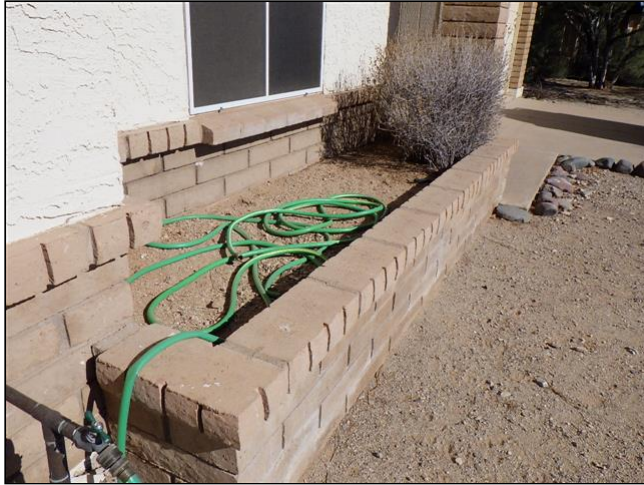
1.0 Item 11(Picture)

(3) The front planter was improperly installed/ designed against the foundation stem wall and/or exterior wall. 4 to 6 inches of foundation is typically recommended to be visible in order to properly identify foundation problems. This condition not only limits inspection visibility but also creates a potential moisture concern. Recommend separating planter materials from exterior structure and ensuring any damages present are professionally repaired.

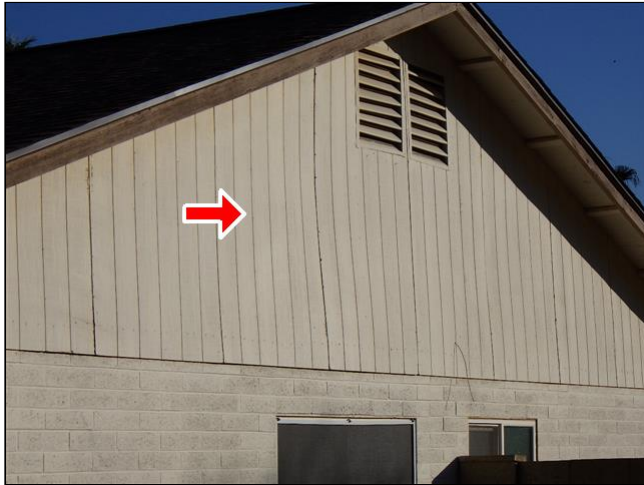
1.2 Item 1(Picture)

(2) The wall is bowed inward on the top left side of the house. I recommend professional evaluation with repairs as necessary.

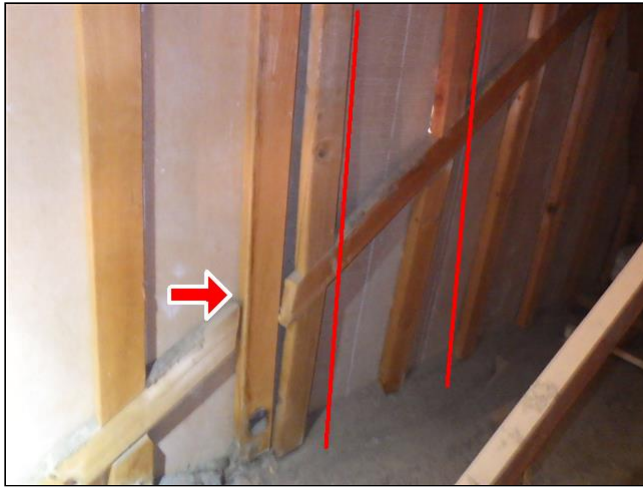
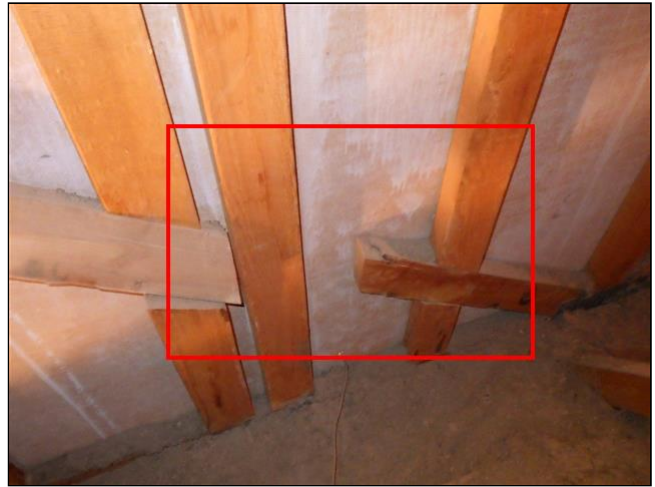
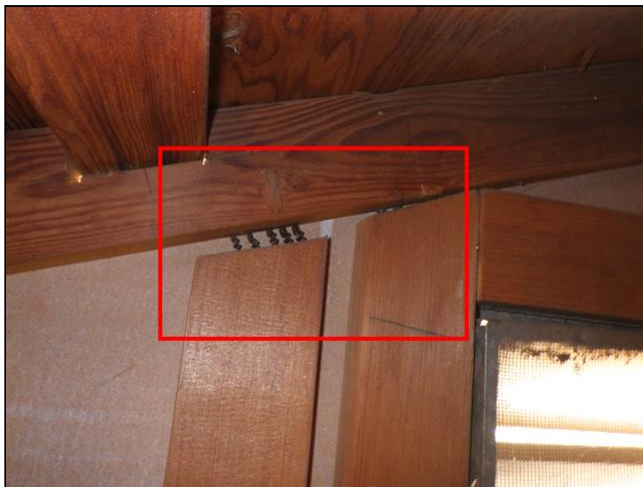
(1) Truss members out of position at the west end of attic and the exterior siding is bowed in at this end. I recommend further evaluation by a licensed professional and repair as necessary.

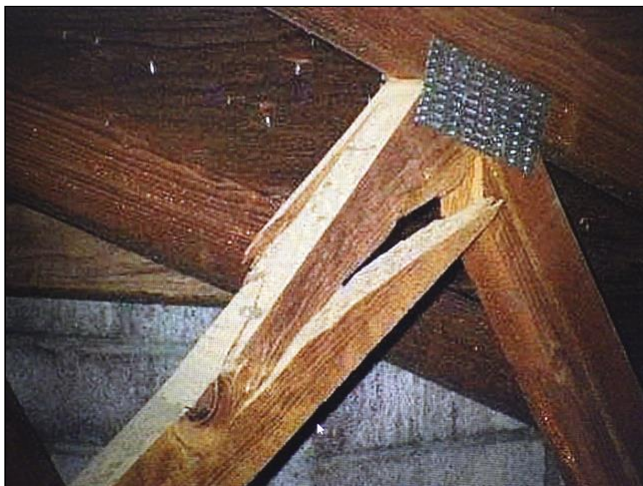
1.4 Item 4(Picture)

(2) There is a cracked/damaged truss member in the middle portion of the attic. I recommend further evaluation by a licensed professional and repair as necessary.

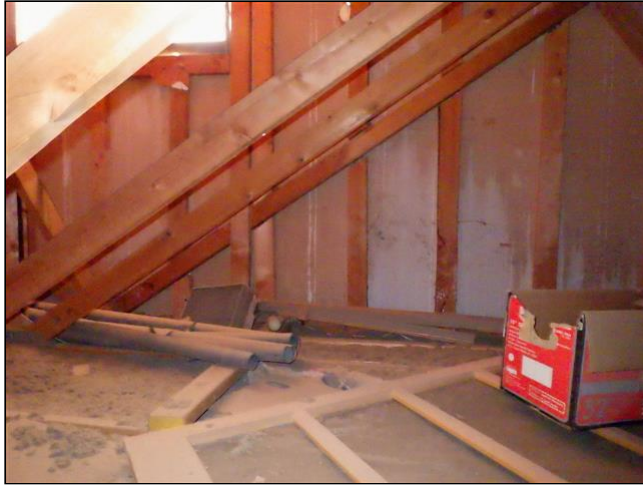
1.8 Item 1(Picture)

I recommend removal of the personal property stored in the attic.

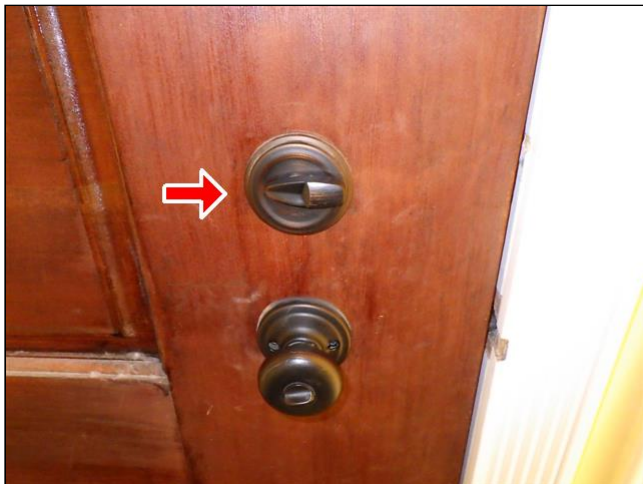
2.2 Item 1(Picture)

(2) The front door bolt lock is very difficult to lock. Repair or replace as necessary.

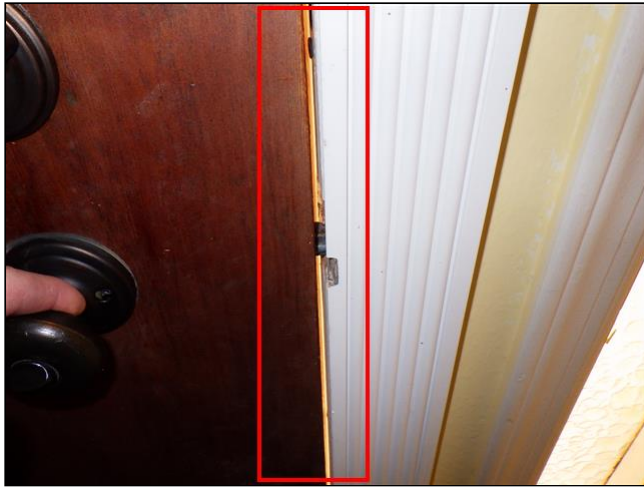
2.2 Item 2(Picture)

(3) There is daylight visible around the front door, remedy as needed.

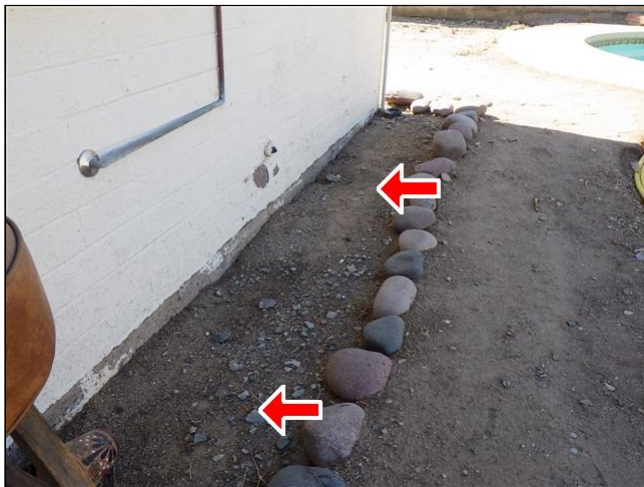
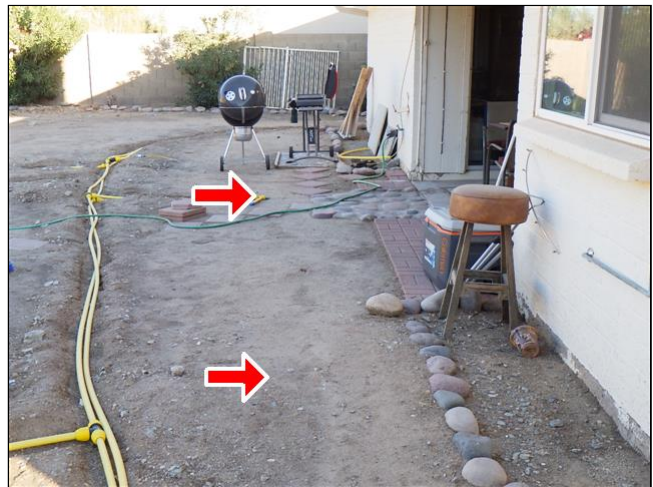
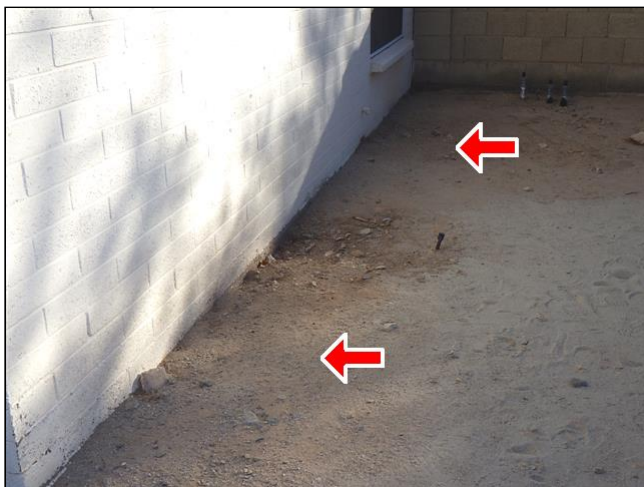
(1) The grade is sloped toward the house in several locations. This will direct surface water into the soil adjacent to the foundation and cause water damage to the foundation concrete. Adjust the grade to direct surface water away from the foundation to prevent water damage.

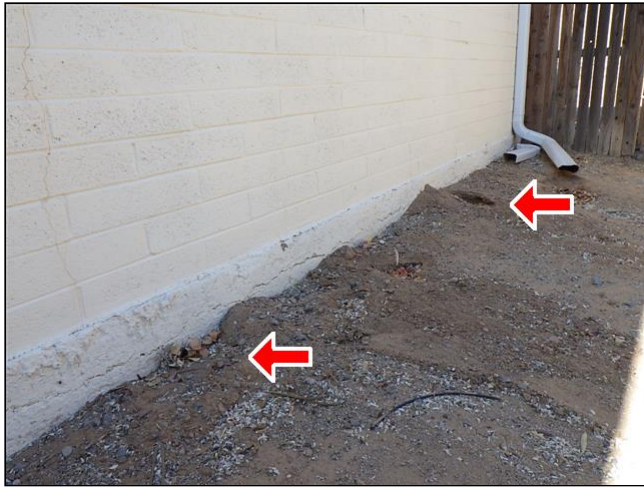
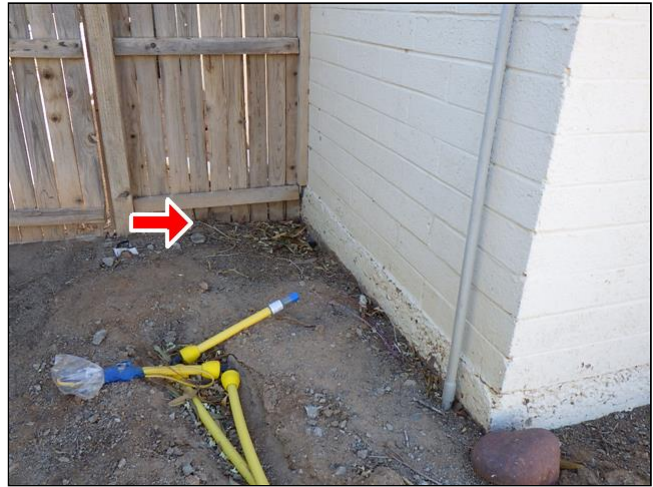
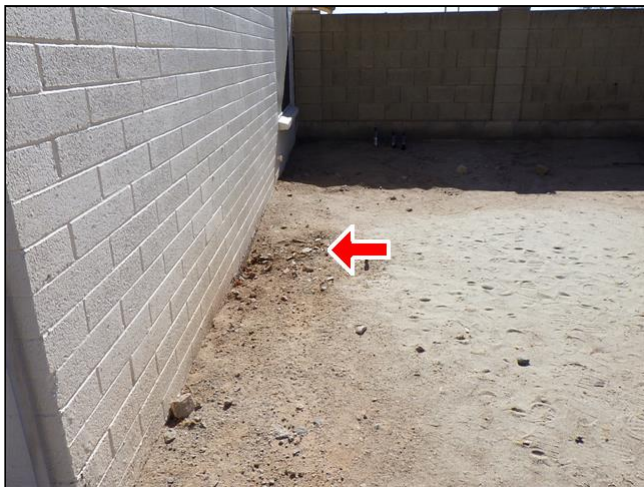
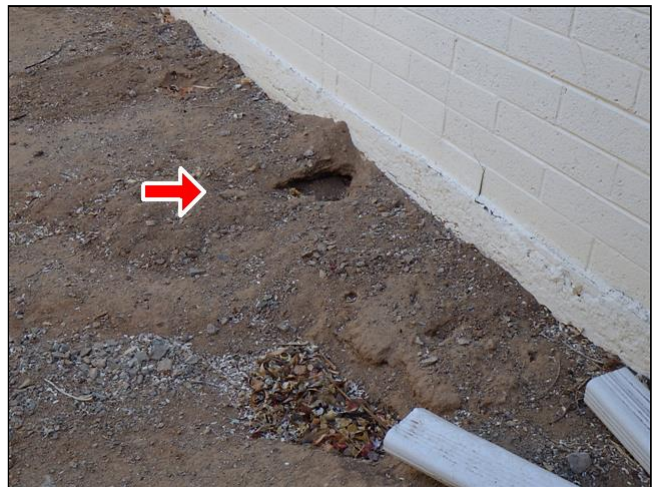
(2) Fill in the holes and adjust the grade to direct water away from the foundation.

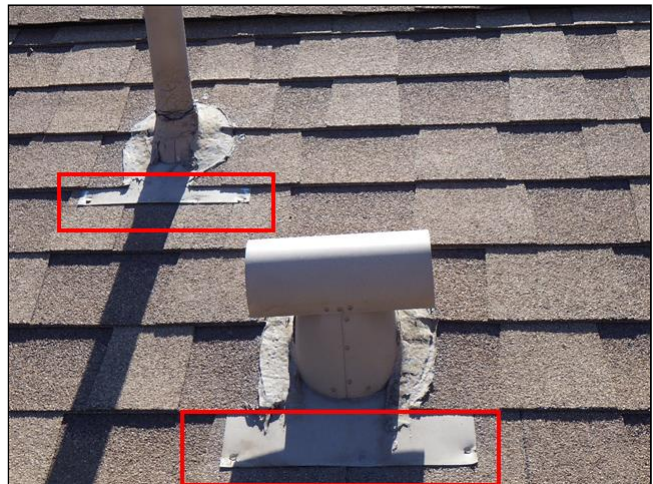
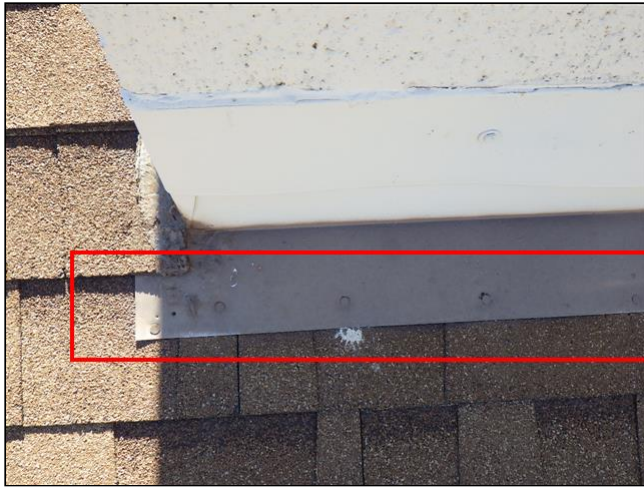
(1) Seal the exposed nails and staples at the flashings to prevent leakage.

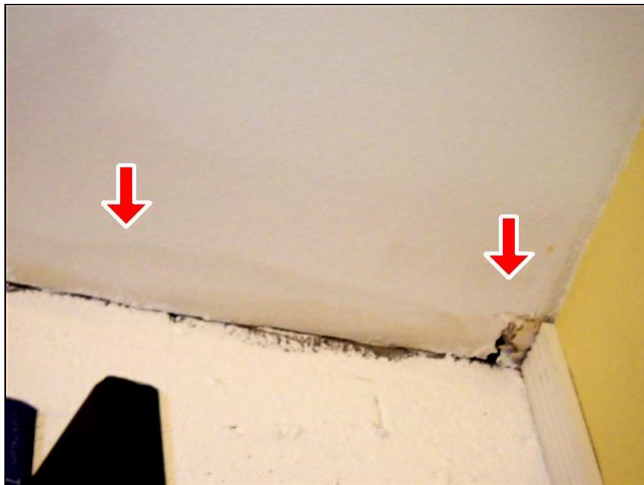
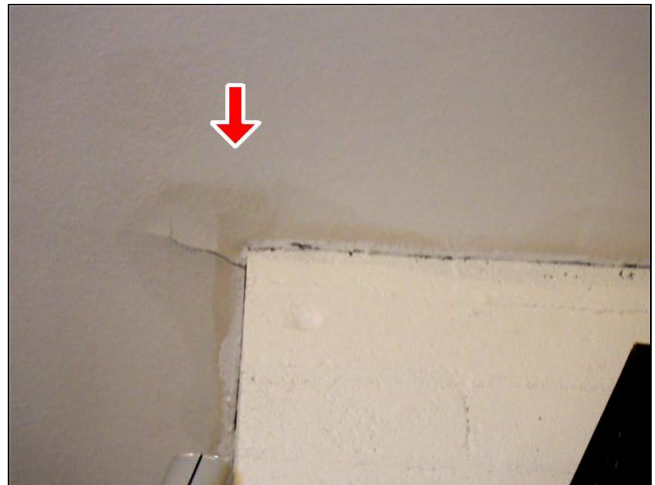
(1) There are signs of leakage (water stains) on the living room ceiling above the fireplace. I recommend professional evaluation and repair as necessary.

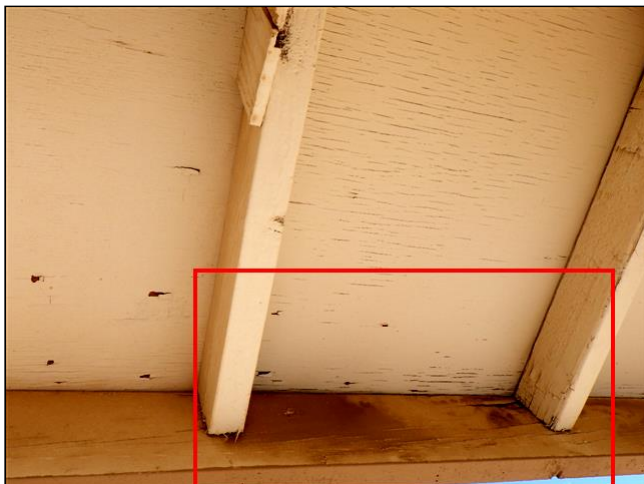
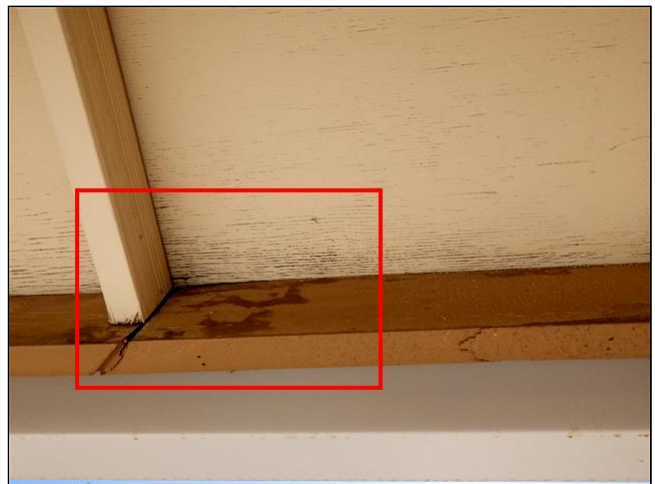
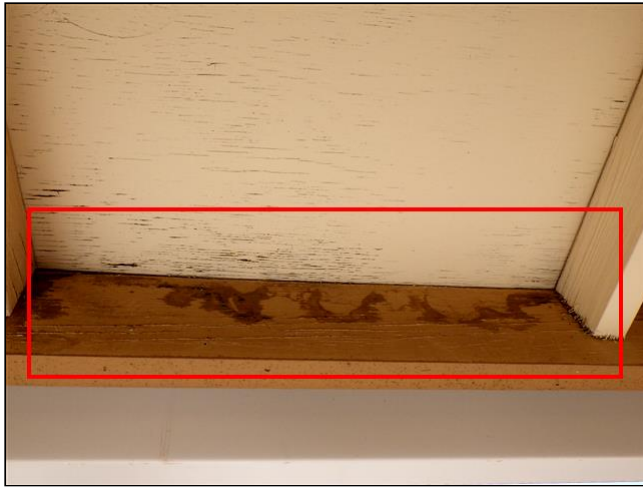
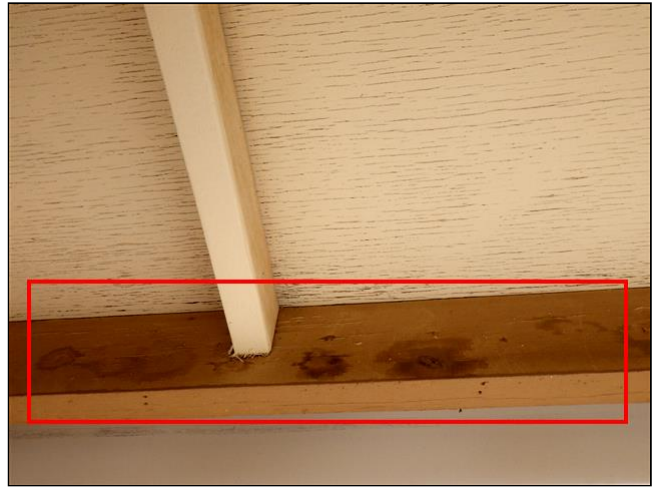
(2) There are signs of leakage (water stains) at the eaves on the front of the house. I recommend professional evaluation and repair as necessary.

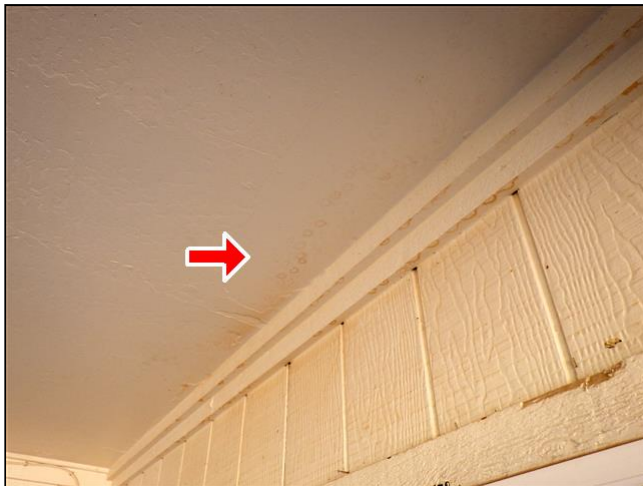
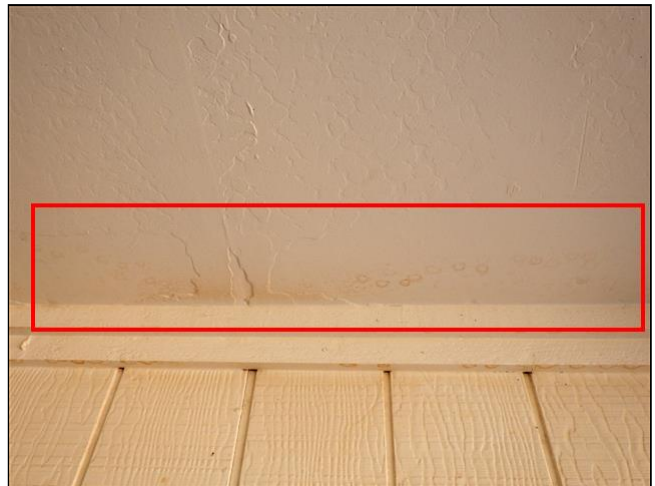
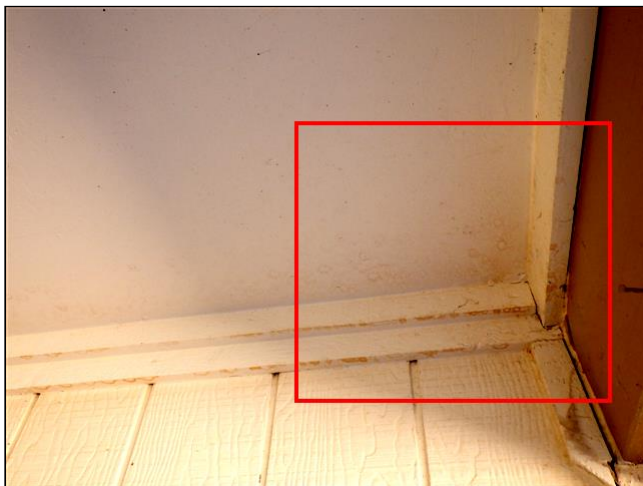
(3) There are signs of previous leakage (water stains) on the rear porch decking. I recommend further evaluation and repairs as necessary.

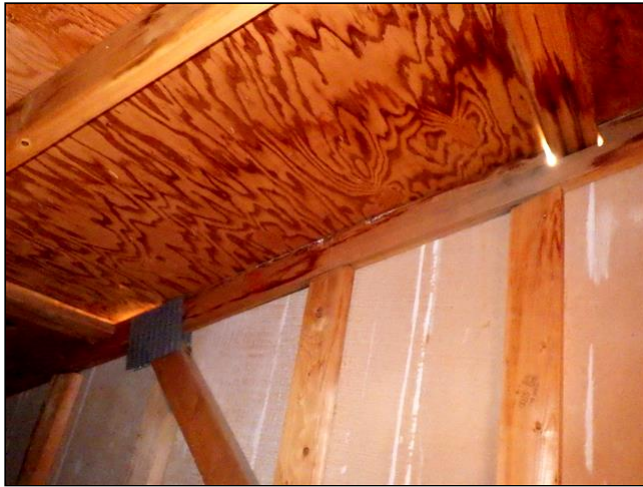
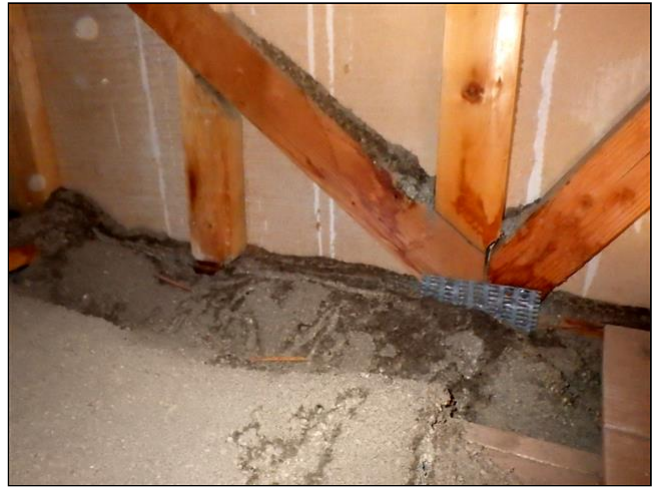
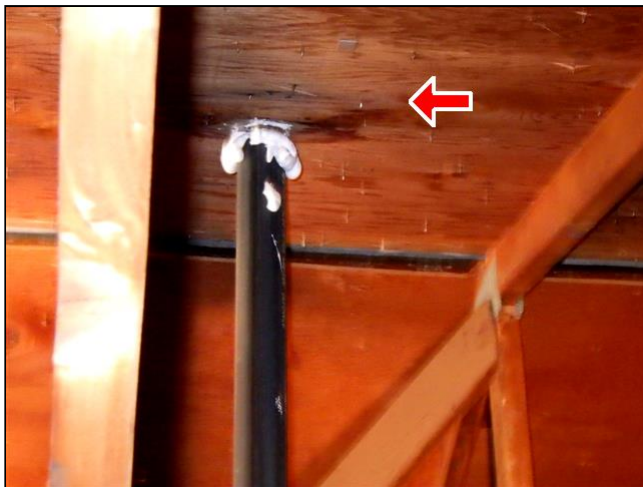
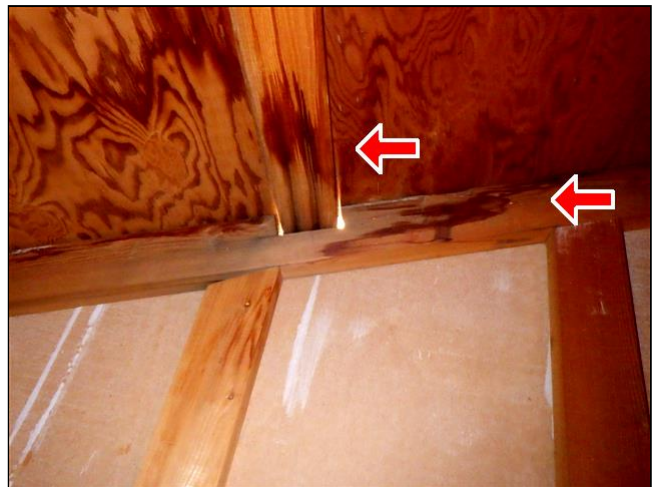
(4) There are signs of leakage (water stains) in the attic on the decking and on the trusses. I recommend professional evaluation and repair as necessary.

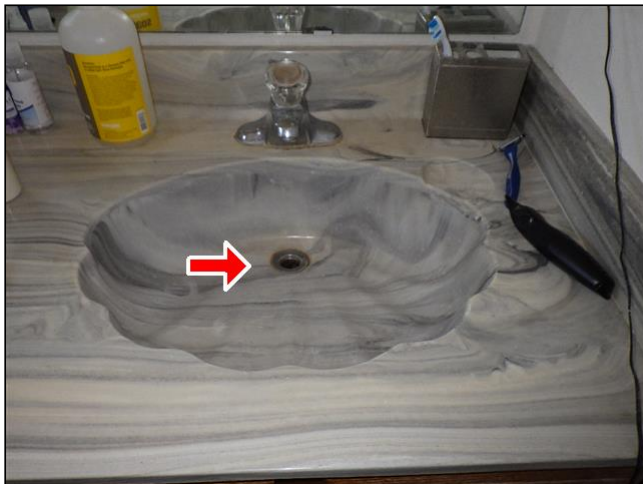
4.3 Item 1(Picture) left and right master sinks

(1) The master bathroom sinks and hallway bathroom sink stops have been removed. I recommend replacement

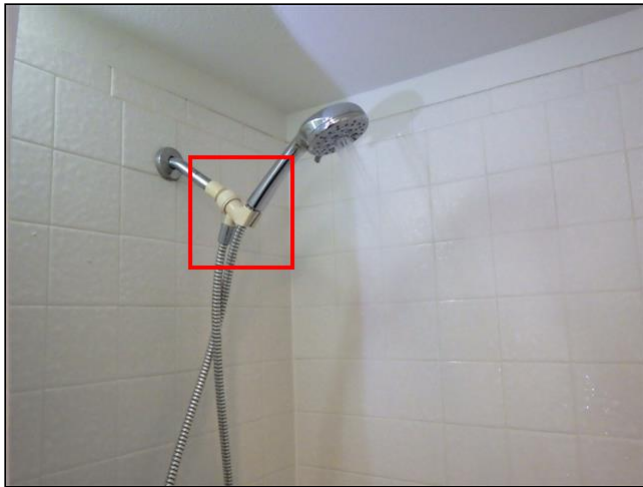
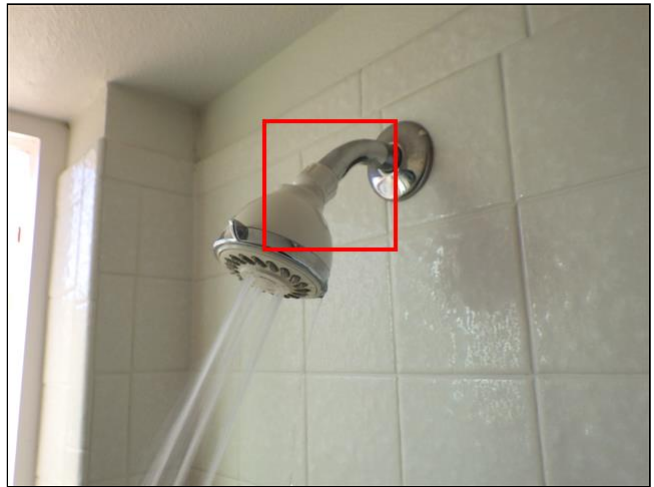
4.3 Item 3(Picture)

(2) The shower heads in the master bathroom and hallway bathroom are leaking. Repair or replace as needed.

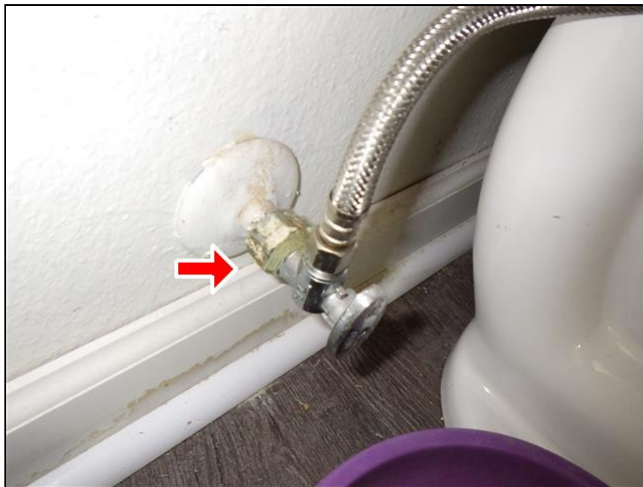
4.3 Item 5(Picture)

(3) There is evidence of leakage at the hall bathroom toilet supply valve. I recommend professional repair/ replacement to prevent further leakage.

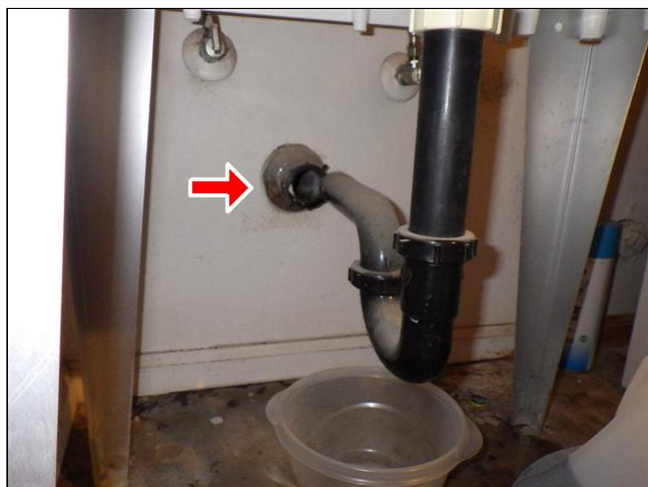
4.8 Item 1(Picture)

The garage laundry sink drain is not connected and leaks out the bottom. Repair as needed

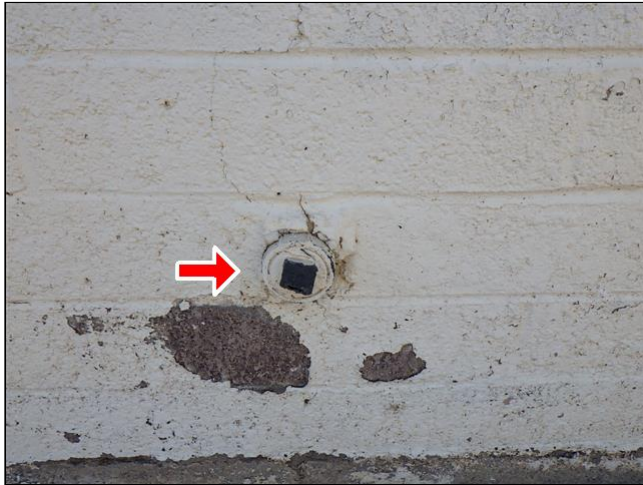
4.19 Item 1(Picture)

The clean out cap is missing from the back wall underneath the kitchen sink window. Recommend replacement or repairs a needed.

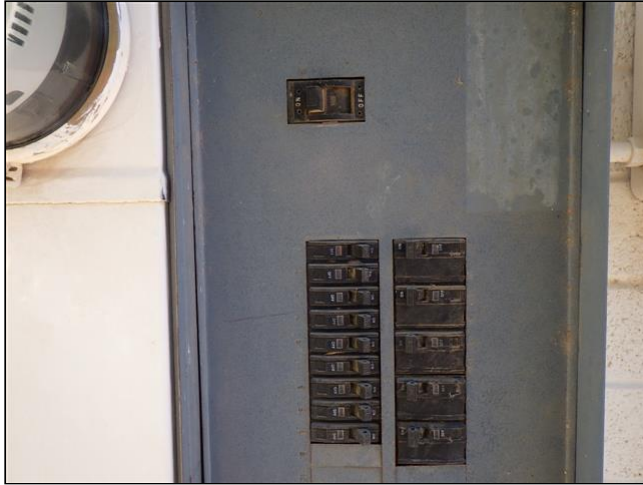
5.0 Item 2(Picture)

(2) Permanently identify the circuits on the dead front panel for future reference.

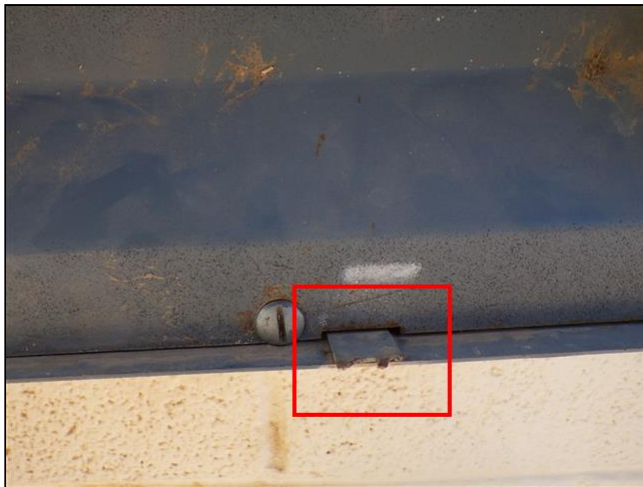
5.0 Item 3(Picture)

(3) The electric panel lock point is damaged/missing, repair as needed.

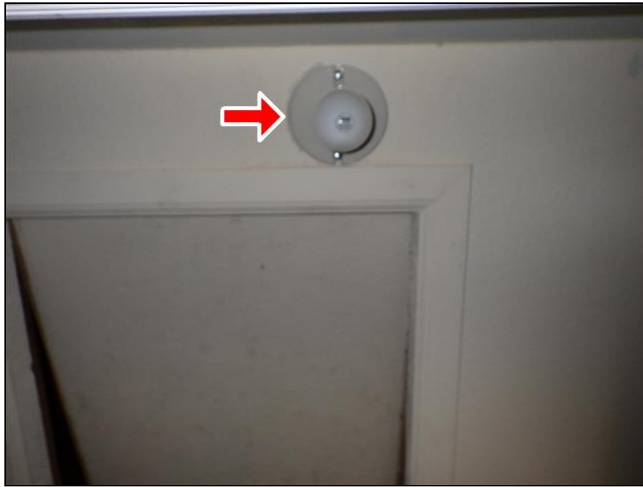
5.6 Item 1(Picture)

(2) Open incandescent bulb fixtures are no longer allowed in closets, fire hazard. A recessed incandescent or surface fluorescent can be installed within 6" of the top shelf or an enclosed incandescent may be installed within 12" of the top shelf or a surface mount fluorescent may be installed on the inside wall over the door. I recommend professional evaluation and remedy as needed.

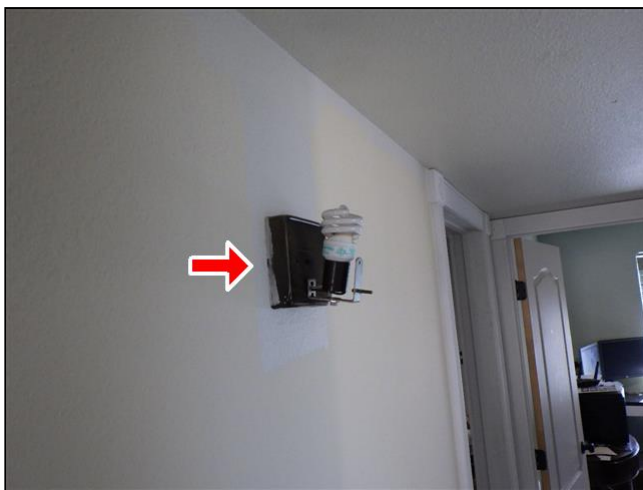
5.6 Item 2(Picture)

(3) The light globe in the hallway has been removed. I recommend replacement.

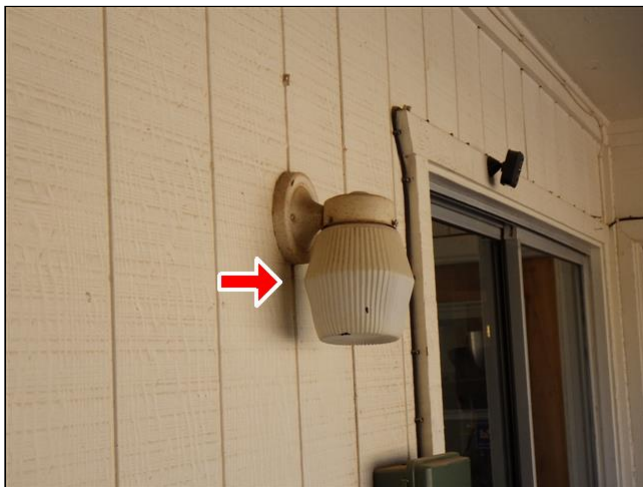
5.6 Item 3(Picture)

(4) The light fixture in the rear patio is inoperable at the switch. Replace the fixtures/bulbs as needed to verify operation or repair as necessary

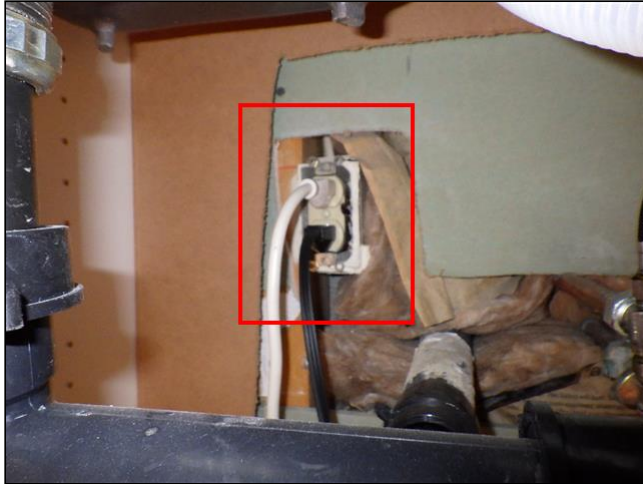
5.7 Item 1(Picture) under kitchen sink

(2) There are several outlet covers that have been removed throughout the house, under the kitchen sink, behind the stove, entry hallway, and both front left and right bedrooms. I recommend replacement.

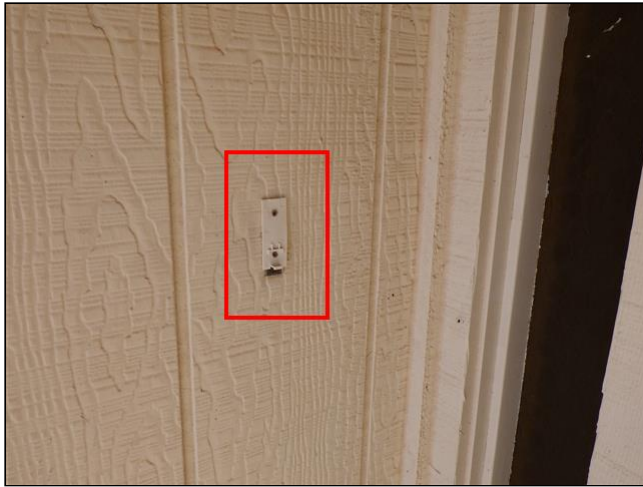
5.10 Item 1(Picture)

(1) The doorbell is inoperable, repair as needed.

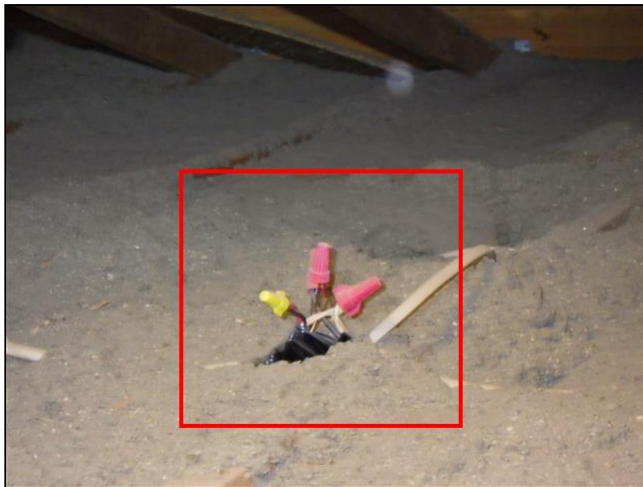
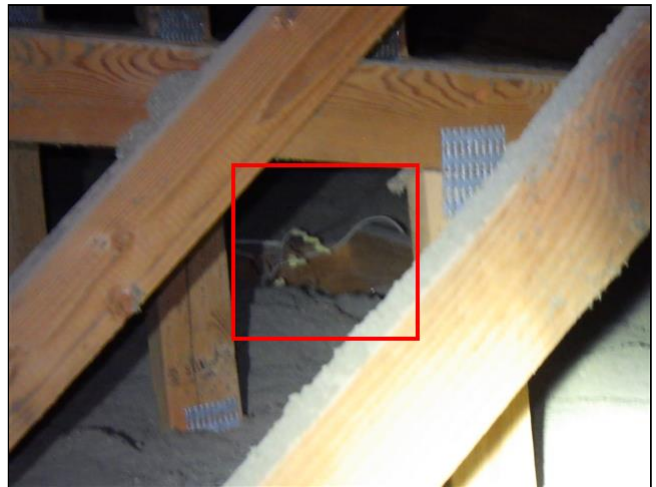
5.10 Item 2(Picture)

(2) There are exposed electric junctions in the attic, remedy as needed.

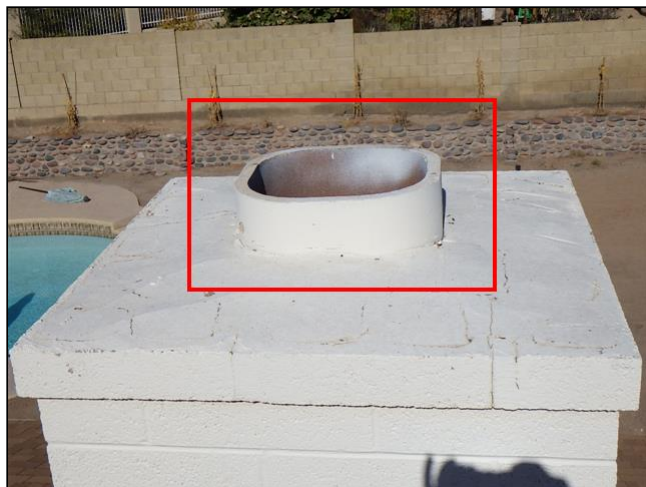
6.2 Item 1(Picture)

(2) Consider the addition of a chimney cap/spark arrestor to keep birds and rain out of the chimney.

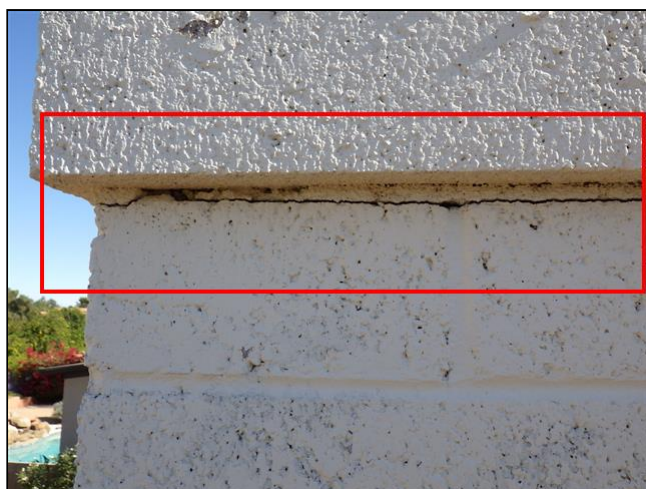
6.2 Item 2(Picture)

(3) Seal up any cracks in the chimney to prevent water intrusion or damage.

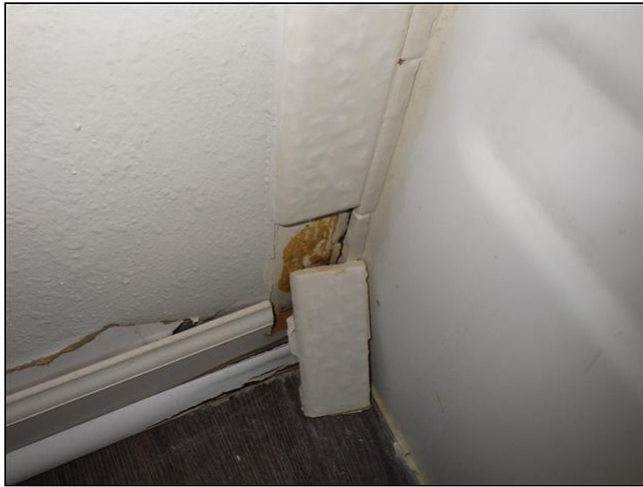
8.0 Item 1(Picture) master bathroom

(2) There is damage to the walls and tiles in the master bathroom and hallway bathroom next to the tub/shower. Repair as needed.

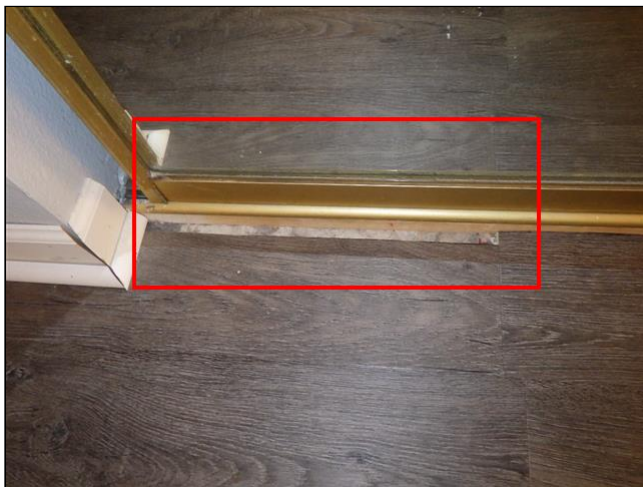
8.0 Item 3(Picture)

(4) The wood flooring incomplete at the west hall closet and there are gaps along the edges and missing sections throughout the home. Recommend repairs as necessary.

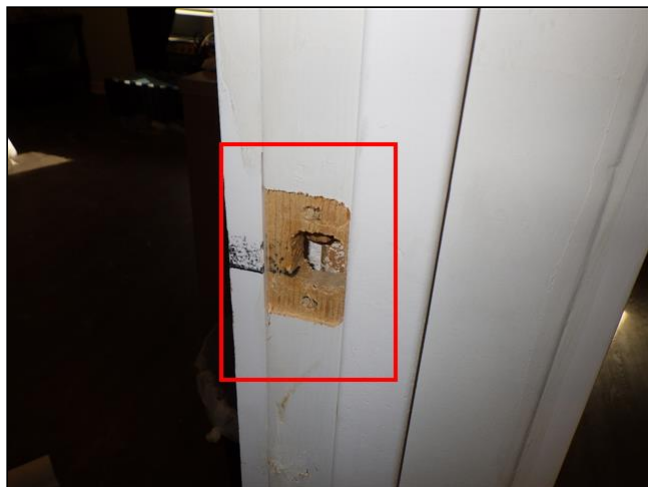
8.4 Item 3(Picture)

(3) The door striker/striker plates are missing at mostly all of the interior doors adjust as needed.

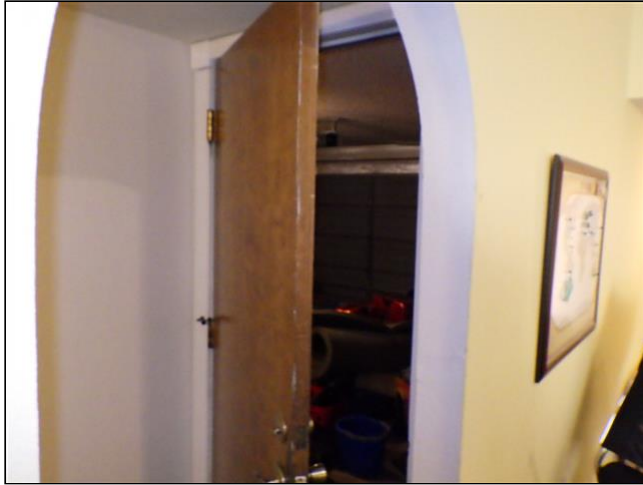
8.6 Item 1(Picture)

(1) The fire separation door between the garage and house is in good condition but does not close, latch and seal automatically. I recommend adjusting the door to close automatically as required.

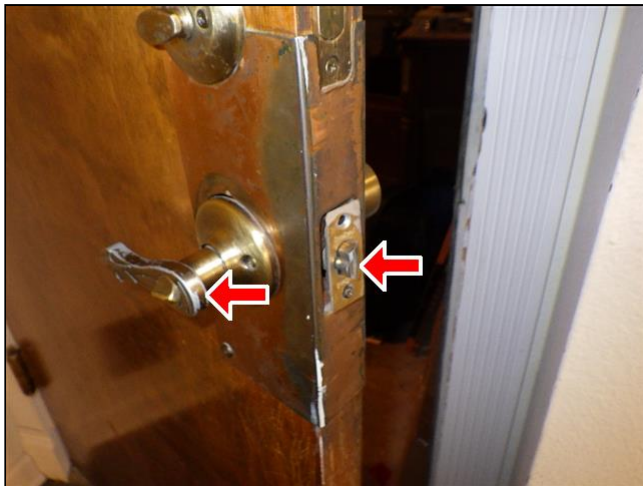
8.6 Item 2(Picture)

(2) The door and jamb is damaged in several areas to the garage, door rubs the jamb and bottom lock is inoperable difficult closing. Recommend repairs as necessary.

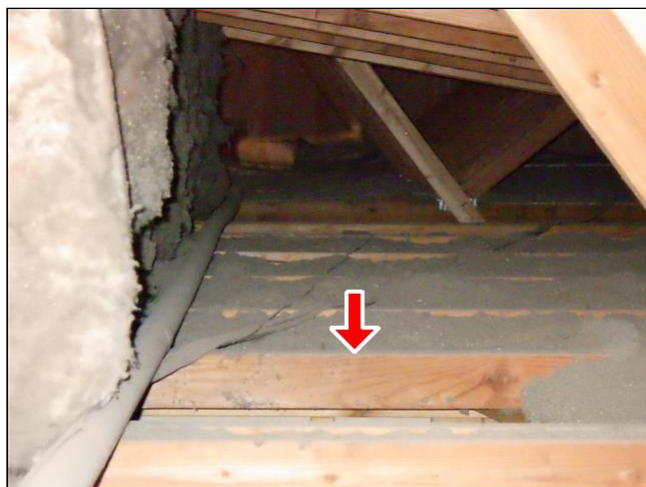
9.0 Item 1(Picture)

(3) The attic insulation is thin in places. Consider additional insulation as needed.

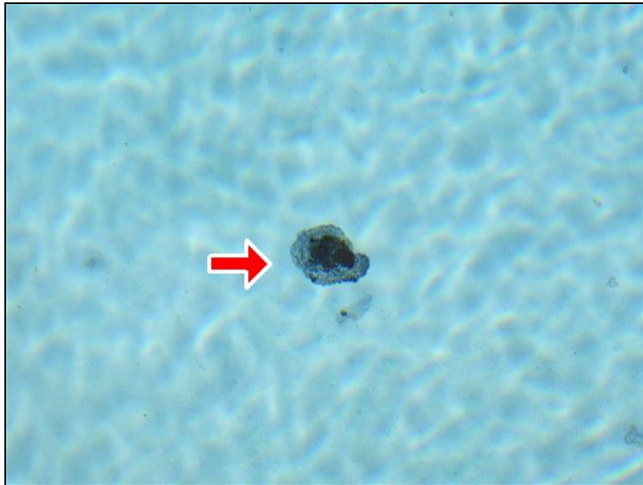
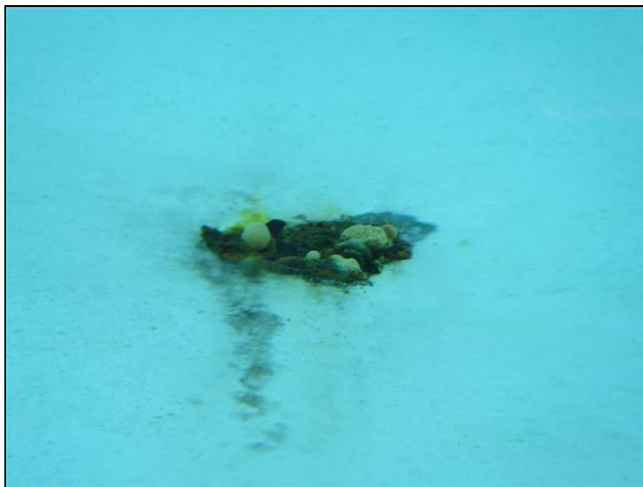
11.1 Item 1(Picture)

(2) The interior finish is in poor condition. Rust spots and wear spots observed. I recommend professional evaluation and repair as necessary.

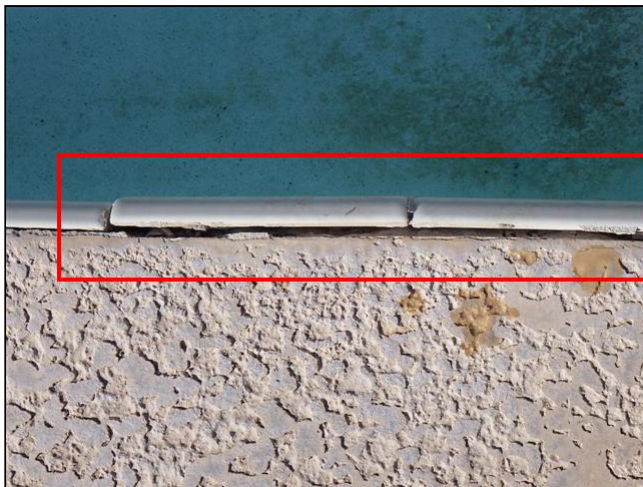
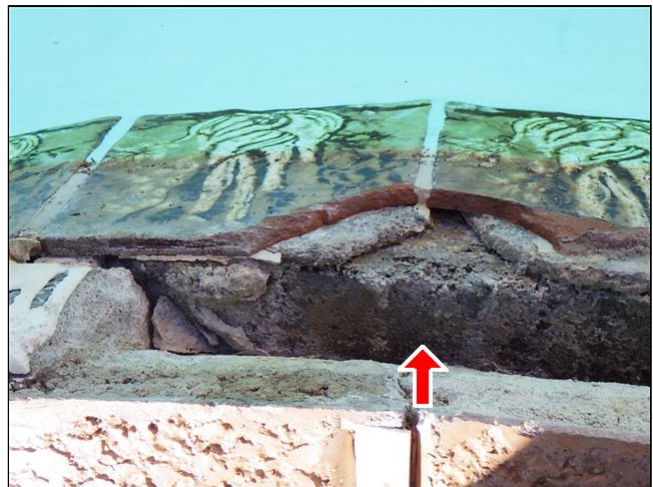
11.2 Item 4(Picture)

(2) There are several loose, missing and cracked edge tiles around the pool deck. I recommend professional repair as necessary.

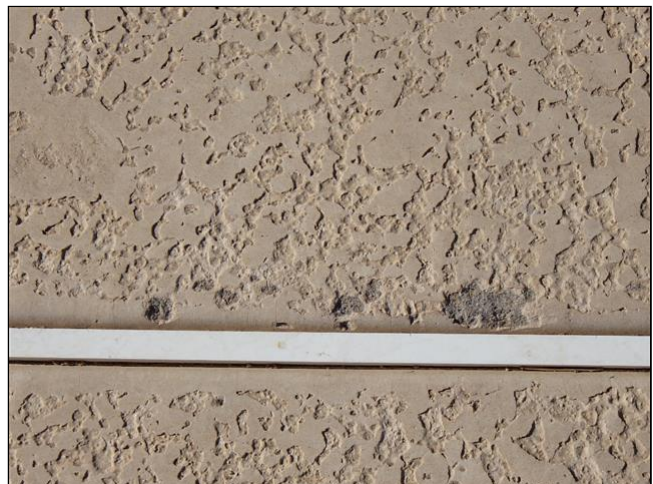
11.2 Item 7(Picture)

(3) The pool deck finish is peeling and chipping. I recommend professional evaluation with repairs as necessary.

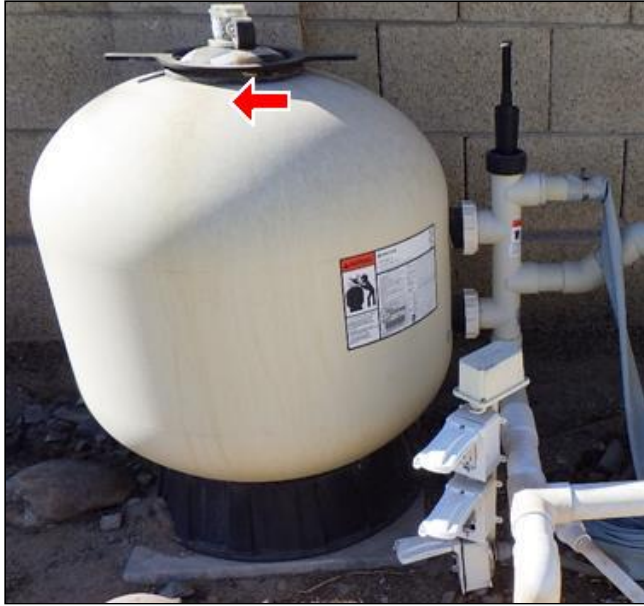
11.3 Item 1(Picture)

(2) The filter has evidence of leaking, I recommend professional evaluation and repair as needed.
