Inspection Report

Property Address:
4338 E Neverland Dr
Phoenix AZ 85044

Keylight Home Inspections

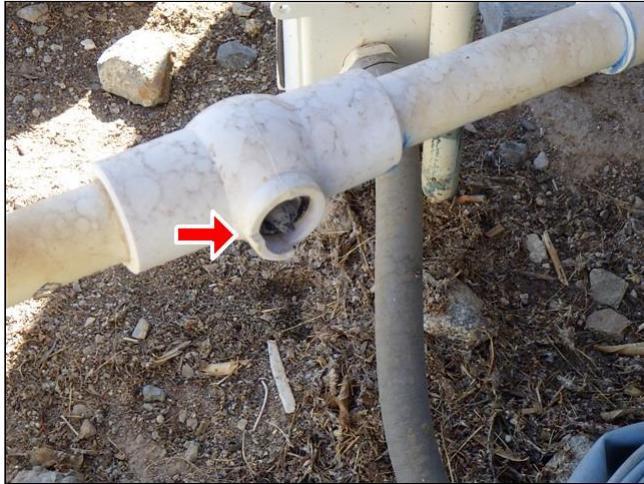
11.5 Item 1(Picture)

(1) The aerator valve handle is broken, I recommend replacement

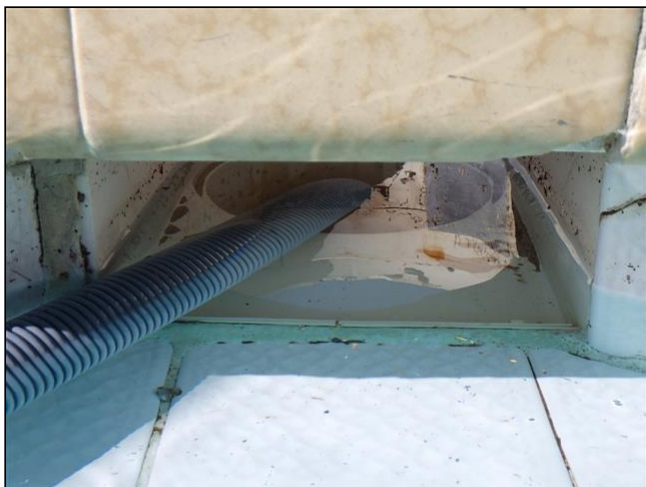
11.5 Item 2(Picture)

(2) The weir door has been removed, I recommend replacement.

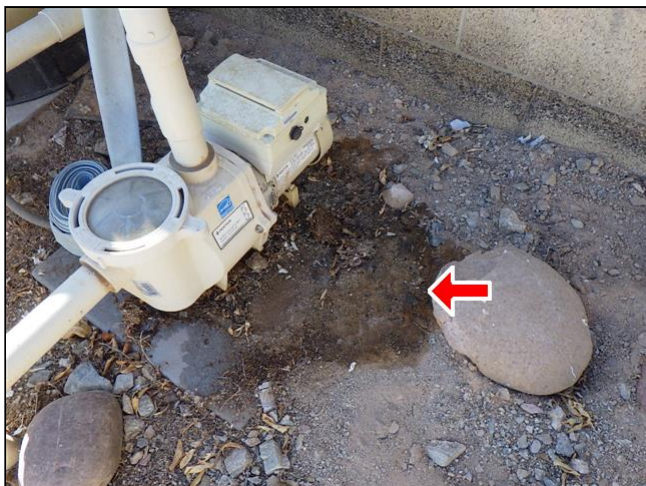
11.5 Item 3(Picture)

(4) The pool filter pump is leaking, repair as necessary.

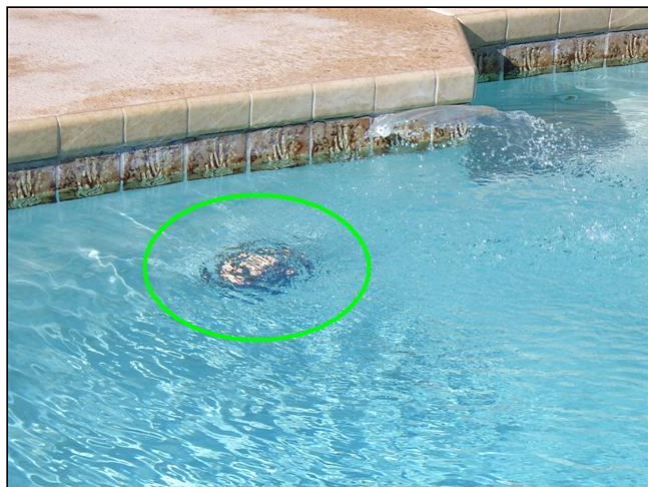
11.6 Item 1(Picture)

(1) The pool light is operational but the GFCI associated does not turn off when tripped at pool. Recommend repairs for proper safety.

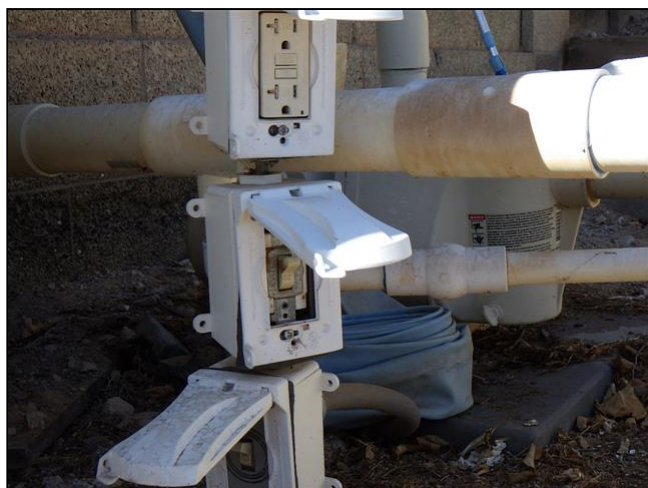
11.6 Item 2(Picture)

(2) The GFCI is present and operational but doesn't turn off the pool light. Recommend further evaluation and repairs for safety.
