NSK Ti-Max Ti95L

Repair Procedure

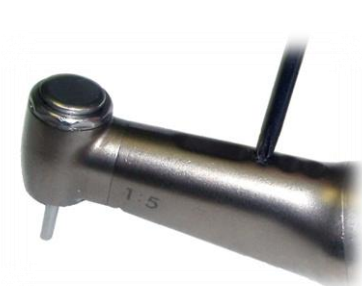
Tooling needed to properly perform this repair.

- 1) Lube Nozzle for E-Attachments (00001A)
- 2) Threaded Ring Removal Tool (10112D)
- 3) Mini Phillips Head Screwdriver
- 4) Mini Flat Head Screwdriver
- 5) Adjustable Wrench
- 6) Mini Channel Lock Pliers

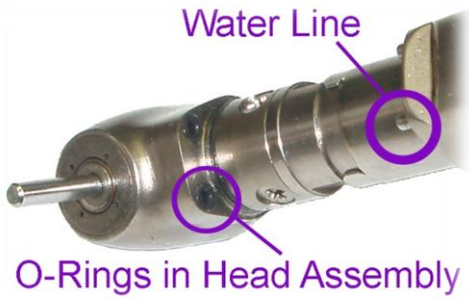
Step 2:

Using an adjustable wrench (as pictured), unscrew the back cap. Again, it is regular thread so turn the cap counterclockwise to loosen. **WARNING: Do Not Use any type of Channel Lock pliers on the back cap, they may damage the cap.**

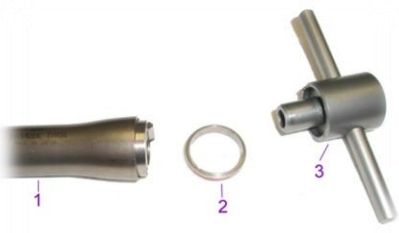
Step 7:

Using your Threaded Ring Removal Tool (3), unscrew the lower retaining nut from the bottom of the attachment (2). It is also regular thread, so turn the nut counterclockwise to loosen. Using a pair of mini Channel Lock pliers, grip the internal manifold as shown in the picture, and pull it out of the attachment. The lower drive assembly will come out with the manifold. If not, you can

gently tap the bottom edge of the attachment on your work surface to remove it. Be careful not to hit the exposed fiber optics on your desk as this could damage them.

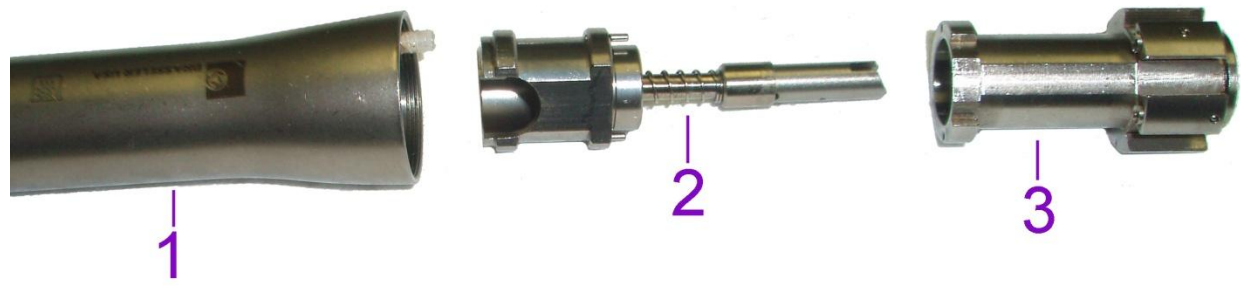
#	Part #	Description
1	N/A	Main Body
2	90139T	Tail Assembly
3	90139M	Lower Manifold

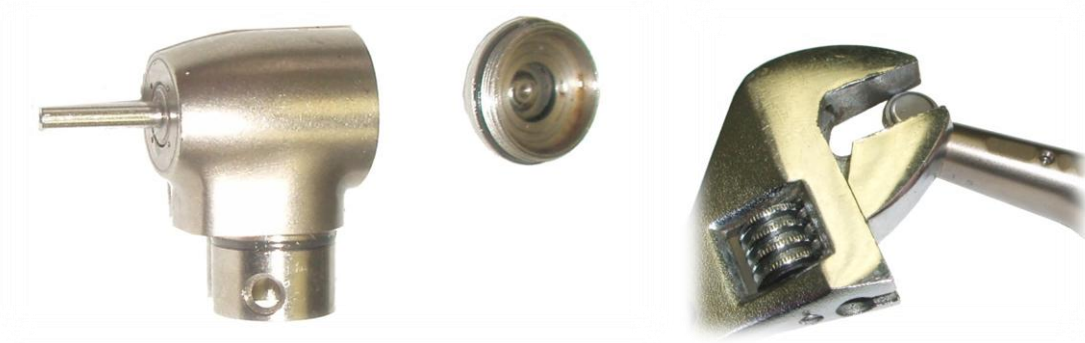
Step 12:

Now insert a new turbine cartridge (part# 90133) into the head assembly. Please place the turbine properly into the head using the small alignment nub on the cartridge and pushing it into the obvious groove on the inside of the head shell. After inserting the cartridge fully, screw the back cap onto the head shell. Use an adjustable wrench only and turn the cap clockwise until secure and tight.

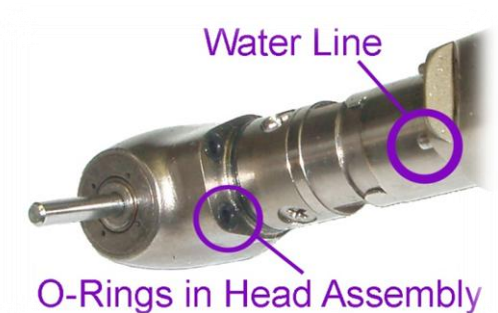
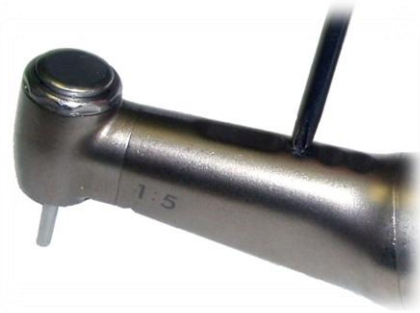
Step 15:

Now insert the head assembly into the neck of the attachment. Again, do not twist the assembly while inserting it as this may cause damage to the waterlines or fiber optics. If the head does not sit flush on the neck of the attachment, twist the bur slightly while applying minor downward pressure to align the internal gearing. Next, install the neck screw into the back of the neck of the attachment. Turn clockwise to tighten, using your mini Phillips Head screwdriver until it is snug.
