# Wilmington's HAB experience

Two sources on different watersheds

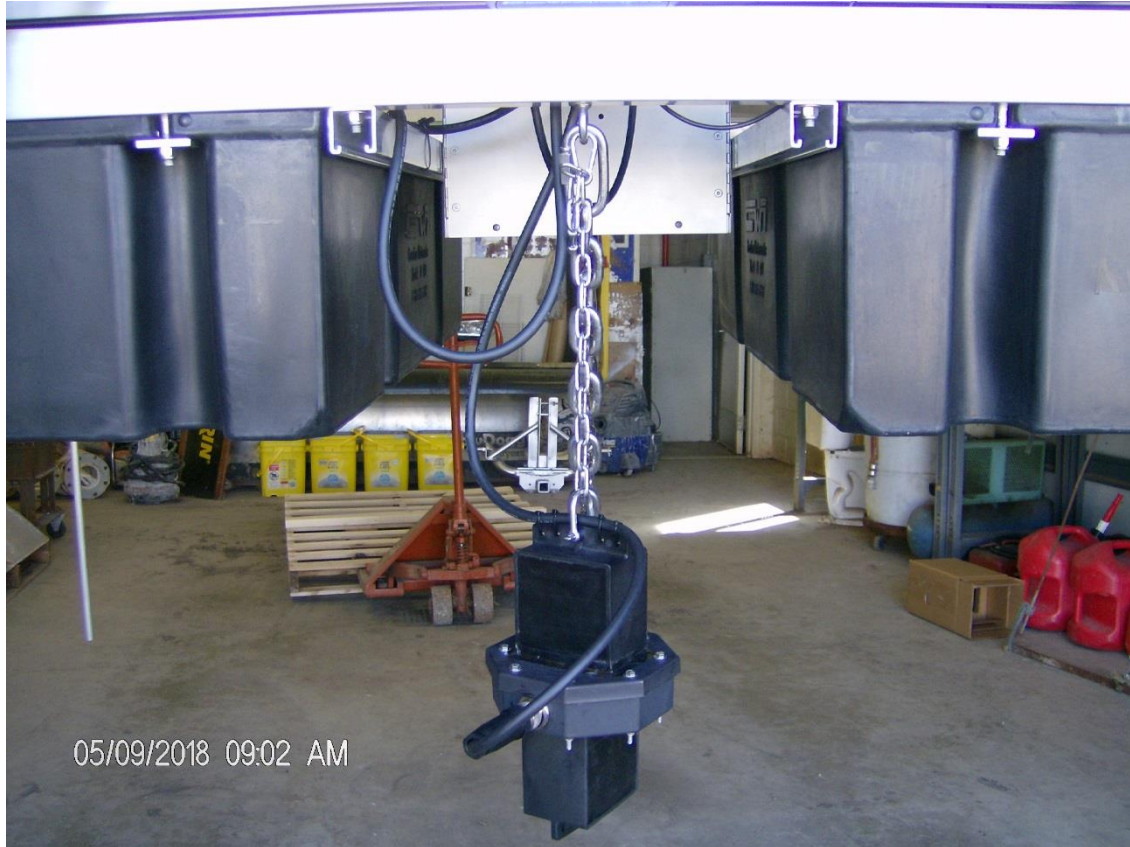
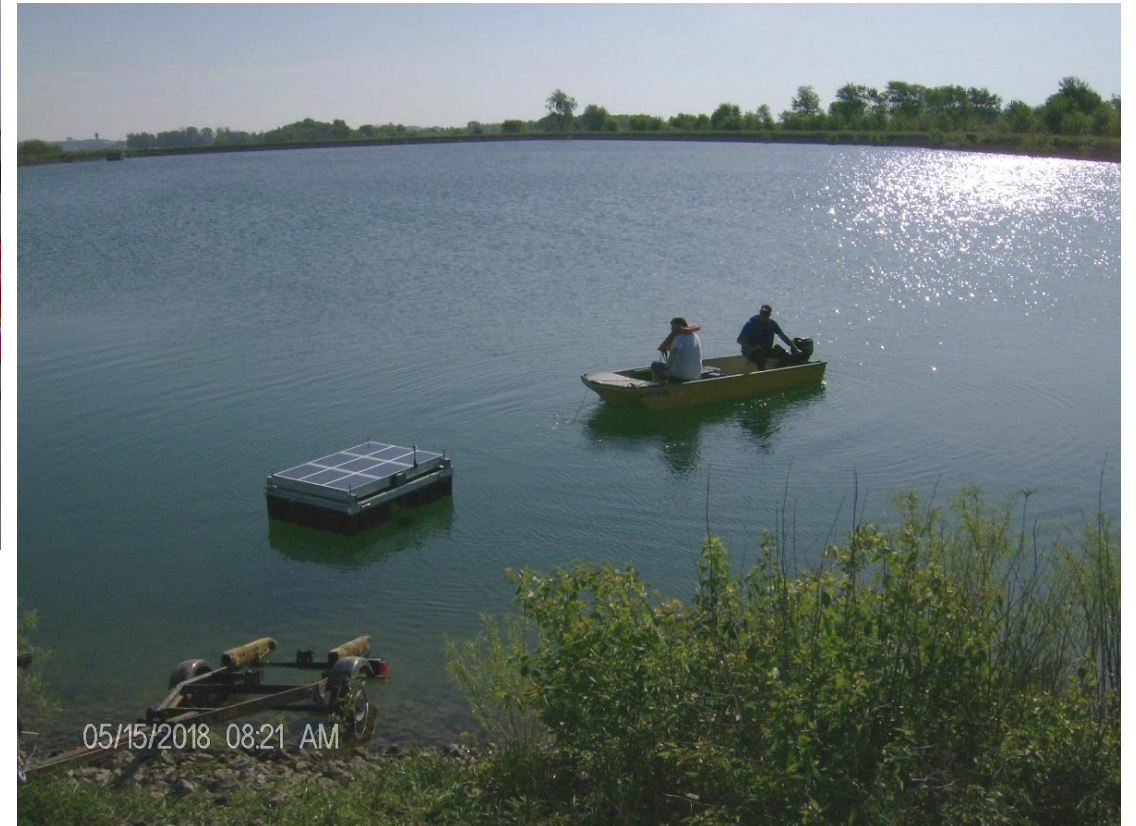
# Sonication

Model: Hydro Bioscience Quattro-DB  
Marketed by: Sonic Solutions Northampton, MA  
Note: NSF 61 certified for use in drinking water source
