PRO Tech

HOME INSPECTION SERVICES

628 Elm Crescent SW, Paradise Valley, T5T 5R5

INSPECTION REPORT

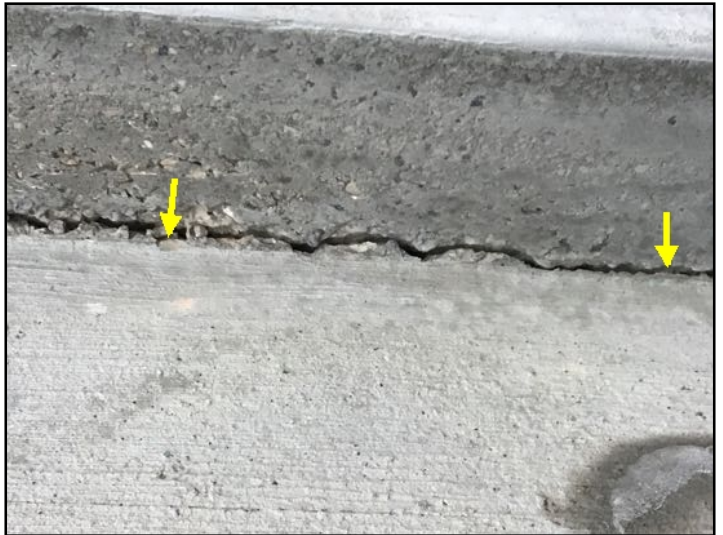
Walkway has settled in areas. Recommend repair as required

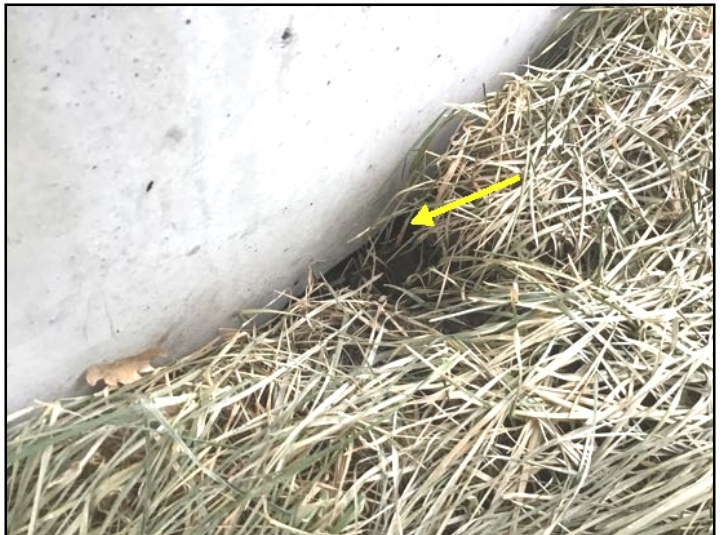
Negative grade / void observed under porch. Recommend back filling to prevent water pooling at foundation wall and to prevent animal intrusion.

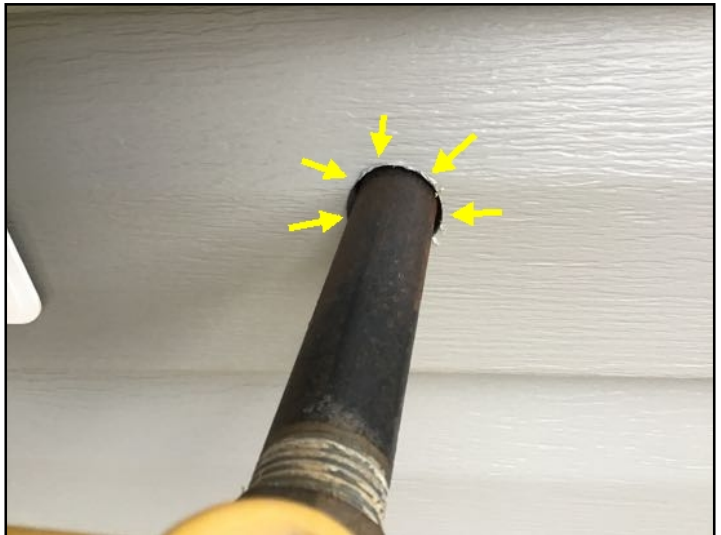
Loose venting noted. Secure to prevent damage

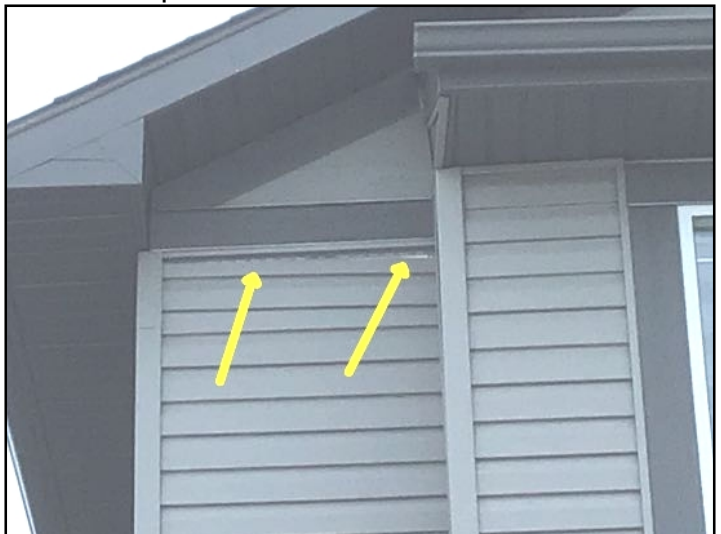
Tag noted at siding. Recommend further review

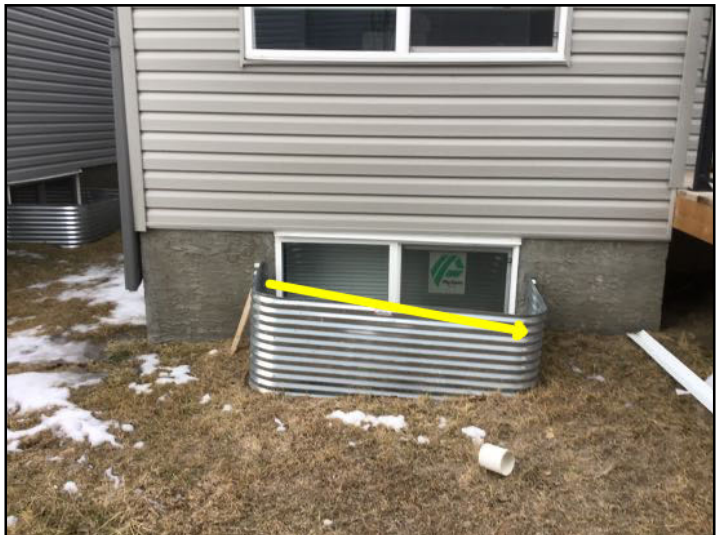
Windows observed at grade level. Wells should be cleaned regularly for proper drainage. Window well covers can be installed to keep out water, snow and debris. Recommend monitoring and grading away from window wells to prevent moisture in well.

Window well has settled on right side. Recommend re-levelling.

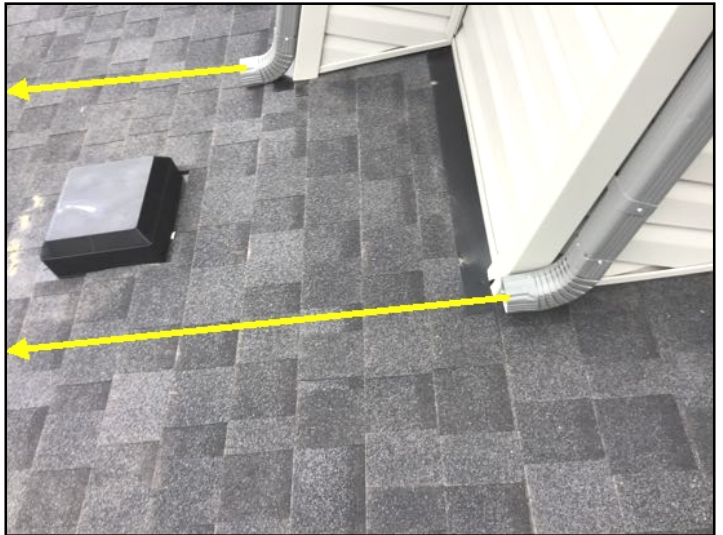
Downspouts that drain on or block walkways can pose slipping and tripping safety hazards. It can also promote downspout damage and concrete damage to walkways / driveways and foundations. It is recommended that these downspouts are redirected away from sidewalks. There are several creative ways to accomplish this including installing an overhead downspout arbour.

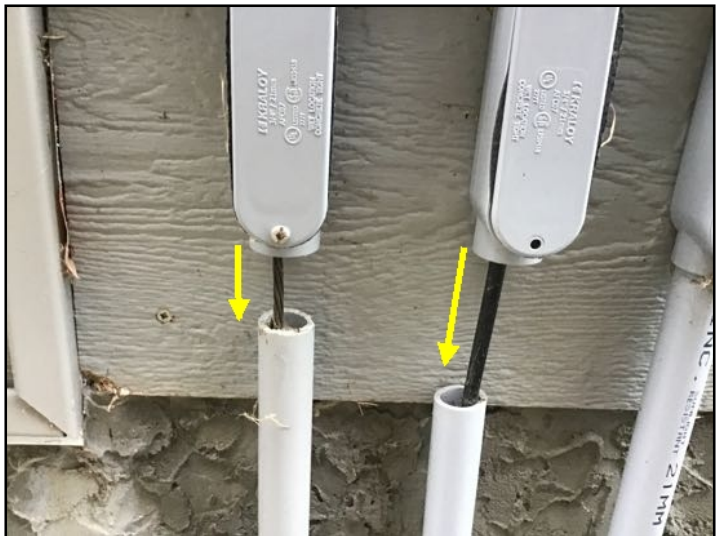
Loose light fixture(s) observed. Recommend securing for safety.

Conduit has pulled away from box. Recommend repairs as required.

Secure loose light fixtures for safety.

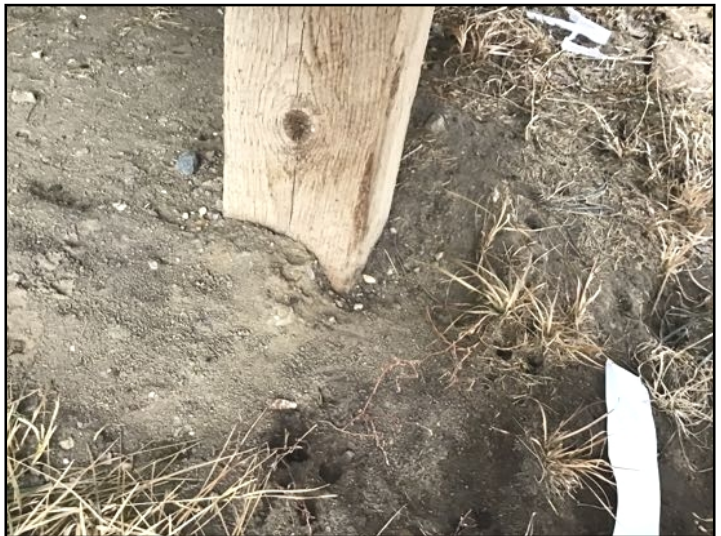
Recommend installing concrete blocks under stair stringers to prevent wood rot.

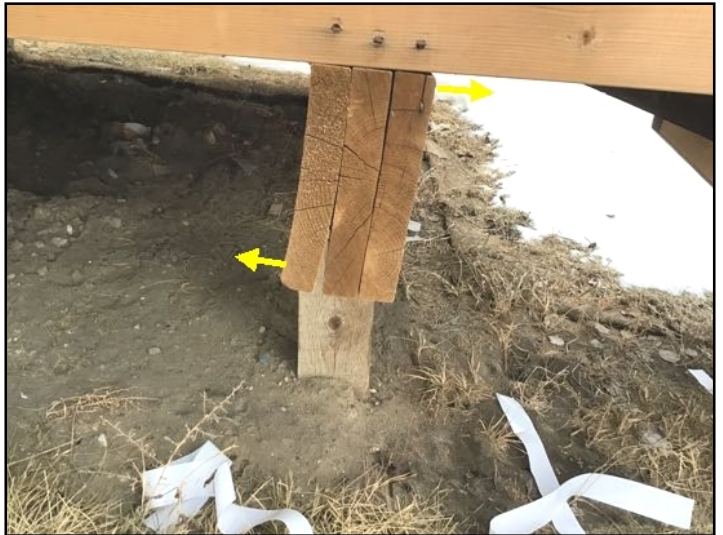
Recommend further review of fasteners at upper riser for repair.

Rotating beam observed at deck. Recommend review by deck contractor

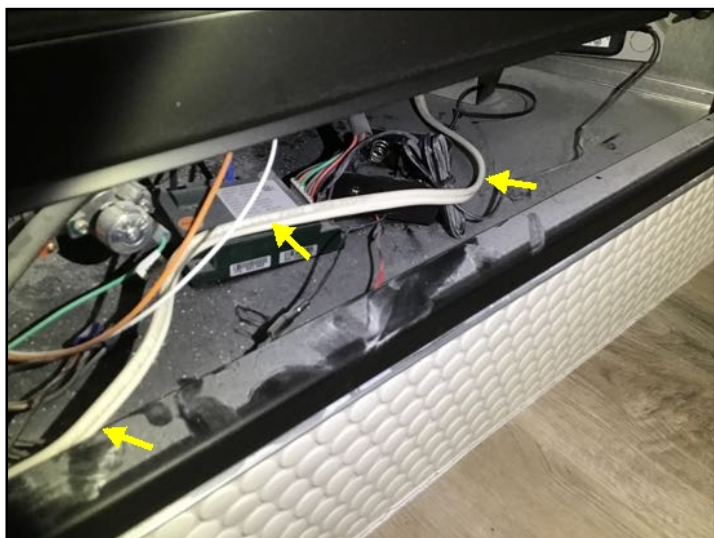
Caution: Exposed loose wiring. Recommend installing away from front access to gas control valve and remote receiver

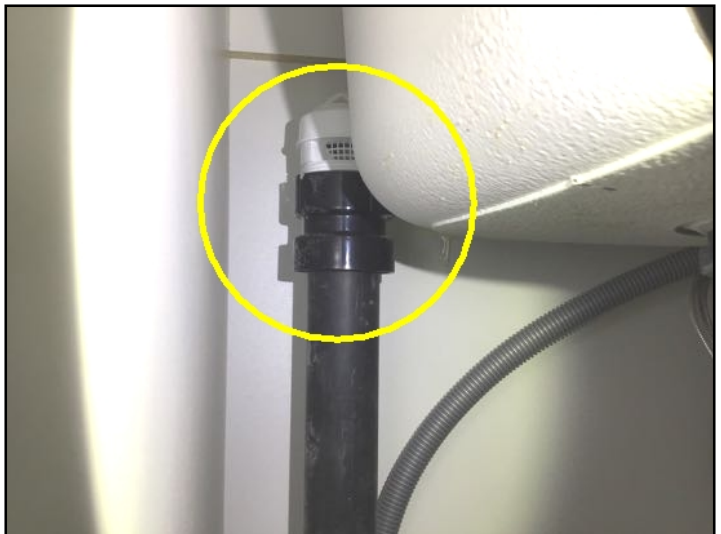
Air Admittance Valve vent observed at waste line. These devices are installed in islands when venting is difficult. Installation of AAV should be installed above flood rim of sink.

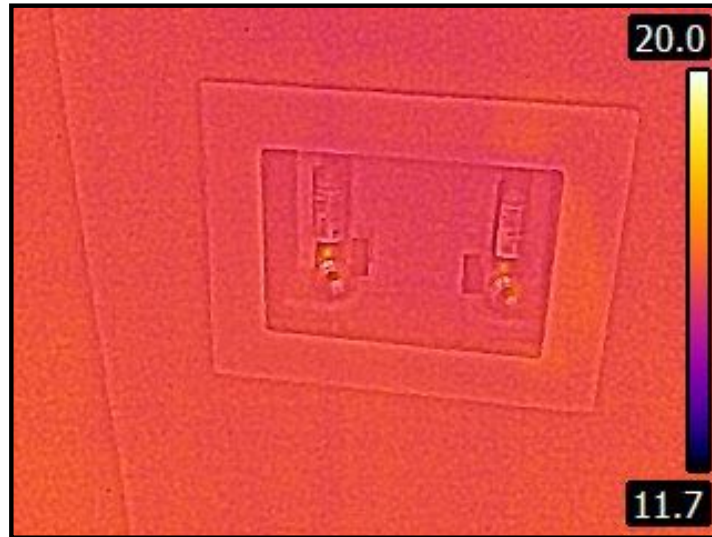
Washer drain knockout has not been removed. Standpipe fitting not visible. Recommend further review

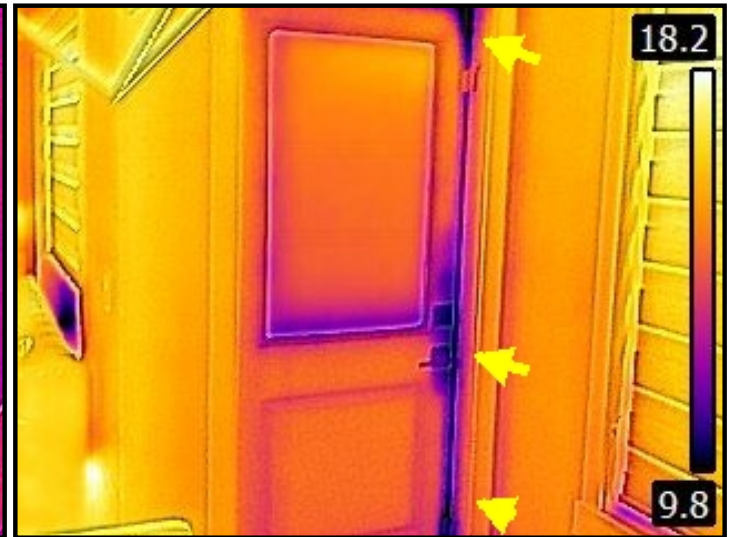
Rear Entryway - Thermal Image Cold drafts noted.

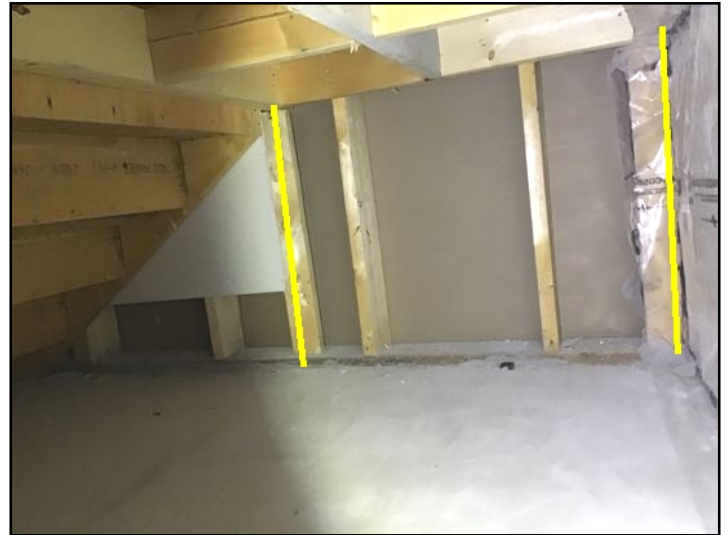
Stud not attached at joist. Recommend further review

Recommend installing additional vertical posts beneath landing framing for additional support.

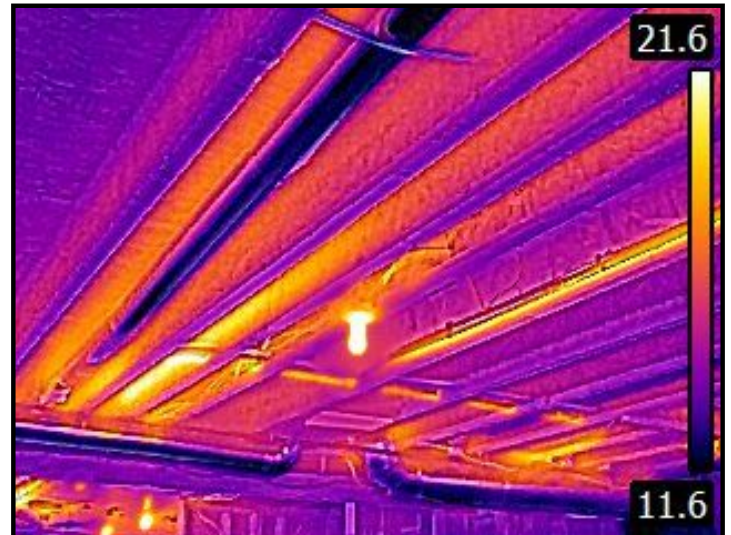
Missing diffuser noted. Replace as required

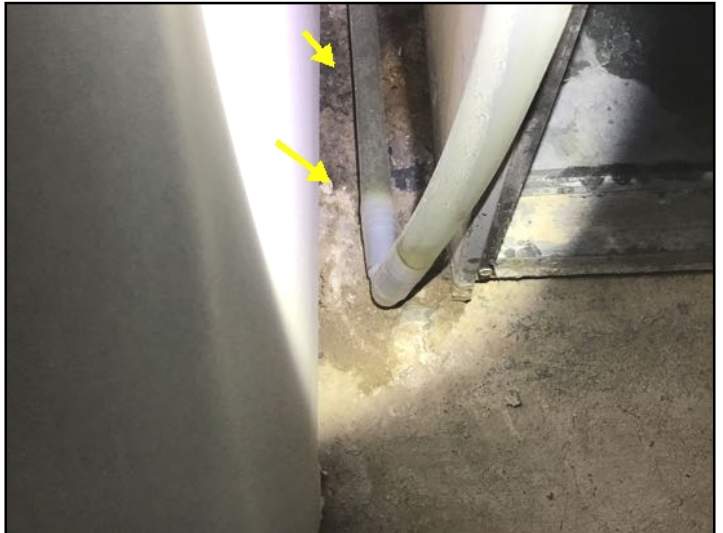
Active condensate leak noted at high efficiency furnace drain line - Repair asap to prevent long term damage to furnace.

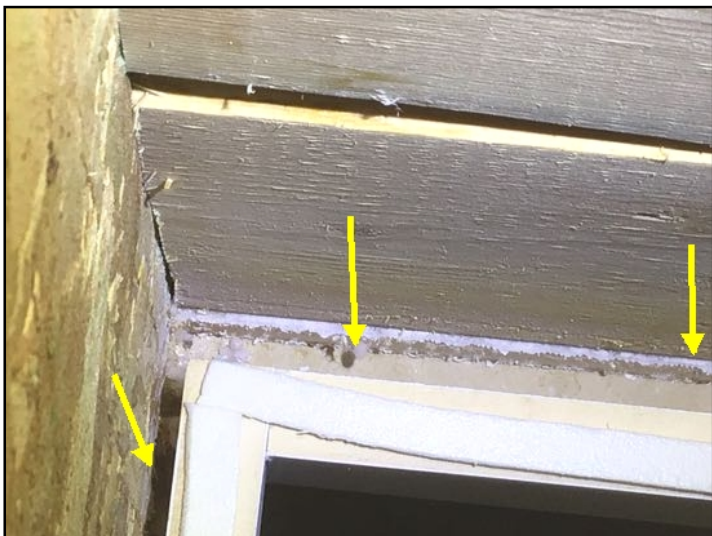
Recommend insulating gaps between hatch lip and curb to prevent heat loss and staining

Attic		
Page 90 Item: 4	Insulation Condition	• Add insulation to back of attic hatch to reduce heat loss
