The Restoration Story!

The Beginning!

In 2004, BVHD was contracted by the Town of Cochrane, Parks and Facilities Department to complete a "Long Term Master Plan for the Protection and Enhancement of Cochrane Streams". One of the recommendations in the report was that a small spring creek, later known as Millennium Creek, was a prime candidate for a major restoration program.

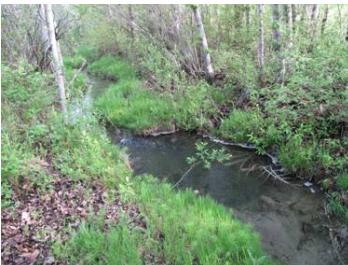
Above: This is a 2011 photo of one of the pool habitats in the spring of the year. By late summer, much of this pools surface area will be hidden by tall grasses and new willow growth.

A total of 19 pool habitats were created along the Millennium Creek during the three year fish habitat enhancement part of the program. In order to maintain there depth and create a self scouring effect, structures were built at the top end of each pool to create a minimal but effective hydraulic jump.

On a number of the pools, an engineered undercut bank with cover was also built into the design. The structures used to maintain the pool habitats were rock and log V-weirs, opposing rock deflectors and rock V-ledges or notches.

Most of the stream is very low gradient, yet the structures are maintaining excellent pool depths!

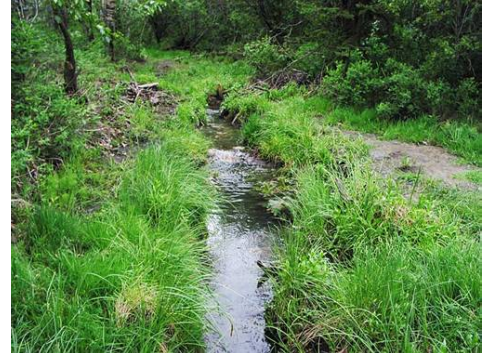
Above: This photo shows a length of stream channel, including a pool habitat as it looked like in 2007. Willows were planted along the stream bank that year.

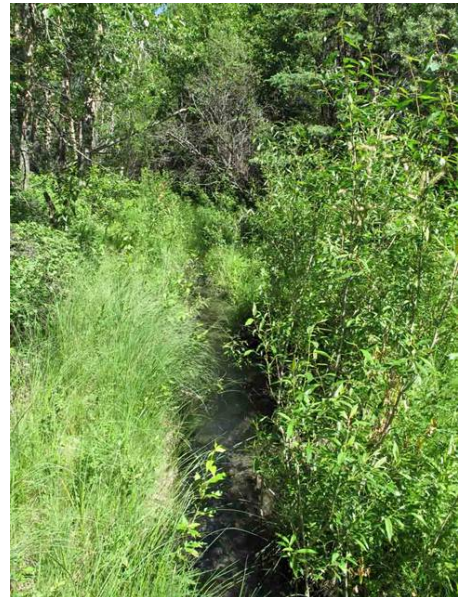
Right Photo: This is a 2011 photo of the same length of stream channel that was planted with willows in 2007. This photo also shows how natural looking the stream channel is after all of the fish habitat enhancement work that was completed on this section of creek!

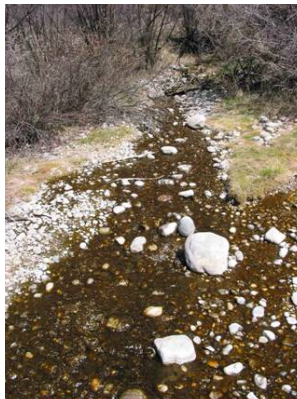
Above: This is a 2009 photo of the site chosen for the creation of a new spawning channel on Millennium Creek. Note the minimal flow!

There was a good location on the creek, for creating a more reliable spawning habitat for brook trout. The site was located on the primary spring pond that was responsible for the majority of the streams spring water.

At the spring pond there was an area where fresh spring water came out of the ground and traveled a short distance before it entered the primary spring pond on Millennium Creek. This section of stream channel would flow free of silt throughout the year and the flows were always constant!

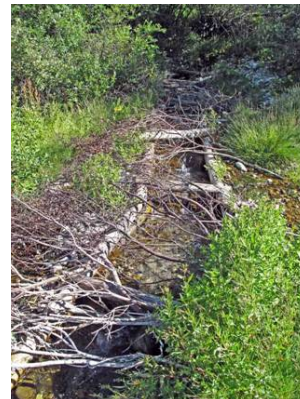
Above: This is a 2011 photo of the new spawning channel, ten months after its construction. Willow plants were placed along the edge of the log retainer walls and they will eventually hide most of the channel!

The project involved excavating a channel down into an existing gravel fan and installing log retainer walls to maintain the channel.

Additional spawning habitat was created in the new channel, along with some large boulder structures to maintain the desired depth and velocity of flow for brook trout spawning.
