## **SURVEY COMPLETED BY MR K BOX**

Survey contents: External Stair Survey inline with the Approved Document K Building Regulations 2010.

1 Victoria Mansions, Malvern Road, Cheltenham GL50 2JH

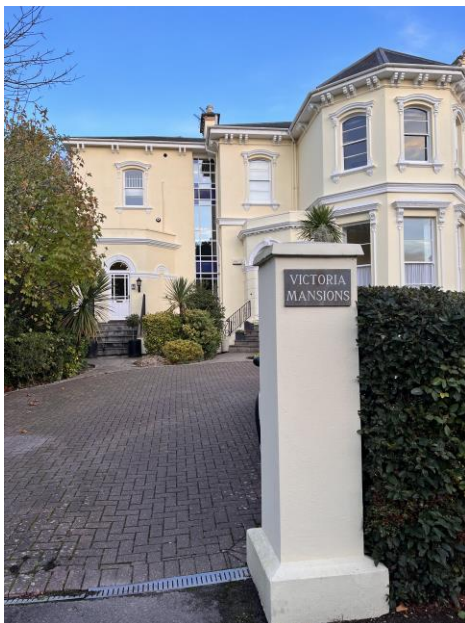
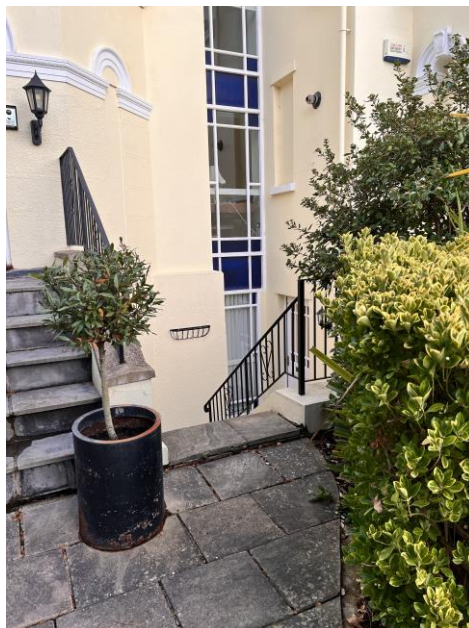
The pictures above highlights Health & Safety Hazards with respect to slips, trips, and falls. Notable observations are as follows.

- The trip hazard at the top of the stairs causing any person to slip, trip or fall down the stairs into an electrical cupboard door.
- Irregular rise and going of the steps presenting a hazard to personnel. In particular the final step down to the courtyard is considerably above the recommended rise height.
- On inspection of the staircase, the general condition of the perp joints is poor.

- The steps have no consistency as they are of different measurements for both the going and the rise causing a major issue when descending or ascending the stairs giving no natural flow to the stairs which in turn could cause a slip, trip, or fall.
- The general condition of the perp joints is poor and would need to be addressed as anymore damage to these joints will cause movement and cause more of an issue to an already dangerous set of stairs.
- It should be noted that due to the dimensional constraints of the stairs it is not possible to meet the 'rise and going' guidance contained in Table 1.1. It is however possible to reduce the risks to 'As Low as Reasonably Practicable' through the recommendations below.

1. Reduce/remove the trip hazard at the top of the stairs which presents a risk to personnel falling down the stairs and is a breach of the Building Regulations 2022.

- ii. In one or two instances there may be some reduction of steps required which can be developed during remediation of the steps.
  - iii. Note the final step down to the courtyard is considerably above the recommended rise height and should be rectified in the near term.

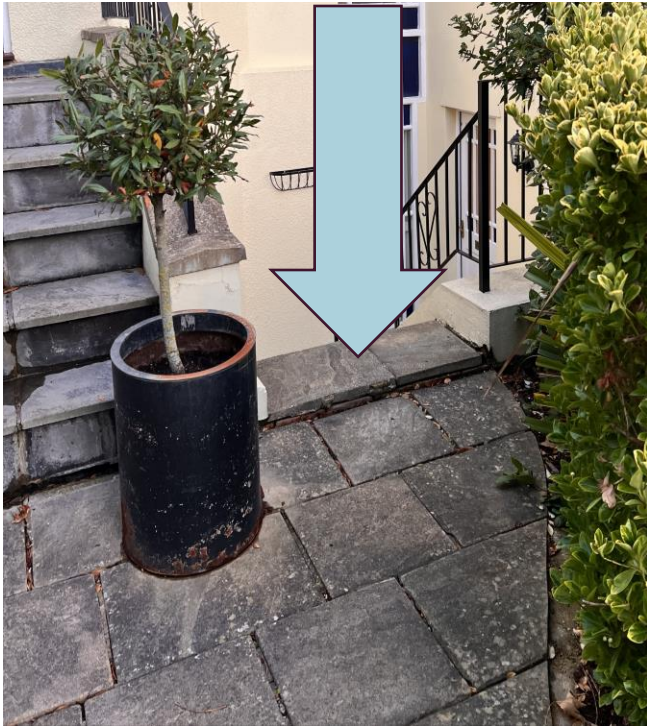
Step One:

Rise measurements

- Left = 68mm
- Middle = 72mm
- Right = 73mm

Going measurements

- Left = 445mm
- Middle = 445mm
- Right = 445mm

I measured the lip at 15mm and a total width of the step of 1065mm

- This is a “trip hazard” and will need to be a level access onto the stairs.
- A “trip” is caused by an obstacle of some kind causing you to stumble.
- The going is 445mm which is 145mm above the maximum shown in table 1.1 from the Approved Document K.

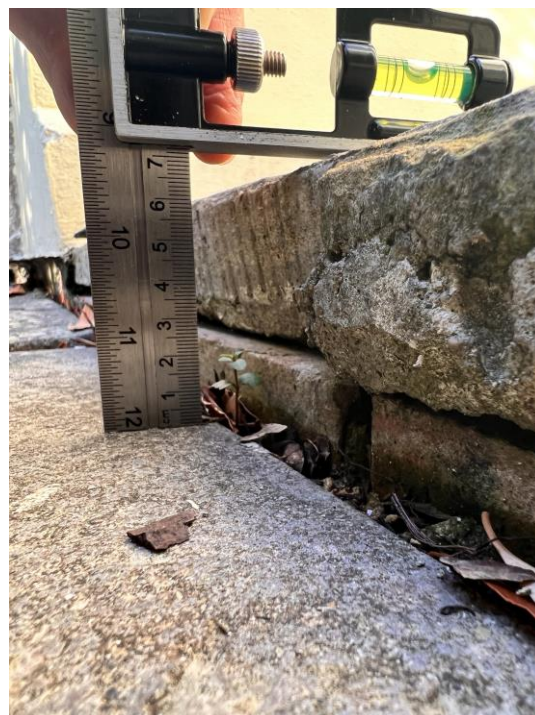
## Step Two:

### Rise measurements

- Left = 265mm
- Middle = 265mm
- Right = 265mm

### Going measurements

- Left = 340mm
- Middle = 340mm
- Right = 335mm

I measured the lip at 19mm with a 5mm fall out of level towards the base of the stairs. The total width of the step was measured at 1070mm

- The rise is 265mm which is 45mm above the maximum shown in table 1.1 from the Approved Document K.
- The going is 340mm which is 40mm above the maximum shown in table 1.1 from the Approved Document K.
- The overall width of the step is 1070mm with a lip measurement of 19mm.

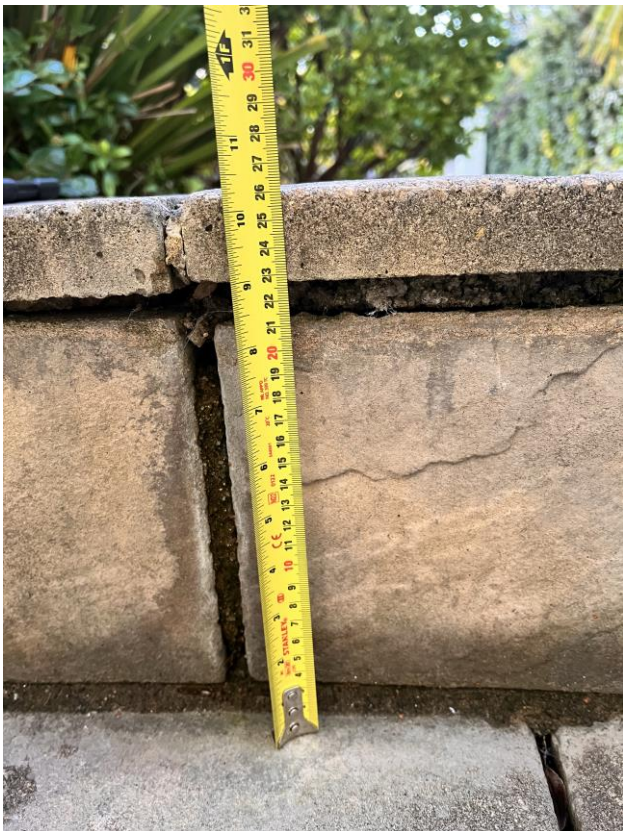
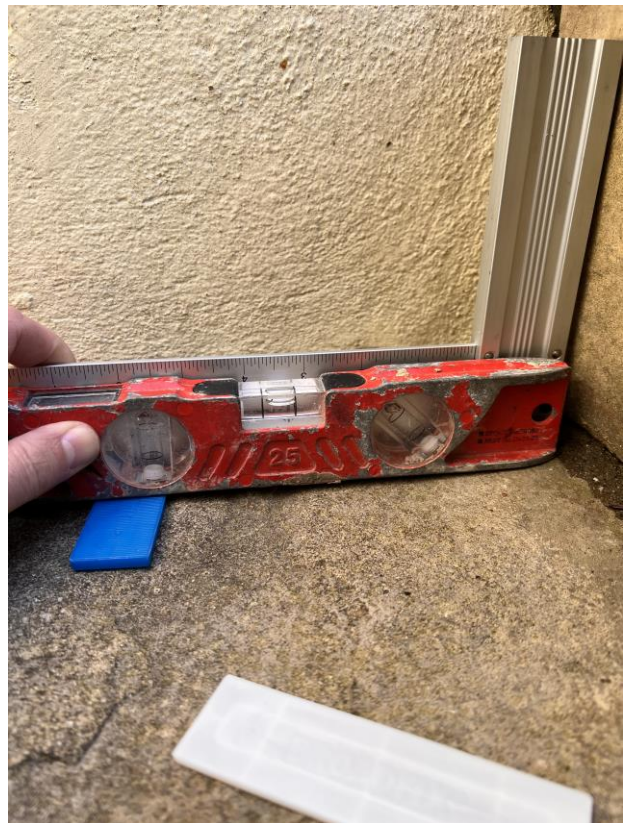
### Step Three:

#### Rise measurements

- Left = 215mm
- Middle = 215mm
- Right = 217mm

#### Going measurements

- Left = 310mm
- Middle = 310mm
- Right = 310mm

I measured the lip at 37mm with a 3mm fall out of level towards the base of the stairs. The total width of the step was measured at 1070mm.

- The rise is 215mm in the middle and right-hand side of the step is 5mm below the maximum shown in table 1.1 from the Approved Document K.
- The going is 310mm which is 10mm above the maximum shown in table 1.1 from the Approved Document K.
- The overall width of the step is 1065mm with a lip measurement of 37mm.

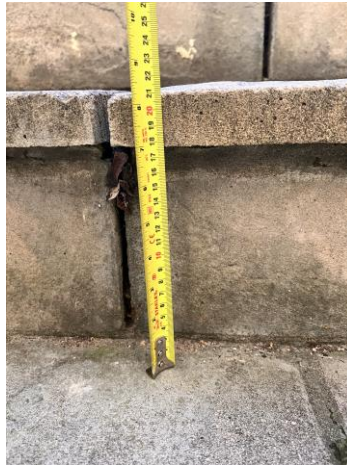
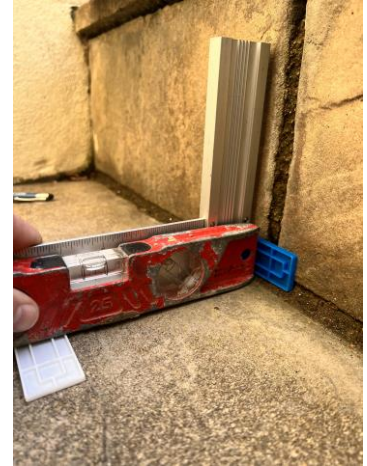
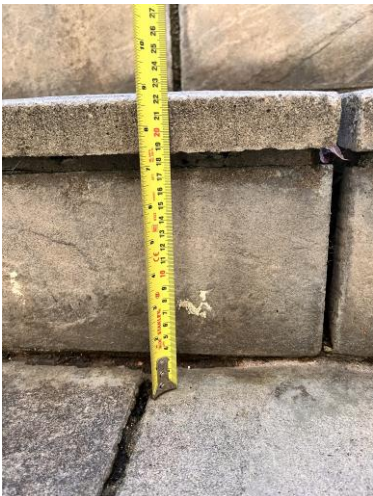
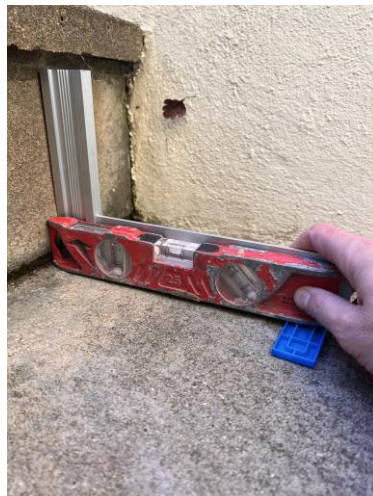
### Step Four:

#### Rise measurements

- Left = 220mm
- Middle = 225mm
- Right = 225mm

#### Going measurements

- Left = 320mm
- Middle = 320mm
- Right = 315mm

I measured the lip at 20mm with a 5mm fall out of level towards the base of the stairs. The total width of the step was measured at 1070mm

### Step Five:

- Left = 220mm
- Middle = 220mm
- Right = 220mm

- Left = 318mm
- Middle = 318mm
- Rise = 319mm

I measured the lip at 21mm

- The rise is 225mm which is 5mm above the maximum allowed shown in table 1.1 from the Approved Document K.
- The going is 320mm which is 30mm above the maximum allowed shown in table 1.1 from the Approved Document K.
- The overall width of the step is 1070mm with a lip measurement of 20mm.

- The rise is 220mm which is the maximum allowed shown in table 1.1 from the Approved Document K.
- The going is 318mm which is 18mm above the maximum allowed shown in table 1.1 from the Approved Document K.
- The overall width of the step is 1070mm with a lip measurement of 21mm.

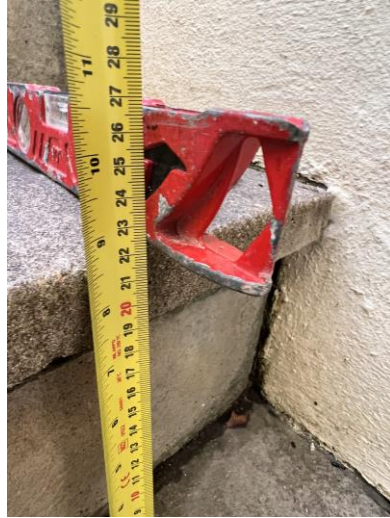
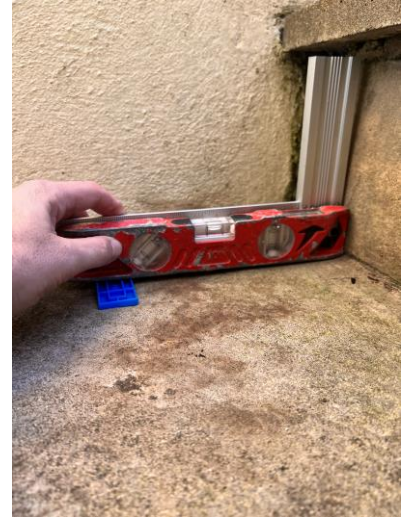
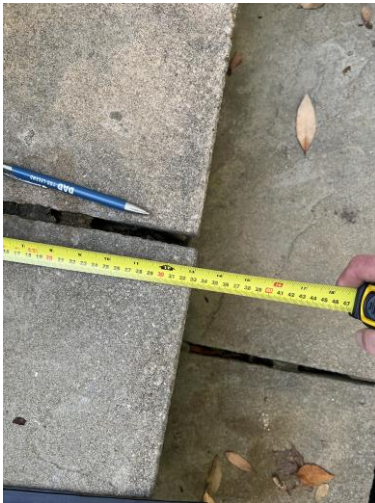
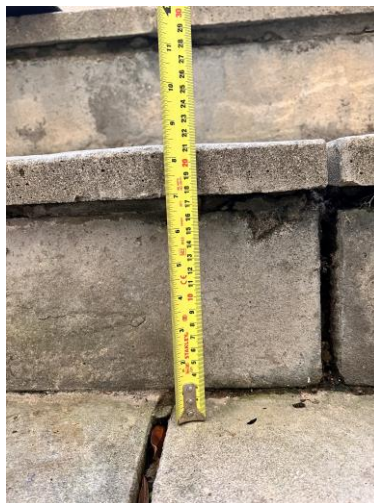
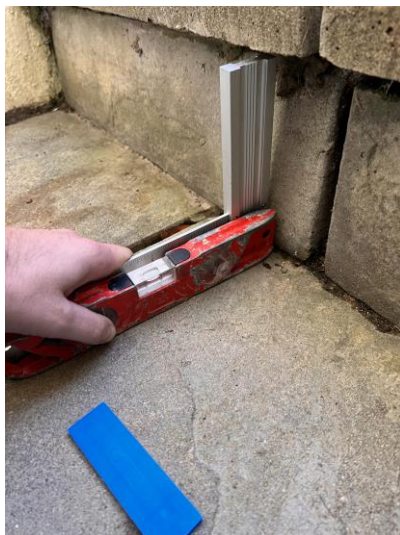
### Step Six:

#### Rise measurements

- Left = 210mm
- Middle = 215mm
- Right = 215mm

#### Going measurements

- Left = 325mm
- Middle = 330mm
- Right = 330mm

I measured the lip at 29mm with a 3mm fall out of level towards the base of the stairs. The total width of the step was measured at 1070mm.

### Step Seven:

- Left = 215mm
- Middle = 215mm
- Right = 215mm

- Left = 325mm
- Middle = 320mm
- Right = 325mm

I measured the lip at 35mm with a 3mm fall out of level towards the base of the stairs. The total width of the step was measured at 1070mm.

- The rise is 210mm which is 10mm above the maximum allowed shown in table 1.1 from the Approved Document K.
- The going is 330mm which is 30mm above the maximum allowed shown in table 1.1 from the Approved Document K.
- The overall width of the step is 1070mm with a lip measurement of 29mm.

- The rise is 220mm which is the maximum shown in table 1.1 from the Approved Document K.
- The going is 330mm which is 30mm above the maximum allowed shown in table 1.1 from the Approved Document K.
- The overall width of the step is 1085mm with a lip measurement of 35mm.

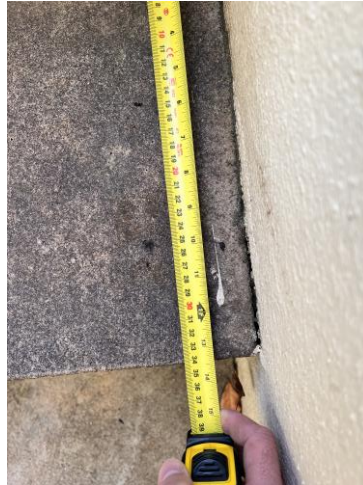
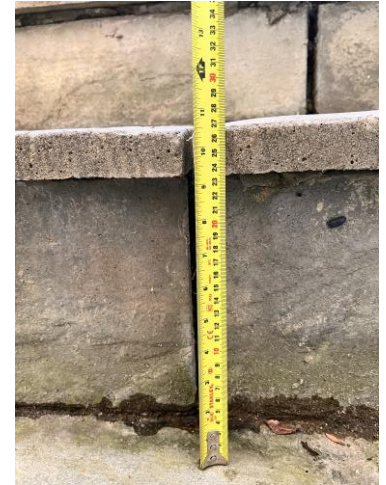
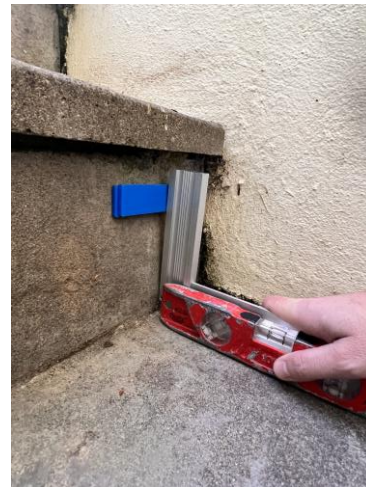
### Step eight into courtyard:

#### Rise Measurement

- Left = 275mm
- Middle = 275mm
- Right = 275mm

- The rise is 275mm which is 75mm above the maximum allowed shown in table 1.1 from the Approved Document K.
- The overall width of the step is 1070mm.

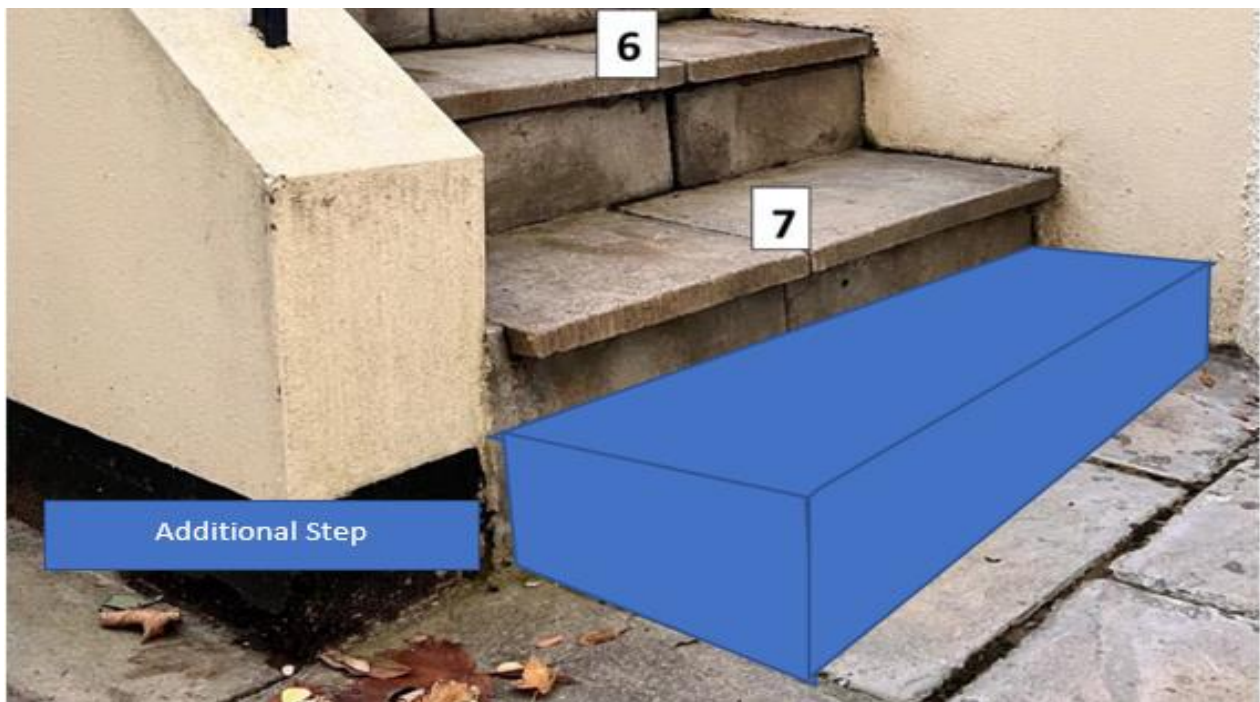
2. 'Even up' the 'rise' through the addition of a lower 'step as indicated in the sketch below.
  - i. This is considered the lowest cost solution as the additional step will allow resetting of the steps above which can be achieved by overlaying slabs against the existing steps.

- iv. The additional step can be positioned without interference to the electric cupboard as it open outwards and will need access at all times.
3. Include a second handrail to the other side of the stairs.
