TEST REPORT

Clients Mark	Brick Slip/Steel Panel	Date Received	28.06.00
Your Reference	N/A	Date Tested	13.07.00 to 04.08.00
Lab Reference	SW190a/00; W3286	Date Issued	16.02.11

DETERMINATION OF FREEZE/THAW RESISTANCE OF CLAY MASONRY UNITS

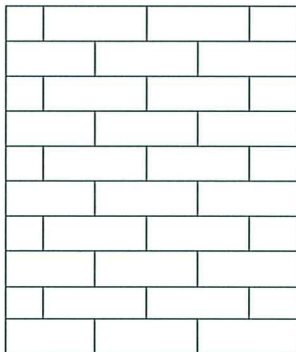
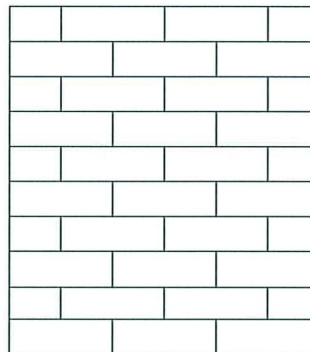
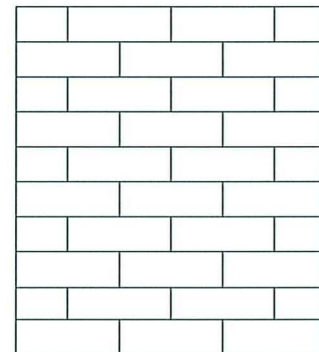
INCIDENCE OF DAMAGE

After 10 cycles

After 50 cycles

After 100 Cycles

Total No. of Damaged Bricks = 0

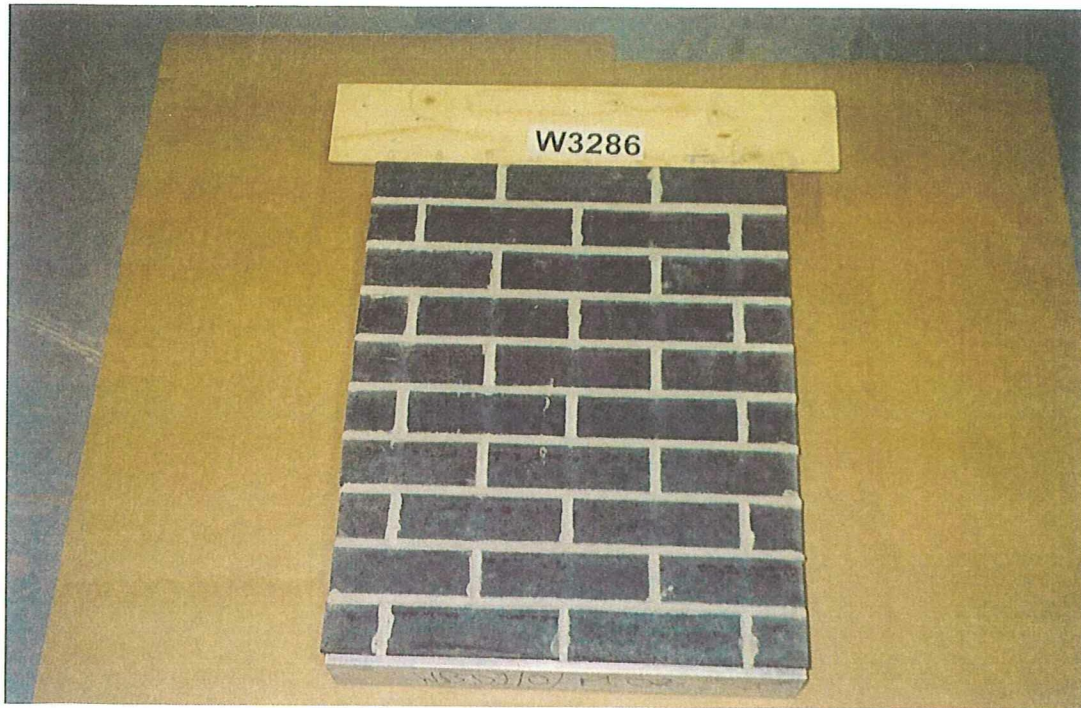
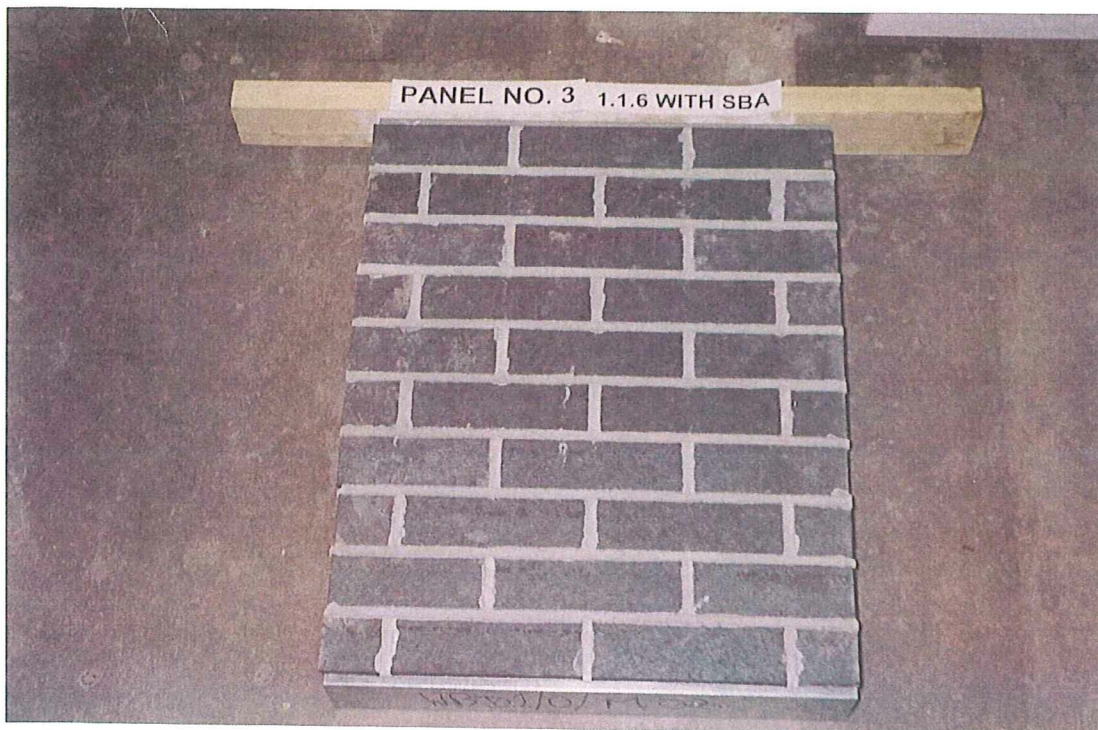
Figure 1.

The panel was examined after 10 freeze/thaw cycles and was removed and thawed after 50 cycles for a more thorough examination before restarting the test. At the end of 100 cycles the panel was again removed, thawed, photographed (Fig 1) and then examined slip by slip for signs of frost damaged as categorised in Table 1. The results of the assessment are displayed in section 2.6. Additionally, all mortar joints were examined for any signs of frost damage, such as flaking or cracking.

The complete panel withstood 100 freeze/thaw cycles as specified with no evidence of frost damage to either the brick slips or the mortar joints.
