Date: August 28, 2023

To: Alex Rabidoux
Solano County Water Agency

Regarding: Putah Creek Accord - Unjustified Claims (Jacinto Ecological Applications article)

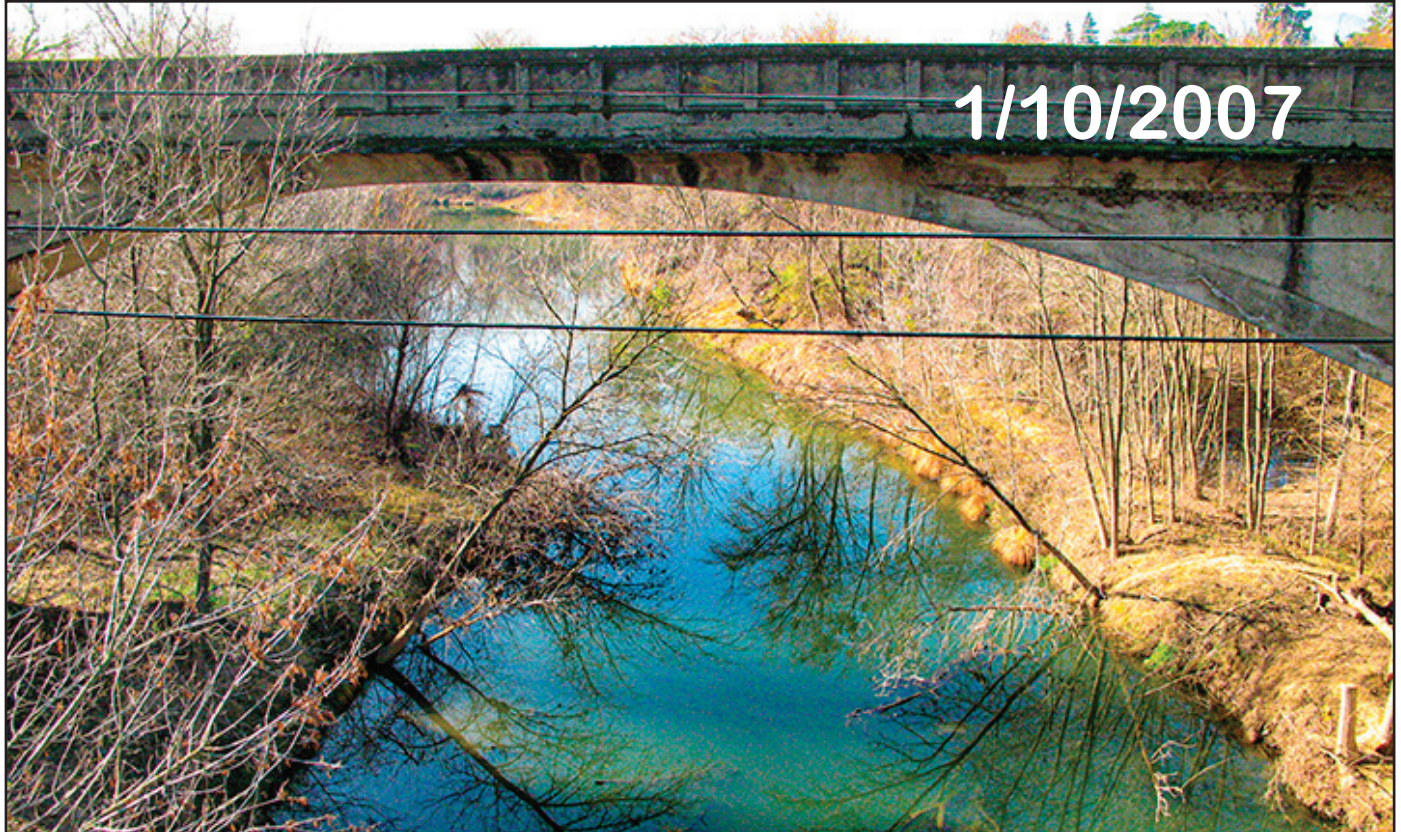
Winters Car Bridge: 1/10/2007: Image from the Winters bike bridge facing upstream with the original Winters car bridge in the image. This is an example of the “Accord” water flowing through an area that is distinctly poor habitat for salmonids and aquatic biota. Ken W. Davis image

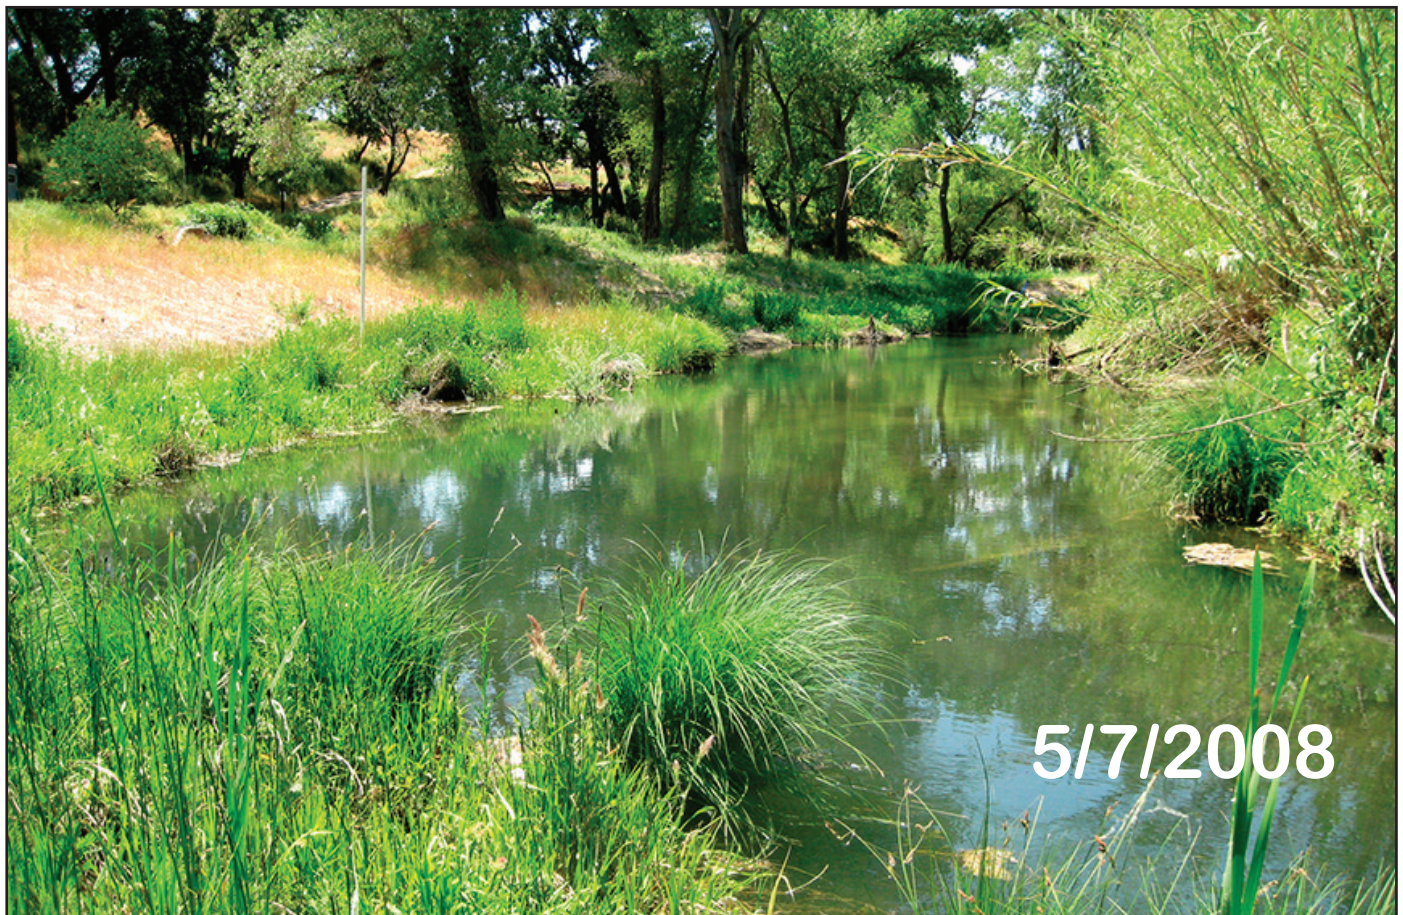
Accord Water in 2008

5/7/2008: Pickerel Section prior to the construction of a W-Weir in 2009. This is very close to the Putah Diversion Dam the upstream source of “Accord Water” which had very little effect on the biota prior to the construction of the Pickerel weir, the NAWCA 2 project, and scarification actions at this site that improved flow regime. Ken W. Davis file image.

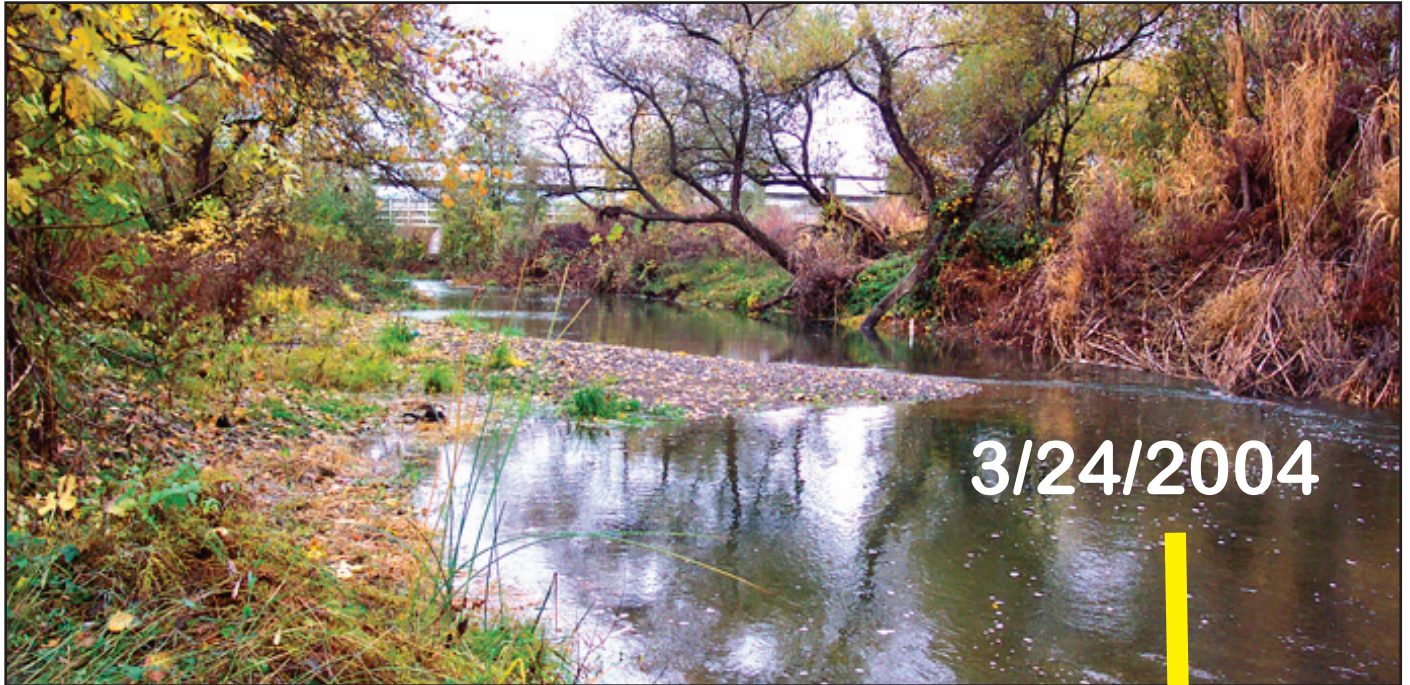
Pickrel Weir: Constructed in 2009

3/24/2004: View of Putah Diversion Dam from the site of the Pickrel Weir before construction of the weir. Ken W. Davis image

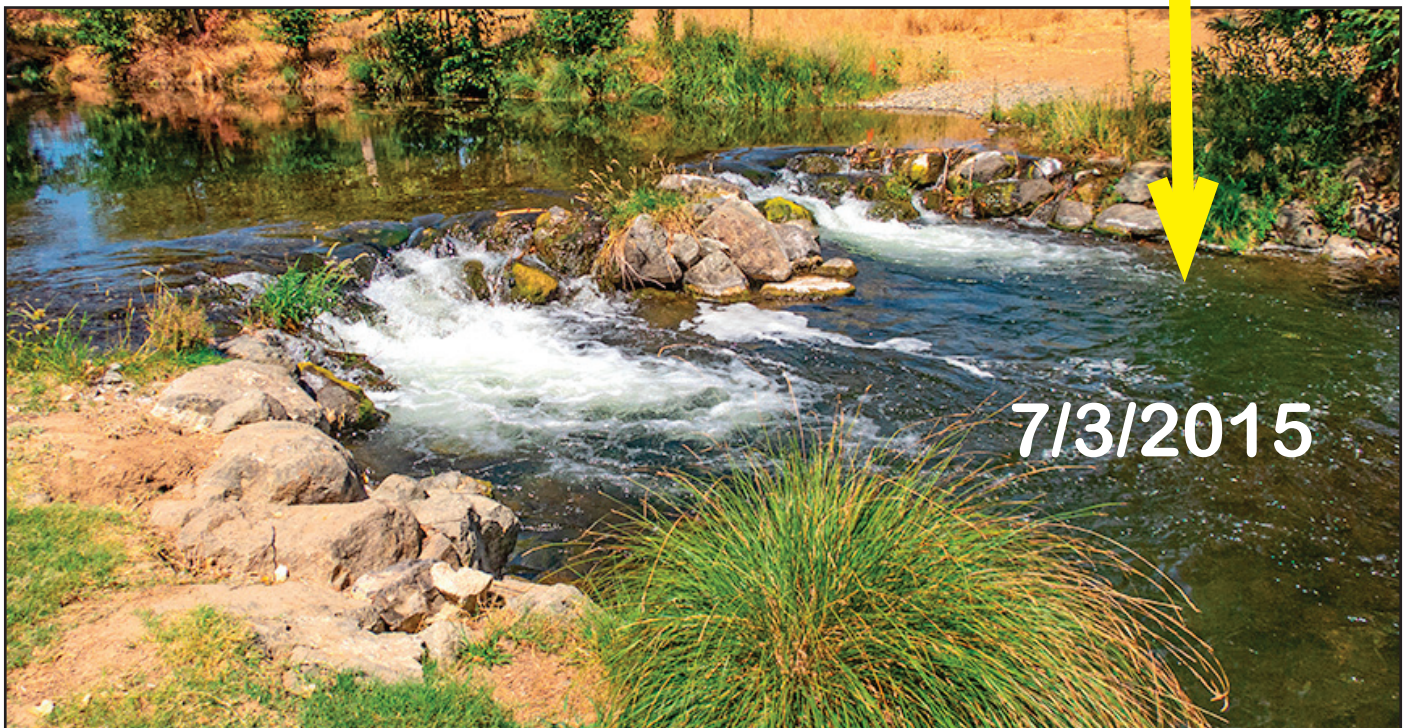
Image taken 7/3/2015: The Pickrel Weir was constructed in 2009. The natural scour just below the weir created a situation similar to mechanical scarification that has proven beneficial for salmon spawning. Information suggests that several salmon spawned in the small section in 2012 amid a sediment-laden waterway. They were undetected. The following spring, thousands of juvenile salmon were found 75 feet downstream (and much further) from the weir on May 1, 2013. I have also documented that the weir had a very positive effect on benthic macroinvertebrates. Ken W. Davis image

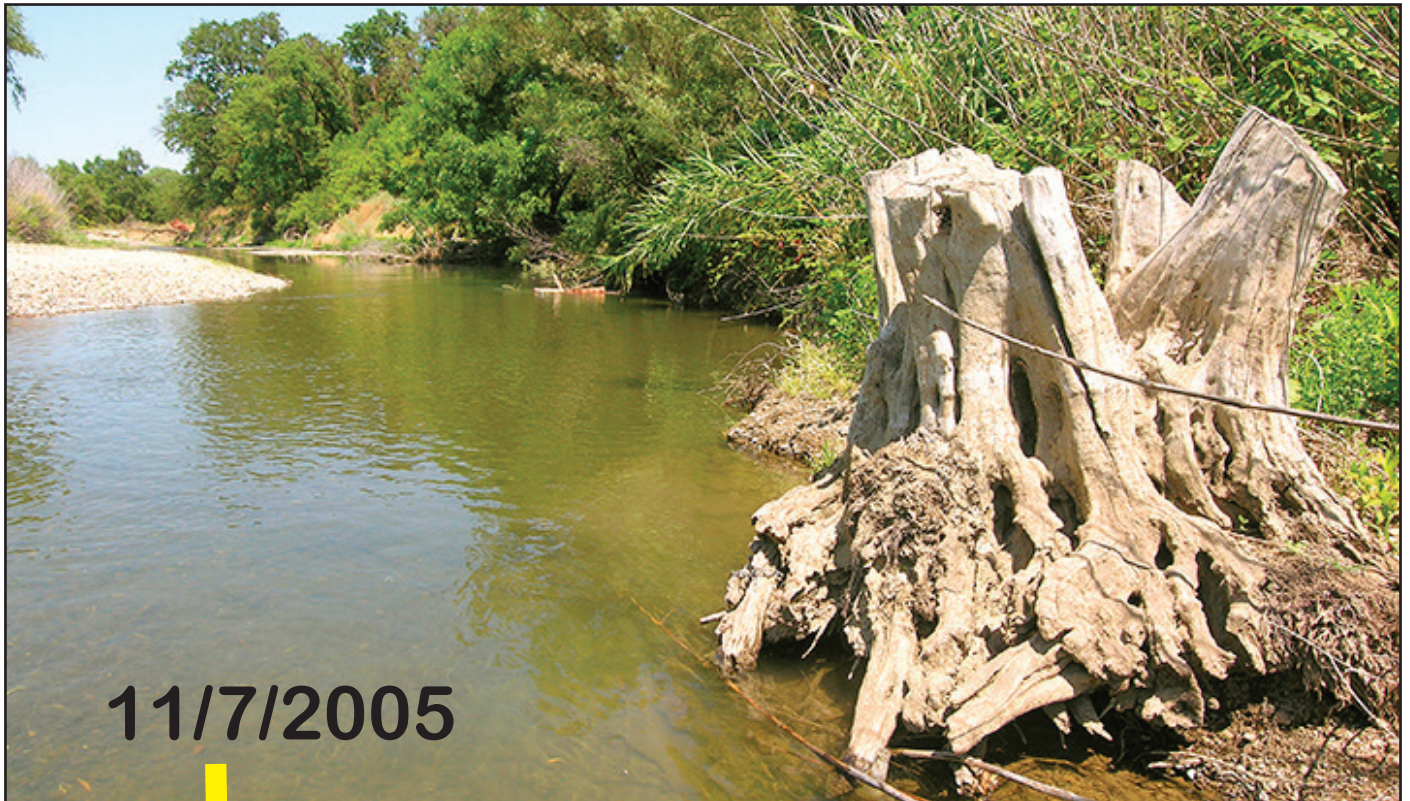
Dry Creek Realignment: 2006:

Bertinoia reach: Image from 2005 prior to the creek realignment away from Putah Creek Road. This is Putah Creek Accord water flowing through very poor habitat. Water alone did not facilitate salmon spawning. Ken W. Davis image

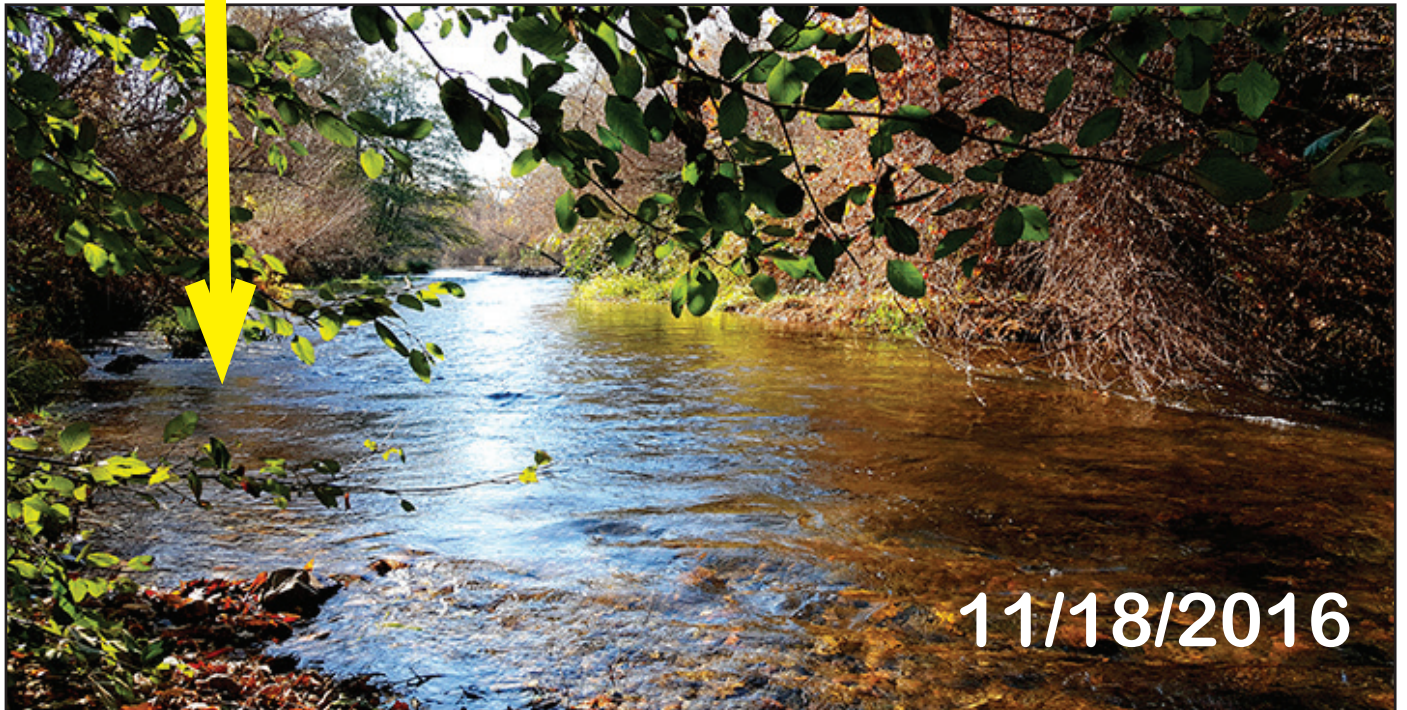
Bertinoia reach in 2016: Section after the reach was realigned and scarified. Salmon have routinely spawned in this section on an annual basis since 2014. Reducing embedded cobble has increased the macroinvertebrate community density and diversity. Ken W. Davis image

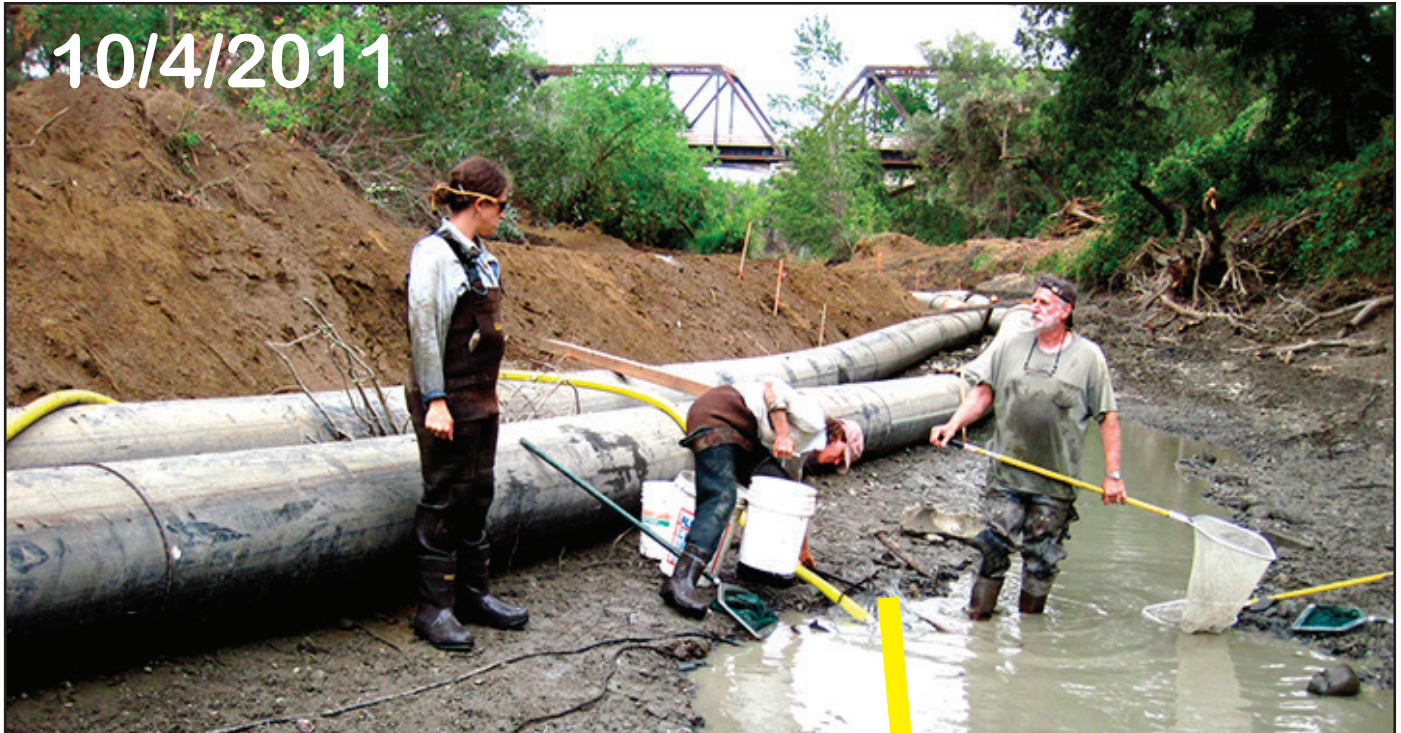
Winters Putah Creek Park: 2011

Winters Putah Creek Parkway on 10/4/2011: The images show part of the organized formal fish rescue just downstream of the Winters Bike Bridge. The “ditch” that was constructed in Phase One has remained a ditch until this day. Enhancement remains necessary. Ken W. Davis image.

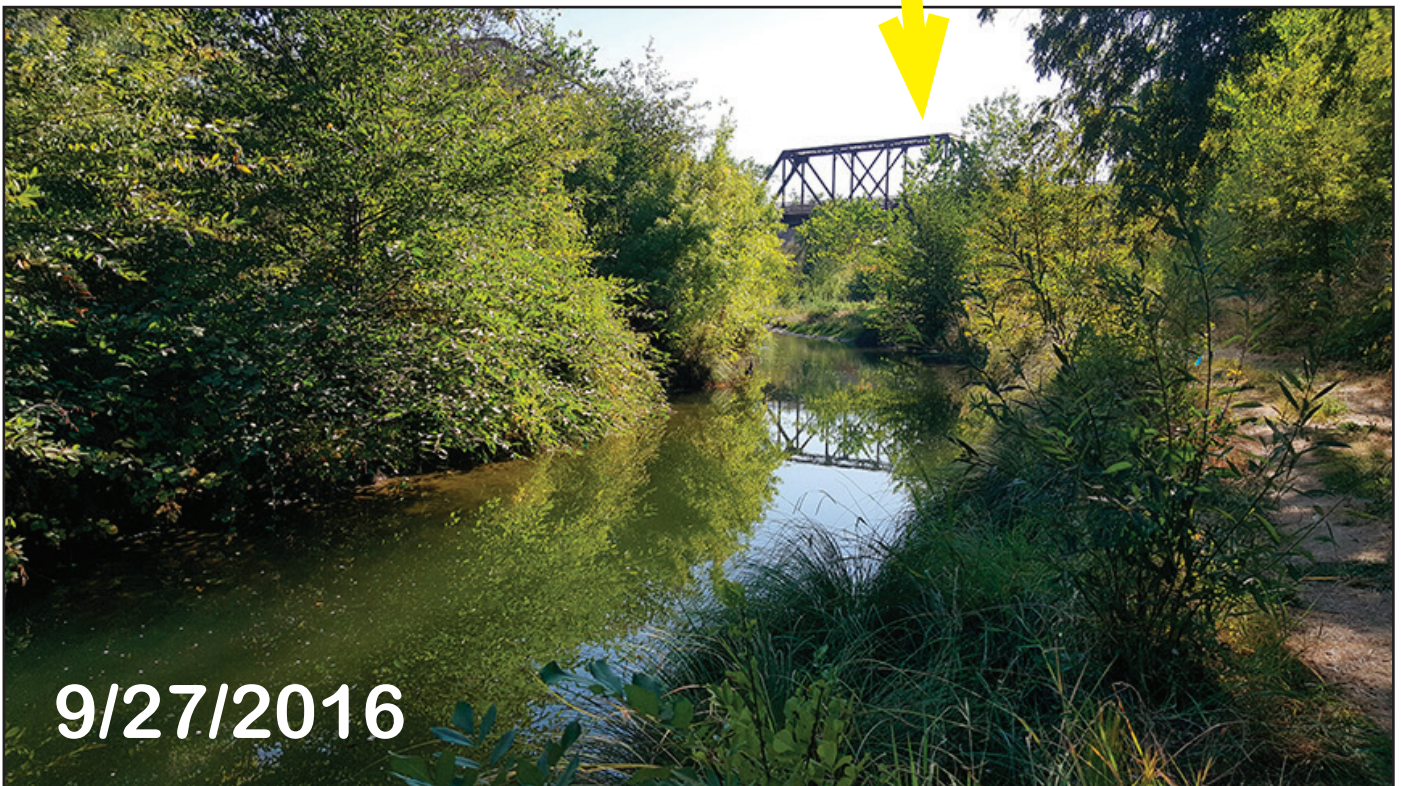
Winters Parkway in 2016: Phase One remains unavailable for salmon spawning due to the width and depth of the creek and lack of benthic structure. Accord water cannot make a difference when the waterway remains marginal despite great intensions. Ken W. Davis image

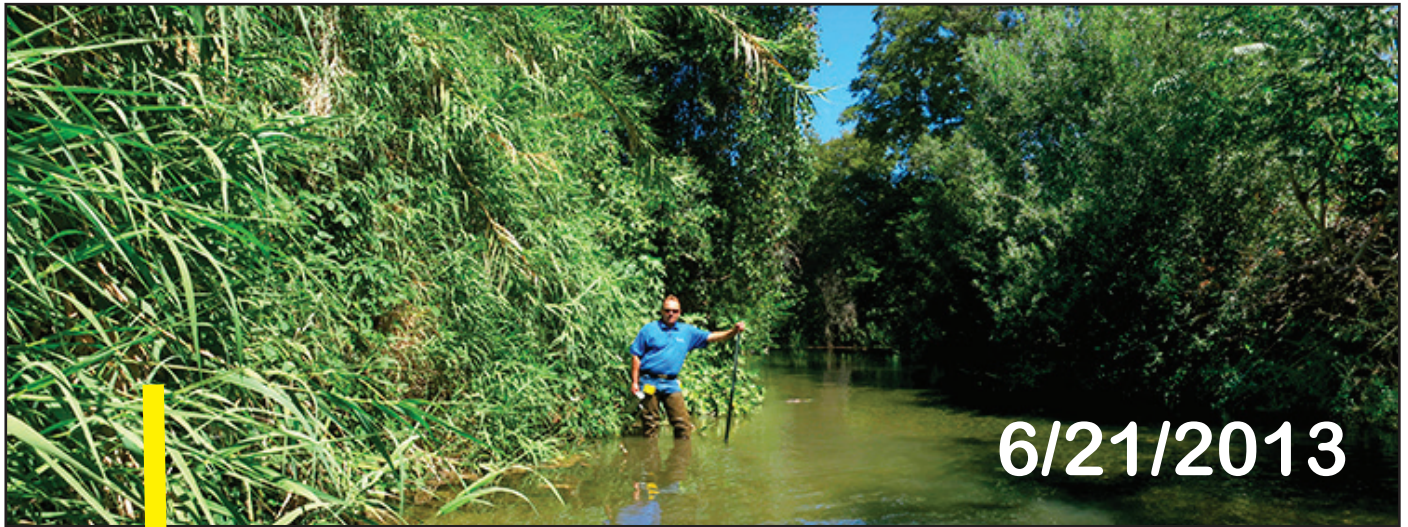
North American Wetland Conservation Act Project: July 1, 2013

Image June 2013: Rick Fowler in the Morales section prior to the NAWCA 2 Project. Another example of “Accord Water” flowing through an area of very poor habitat. The section was inundated with Arundo and blackberries before the bank on the right (south) side of the creek was lowered. See images below.
Ken W. Davis images

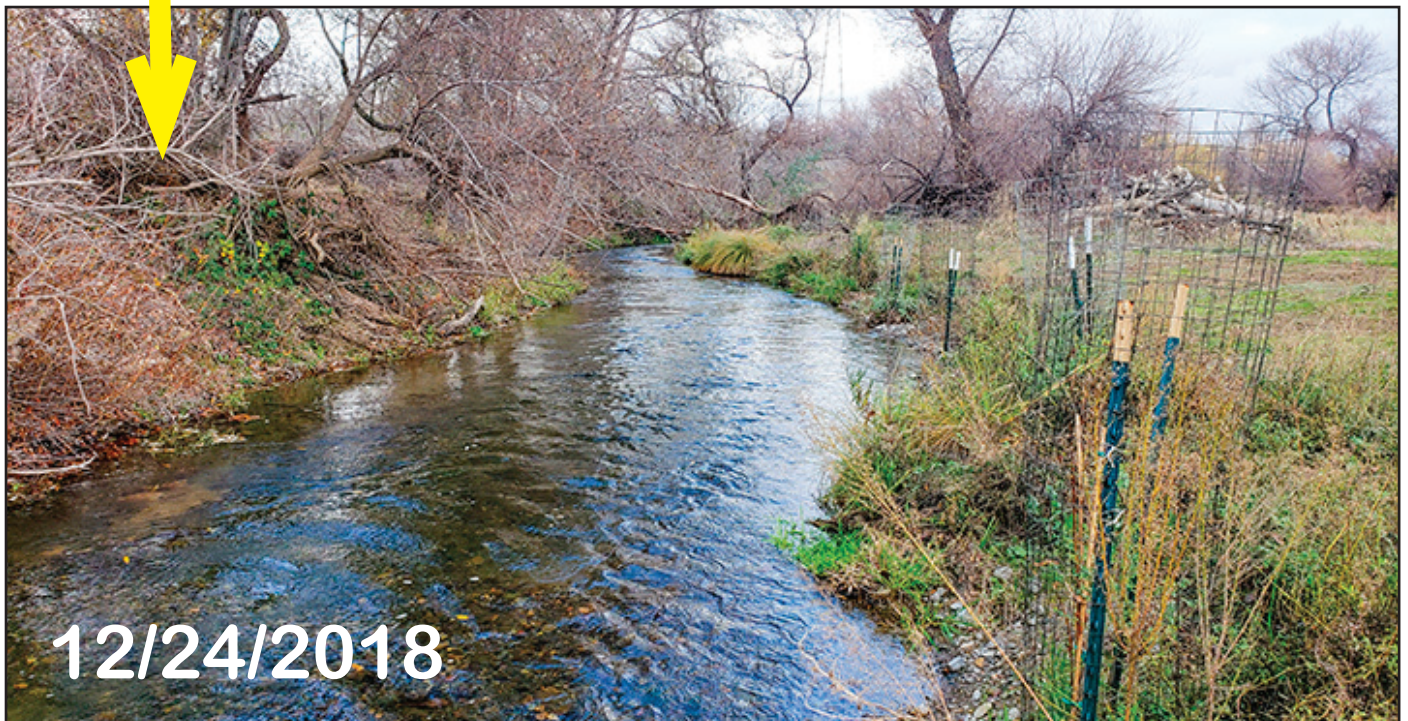
Morales Scarification Project Site on 12/24/2018: Image close to the same site as the image above by using GPS data to locate the site. This is after NAWCA 2 restoration with a flood plain on the right. It has been a very active salmon spawning area after NAWCA 2 and scarification. This is another example of the Accord Water before and after significant restoration actions. Note, this restoration cannot be considered reconciliation ecology as suggested in the article. I find it difficult to claim that the Accord was solely responsible for the some of the claims in the Jacinto article. We need the water flow, but acknowledging specific restoration actions is paramount to accurately and professionally reporting success.
Ken W. Davis image.

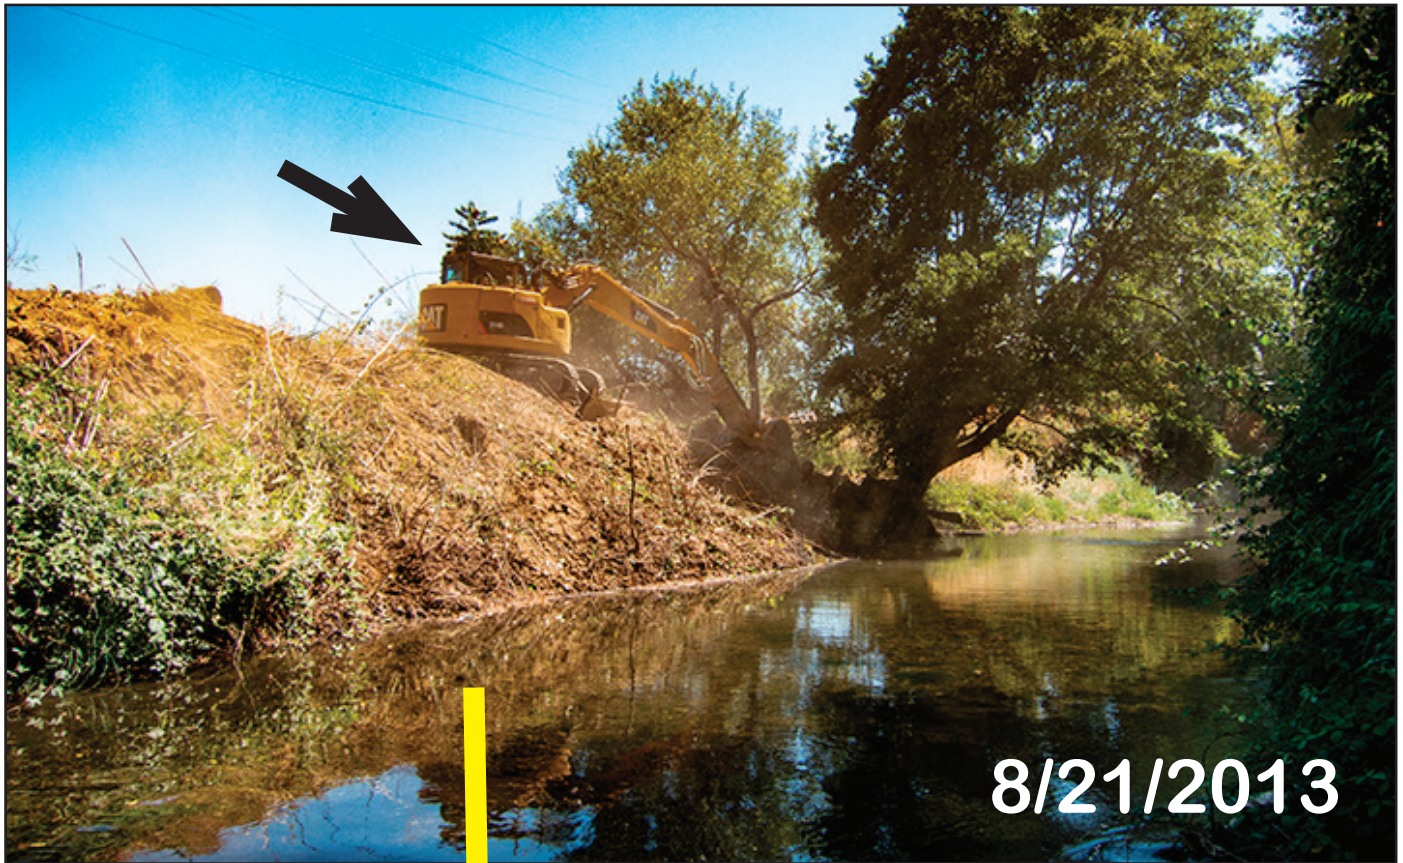
North American Wetland Conservation Act Project: July 1, 2013

Image August 21, 2013: Shows excavator working to lower the south bank of Lower Putah Creek to create a functional flood plain. This section did not have appropriate spawning areas prior to the NAWCA 2 project and scarification. Ken W. Davis image.

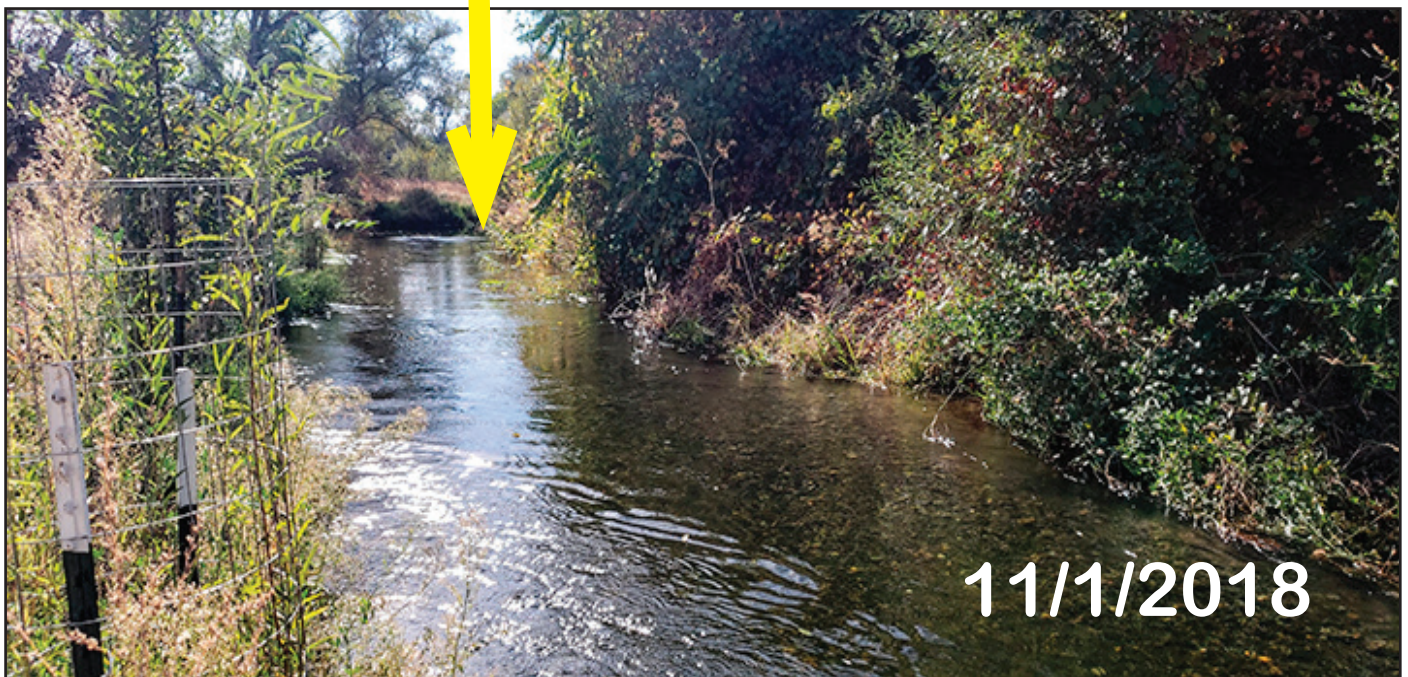
Image November 1, 2018: The Morales section after scarification and riparian planting. Salmon have spawned in this section every year since 2014 post scarification. Ken W. Davis images

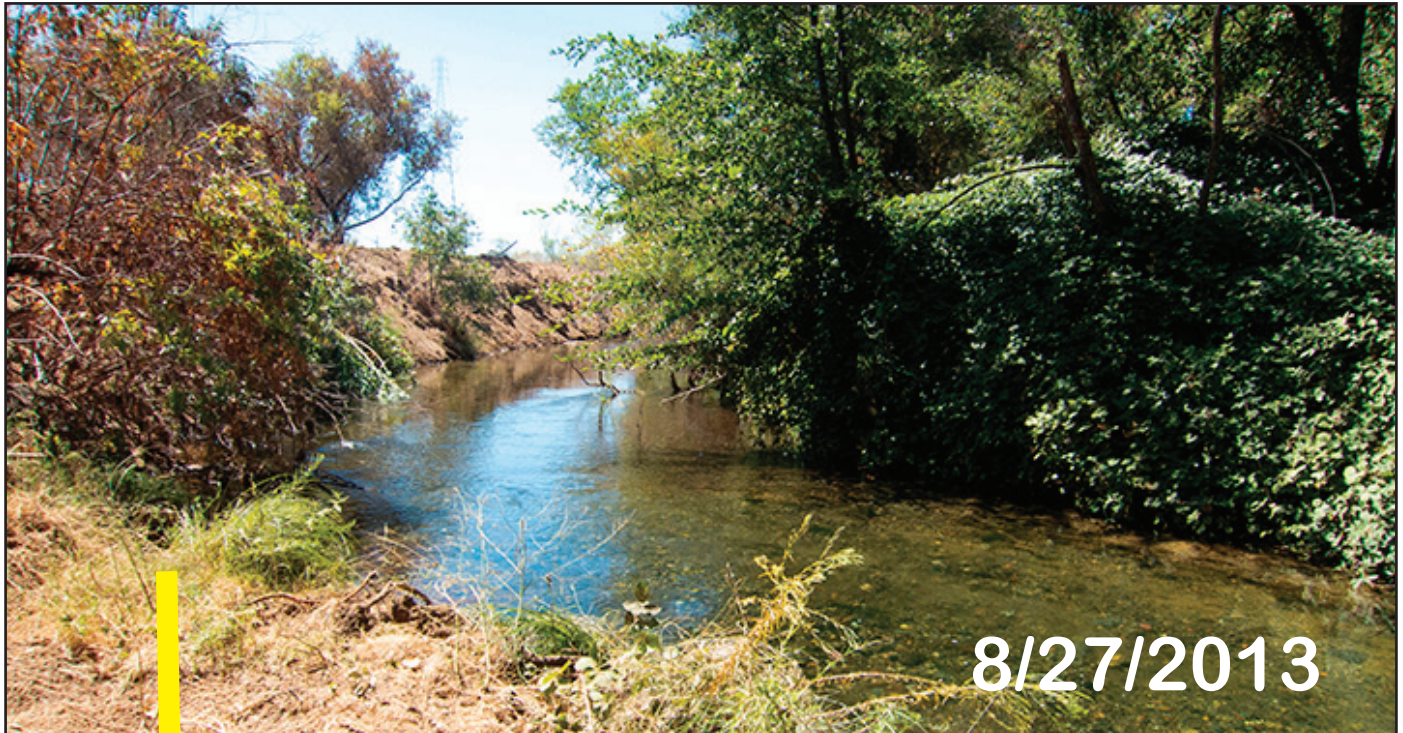
Scarification Project: 2014

Lower Putah Creek - Morales Section: Image shows the creek **DURING** the NAWCA 2 Project. Note the bare dirt on the upper left of the picture. The slope was eventually lowered to facilitate flood plain conditions. Ken W. Davis image

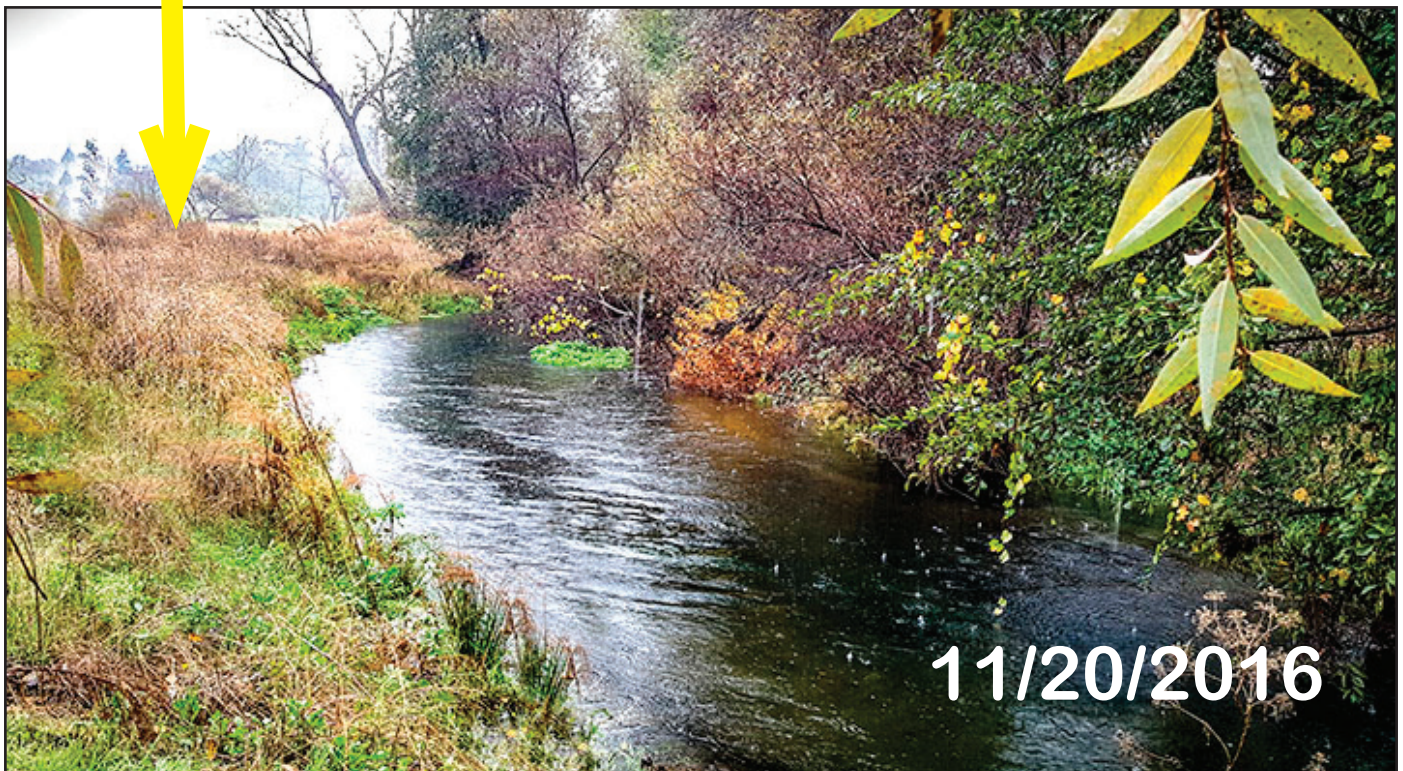
Morales section: Shows LPC after NAWCA 2 Project and scarification. The image is close to the exact site shown in the image above. Ken W. Davis image

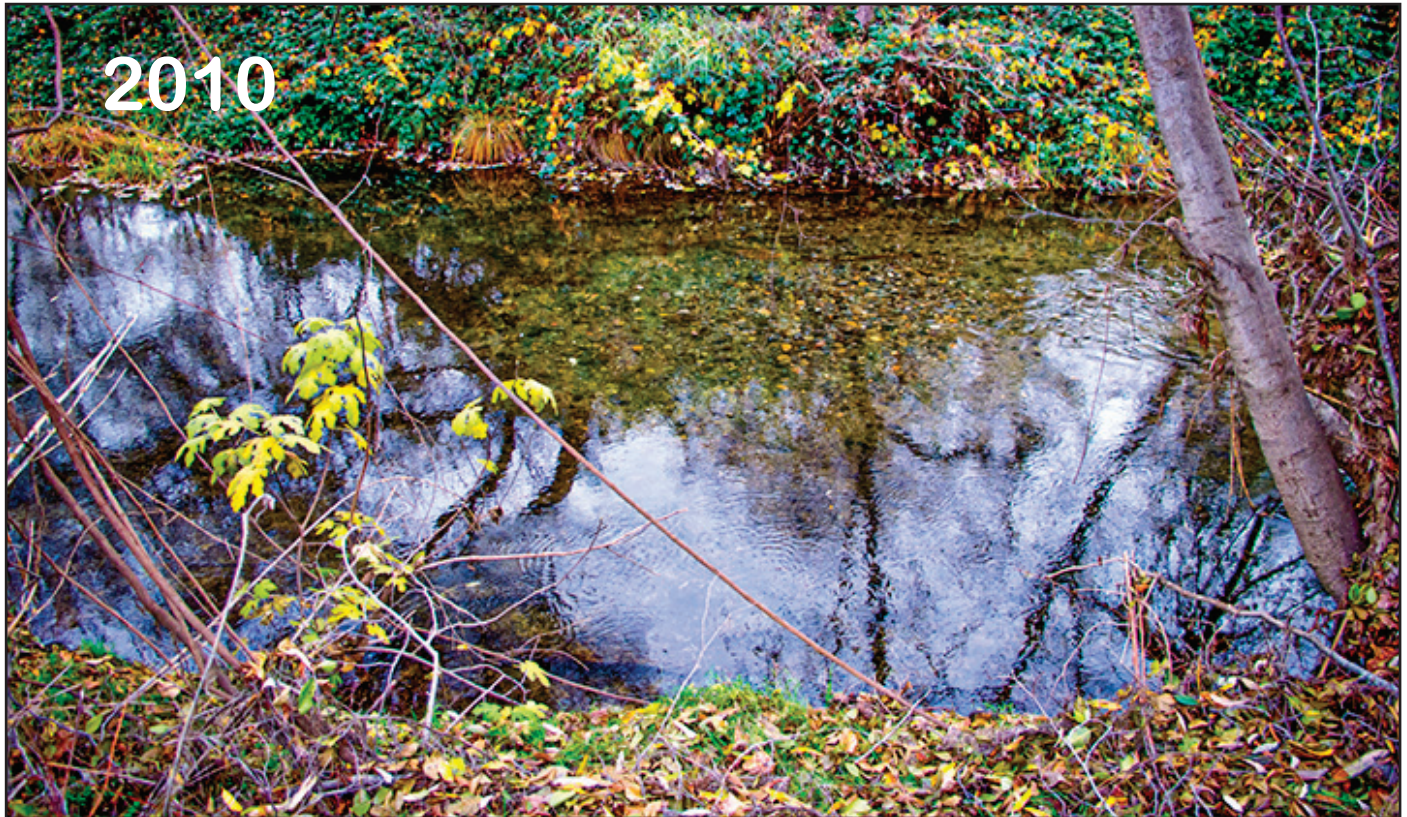
Morales section: Shows a salmon redd photographed in 2010 in the Morales scarification section. This is the ONLY salmon redd I found in the 2010 spawning period. Note the redd is very wide and shallow, typical of salmon redds in Lower Putah Creek prior to the scarification project. Scarification facilitates female salmon to dig deeper and construct “healthier” redds if the appropriate gravel is available. Ken W. Davis image

In December 2004, I watched a couple of Chinook salmon attempt to spawn in a section near Yolo Housing. The benthic condition was inappropriate and there was nothing in the area that was suitable spawning substrate. Many salmon eggs tumbled downstream, over embedded gravel and claypan and eventually ended up in my invertebrate net. A similar event happened (2010) in the Morales section when I watched a female salmon dig a redd in a heavily embedded section. Her redd was close to 15 feet wide and maybe 4-5 inches deep (Image above). While I’m certain that a few eggs survived it certainly was not a healthy redd in an area

that desperately needed appropriately-sized gravel and other benthic structure. Because of the width and depth of the site, the flow was very slow and did not facilitate a condition that would protect salmon eggs and alevin. The Accord water would have benefited the salmon if the site had appropriate width, depth, and benthic conditions. Severely embedded gravel is not a healthy benthic condition.
