New York Data Collection - Final

Investigation of data points along the Hudson River, Wappingers Falls, Highland Falls Township, New Windsor Township, Newburgh Township, Harlem River and the Palisades Neighborhood.

January 12, 2023

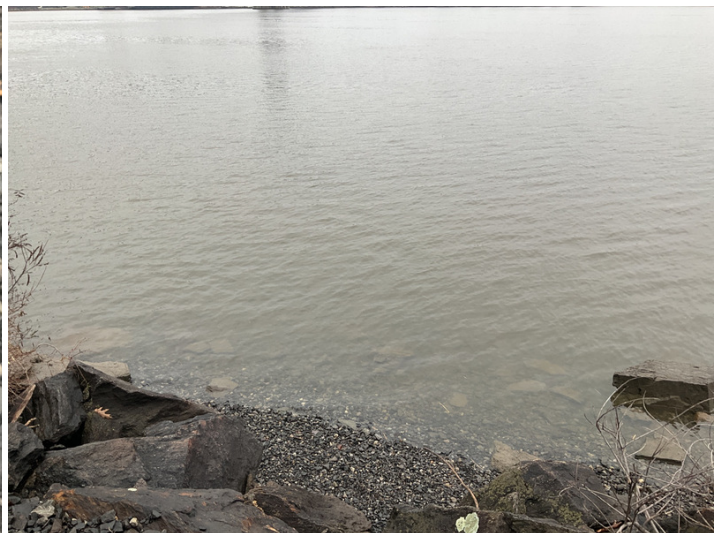
Photo of Water Control, Intake, or Drinking Fountain Sample(s)

Location of Collected Water Control, Intake or Drinking Fountain Sample	Surface Sample
Time of Collection - Water Control, Intake, or Drinking Fountain	10:08
Sample Prefix - Water Control, Intake, or Drinking Fountain	Hudson
Sample ID (#) - Water Control, Intake, or Drinking Fountain	5
Additional Notes - Water Control, Intake, or Drinking Fountain Sample (if any)	None.

General Site Notes | Control Water for Site 3.

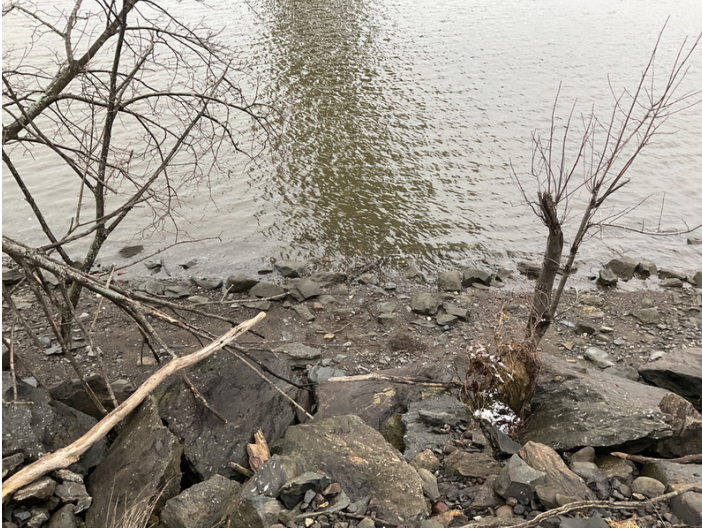
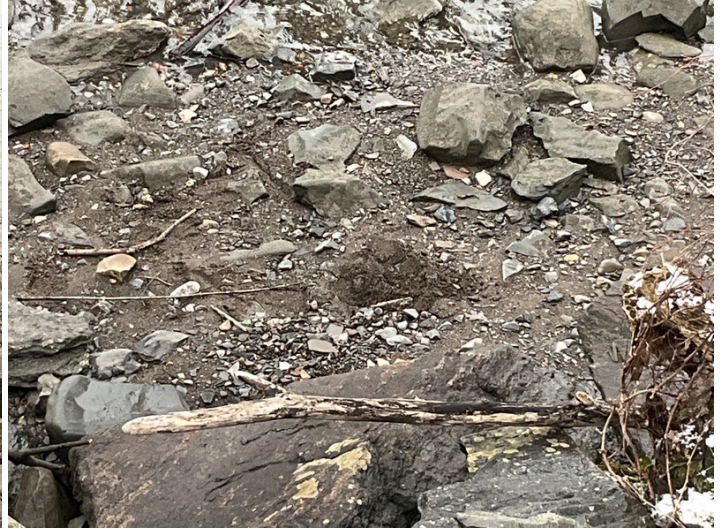
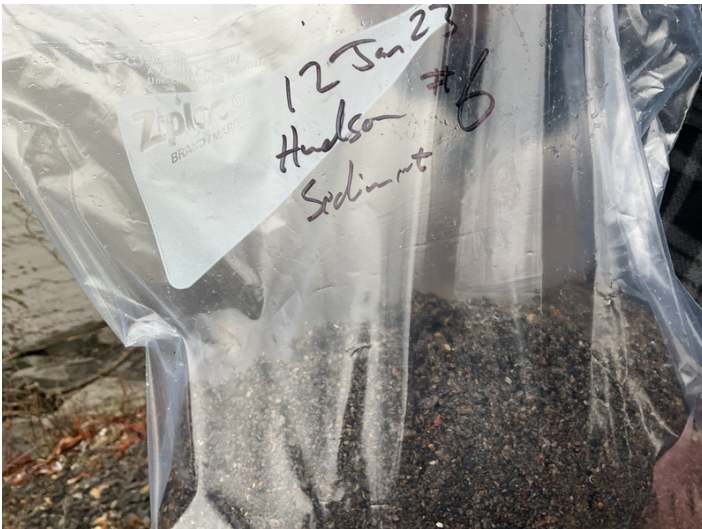
Photo of GS Sample(s)

Location of Collected Sample - GS	Control Location
Time of Collection - GS	10:16
Sample Prefix - GS	Hudson
Sample ID (#) - GS	6
Additional Notes - GS (if any)	None.

General Site Notes	Control Sediment for Site 3.
---------------------------	------------------------------

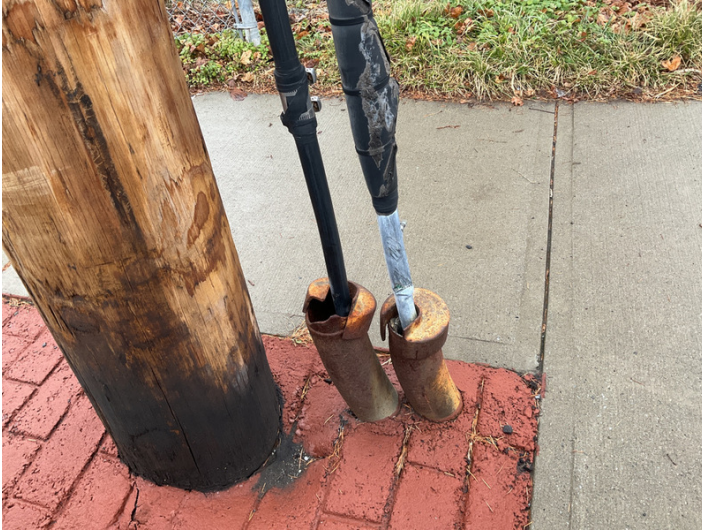
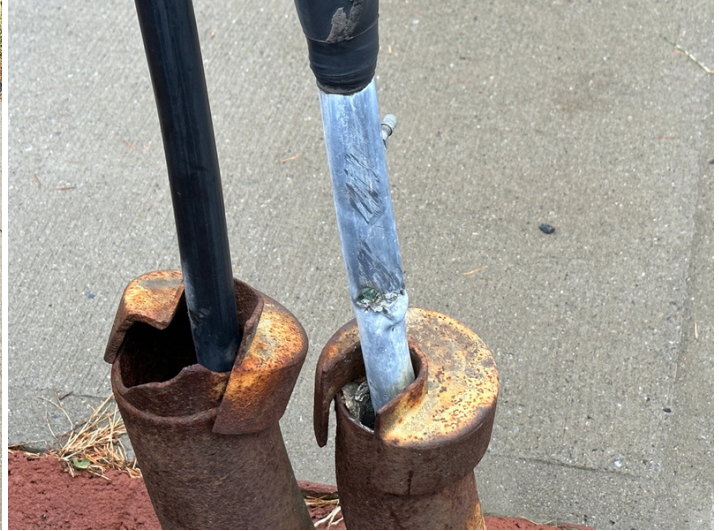
Photo of GS Sample(s)

Type of Sample for GS	Lead Scraping
Location of Collected Sample - GS	Cable
Time of Collection - GS	11:15
Sample Prefix - GS	Wappingers Falls
Sample ID (#) - GS	3
Additional Notes - GS (if any)	No notes related to the field. Sample was originally sent to the lab 12 January 2023. It was returned from the lab and resent 25 January 2023.

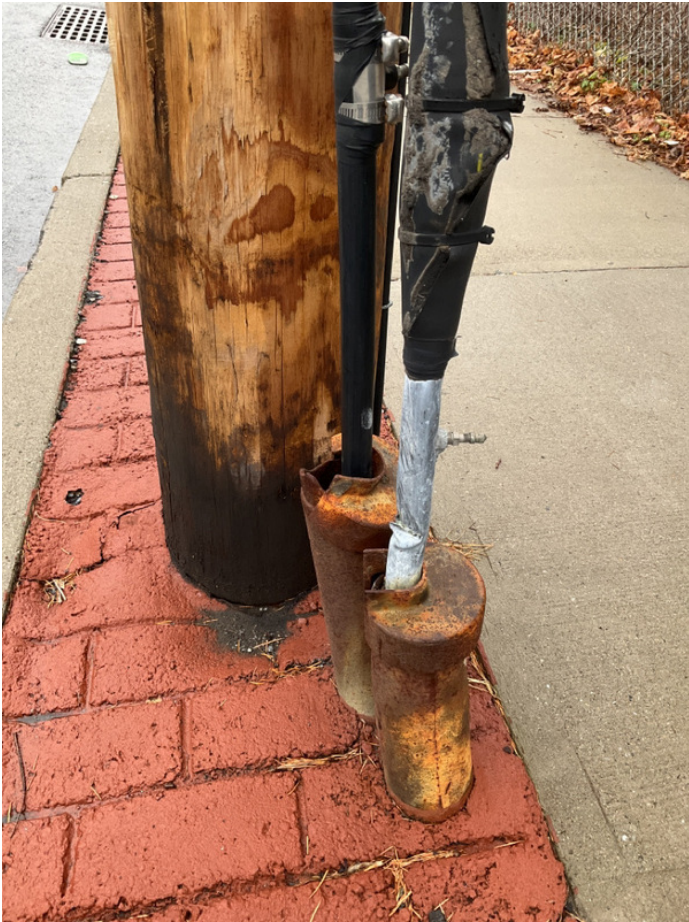
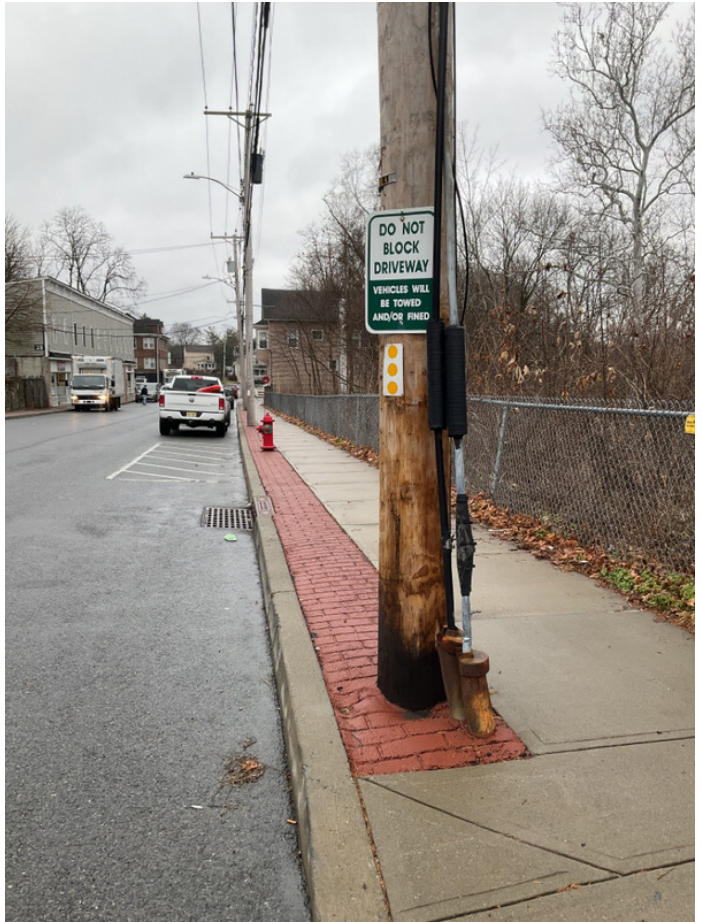
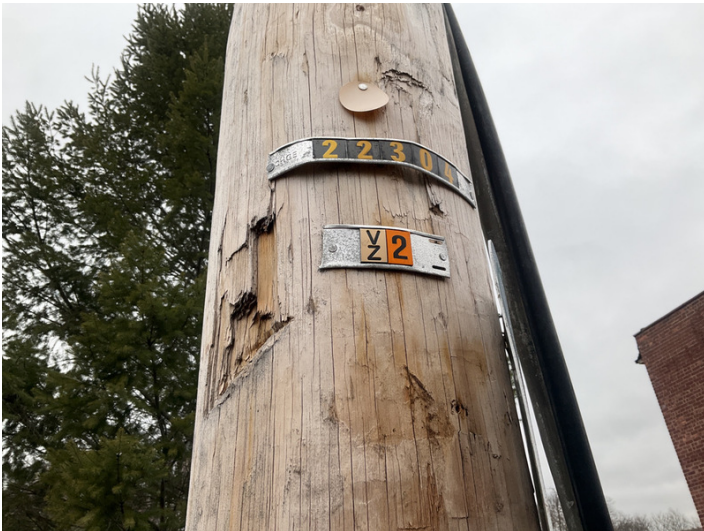
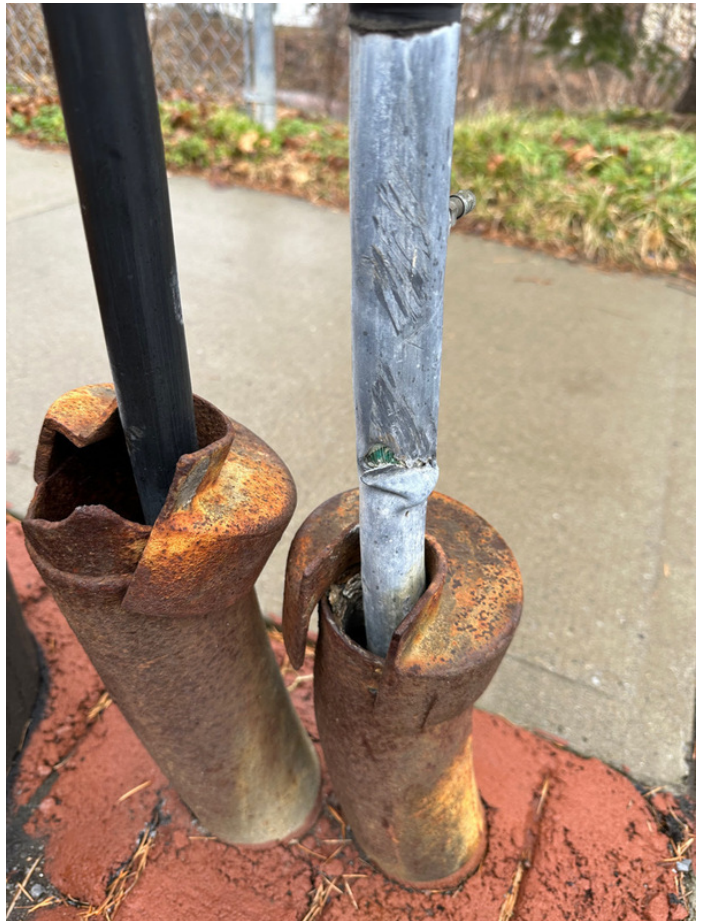
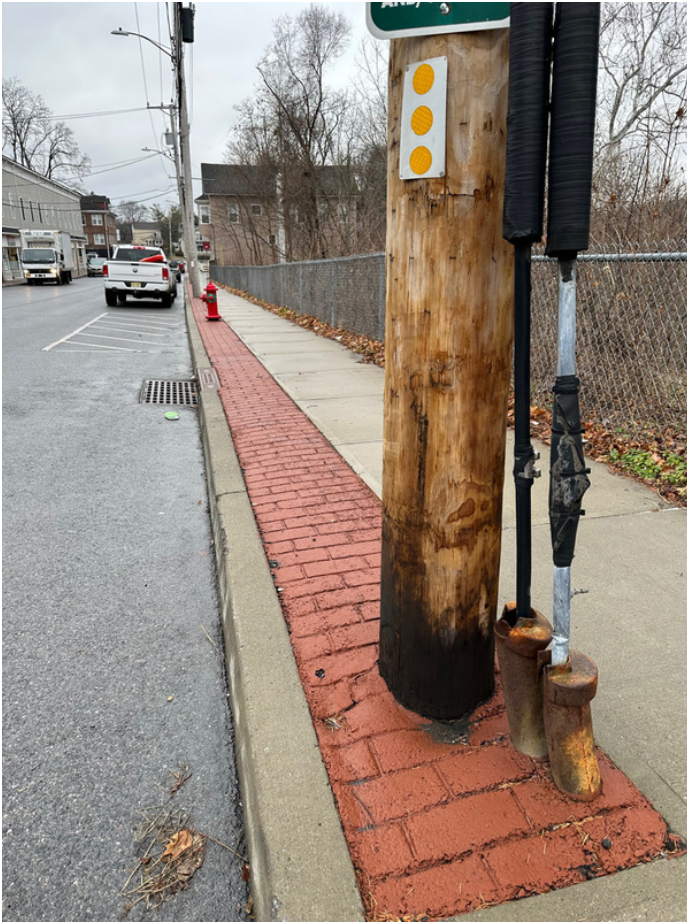
Site Photos

Way Point Prefix	Wappingers Falls
Way Point Number	3
Time at Way Point	10:47
Way Point Description	Splice Box
Are there visible signs indicating a cable crossing?	No
Is there visible cable at location?	Yes
How many cables are visible?	1
Is lead visible?	Yes
Was there a general site sample collected?	Yes

General Site Notes	1 leaded line with splice going into the ground. Broken open and not functioning.
--------------------	---

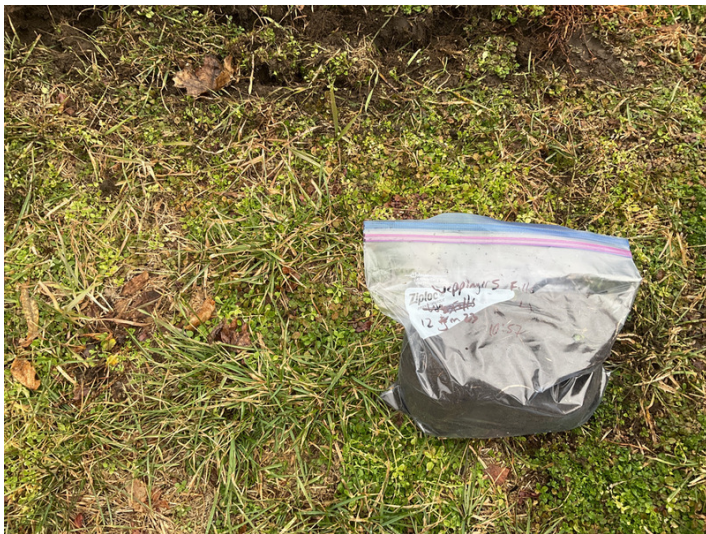
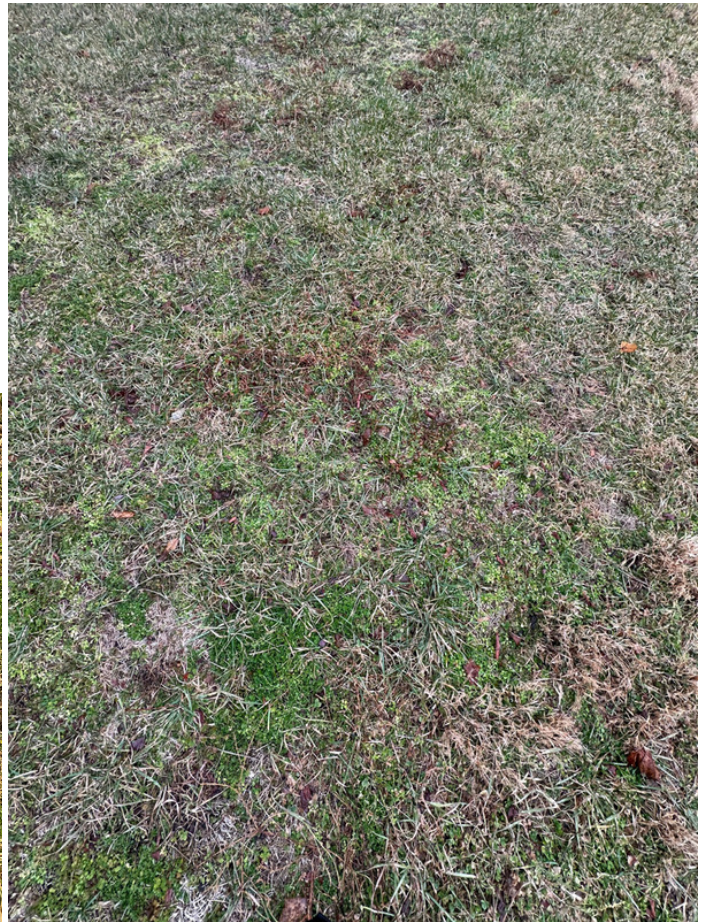
Photo of GS Sample(s)

Type of Sample for GS	Sediment Collection
Location of Collected Sample - GS	Underneath Overhead Cable
Time of Collection - GS	10:57
Sample Prefix - GS	Wappingers Falls
Sample ID (#) - GS	4
Additional Notes - GS (if any)	Leaded overhead lines running in area and at other locations in town. Sample was collected underneath an overhead cable, in a grassy park area.

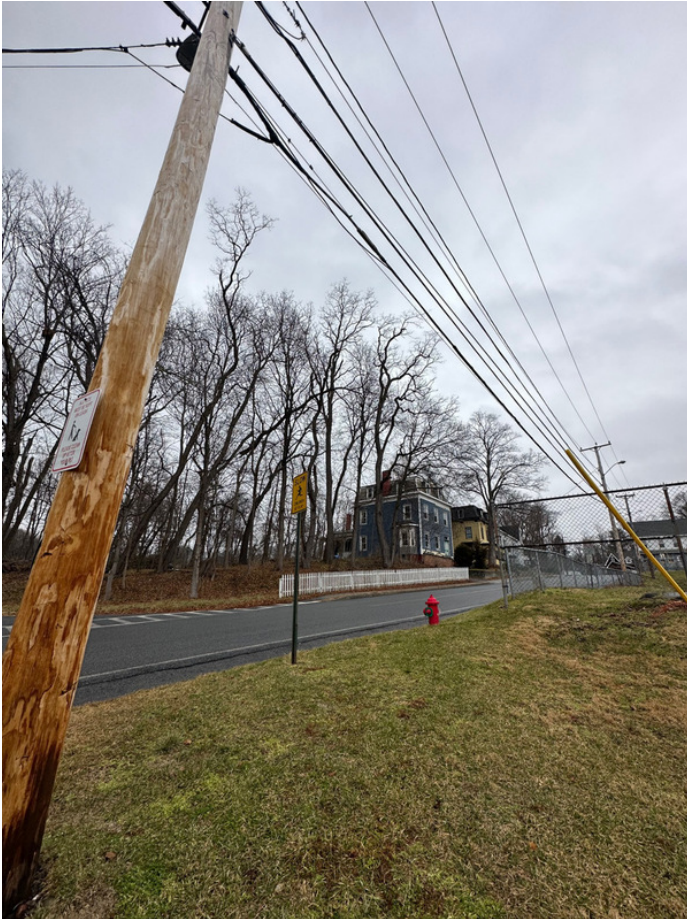
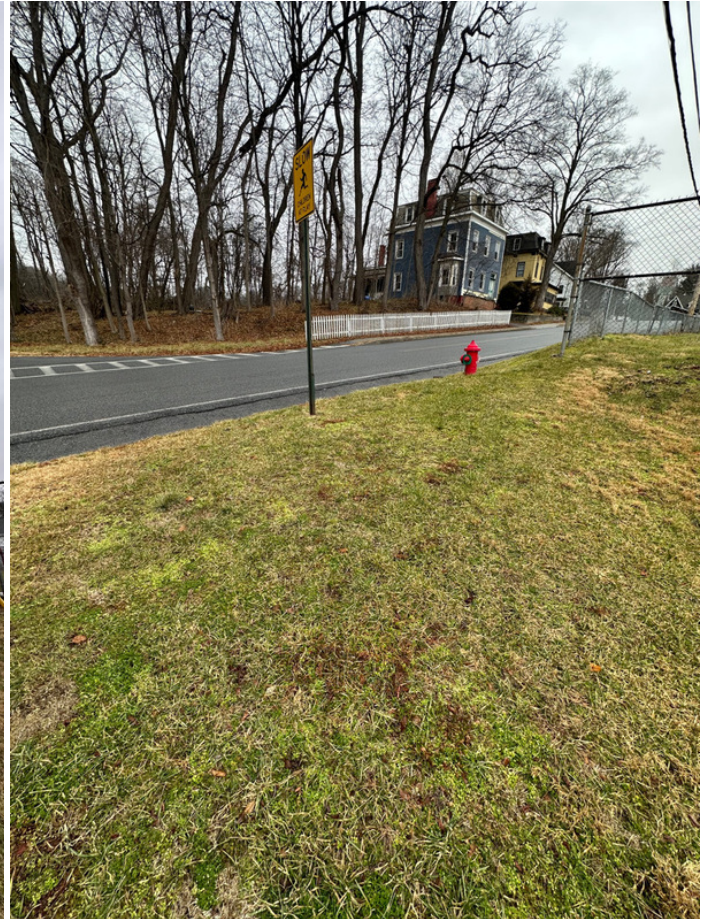
Site Photos

Overhead, Exposed Leaded Telecom Cable

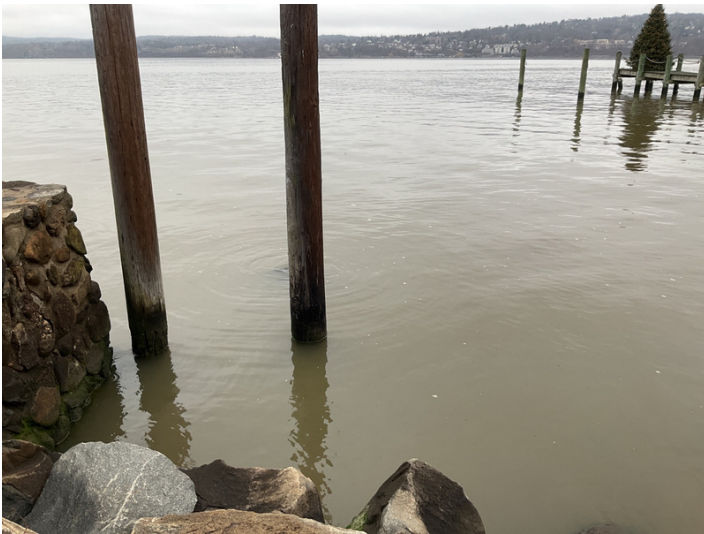
Photo of Specific Cable Sample(s)

Cable #	1
Visible Length (ft)	20
Type of Cable (Power, Telecom, Fiber Optic, Other)	Telecom
Is this a leaded cable?	Yes
Is the cable(s) Terrestrial, Submarine or Both?	Both
Was there a sample collected?	Yes
How many samples collected?	2

Type of Sample for Specific Cable	Water: Directly on Cable
If more than one cable, what Cable was Sample collected from?	1
Time of Collection - Specific Cable	14:35
Sample Prefix - Specific Cable	Hudson
Sample ID (#) - Specific Cable	7
Additional Notes - Specific Cable Sample (if any)	None.

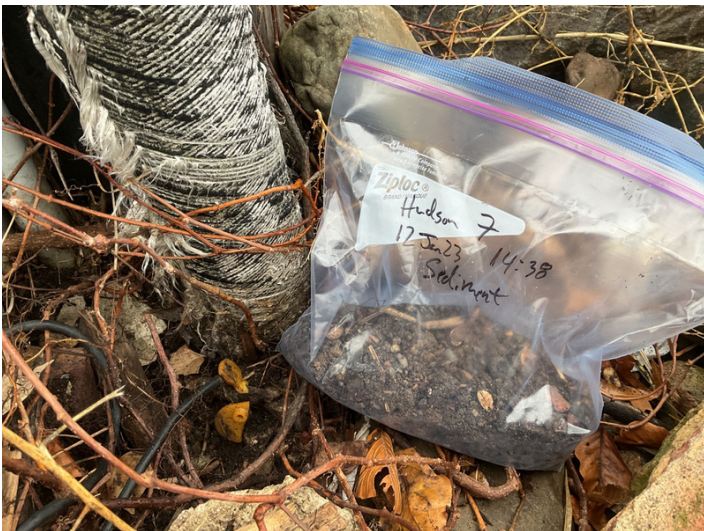
Photo of Specific Cable Sample(s)

Type of Sample for Specific Cable	Sediment Collection
If more than one cable, what Cable was Sample collected from?	1
Location of Collected Specific Cable Sample	Near the Cable
Time of Collection - Specific Cable	14:38
Sample Prefix - Specific Cable	Hudson
Sample ID (#) - Specific Cable	7
Additional Notes - Specific Cable Sample (if any)	None.

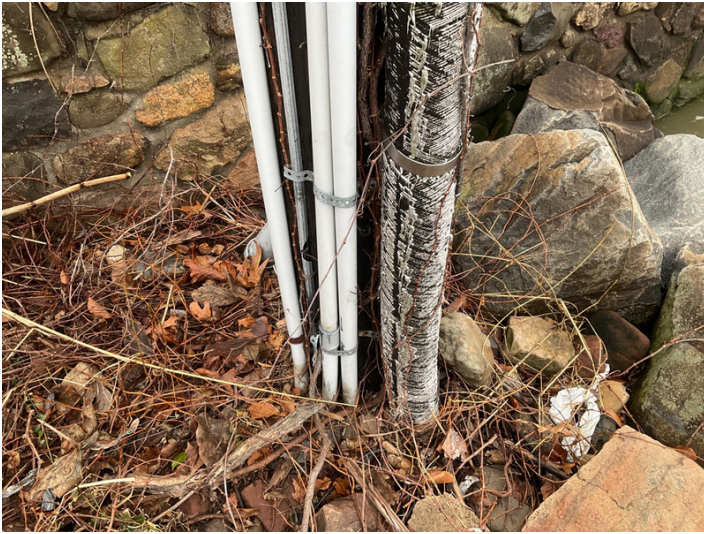
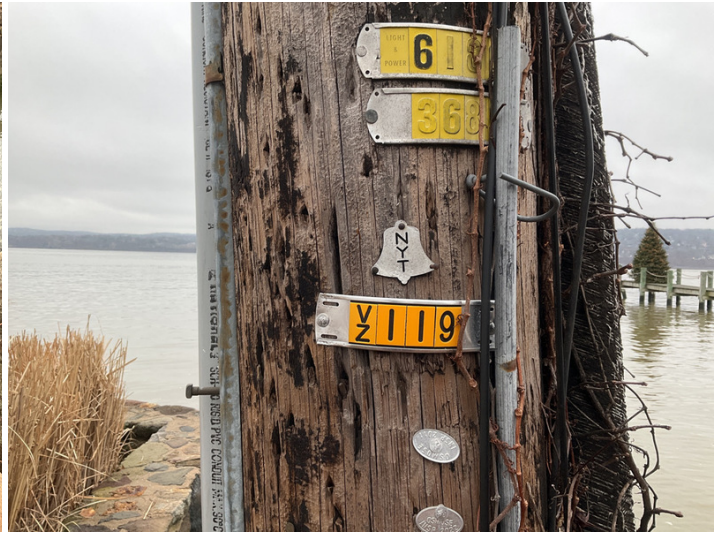
Site Photos

Abandoned 5" Cable. Area photos are under Palisades, End at Hudson River. Move data over to this point for final reporting. These points are one and the same.

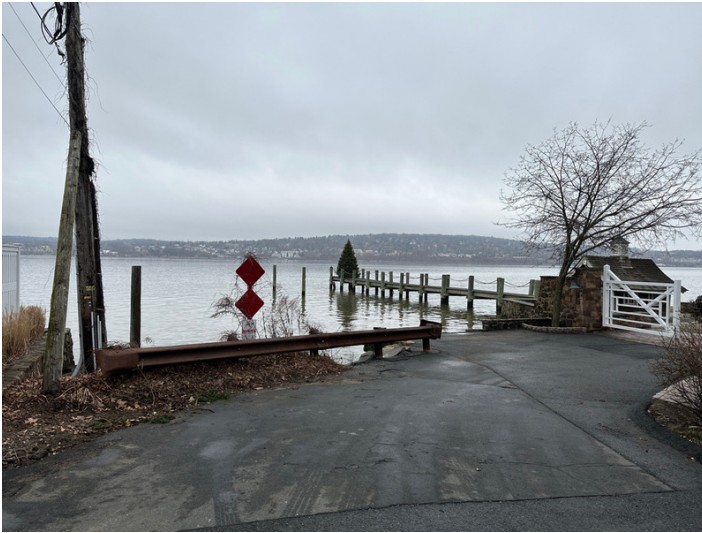
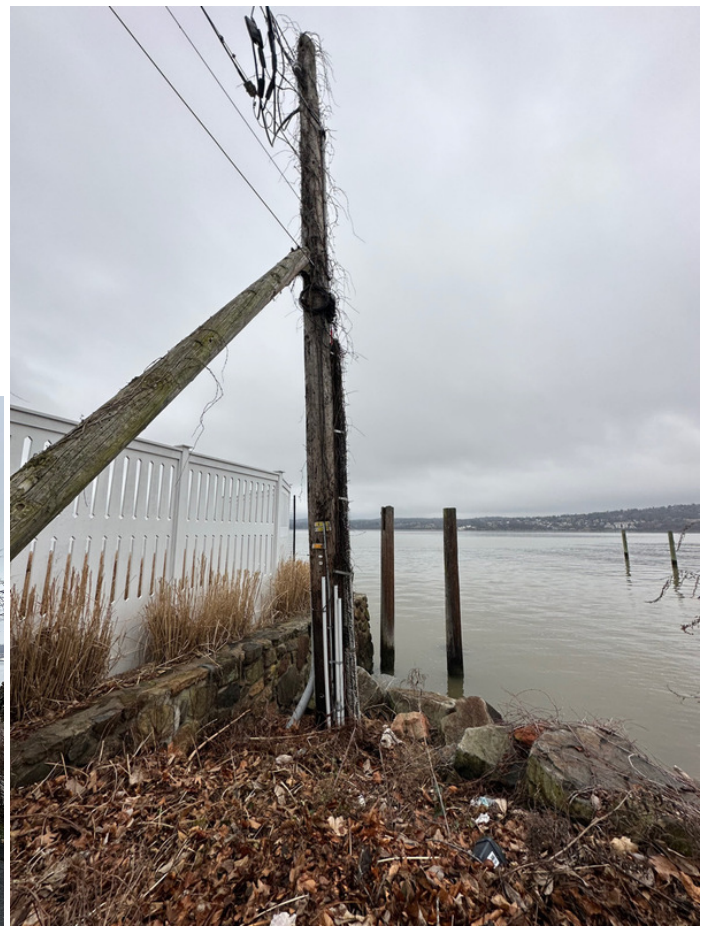
Site Photos

Way Point Prefix	Palisades
Way Point Number	1
Time at Way Point	14:43
Way Point Description	Overhead, Exposed Leaded Telecom Cable, (End at Hudson River. Corresponds with Hudson Pt 7)
Are there visible signs indicating a cable crossing?	No
Is there visible cable at location?	Yes
How many cables are visible?	1
Is lead visible?	Yes
Was there a general site sample collected?	No

General Site Notes	5" cut Telecom Cable, ends at nice parking area for nearby mansion. Photos correlate with Hudson 7. Move data to Hudson 7.
--------------------	--

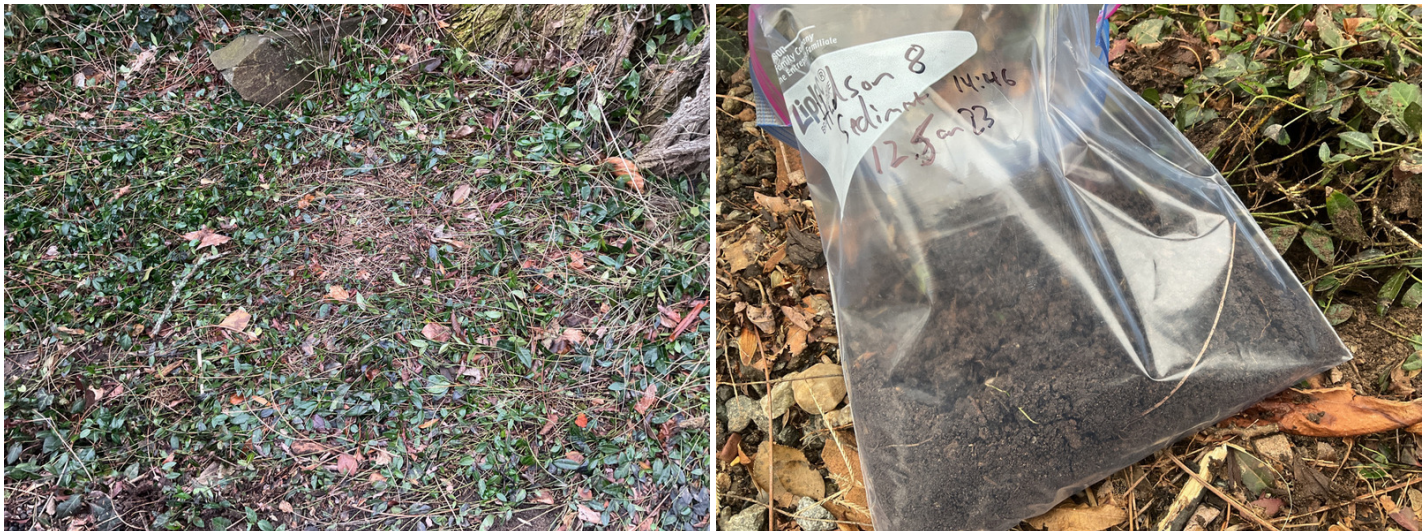
Photo of GS Sample(s)

Type of Sample for GS	Sediment Collection
Location of Collected Sample - GS	Other
Time of Collection - GS	14:46
Sample Prefix - GS	Hudson
Sample ID (#) - GS	8
Additional Notes - GS (if any)	Control for Hudson Pt 7.

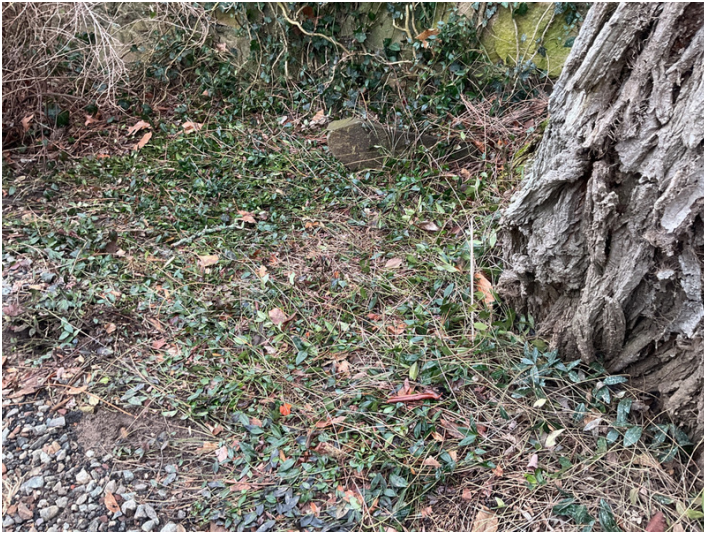
Site Photos

General Site Notes	Control sediment
--------------------	------------------

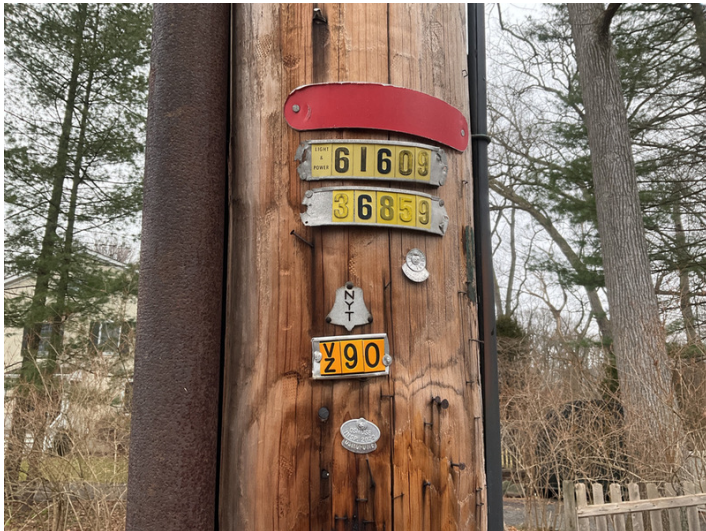
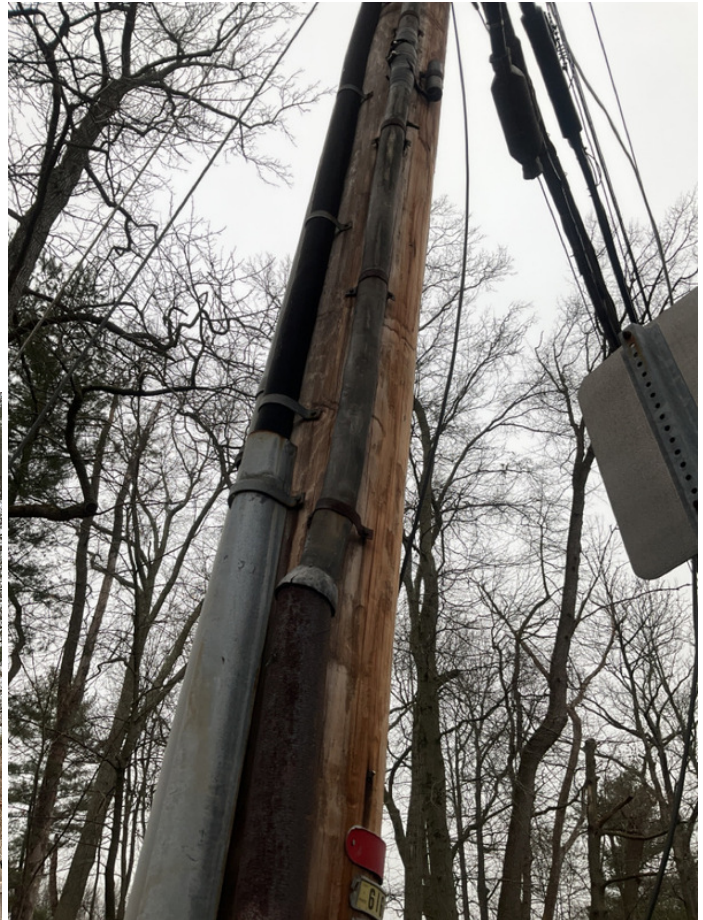
Site Photos

Way Point Prefix	Palisades
Way Point Number	3
Time at Way Point	15:05
Way Point Description	Overhead, Exposed Leaded Telecom Cable
Are there visible signs indicating a cable crossing?	No
Is there visible cable at location?	Yes
How many cables are visible?	2
Is lead visible?	Yes
Was there a general site sample collected?	No

General Site Notes | Washington Springs Road. Bare leaded cable goes into ground at this point. Video collected.

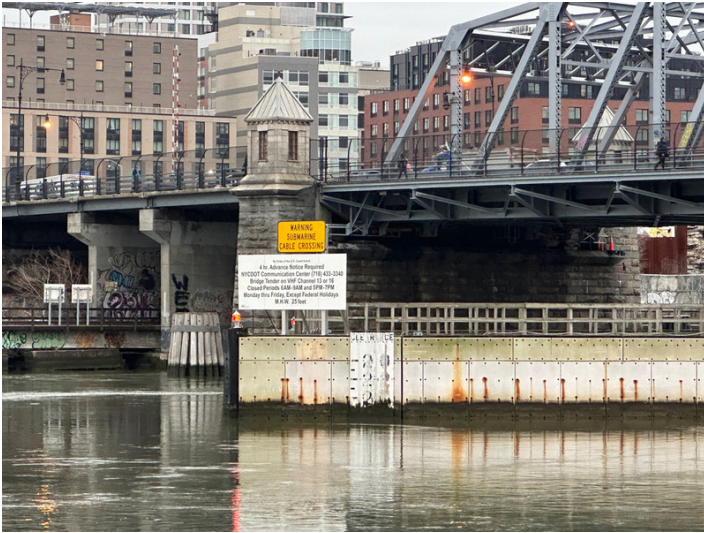
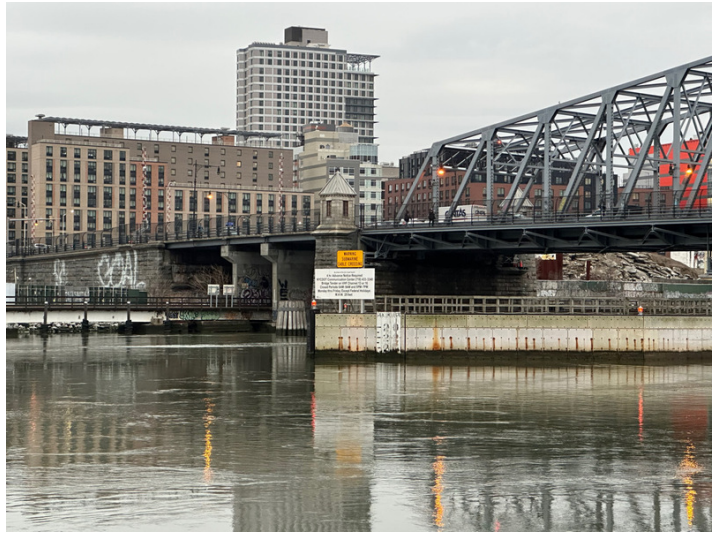
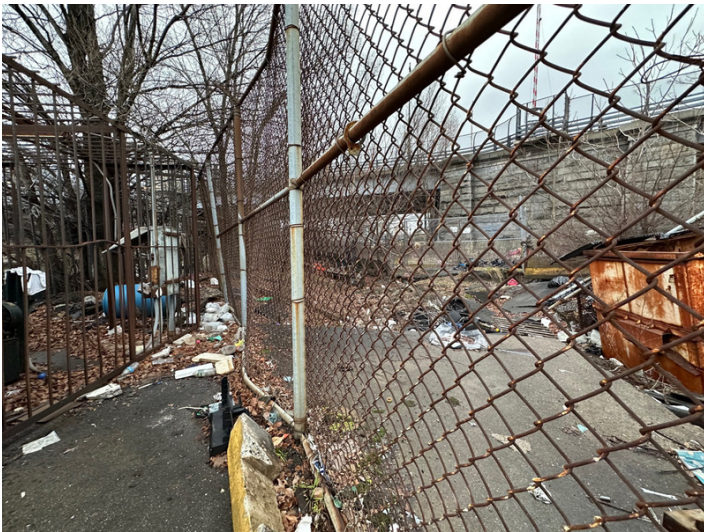
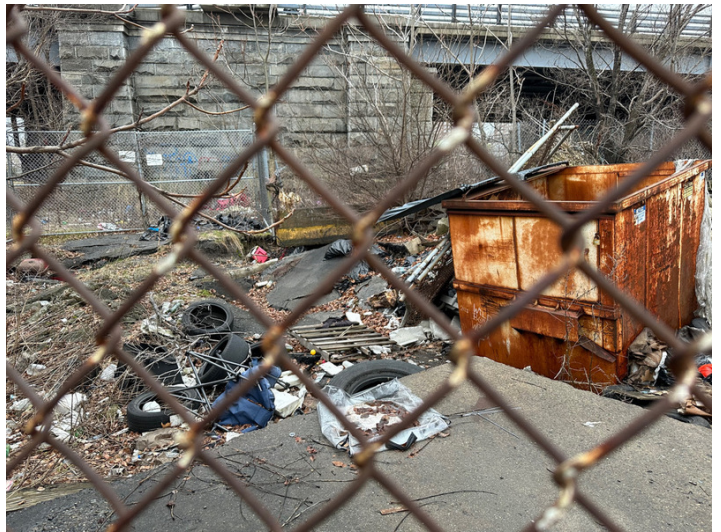
Site Photos

Way Point Prefix	Harlem River
Way Point Number	1
Time at Way Point	15:59
Way Point Description	Cable Location
Are there visible signs indicating a cable crossing?	Yes
Identify what the signs say.	Warning. Submarine Cable Crossing.

Is there visible cable at location?	Yes
How many cables are visible?	New Cables
Is lead visible?	No
Was there a general site sample collected?	No

General Site Notes | Site visit was at high tide. Newer cables present. No signs of old cables.
