DOCUMENT NO.	<u>Qualification Test Report</u>
TOTAL NO. OF PAGES	<u>130</u>
REVISION	<u>R1</u>

**QUALIFICATION TEST REPORT
FOR THE
REDUNDANT SEAL, SHUT-OFF VALVE, LH₂
TAERON PART NUMBER: 13079000-01
TAERON PART NUMBER: 201-023702-5
SPACE LAUNCH SYSTEM (SLS) CORE STAGE
SDRL SE-007**

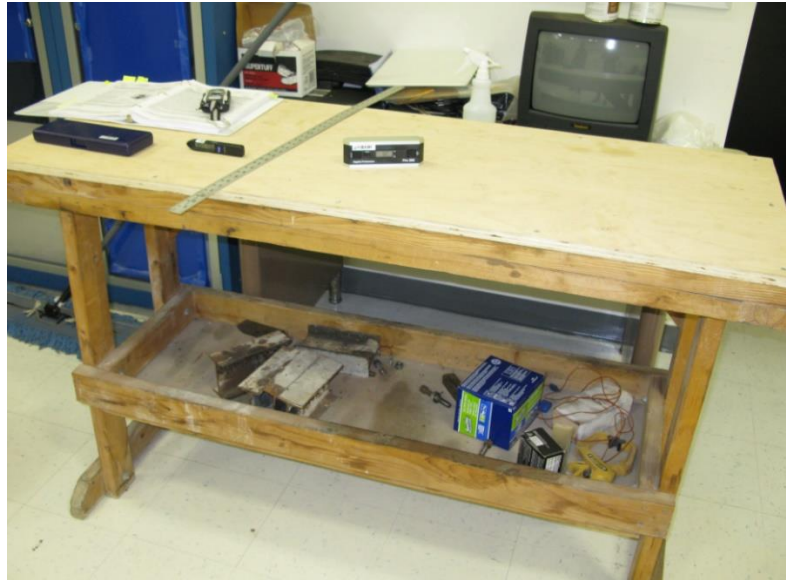
**FIGURE 2
BENCH SHOCK TEST BENCH**

- 6.4.2** Test Conditions: The RS unit was subjected to a total of 24 drops (4 drops per 6 sides) from an angle of 45 degrees onto the wooden bench top. See Figure 3, Figure 4, and Figure 5.

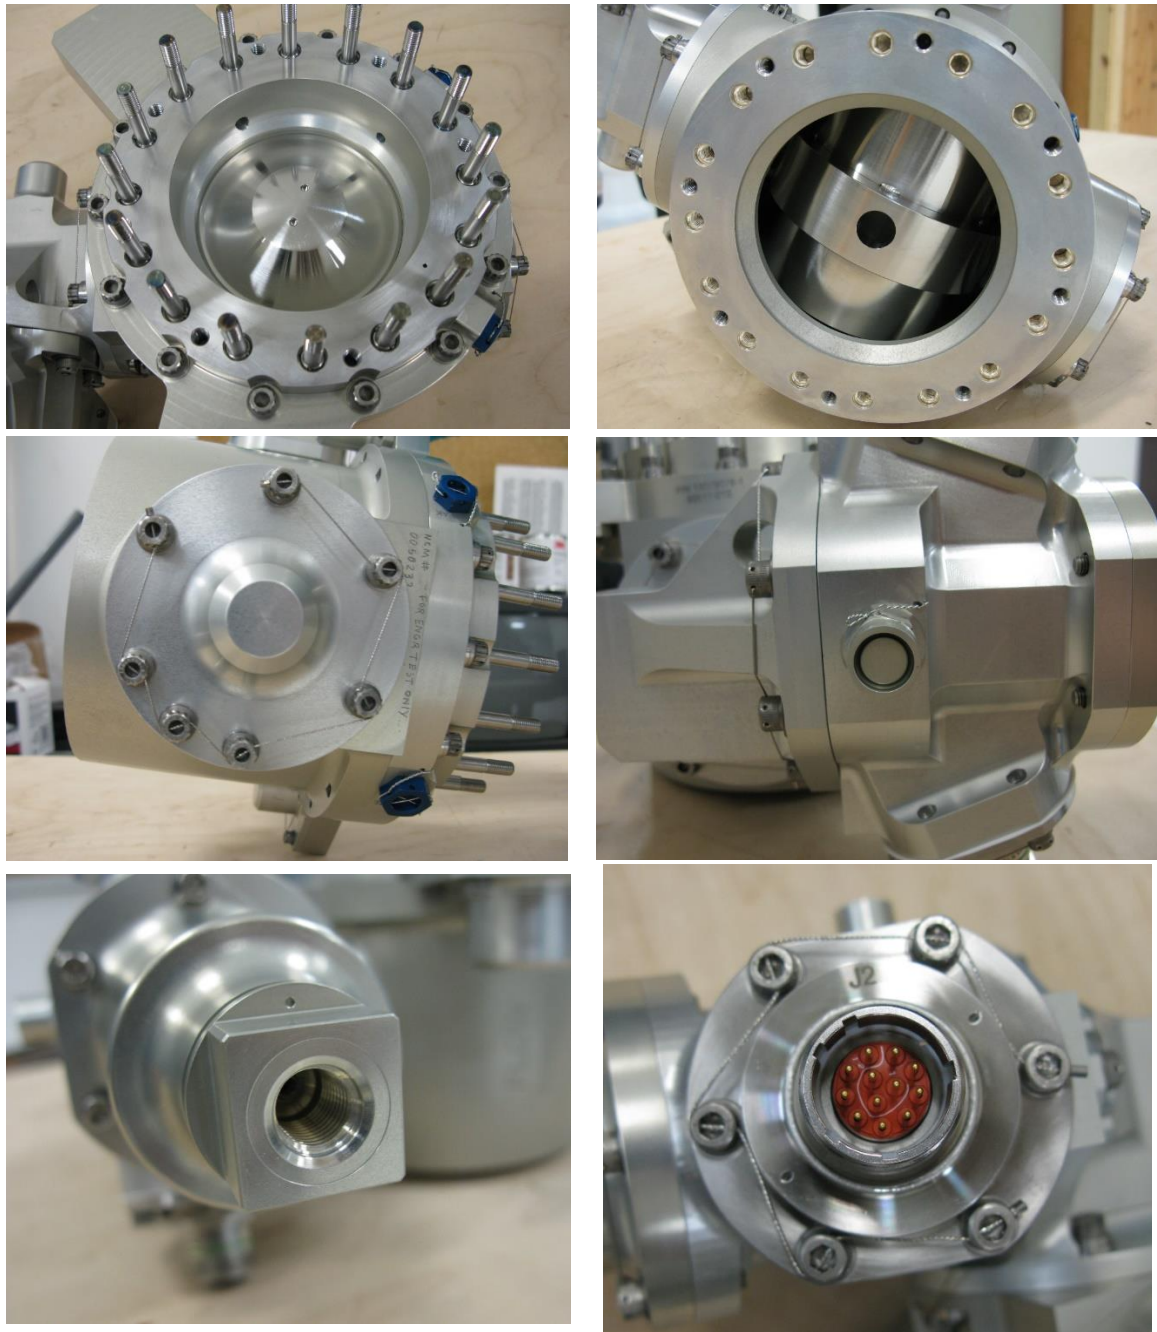
FIGURE 6
POST-BENCH SHOCK: TEST UNIT CONDITION

- 6.4.3** Results: The RS unit remained intact and showed no visible structural damage after the 24 drops. See Figure 6.

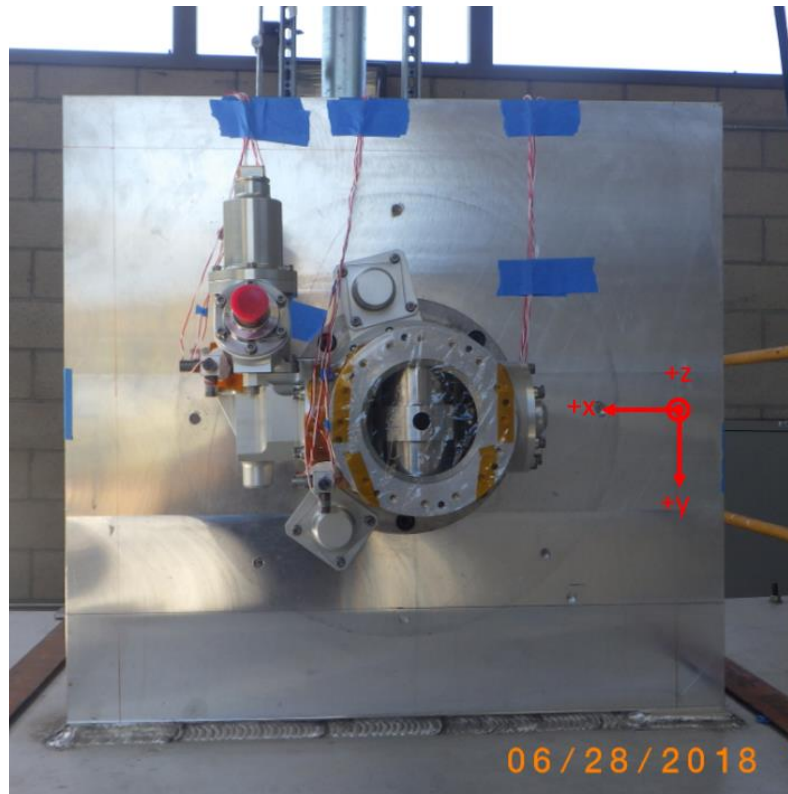
FIGURE 10
SHOCK TEST: TEST SETUP

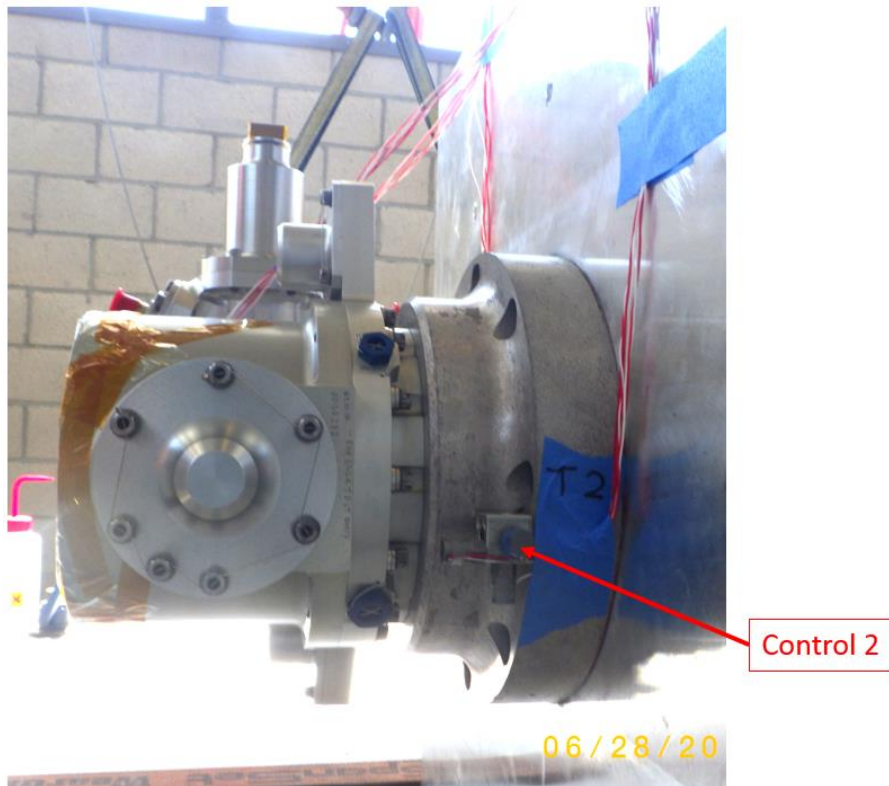
FIGURE 12
SHOCK TEST: ACCELEROMETER PLACEMENTS (SIDE 2)

- 6.5.2** Test Conditions: Prior to shock testing, a series of equalization shocks and a fixture survey were performed using the RS mass simulator P/N 13079446-01. See Figure 7, Figure 8, and Figure 9. The RS mass simulator and RS qualification unit were each installed on the Shock/Vibration Test Fixture P/N 13079446-01-1 (originally designed for vibration testing but approved as an acceptable equivalent test fixture for shock), which was fastened onto a test plate welded onto the impact table. See Figure 7 and Figure 10. Mounting fasteners for both the simulator unit and test unit were torqued to 125 in-lb above running torque and torqued striped to be visually inspected for any loosening after each axis. Two control accelerometers were attached to the test fixture and two response accelerometers were attached to the test unit at the locations shown in Figure 8, Figure 9, Figure 11, and Figure 12.

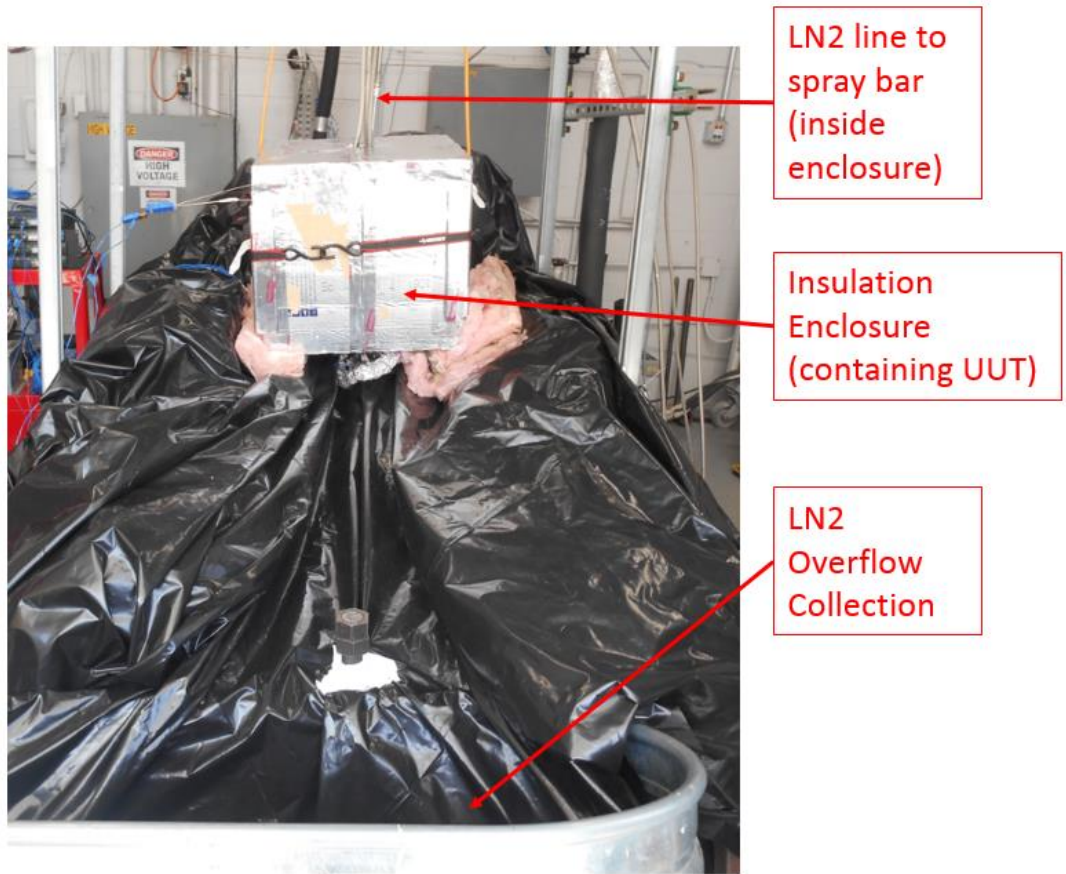
FIGURE 21
X-AXIS VIBRATION TEST CRYO SETUP

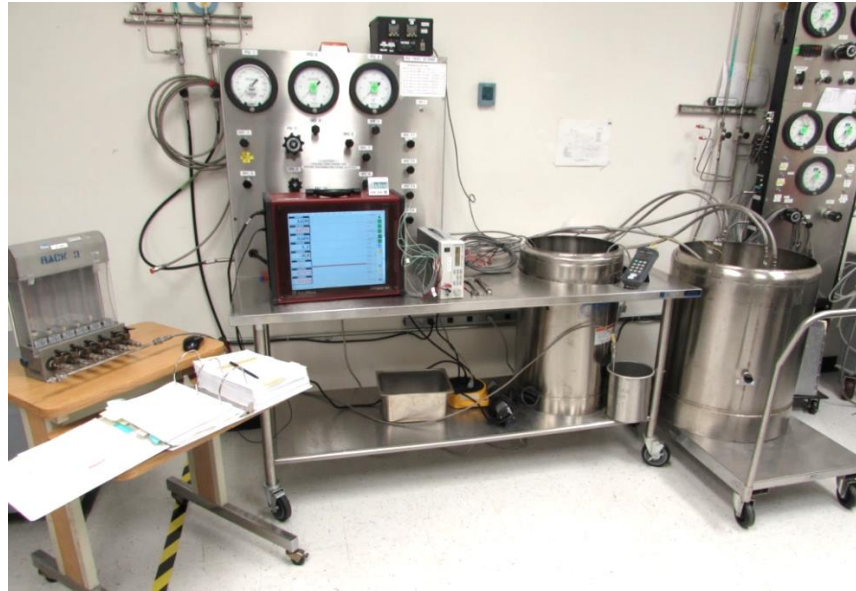
**FIGURE 52
AMBIENT LEAKAGE TESTS: TEST SETUP**

- 6.30.2** Test Conditions: The leakage test fixtures (P/N 13079423-01) were installed on the test unit and placed inside the dewar. See Figure 52 and Figure 53. Test unit was body temperature was at 73.7°F (body) and 77.7°F (actuator).
- 6.30.3** The RS inlet was pressurized to 75.5 psig and held for 5 minutes before leakage reading was recorded.
- 6.30.4** Results: The RS unit passed the test with inlet-to-outlet leakage of 0 scim.

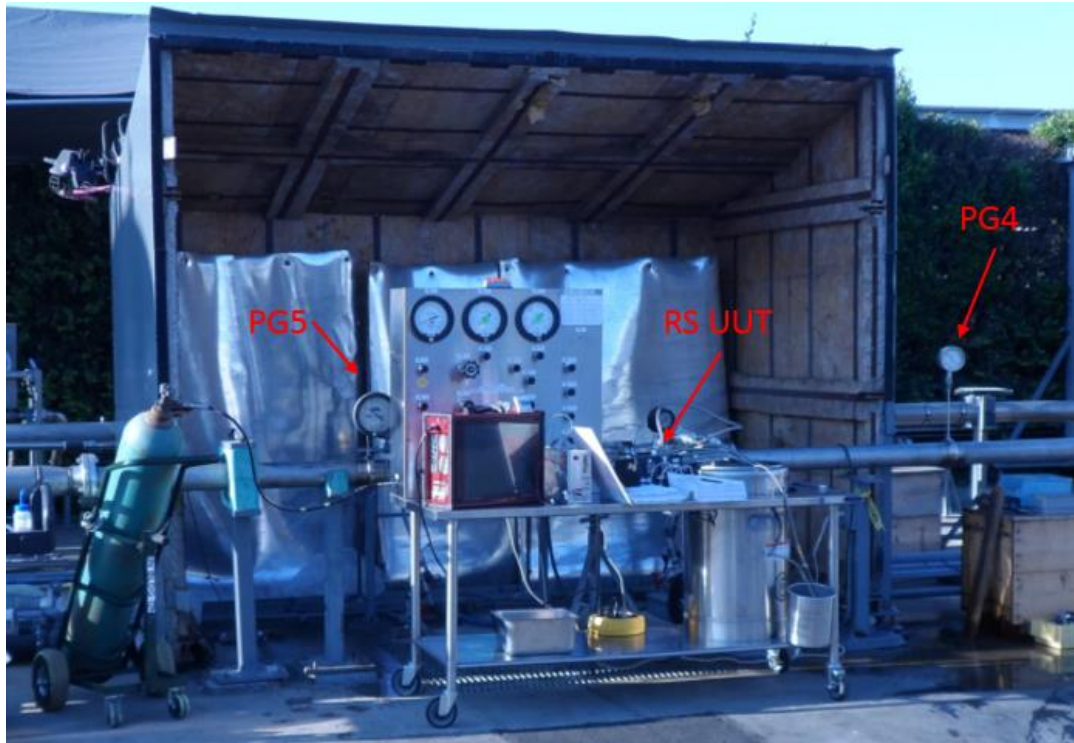
FIGURE 60
CLOSING RESPONSE WITH FLOW: WATER FLOW TEST STAND

6.36.2 Test Conditions: The RS unit was installed on the water flow test stand with the inlet and outlet test fixtures (P/N 13079450-01). See Figure 60, Figure 61, and Figure 62. The RS unit was actuated to open position by applying 600 psig at the actuator. The water flow was adjusted to 95 GPM and 53 psig downstream (PG4). The actuator pressure was increased to 910 psig and then suddenly depressurized using test stand solenoid valve. The closing response times were recorded using the Position Indication Box.

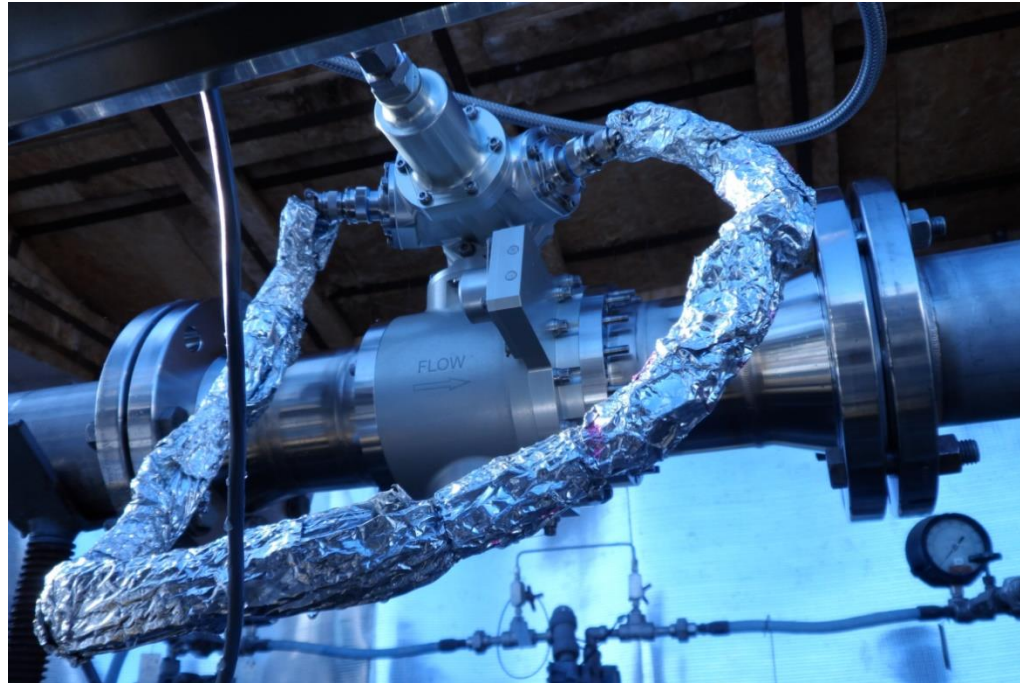
FIGURE 62
CLOSING RESPONSE WITH FLOW: TEST SETUP (BOTTOM VIEW)

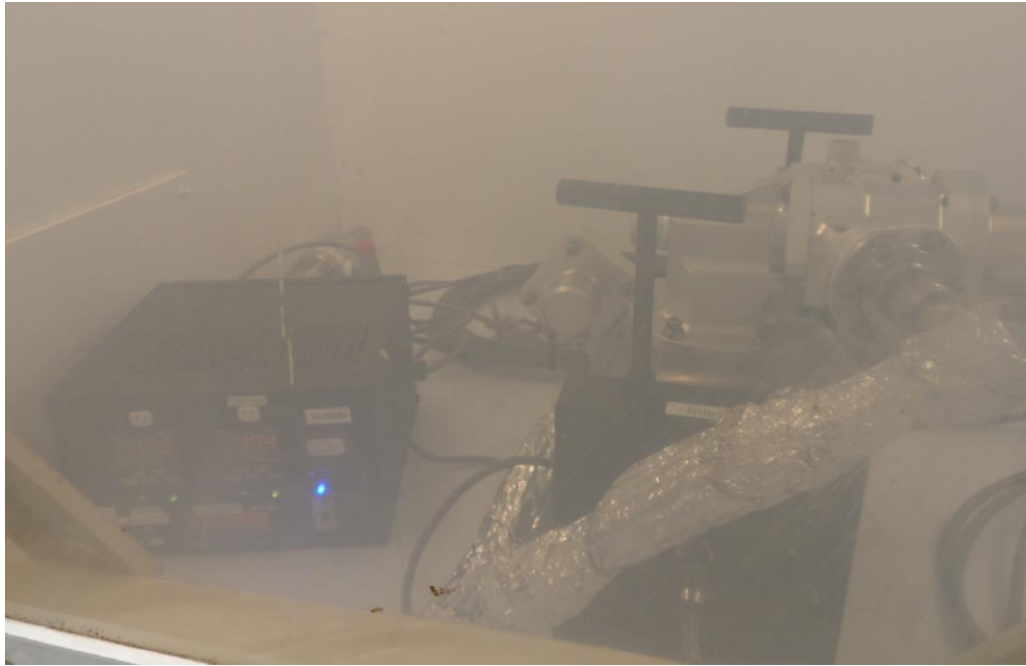
**FIGURE 63
BURST PRESSURE TEST: RS INLET (OPEN POSITION)**

- 6.37.3** Results: The RS unit passed all three burst cases, for it withstood the burst pressures without rupture.

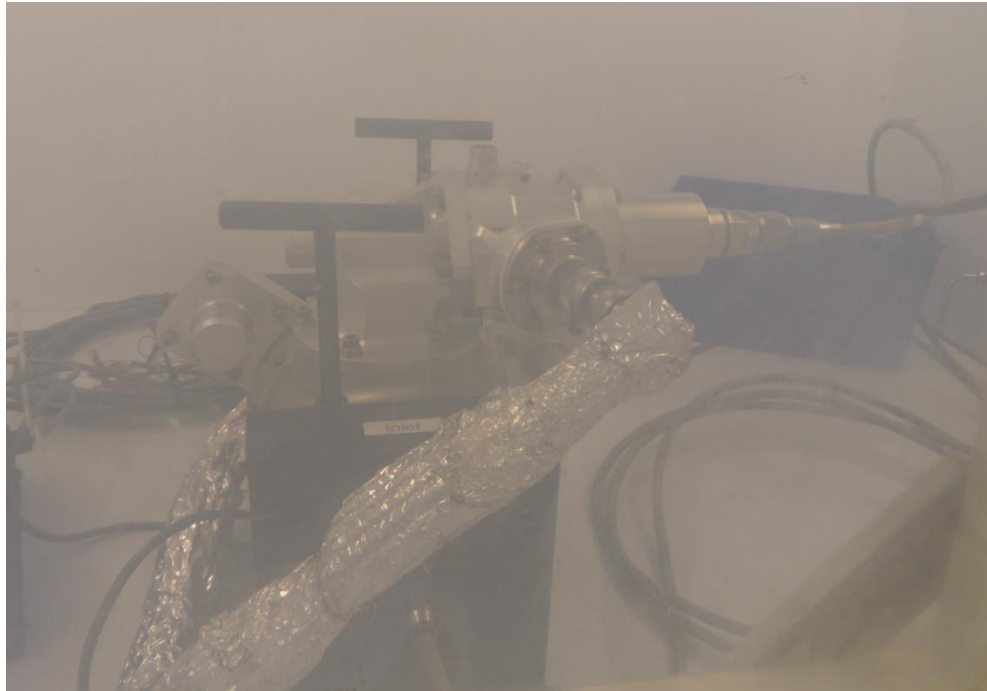
**FIGURE 65
BURST PRESSURE TEST: ACTUATOR**

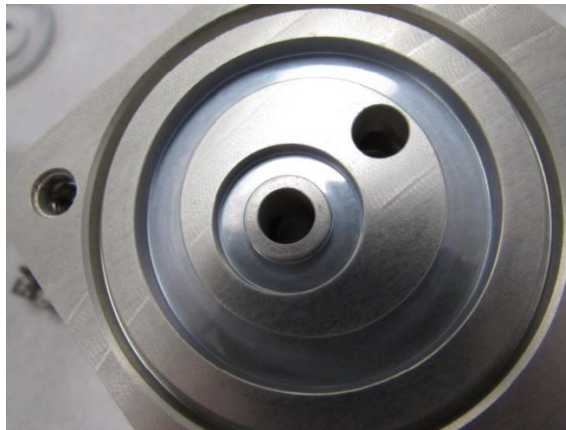
**FIGURE 142
RELIEF VALVE SEAL GROOVES, S/N 00011 (LEFT) S/N 00005 (RIGHT)**
