**RE: MAJOR DEVELOPMENT PERMIT WITH VARIANCE and MINOR DEVELOPMENT PERMIT (SPEA AND EAGLES NEST); 1650 GALERNO ROAD & 0 ALDER STREET**

October 21, 2022  
File No: 8298-15

### 1650 Galerno Rd - Slope Stability Analysis

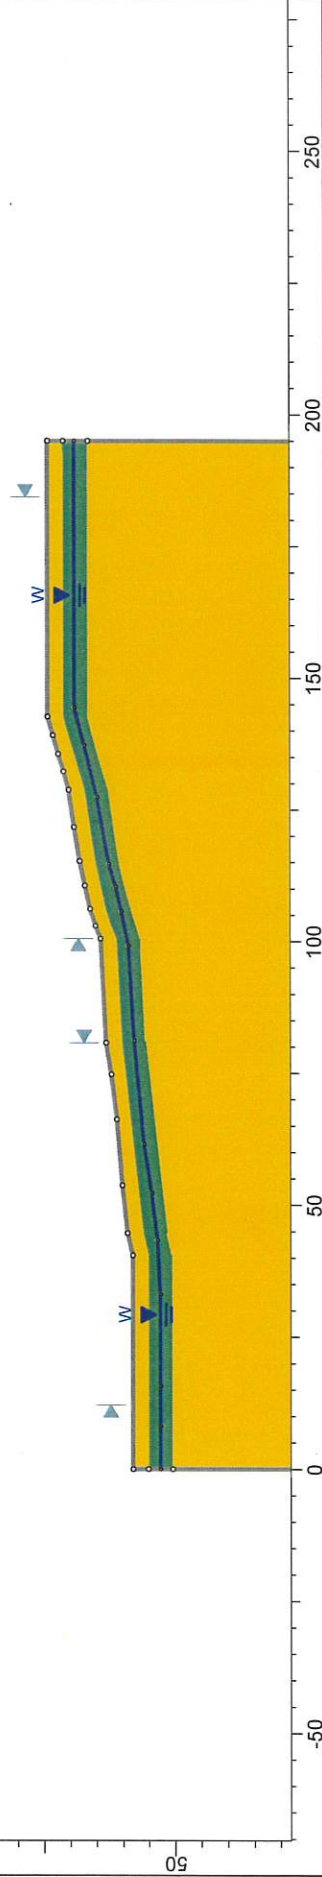
Method Name	Min FS
Bishop simplified	1.125
Spencer	1.150
GLE / Morgenstern-Price	1.159

<b>Project</b>		1650 Galerno Rd - Slope Stability Analysis	
<i>Group</i>	Section 1 (as per Section Location Plan)	<i>Scenario</i>	Full Seismic Scenario
<i>Drawn By</i>	SG	<i>Company</i>	Ryzuk Geotechnical
<i>Date</i>	2022-10-07, 3:55:52 PM	<i>File Name</i>	Slide.section1.slmd

A computer-based assessment of slope sections near the southern property limits of civic addresses 1502 and 1570 Stag Rd were completed using the above noted site plan and topographic survey to replicate the slope geometry to estimate the potential of deep-seated instability impacting the proposed development location. The analysis was carried out using Slide2 software developed by Rocscience Inc., where static and seismic scenarios were analyzed by Limit Equilibrium (LE) method. Furthermore, our analysis took into consideration Bishop’s Simplified, Spencer, and GLE/Morgenstern-Price methods to compute a Factor of Safety (FOS) regarding slope stability.

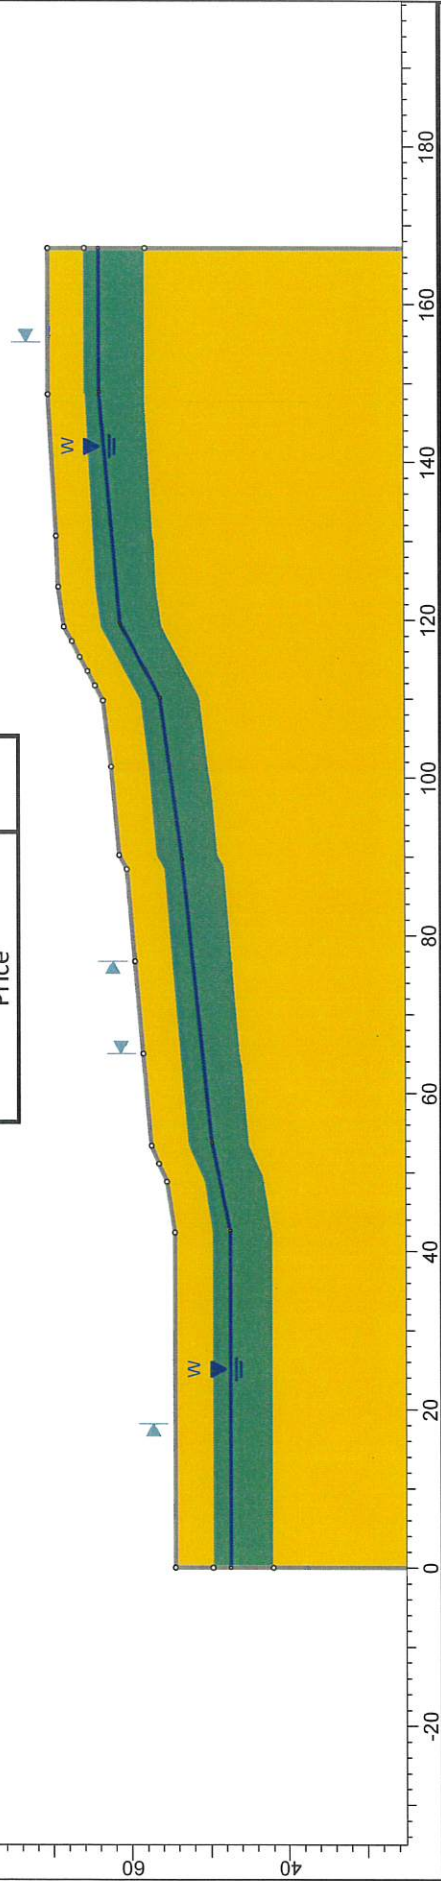
Method Name	Min FS
Bishop simplified	1.170
Spencer	1.204
GLE / Morgenstern-Price	1.208

<b>rocscience</b>		Project	
Group	Section 2 (as per Section Location Plan)	Scenario	Full Seismic Scenario
Drawn By	SG	Company	Ryzuk Geotechnical
Date	2022-10-07, 4:13:44 PM	File Name	Slide.section2.sifmd

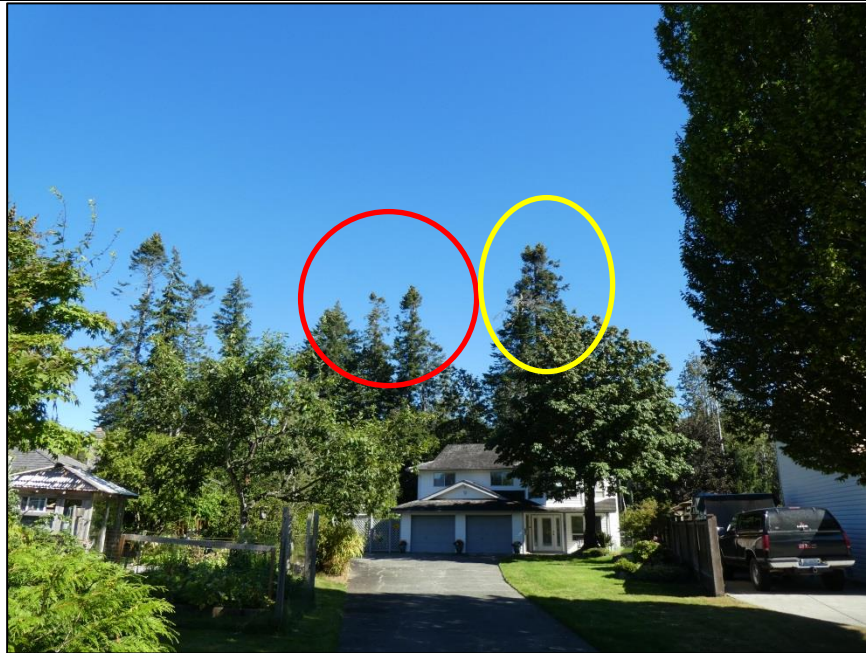
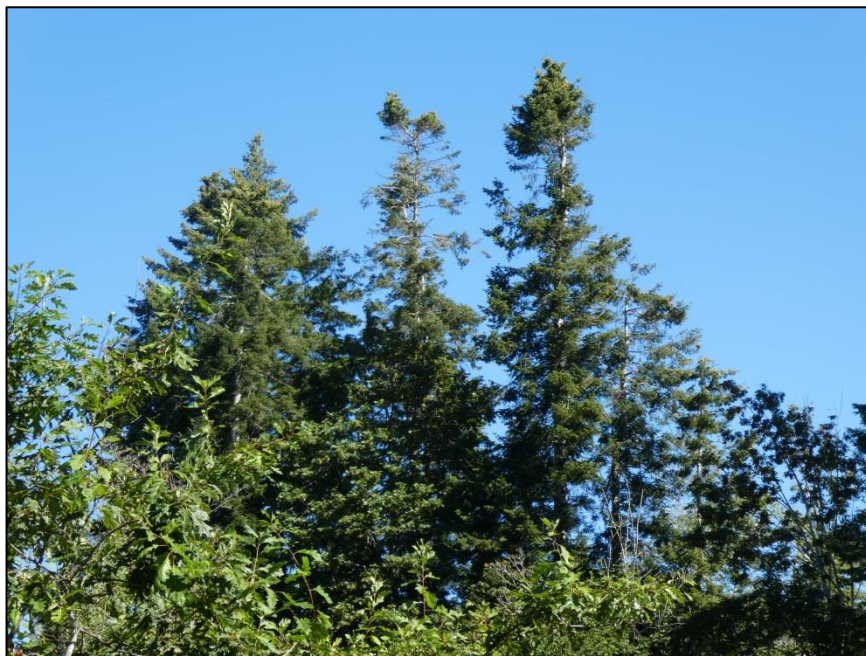
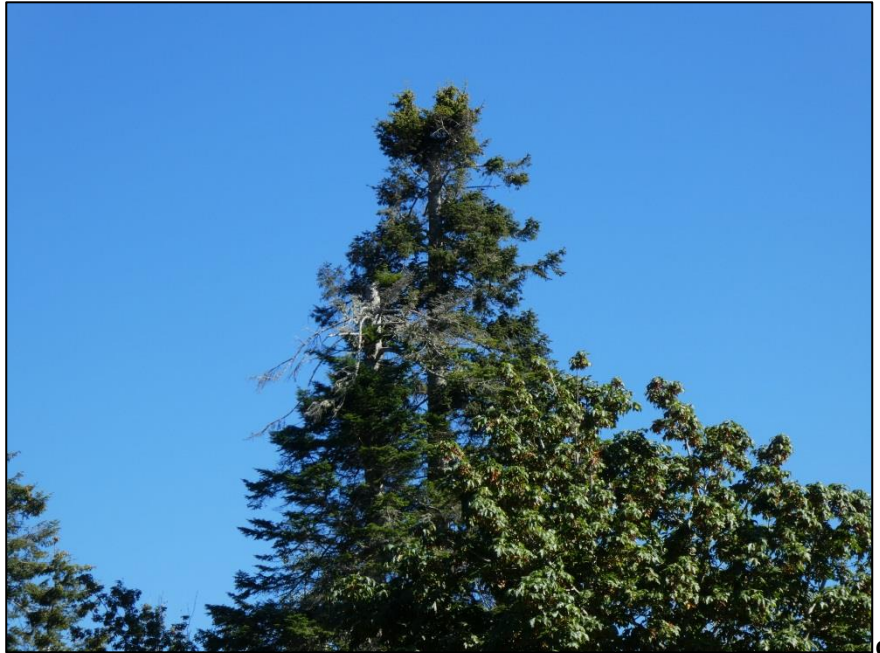
**Figure 3: View of the suspected Nest 1 nest tree from Cottonwood Drive looking north (a), on August 30, 2022. There is no nest within the tree, or any of the surrounding trees. See the close up views of trees within the area that could support a nest (b) and (c), with no nests currently in the trees.**

The nest tree was observed on February 3 and 4th, May 10, and August 30, 2022. No bald eagle nest, or other stick nest remains in the suspected nest tree. See Figure 3 for a photograph of the suspected nest tree, without a nest. A pair of bald eagles were heard on the subject property in February, 2022, but were not observed in May or August, 2022. Whitewash and eagle feathers were found sporadically across the subject property, but were not concentrated in any one area. A sharp-shinned hawk (*Accipiter striatus*) was observed perched within the subject property on February 3<sup>rd</sup>, 2022; and multiple plucking posts were found throughout the subject property.

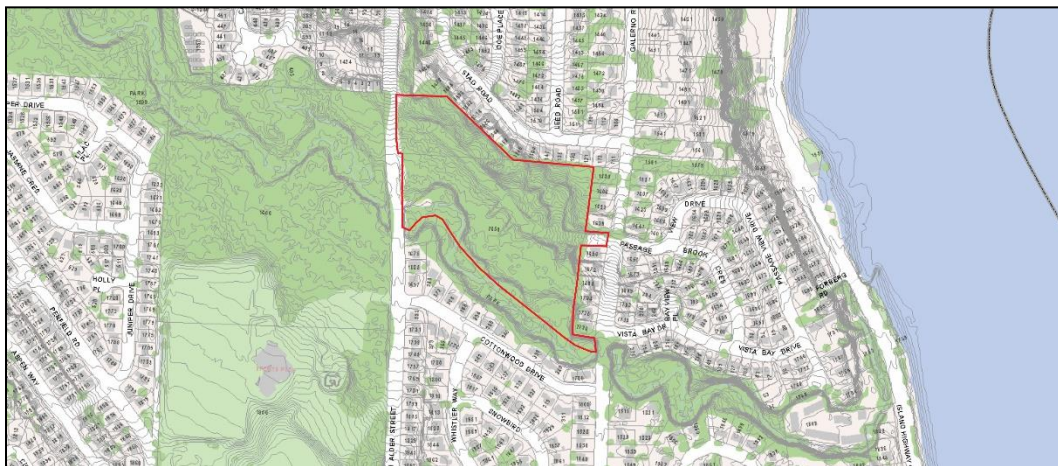
Figure 2, Image showing topography of subject property.

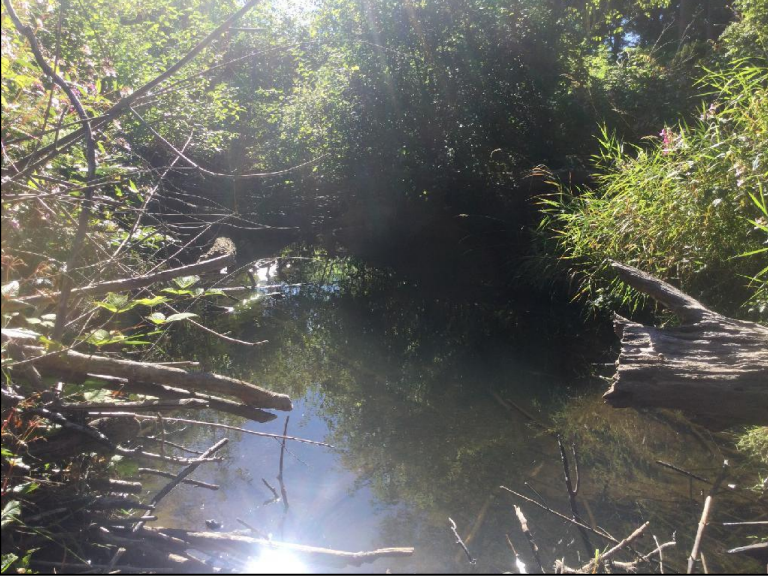
Label	Photo 1, Simms Creek: View of Simms Creek from the mid-point, looking downstream.

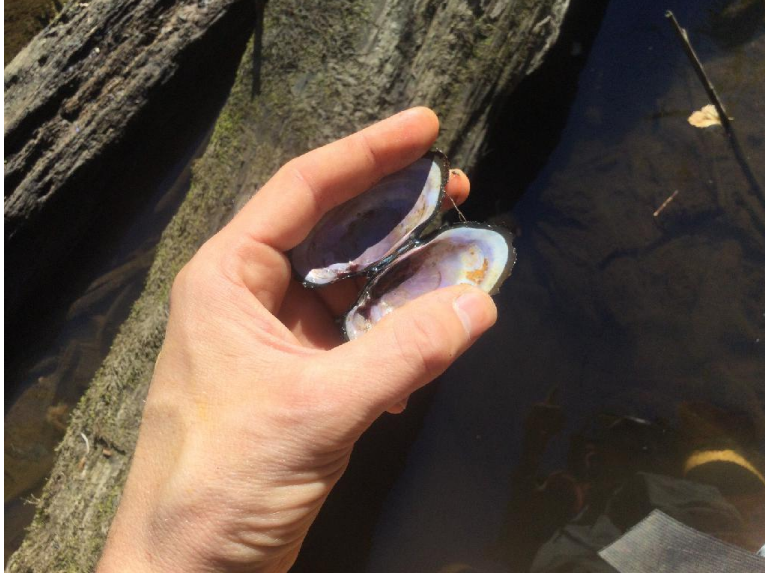
Label Photo 3, Simms Creek: Western pearlshell mussels (*Margaritifera falcate*) were observed within Simms Creek, located near the mid-point.

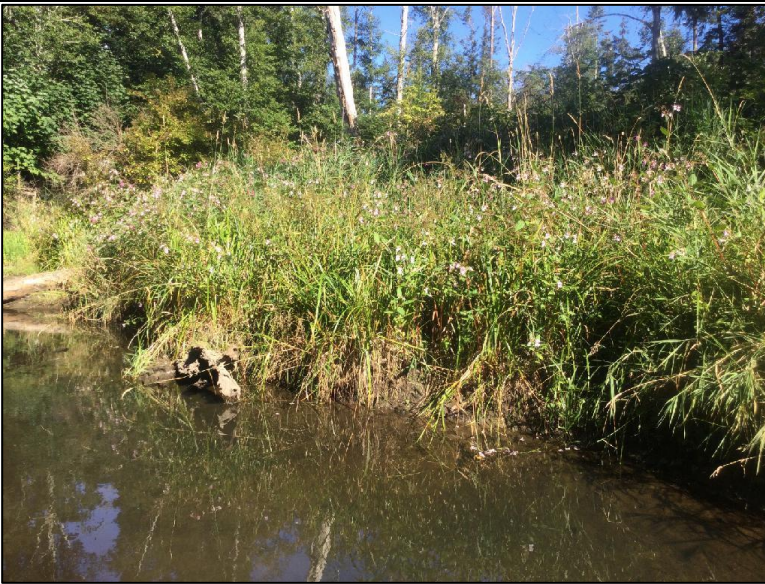
Label Photo 4, Simms Creek: View of the riparian area dominated by non-native species, such as Himalayan balsam (*Impatiens glandulifera*) and reed-canary grass (*Phalaris arundinacea*).

The riparian area immediately adjacent to Simms Creek is degraded, and is lacking an overstory layer. The overstory is sparsely composed (<100 stems per hectare) of red alder (*Alnus rubra*), grand-fir (*Abies grandis*), and Sitka spruce (*Picea sitchensis*) with two coastal redwoods planted along the channel (*Sequoia sempervirens* [non-native]). The riparian area is a mosaic of two different types; invasive dominated areas and native species dominated areas. The invasive areas are dominated by Himalayan balsam (*Impatiens glandulifera* [invasive]), Himalayan blackberry (*Rubus armeniacus* [invasive]) and reed-canary grass (*Phalaris arundinacea*). These species form pure, dense stands, and are preventing the reestablishment of conifers adjacent to Simms Creek (Photo 4). Portions of these areas are also maintained by local residents and appear to be mowed to create recreation areas immediately along the stream edge (Photo 5). The native areas are dominated by red-osier dogwood (*Cornus stolonifera*) and salmonberry (*Rubus spectabilis*, with an understory of horsetails (*Equisetum* spp.).

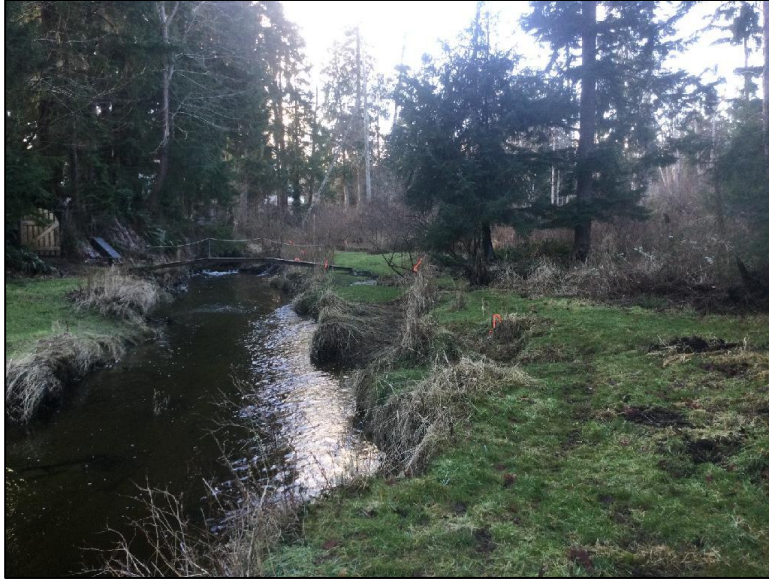
Photo 5, Simms Creek: Portions of the riparian areas have also been maintained by local residents to create recreation areas immediately along the stream edge.

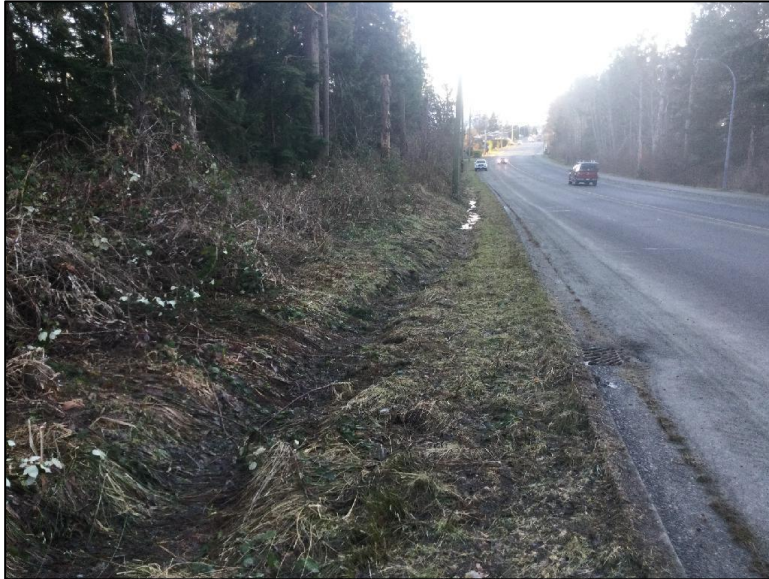
Photo 6, Ditch 1: Ditch 1 is a shallow swale, along the east side of Alder Street.

Ditch 1 is a shallow swale, along the east side of Alder Street (Photo 6). It flows south for 110 m, before being ditched into a large dug out pit adjacent to Simms Creek (Photo 7). There is a large berm around the pit, and there is no evidence that it is directly connected to Simms Creek. It appears as water sits in the pit and infiltrates into the ground. The riparian area is developed to the west (Alder Street) and undeveloped to the east. As this ditch does not directly connect to fish habitat, the RAPR does not apply.

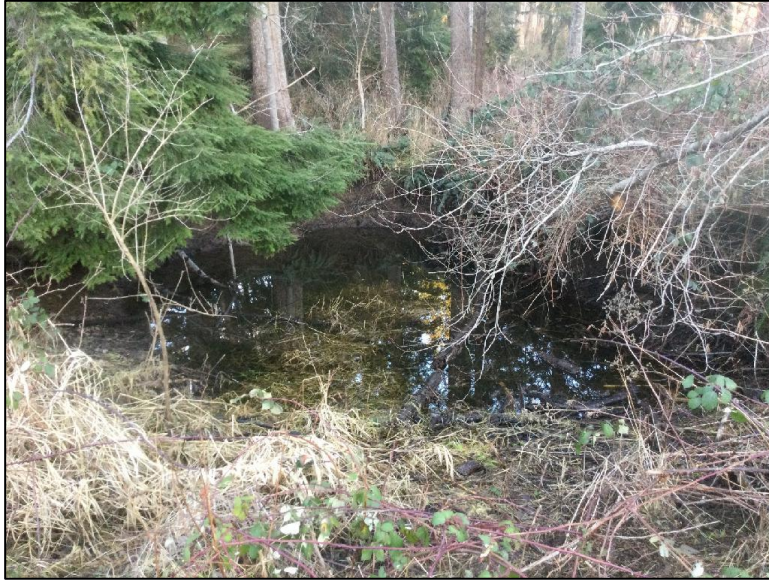
Label Photo 7, Ditch 1: Ditch 1 is approximately 110 m long, and is ditched into a large dug out pit adjacent to Simms Creek. There is no direct connection to Simms Creek.

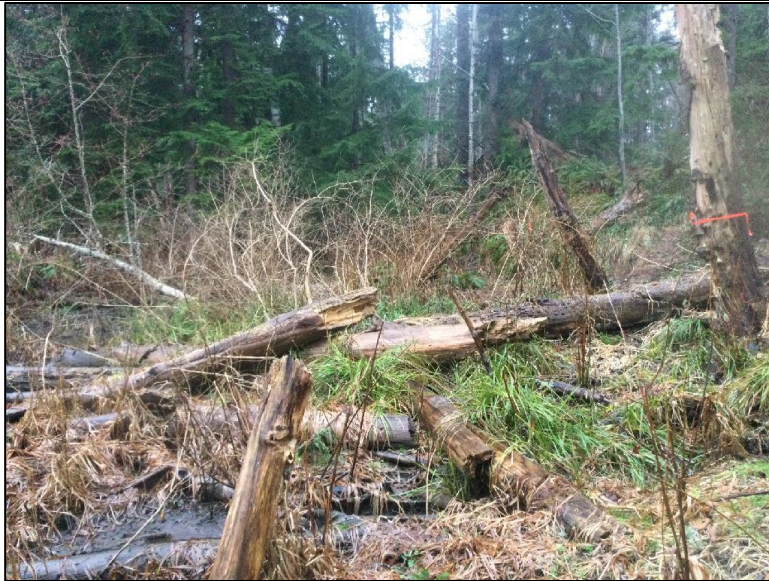
Label Photo 8, Wetland 1: View of Wetland 1. This area is dominated by a mix of reed canary grass, Himalayan balsam, salmonberry, horsetail, skunk cabbage and sedges.

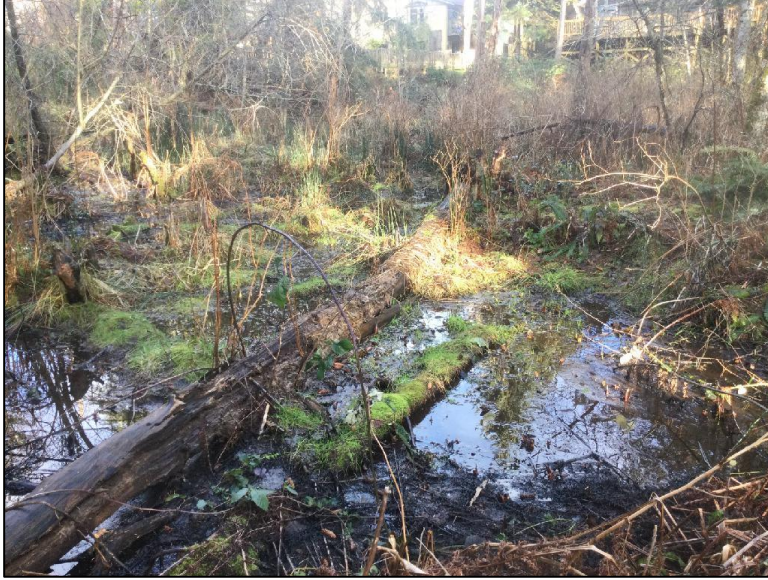
Label Photo 9, Wetland 4: View of Wetland 4. This area is dominated by salmonberry, skunk cabbage and horsetail.

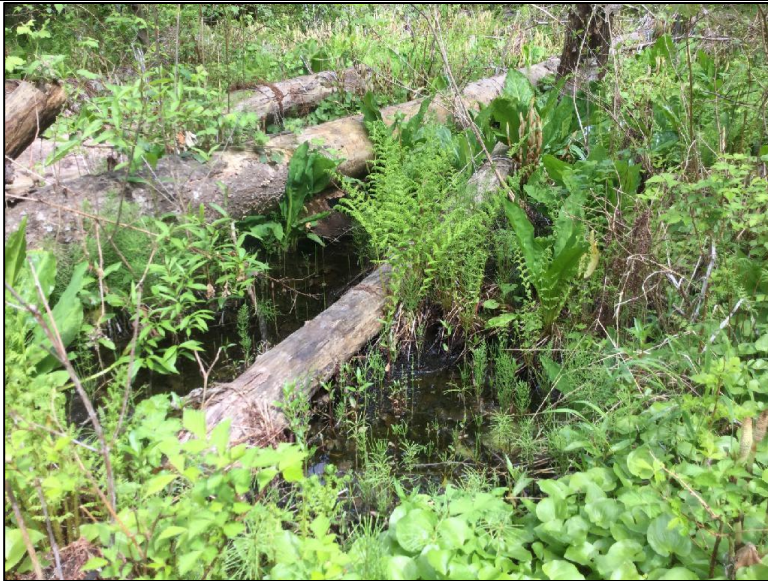
Label Photo 10, Wetland 5: View of Wetland 5, which is best described as a red alder – skunk cabbage swamp (Ws52).

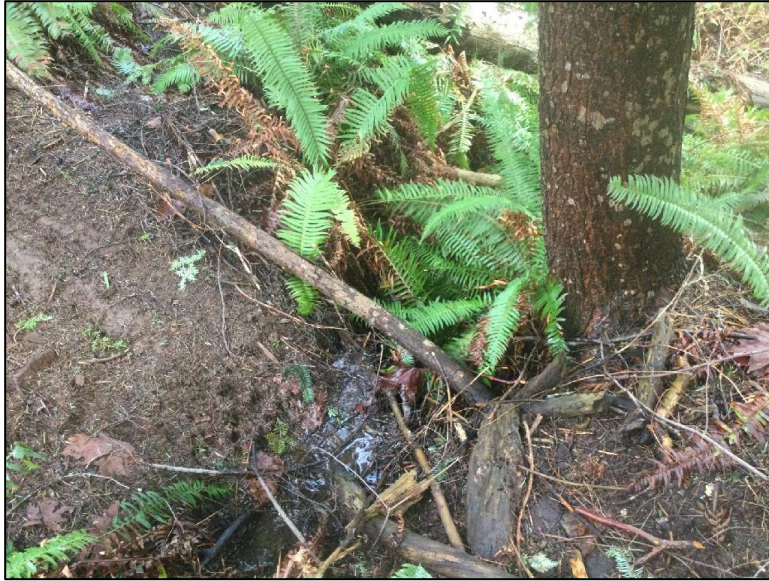
Label Photo 11, Wetland 5: Wetland 1 is connected to Simms Creek by a small non-classified drainage like waterway.

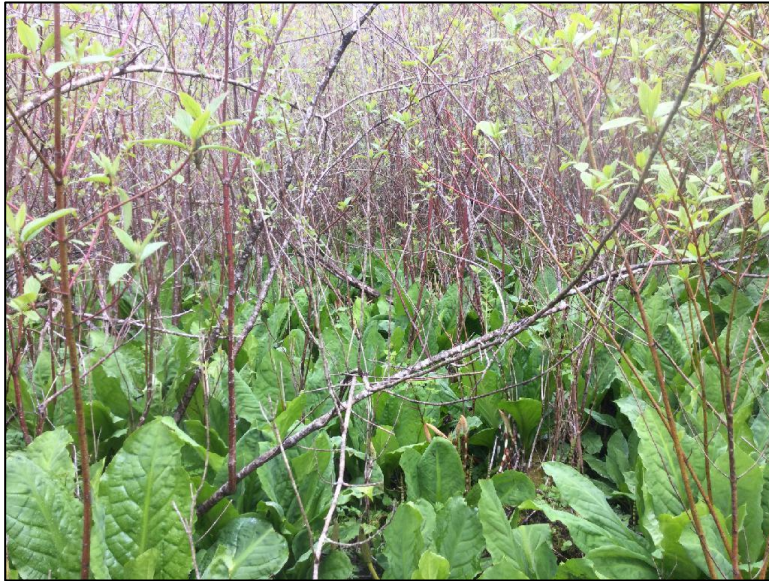
Label Photo 12, Wetland 6: View of Wetland 6 from the approximate center. The wetland is dominated by red-osier dogwood and an understory of skunk cabbage.

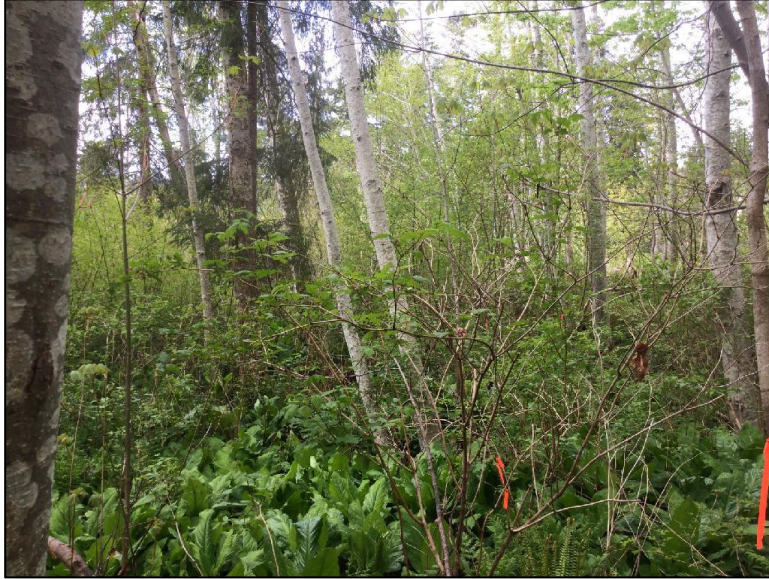
Label Photo 13, Wetland 6: View of Wetland 6 near the northern edge. Here the wetland has a young red alder overstory, with a salmonberry and skunk cabbage understory.

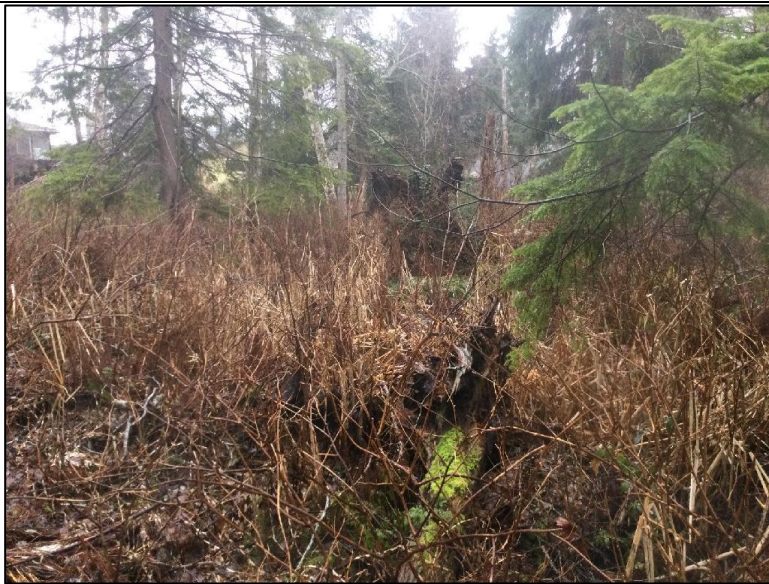
Label Photo 14, Wetland 6: View of Wetland 6 near the eastern edge. There is a small cattail wetland located within the wetland complex where standing water exists for longer periods of time.

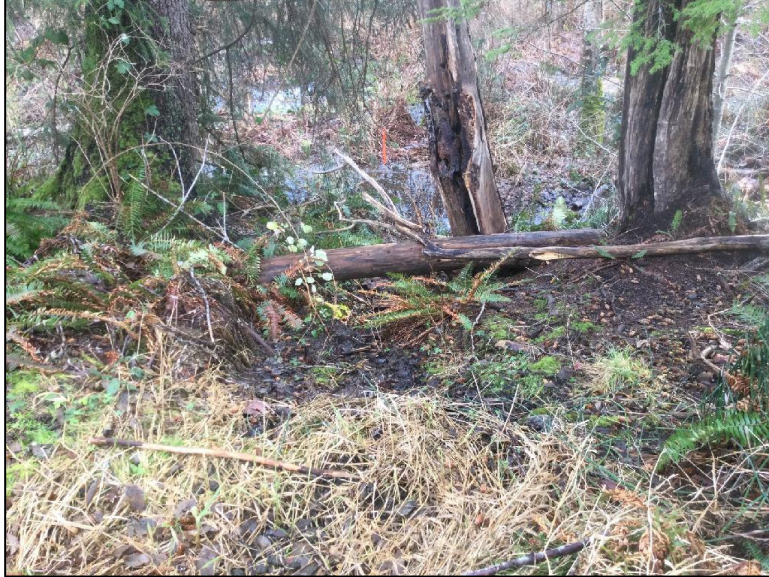
Label Photo 15, Wetland 6: View of a small seepage channel that connects Wetland 6 to Simms Creek. This is the southernmost connection, and is representative of the four other connections.

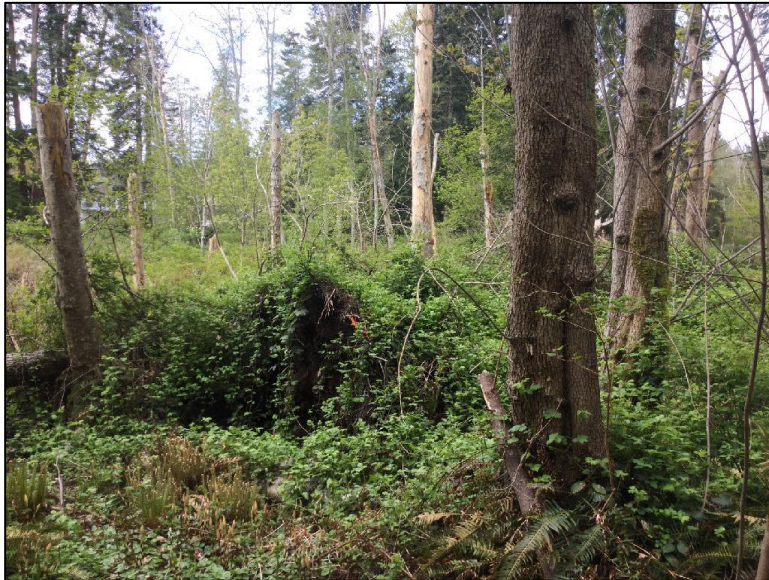
Label Photo 16, Wetland 6: View of the degraded portion of Wetland 6, where Himalayan blackberry has invaded and shaded out native wetland vegetation.

The SPEA along Wetland 6 has been degraded by the construction of an access road (historic logging road and spurs) and introduction of non-native species. The stand is composed of red alder and bigleaf maple; up to 20 m tall, up to 28 cm DBH, 1100 SPH. The understory is composed of swordfern, trailing blackberry (*Rubus ursinus*), daphne (*Daphne laureola* [invasive]) vanilla leaf (*Achlys triphylla*), bleeding heart (*Dicentra formosa*), rough moss (*Claopodium crispifolium*) and various grasses (Photo 18). Other non-native/invasive species that were noted within the SPEA include woolly burdock (*Arctium tomentosum*), yellow archangel (*Lamium galeobdolon*), and English holly (*Ilex aquifolium*).

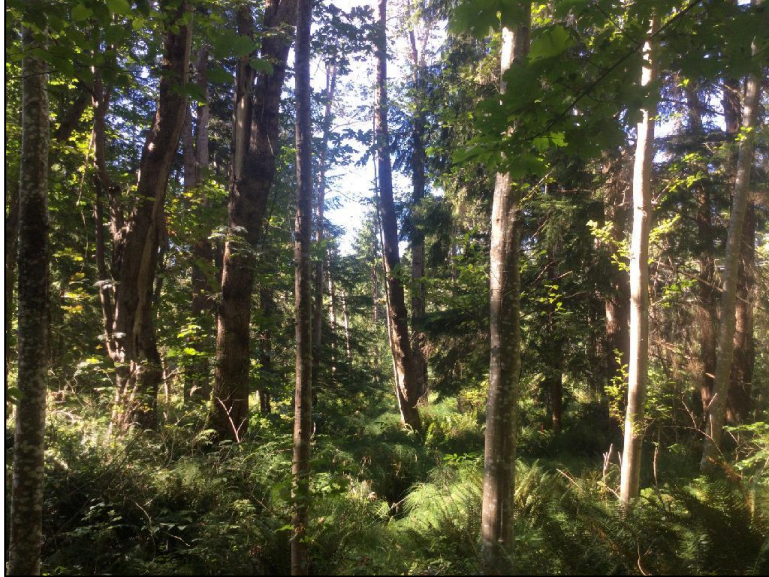
Label Photo 17, SPEA Condition: View of the SPEA along the northern portion of the subject property. The SPEA is composed of a mature forest type with a low number of non-native species.

The condition of the SPEA varies across the site. Along the northern portion of the SPEA, along Wetland 5, the SPEA is in a healthy condition with a low number of non-native species. The stand is composed of mature bigleaf maple (*Acer macrophyllum*) and Western hemlock; up to 27-33 m tall, up to 60 cm DBH, 200-400 stems per hectare. The understory is open and composed of swordfern (*Polystichum munitum*), giant horsetail, salmonberry, and red elderberry (*Sambucus racemosa*) (Photo 17). Lungwort (*Lobaria pulmonaria*) is established within the canopy.

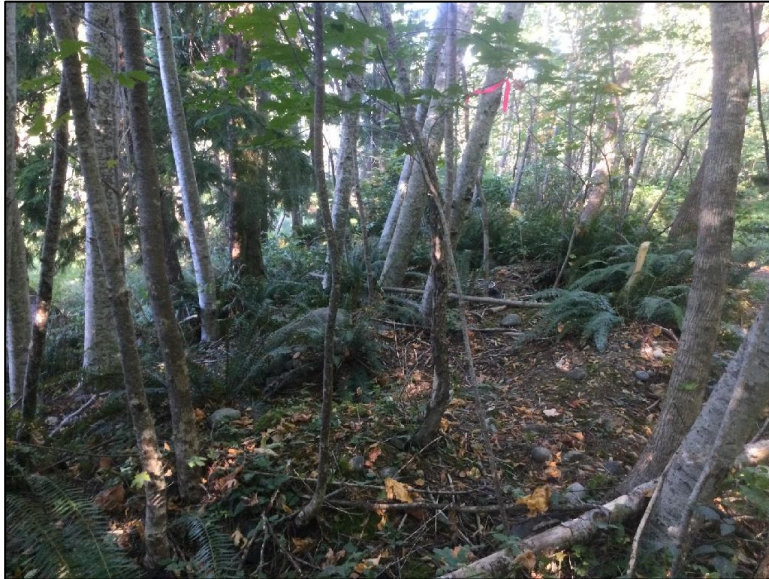
Label Photo 18, SPEA Condition: View of the SPEA along the central and southern portions of the subject property. The SPEA is composed of a young stand type along an old logging road and spur roads.
