NEW FAA-PMA FUEL GAUGES

**FAA-PMA
Stearman Fuel
Gauge**

Stearman Fuel Gauge

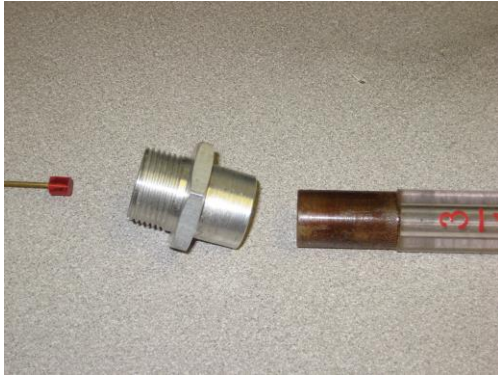
This is an example of what appears to be Shellac used to seal the sight tube to the retaining nut.

The fuel gauges that have been available in the past from different suppliers have had their share of problems. For example, we have seen the threads on the attaching nut of some gauges with pipe thread pitch, but pipe threads are tapered and the fuel tank has straight threads. The fuel gauges of the past have had sealing problems as well. When the tube is loosened to get the numbers to face the pilot it will start leaking then or in the near future. Previous gauges use putty or shellac to seal the tube and nut to keep it from leaking! Operators have tried everything from JB Weld to gasket setups to help keep these gauges from leaking.

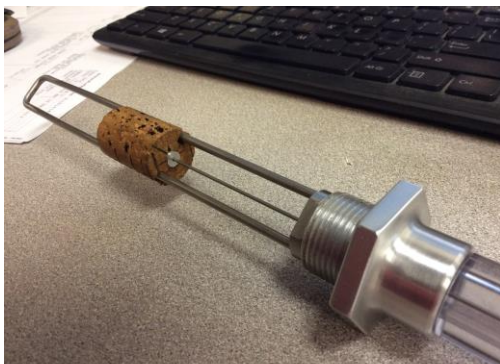
Retaining washer can be seen at the bottom of the float.

In studying the original Boeing prints, we discovered that there are two different fuel gauge models. The early style has a silver soldered joint in the cork guide wire and the later style is made of one piece. The later gauge also has a metal band at the end of the sight tube to stop the tube from splitting when the plug is screwed in. We decided that the new FAA-PMA gauge should incorporate all of the later improvements in the new design. The cork is also held in place mechanically, using an Aluminum washer crimped to the indicator wire. All of the original steel parts are manufactured with stainless steel.

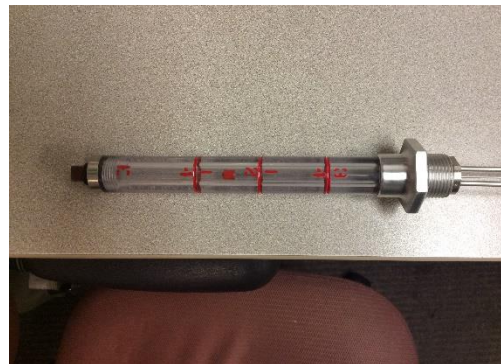
As can be seen in this picture the reinforcement ring at the bottom of the tube.

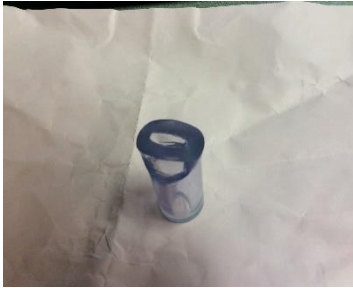
Sight gauge tubing material after being crushed flat in a vise. No cracks or breaks.

Next was several months researching plastics to find the best to make the sight tube. Through research it was found that the original material that Boeing use is still available. It is not affected by avgas and is not brittle like the Acrylics that have been used in the replacement gauges of the past. An order of six hundred feet of this material was required to get the I.D. O.D. dimensions needed to make the sight tube. One test of the tube material that we performed was pinching it in a vise to see if it would shatter like Acrylics. The results revealed no cracking or breaks in the tube. This we thought was a big plus in case of a bird strike on the gauge. This is probably one of the reasons Boeing used this material during production.

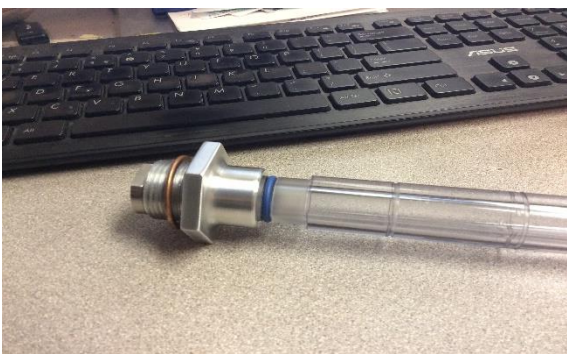
This shows the O-Ring seal installed at the top of the sight tube to create a positive seal.

The leaking problem with these fuel gauges was the next problem to solve. We designed the top portion of the tube to accept an O-Ring seal. We experimented with two O-Rings instead of one, but found that two can cause problems getting O-Rings to seal properly. The one ring seal has proven superior. We are using the best material available for the sealing ring. At the same time the upper portion of the tube was redesigned so it was adjustable. This change makes it so the sight tube can be turned after installation so the numbers face the pilot. No loosening is required, just simply turn it with your fingers and leave it.
