INSPECTION REPORT

For the Property at:
82nd AIRBORNE ST
ST. PETERSBURG, FL 33703

Prepared for: Farrah Faucet
Inspection Date: Tuesday, June 28, 2022
Prepared by: Derle Parmer HI11344

RE: Report No. 1312
82nd Airborne St
St. Petersburg, FL
33703

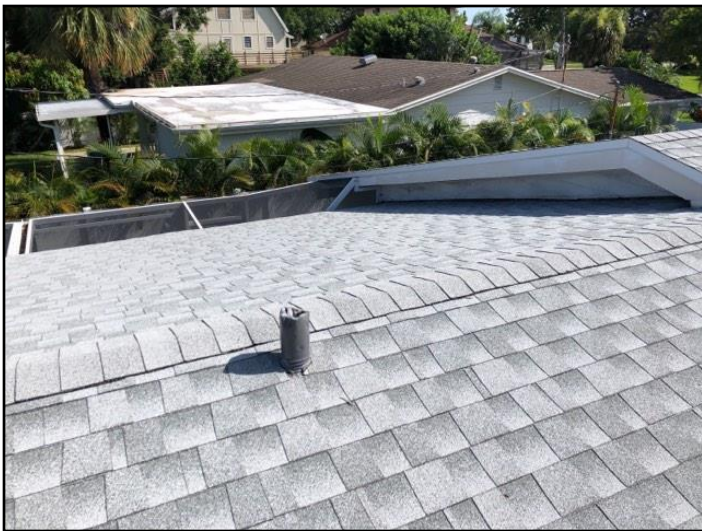
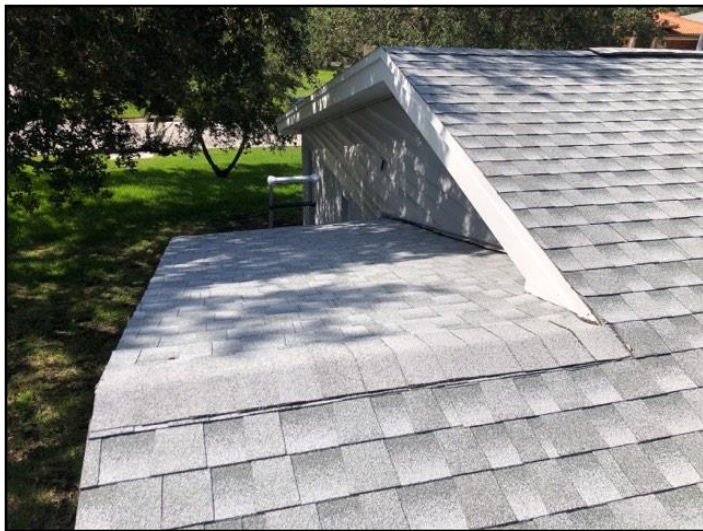
1. Condition: • Caulk/ Sealant Cracked. Seal with appropriate caulk to protect structure and prolong roof life.

Implication(s): Water damage and premature roof failure.

Condition: • Caulk/ Sealant Cracked. Seal with appropriate caulk to protect structure and prolong roof life.

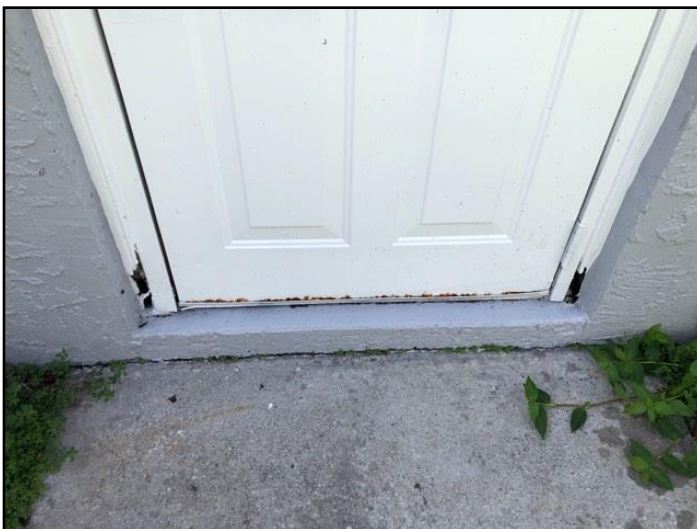
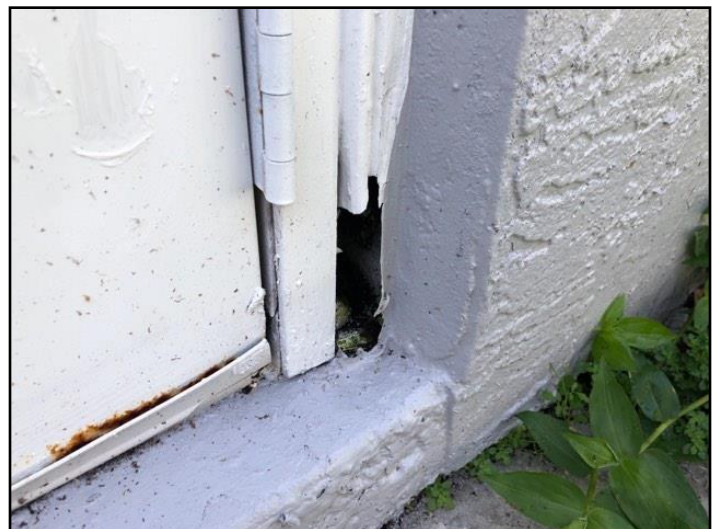
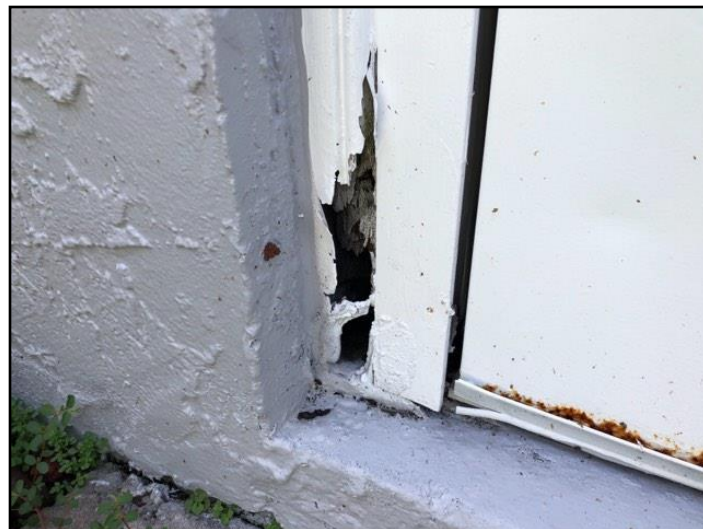
3. Condition: • Water damage on door or door frame.

Implication(s): Chance of damage to finishes and structure

Task: Repair,

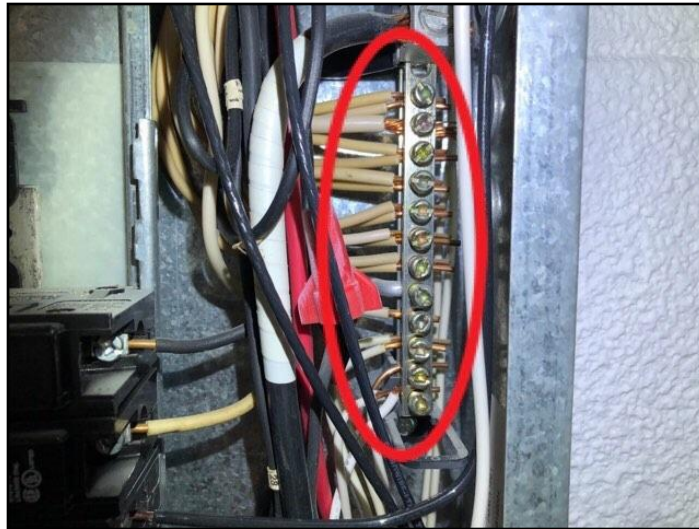
5. Condition: • Double Tapped Neutrals

Implication(s): Electrical shock / Damage to equipment / Fire hazard

Task: Repair, 4-Point Failure

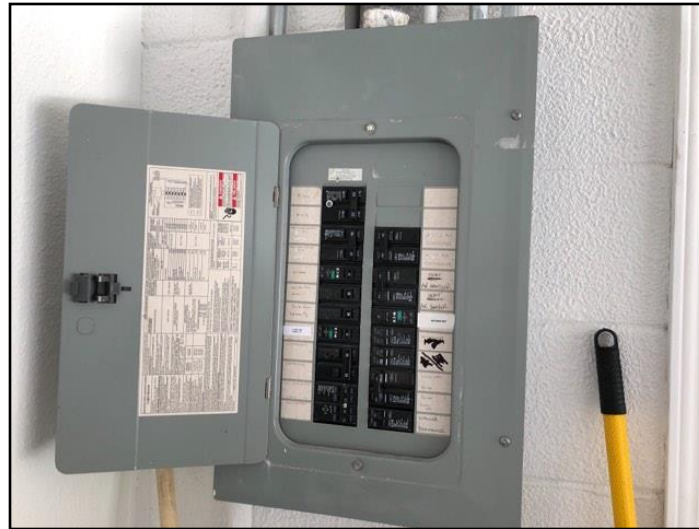
Breakers not properly labeled

Condition: • Circuits not labeled

Implication(s): Safety hazard | Risk of electric shock

Task: Correct, 4-Point Failure

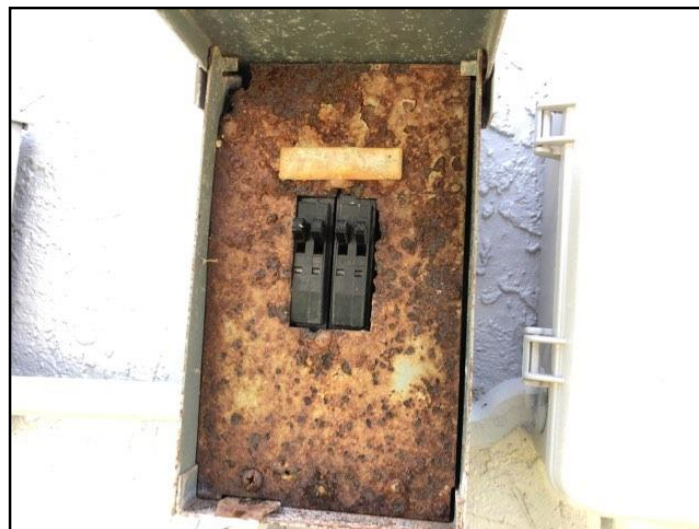
7. Condition: • Electrical panel severely corroded
Implication(s): Electrical shock / Equipment damage / Fire hazard
Location: Pool Elect Subpanel
Task: Replace,
Time: Immediate,

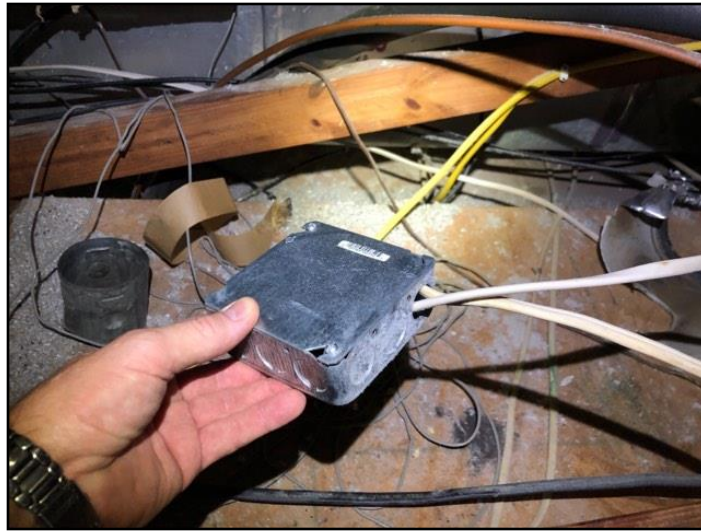
8. Condition: • Not properly secured
Junction box not properly secured to structure to prevent damage to wire and component.
Implication(s): Electric shock | Fire hazard
Task: Repair, 4-Point Failure
Time: Immediate,

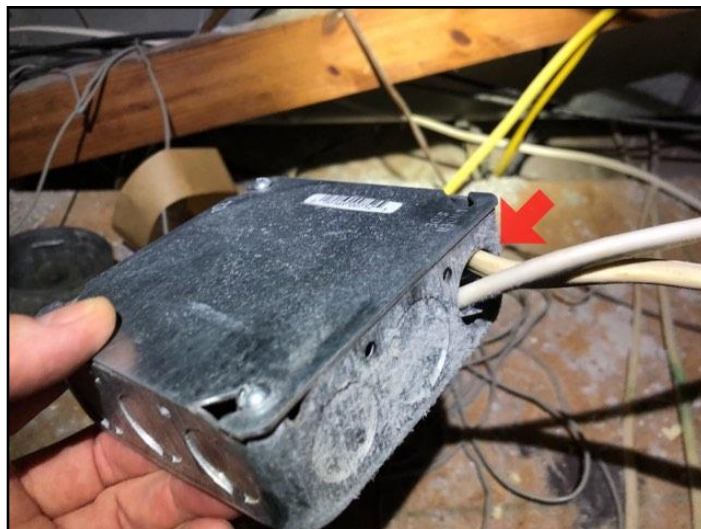
9. Condition: • Strain Relief Clamp missing

Strain relief clamp (wire clamp) protects wire from sharp edges that will damage the sheathing and cause an electrical shock or equipment damage.

Task: Correct, 4-Point Failure

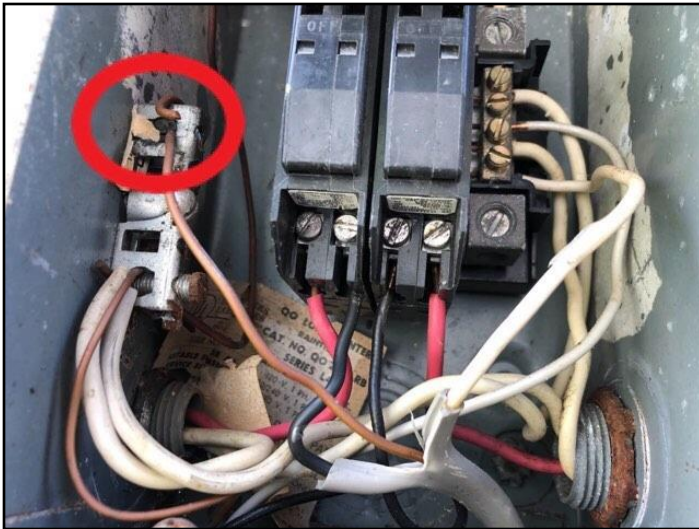
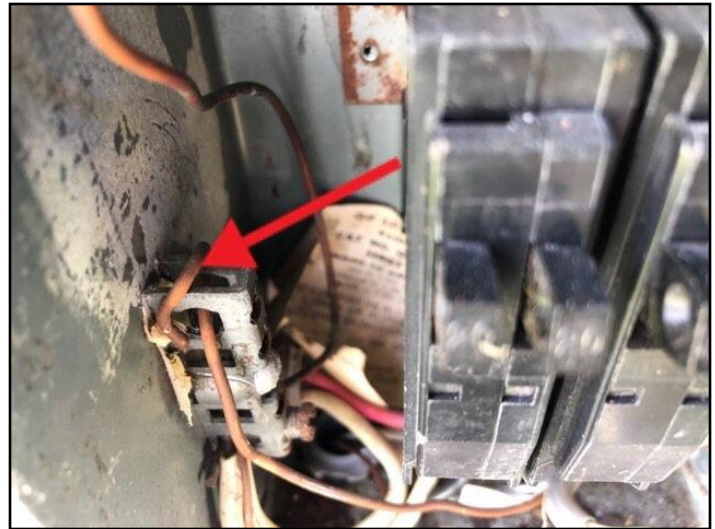
10. Condition: • Ground wire not connected

Location: Pool Elect Subpanel

Task: Repair, 4-Point Failure

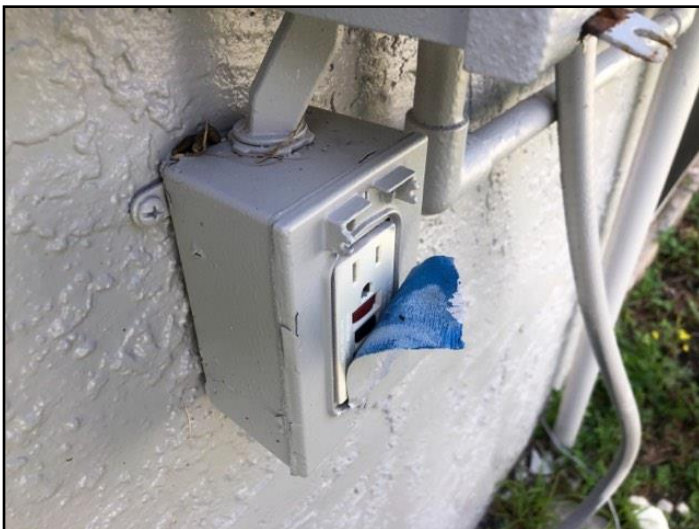
11. Condition: • Weatherproof outlet cover missing or damaged. Replace cover.

Cover missing beside pool pump

Task: Replace, 4-Point Failure

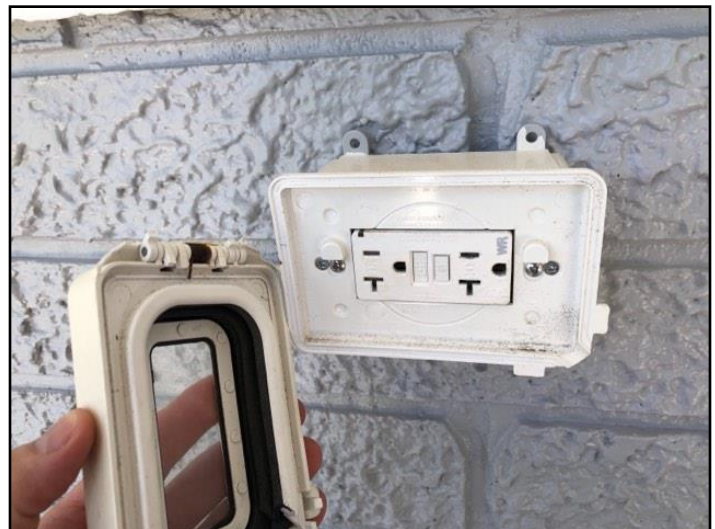
Cover broken at front entrance

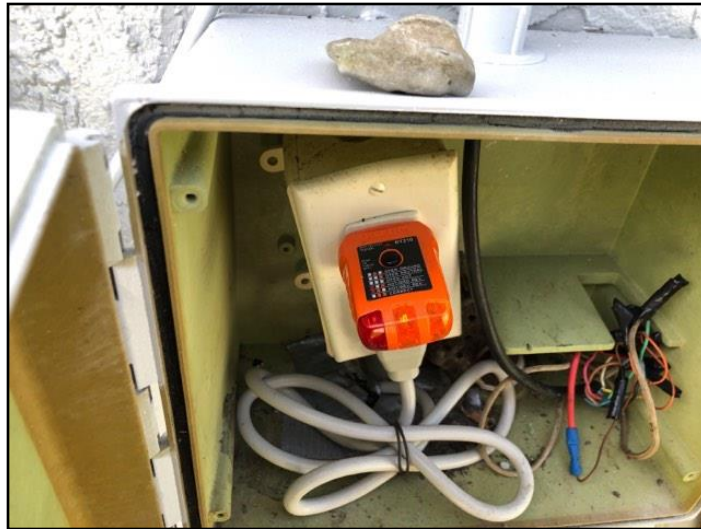
13. Condition: • GFCI Test button faulty
Implication(s): Electric shock
Location: Hallway Bathroom
Task: Replace, 4-Point Failure
Time: Immediate,

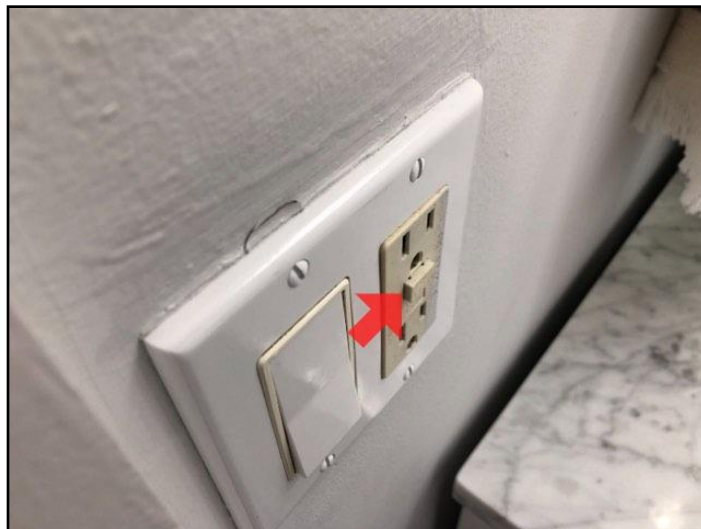
Failing GFCI receptacle

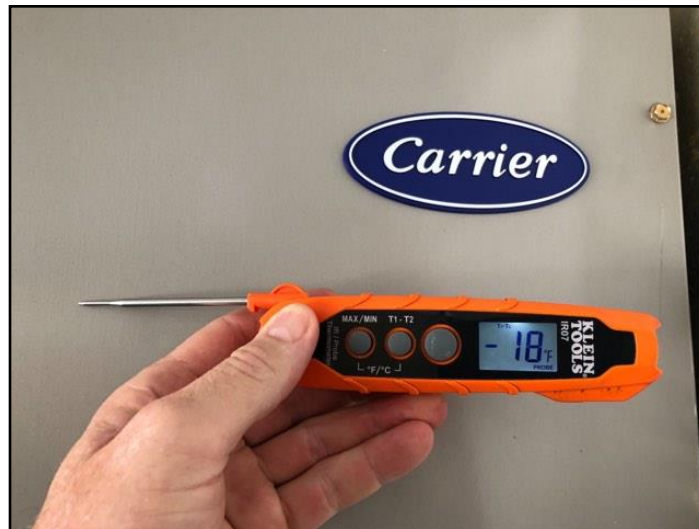
- Acceptable temperature difference: estimated 14° to 22°. A basic temperature differential is determined by measuring the temperature on each side of the air handler coils. These values are subtracted from each other to determine the temperature differential and give a basic indication of the unit's operation.
- 18°

- This suggests good performance. Regular service and monthly filter replacement is recommended to ensure reliability of the system.

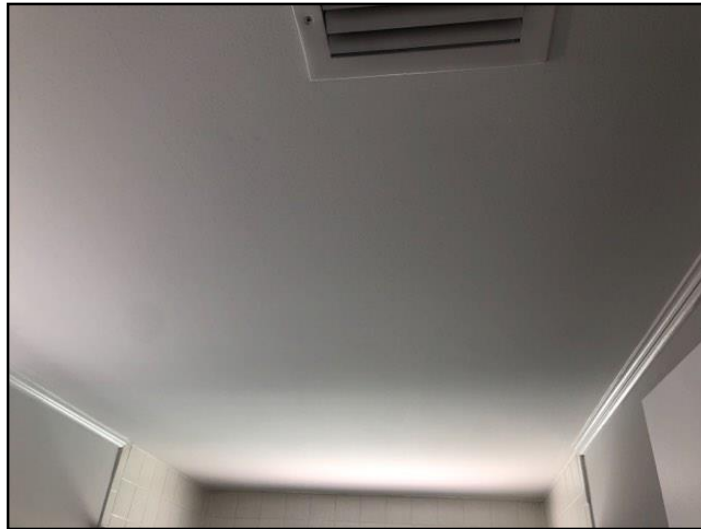
Exhaust fan not installed

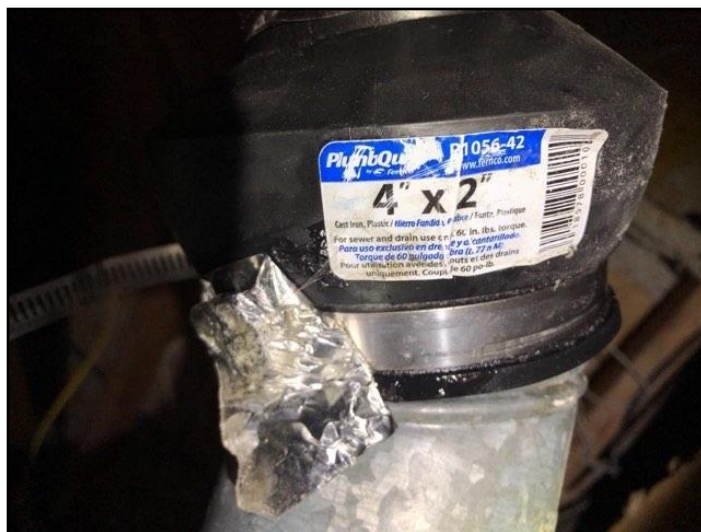
20. Condition: • Tankless water heater exhaust incorrectly connected. The connection requires an appropriate connector for the different sizes that fully seals dangerous fumes. The rubber connector is also not intended for this use as marked on the label (For sewer and drain use only).

Wrong connector for exhaust connection

Task: Replace,

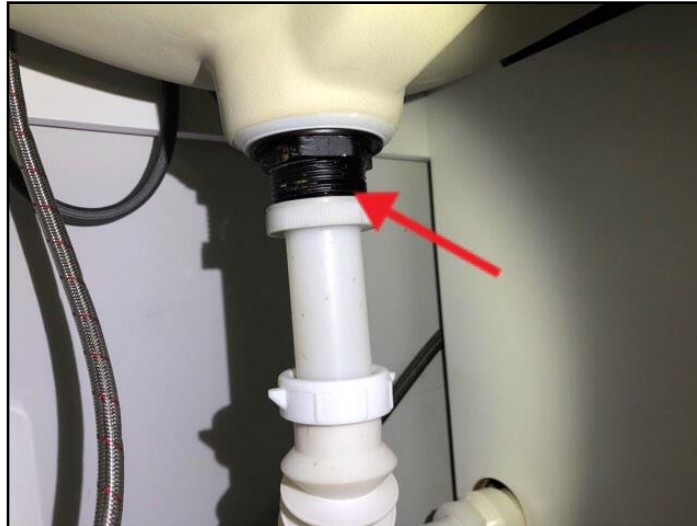
Implication(s): Water damage to cabinets and/or structure

22. Condition: • Leak

Task: Repair, 4-Point Failure

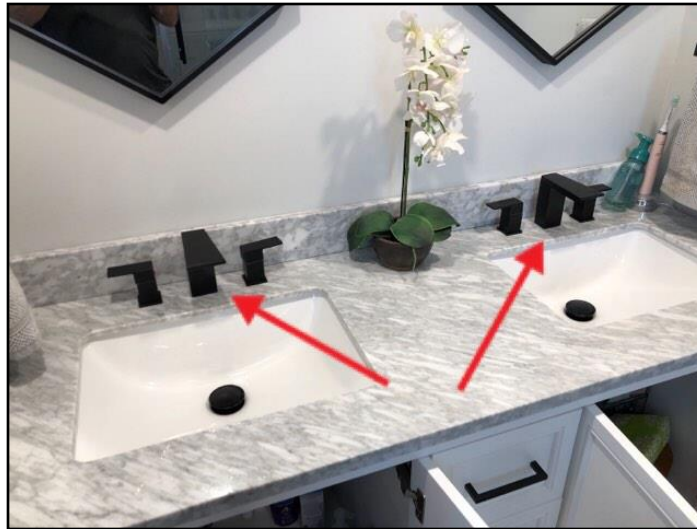
25. Condition: • [Hot and cold reversed](#)

In typical installations, Hot is on the left and Cold is on the right. Reversed hot and cold lines are an inconvenience and are typically corrected by reversing the supply lines under the sink if accessible. A bathtub/shower diverter plumbed backwards may be more difficult if not accessible. Consult a licensed plumber for correction options.

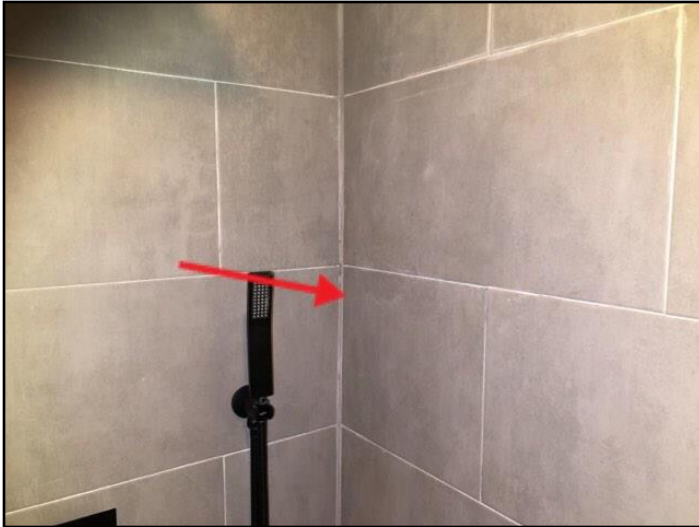
29. Condition: • Windows in a shower require more frequent periodic maintenance to prevent damage to the structure. All seams, joints and trim of caulked or grouted surfaces should be sealed properly. Recommend a frequent inspection and repair worn areas as needed.

Location: Master Bathroom & hallway bathroom

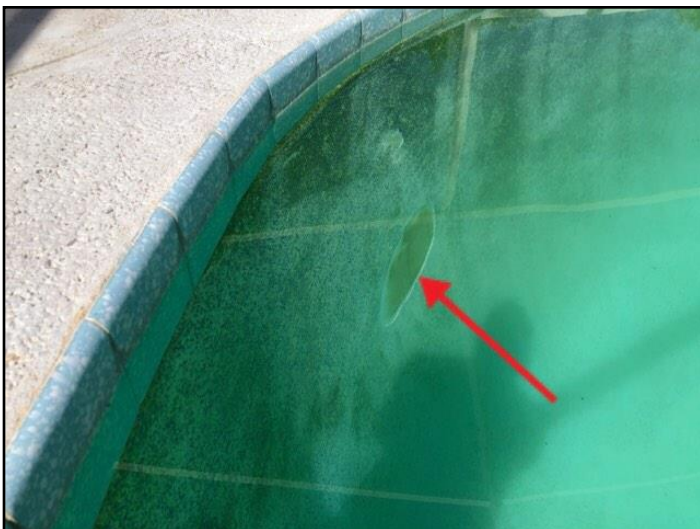
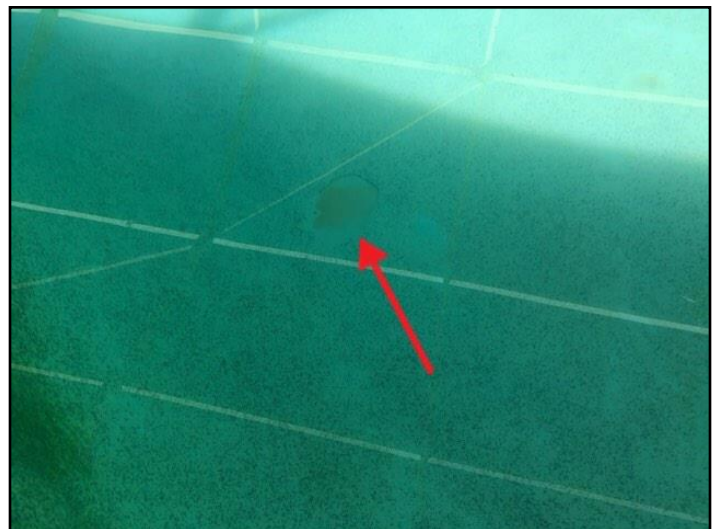
33. Condition: • Surface defects noted

Task: Repair,

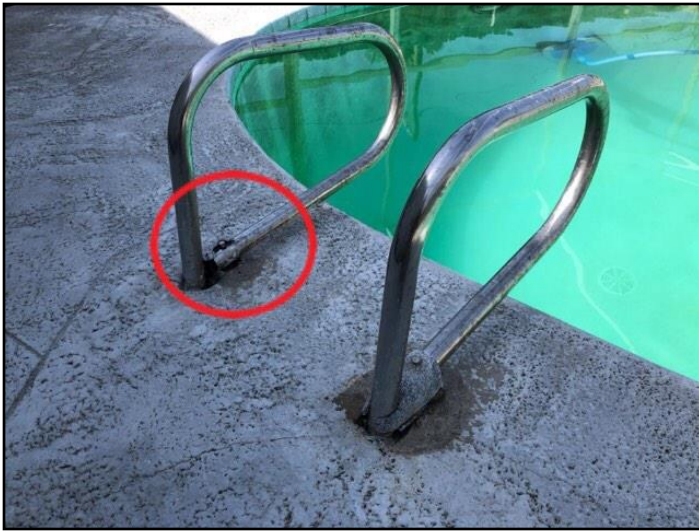
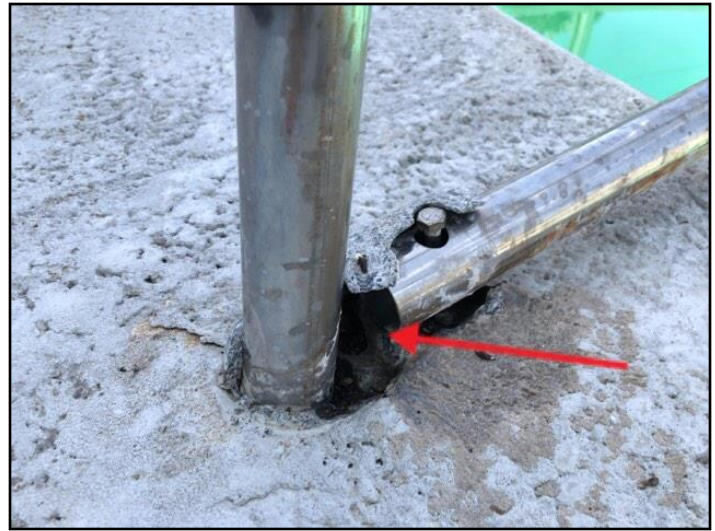
34. Condition: • Pool ladder components excessively corroded.

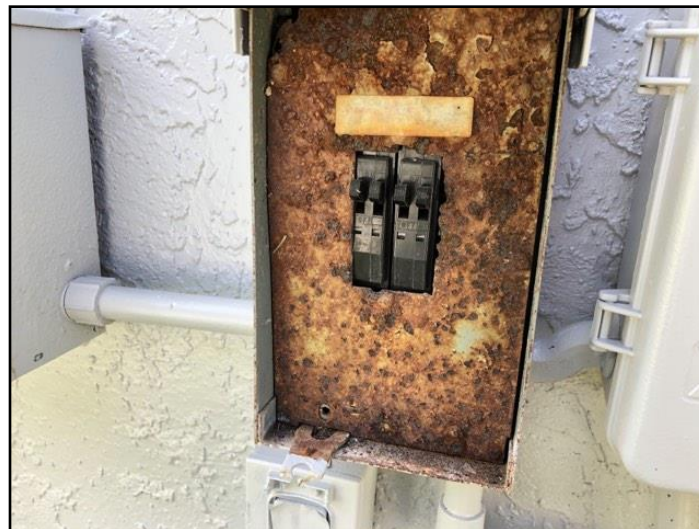
Pool motors and equipment are required to be connected to a GFCI breaker at some point in the system. No GFCI was found in the circuit, either in the pool panel or the main panel. Recommend installation of a high quality GFCI breaker to protect occupants.

35. Condition: • Pool GFCI breaker missing/ not identified.

No pool GFCI breaker found during inspection

Task: Repair,

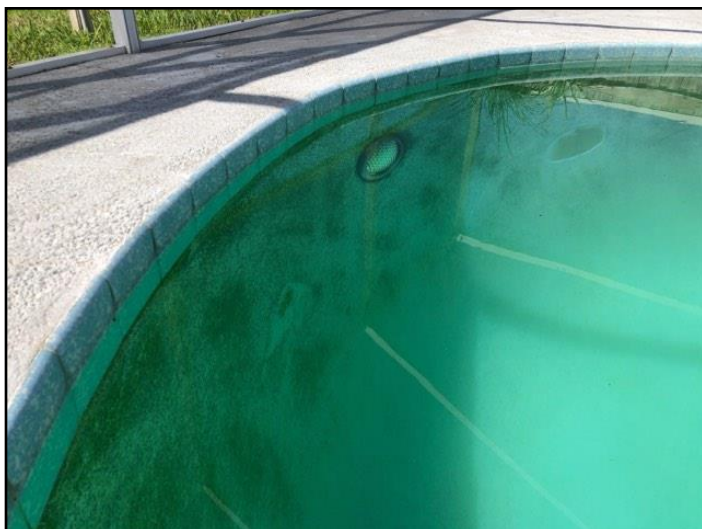
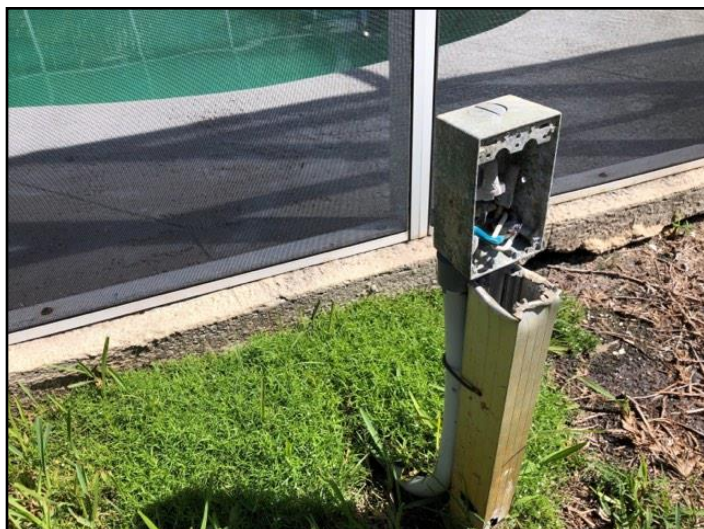
Light junction box corroded

Light should be repaired to ensure proper connection for pool electrical system.
