TECH TALK

Factory Sending Unit Modification for External Electric Fuel Pump

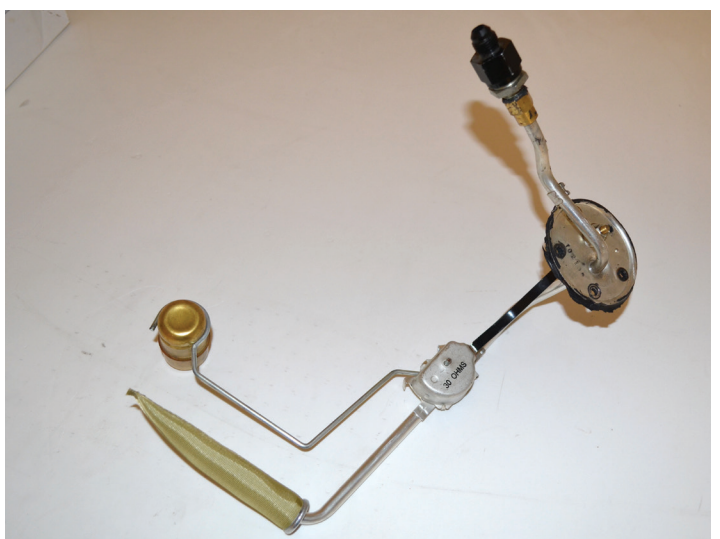
Unfortunately no one makes a wagon tank with an in tank pump so for our project Wagonie we chose to use a new Golden Star GT13-553 (Photo #2) wagon tank and modify it to work with our EFI engine. First we added a bung for a return line to be hooked to. It is the next step that hurt us! Most aftermarket pump manufactures say right in their instructions that the "sock" that is on the pick-up tube must be removed prior to installing the sending unit, so we did just that. The reasoning is that due to the extreme pull that an electric pump has compared to a mechanical pump the sock can get sucked into the pick-up tube and restrict fuel flow. Most instructions go onto say that

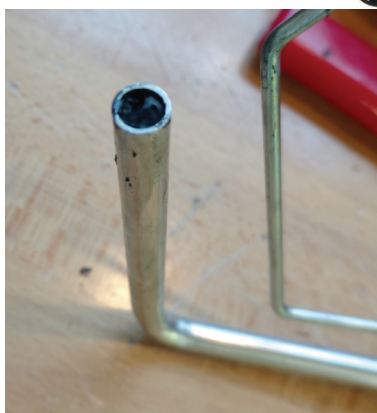
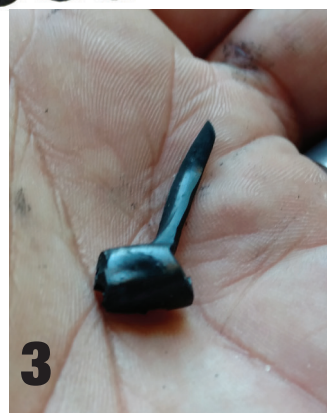
What was found when pulling the sending unit was alarming. A piece of RTV silicone had gotten lodged in the pick-up tube (Photo #3). How did it get there? Only guess is that when the sending unit was put on I normally put a small bead of RTV around the unit where the screw holes are to prevent fuel leaks. A small amount of RTV must have pushed through one of the holes and ended up in the tank. When RTV comes in contact with fuel it swells to about 4 times its normal size and once it got sucked into the pick-up tube it was only a matter of time before the fuel stream was restricted enough to cause an issue (Photo #4).

Now that I have described the how the problem happened I will tell you the solution that I came up with. First off I dropped the tank and completely rinsed it out to be sure there were no other possible issues that could come back to bite me later on. Then I came up with a solution to the "sock" not being able to be used in this type of application. Since the pick-up tube has only one 3/8" opening it is
