# Confidential Inspection Report

LOCATED AT:  
1022 7th St  
Hermosa Beach, California 90254

INSPECTED ON:  
Tuesday, December 20, 2022

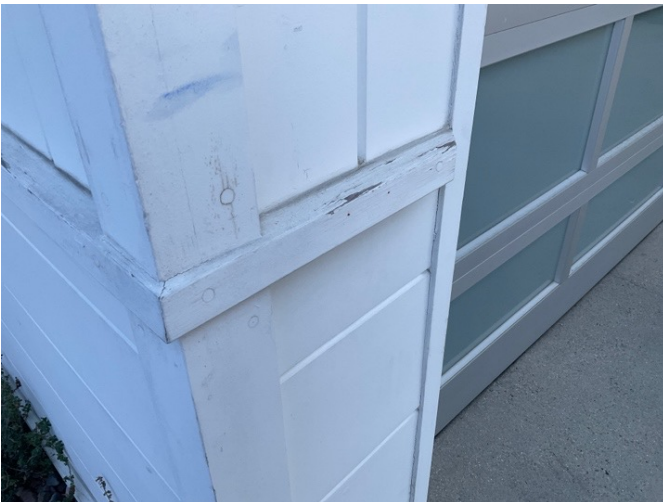
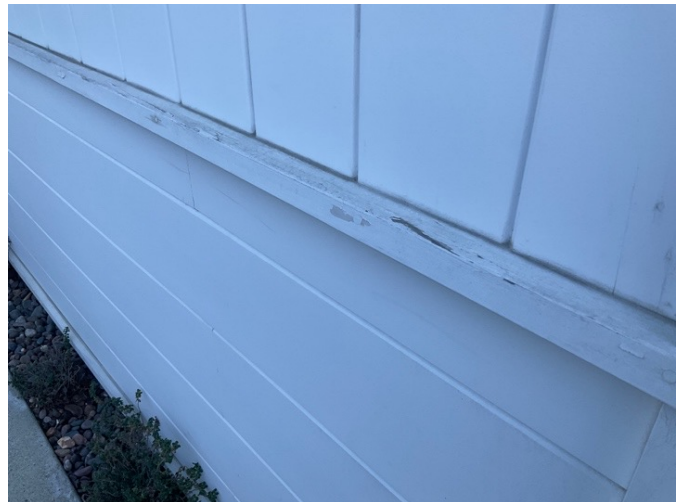
**22:** The siding will soon be in need of preparation and painting or refinishing as areas are peeling and exposed wood is present.

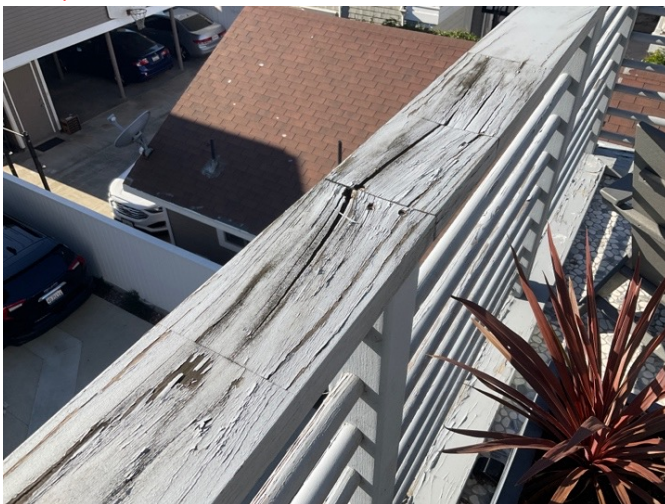
**31:** Degraded wood was noted at the balcony guardrail (consult a licensed termite inspector for further evaluation of this and any other wood related problems as we are not qualified in this field).

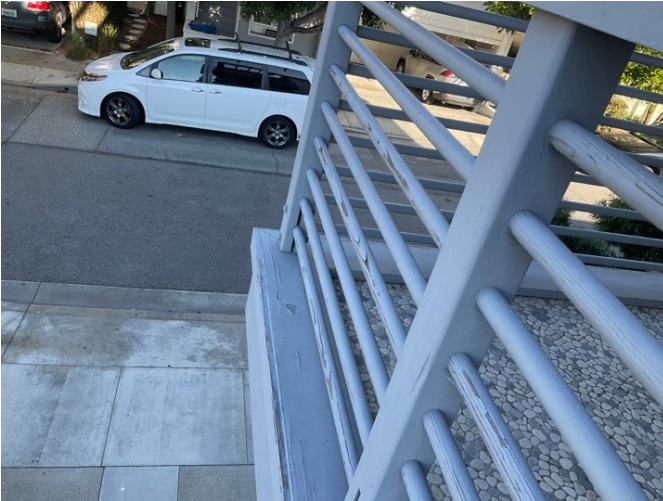
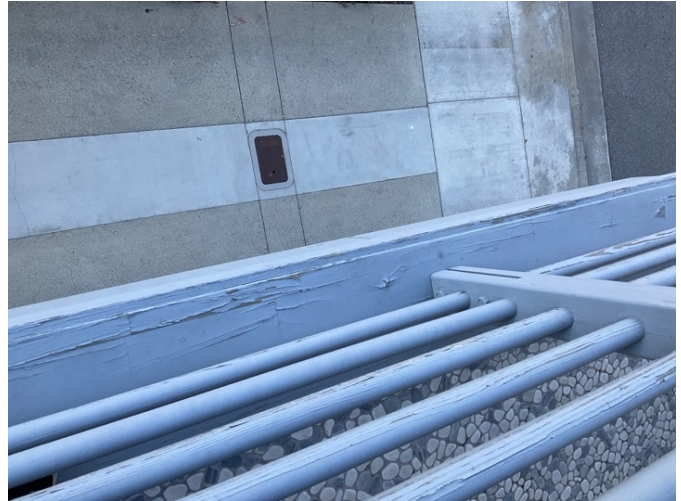
**32: Preparation and painting or other finish work are needed at the guardrail.**

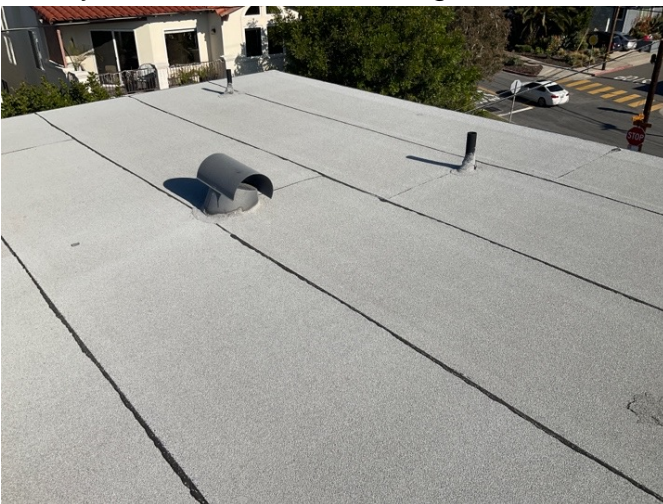
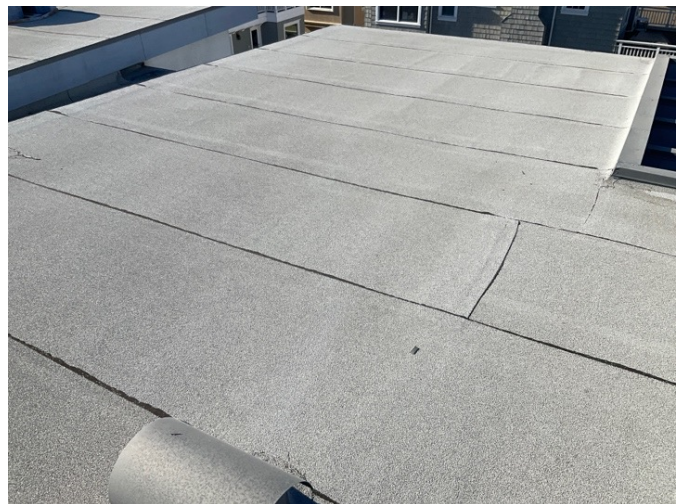
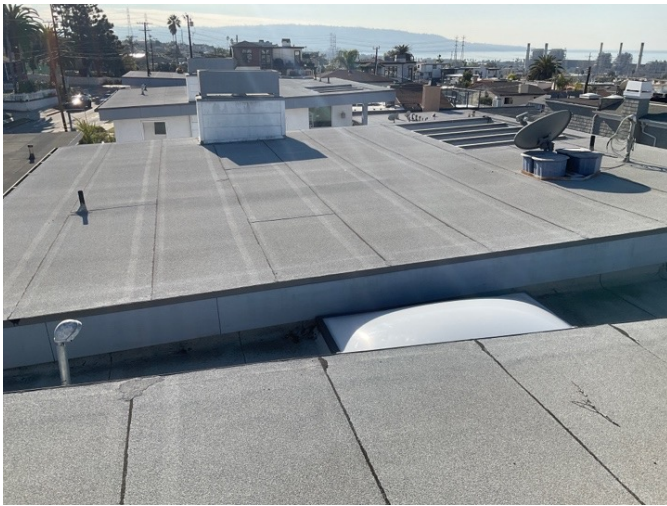
**48:** Cap sheet is used as a roof covering. Their life expectancy will vary depending on the type and weight of the cap sheet as well as the weight of and number of layers of asphalt paper that underlay the cap sheet. These type of roofs are low-pitched and therefore do not usually drain efficiently. Low pitched roofs must be kept clean and maintained. Our inspection does not include any guarantee against leaks. For such a guarantee, you would need to have a roofing company perform a water-test and issue a roof certification. The sellers or the occupants will generally have the most intimate knowledge of the roofs repair history. You should ask them about its history and then schedule a regular maintenance service.

**49:** The cap sheet roof appears to be approximately 5 to 7 years old, but this is just an estimate. You should request the installation permit from the sellers which will reveal its exact age and any warranty or guarantee that might be applicable.

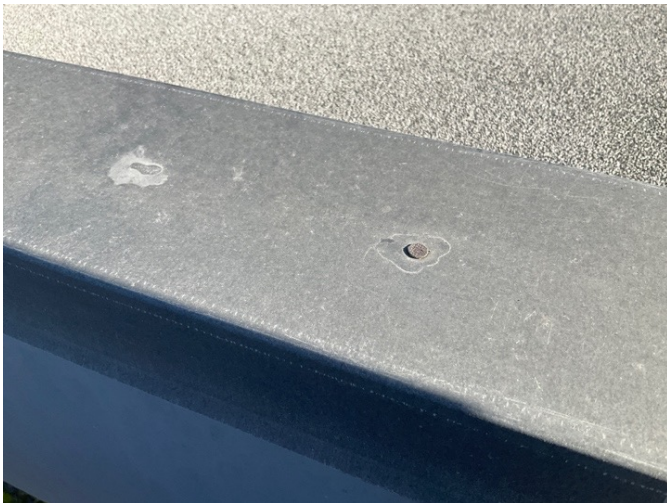
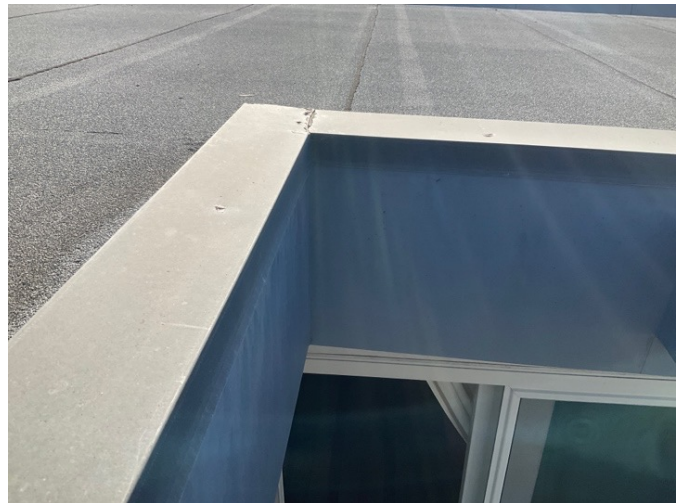
**52:** The exposed fasteners at the flashings should be re-sealed to prevent possible water intrusion.

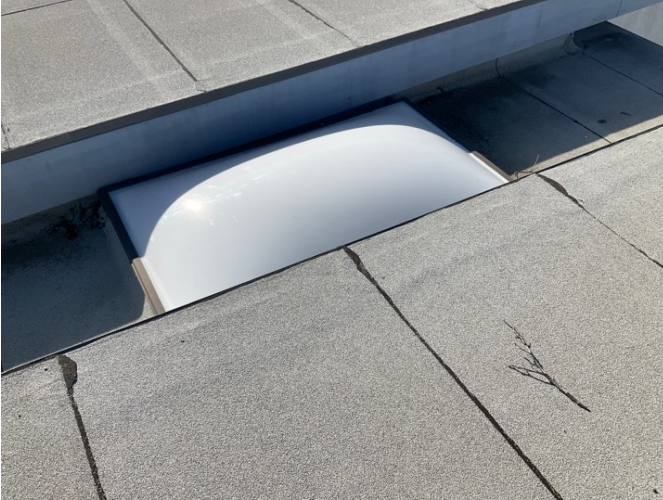
**53:** The roof includes one or more skylights. Skylights can be problematic and are a common point of leaks. Although there was no evidence of leakage at the time of our inspection, the seller should be consulted to determine if leakage has ever been an issue with these particular units. Regular maintenance is recommended.

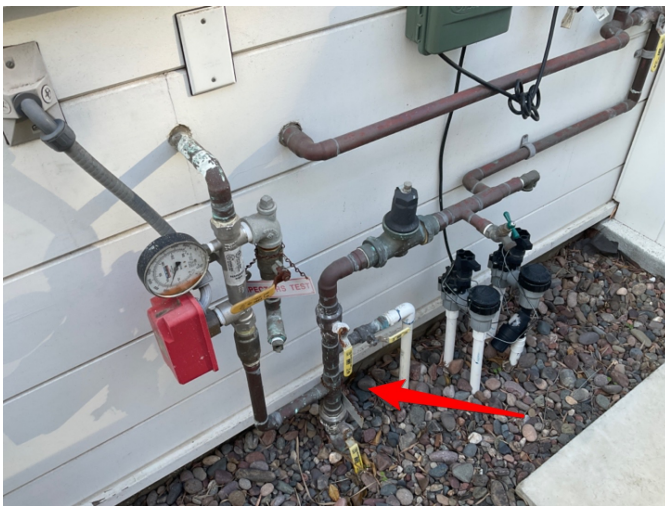
**58:** The main water shut-off valve is located in the east sideyard.

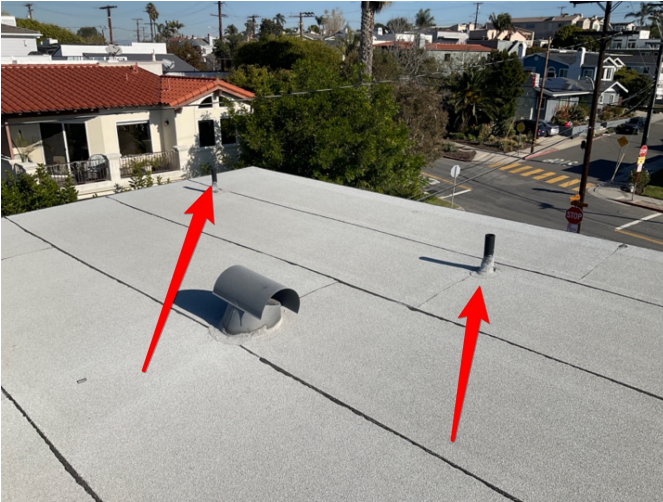
**68:** The portion of the vent pipes that are exposed above the rooftop are required to be painted to protect them from ultraviolet rays.

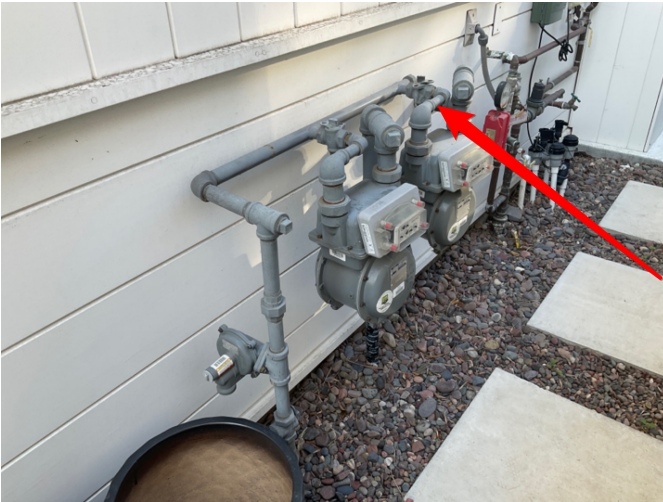
**70:** The gas main shut-off is located in the east sideyard.

**71:** The gas main is not equipped with a seismic shut-off valve. Although its presence may not be required by the local building authority, we recommend that you consider having one installed.

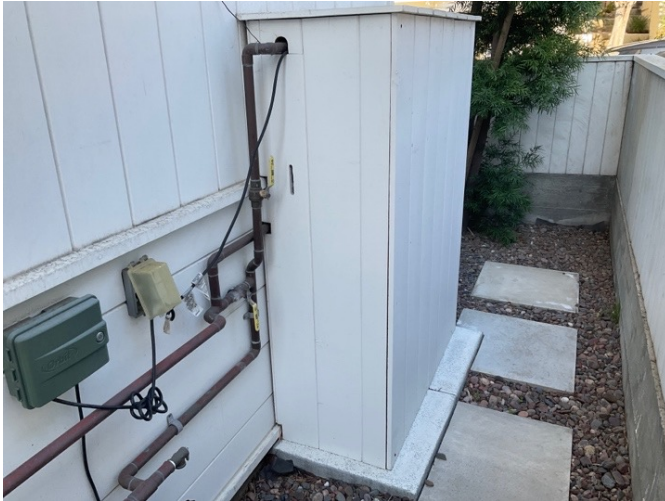
**76:** The plumbing system includes a water softener. Some water softeners are owned and maintained by the owners, others are leased and maintained by the lessor. The water softener and its components are excluded from our inspection and were not examined or otherwise evaluated.

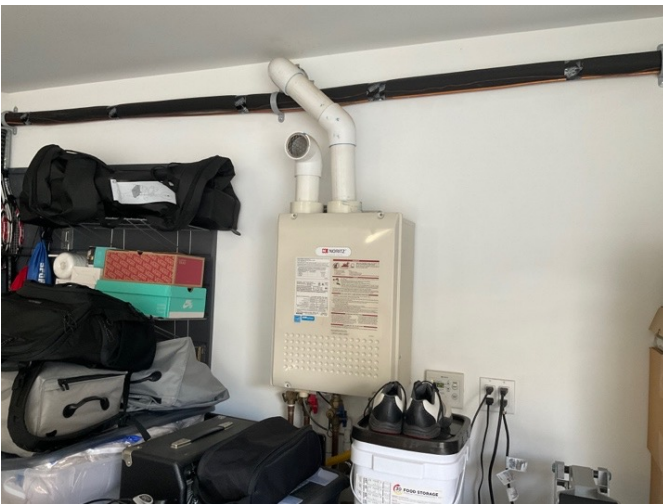
**77:** The water heater is a 'tankless' system that uses natural gas for fuel. This on demand, or "use it as you need it", water-heating technology is more energy efficient than conventional water heaters which use a tank to store heated water. Tankless water heaters produce an endless supply of hot water by rapidly heating water the moment it is needed. Because there is a limit to how much water can pass through the system at a time, it is important that you organize your hot water tasks one after another as a tankless water heater is not as effective when more than two tasks draw from it at one time. You should question the sellers about the water heater and its ability to provide sufficient hot water for the home, as this determination is beyond the scope of our inspection for this type of system.

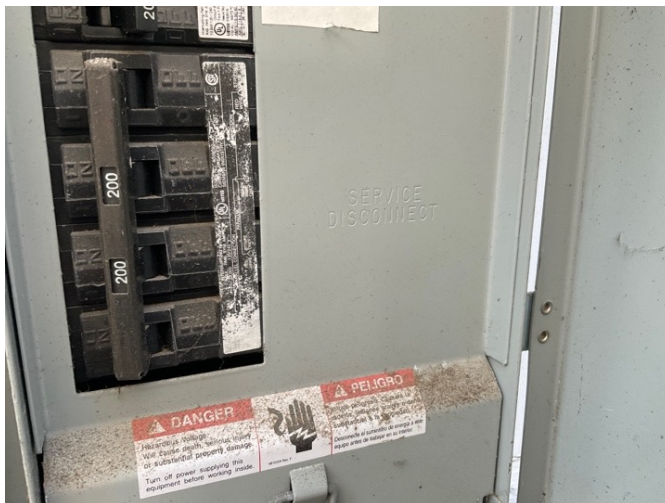
**89:** The residence is served by a 200-amp, 120/240-volt panel.

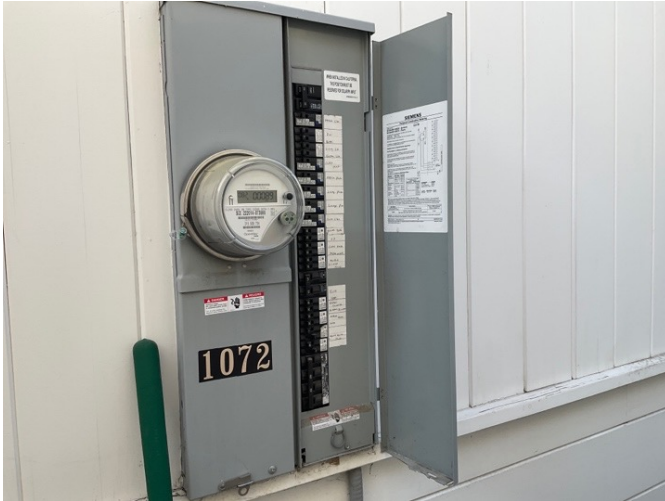
**92:** The main panel and its components appear functional and in serviceable condition.

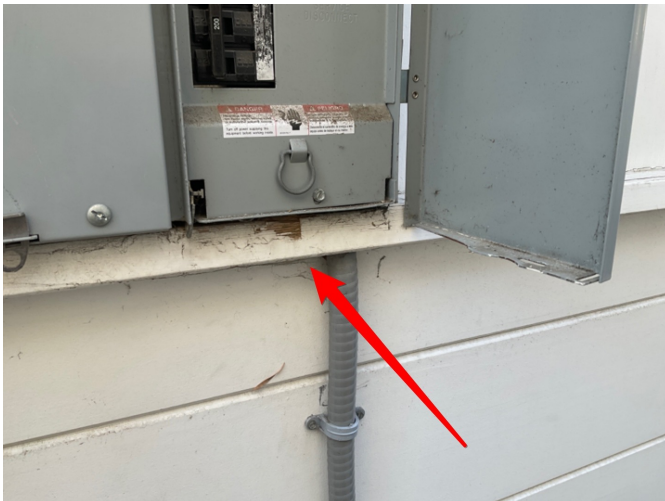
**94:** The exterior cover is difficult to open due to the wall siding trim.

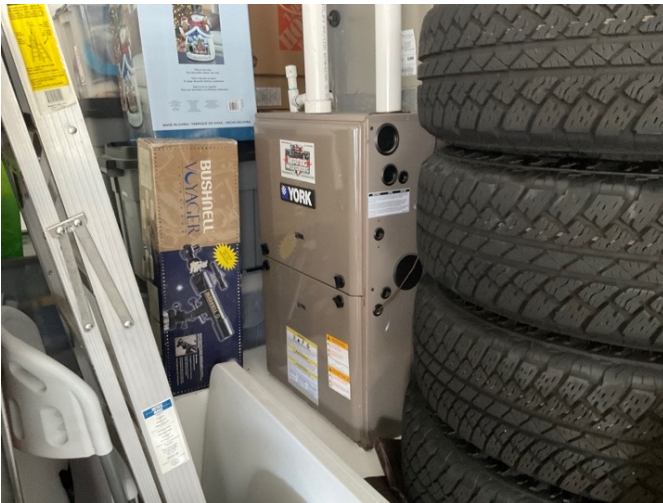
**109:** Comfort heating is provided by a gas-fired direct-vent forced-air furnace. Forced air furnaces operate by heating a stream of air moved by a blower through a system of ducts. Important elements of the system include the heat exchanger, exhaust venting, blower, controls, and ducting.

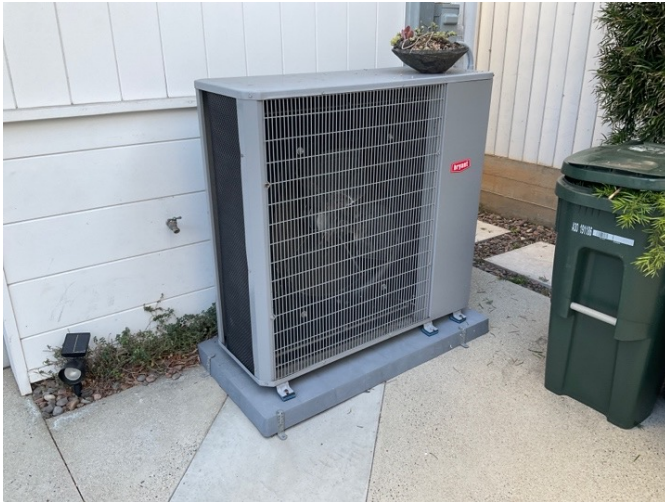
**117:** Comfort cooling is provided by an electric split system.

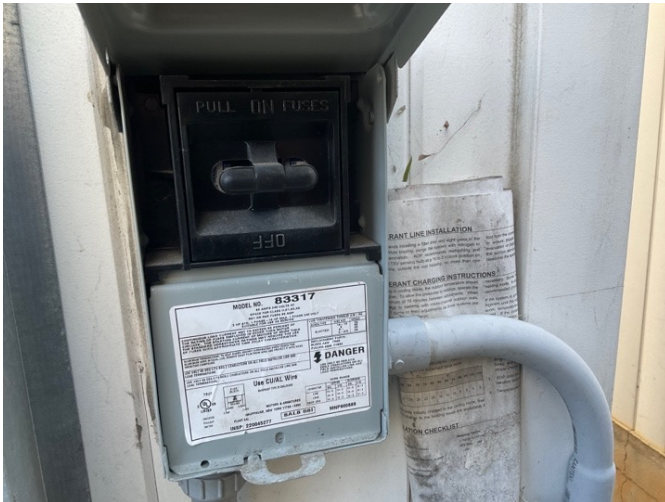
**122:** The electrical disconnect at the compressor/condensing coil appears functional. We can not determine if the fuse installed within the disconnect is sized properly.

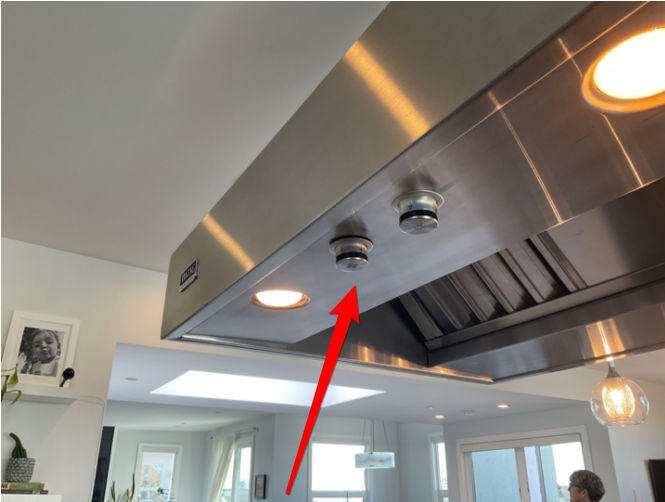
**135:** The kitchen exhaust fan control knob is loose and should be serviced.

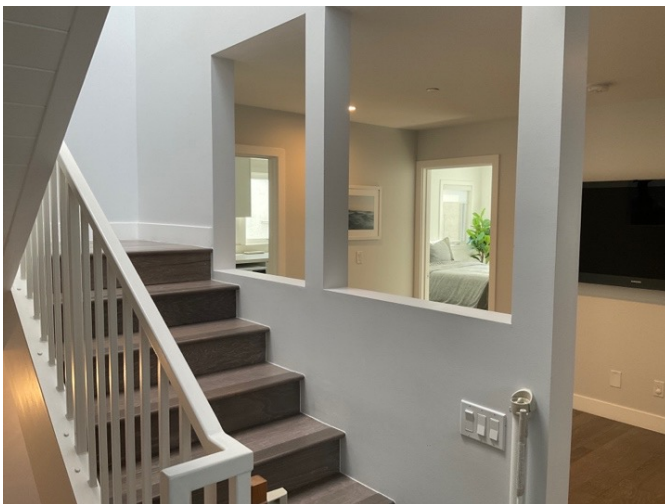
**268:** There is no guardrail at the open side of the stairway. This is an essential safety feature that should be added.

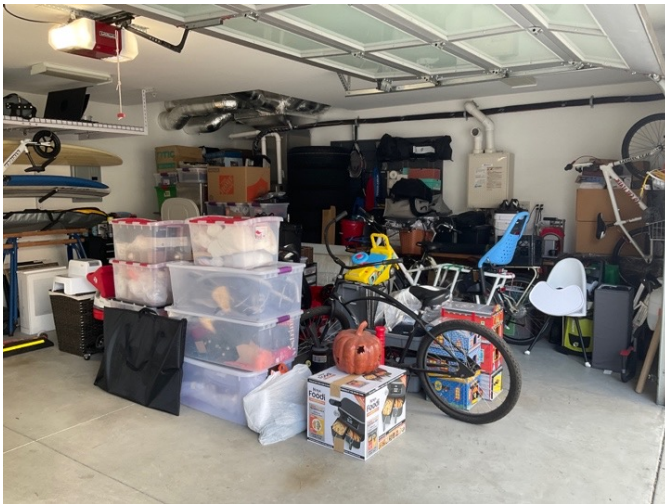
**273:** We were unable to view all areas of the floor slab and other components within the garage due to heavy storage.

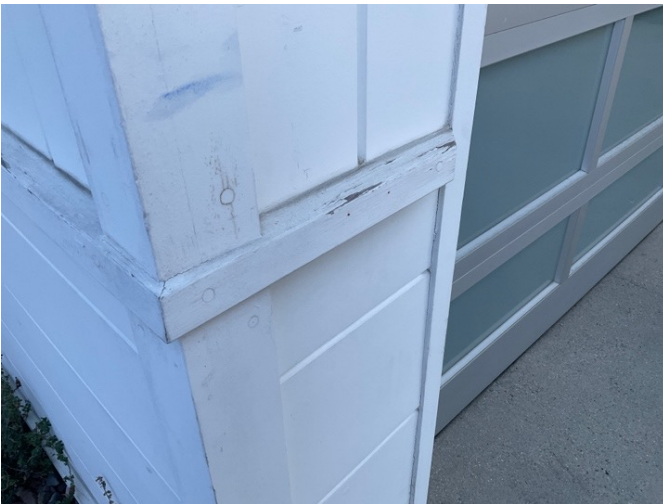
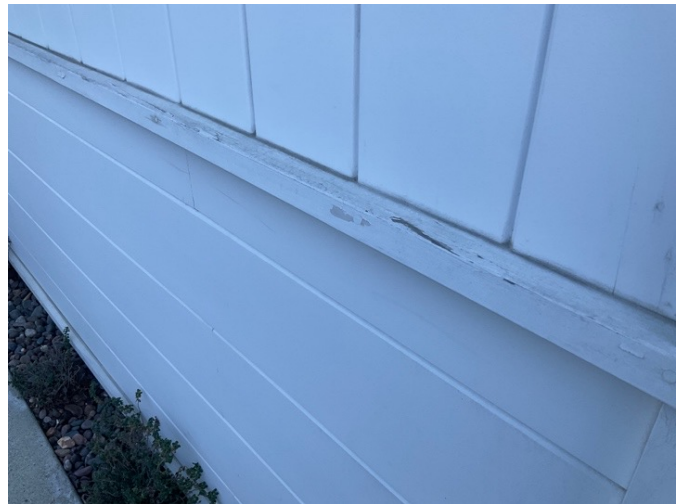
**s-22:** The siding will soon be in need of preparation and painting or refinishing as areas are peeling and exposed wood is present.

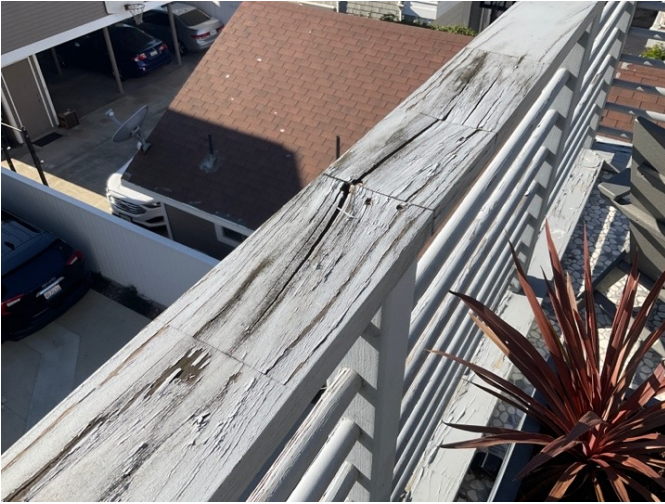
**s-31:** Degraded wood was noted at the balcony guardrail (consult a licensed termite inspector for further evaluation of this and any other wood related problems as we are not qualified in this field).

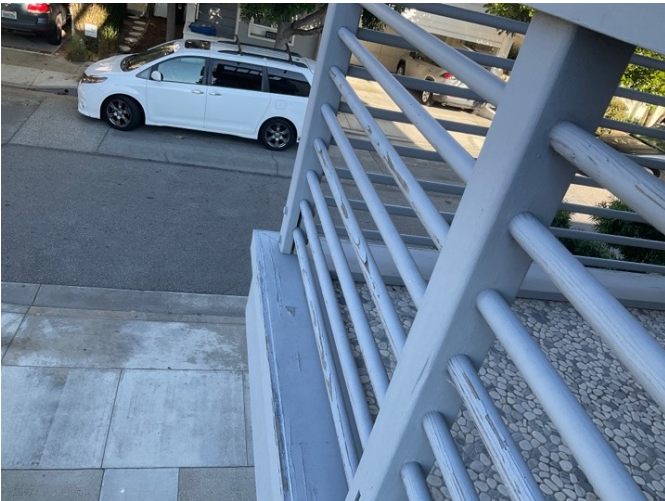
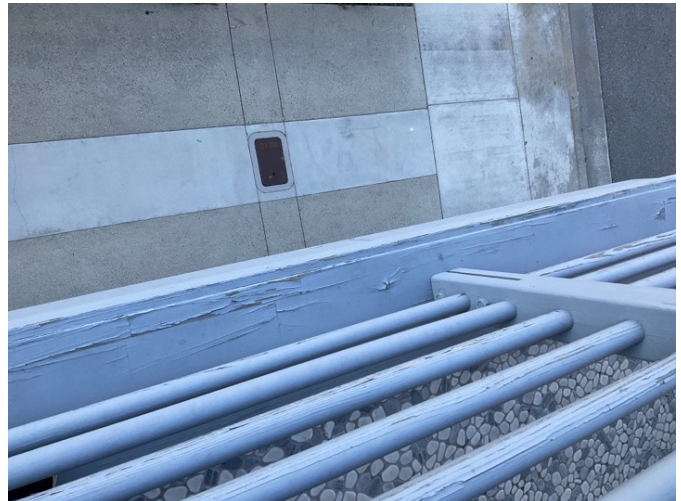
**s-32:** Preparation and painting or other finish work are needed at the guardrail.

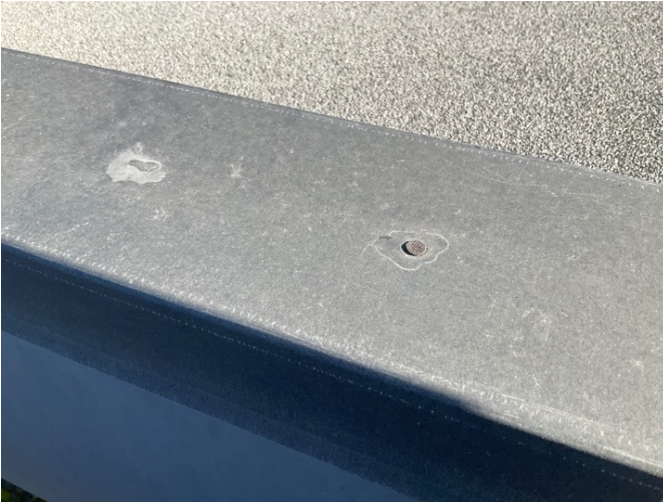
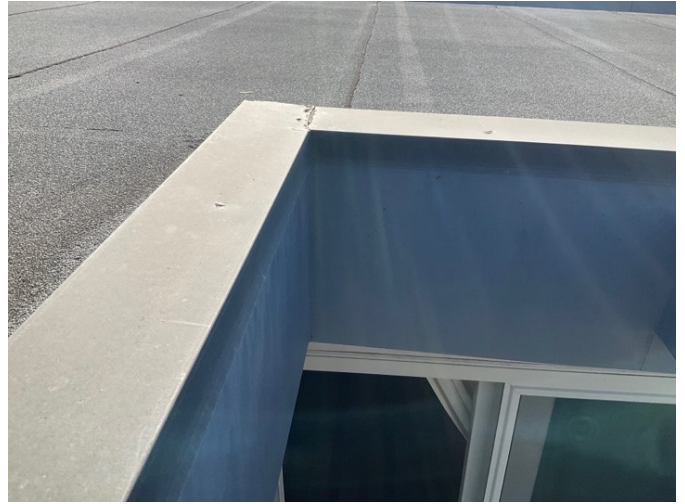
**s-52:** The exposed fasteners at the flashings should be re-sealed to prevent possible water intrusion.

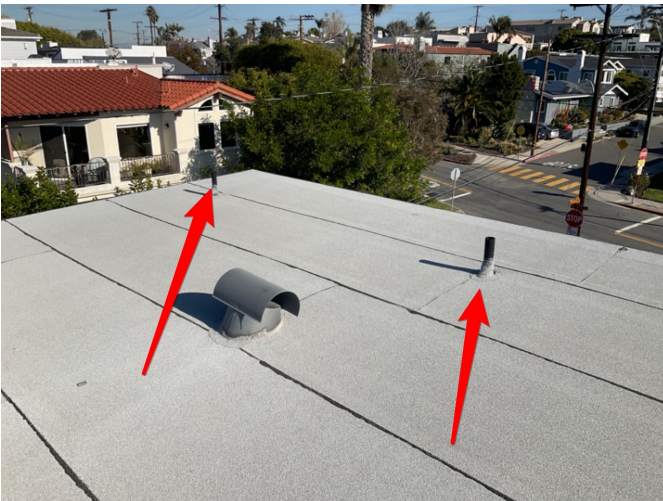
**s-68:** The portion of the vent pipes that are exposed above the rooftop are required to be painted to protect them from ultraviolet rays.

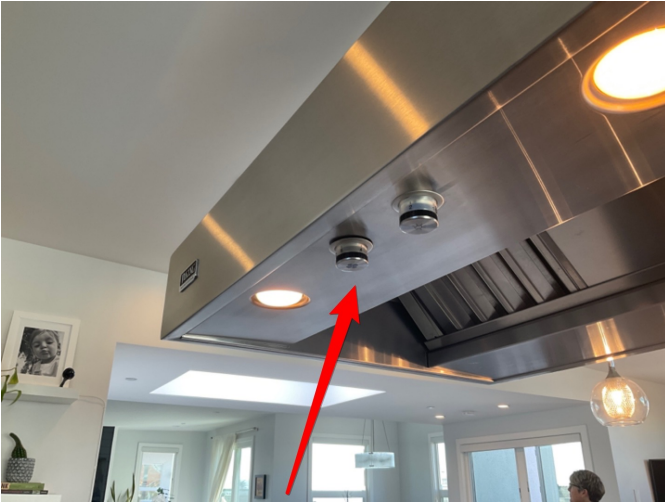
s-135: The kitchen exhaust fan control knob is loose and should be serviced.
