# Little Traverse Lake 2020 Aquatic Plant and Algal Survey Final Report

Prepared by Kelsey Froelich, Biologist

In collaboration with Freshwater Solutions, LLC

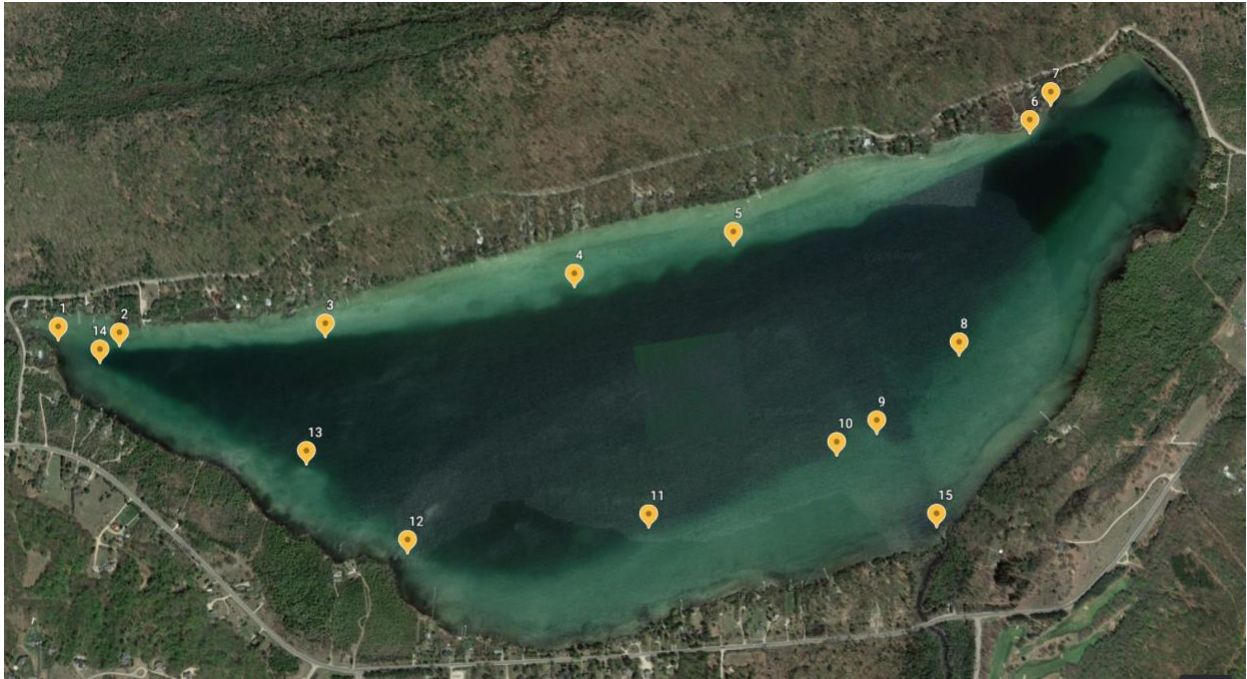
We trolled the 12 to 15-foot break line around the perimeter of Little Traverse Lake on 30 July and stopped to sample aquatic plants beds by tossing a double-sided rake in each of the four cardinal directions at each site. The rake was pulled back to the boat and all plants were identified to at least the genus level of classification from our previous knowledge and validation from the “Aquatic Plants of the Upper Midwest” key (Paul M. Skawinski). Relative abundance was recorded (Table 1) as the presence of plants observed with each toss. The number in the box represents the number of rakes that pulled up a plant at a particular site. For example, *Chara contraria* was found on all four rake throws at Site 1 and 2, but only one throw at Site 3. To facilitate repeated surveys in future years, GPS coordinates and approximate depth of sampling for each site were recorded (Table 2). Visual representation of each location can be seen in Figure 1.

Figure 1. Break line plant survey sample sites.

No invasive species were found at any of the 15 aquatic plant beds. This is good news for the health of Little Traverse Lake. It is recommended that this plant survey be repeated yearly for early detection of invasive species. That way, if a plant like Eurasian Watermilfoil is found, it can be treated and eradicated early before it has a chance to disrupt the ecosystem. Alpine Pondweed, Water Celery, Slender Naiad and Common Stonewort were the most commonly found plants in the survey. Note, Common Stonewort and *Cladophora* are actually macro phytic algae; we included them in this survey because of their size, prevalence, and proximity to vascular plants. Plant growth in Little Traverse Lake appeared to be comparable with other healthy lakes we work on in Northwest Michigan.

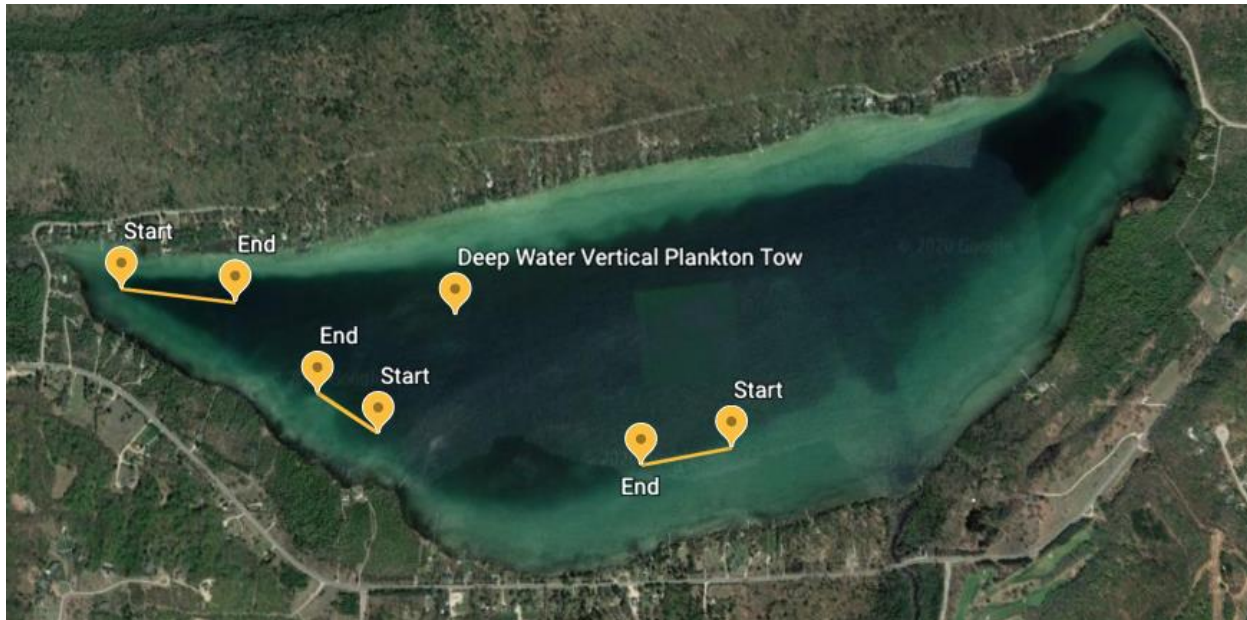
A plankton tow (20um) was dragged slowly behind a boat for five minutes, three times on 30 July. Another plankton tow was dropped in a deep part of the lake (44.9229973, -85.8491820) and slowly brought to the surface for vertical collection. All samples were brought back to the lab and examined using a compound microscope. Common species were identified to at least the genus level of classification. Figure 3 shows the areas sampled.

Figure 3: Areas sampled during the algal surveys.
