Bolt Shear Impact Test on In-Pavement Light Fixture Bolt Configurations

For	MCB Industries Inc. 310 North Wisconsin Suite E De Pere, WI 54115
P.O. Number	Credit Card
Date Tested	September 8, 2021
Test Personnel	Kate Fanning
Test Documents	Customer Test Plan Environmental Procedure: FAA EB83A Bolt Shear Impact rev1.0

Elite Electronic Engineering Inc.

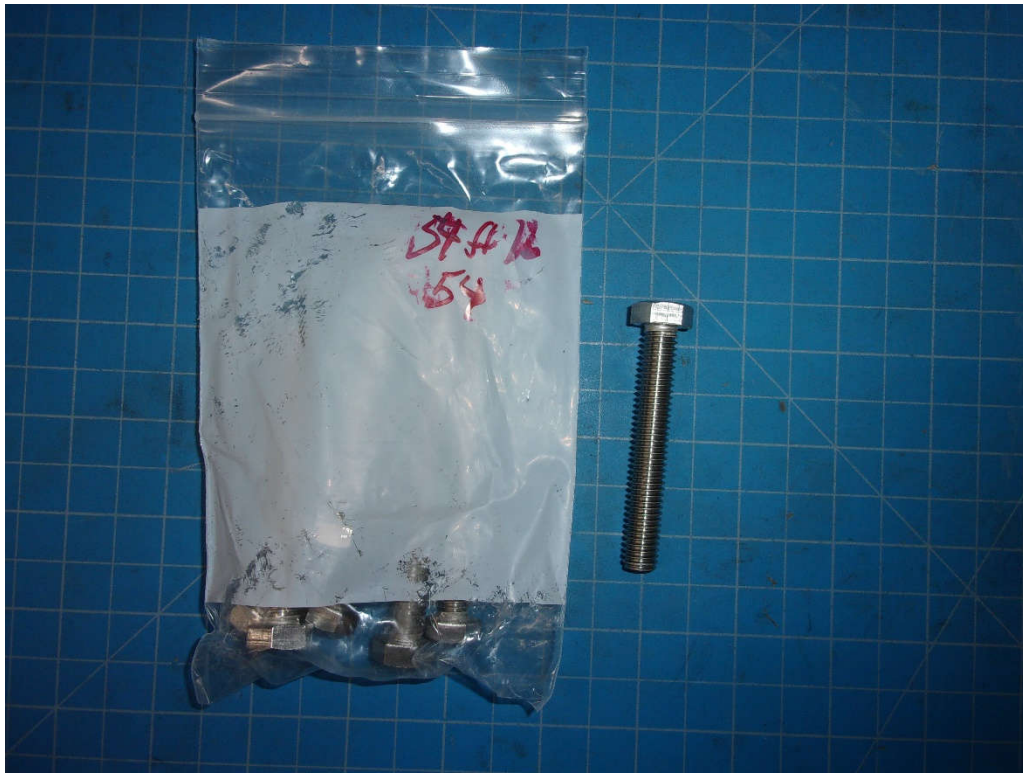
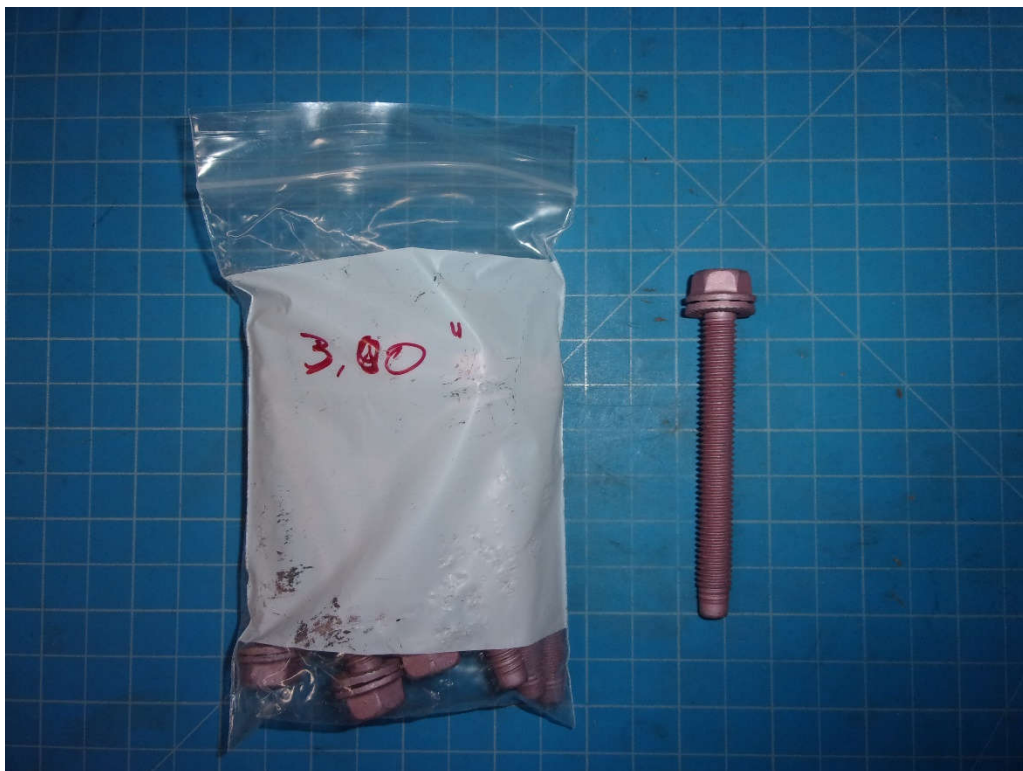
DUT Test Bolts (SAE J429 Grade 5 Bolt – Top and ASTM F593C Bolt – 3.00” – Bottom)

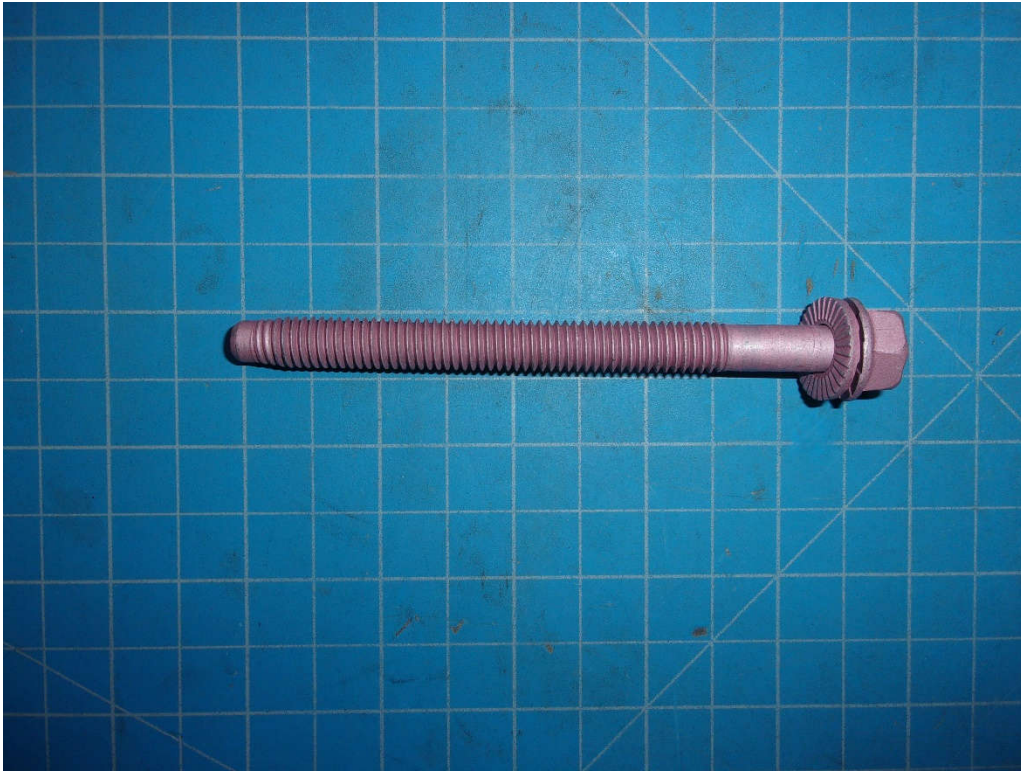
DUT Test Bolt (ASTM F593C Bolt – 4.00")

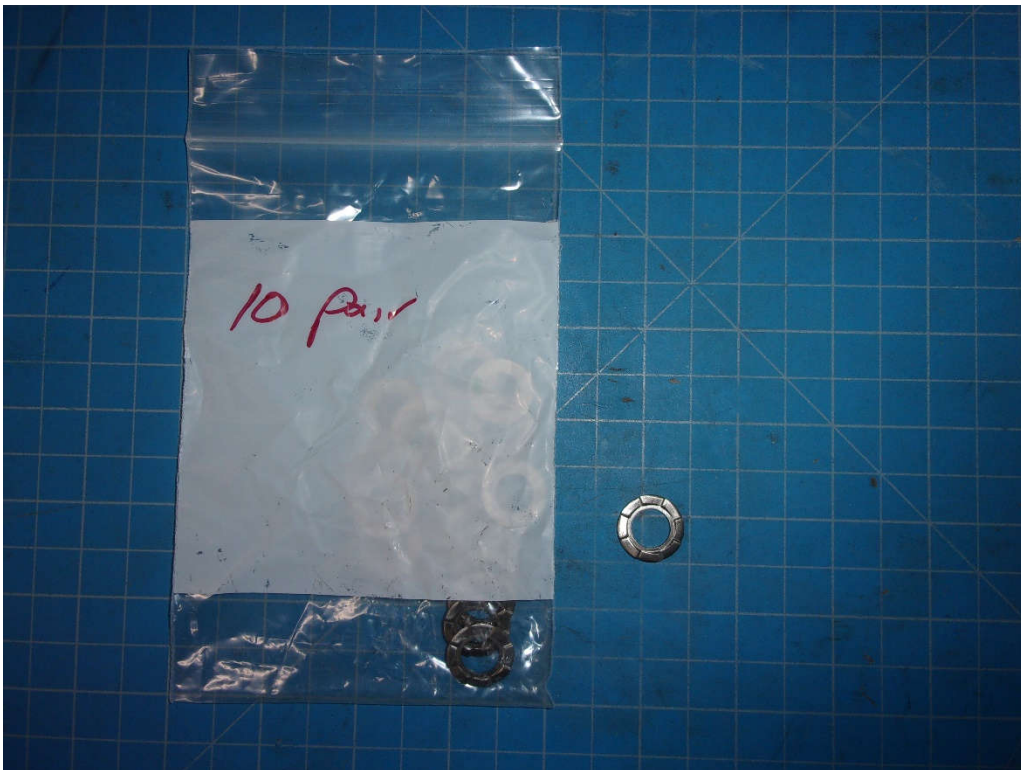
2-part Ramp Washers

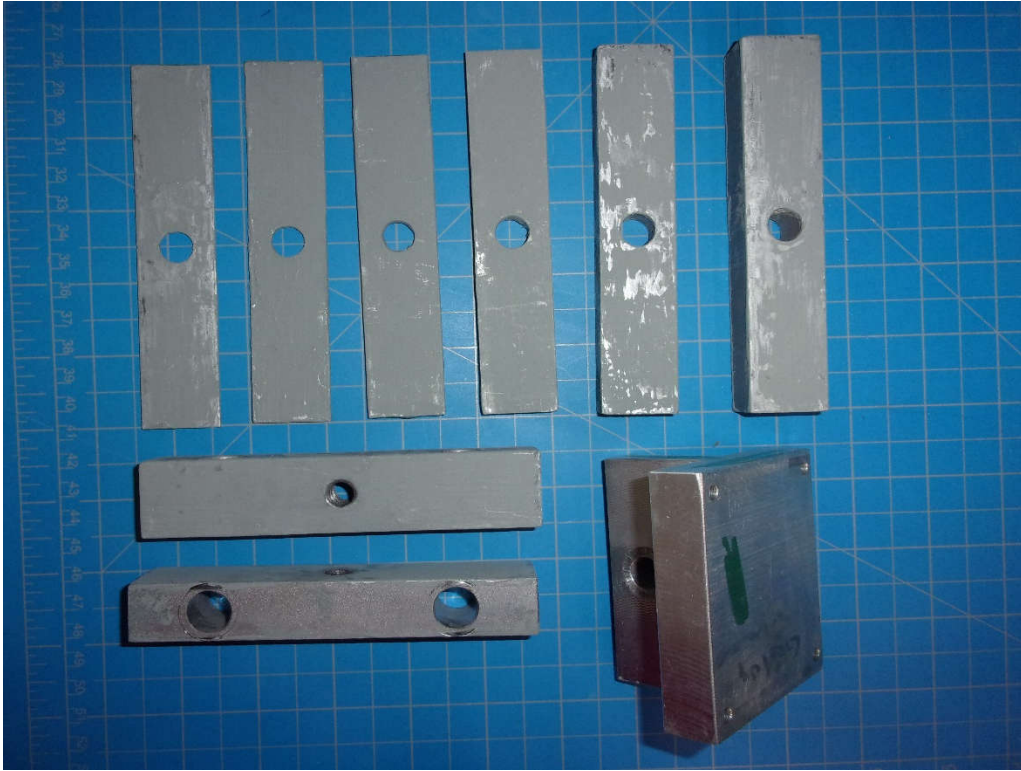
B50 (RCSC Class B Coating) Samples:
Spacers – (1) 3/4"; (1) 1/2"; (1) 1/4"; (1) 1/8"; (2) 1/16"
Impact Plate and Mounting Bars

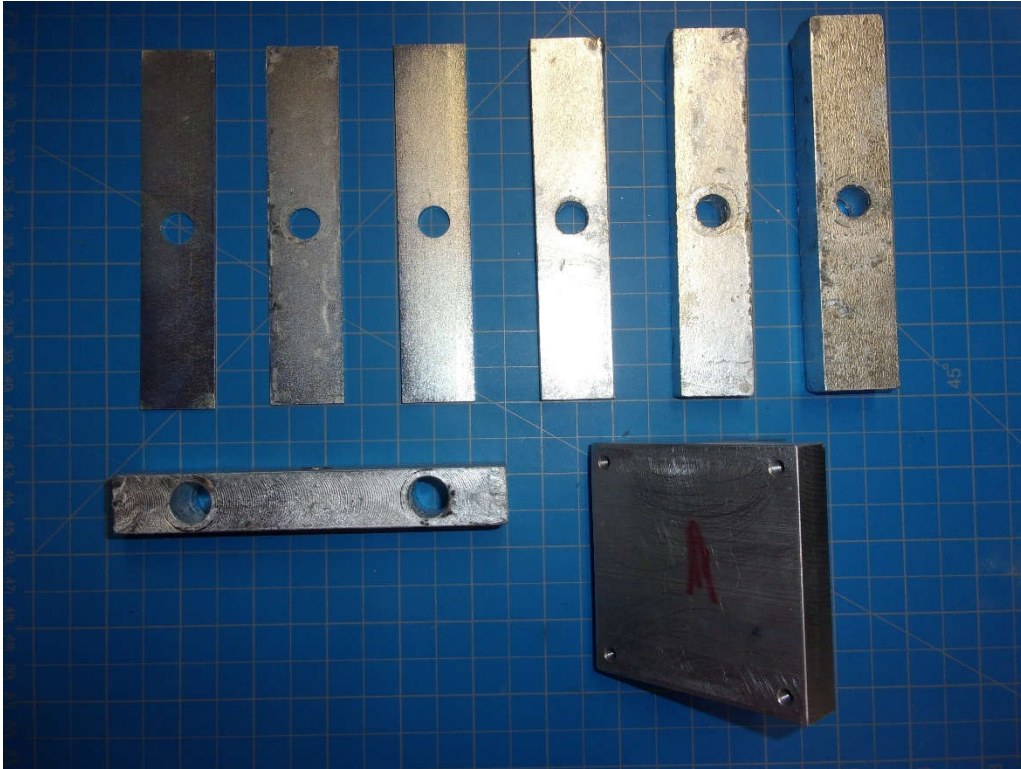
HDG (Galvanized) Samples:
Spacers – (1) 3/4"; (1) 1/2"; (1) 1/4"; (1) 1/8"; (2) 1/16"
Impact Plate and Mounting Bar

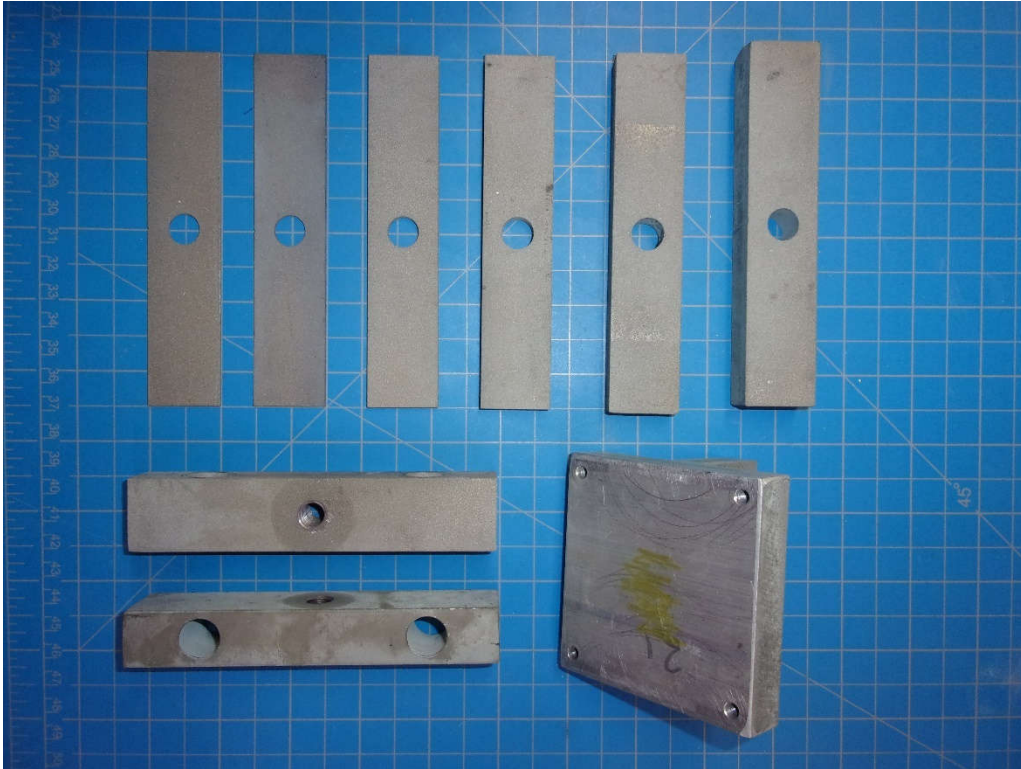
#21 Samples:
Spacers – (1) 3/4"; (1) 1/2"; (1) 1/4"; (1) 1/8"; (2) 1/16"
Impact Plate and Mounting Bars

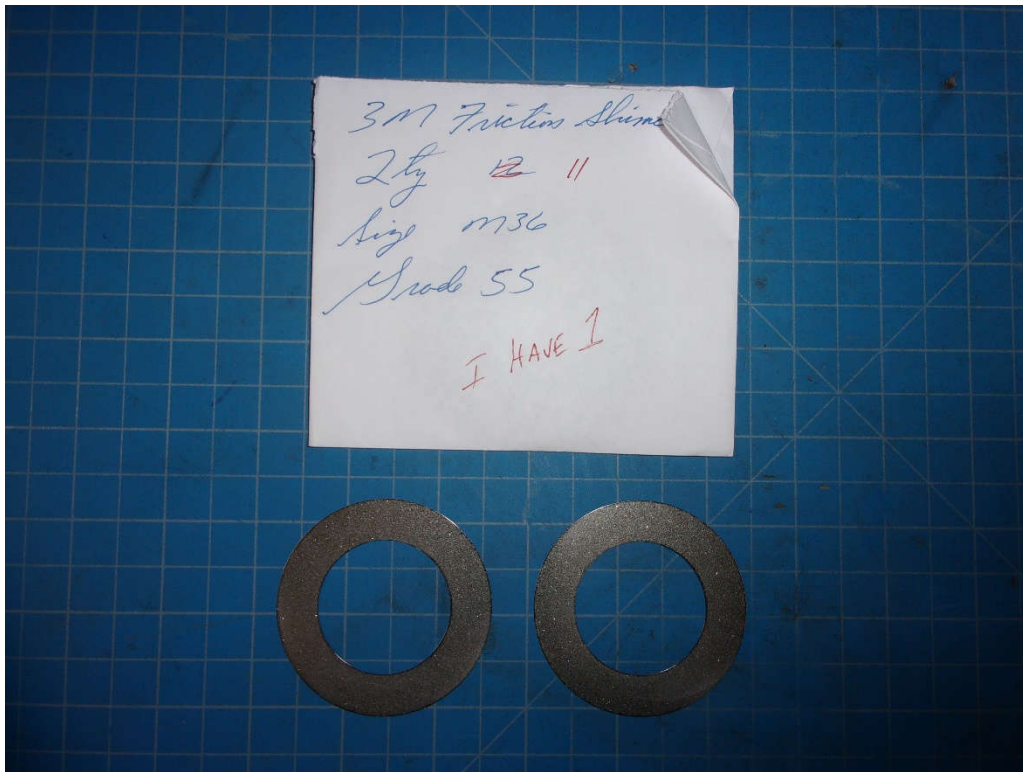
GR55 Washers

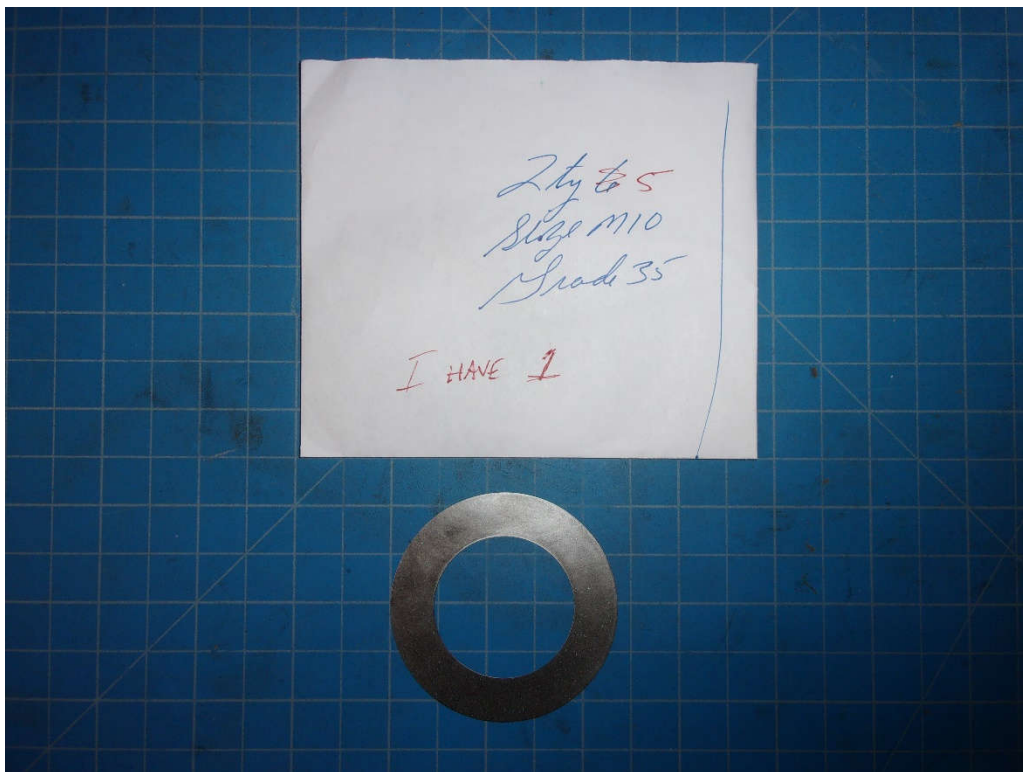
GR35 Washer

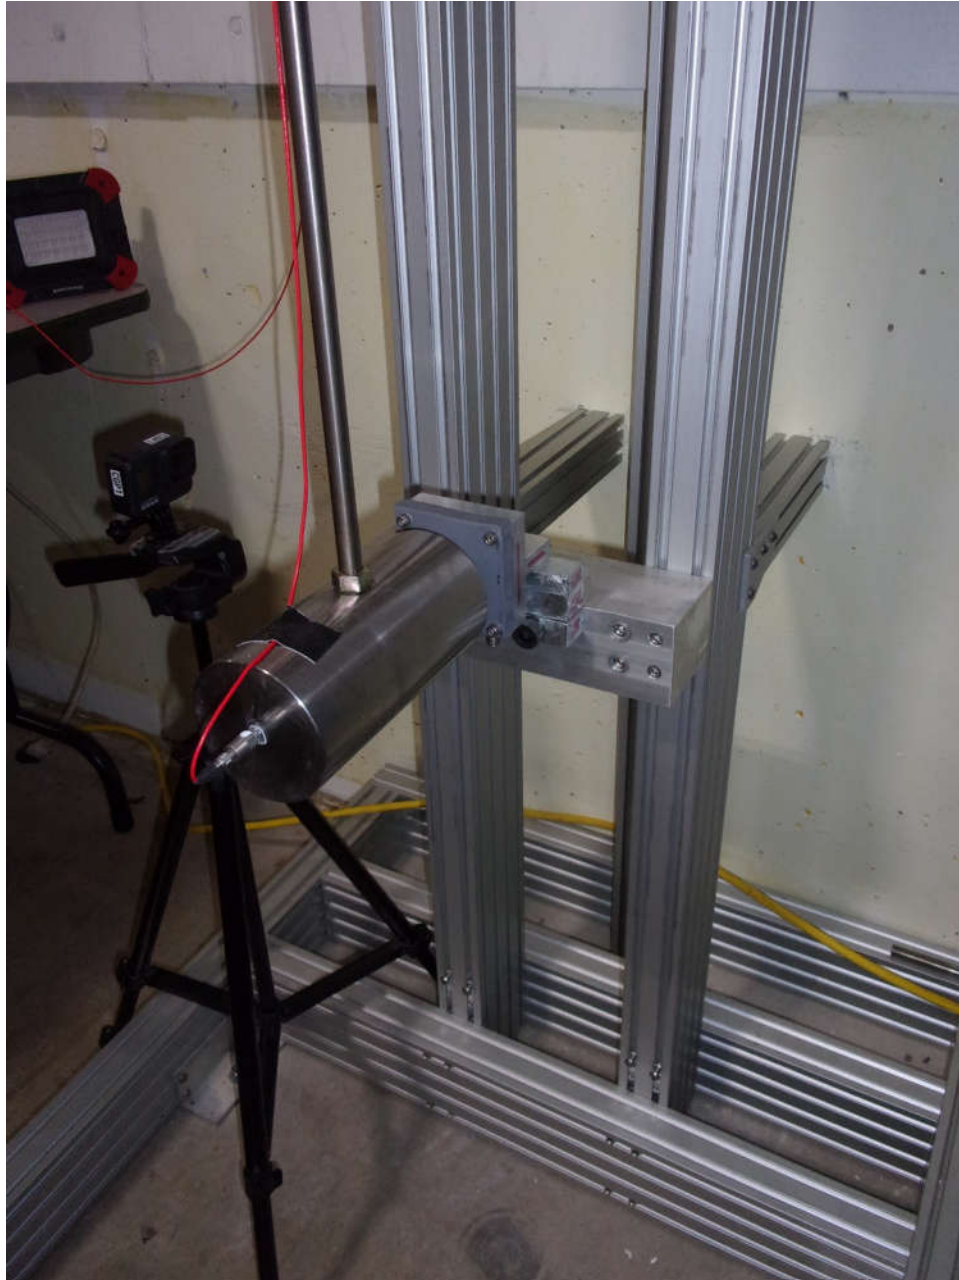
Test Setup Photograph

A pendulum hammer with a one (1) meter swing arm and a minimum 7.4-kilogram hammer were used and swung from a height of approximately one (1) meter. An accelerometer was attached to the impact hammer. A 1/2" thick impact-resistant PVC plate was attached to the impact plate for each orientation. A GoPro camera was used to capture high speed video of each test.

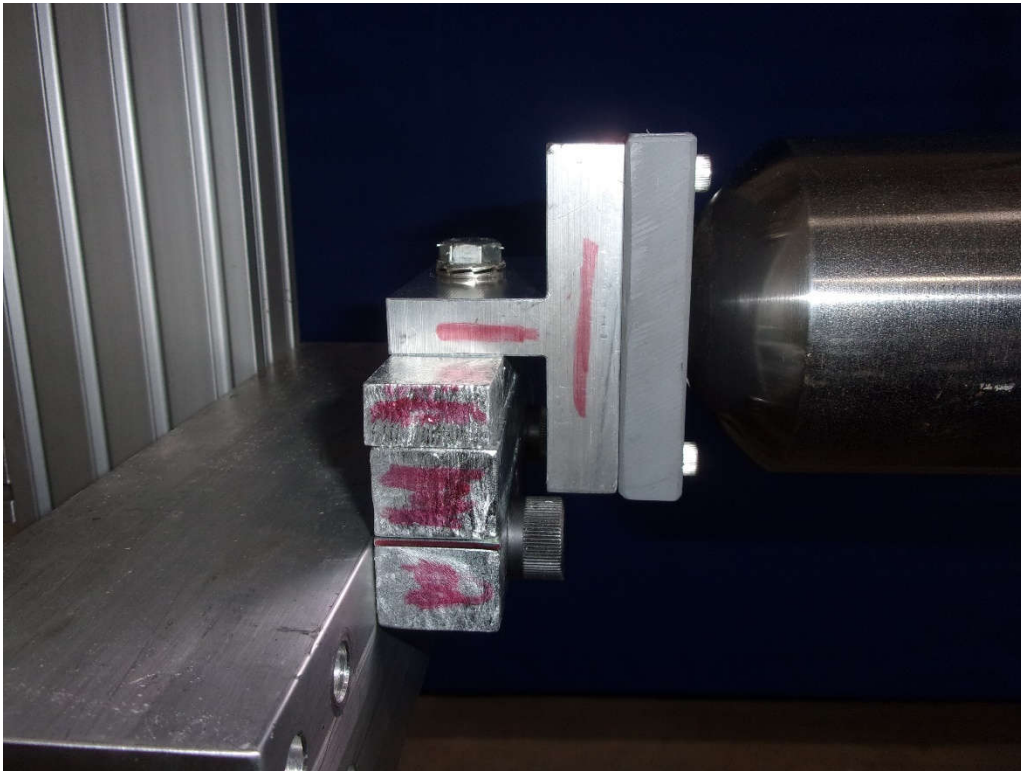
Test Setup Photograph (Orientation A)

Orientation	Components	Number of Hits	Target Force (lbf)
A	<ul style="list-style-type: none"> • Grade 5 3.00" Bolt • HDG (Galvanized) Impact Plate • HDG (Galvanized) Spacers – (1) 3/4"; (1) 1/2"; (1) 1/16" • HDG (Galvanized) Mounting Bar 	1	3300

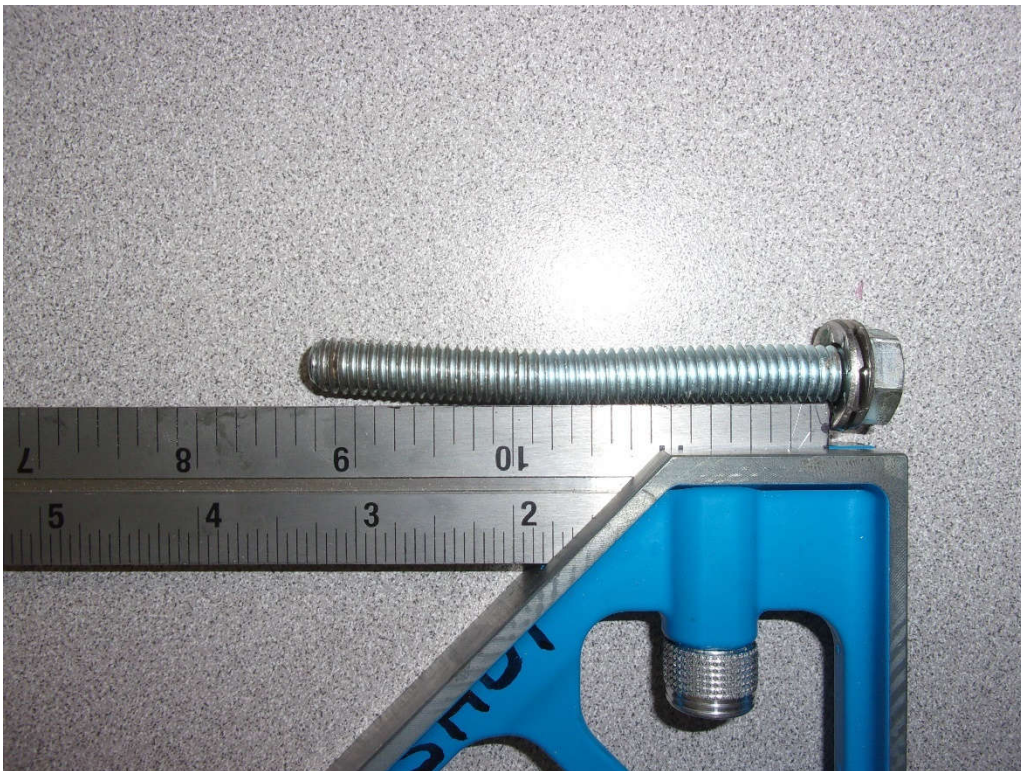
Post-test Photograph (Orientation A)

Orientation	Pretest Torque (ftlb)	Breakaway Torque (ftlb)	Peak Force (lbf)	Duration (ms)	Corrected Duration (ms)	Observations
A	61.8	-	4877.675	0.55	N/A	Significant bending.
A1	63.1	19.9	4314.175	0.55	N/A	Significant bending in two sections. For strike 3, there was some ringing in the fixture. A corrected duration for the initial hit was determined.
			3928.255	0.55	N/A	
			3473.017	6.55	0.50	
B	45.3	12.3	3971.698	7.30	0.65	Significant bending. There was some ringing in the fixture. A corrected duration for the initial hit was determined.
C	42.6	19.1	4012.632	7.45	0.60	Slight bending. There was some ringing in the fixture. A corrected duration for the initial hit was determined.
D	43.4	12.0	4541.454	6.65	0.60	Slight bending. There was some ringing in the fixture. A corrected duration for the initial hit was determined.
E	43.0	18.9	3964.204	0.55	N/A	Slight bending
E1	42.5	15.1	4419.703	0.55	N/A	Significant bending in two sections. For strike 2 and 3, there was some ringing in the fixture. A corrected duration for the initial hit was determined.

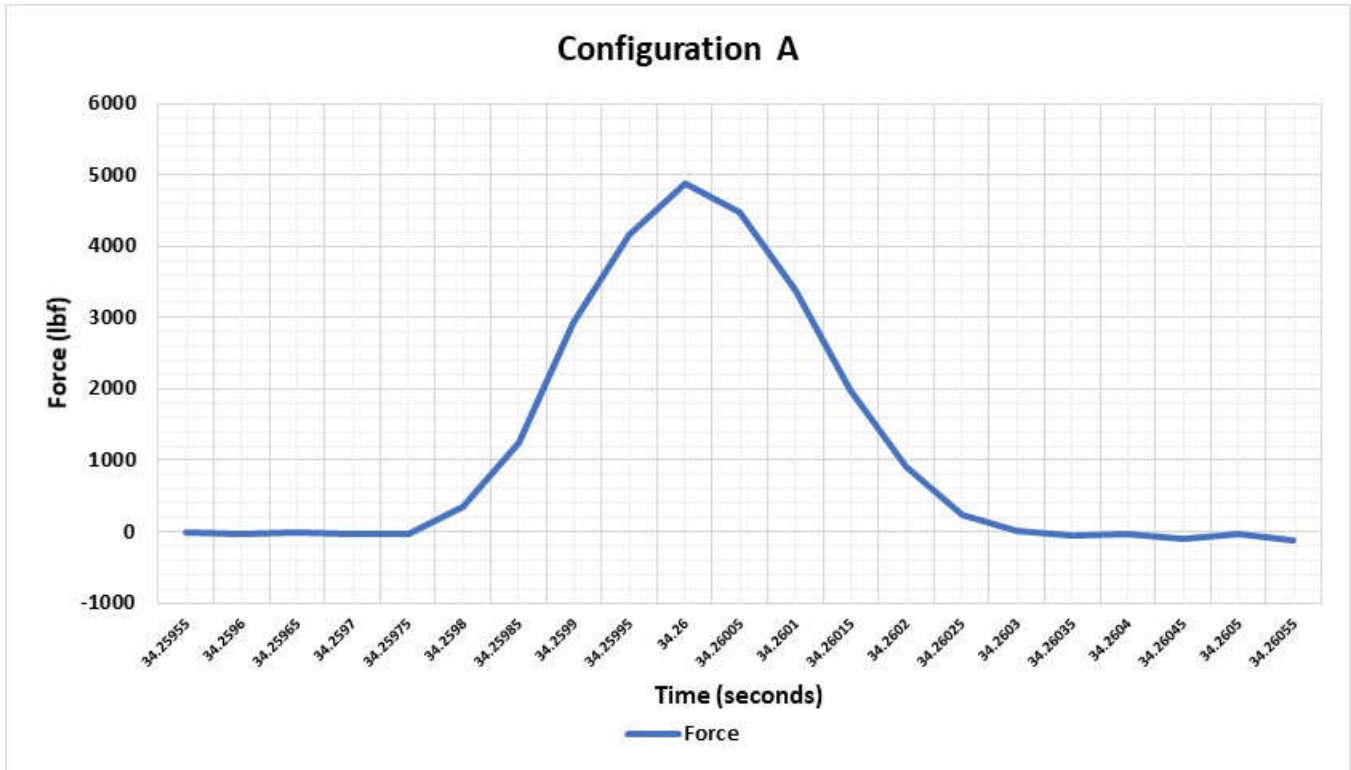
Force Graph

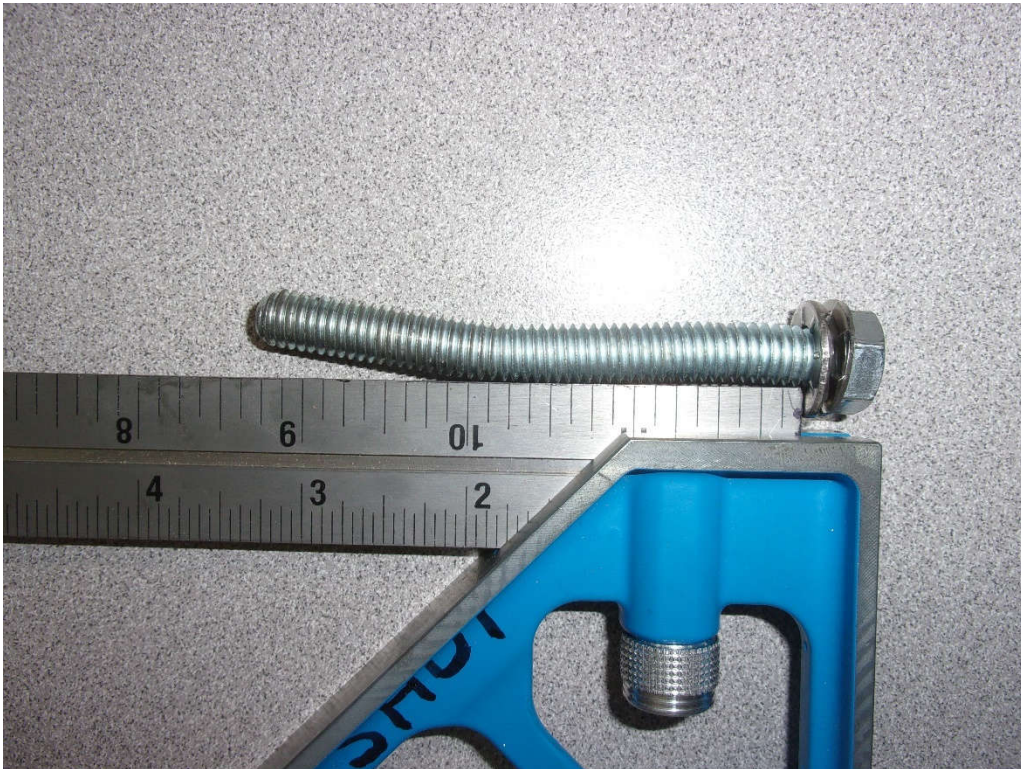
Post-test Photograph (Orientation A1)

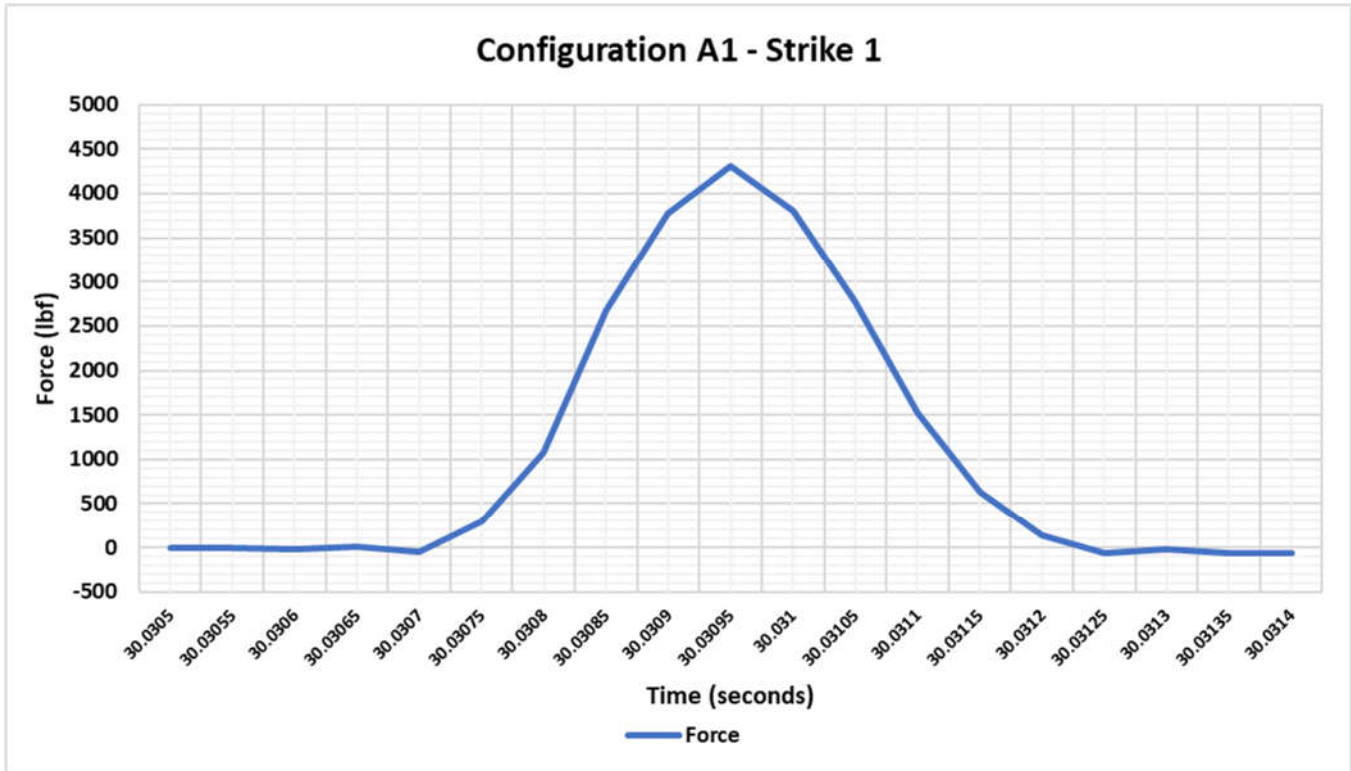
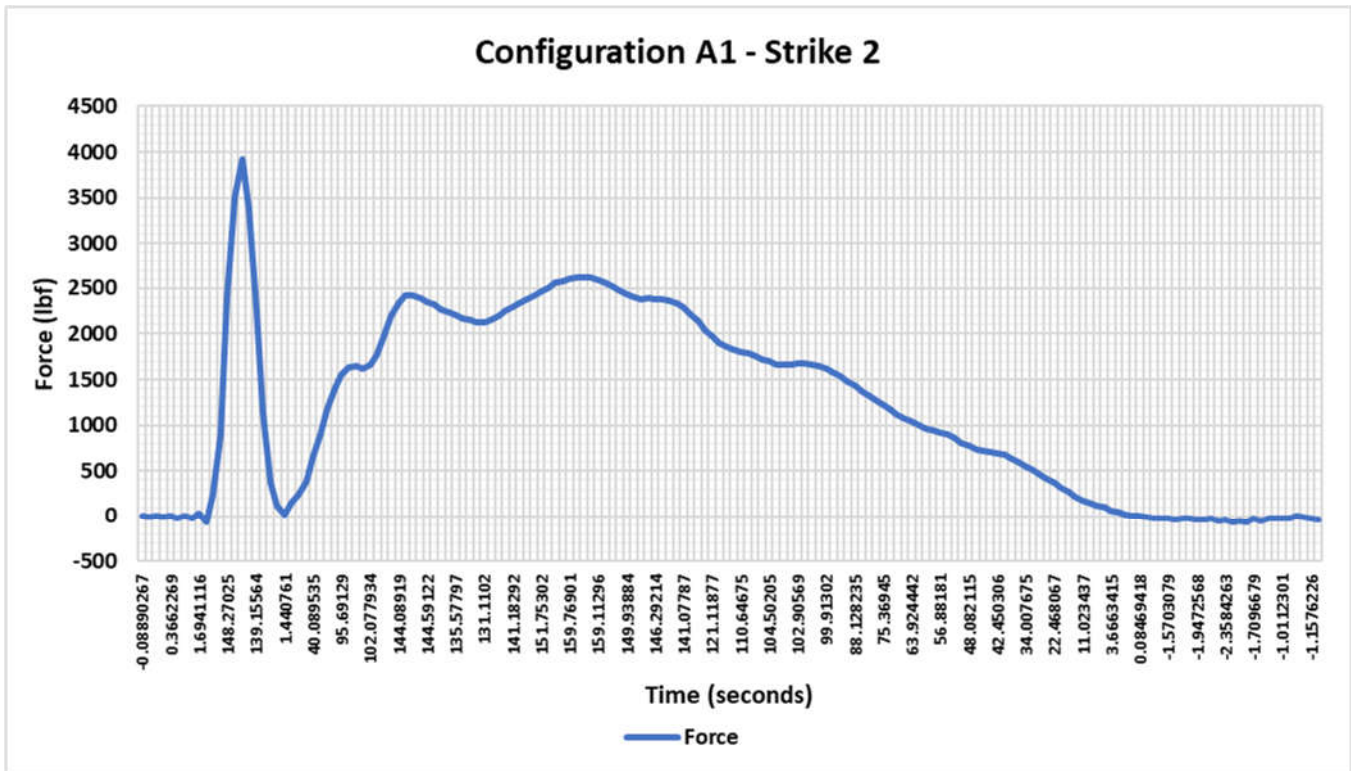
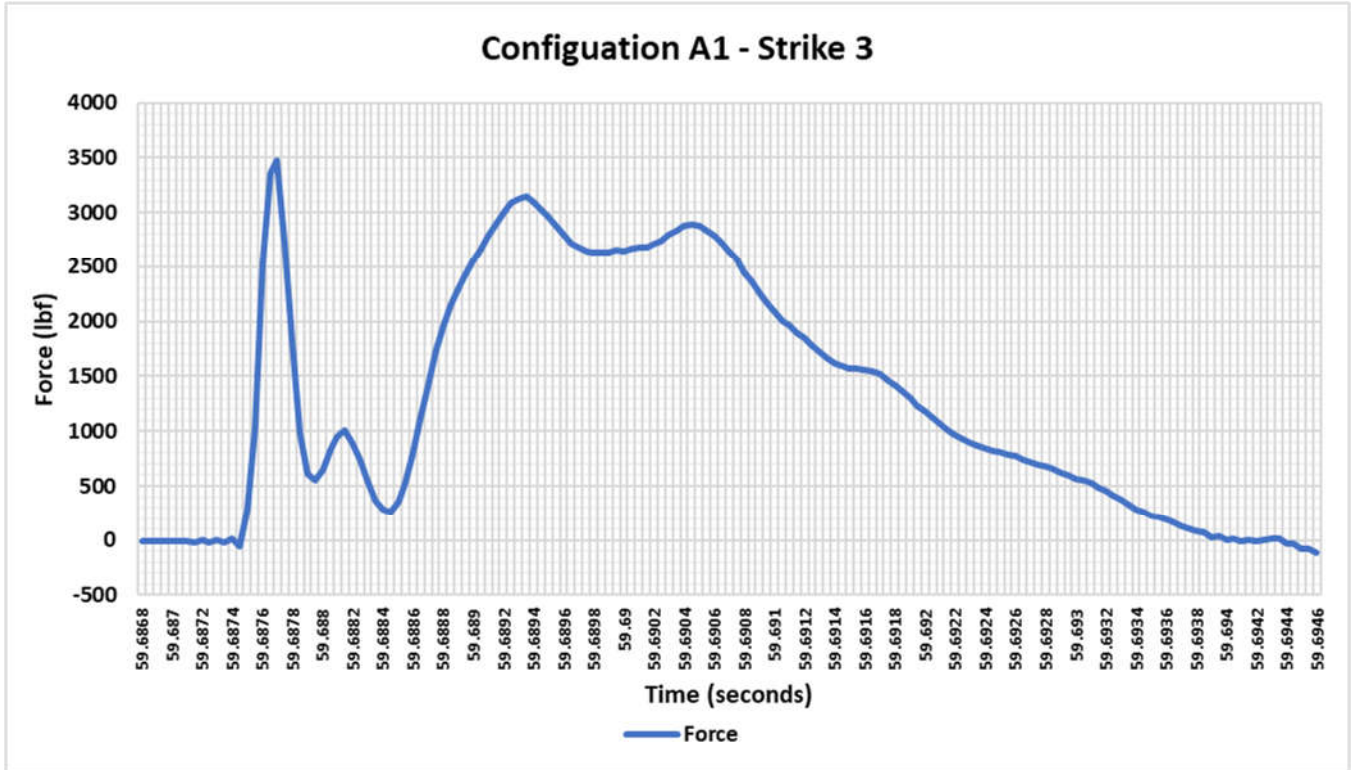
Force Graph (Strike 1)

Force Graph (Strike 2)

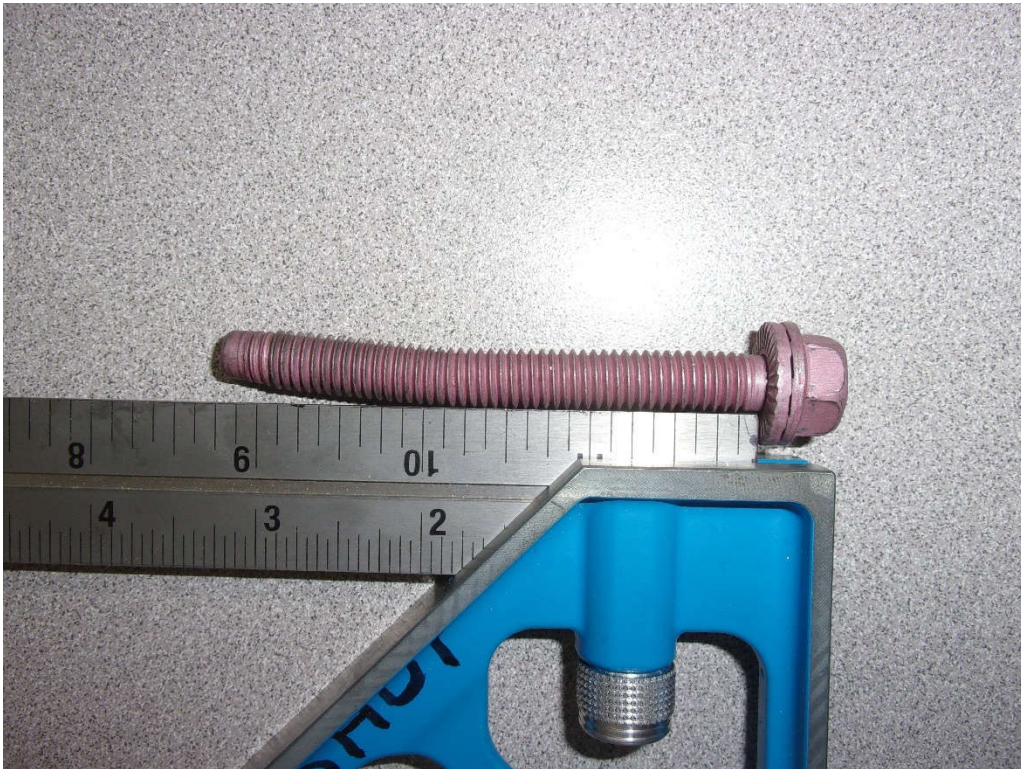
Post-test Photograph (Orientation B)

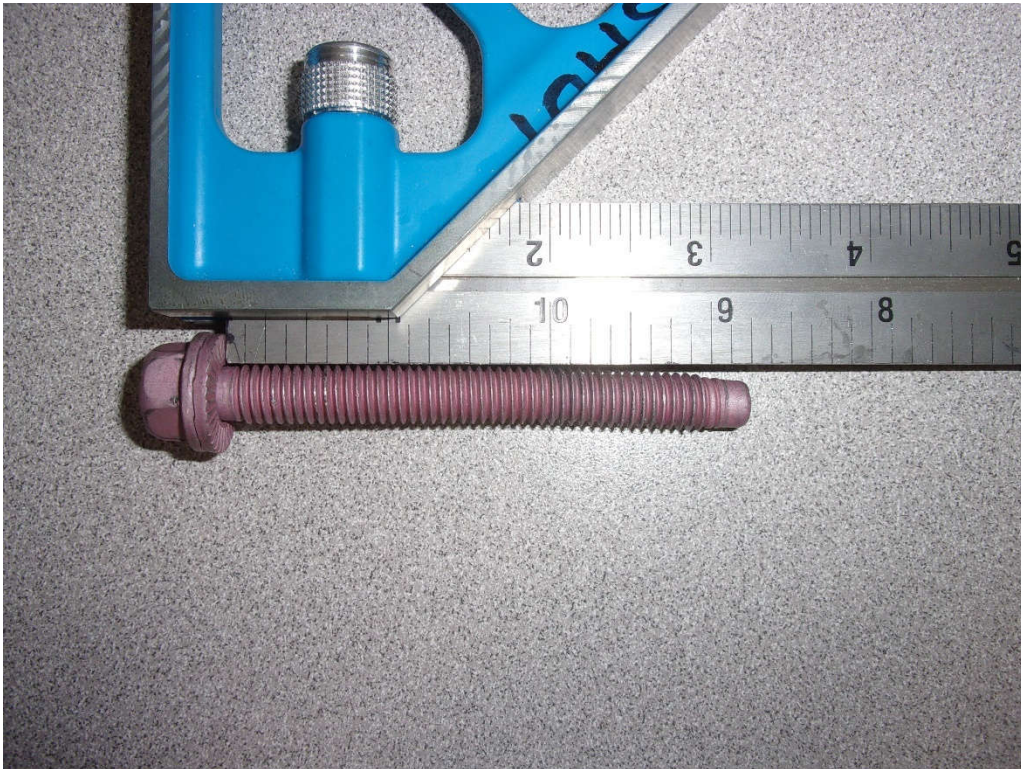
Post-test Photograph (Orientation H)

4102.92	6.50	0.65	
			3839.141	6.75	0.65	
G	42.5	15.8	4512.568	0.60	N/A	Significant bending.
H	42.9	13.3	4924.993	0.65	N/A	Slight bending.
I	42.6	8.6	4491.204	5.05	0.60	Slight bending. There was some ringing in the fixture. A corrected duration for the initial hit was determined.

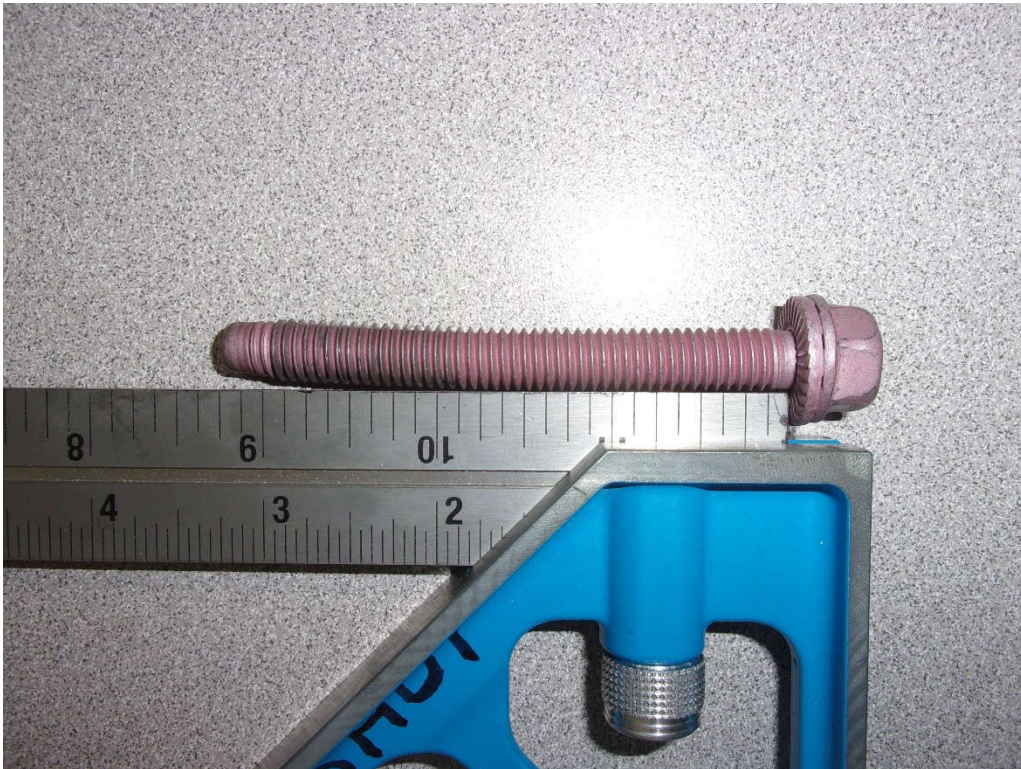
Post-test Photograph (Orientation I)

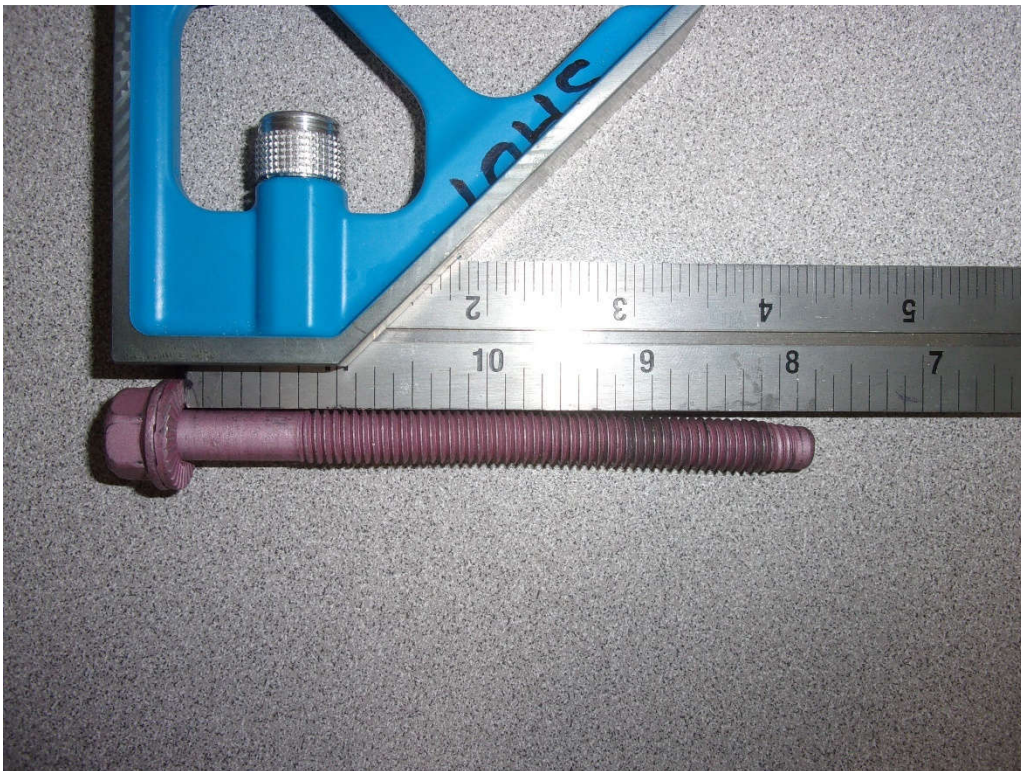
Post-test Photograph (Orientation M)

I1	43.2	15.5	4813.994	4.75	0.55	Slight bending. For strike 1, there was some ringing in the fixture. A corrected duration for the initial hit was determined.
			4274.13	0.60	N/A	
			4207.865	0.50	N/A	
M	42.5	5.9	4311.439	5.85	0.65	Slight bending. There was some ringing in the fixture. A corrected duration for the initial hit was determined.
N	62.9	53.9	3141.896	0.80	N/A	Little to no bending.
O	42.7	23.3	2923.946	6.50	0.75	Little to no bending. There was some ringing in the fixture. A corrected duration for the initial hit was determined.
P	42.9	15.3	2907.17	6.15	0.65	Little to no bending. There was some ringing in the fixture. A corrected duration for the initial hit was determined.
R	42.2	22.3	2817.721	0.60	N/A	Little to no bending.

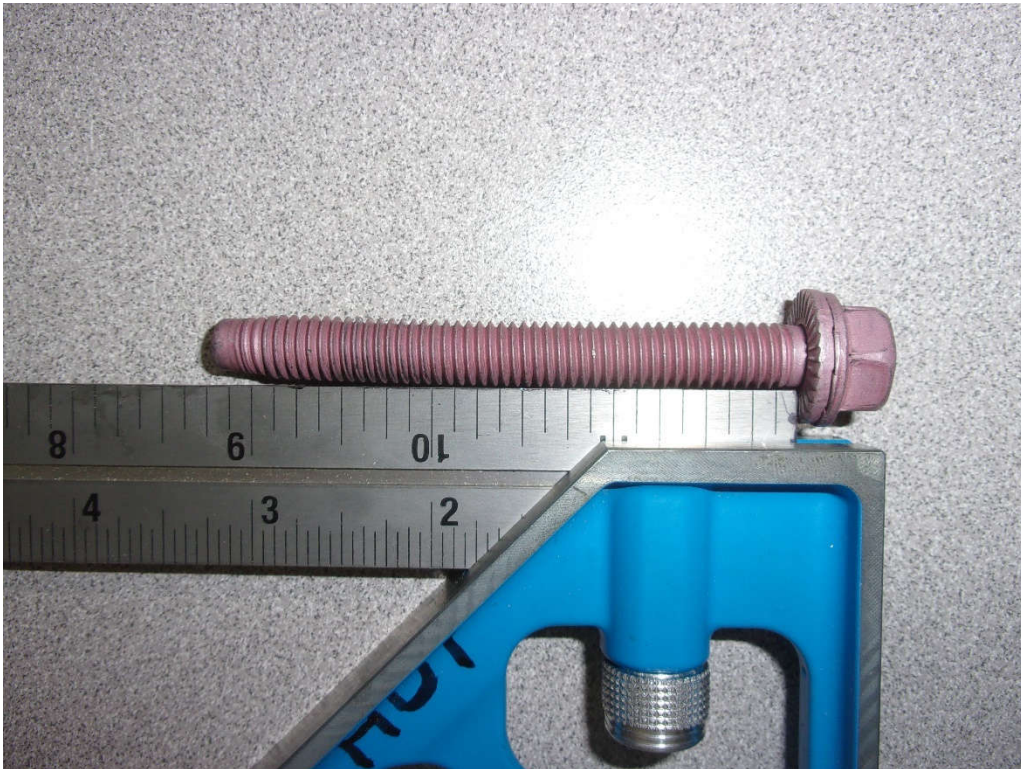
Post-test Photograph (Orientation R)
