Report No. 102710532CRT-001 rev.1

# MCB Industries, Inc.

Purpose: Performance testing of Isabel fastening system

Model / Type: Isabel Fastening System

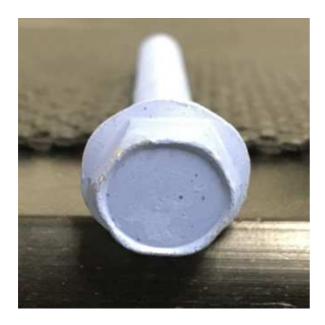
Samples used for Vibration, Horizontal shear and Compressive load testing						
	Bolt description					
Length:	4.36 inches (thread length)					
Diameter:	3/8 inch					
Threads per inch:	16					
Material:	ASTM F593C					
Blue Coating:	Xylan 1424					
Head:	Hex with Flange

Isabel clip and serrated flange nut description				
Nut size:	3/8 inch			
Nut Material:	302HQ			
Red Adhesive:	Precote 80-3 High Strength and Heat Resistant Thread Coating			
Threads per inch:	16			
Clip material:	301 SS

Above pictures of sample representations used for Vibration, Horizontal shear and Compressive load tests

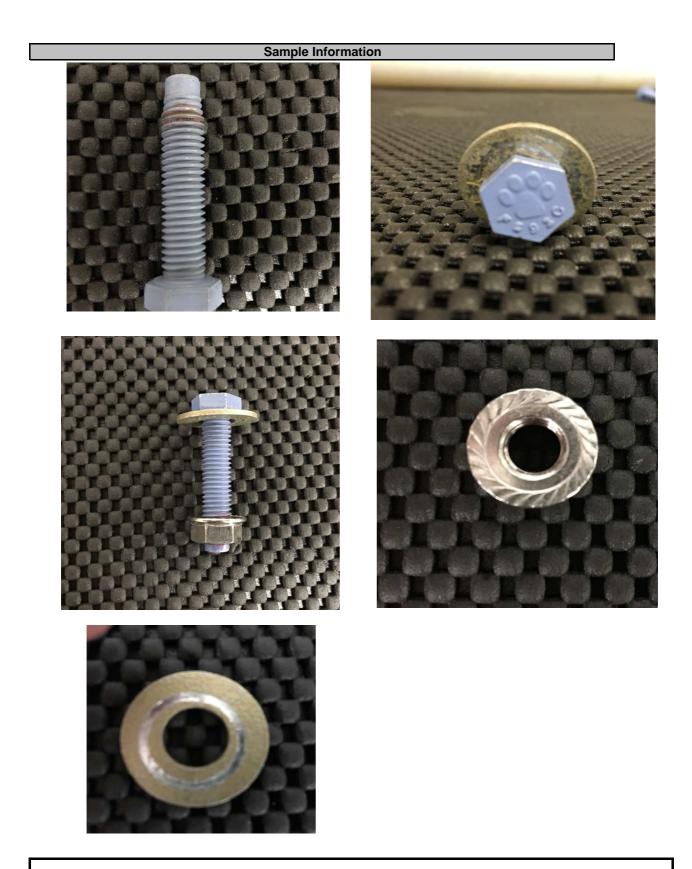
Samples used for torque vs. tension comparison, and torque to failure						
	Bolt description					
Length:	1.84 inches (thread length)					
Diameter:	3/8 inch					
Threads per inch:	16					
Material:	ASTM F593C					
Blue Coating:	Xylan 1424					
Head:	Hex					
	Serrated Flange Nut description					
Nut size:	3/8 inch					
Material:	302HQ					
Red Adhesive:	Precote 80-3 High Strength and Heat Resistant Thread Coating					
Threads per inch:	16

Above pictures of sample representations used for Torque vs. Tension comparison

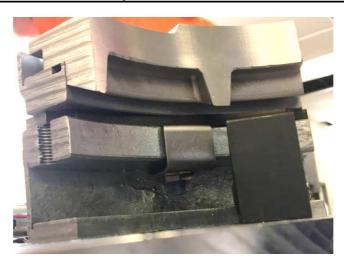
Above pictures of fixtures used for testing

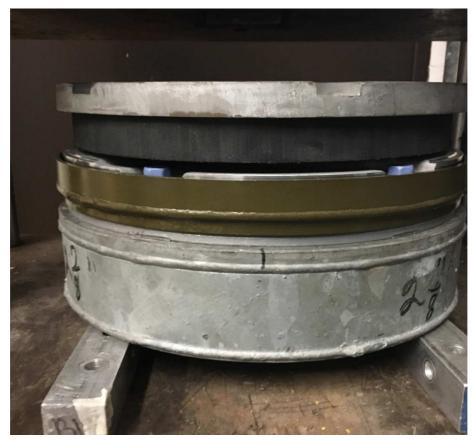
$Perform\ a\ static\ load\ test\ on\ the\ light\ fixture.\ Apply\ the\ compressive\ load\ in\ pounds\ of\ 450\ times\ the\ area\ in$ inches of the light fixture to the top part of the light fixture through a rubber block at least 1 inch (25.40mm) less than the outside diameter of the light assembly, 1 inch thick, and of a Shore A hardness of 55 70. Apply the load uniformly at a rate of not greater than 10,000 pounds per minute and hold there for 1 minute. Test to be completed 3 times. Check torque between each application of compressive load.

Light F Fixture Dia.	12	inches
Light Fixture Area	113	inch sqr
Compressive Load	50868	lbs.

R	ubber Bloo	Req,	
Diameter	11	inches	≤ Fixture Dia -1"
Thickness	1	inches	1" (25.40mm)
Shore "A"	66	NA	55-70

Post Test Observations	Y/N
Permanent Deformation	N
Cracking of material or finish	N
Breaking or damage to Light	N

Torque values (in.lbs.)							
Bolt identification	nitial torqu	er 1st load	er 2nd load	After 3rd loading					
1	360	320	345	360					
2	360	309	315	345					
3	360	289	300	310					
4	360	300	300	300					
5	360	289	310	300					
6	360	315	315	325

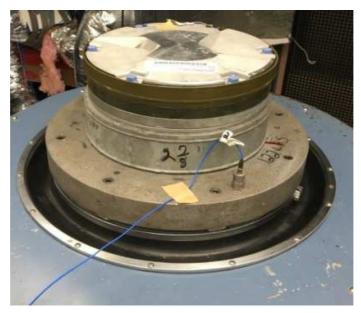
Vertical Axis set up control with ch3 on top of bolt head

Subject the light fixture to a sinusoidal vibration along three mutually perpendicular axes. Operate the lamps to monitor the continuity continually. Vibrate the fixture over a frequency range of 20 to 500 Hz, with a maximum acceleration of 10 Gs for 10 minutes. Then vibrate the fixture from 500 to 2000 Hz, with a maximum acceleration of 15 Gs for 10 minutes. If the lamp filament or envelope is damaged, replace the lamp and repeat the test at 3 Gs. After the test, inspect the interior of the fixture for mechanical failure, loosening of any part, or displacement of any part.

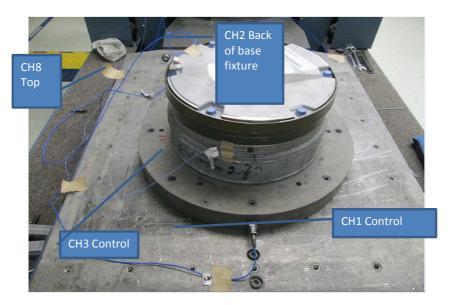
Lateral set up control averaging ch1 and ch3

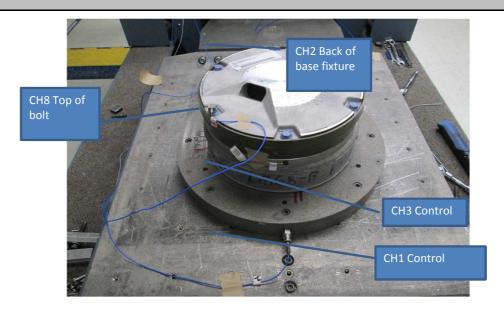
Horizontal set up control averaging ch1 and ch3

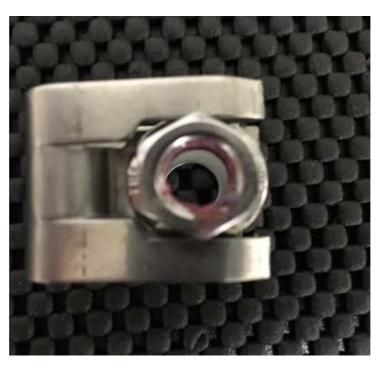
Noted that hex nut was found turned in clip after vibration testing

Post Test Observations	Y/N
Mechanical Failure of any Component	N
Loosening of any Part or Fastener	Υ

Torque values changed after each vibration segment

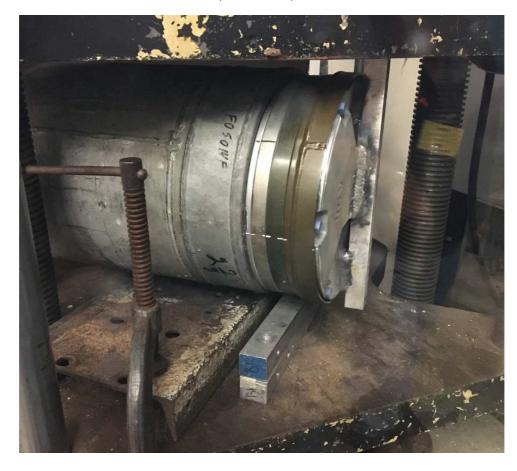
Perform a test to simulate the shearing load applied to the top surface of an in pavement fixture by a braking aircraft tire. Weld a bar to the top of the fixture parallel to the runway centerline and parallel to the ground plane. Apply a shearing load of 6000 pounds and release 20 times to each end of the bar. Inspect the sample for any mechanical damage.

# Horizontal Shear FAA AC 150/5345-46E 4.5.13 (excepting load applied was 6000 lbs.) Test set-up in the Fore position

Results								
				Bolt iden	tification			
Direction	Fore	19	20	21	22	23	24	
itial (in.lb:	na	360	360	360	360	360	360	
Load 1	Χ	na	na	na	na	na	na	
Load 2	Χ	na	na	na	na	na	na	
Load 3	Χ	na	na	na	na	na	na	
Load 4	Χ	na	na	na	na	na	na	
Load 5	Χ	na	na	na	na	na	na	
Load 6	Χ	na	na	na	na	na	na	
Load 7	Χ	na	na	na	na	na	na	
Load 8	Χ	na	na	na	na	na	na	
Load 9	Χ	na	na	na	na	na	na	
Load 10	Χ	305	315	290	308	295	318	
Load 11	Χ	na	na	na	na	na	na	
Load 12	Χ	na	na	na	na	na	na	
Load 13	Χ	na	na	na	na	na	na	
Load 14	Χ	na	na	na	na	na	na	
Load 15	Χ	na	na	na	na	na	na	
Load 16	Χ	na	na	na	na	na	na	
Load 17	Χ	na	na	na	na	na	na	
Load 18	Χ	na	na	na	na	na	na	
Load 19	Χ	na	na	na	na	na	na	
Load 20	Χ	323	325	300	320	305	320

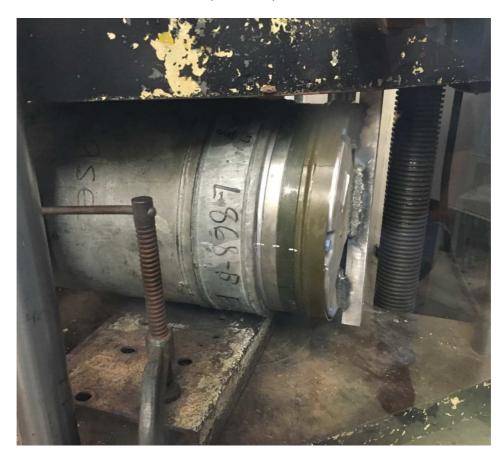
Test set-up in the Aft position

Post Test Observations	Y/N
Any Structural Damage	N
Movement of any Part	Υ
Loosening of any Fasteners	Υ

Movement of spacer rings noted in post test visual exam Torque value changed after load applied

Bolt identification						
Direction	Aft	19	20	21	22	23	24	
itial (in.lb:	na	360	360	360	360	360	360	
Load 1	Χ	na	na	na	na	na	na	
Load 2	Χ	na	na	na	na	na	na	
Load 3	Χ	na	na	na	na	na	na	
Load 4	Χ	na	na	na	na	na	na	
Load 5	Χ	na	na	na	na	na	na	
Load 6	Χ	na	na	na	na	na	na	
Load 7	Χ	na	na	na	na	na	na	
Load 8	Χ	na	na	na	na	na	na	
Load 9	Χ	na	na	na	na	na	na	
Load 10	Χ	288	306	279	320	300	280	
Load 11	Χ	na	na	na	na	na	na	
Load 12	Χ	na	na	na	na	na	na	
Load 13	Χ	na	na	na	na	na	na	
Load 14	Χ	na	na	na	na	na	na	
Load 15	Χ	na	na	na	na	na	na	
Load 16	Χ	na	na	na	na	na	na	
Load 17	Χ	na	na	na	na	na	na	
Load 18	Χ	na	na	na	na	na	na	
Load 19	Χ	na	na	na	na	na	na	
Load 20	Χ	320	323	320	340	325	320
