Inspection Report

Interior Exterior Home Inspection, Inc.

Sample Report

Report Information

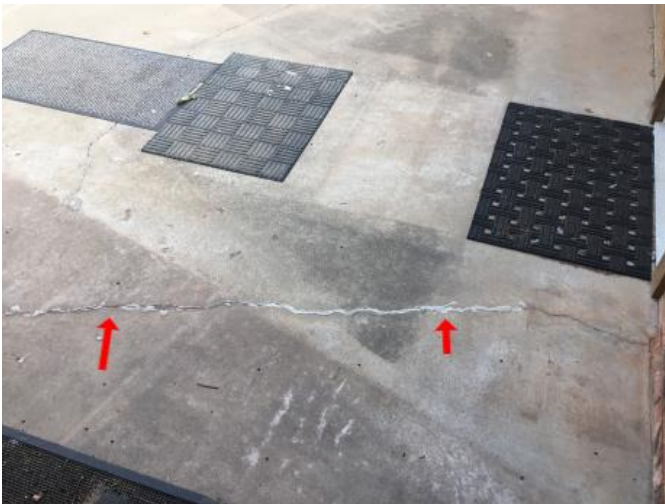
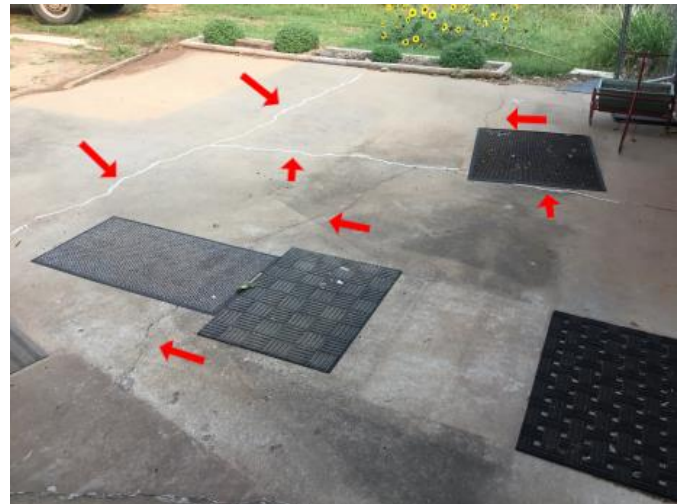
1.3) Driveway Conditions R

Common cracks and settlement were observed. Recommend sealing and monitoring the cracks.

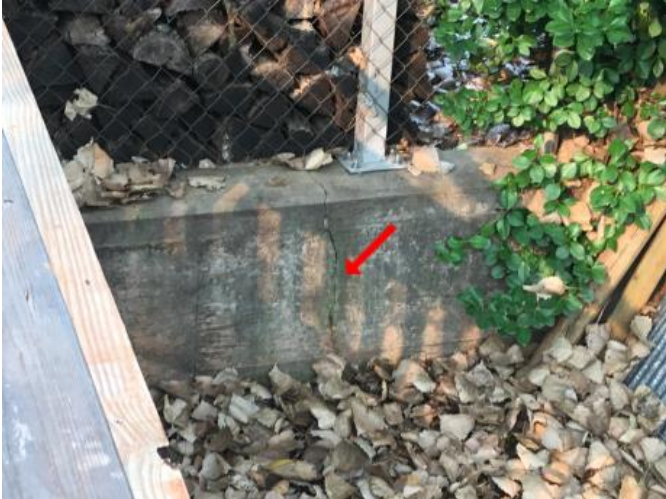
Crack

A common crack was observed on the retaining wall. Recommend sealing and monitoring the crack.

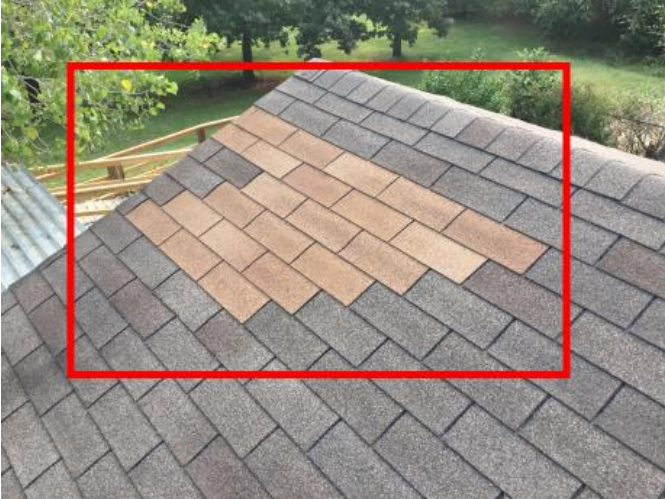
Repairs made to the area

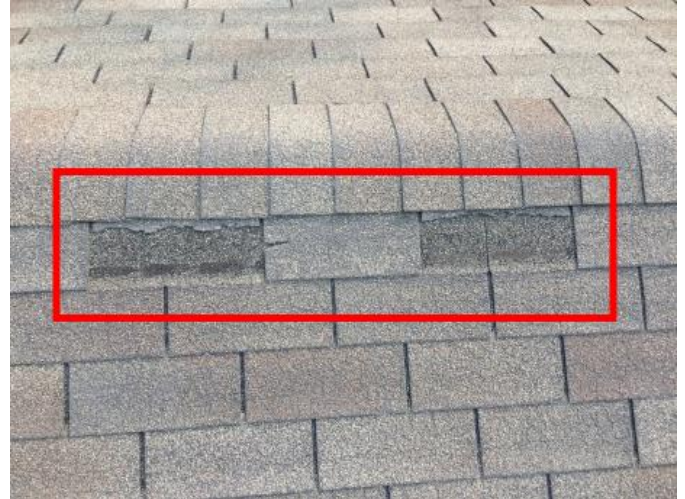
Broken Shingles

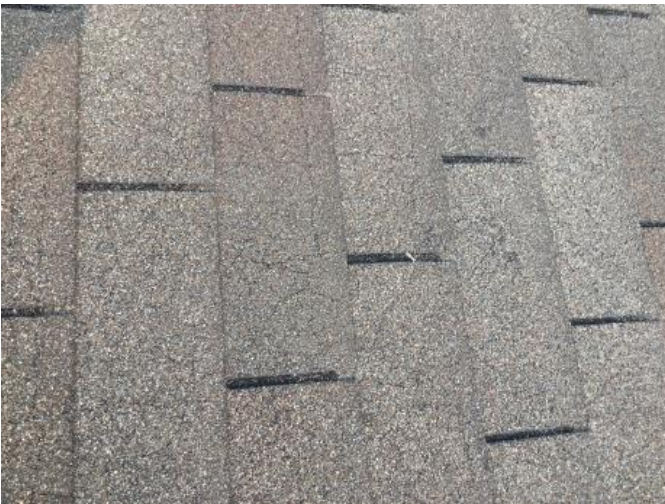
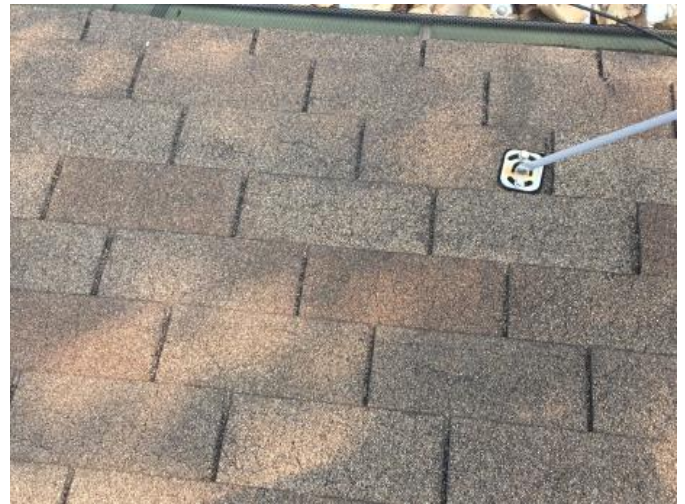
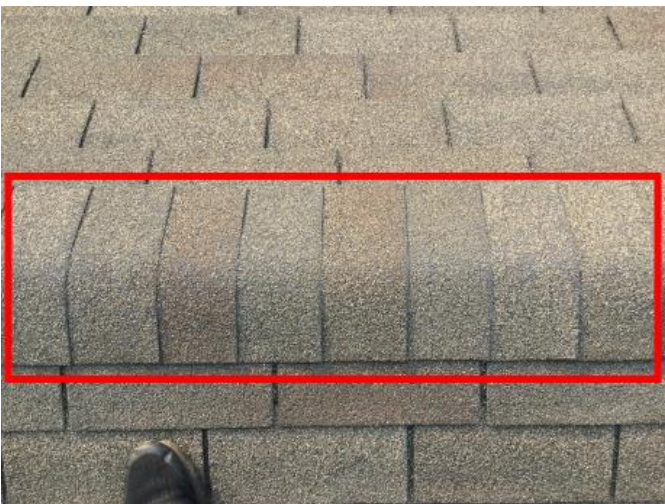
2.1) Roof Covering Condition

- The roof covering showed signs of cracking, curling, and loss of granules. This condition generally indicates that the roofing materials are approaching or close to the end of their useful life. Replacement is most likely needed in the near future. The inspector cannot offer an opinion as to whether the roof leaks today unless it is moderately raining at the time of inspection. We recommend further evaluation by a qualified roofing contractor prior to close. The client should obtain full disclosure/history information from the seller prior to close.

Cracking and Loss of Granules

Loss of Granules

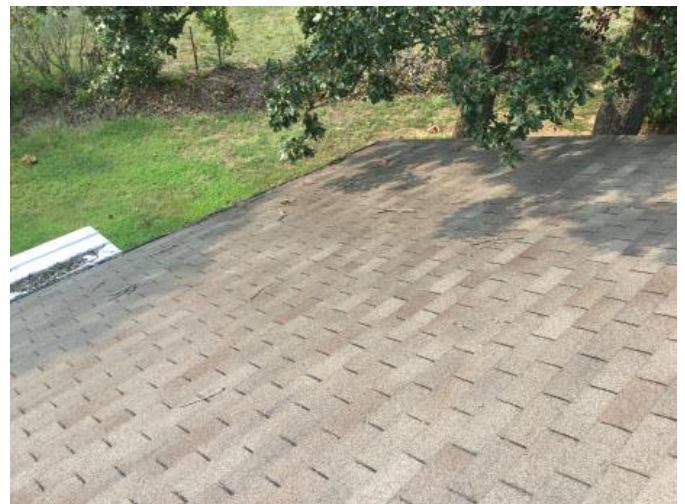
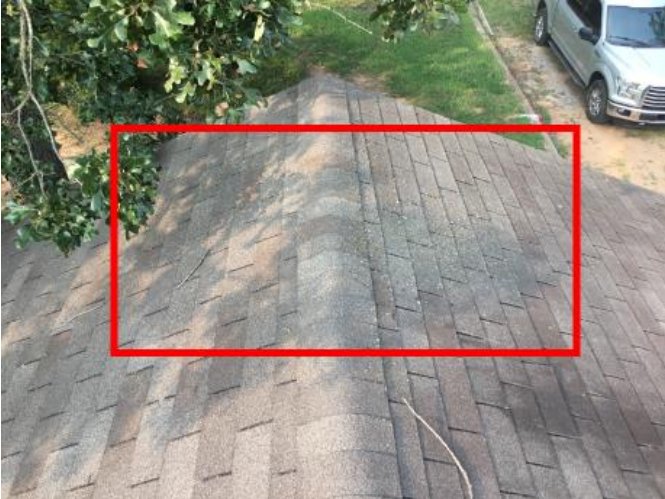
- Debris was observed on the roof. Recommend clearing the debris to prevent damage to the roof.
- Moss covering was observed on the roof. While mostly cosmetic and not immediately harmful, this condition can indicate a moisture-related condition. This condition may also be seasonal depending on tree/leave coverage and the position of the sun during the changing seasons. The client should consult a roofing contractor or roofing supply company regarding maintenance related issues and products that can reduce this condition.

Debris on roof

Moss on roof under tree

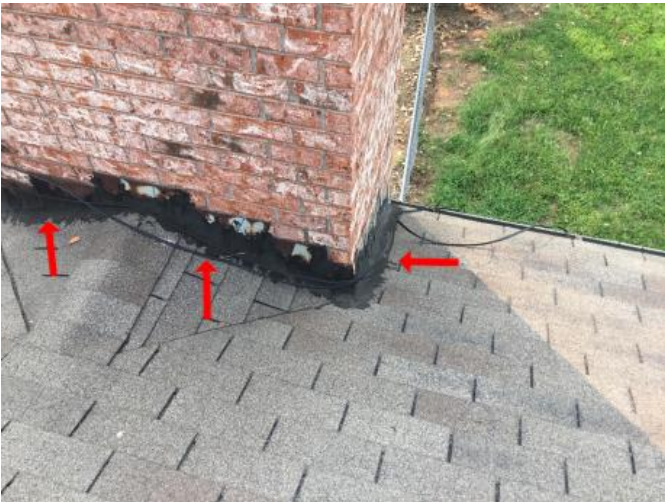
2.2) Flashing Conditions

The flashings had evidence of patching and repair at the chimney. Given this condition, it is likely that the roof has leaked at one time. The inspector cannot offer an opinion as to whether the roof leaks today unless it is moderately raining at the time of inspection. The client should obtain full disclosure/history information from the seller prior to close.

Chimney flashing repaired with roofing sealant

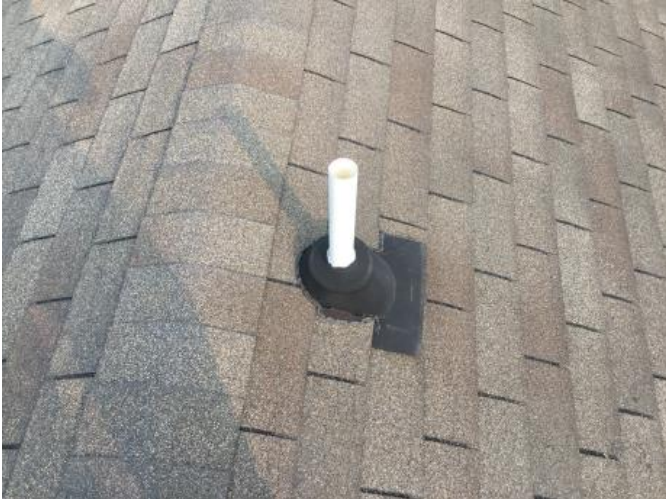
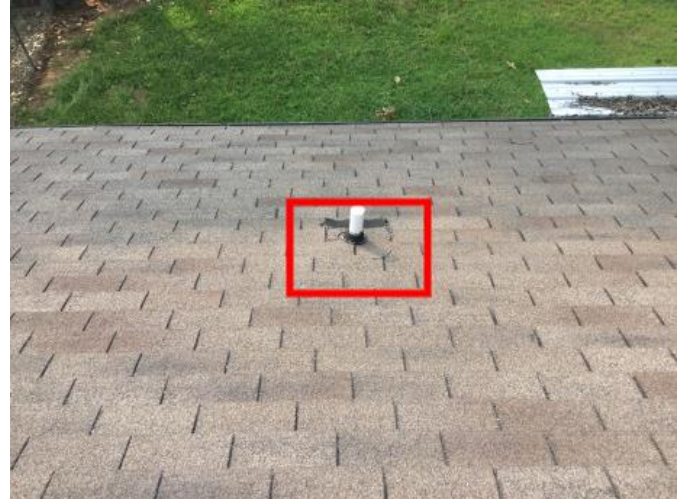
2.3) Roof Penetrations

The roof penetrations sealant was deteriorating. No signs of water enter the home was observed during the inspection. Recommend correction to the roof penetrations.

Vent sealing deteriorating

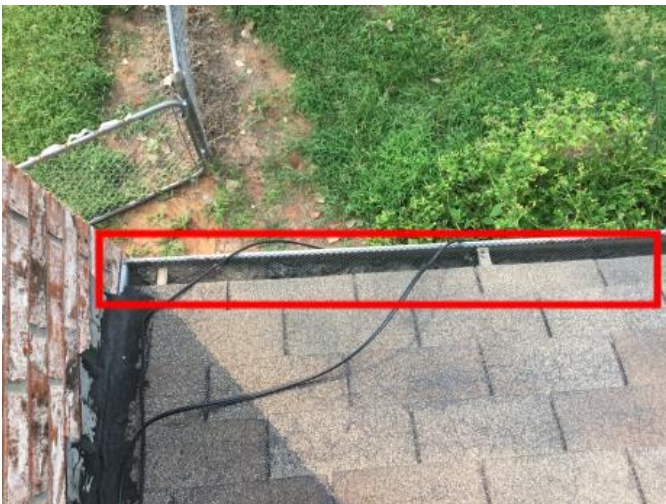
2.4) Gutter & Downspout Conditions

- The gutters were filled with debris at the time of the inspection. Suggest cleaning and removal of debris on a regular basis. This condition can cause water penetration at the eave area.
- Recommend gutter downspouts be extended and routed away from the building for proper drainage. Water seepage under foundations can be caused by inadequate removal of rainwater from the perimeter of the house.

Debris filled

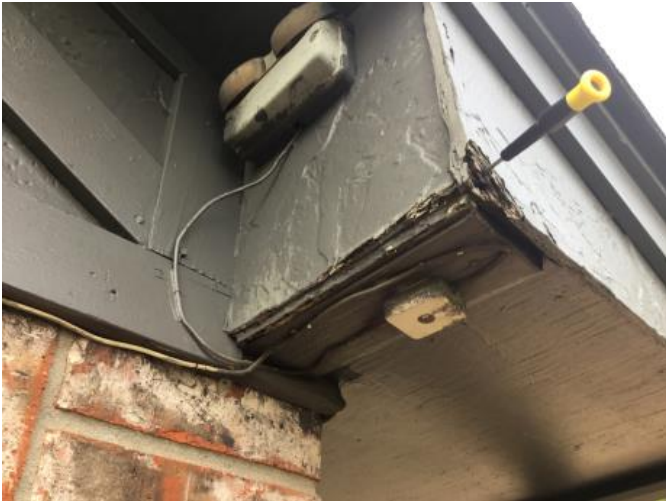
Some moisture damage was observed during the inspection. Recommend correction to the area.

Moisture damage on fascia

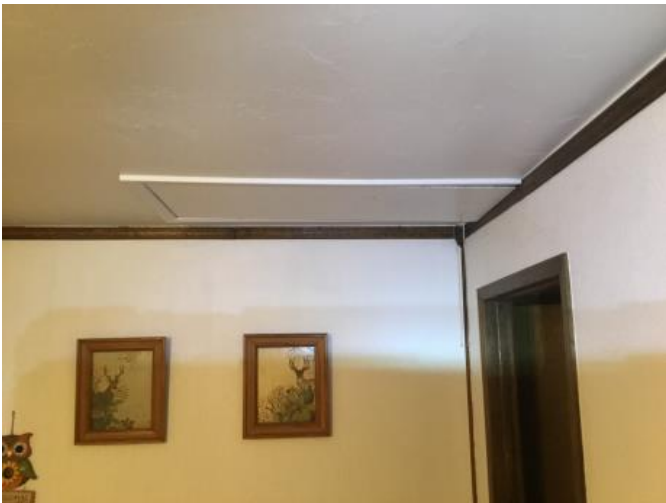
Attic Access

- Guest Bedroom.
- The pull-down attic stair assembly needs repair or adjustment. The stairs will not open fully because it is too long.

Attic access

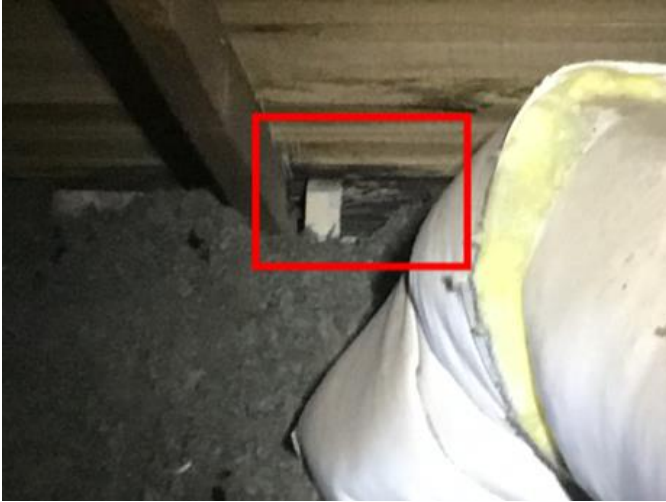
2.6) Roof Sheathing Condition

Minor water stains were observed. The inspector was unable to determine if the water stains were active at the time of the inspection. The stains may have been caused by condensation or leakage at a previous time. The inspector does not offer an opinion or warranty as to whether the roof leaks now (unless it is moderately raining at the time of inspection) or is subject to future leakage. The client should obtain disclosure/history information from the current owner or occupant prior to close.

Water stains by chimney

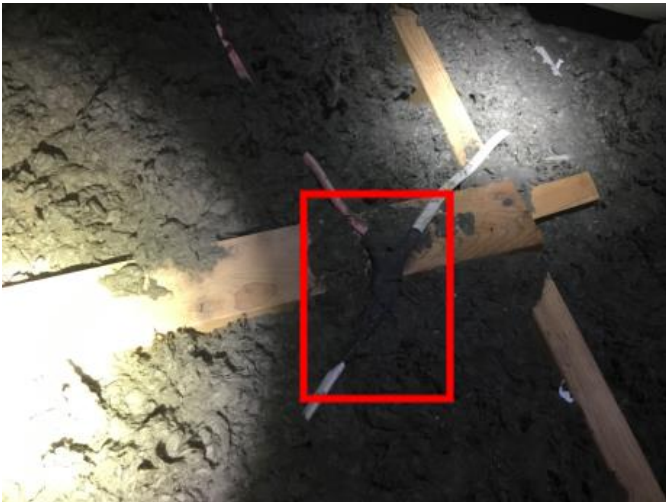
2.7) Attic Conditions

Improper electrical splices were observed in the attic. Any electrical splice should be made in the appropriate junction box. Recommend correction.

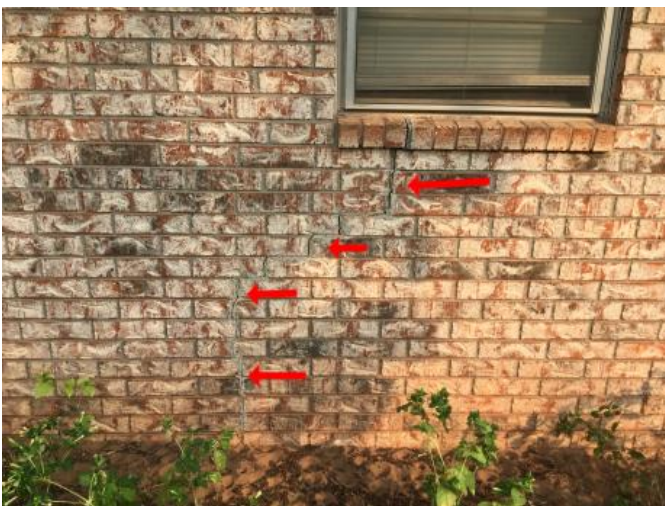
3.3) Exterior Wall Conditions

A crack of 1/8 " or more was observed in the exterior wall. The cracking implies that foundation movement has occurred. Recommend further review and inspection by a qualified foundation/masonry contractor.

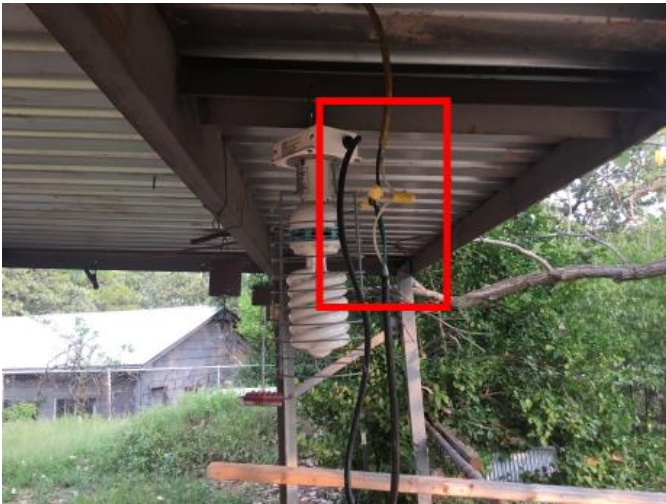
An exposed splice was observed on the rear patio. This could be a shock hazard. Recommend correction.

Open splice

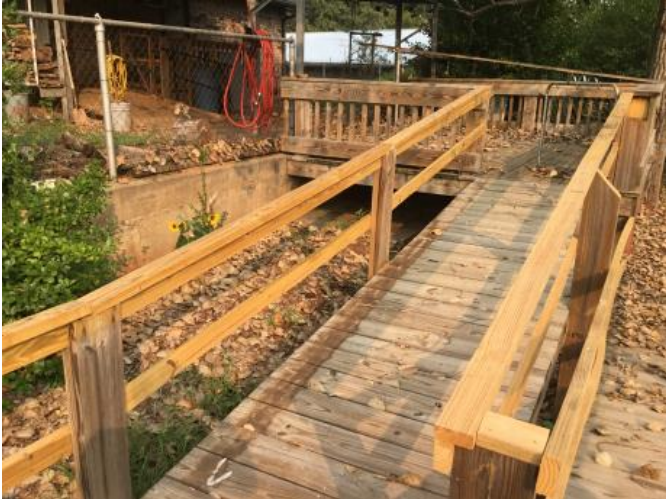
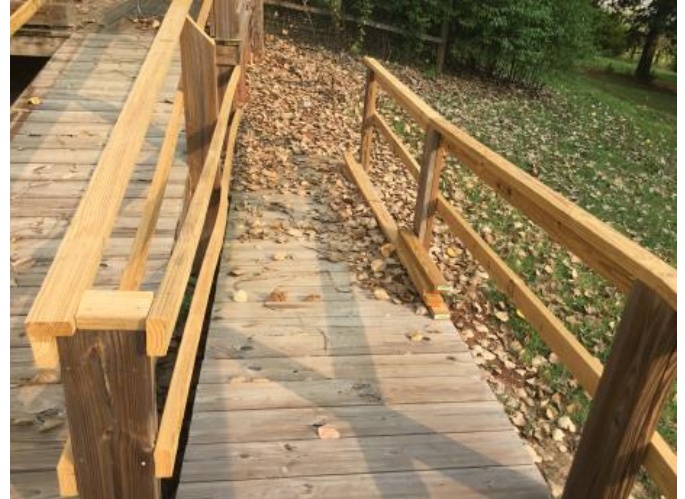
The rear patio ramp was missing balusters. Recommend adding balusters to the area for safety.

Missing balusters

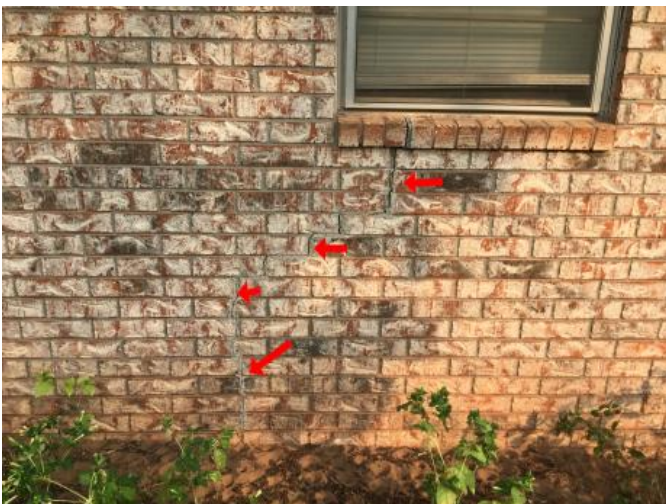
4.1) Foundation Conditions R

A crack of 1/8 " or more was observed in the foundation wall. The cracking implies that foundation movement has occurred. Recommend further review and inspection by a qualified foundation/masonry contractor.

Settlement Crack

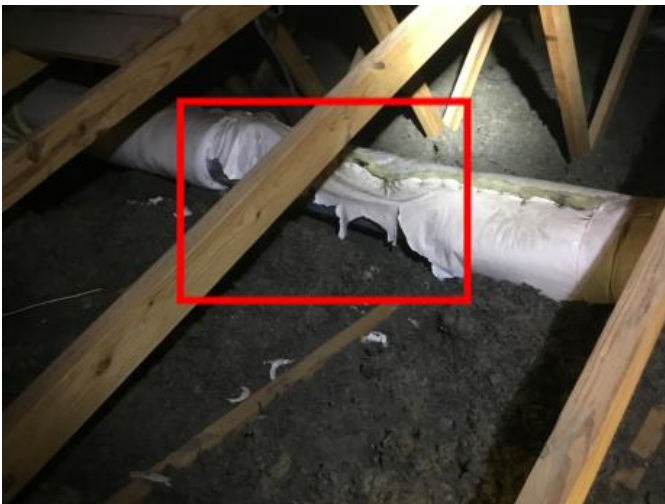
5.2) Distribution Conditions R

Insulation on the duct was damaged during the inspection. Recommend adding insulation to the duct.

Duct insulation damaged

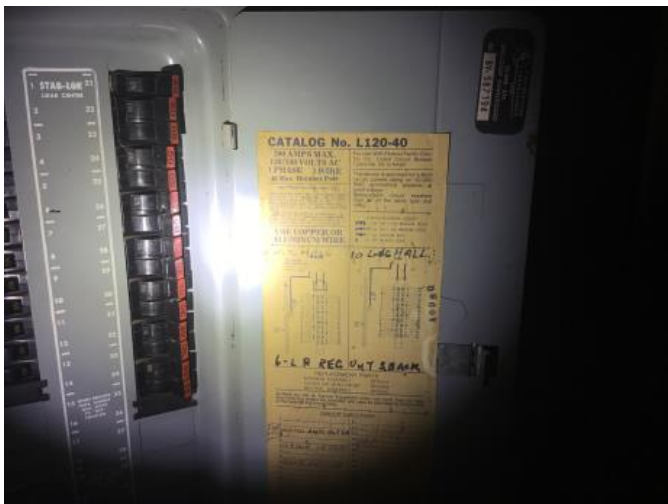
6.2) Electrical Panel Conditions

The panel manufacturer is Federal Pacific. The company is no longer in business. Thousands of these panels were installed from about the 60's to the early 80's. In some cases, problems have been associated with breakers not tripping when needed. Client is advised to consult a licensed electrician for further information.

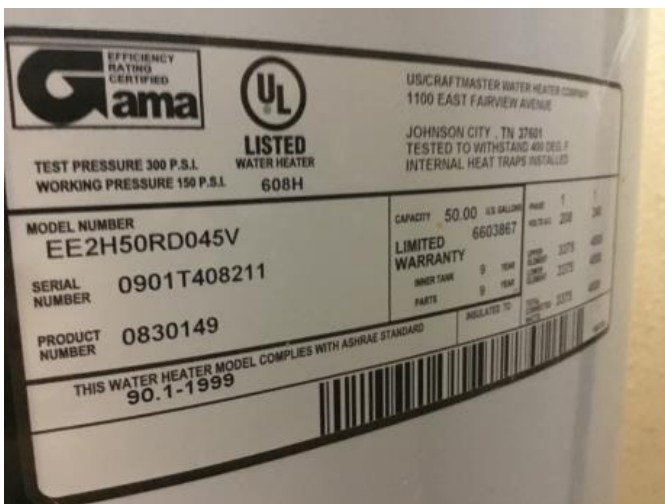
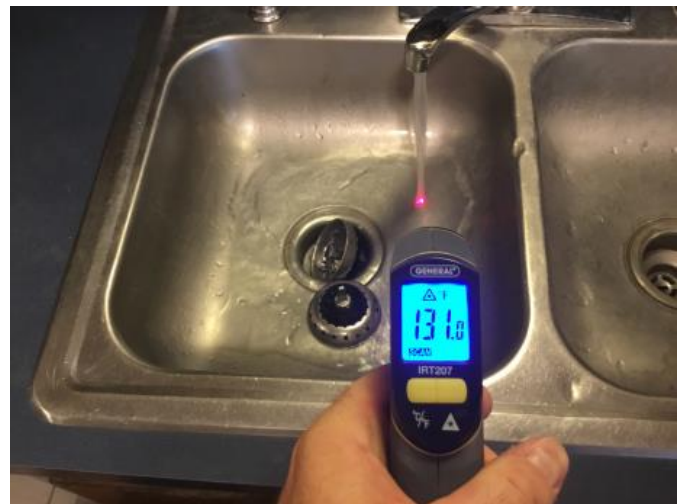
7.4) Water Heater Conditions IN

- The water heater was operable at the time of inspection. This does not however guarantee future performance, operation, or condition. The system date is 2009. The average lifespan of a water heater is 8-12 years. The system is nearing its useful lifespan. Recommend preparing for replacement in the near future.
- T P R (temperature pressure relief) valve overflow pipe was missing at the time of the inspection. Recommend the installation of an extension pipe for increased safety.
- The water temperature set point was too high. This condition can cause scalding. Recommend lowering the temperature of the hot water. The hot water temperature should not exceed 125 degrees.

Hot water measured at 131 degrees

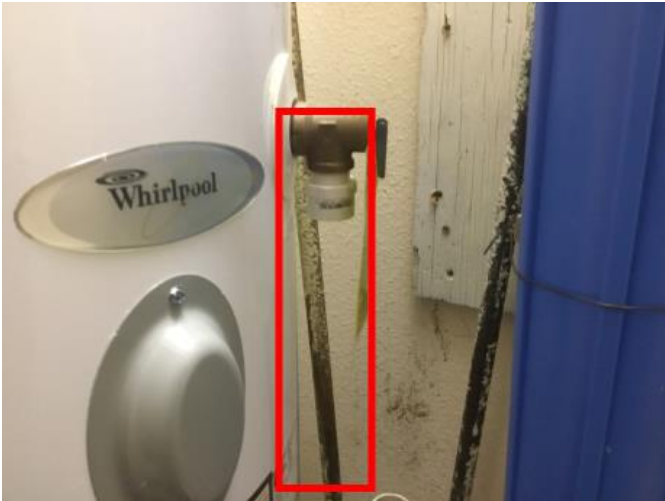
No TPR valve extension

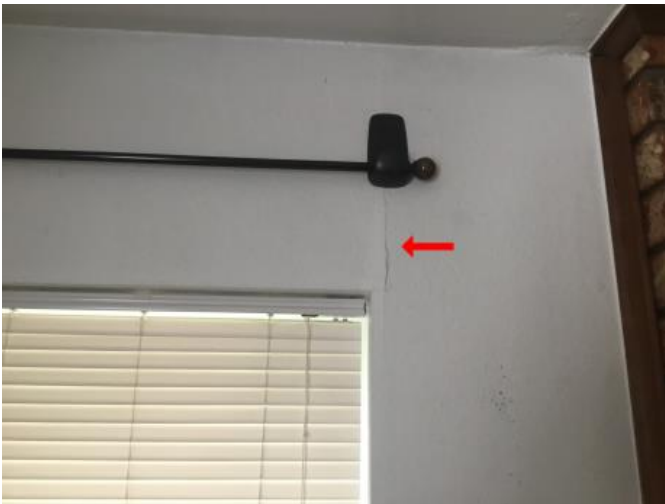
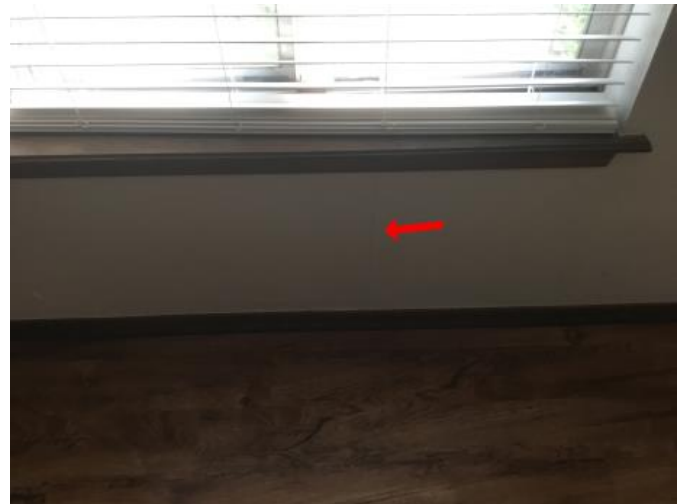
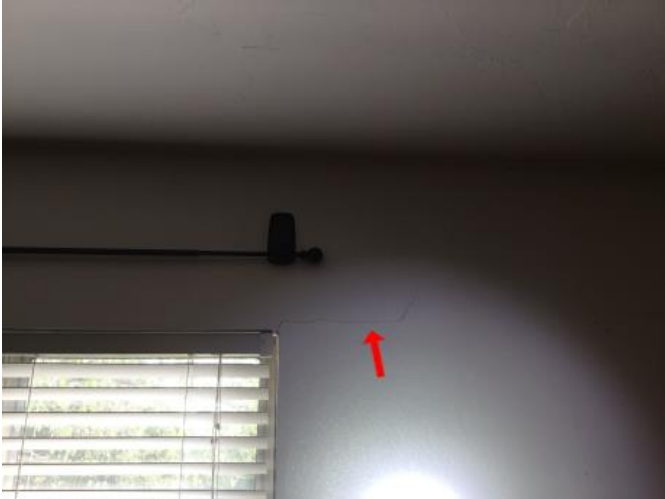
8.1) Wall Conditions

There were common settlement type cracks observed on the interior walls. Although these conditions are common in most homes, client is advised to monitor cracks for future movement.

Common Crack

Settlement Crack

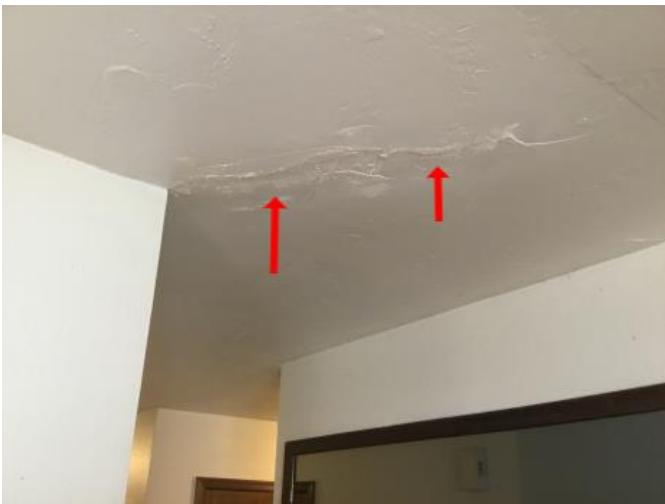
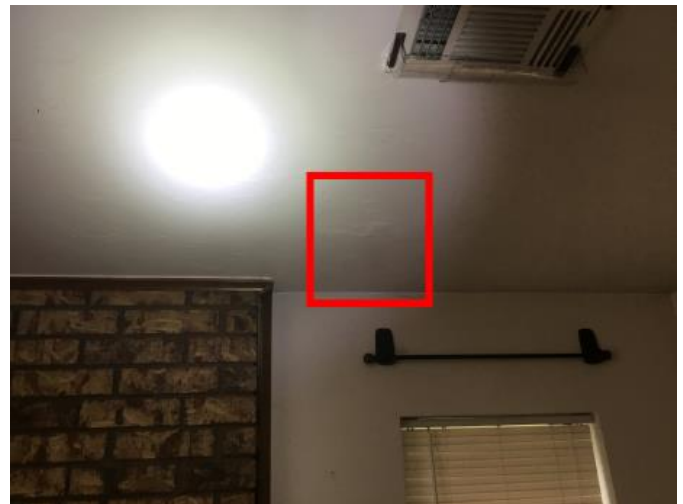
8.2) Ceiling Conditions

- There was a settlement type crack observed on the ceiling. This crack is related to the exterior crack found. The client is advised to monitor cracks for future movement.
- Moisture damage was observed in the living room. The area was tested with a moisture meter. No moisture was detected during the inspection. Recommend monitoring this area.

Moisture damage

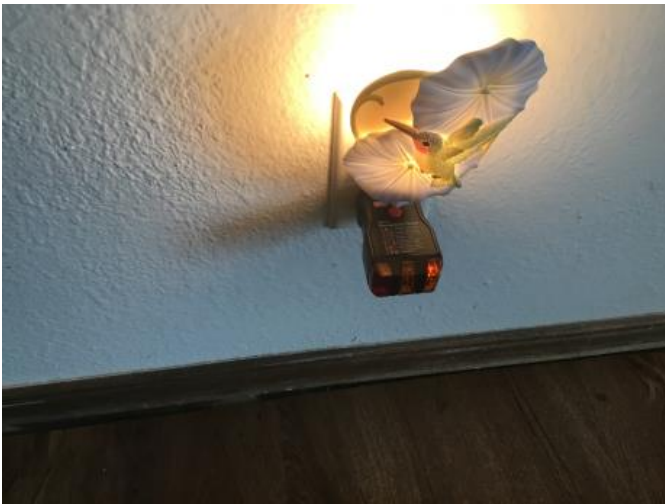
8.6) Electrical Conditions

An open neutral wire condition was observed at an outlet(s) located in the living room. This condition is usually corrected by minor wiring adjustments at the specified item. Recommend correction.

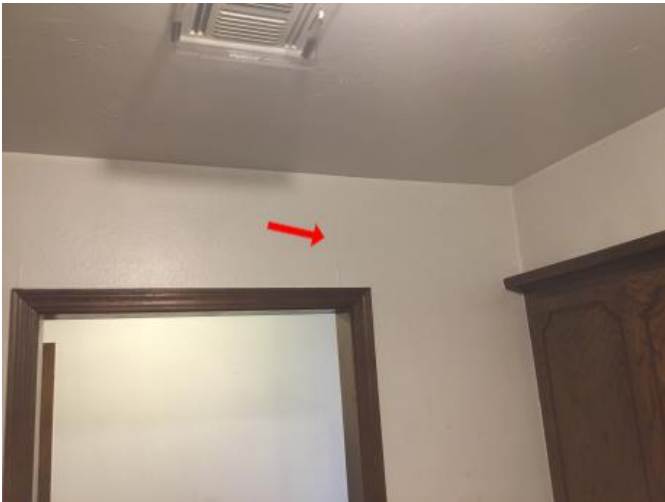
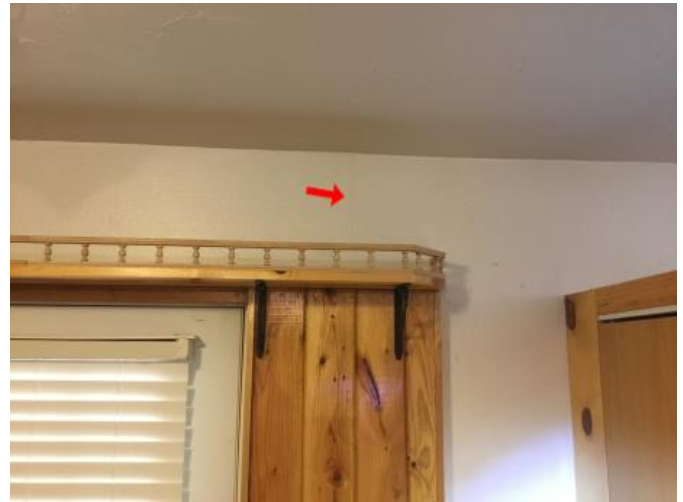
10.1) Wall Conditions

There were common settlement type cracks observed to the interior walls. Although these conditions are common in most homes, client is advised to monitor cracks for future movement.

Common Crack

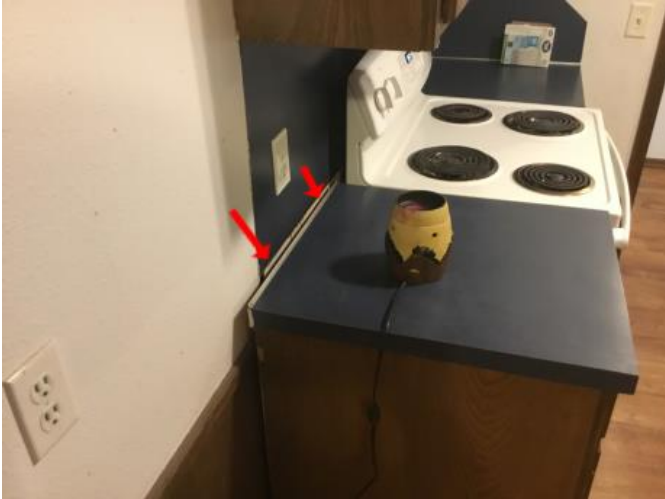
10.7) Counter Conditions

The counter was loose. Recommend repair for increased safety.

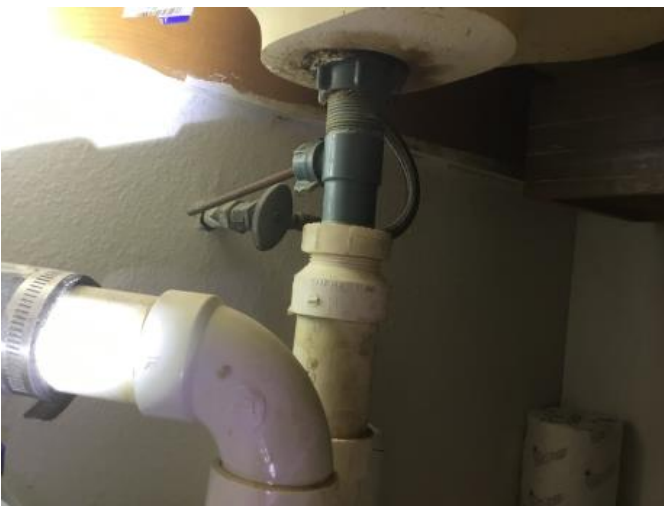
12.11) Sink Conditions

- The sink was scratched and had possible small cracks, and signs of leakage were observed at the sink in the bathroom. The sink(s) has approached the end of its life. Recommend correction.
- The sink drained slowly at the time of inspection in bathroom. Repair may be warranted.

Sink leaking

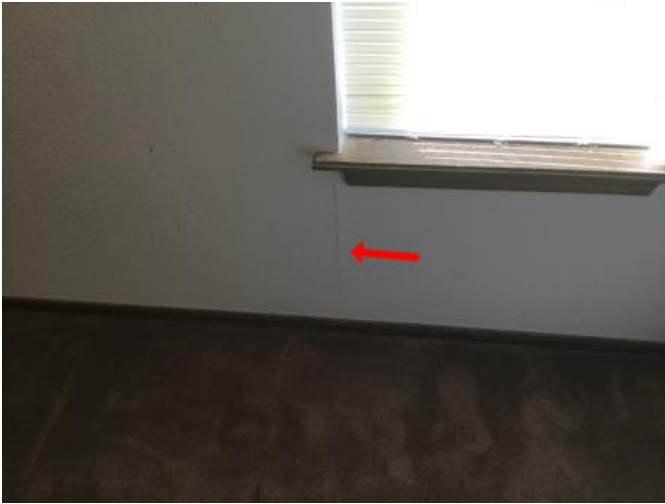
There were common settlement type cracks observed on the interior walls. Although these conditions are common in most homes, client is advised to monitor cracks for future movement.

Common Crack

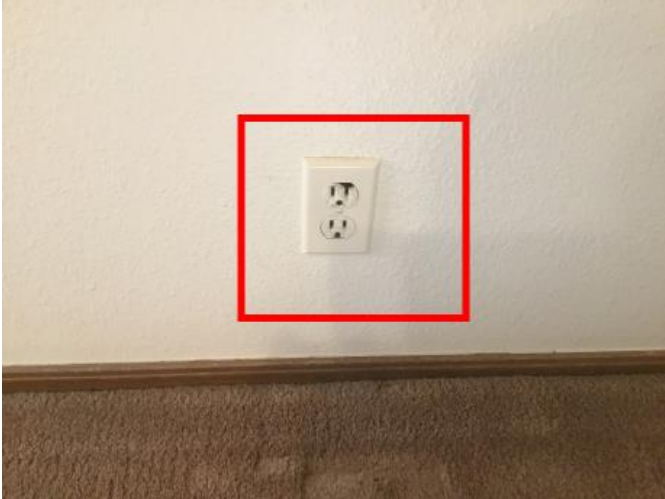
Damaged outlet was observed in the master bedroom. Recommend correction.

Damaged outlet

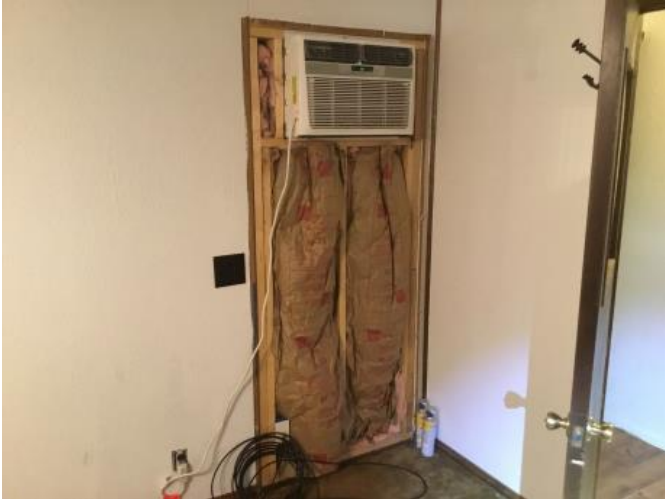
Drywall was not installed in the bedroom behind the door. Recommend installing drywall to the area.

No drywall installed

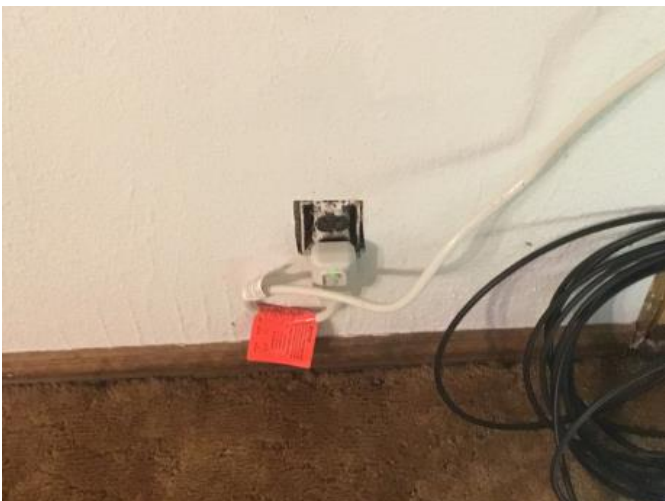
Missing receptacle cover was observed. Recommend covers be installed for safety.

Missing Cover
