BPG Inspection, LLC

Client(s):
Inspection Date: 11/29/2023
Inspector: Dan Pierce , 68780 (AZ)

Date: 11/29/2023	Time: 08:00:00 AM	Report ID: 1025173
Property:		Prepared By: Dan Pierce

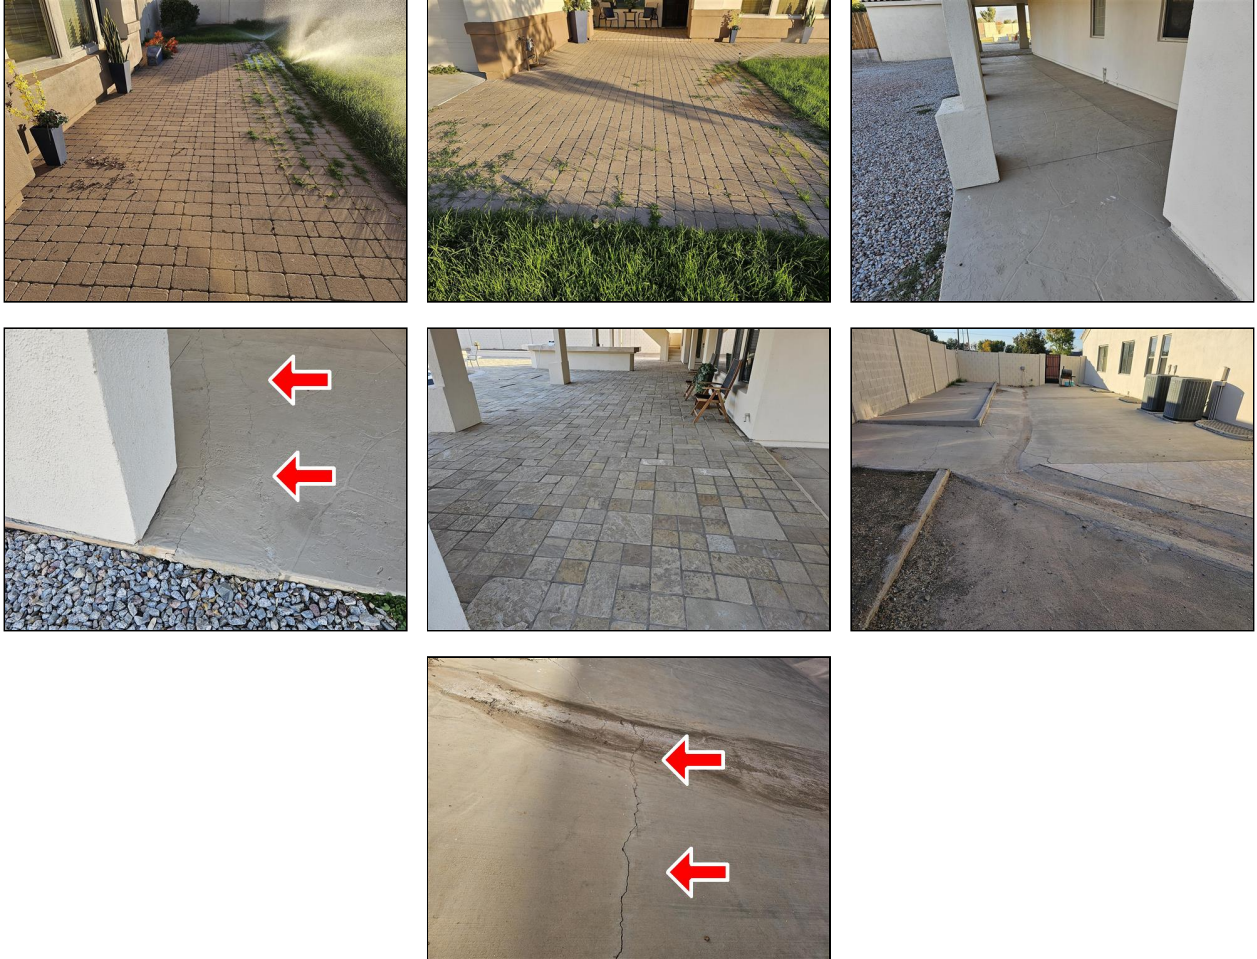
- ◆ Common cracks (1/4 inch or less) were visible at the time of the inspection. Cracks exceeding 1/4 inch should be patched with an appropriate sealant to avoid continued damage to the walkway surface from moisture.

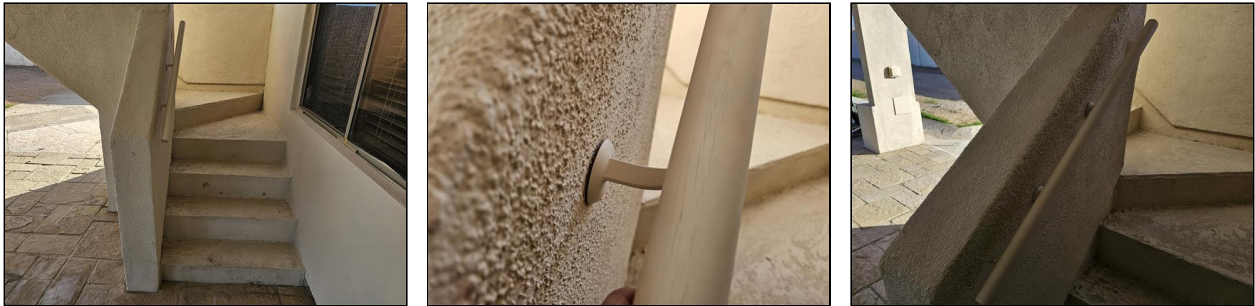
- ❌ ♦ The hand/guard rail for the upstairs loose. A fall or injury could occur if not corrected. A qualified technician should repair or replace as needed.

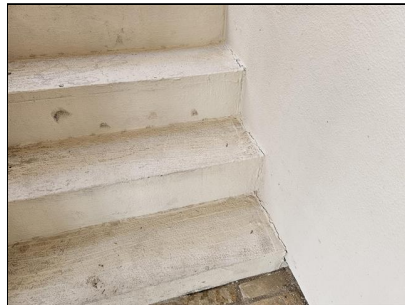
- ⊠ ♦ The exterior steps are cracked and may allow water to enter below. Recommend sealing the stairs to prevent water damage.

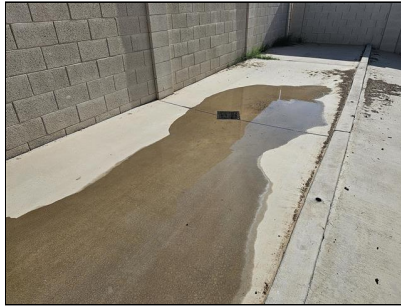
- ⏏ ♦ We could not verify what this drain is meant for, ask the seller.

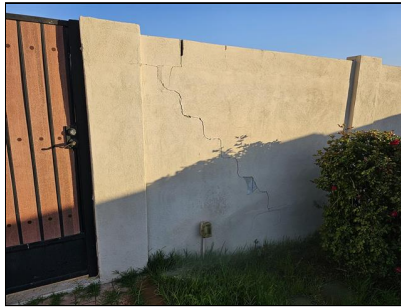
- ⏏ ♦ There are step cracks in the mortar of the masonry fence at the property. If the wall has settled due to wet conditions, the source of moisture should be eliminated to prevent further cracking.
- SUGGESTION: A qualified technician could patch the cracks.

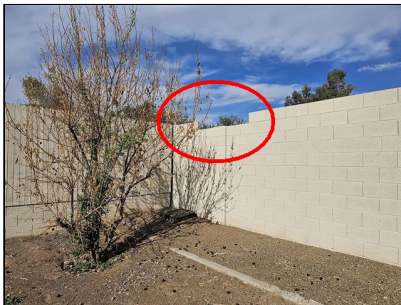
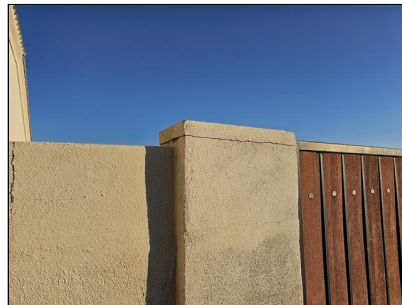
- ⏏ ♦ Cap blocks are loose or missing at one or more of the masonry fence pilasters. Recommend repair by a qualified technician. This will be an ongoing maintenance issue for the homeowner and should be periodically checked for proper adhesion.

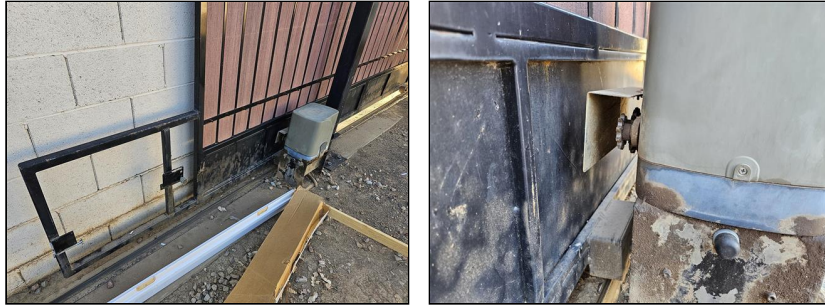
- ⊗ ♦ The front vehicle gate was not fully operational. The chain was missing at the gate. Recommend a qualified repairman restore the operation to the gate and provide keyless openers for access.

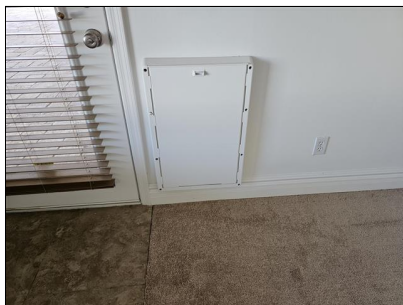
- ☒ ◆ There is a Pet door installed in this home. This is an easy entrance point for pests. If not being used I recommend closing off and sealing the pet door.

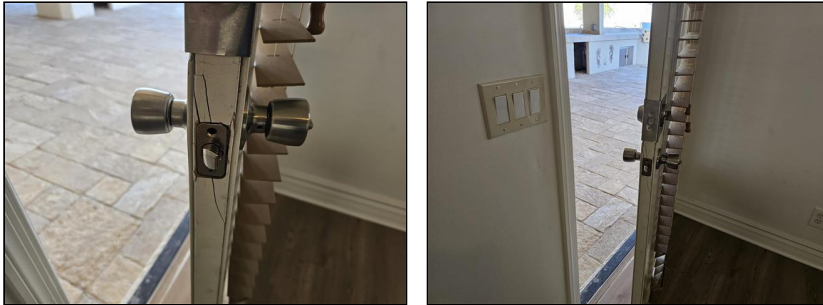
- ❌ ♦ A door to the exterior at the back room is damaged. Recommend replacing the door for safety.

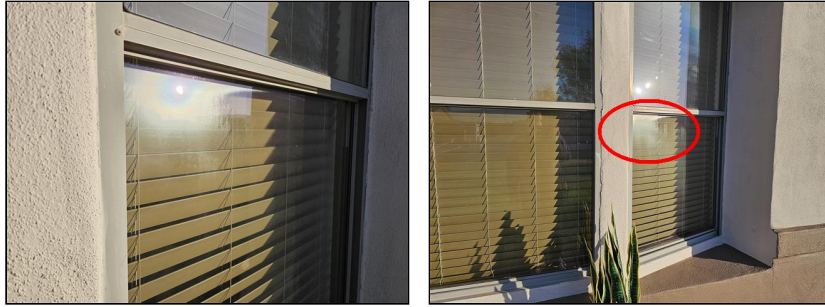
- ❌ ♦ Condensation staining, or droplets, is present between the panes of one or more insulated glass windows in the home. See Photos. This suggests a failure of the factory seal between the twin pieces of glass. There are some companies that can repair windows with moisture between panes without replacing the window. "Fogged" windows can still perform their function for ventilation and light admittance, but can become so opaque that visibility is impaired. We did NOT attempt to list every fogged window. Have a qualified glass contractor check ALL windows and determine if the breach can be fixed or if the window needs to be replaced. Any insulated glass units which display symptoms of breached seals should be repaired or replaced as desired.

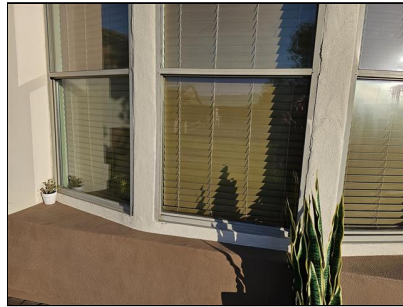
♦ Several window screens are missing. All window screens should be replaced as needed.

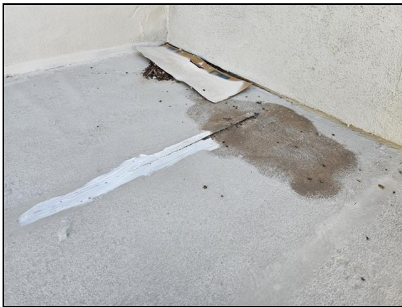
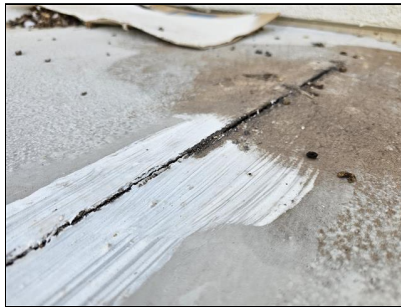
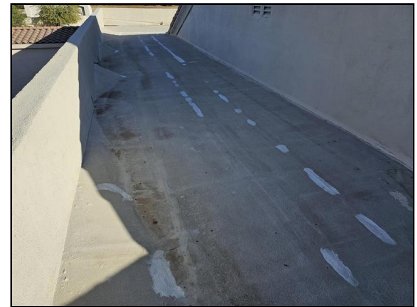
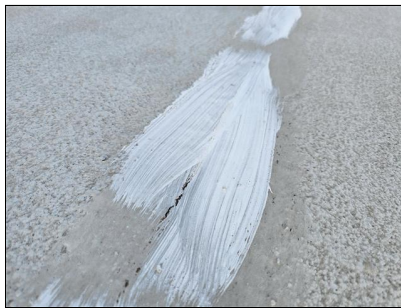
- ◆ Areas of minor peeling and cracking were noted in the elastomeric coating. Maintenance service is needed.

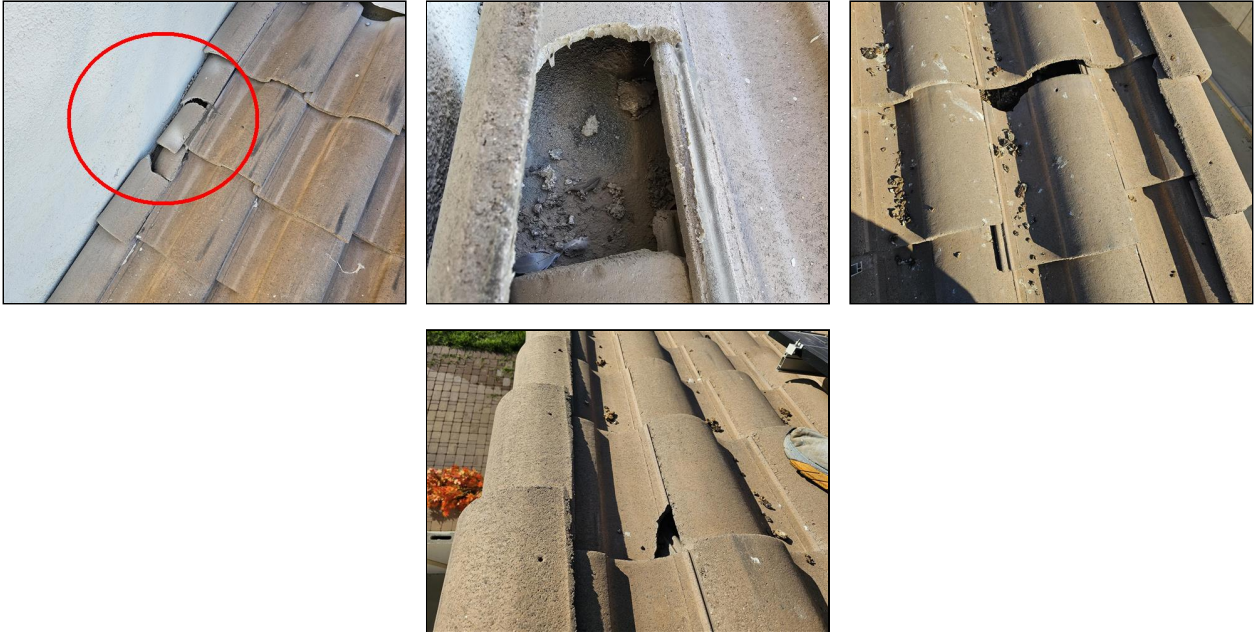
- ❌ ♦ There are dislodged tiles at various locations leaving the felt underlayment, flashing exposed. Dislodged concrete tiles create vulnerable entry points for water, potentially leading to leaks, water damage, and compromised insulation. These gaps can also expose the underlying structure to the elements, increasing the risk of further deterioration. A qualified roofing contractor should review the roof covers and repair, replace tiles / underlayment as necessary.

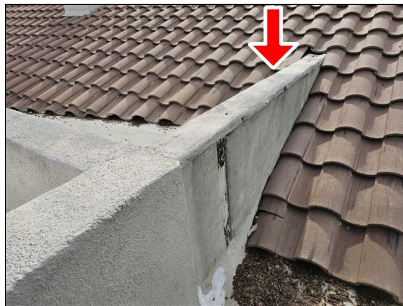
- ⚠️ ♦ Mineral paper cap sheet was used on a separation wall on the roof. This material may have been added to prevent bird damage at this area.

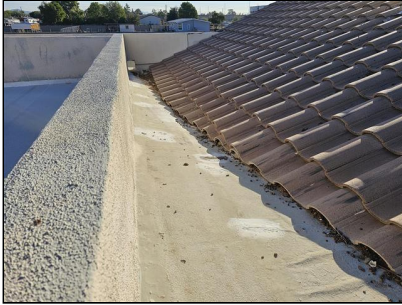
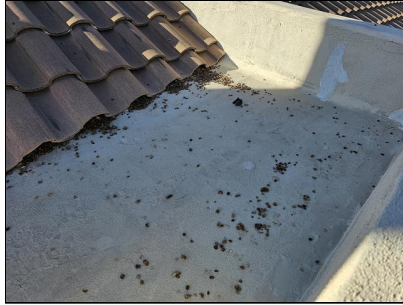
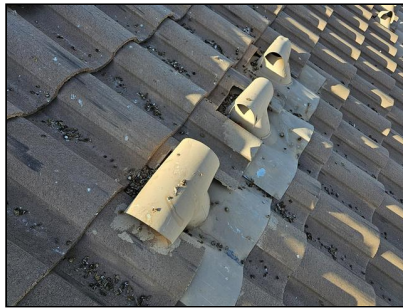
- ✘ ◆ The valleys are obstructed by an accumulation of bird debris. The debris can promote moisture penetration of the roofing system. Regular maintenance and clearing of all debris from the valleys is recommended as part of routine roof maintenance.

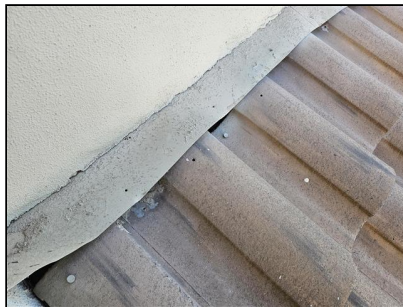
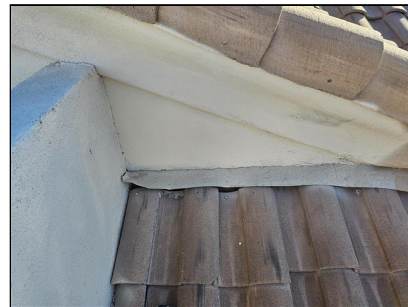
- ✘ ◆ The sidewall flashing at the front of home is loose and has exposed fasteners. Leaks can occur at the exposed fasteners. A qualified technician should repair or replace as needed.

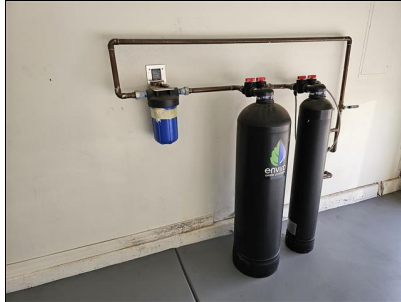
- ❖ Water softeners or water treatment systems are not within the inspection scope. As a courtesy, your inspector observed one or more of the following conditions. Unit unplugged and does not appear functional. Unit in By-Pass mode, out of service. Water softener is old leaking. We advise you to consult a qualified person regarding operation and maintenance of this appliance.

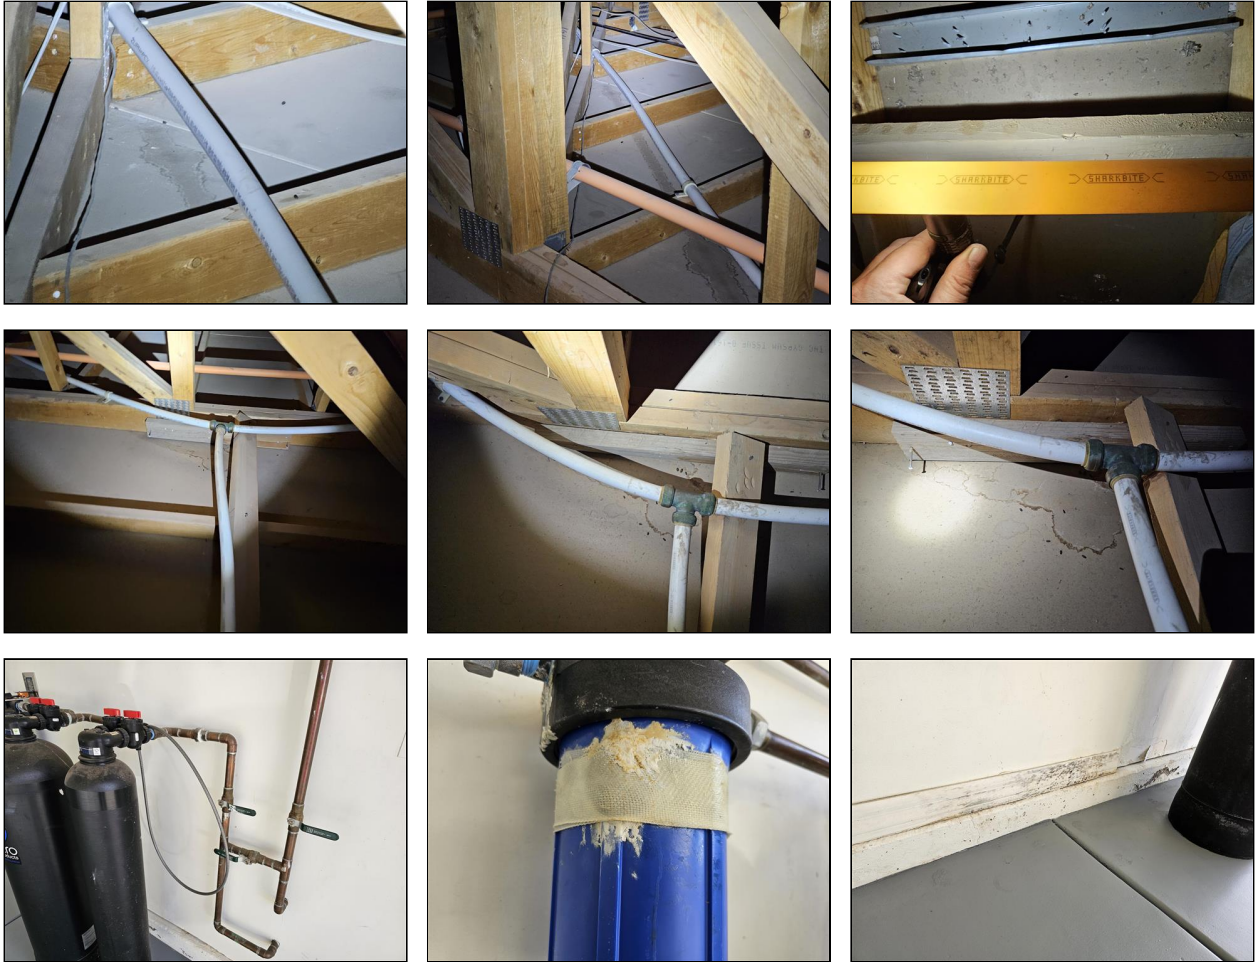
- ❖ A water line in the attic that is attached to the water filter is sweating above the garage. This could cause staining of the garage ceiling. Some staining and possible mold is visible under the filter in the garage on the wall. The system should be fully evaluated by a qualified technician for leaks and repaired as needed.

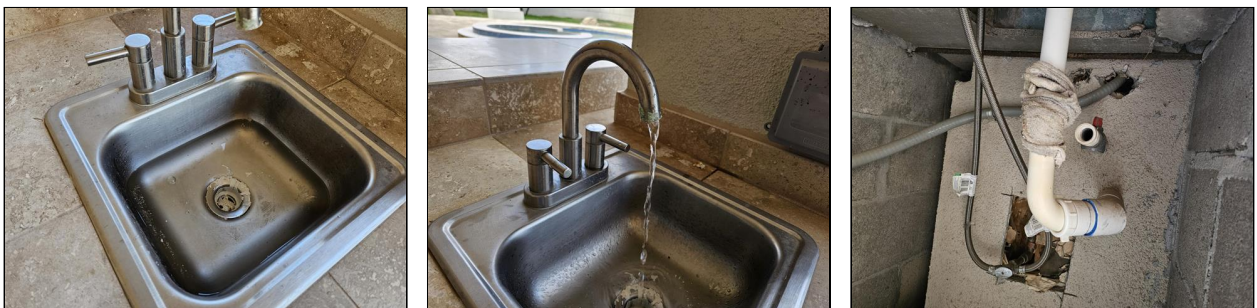
- ❌ ◆ A sink at the exterior had poor flow and drainage at the time of the inspection. The Inspector recommends that an evaluation and any necessary work be performed by a qualified plumbing contractor to restore flow. A proper p-trap should be added as to prevent unwanted sewer gases from coming up.

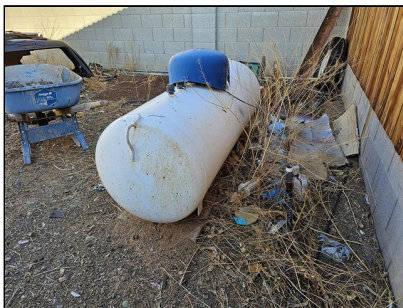
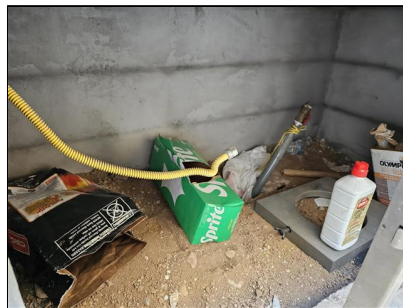
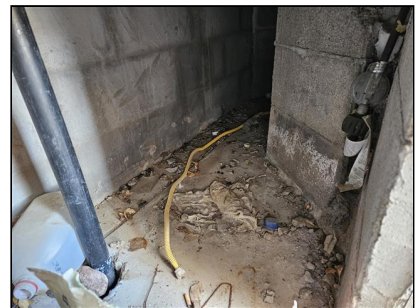
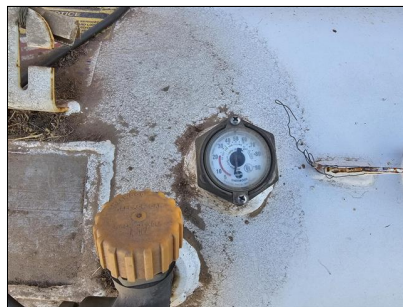
- ✗ ◆ This building is served by a private liquefied petroleum gas (LPG) supply, which is stored in an aboveground storage tank located on the property. The main gas shutoff valve is located on top of the tank. Testing of the tank and its controls is beyond the scope of this inspection. There is no propane in tank. We did not inspect for leaks.

Underground gas lines were abandoned at the outdoor kitchen and pool heater. We could not test the interior fireplace, exterior fireplace, or any other appliance that needed propane for operation. Recommend having a qualified plumber evaluate these lines prior to using them to verify there are no underground leaks.

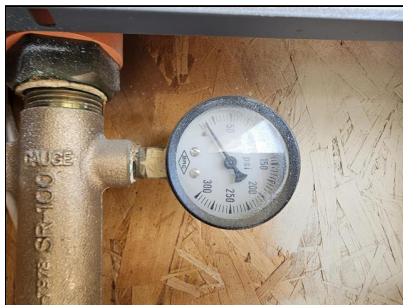
- ✘ ◆ There is a fire sprinkler system in the building. Inspection of this system is not included in the scope of this inspection. Code generally requires one head per 100 square of livable space.

SUGGESTION: The inspector does not do the calculations required to determine if the code is followed. Ask the owner about the service history of the system, or have it evaluated by a qualified fire sprinkler contractor as desired. Have system inspected by qualified contractor bi-annually or as required by home insurance company.

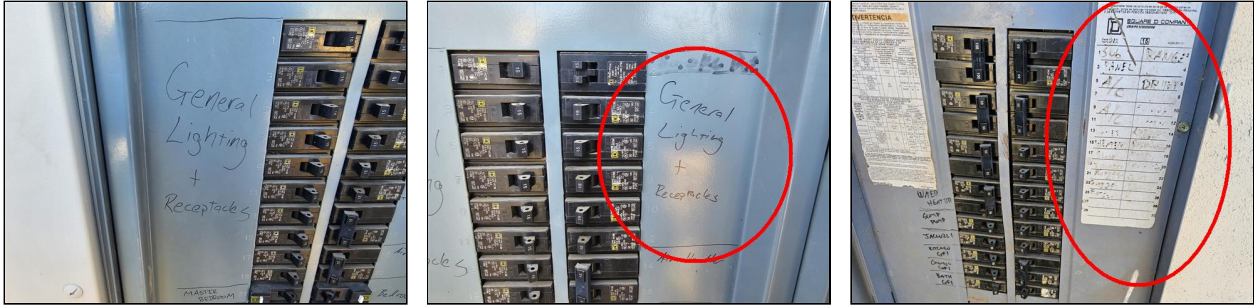
- ⏏ ◆ The main distribution panel has several circuit breakers that need labels identifying their location(s). General Lighting is not useful for most situations. Many labels are hard to read and should be reprinted.

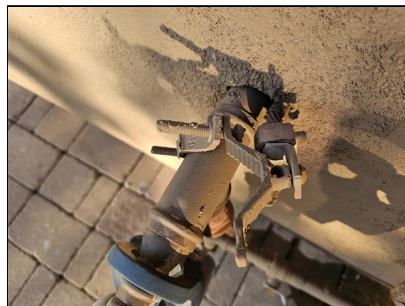
- ☒ ◆ The bonding clamp on the water supply is loose. Recommend reattaching as needed. Some of the interior plumbing has been converted to plastic so bonding wouldn't be necessary/

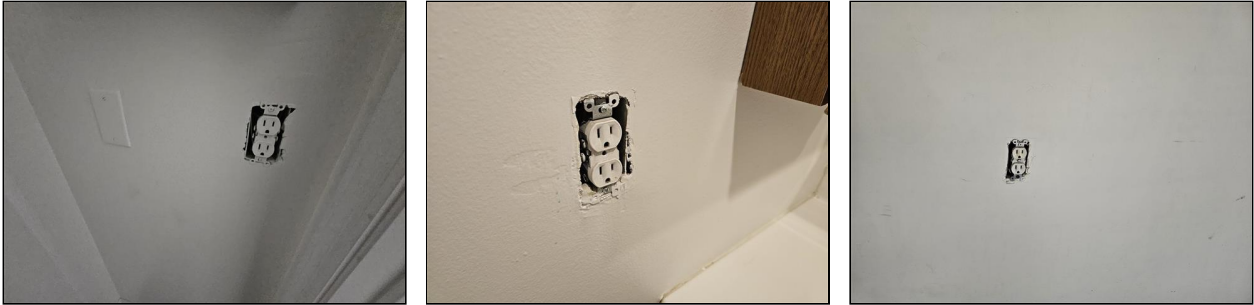
- ◆ A representative number of receptacles, switches, and fixtures, (one per room) performed their intended function on the day of the inspection.
- ☒ ◆ A switch cover plate is missing in the several areas of the home, we did not attempt to list every location. This leaves bare conductors exposed, creating a shock hazard. We DID NOT necessarily list all locations. Any missing cover plates should be replaced.

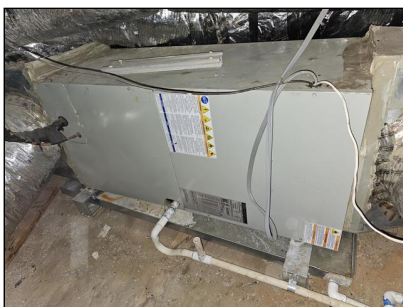
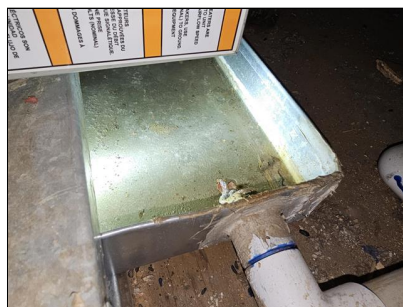
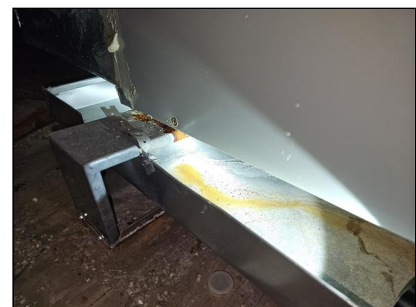
- ♦ The condensing unit located at the building exterior performed its intended function and showed no visible signs of distress on the day of the inspection.
- ✘ ♦ The condensate overflow pan has rust present. This indicates a prior or ongoing leak in the evaporator coil or a clogged primary drain line, and possibly a blockage in the pan's drain line. If the pan overflows, the structure below will be damaged. No moisture was detected at the time of inspection.
 - SUGGESTION: Recommend HVAC technician to evaluate and repair the system as needed.

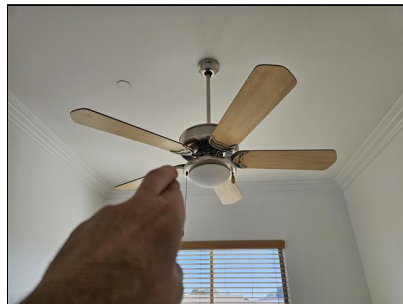
- ◆ Since ceiling fan mounting boxes are concealed in the ceiling, they are inaccessible and cannot be inspected. Proper mounting of ceiling fans require the use of specially-designed boxes which must be properly secured to the ceiling structure. Proper mounting is necessary to ensure that the fan does not fall. If you have any doubt about any ceiling fan installation, we recommend a thorough check by a technician familiar with the manufacturer's installation instructions.
- ☒ ◆ A ceiling fan is not functional in the Bedroom. A qualified technician could evaluate the fan and determine what corrective action is necessary.

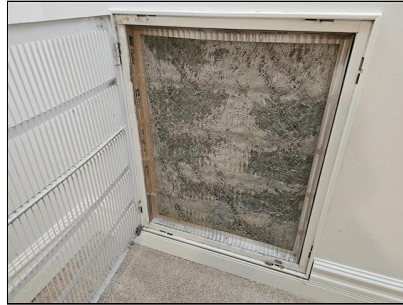
- ☒ ◆ The filter is dirty. This decreases its effectiveness, and blocks airflow. This can dramatically decrease the efficiency of both the heating and cooling system if present. Change or wash the filters now, and at regular intervals thereafter. The filter should be replaced with a properly sized filter to ensure proper function. If the system has been operating in this condition for an extended period of time, service by a licensed HVAC contractor is advised to check the cleanliness of the fan, evaporator coil, ducts, etc., and clean it as needed.

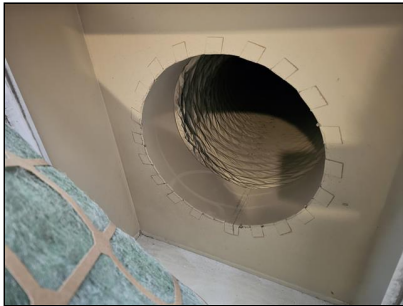
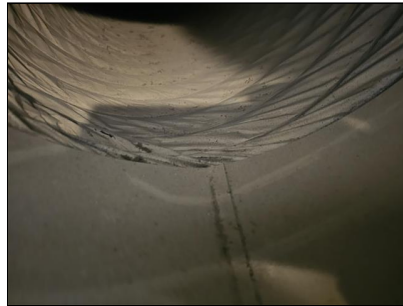
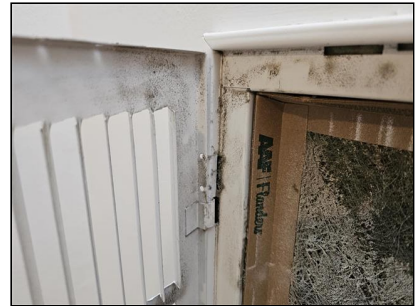
- ◆ Although a complete visual inspection of the inside of the ductwork is not possible, debris was seen in the vents; indicates the need for cleaning ducts. Have a qualified technician that specializes in this area, clean the ducts.

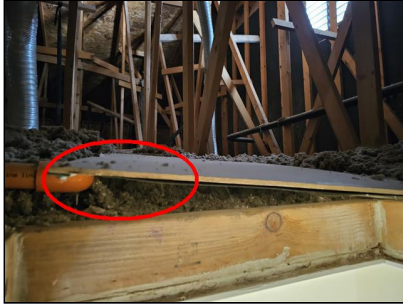
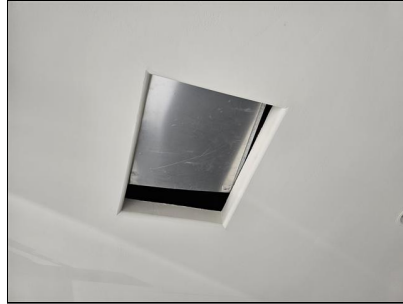
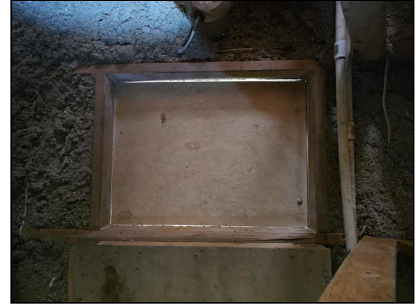
- ◆ The photos show the areas in the attic that were accessible to your inspector, these areas when reviewed showed no signs of any deficiencies on the day of the inspection.
- 📷 ◆ The hatch cover over the attic access is not insulated or the insulation is not attached. This can allow cool or warm air to escape the home. Recommend installing proper insulation on the attic hatch. A handy person can do the work.

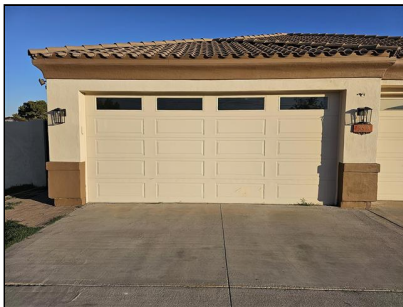
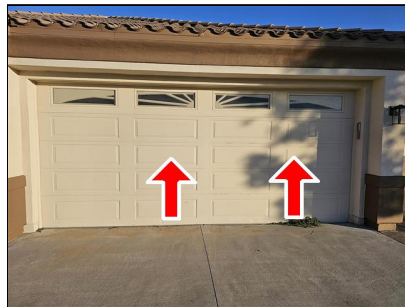
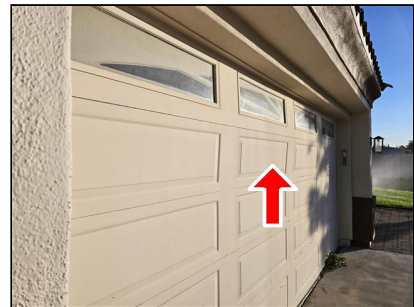
- ◆ The garage door responded to automatic opener and to its optic safety reverse. The downward pressure safety reverse was not tested; check it periodically to ensure it reverses properly.
- ☒ ◆ A garage vehicle door panel had moderate damage visible. The Inspector recommends maintenance be performed by a qualified contractor.

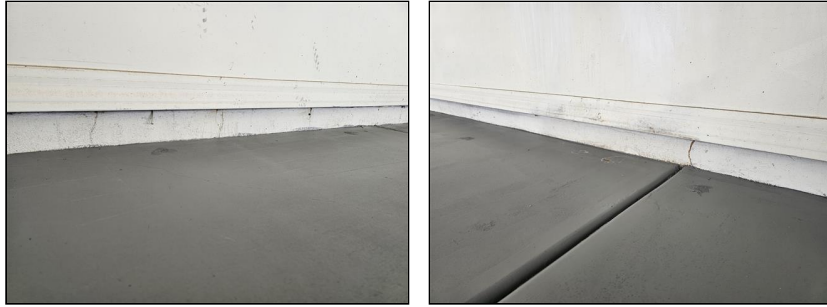
- ◆ The garage walls and ceilings were intact and functional where they could be viewed. Typical cosmetic cracks / wear and tear for age of home.
- ☒ ◆ Termite shelter tubes were observed at one or more areas of the garage walls. mud tubes are telltale signs of a potential termite infestation, and professionals can confirm the presence, identify the termite species involved, and assess the extent of the problem. Following their inspection, a tailored treatment plan will be recommended, which may include localized or whole-house treatments. It's essential to heed their advice, which may also involve repairing damaged wood and implementing preventive measures. Regular termite inspections are wise for ongoing home maintenance, particularly in termite-prone regions, to prevent further damage and protect the structural integrity of the property. See your WDO report for details.

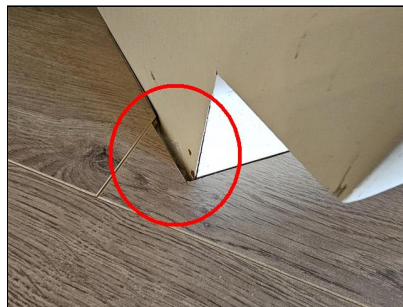
- ◆ The flooring components were in acceptable condition on the day of the inspection. House cleaning is not a part of this evaluation.
- ☒ ◆ While beyond the scope of this inspection to comment on flooring items it is noted that there are gaps in the pergo type flooring. Recommend repair by a qualified individual.

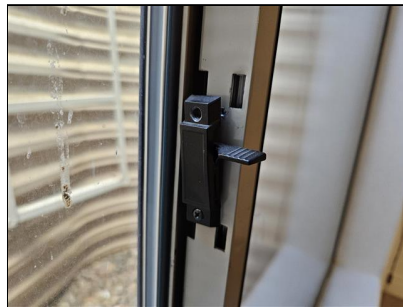
- ❌ ◆ There is a damaged latch at the window in the Bedroom. We did NOT attempt to list every affected latch. Replace affected latches as needed.

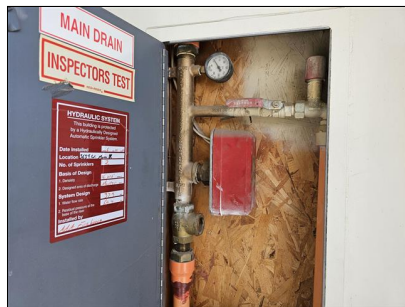
- ◆ There are no spare sprinkler heads in the control box. Recommend installing one of each type used in the home in the control box.

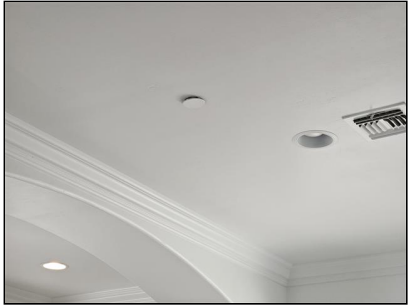
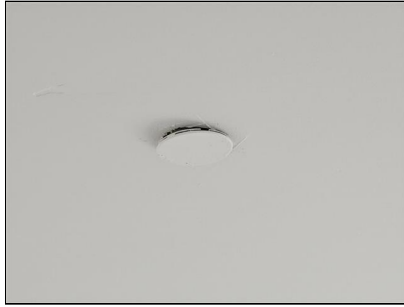
- ◆ The trim ring around some of sprinkler heads are missing or loose to the ceiling. This allows unfiltered air to enter into the home. Recommend repair by qualified contractor.

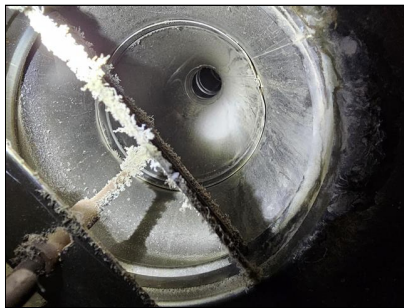
- ◆ The flue has a heavy build-up of soot or dust, which could lead to a chimney fire. The condition of the flue could not be determined. A qualified chimney sweep should evaluate the flue, then make repairs or modifications as necessary.

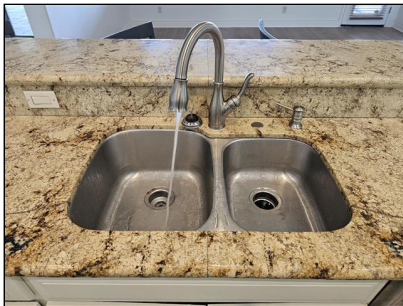
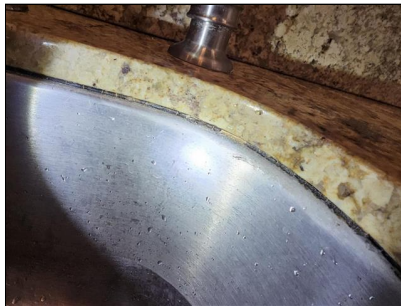
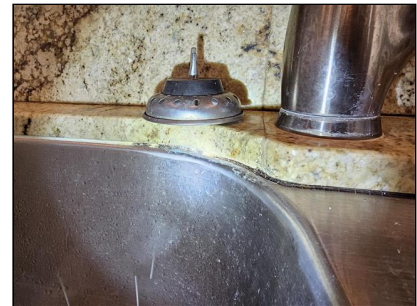
- ◆ The kitchen sink(s) and visible plumbing exhibit typical wear and tear normal for this heavily used component. The flaws are cosmetic in nature. No remedial action is indicated.
- ☒ ◆ Caulking at the kitchen sink area is deteriorated and/or missing. This could allow water to enter into the cabinet below and cause further damage. A qualified technician should remove the old caulking and re-caulk as needed.

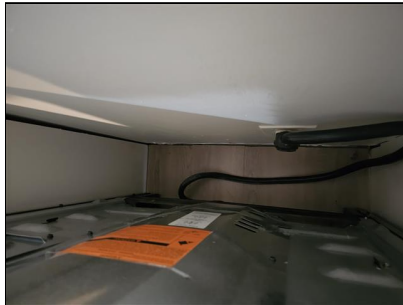
- ❌ ◆ Anti-tip hardware is not installed on this range. This is a safety feature that prevents the oven from falling over if a child climbs on the open oven door. Although this safety feature may not have been required when the unit was manufactured or installed, it is needed for safety. We strongly recommend the hardware be installed as a safety upgrade.

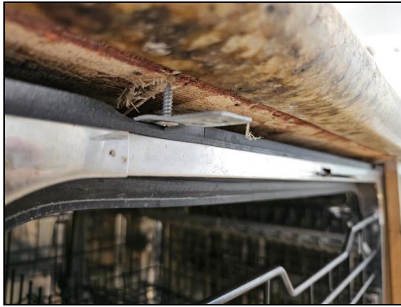
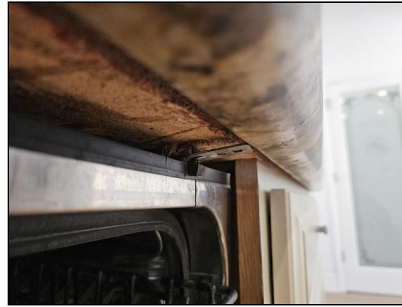
- ☒ ◆ The dishwasher is loose in the cabinet and needs securing to underside of countertop (using a proper length screw). I recommend repair as necessary.

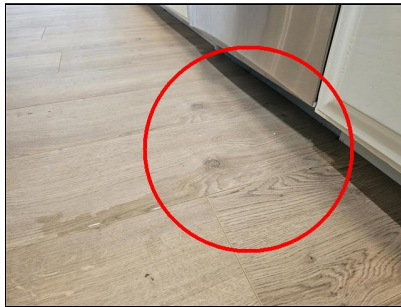
- ☒ ◆ The dishwasher is leaking around the door. A qualified technician could repair or replace the door gasket, or other parts as needed.

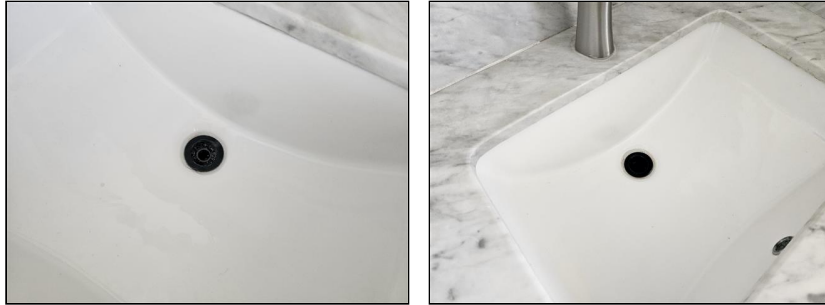
- ◆ No leaks and or deficiencies associated with the bathroom sinks were visible on the day of the inspection.
- ◆ The drain stop(s) for the wash basin in the guest bathroom is damaged. It should be repaired or replaced to restore proper function.

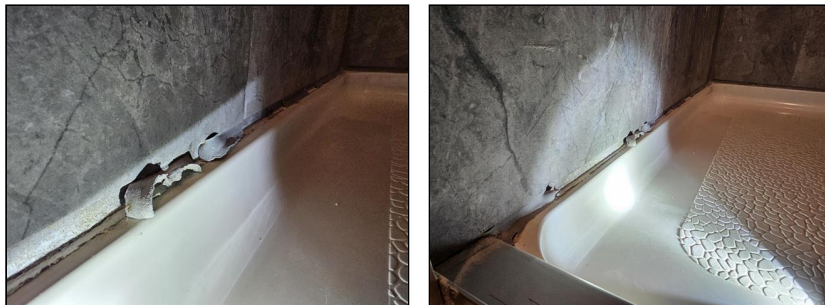
- ☒ ◆ Caulking/Grout at the hall bathroom shower is deteriorated. Missing or deteriorated caulking can promote water penetration into the adjoining structure. The old caulking should be removed and re-caulked. NOTE: Treat the area as needed before re-caulking to prevent mildew from occurring.

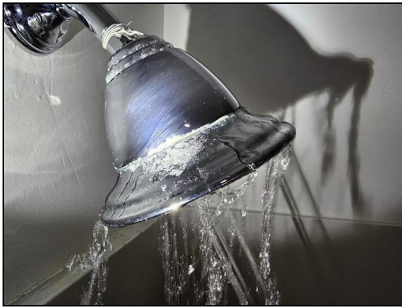
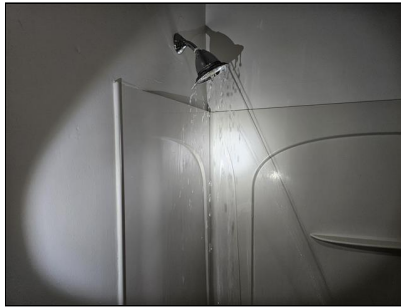
- ▣ ♦ When operated the shower head was observed to be leaking at the fitting. A qualified person should make the repairs.

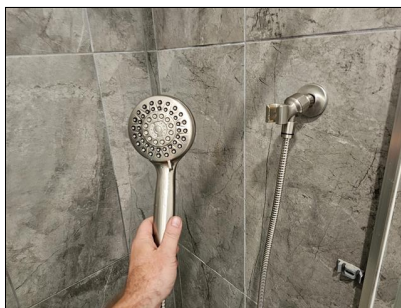
- ♦ The wand shower head was not functional at the bathroom. Recommend repairs by a qualified person as needed.

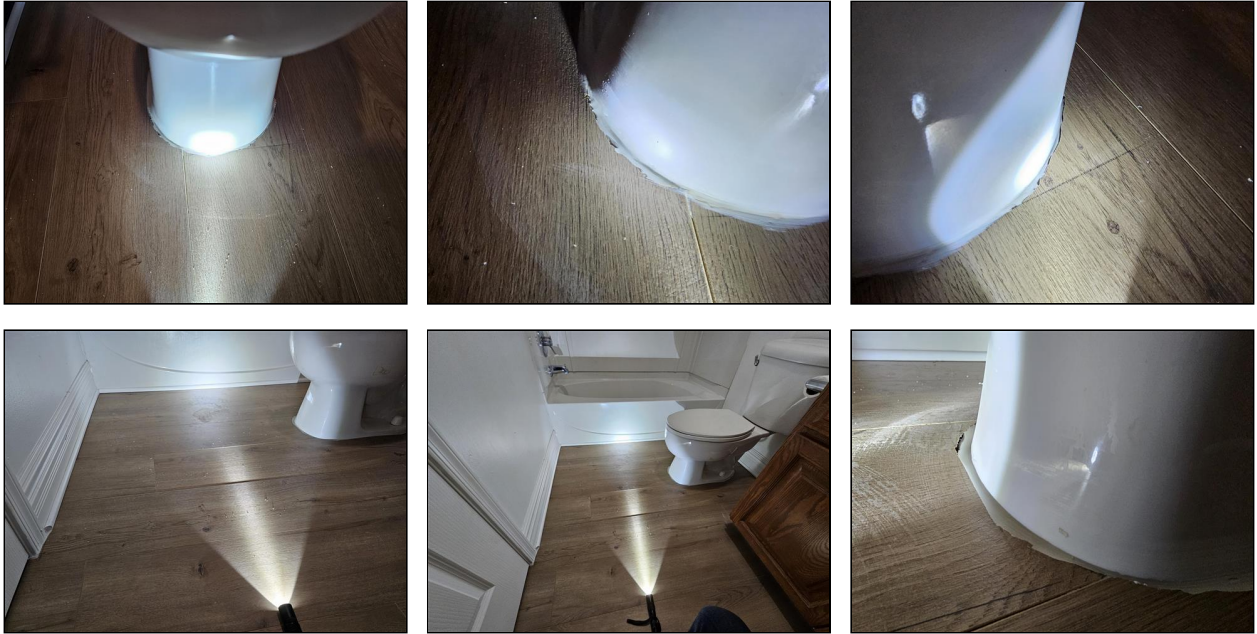
- ♦ The bathroom flooring and walls were in acceptable condition on the day of the inspection.
- ▣ ♦ Caulk lines in the floor of the bathrooms needed maintenance at the time of the inspection. Loose flooring was noted in front of a bathroom toilet that should be secured. All work should be performed by a qualified contractor.

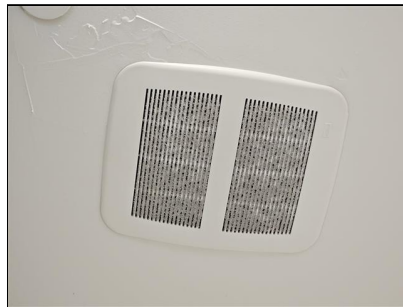
- ☒ ◆ The vent in the bathroom is very dirty and will not vent properly. Recommend removing and cleaning the bathroom vent and fan components.

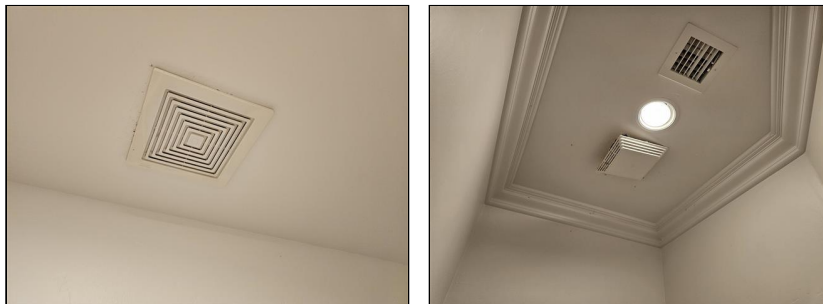
- ☒ ◆ Several vent fans in the bathroom are unusually noisy or not functional. The noise could indicate imminent failure of the fan. Have the fan serviced or replaced by a qualified appliance technician.

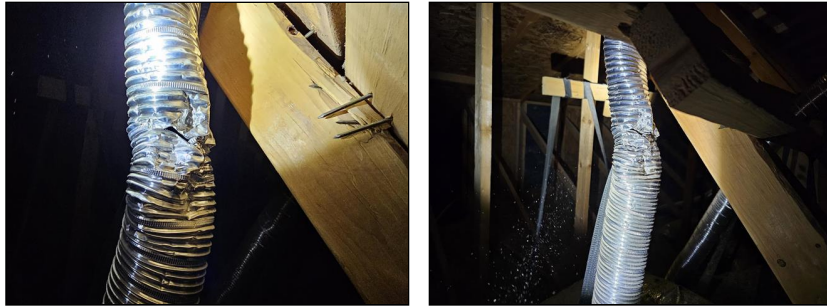
- ❌ ♦ Bathroom ventilation piping in the attic is damaged, allowing moisture to enter the attic. Recommend the vent pipe be repaired to prevent excessive moisture in the attic.

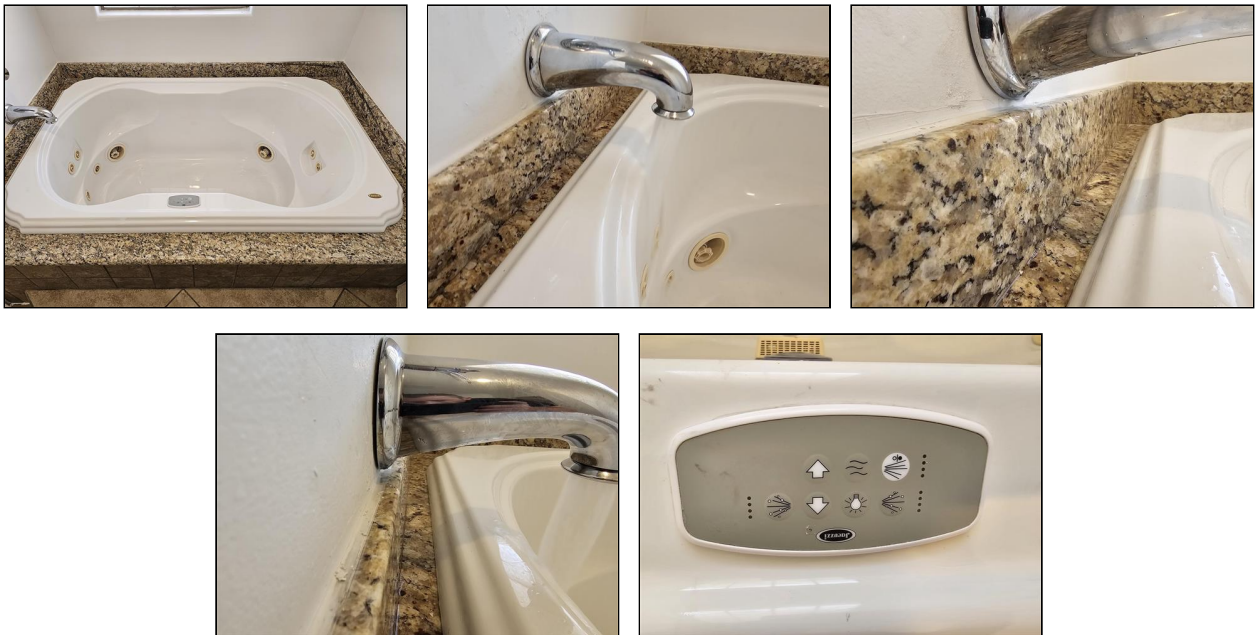
- ❌ ♦ There is a plumbing leak in the wall behind the tub spout in the primary bathroom. The jetted tub turned on but could not be fully tested until the leak is stopped. Damage to the interior of the wall is possible if we kept filling the tub. Recommend the tub be repaired by a professional plumber and tested for operation.

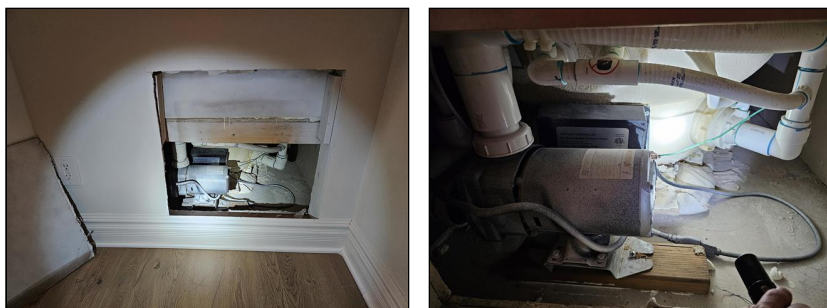
- 🔲 ♦ An access panel should be fitted behind the primary bathroom jetted tub.

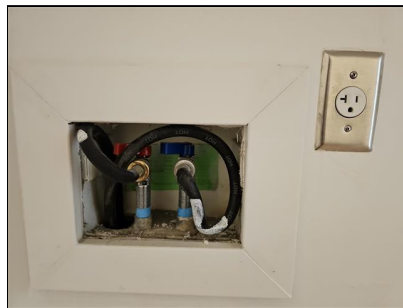
- ◆ The plumbing connections for the washing machine were not leaking on the day of the inspection. NOTE: We do not turn any shutoff valves or angle stops. These valves should be lubricated annually to prevent "freezing".

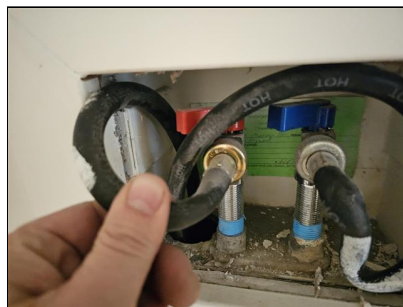
- ☒ ◆ The clothes washer is installed at the interior of the building. The original rubber hoses are installed for the clothes washer supply lines. We recommend for all interior installed clothes washers to upgrade to burst proof supply hoses.

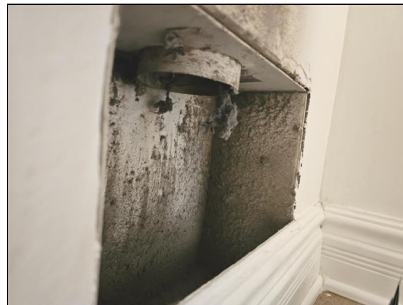
- ☒ ◆ The dryer vent is installed through the roof. Installation in this manner makes condensation problems or lint buildup in the vent more likely. The vent should be cleaned frequently. A qualified technician could re-route the vent.
- ☒ ◆ Unless the dryer vents at an exterior wall directly behind the appliance, we recommend that you clean the dryer vent of any lint build up. This is particularly important if the dryer vents to the roof.

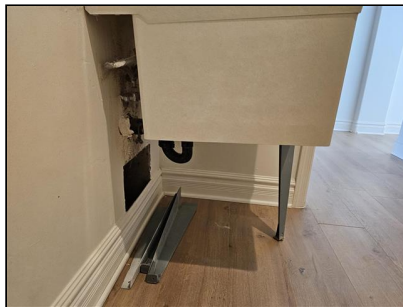
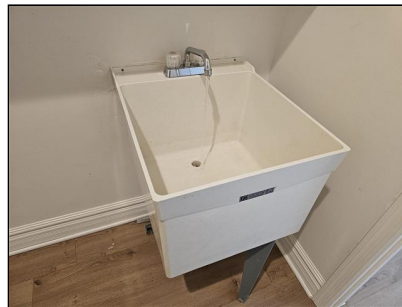
- ☒ ◆ The laundry tub legs are missing. Recommend the legs be replaced to prevent the sink from disconnecting from the wall. The back is screwed onto the wall with a couple screws only.

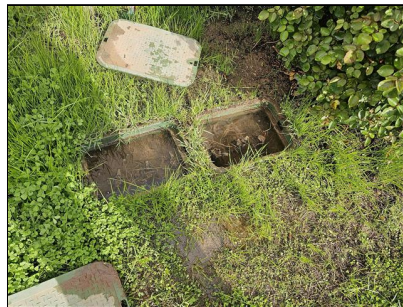
- ❌ ♦ Zone valves on the east side of the home were full of water. This could be from leaking or just poor grading around the boxes. The area they are mounted in is designed to carry water away from the backyard.

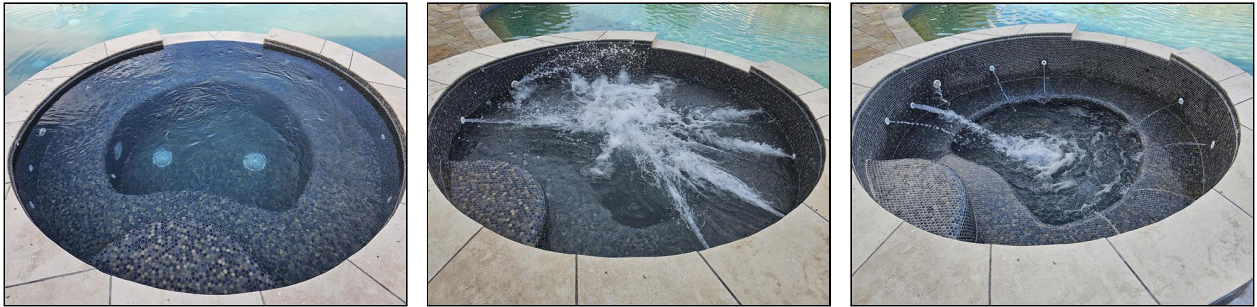
- ✘ ◆ The spa did not stay filled, but did fill up after running the spa booster for several minutes. There is likely a balance or equalizing issue between the pool and spa. Recommend a pool professional evaluate the system for proper operation.

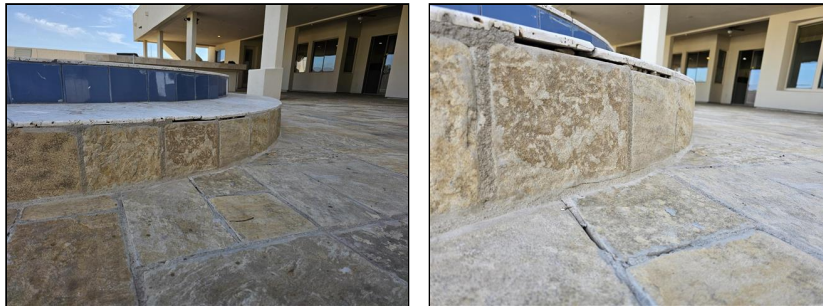
- ◆ The pool and or spa decking shows typical cracks and wear. Any missing, chipped or cracks are cosmetic and can be repaired.

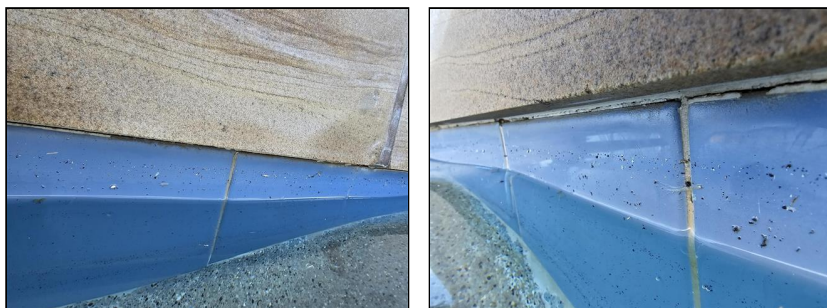
- ❌ ♦ Pool or spa vessels that have been empty for any lengthy of time can be subject to loss of the plaster or pebble finish when re-filled. Drained pools /spas are common to homes left vacant or foreclosed. We cannot determine if that was the case with this pool and or spa. Ask the seller for maintenance receipts or verification that the pool / spa has remained filled during the time this home has been vacant.
- ❌ ♦ The caulk joint between the pool vessel and deck is loose. This can lead to further deterioration if not corrected. A qualified person could seal the joint with approved material.

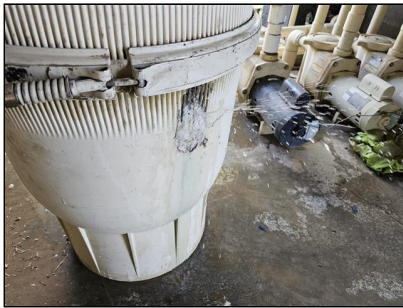
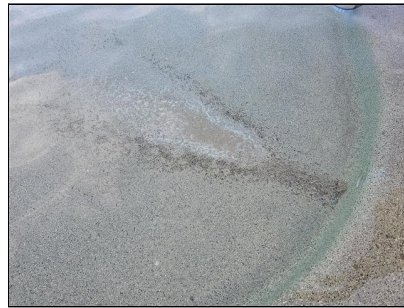
- ❌ ♦ The canister tank or body was damaged and flooded the pool house. Debris was being pushed back into the pool. The Inspector recommends service by a qualified contractor.

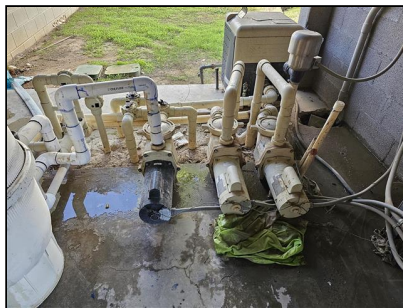
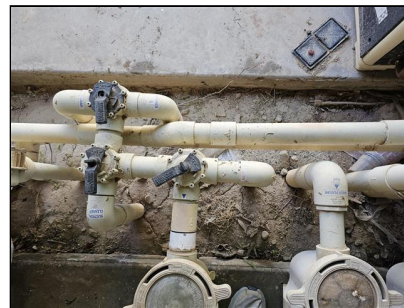
- ♦ The pool pump installed preformed its intended function at the date of inspection

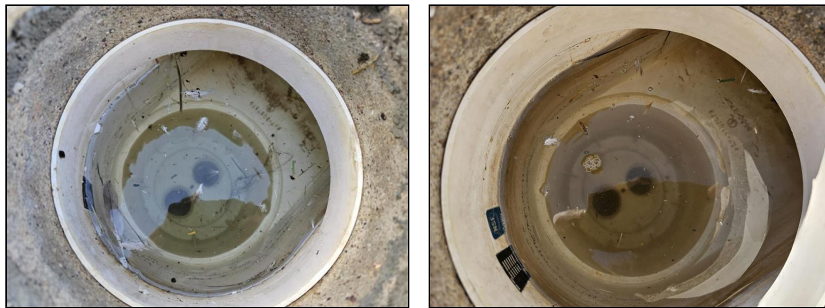
- ❌ ◆ The diverter plate, a device used in the skimmer to control the flow of water between the skimmer and the main drain is missing. A qualified technician should replace the diverter plate.

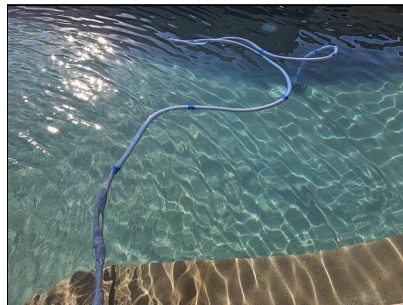
- ◆ The pool sweep operated normally at time of inspection. All cleaning systems will require monitoring for repair and maintenance throughout the year.
