BPG Inspection, LLC

Client(s):
Inspection Date: 11/29/2023
Inspector: Dan Pierce , 68780 (AZ)

Date: 11/29/2023	Time: 08:00:00 AM	Report ID: 1025173
Property:		Prepared By: Dan Pierce

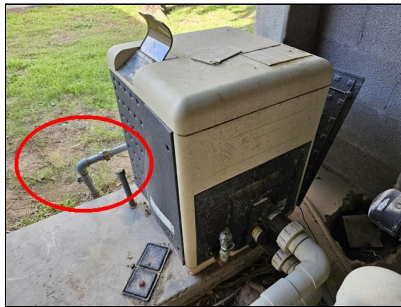
- ◆ The propane gas to the pool/spa heater was turned off at the time of the inspection. We could not test the heating system. We recommend that the heating system be activated and tested before closing escrow.

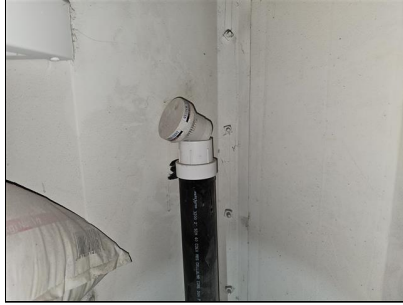
- ♦ The AAV valve in the bathroom is not connected. This may allow sewer gases to enter the home. Recommend securing for safety.
