Living Streets' 'Cut the Clutter' 2022

Every year Living Streets run a 'Cut the Clutter' campaign to highlight the problems people find getting around. I decided to focus very much on my local area, within half a mile of home: that is, in and around King's Reach, Biggleswade. I took a number of walks and recorded the obstructions I found.

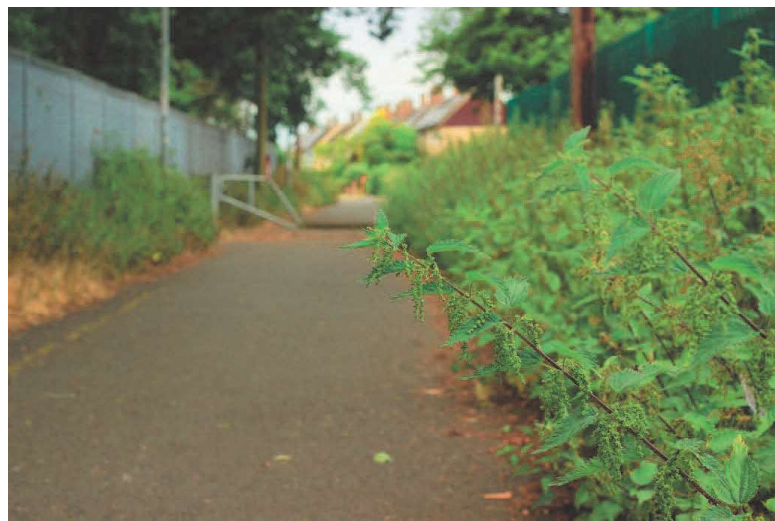
1. Beside Ivel Valley school, the footpath (shared with cyclists and occasional horse riders) is becoming overgrown with nettles. There's over 2 metres gap at the moment, but should someone fall into them they might receive a nasty injury.

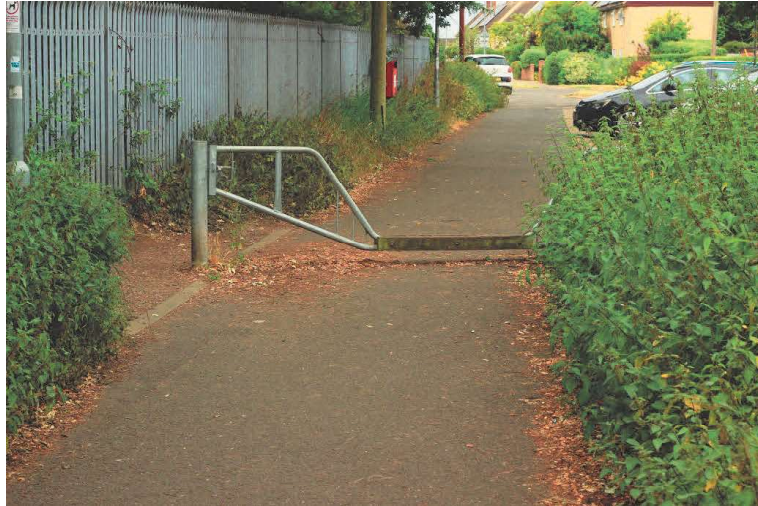
2. Further along this path there is a 'bridleway gate' (I think it is called), designed to allow pedestrians, horse riders and cyclists through but not motorbikes. (It's not actually locked and I think motorbikes do use it occasionally, so what's the point?) There is an unsurfaced gap to one side to allow prams etc through; this is 90cm wide, a little over the 81.5 minimum recommended for a wheelchair user ², but this space is, like other parts of the path, becoming invaded by stinging nettles. Should 'chair users have to risk getting stung as they go around?

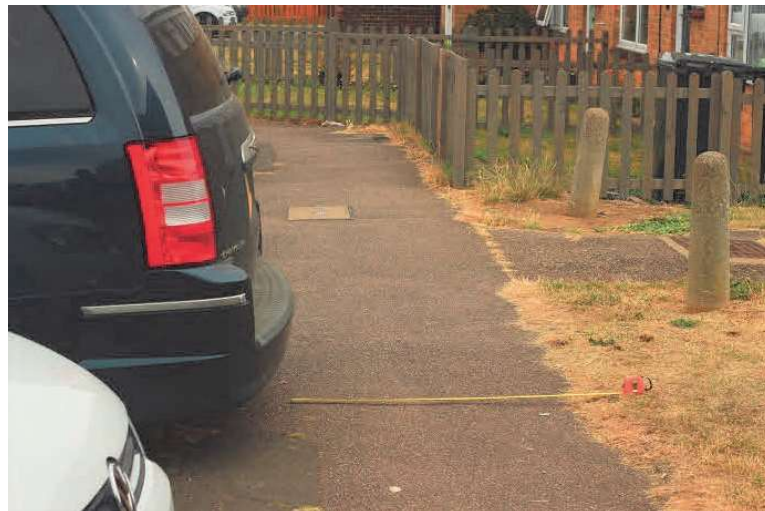
3. On Stratton Way there are a number of parking spaces that are laid out so that cars park 'end on', that is, perpendicular to the footpath. Drivers often position their vehicles in such spaces with one set of wheels against the kerb, so that part of the vehicle overhangs the footpath - which is inconvenient to pedestrians, and against the spirit of Highway Code rule 244 if not actually the wording (the driver may not feel their vehicle is 'on' the pavement). One vehicle today was parked leaving around 95cm of the path clear.

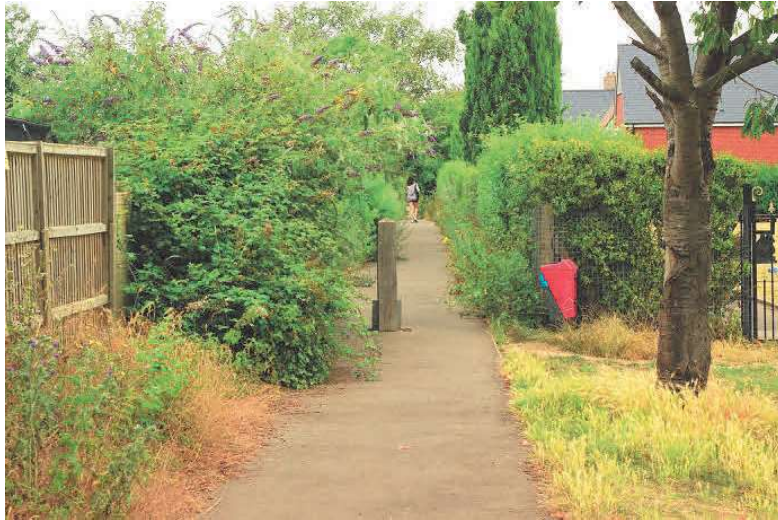
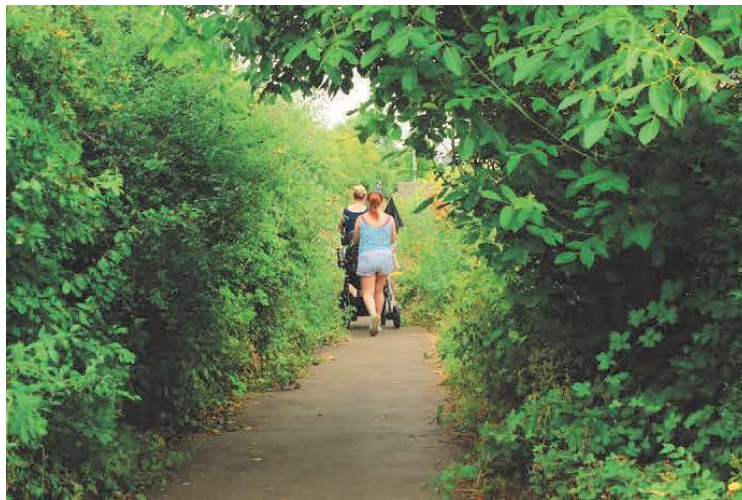
4. The footpath that runs north of Biggleswade Cemetery and south of Edward Peake school is very overgrown.

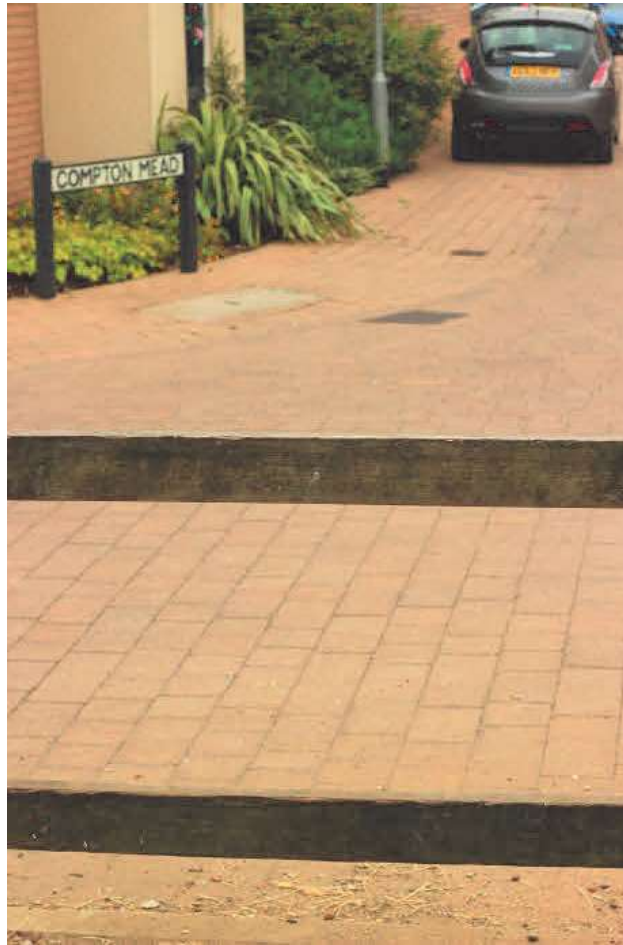
There also used to be (and was intended to be) pedestrian access from this footpath to Compton Mead, but this has been closed off for around four years by one of the residents.

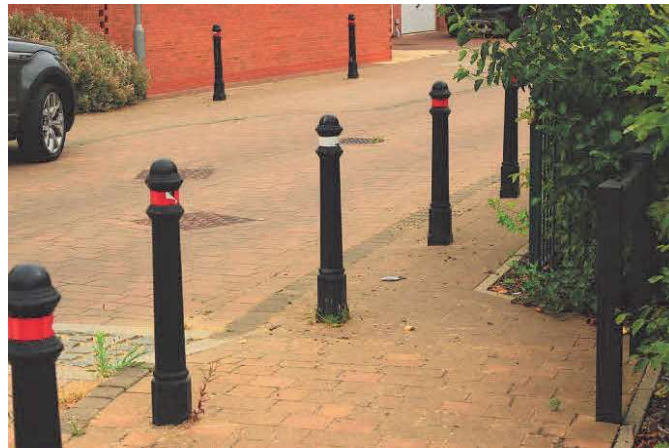
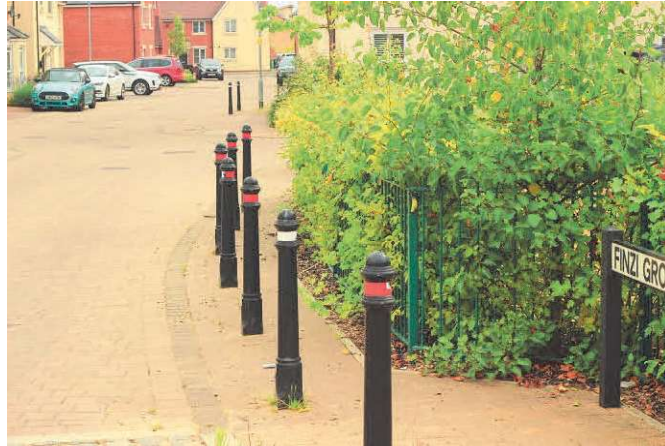
5. On Walker Mead, pedestrians walking north on the east side of the road and wishing to turn into Finzi Grove are confronted by an array of bollards, many of which are placed only around 60 cm from a fence (this, in addition to the path on the north side of Finzi Grove being obstructed by a parked car):

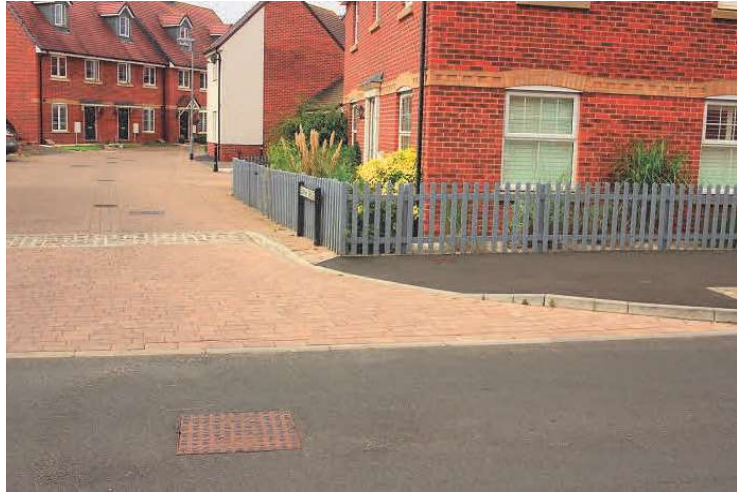
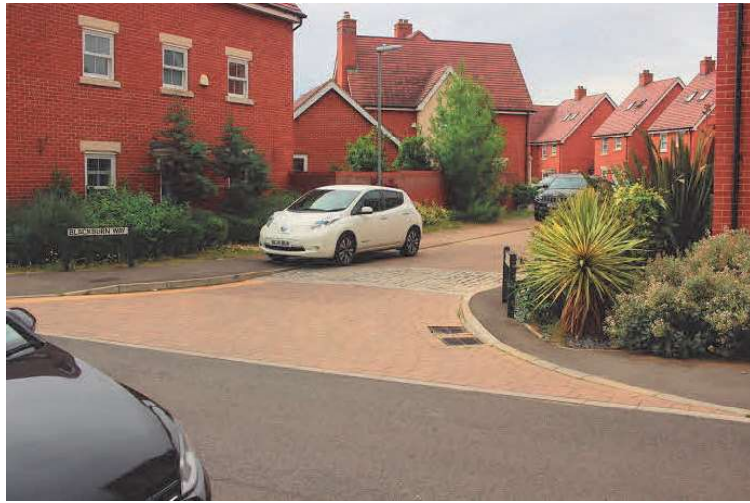
7. The roads on the west side of Walker Mead all have narrow footpaths on one side; this will lead to complications for some, especially wheelchair users, and when a car is parked on the side with the wide pavement (as in the photo, at Blackburn Way), for the traffic calming cobbles are not easy for those with mobility issues, and can cause a wheelchair to turn over.

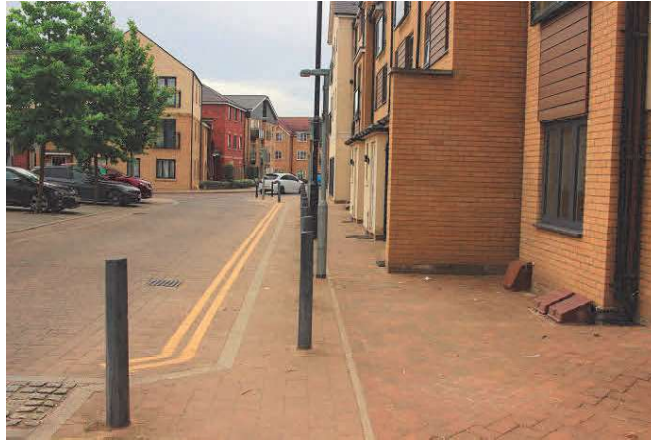
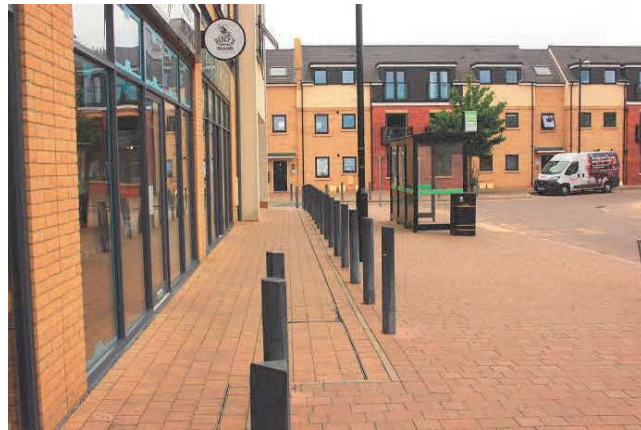
8. Sullivan Court seems to have been laid out by someone with shares in a company that makes bollards; some may be there to stop 'ram raiding' but probably aren't substantial enough.

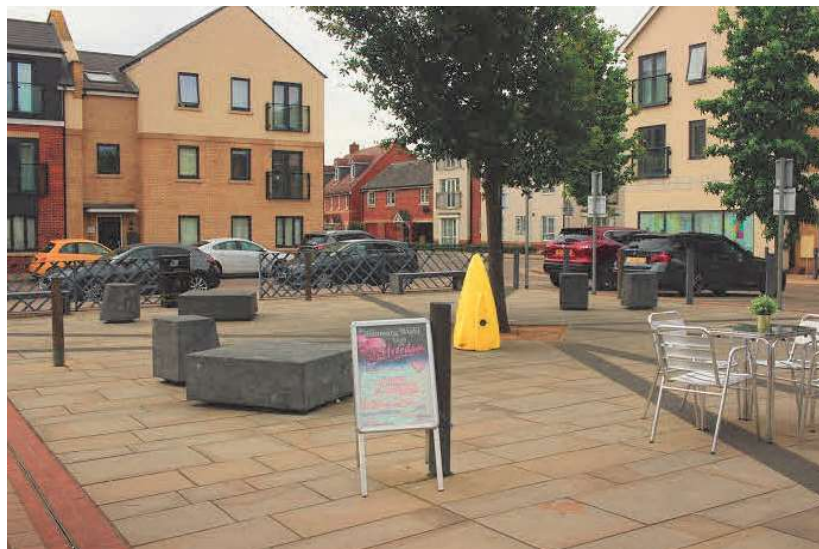
9. The obvious route across the square in Sullivan Court for pedestrians going from Sainsbury's to Planets Way or Maunder Avenue is littered with, er, things - an 'A' board, cafe furniture, blocks that form seating, an RAF Tornado nose cone, a tree, parked cars (in marked spaces), parking signs and a fence.

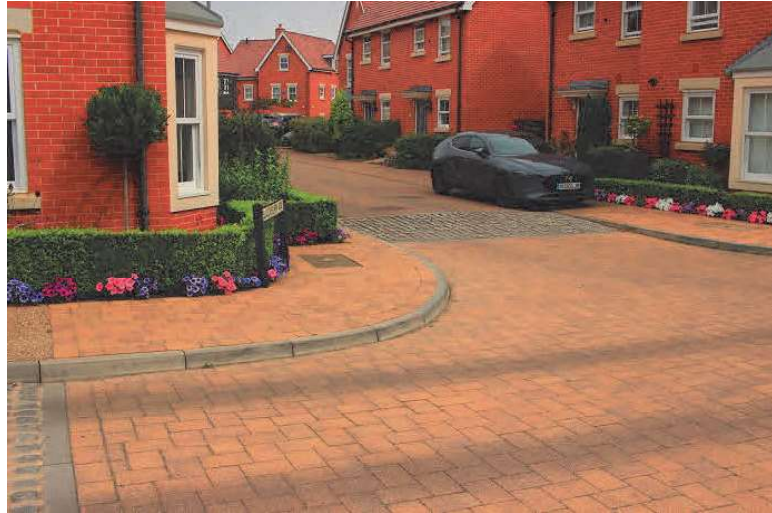
10. The south end of Blackburn Way is, if anything, worse for a pedestrian than the north end (pictured above, item 7):

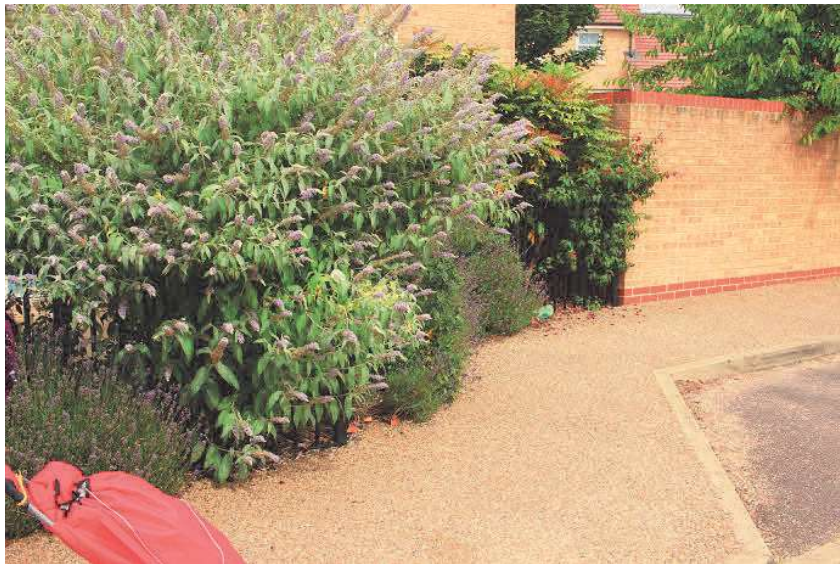
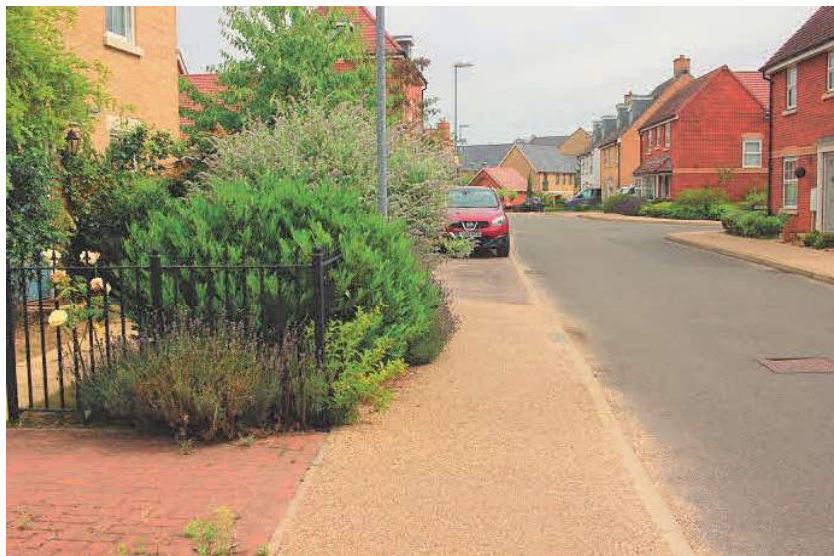
11. One garden in Hawking Drive is very overgrown, reducing the effective width of the pavement to around a metre in places, perhaps less because of the corners around the parking bay:

The pavements in Hawking Drive also feature a surface that has been dressed with small - perhaps 5mm - shingle; this has caused two problems for pedestrians, which, although minor, act as a disincentive to walk along that route:

- Anyone wearing sandals or open shoes is likely to get a stone in their shoe, causing discomfort;
- The surface of the footpath is very abrasive, and anyone falling on it - and children do trip in the street - is liable to sustain more a severe graze injury than they would if the surface were smooth tarmac.

The rationale behind the choice of such a surface - which surely must have added to the cost of construction, and does nothing to encourage people to walk locally - is not known.

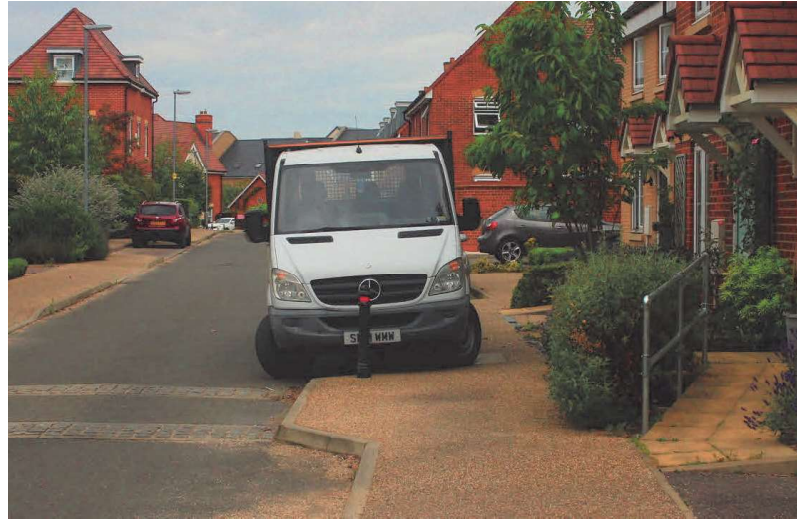
12. On the south side of Hawking Drive a commercial vehicle was parked, obstructing most of the footpath:

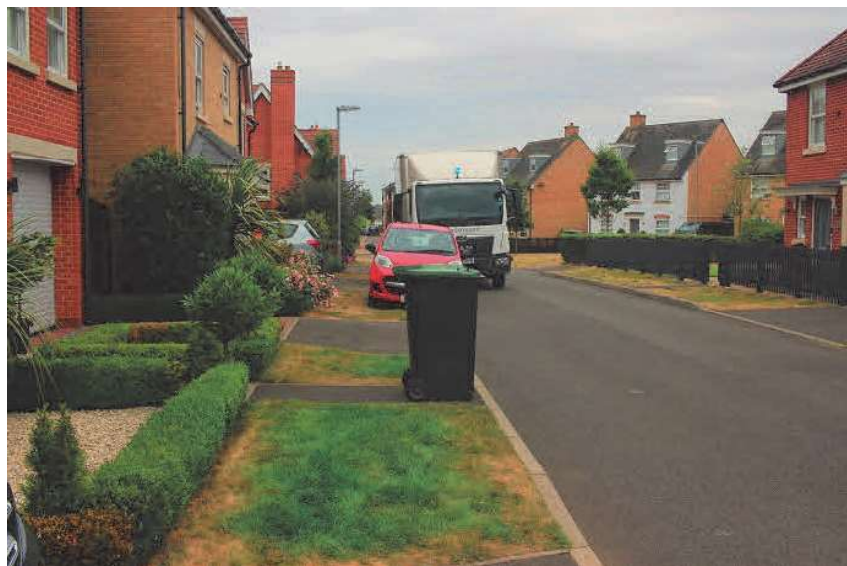
13. On the north side of Maunder Avenue, a wheelie bin and a parked car in the way along the unmade footpath (this photo taken looking east):

Bins are collected on a Thursday in King's Reach; this bin should surely have been in its owner's garden at this time. (Also, the delivery lorry in the background shows the problems caused by the narrow width of this and other roads on the development).

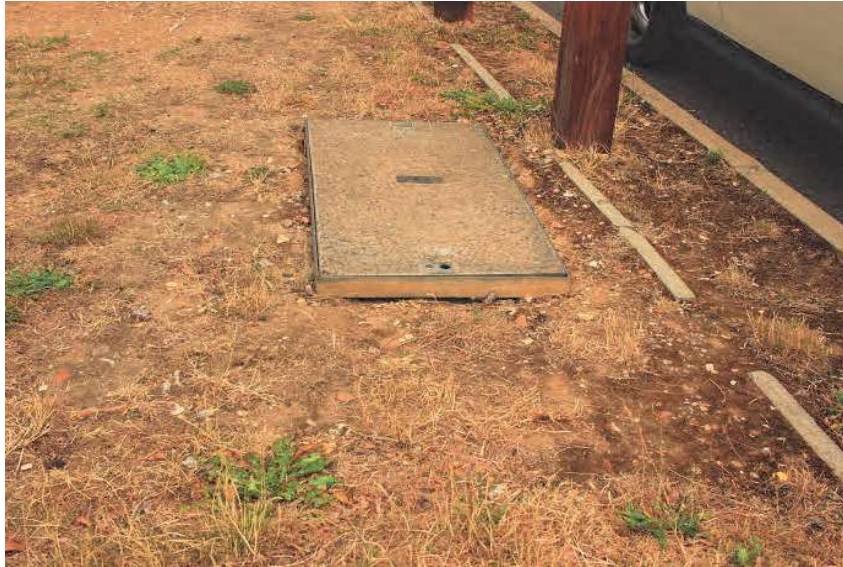
14. Further west on the north side of Maunder Avenue, a BT junction box cover protrudes somewhat untidily from the worn, unmade surface:

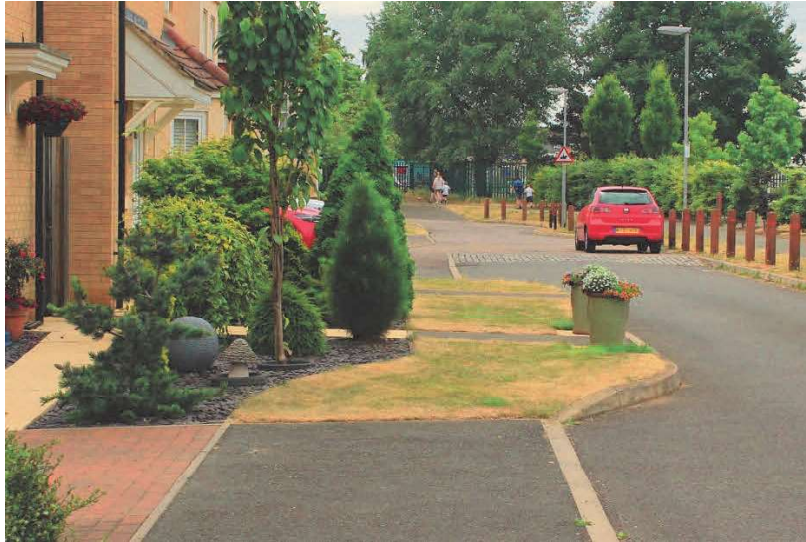
A resident has used part of the adoptable footpath space at the point of this width restriction to extend their garden:

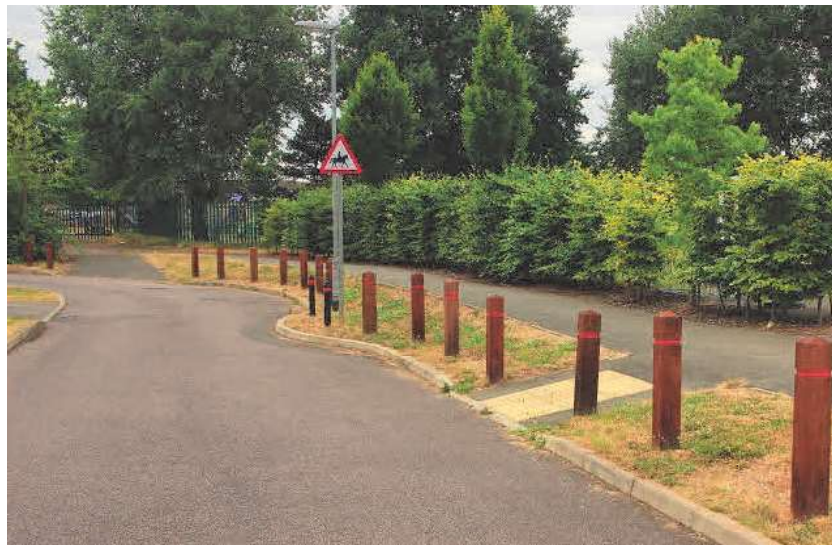
16. West of the junction with Aston Croft there is a dropped kerb to allow pedestrians to cross Maunder Avenue to reach the outdoor exercise equipment on the Western Recreation Area; the gradient of this appears to be around 1 in 5. Disabled groups³ recommend that ramps for wheelchairs should be no more than 1 in 12 for manual chairs, and 1 in 8 for powered ones. (The exercise equipment at the WRA is known to have been used by at least one wheelchair user as part of their rehab.)

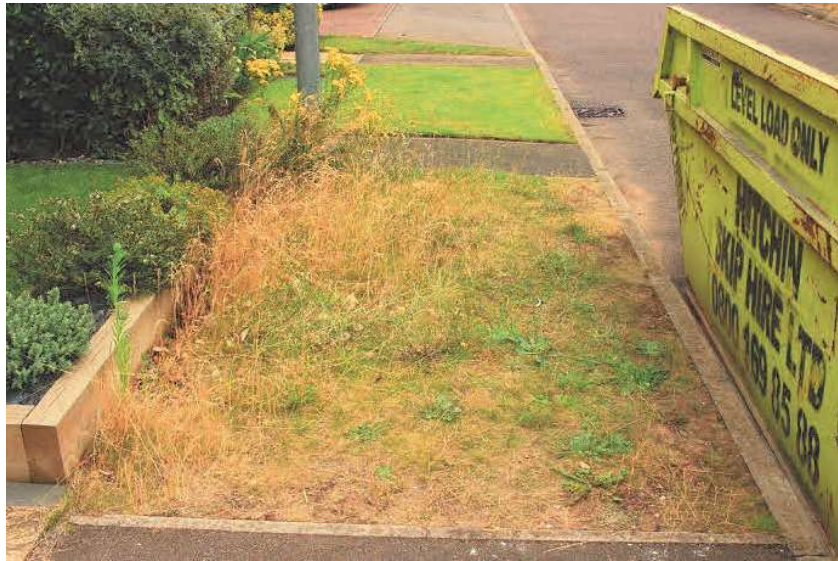
17. Further west on Maunder Avenue the footpath (on the east side) is quite overgrown:

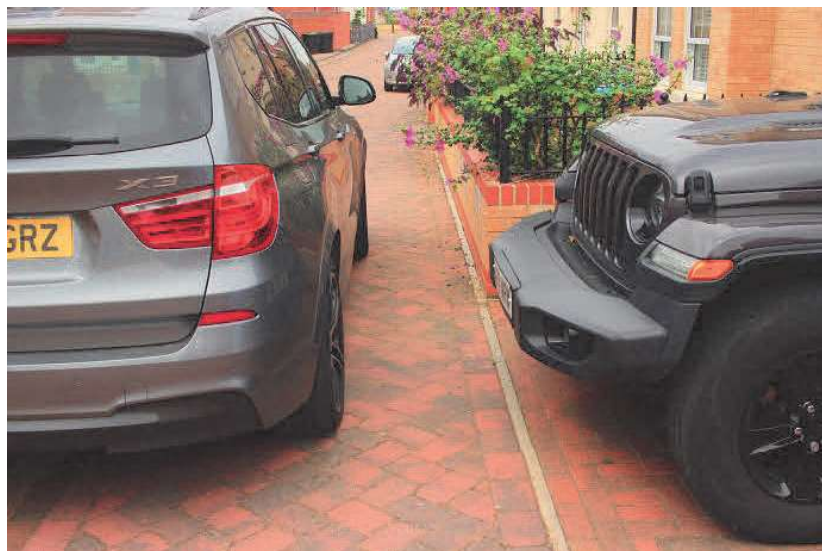
18. On Aston Croft the footpath appears to run on the east side, but was obstructed by parked vehicles:

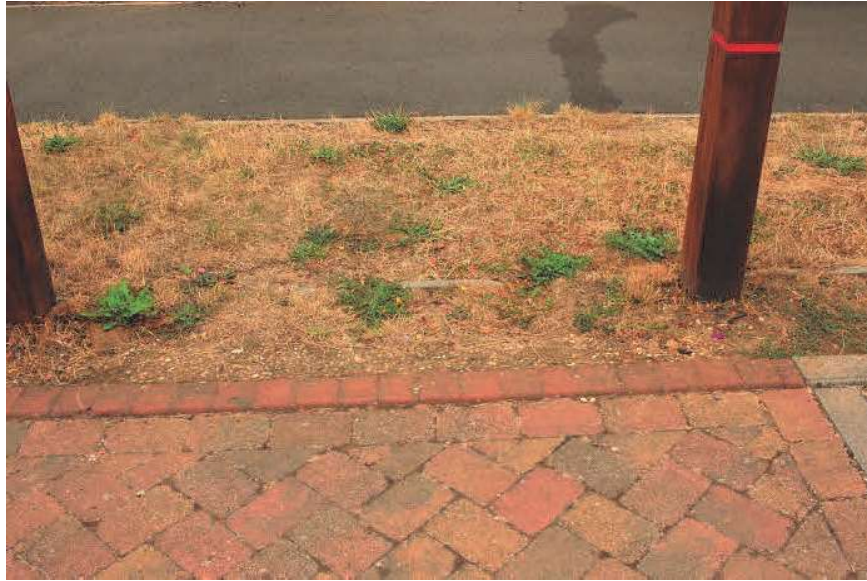
19. Crossing Maunder Avenue onto the Western Recreational Area involves traversing a narrow, once-grassed verge in which concrete marker stones denote the edge of the adoptable road; in places these protrude from the unmade surface, posing a trip hazard:

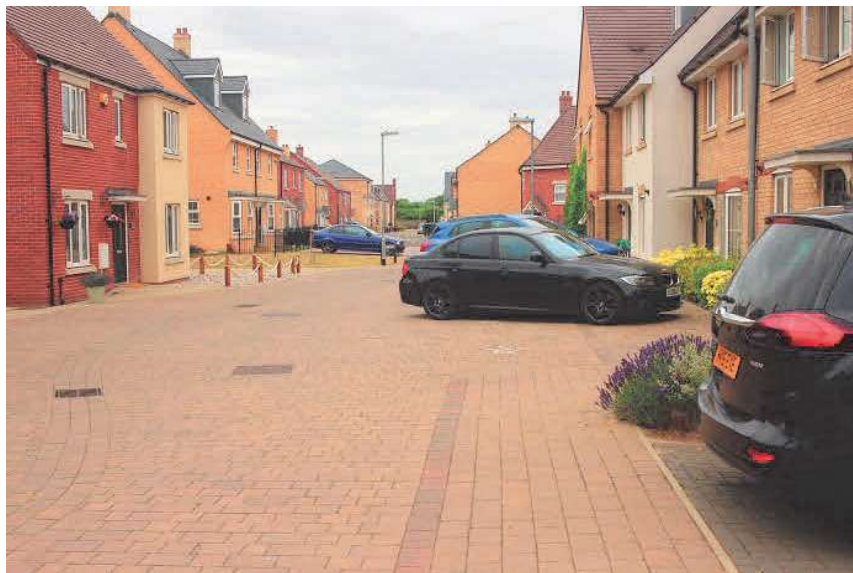
20. In Hunt Road, the location of the footpath is unclear:

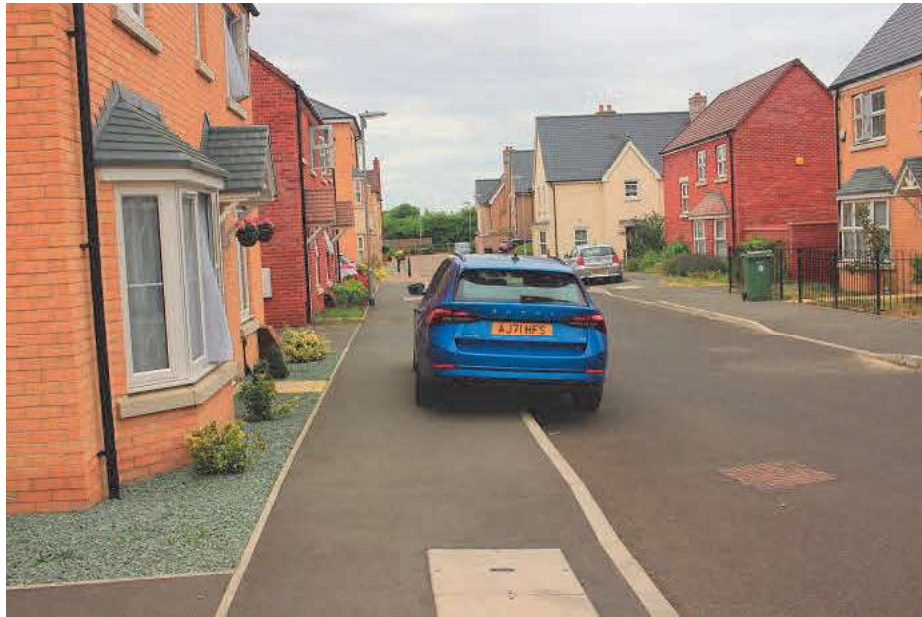
21. In Maskin Drive, a parked vehicle restricts the space available on the pavement on the west side:

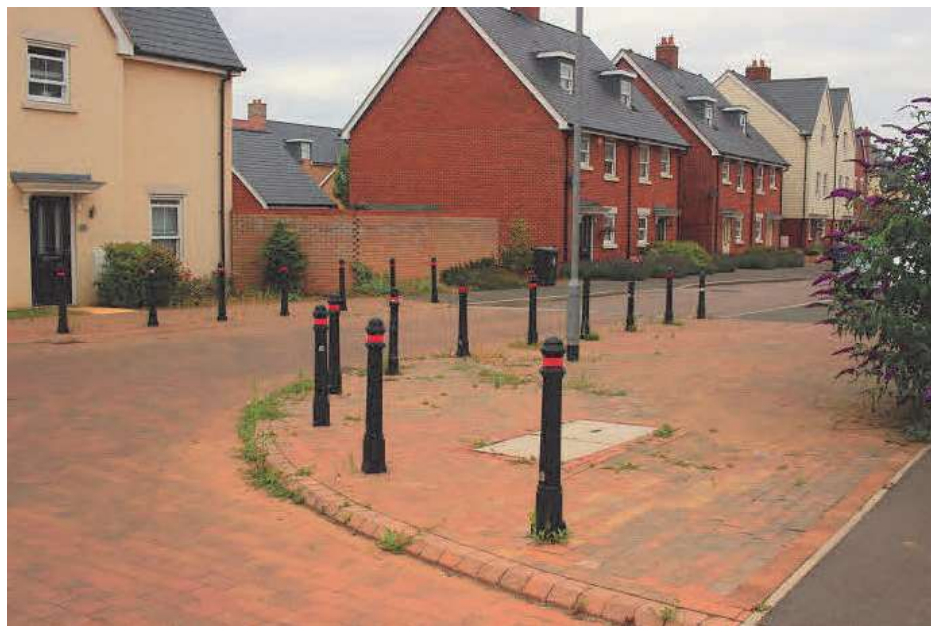
22. At the junction of Sherrington Grove there was plenty of space, but many bollards, an overgrown buddleia, and another dustbin with a long wait for the refuse operatives:

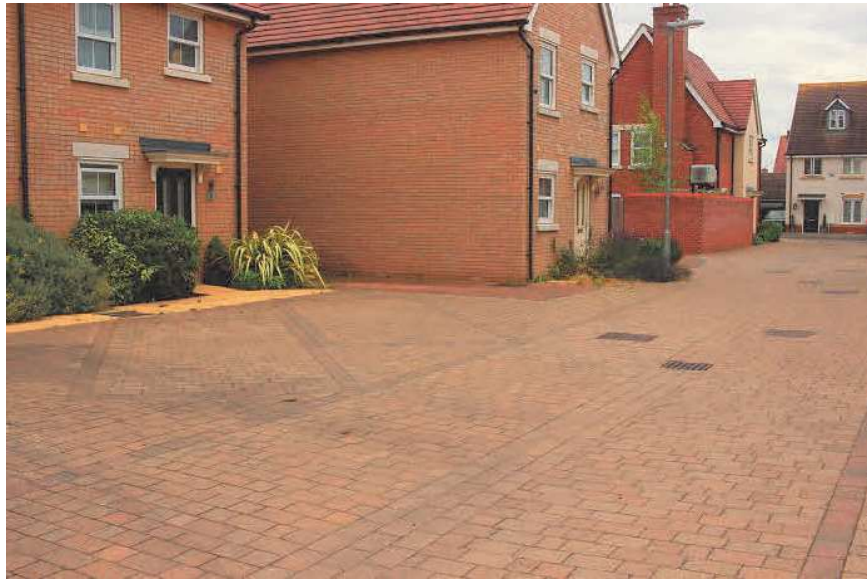
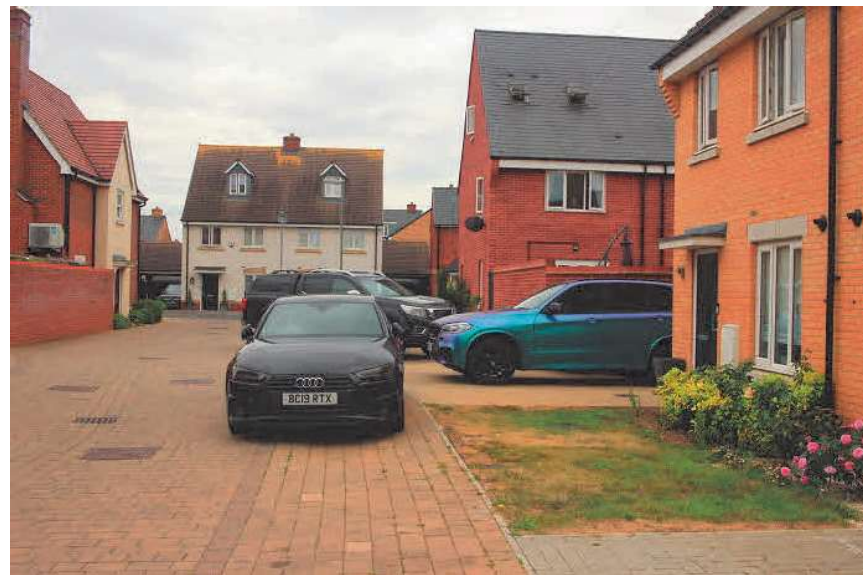
23. In Crick Road, parking spaces seem to be marked out on the east side, and available, but opposite what appeared to be the footpath was blocked by a parked car:

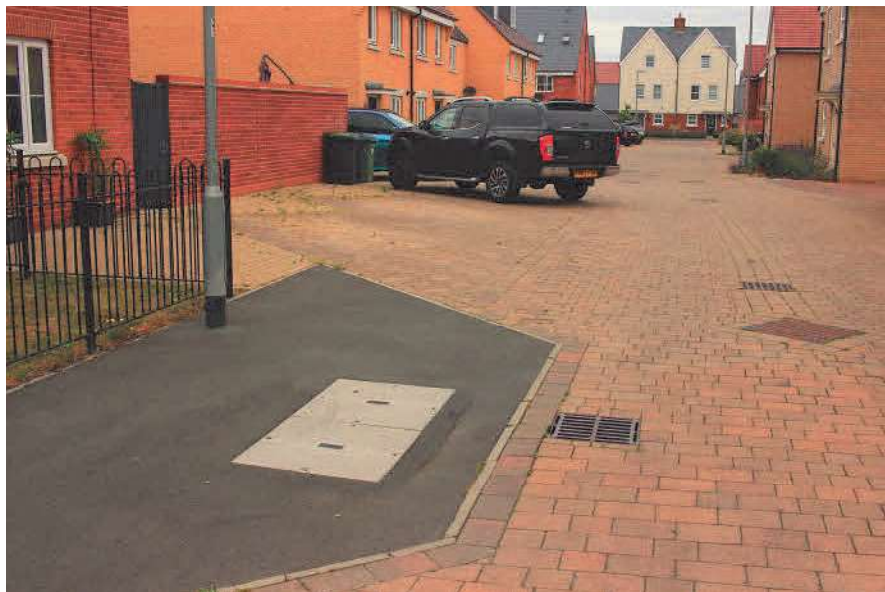
the other side of which are more parking spaces, seeming located across what is meant to be a footpath:

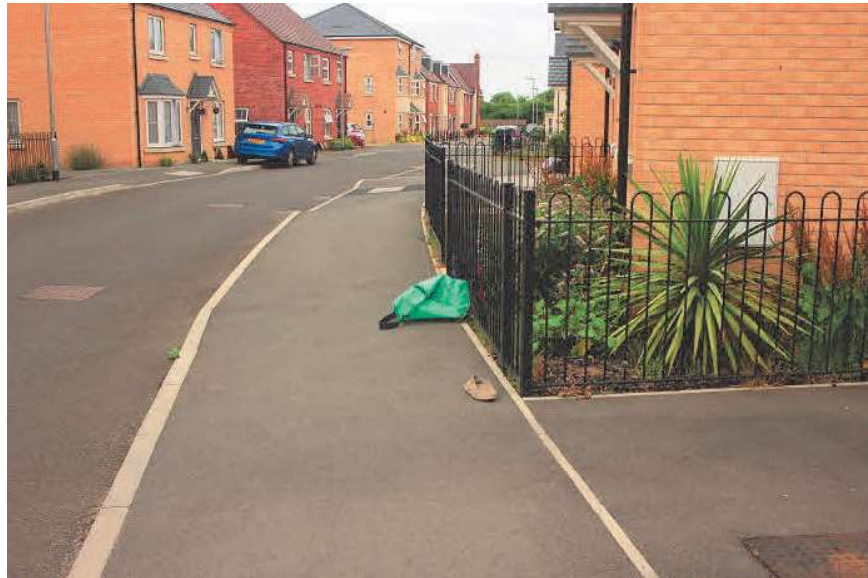
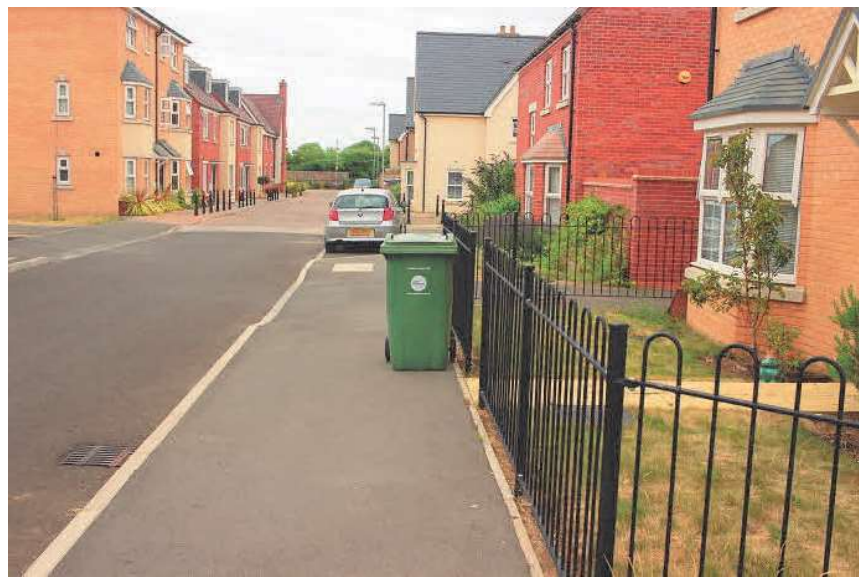
24. Walking back round Maskin Drive, on the east side I found a garden waste bag posing a trip hazard and, beyond, a garden bin - both five days after they would have been emptied by the refuse team:

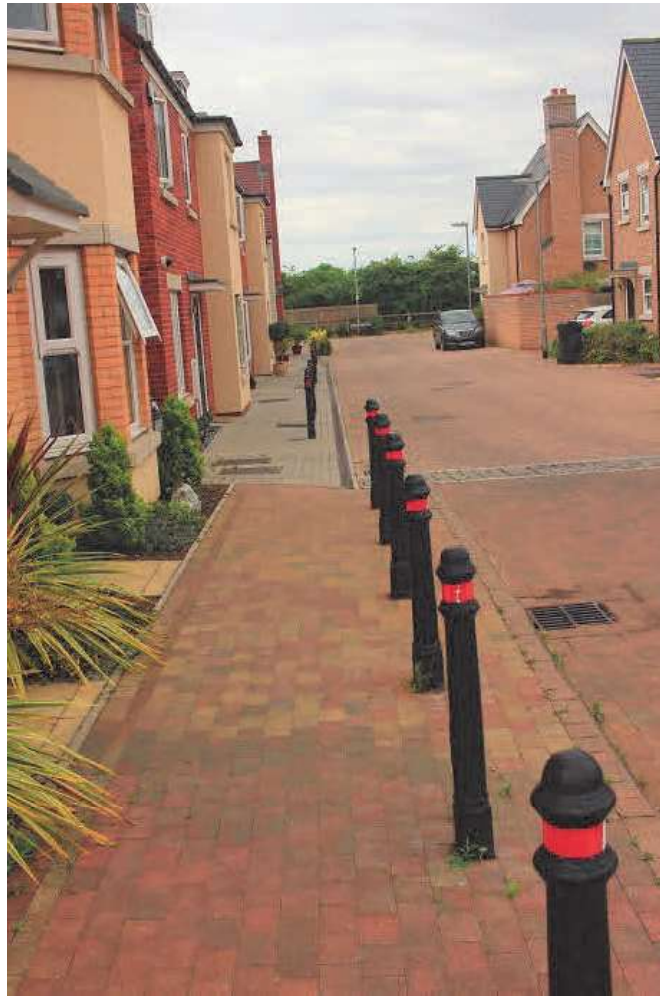
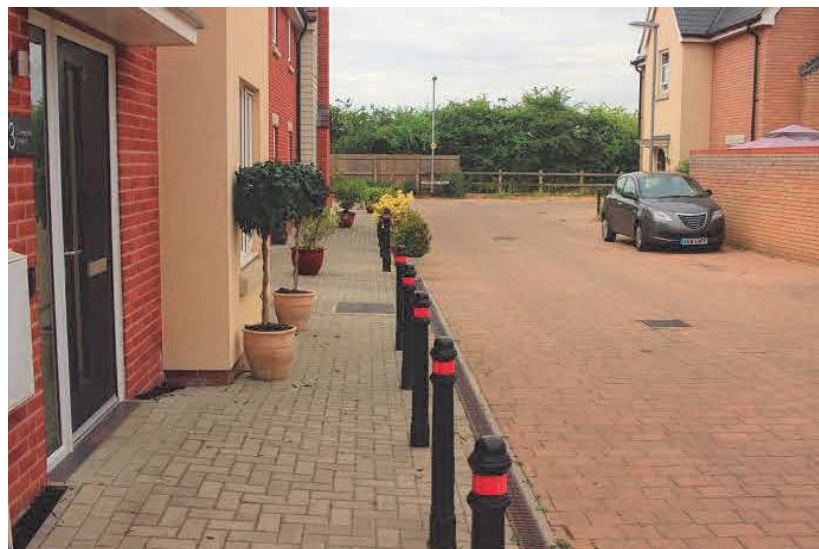
25. On the west side of Maskin Drive and Compton Mead are an untidy collection of bollards, protecting what seems to be the (badly aligned) footpath (there is a parking space on the other side), ending in a collection of randomly placed container plants:

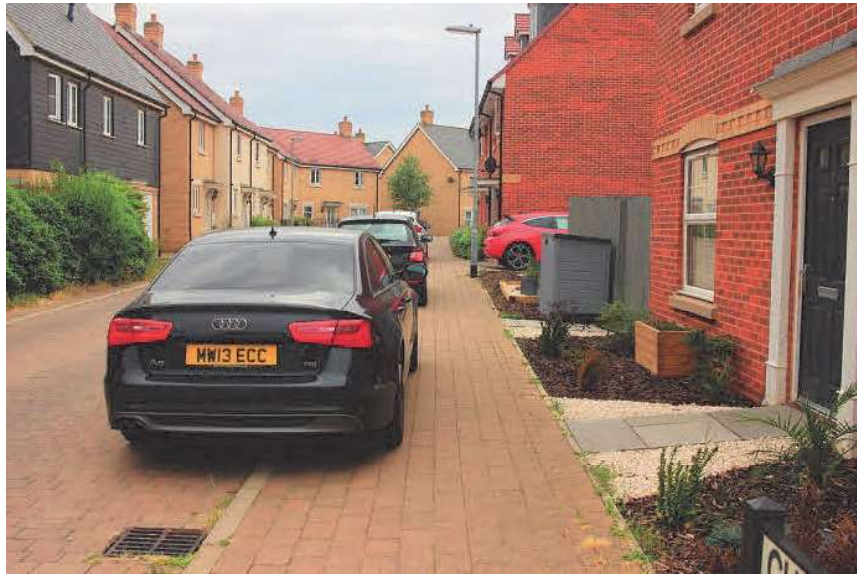
26. Half the width of the footpath at the east end of Chamberlain Park was blocked by parked vehicles:

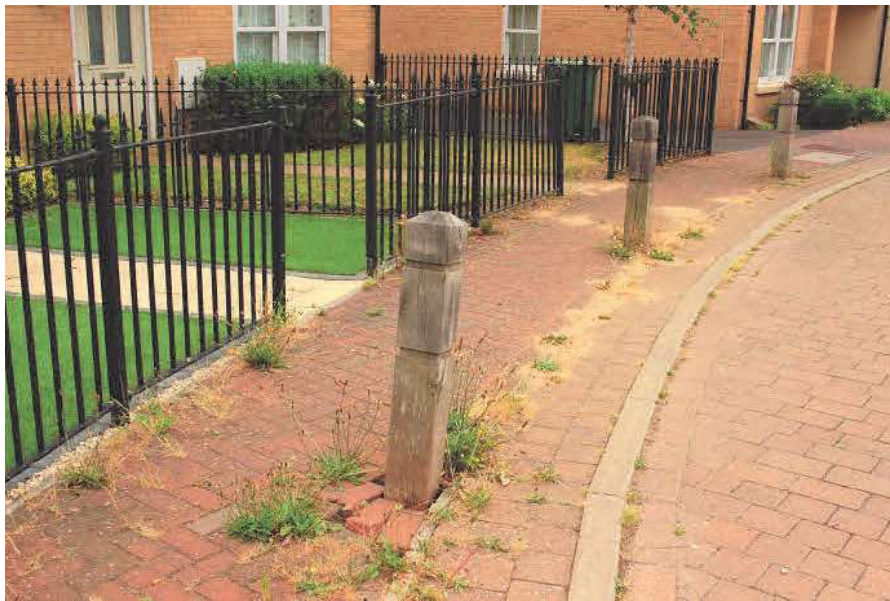
27. Farther along, there is a footpath on the south side of Chamberlain P, but partly blocked by bollards, and in very poor condition:

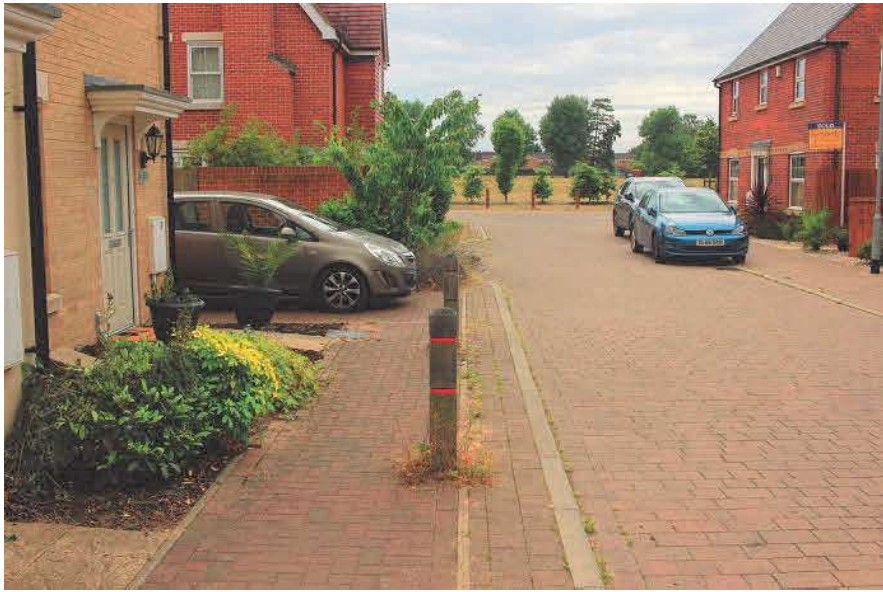
which seems to end in a confused jumble of plants beyond a parked car:

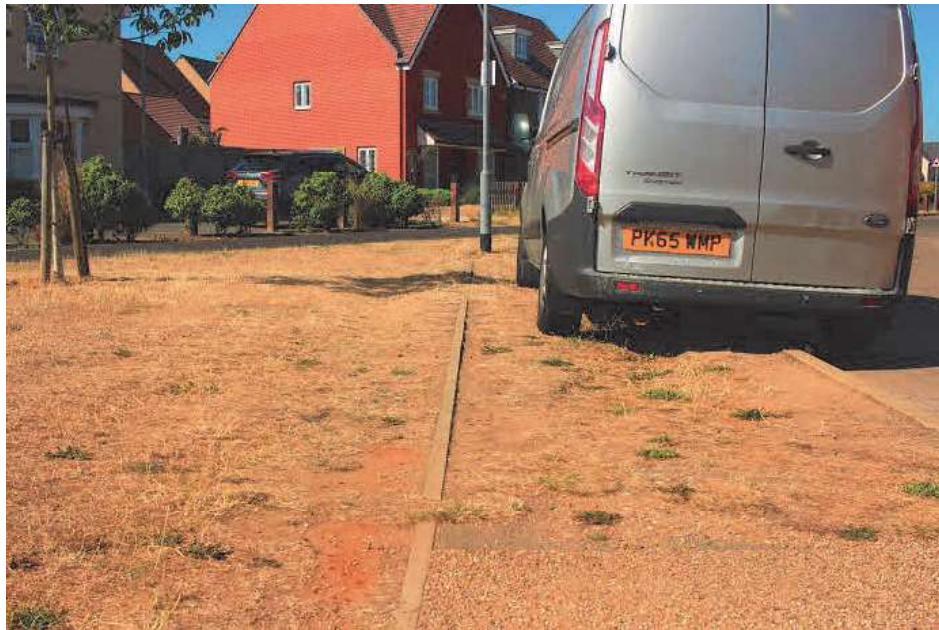
28. At the west end of Hawking Drive the gravel-dressed footpath just comes to an end; to reach the footpath to Stratton Way pedestrians must cross an uneven, rough surface, which, in winter, becomes muddy, and is often used for parking:

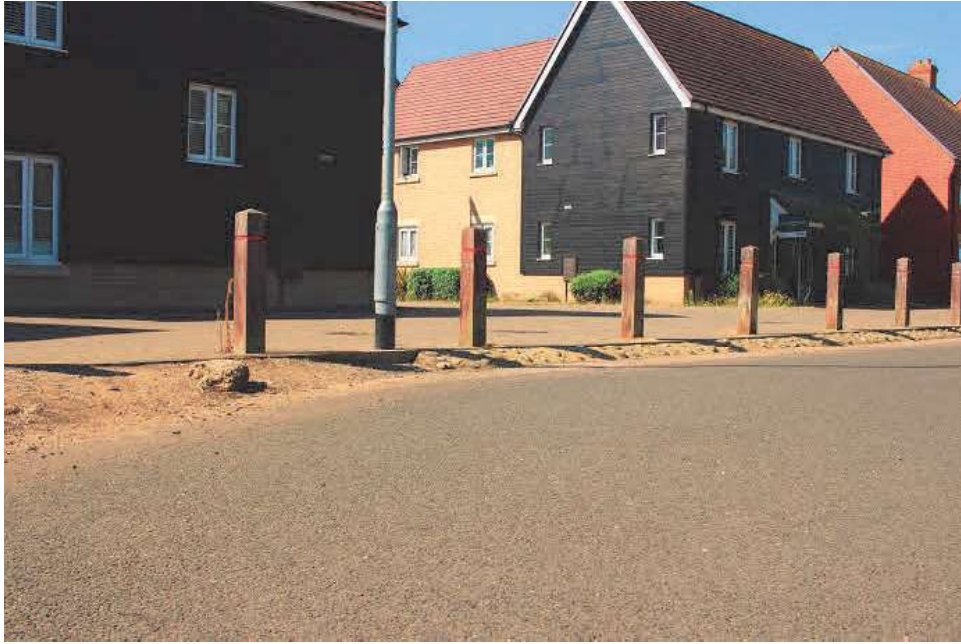
29. To get to Darwin Drive pedestrians must cross either a rough, unsurfaced area (that was originally planted) or a narrow step that is inset with cobbles; neither are ideal solutions for a wheelchair user (it is not known why a dropped kerb was not used at this point, which is shown as a footpath on Google Maps):

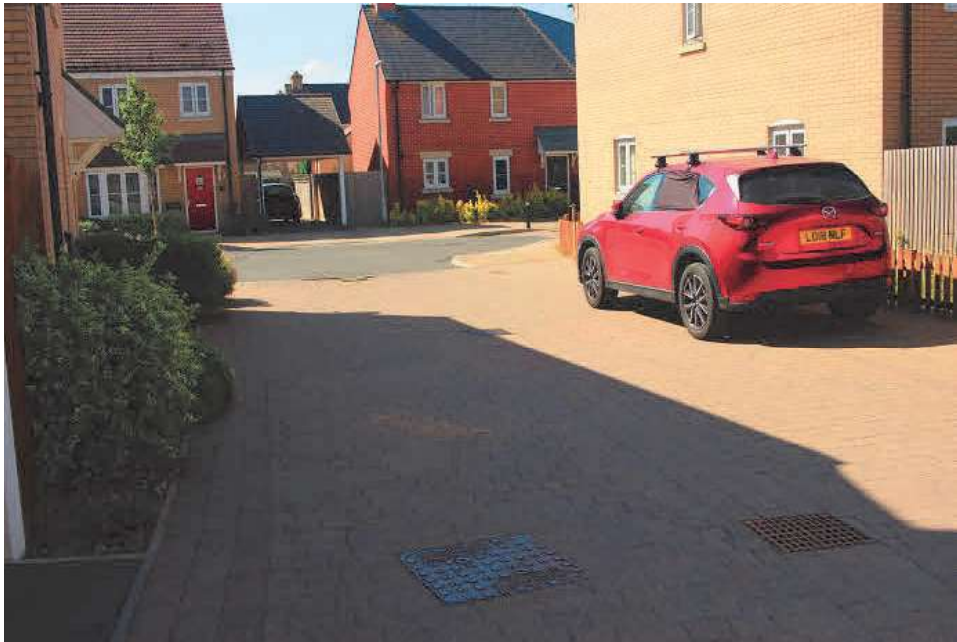
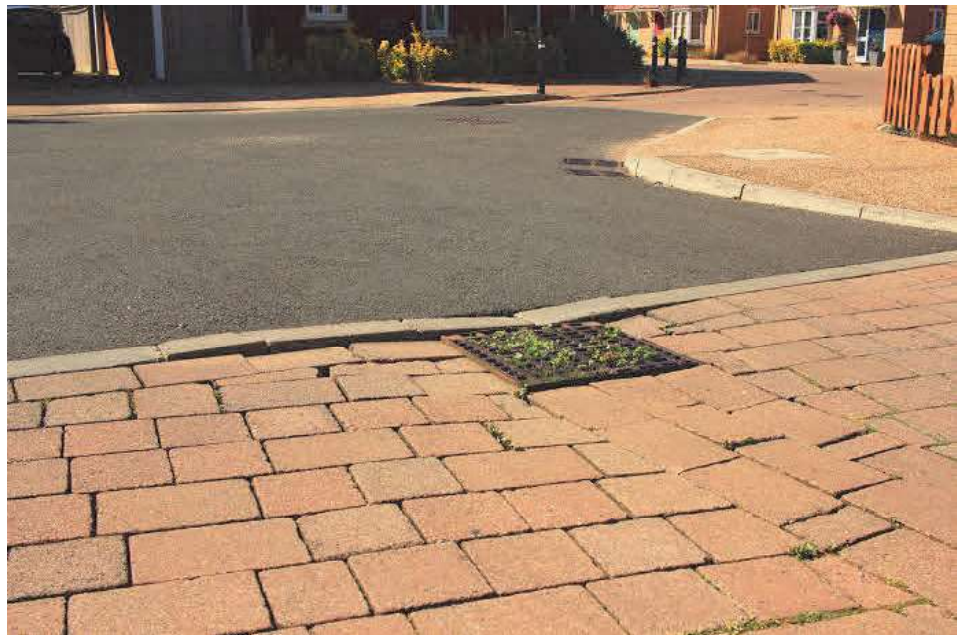
30. It's not clear where the footpath is in Darwin Drive; pedestrians may end up walking in the middle of the road, which puts them at risk of a trip hazard from the badly-deteriorated block paved surface at the junction with Rutherford Way:

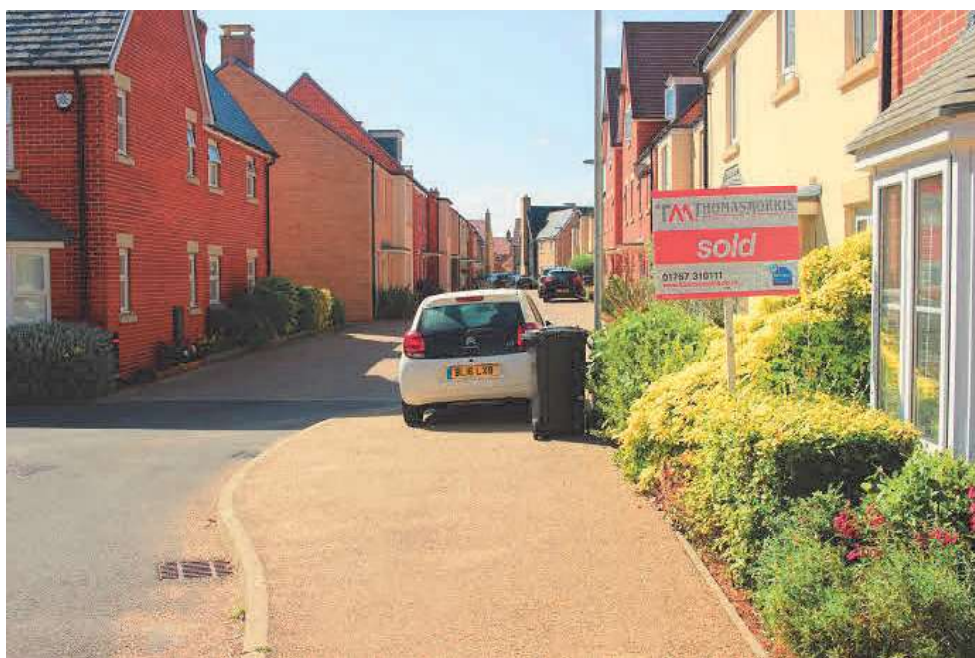
31. The footpath along Rutherford way is (unusually, for King's Reach) wide and was generally clear, until I reached Gilbert Avenue, where it was completely blocked by a parked car and a bin (two days after bin collection day) :

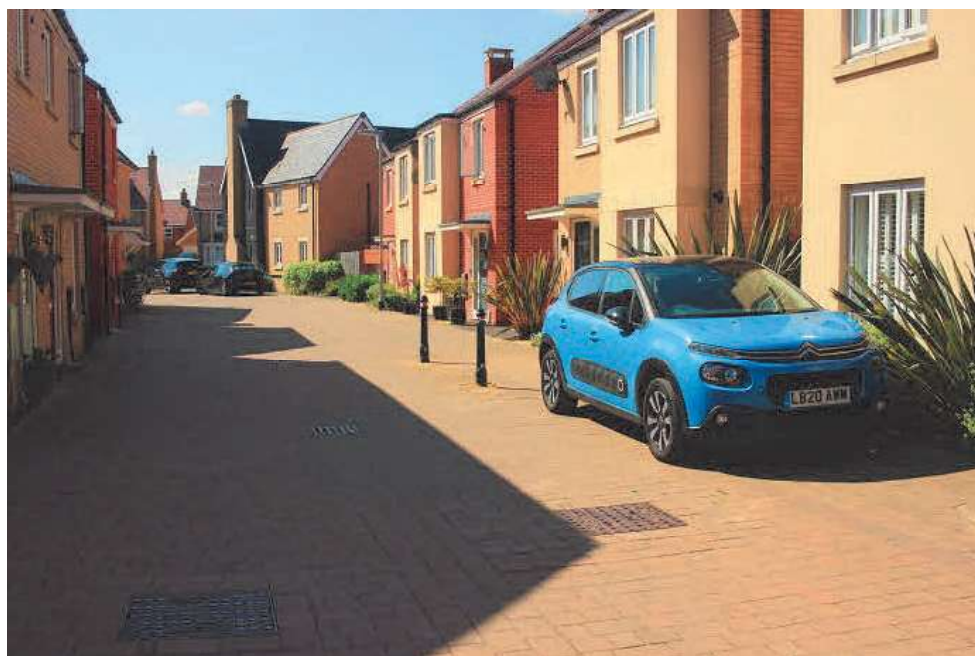
32. Farther along Gilbert Avenue what seems to have been intended as a footpath (the west side) was blocked by a parked car; beyond that, two bollards that would appear to achieve little, apart from forcing vehicles to pass closer to the houses on the east side than might be desired - these houses have front doors that open directly onto the road:
