Living Streets' 'Cut the Clutter' 2022

Every year Living Streets run a 'Cut the Clutter' campaign to highlight the problems people find getting around. I decided to focus very much on my local area, within half a mile of home: that is, in and around King's Reach, Biggleswade. I took a number of walks and recorded the obstructions I found.

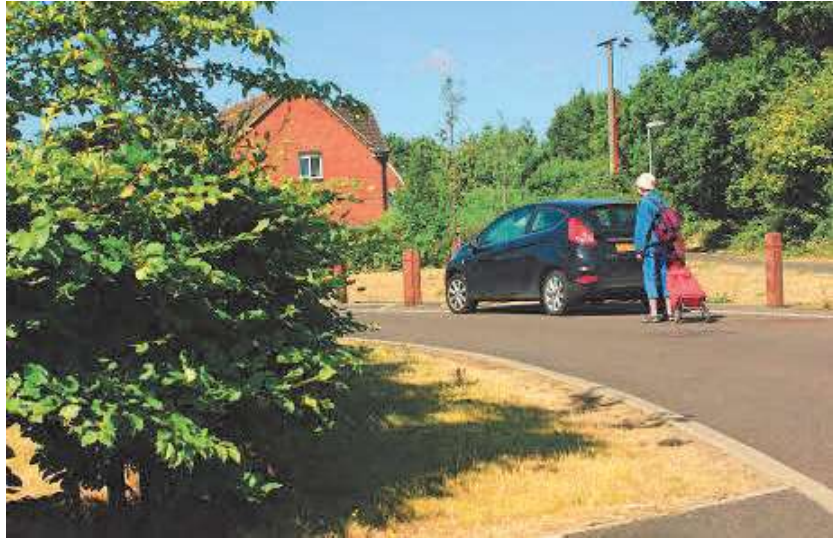
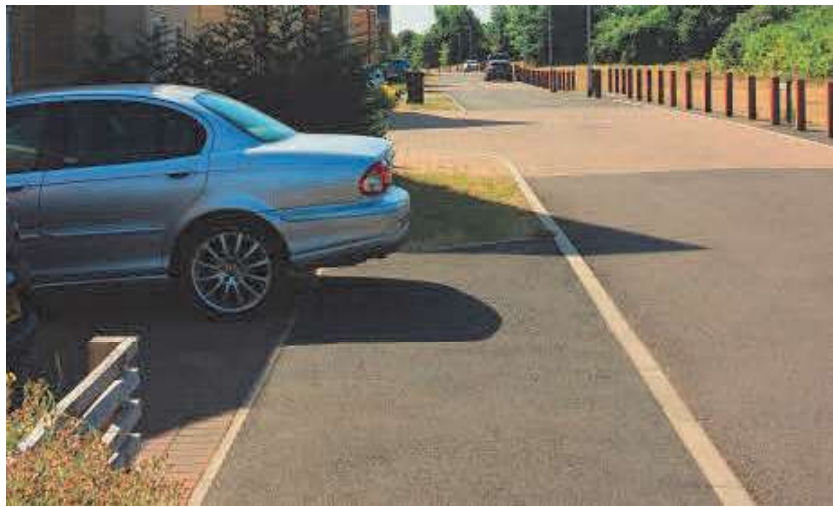
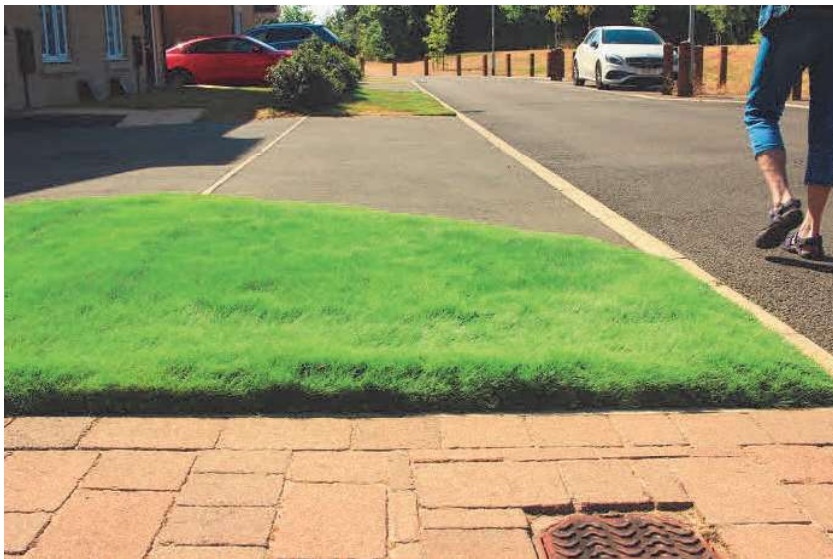
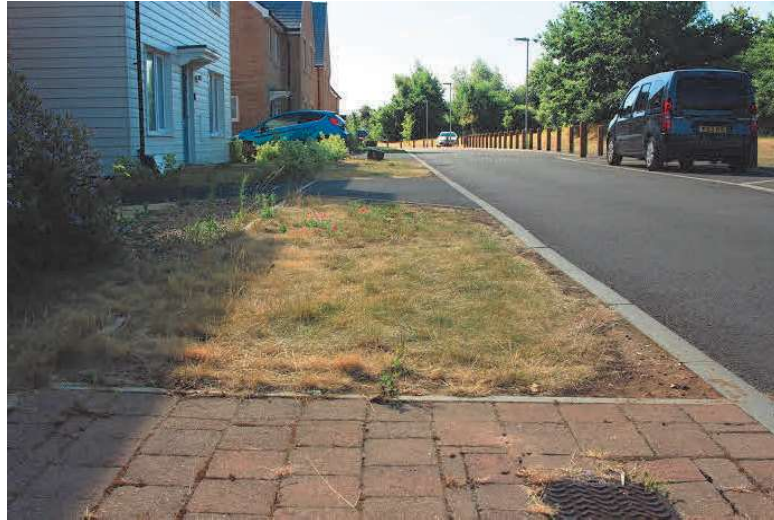
33. Wensum Grove features a similar unsurfaced footpath to Maunder Avenue, although does not have a proper kerb; the grassed area that I took to be a footpath was obstructed by overgrown hedges and parked cars, and, in places featured rough surfaces, or lush grass (which is difficult for wheelchair users):

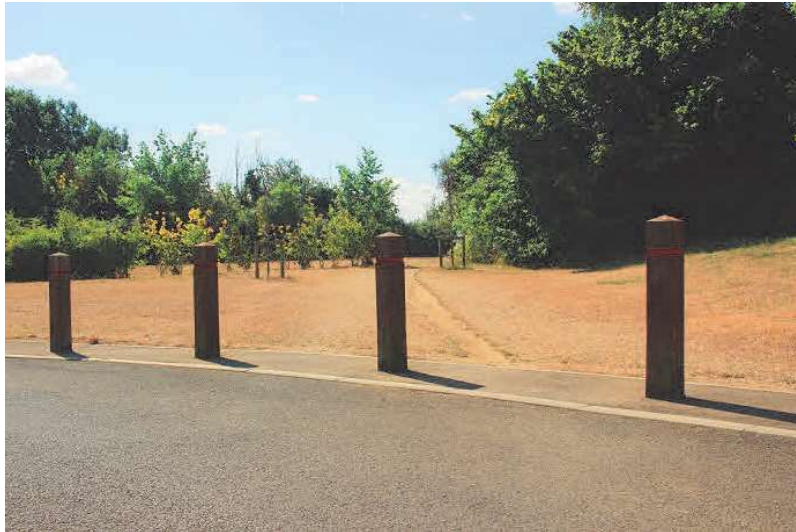
34. At the end of Wensum Grove there is an unsurfaced path that leads to Baden Powell Way and the shops and sports centre at Saxon Gate; in winter this becomes muddy:

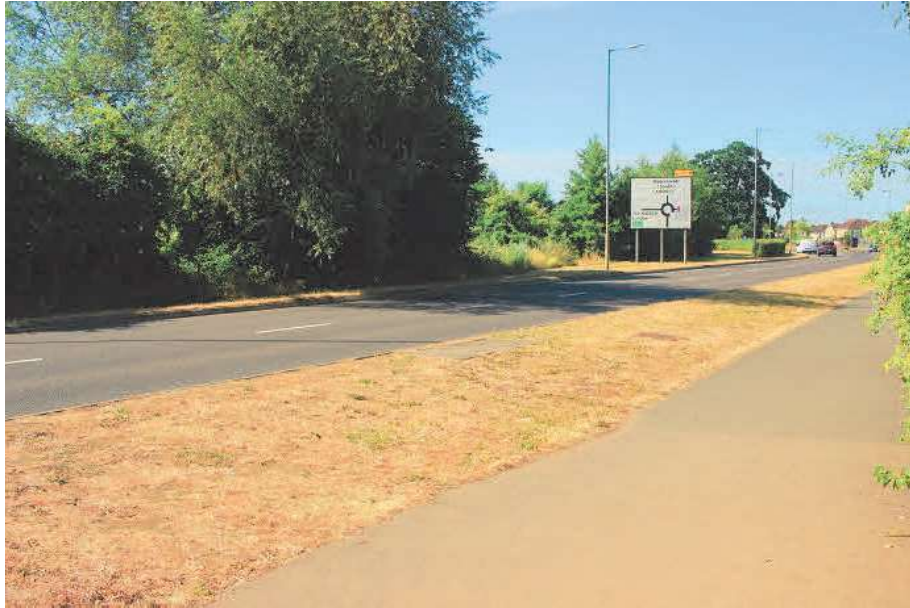
35. This path meets Baden Powell Way opposite the Biggleswade Green Wheel, but there is no crossing point - any pedestrian wishing to walk further, such as to the A1 Retail Park, has to either take this risk of crossing the 40mph road at this point, or walk further to the roundabout near Saxon Gate:

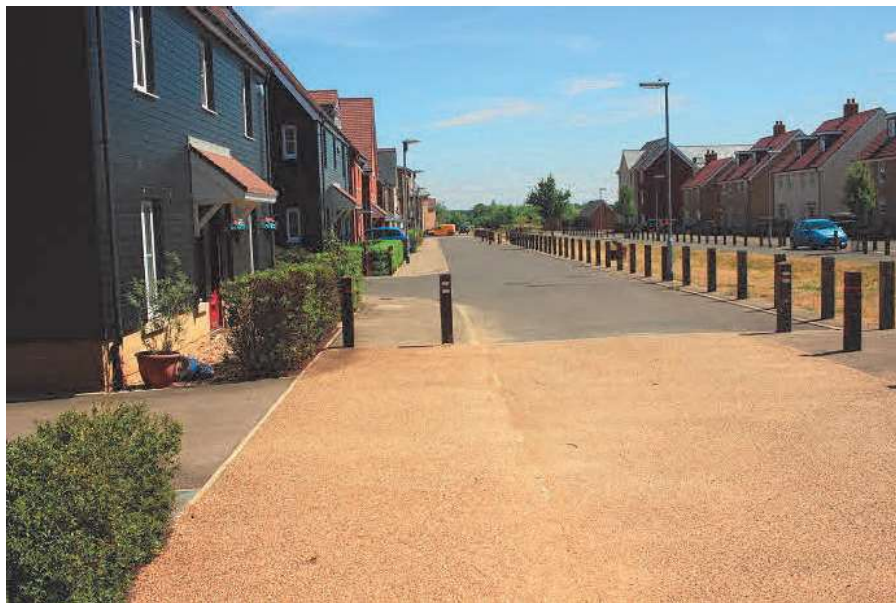
36. Walking east along Whittle Drive I encountered a pair of bollards, with a gap of about 110cm between them; the purpose of both is questionable, but the one closest to the hedge seems to achieve nothing:

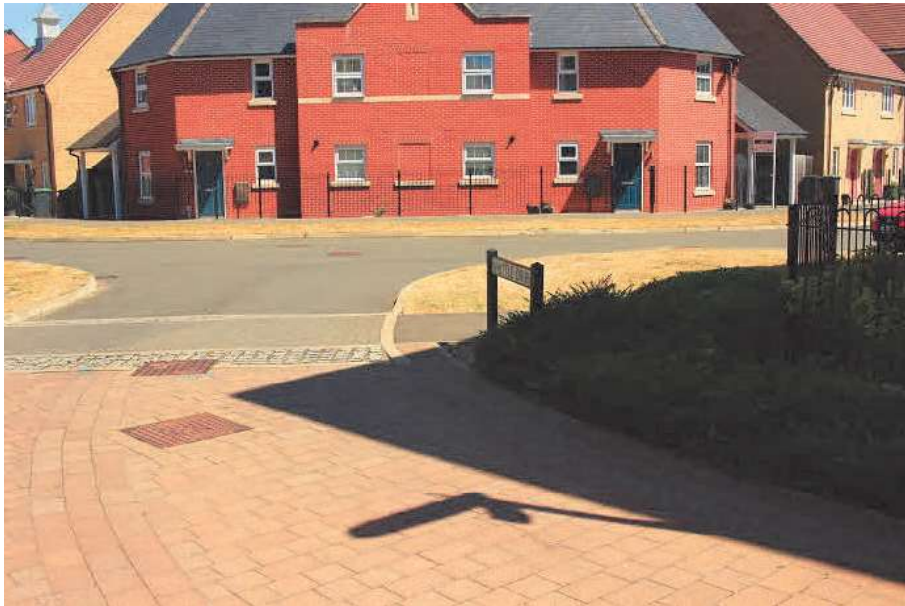
37. At the end of Whittle Drive there is a junction similar to others seen around King's Reach, with no space for a wheelchair or pram to get around the traffic calmer on one side:

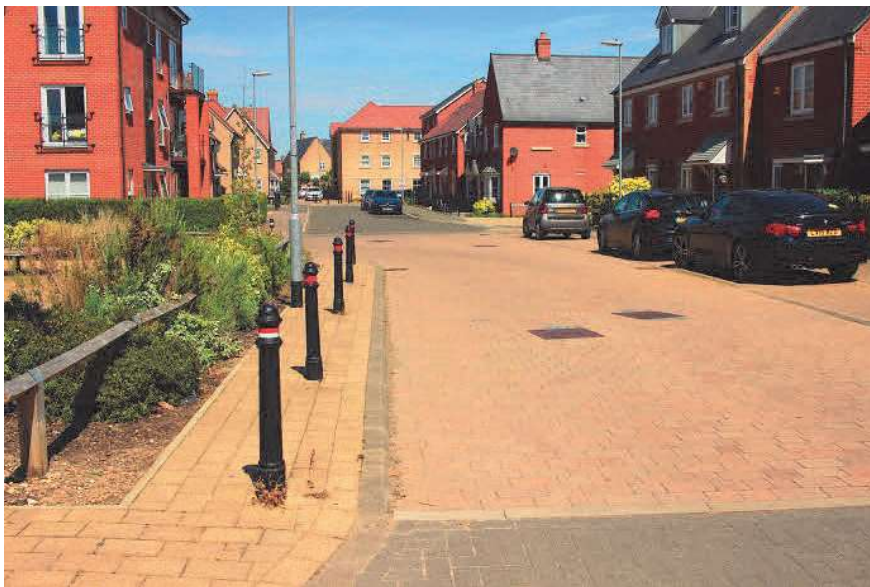
38. In Anderson Road, bollards have been placed on the narrow footpath, presumably to stop cars being parked there by families visiting the playground; unfortunately, these also more or less prevent use of the footpath by pedestrians:

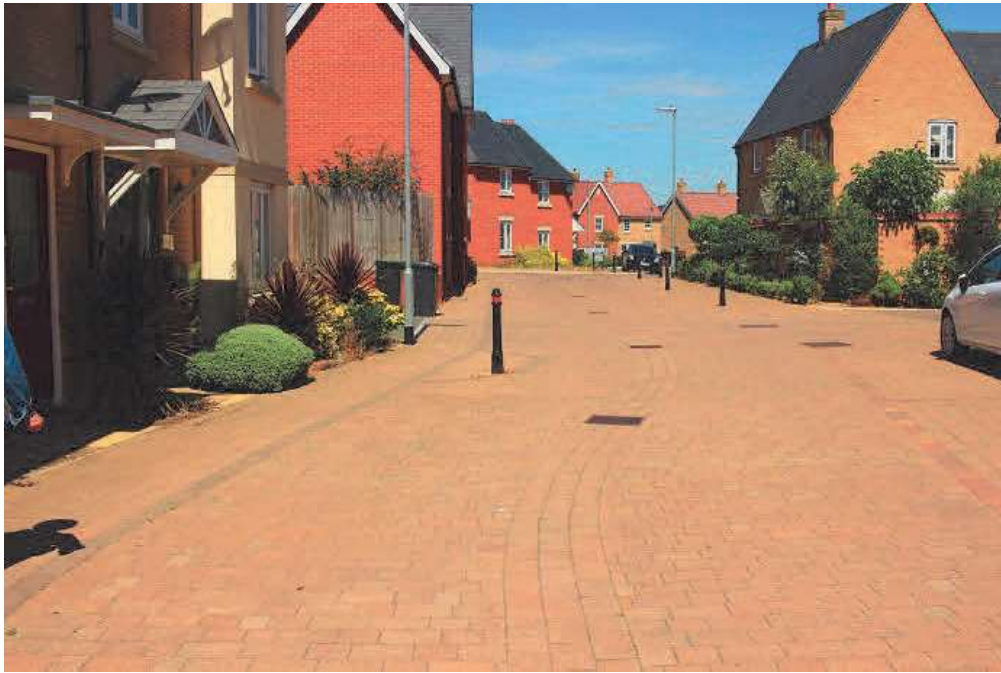
39. In Sanger Avenue a lone bollard stands, seemingly for no purpose whatsoever:

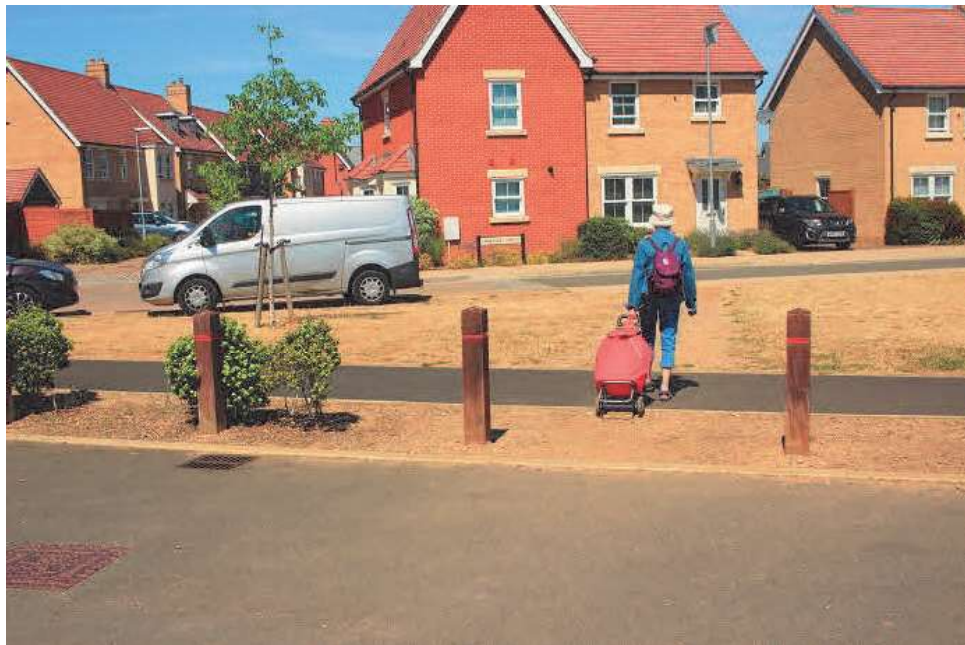
40. To return to Hawking Drive involves crossing what was intended as a planted space, and then a path worn into the rough unsurfaced area that separates Hawking Drive and Babbage Lane:
