THE CHESTERTOWN ARMORY

REPURPOSING
FOR A
BOUTIQUE HOTEL

BUILDING CONDITION PHOTOS

January 2023 Building Visit

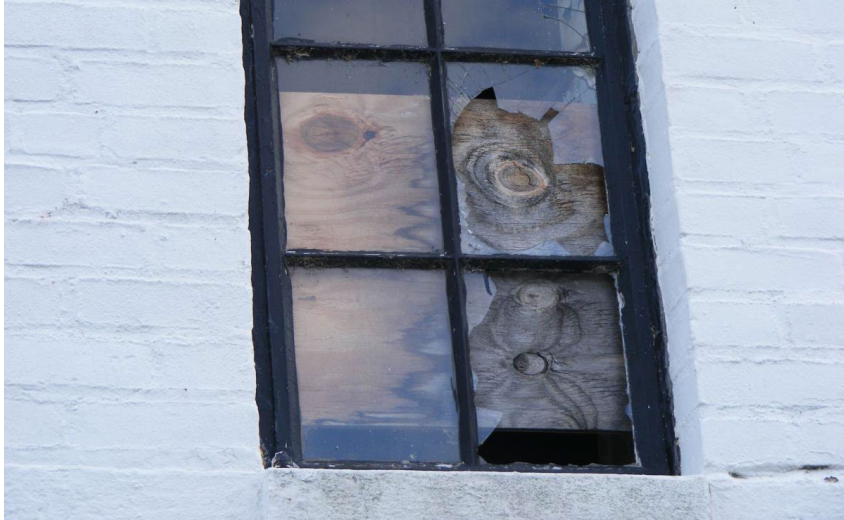
Water Intrusion at Exterior Windows

Broken glass and open windows have allowed for water intrusion causing deterioration of interior finishes and elevating humidity levels to foster mold development.

New windows are required throughout.

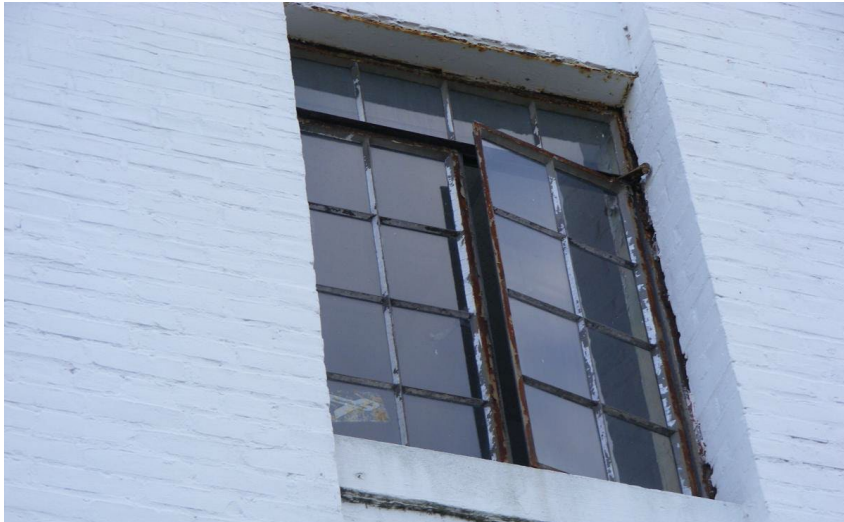
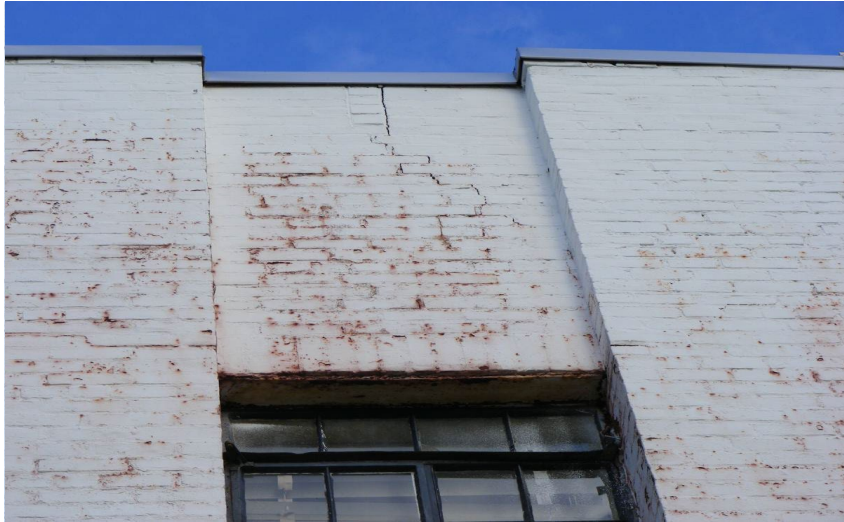
Water Intrusion at Exterior Walls

Unsealed wall cracks and openings have allowed for water intrusion causing deterioration of brick and paint finishes due to water entry and repeated freeze thaw cycles.

Conditions are repairable.

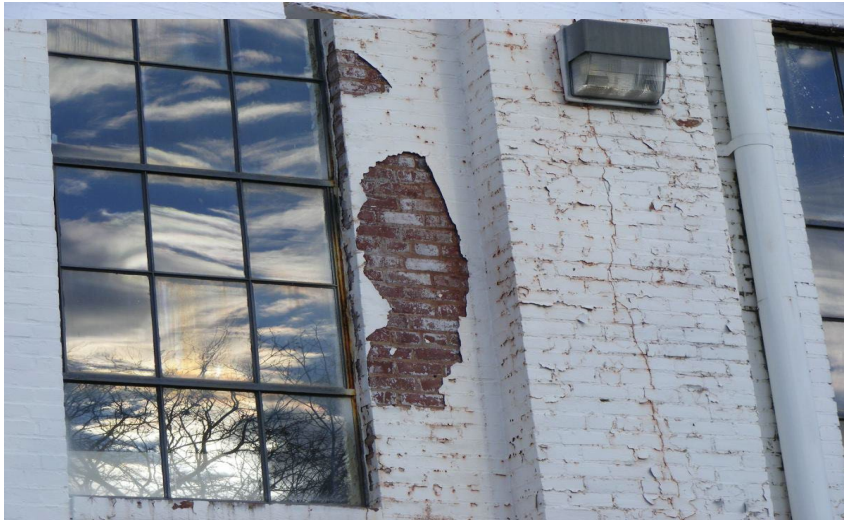
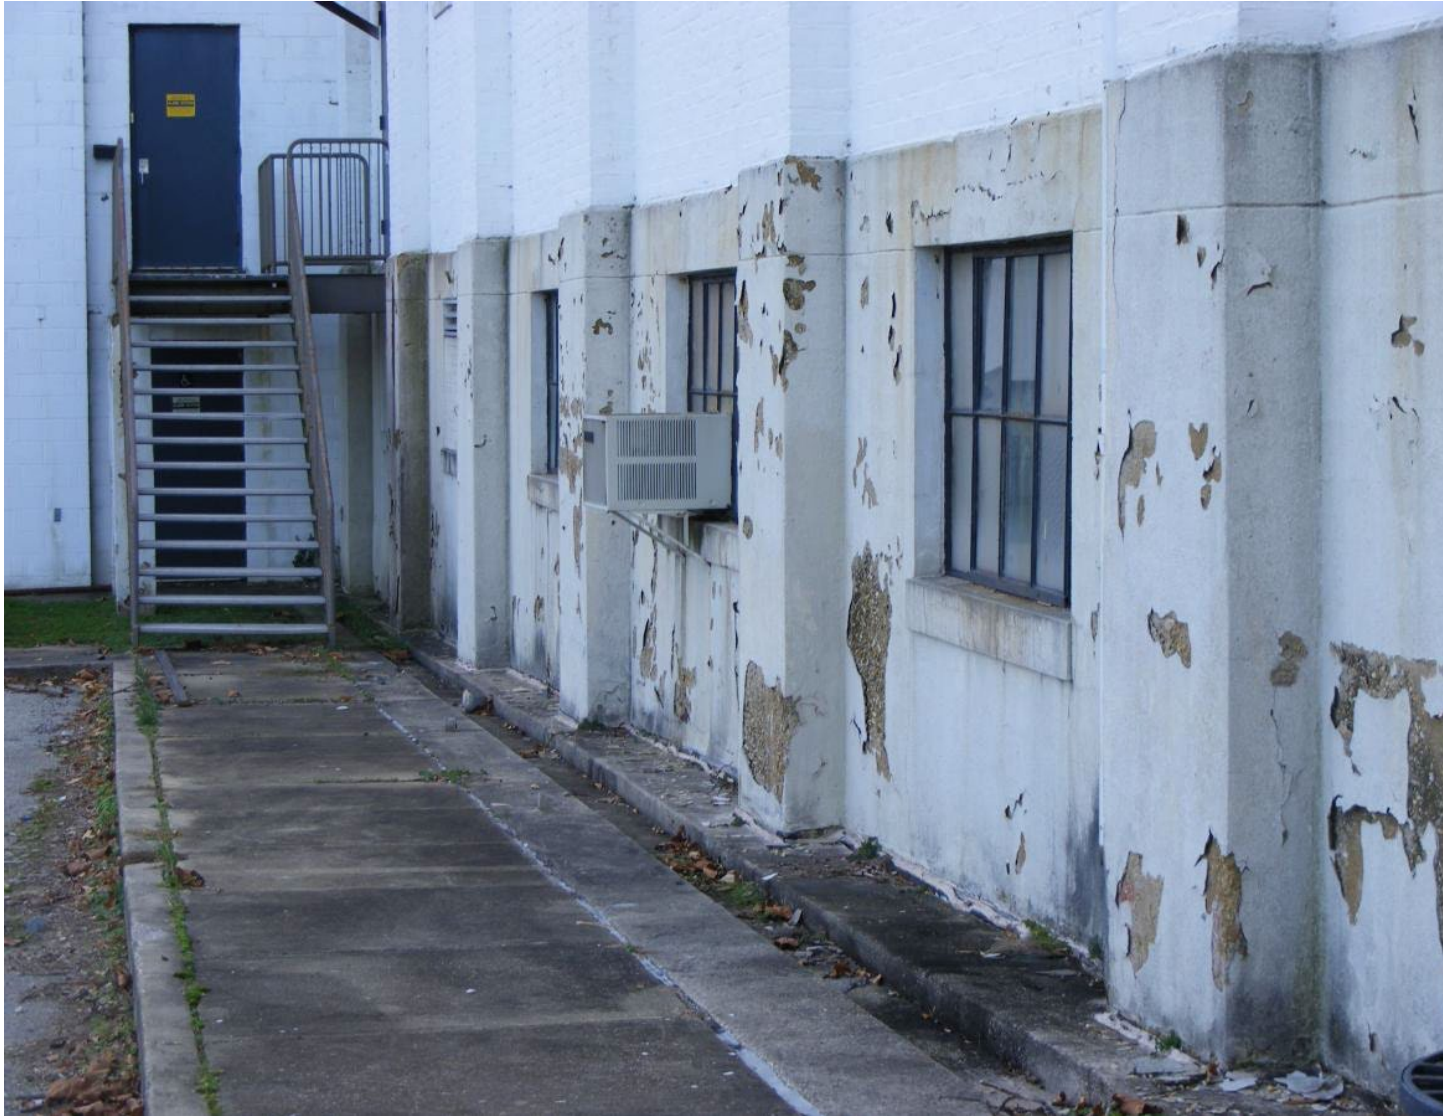
Water Intrusion & Damage at Exterior Walls

Lack of repairs at foundation walls has allowed for water intrusion causing deterioration of concrete by spalling and failure of protective paint coatings due to repeated freeze thaw cycles. Failure to manage surface runoff has exacerbated deterioration.

Conditions are repairable.

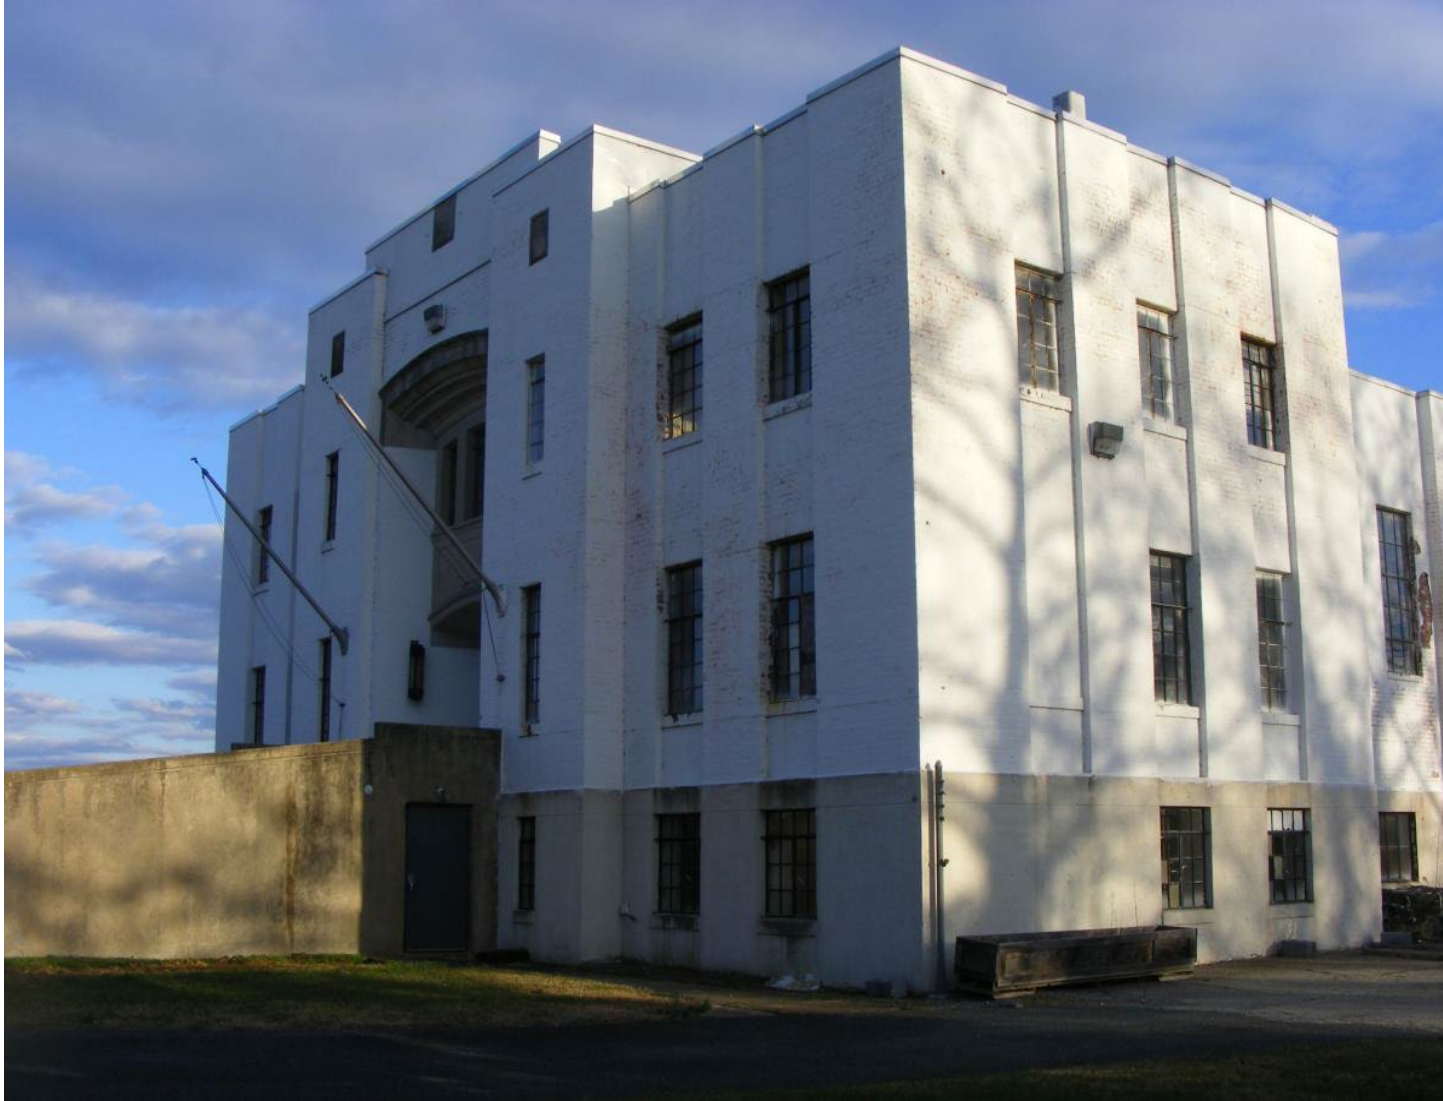
Water Intrusion & Damage at Exterior Walls

Lack of wall repairs and painting has allowed for water intrusion causing deterioration and failure of paint coatings from repeated freeze thaw cycles. Failure to manage roof and surface runoff has further exacerbated deterioration.

Conditions are repairable.

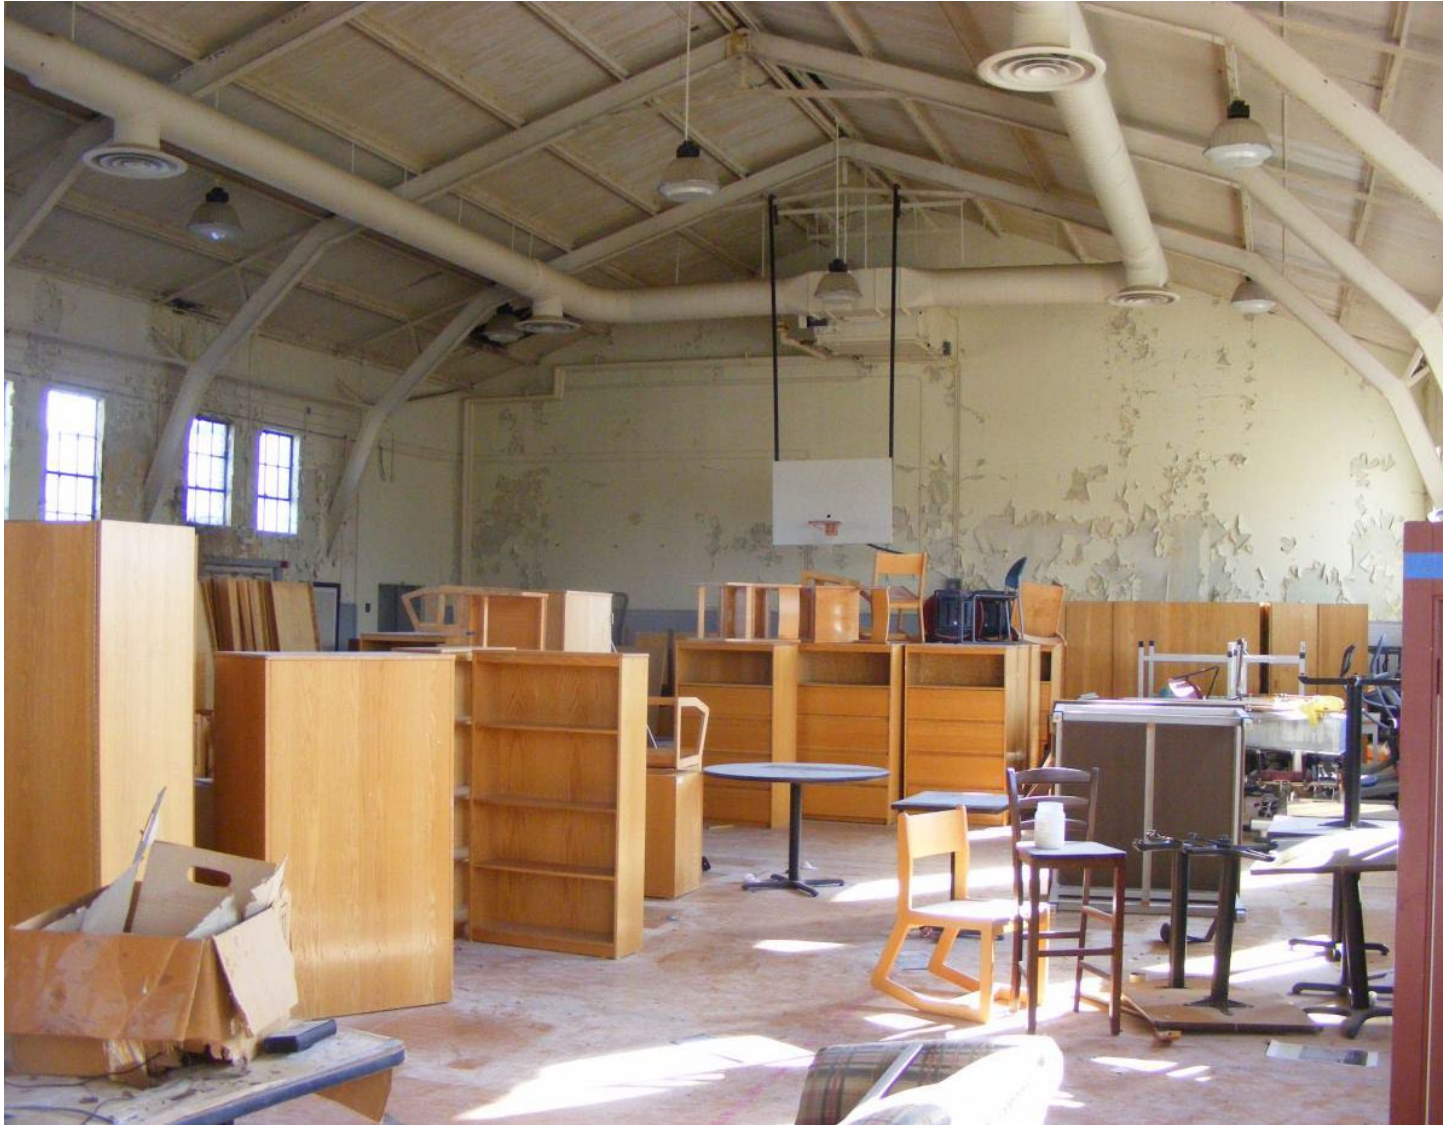
First Floor Drill Hall

Lack of operating the HVAC system and correcting conditions responsible for water intrusion has caused deterioration of interior finishes, yet the hall is in remarkably good and stable condition and very suitable for repurposing.

Conditions are repairable.

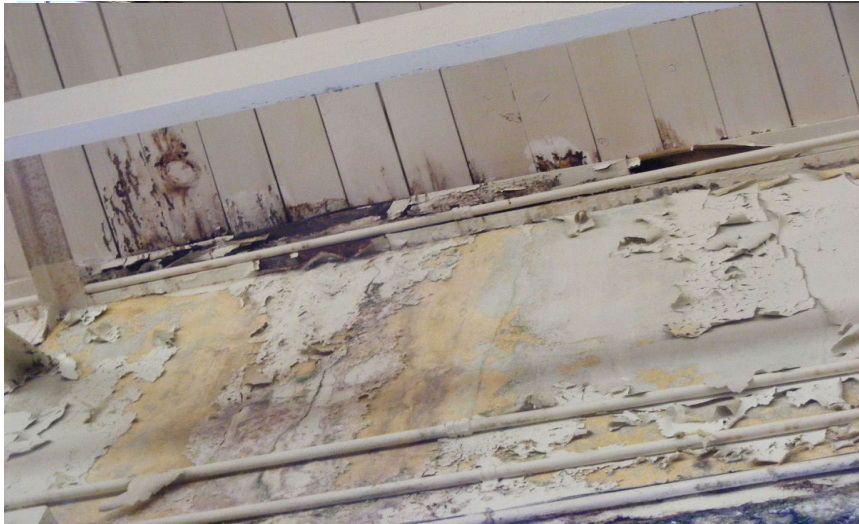
Interior Roof Leaks & Non-Operating HVAC System

Uncorrected roof leaks has allowed for water intrusion causing deterioration to paint and plaster finishes and fostering mold growth.

Existing HVAC system is modern and suitable for conditioning the building as intended. Failure to operate the system has exacerbated deterioration and promoted mold growth.

Conditions are correctable.

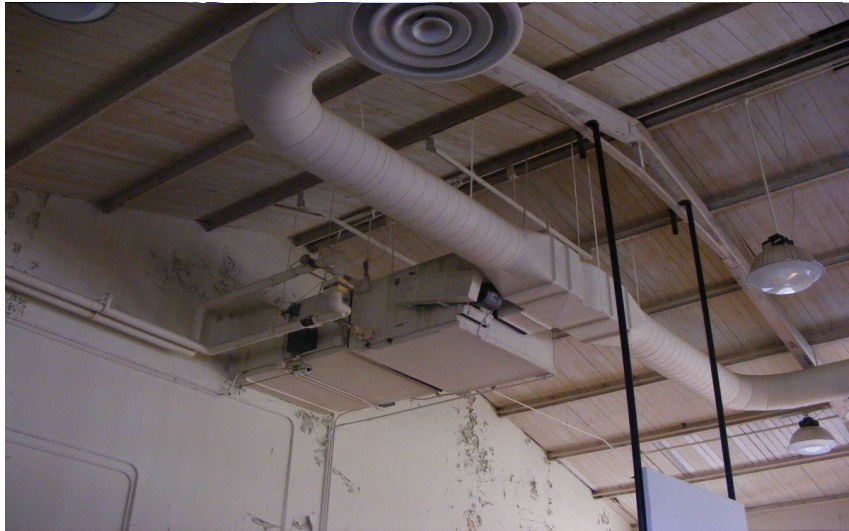
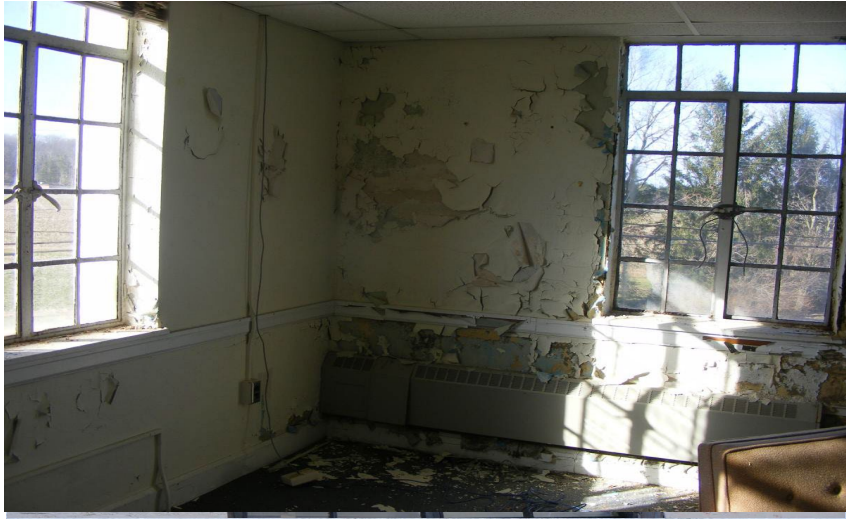
Water Intrusion at Interior Walls

Unsealed wall cracks, openings and spalling have allowed for water intrusion causing deterioration of paint and plaster finishes. Water intrusion has fostered growth of mold.

Conditions require removal of interior paint and plaster throughout followed by mold remediation and new wall finish system with thermal insulation. All routine construction.

Conditions are correctable.

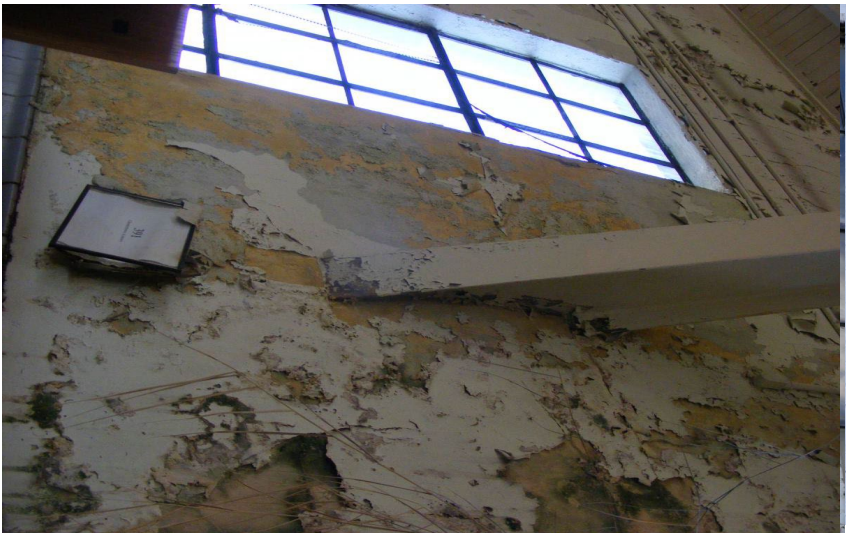
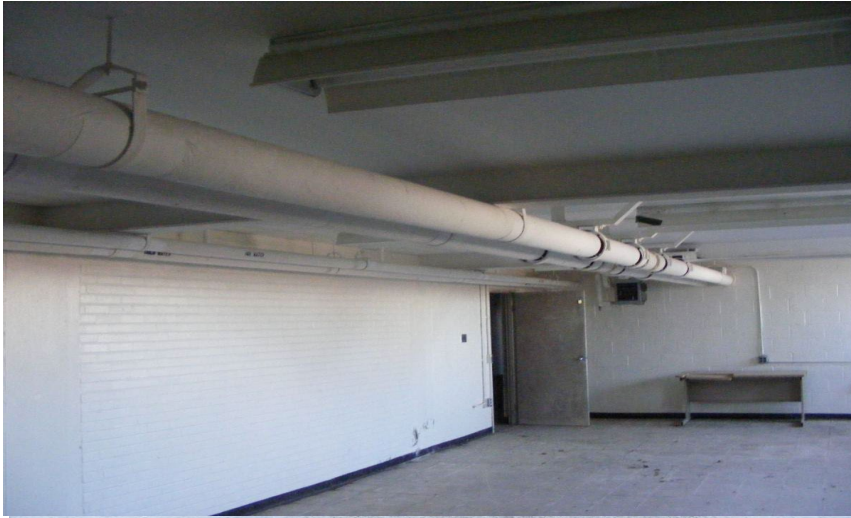
Ground Level Interior Conditions

Conditions are stable and serviceable despite absence of an operating the HVAC system. Exterior walls are poured concrete. Interior partitions are concrete block with durable epoxy paint. Surface prep required prior to remediation and then onto new routine interior construction.

Conditions are repairable.

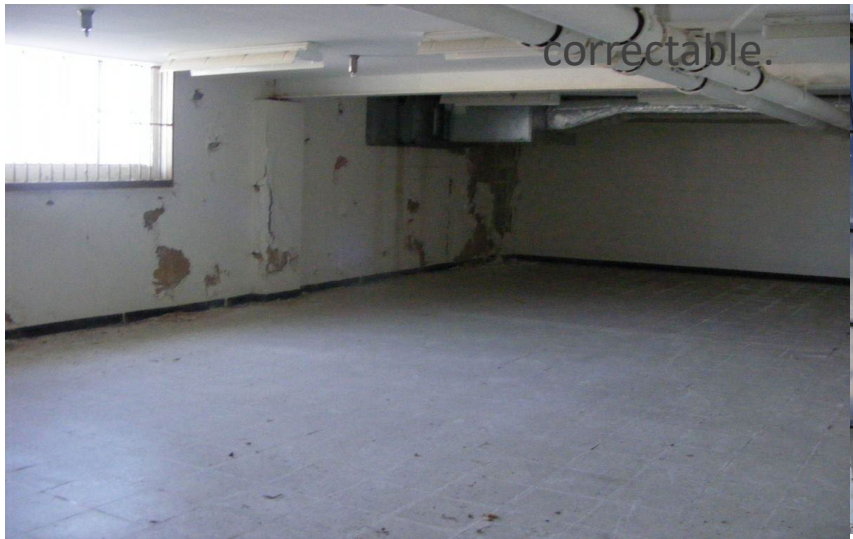
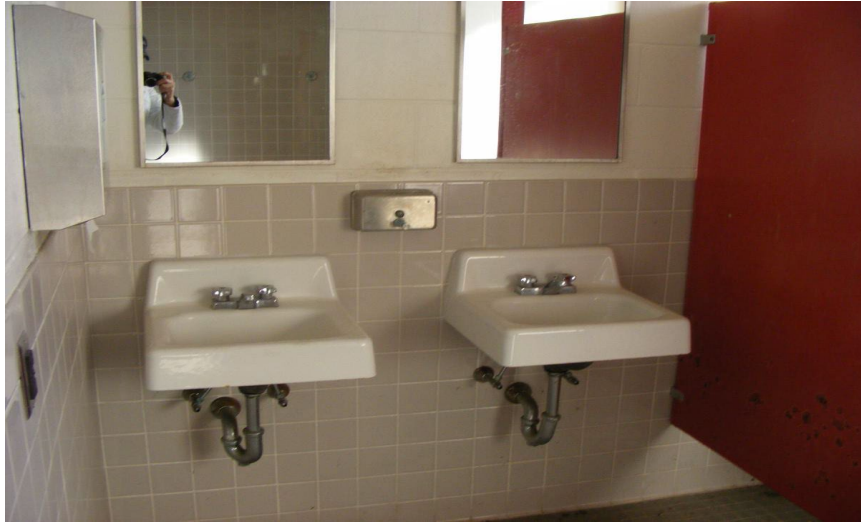
Ground Level Bathrooms

Conditions are remarkably stable and serviceable despite the absence of operating the HVAC system and performing routine maintenance. No evidence of concerning deterioration was observed.

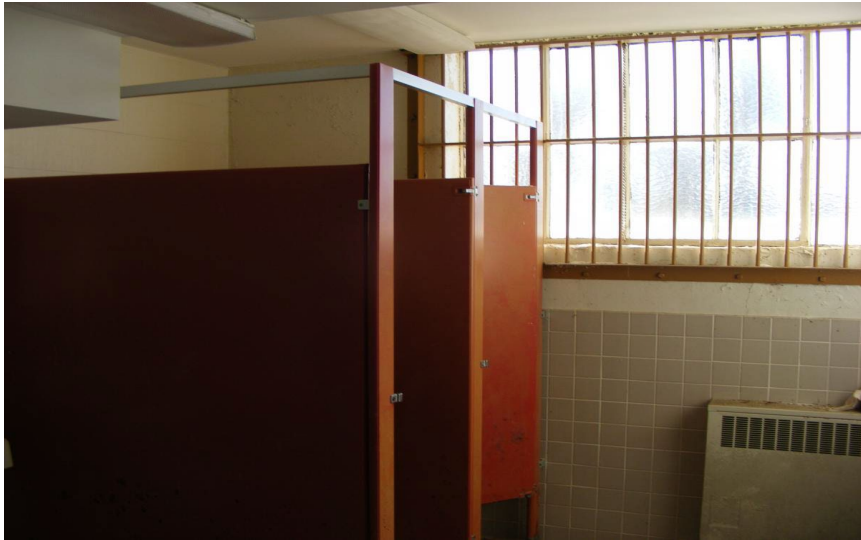
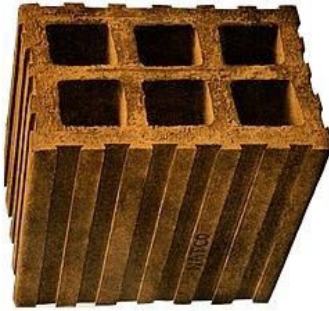
FIRED CLAY HOLLOW TILES

Sussex Environmental reported that moisture issues at exterior masonry block walls are fostering mold growth inside the 1931 armory.

Fired clay hollow tiles were commonly used in 1931. The tile was dense with low absorption. The use of clay tile within exterior walls was found during my field visit. Sussex is incorrect - exterior wall construction is not fostering mold. Neglect is the cause.

It was most commonly used for buildings constructed during the first quarter of the 20th century. Also common in military buildings and gas stations built as late as 1940. It was also used to back brick veneer. Fired in kilns at temperatures over 400 degrees, the unit was rendered hard and impervious, thus its use to also provide fire protection in early skyscrapers.

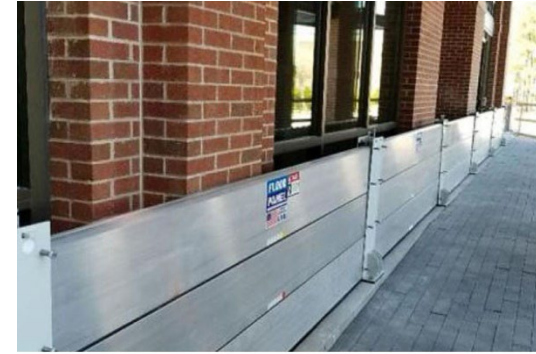
PERIMETER FLOOD BARRIER

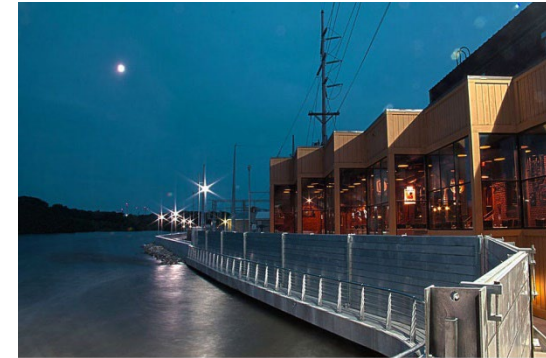
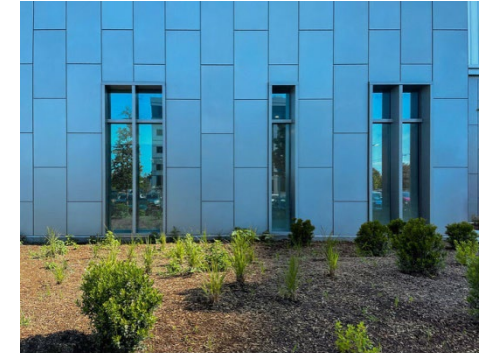
FLOOD RATED WINDOWS
