620 Shuttle Hill Road

August 26th, 2022

Inspected by Bradley W. Koser Prepared for Jason

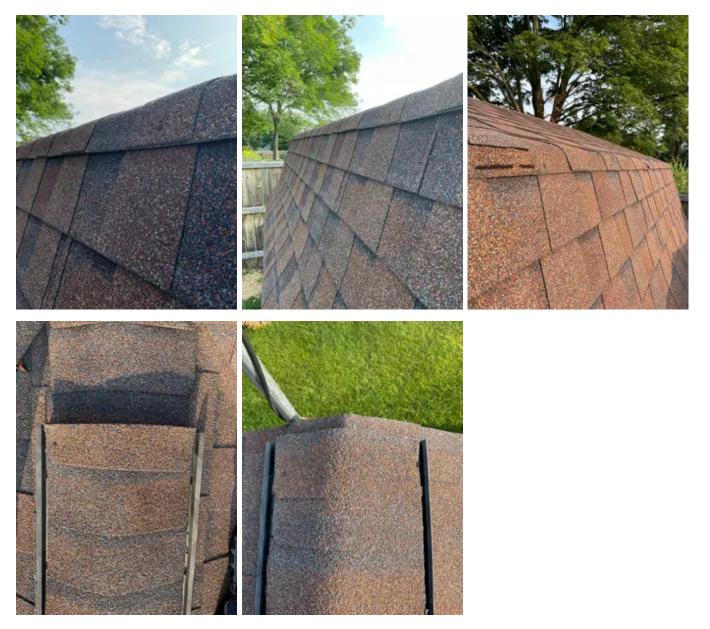
1.2 · EXPOSED NAILS

Under-driven or exposed nails were found in one or more roof coverings. Recommend further evaluation by a qualified contractor.

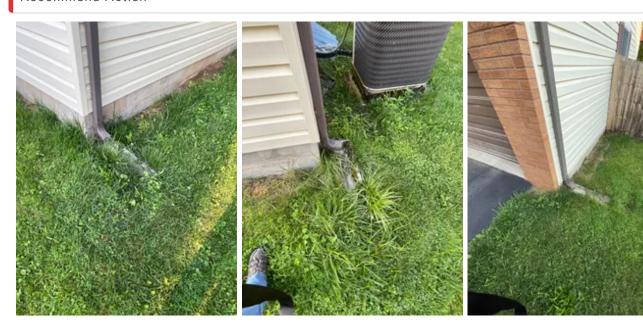
1.5 · DOWNSPOUTS DRAIN NEAR HOUSE

One or more downspouts drain too close to the homes foundation. This can result in excessive moisture in the soil at the foundation, which can lead to foundation/structural movement. Recommend further evaluation by a qualified contractor to have drain at least 6 feet from the foundation.

Here is a helpful DIY link https://www.thisoldhouse.com/how-to/how-to-drain-downspout-water-flow-away-house and video on draining water flow away from your house.

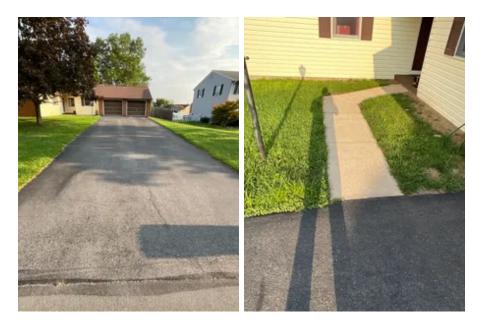
2.4 · DRIVEWAY AND WALKWAY MATERIALS

Asphalt

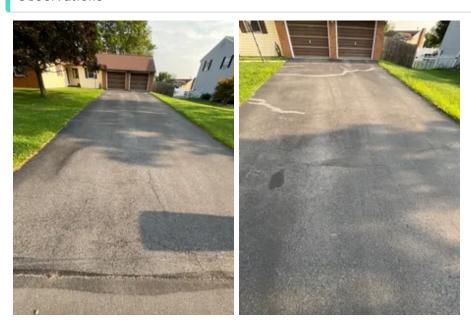
2.5 · DRIVEWAY CRACKING - MINOR

Minor cosmetic cracks observed, which may indicate movement in the soil. Recommend monitor and/or have driveway contractor patch/seal.

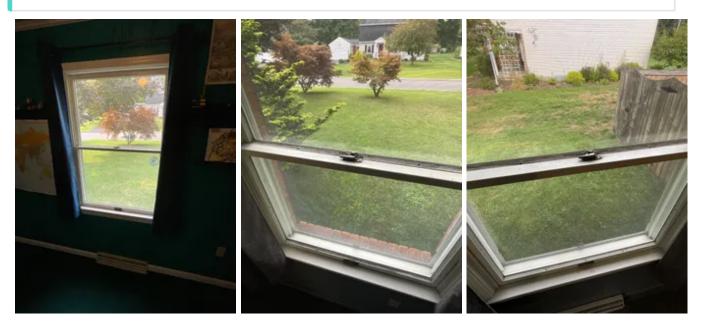
4.1 · DAMAGED

One or more windows appears to have general damage, but are operational. Recommend a handyman or contractor paint, lubricate & adjust as necessary.

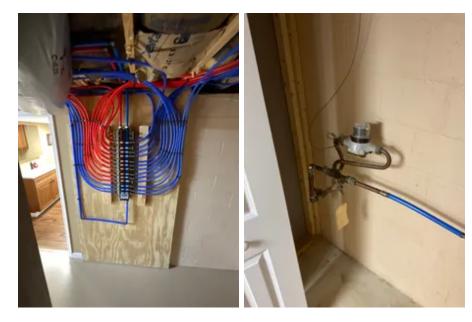
$7.2 \cdot \text{MAIN WATER SHUT-OFF DEVICE (LOCATION)}$

Main water shut off

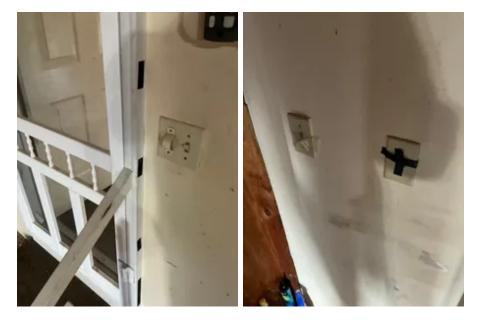
8.5 · INOPERABLE SWITCH

Could not operate switch at time of inspection. Recommend further evaluation by a qualified electrical contractor.
