FIXING AN ISSUE WHERE CLIENT REMOVED SET SCREWS FROM NEW 2023-24 BEARING HOLDER

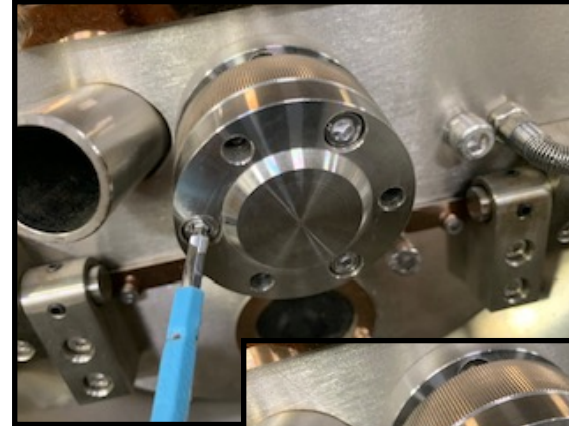
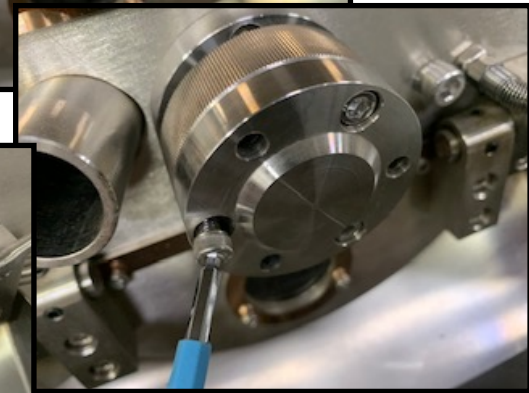
1. Using a metric HEX KEY remove the front cover of the bearing holder (The 3 screws are the type with the visible heads on them)

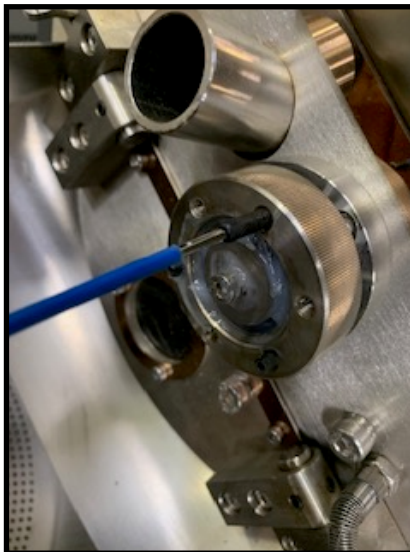
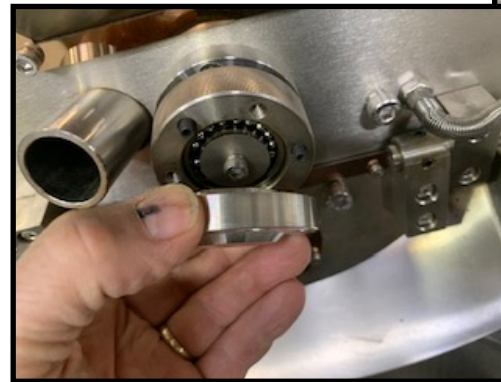
2. Once front cover is off you will see where the holes are where you took out set screws and reinsert them and screw them in all the way until just tight:

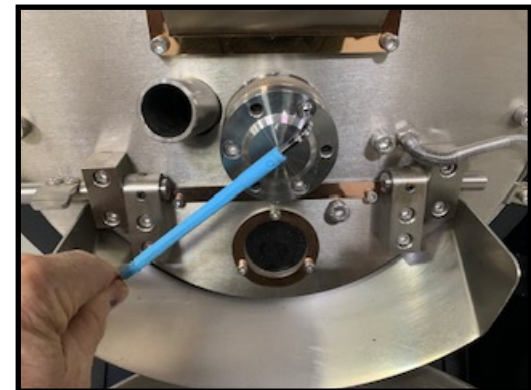
3. Once you have screwed all the set screws into place FIT the cover back over holder and insert the 3 screws that holds cover into place and hand tighten

TIP: NEVER REMOVE SET SCREWS AGAIN
