Inspection Report

Property Address:
1041 Somewhere Ct
Fairfax VA 00000

Date: 5/2/2019	Time: 02:30 PM	Report ID: 20190502-Sample Report
Property: 1041 Somewhere Ct Fairfax VA 00000	Customer: John Doe	Real Estate Professional: Wendy Hill

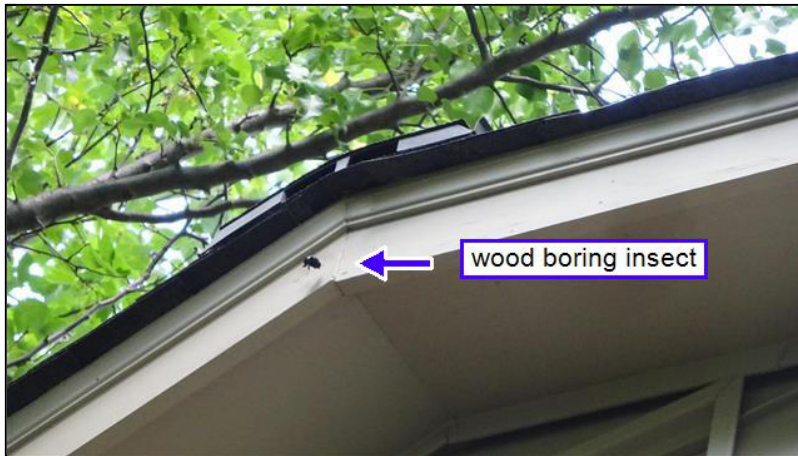
(1) Areas of wood boring insect damage on fascia/soffit.

(1) Areas of wood boring insect damage on fascia/soffit.

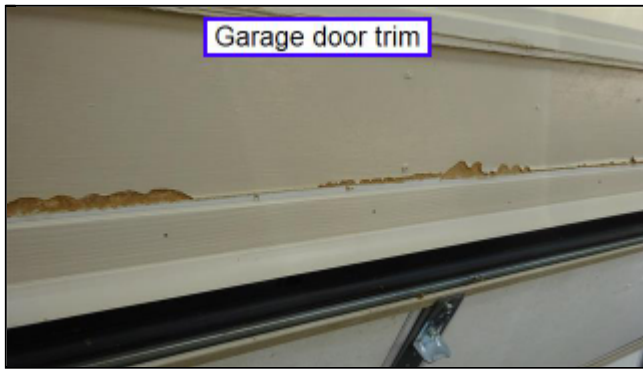
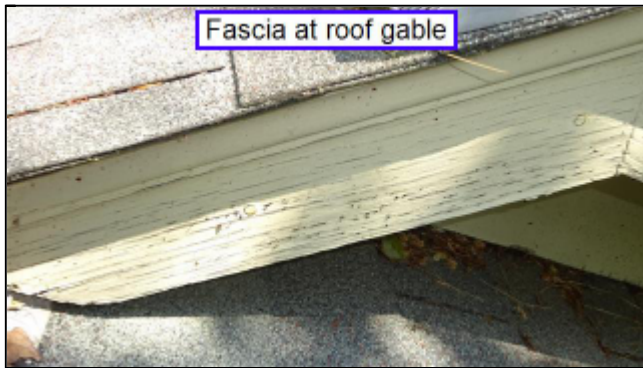
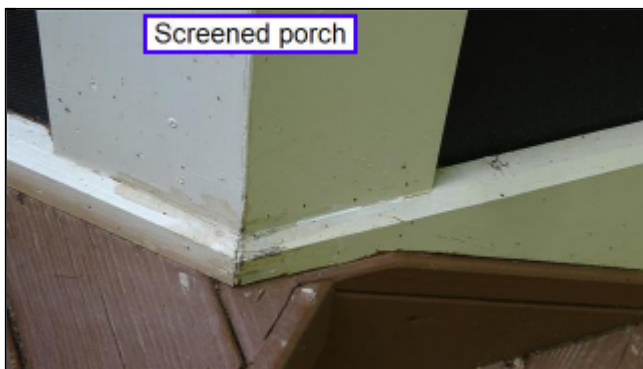
(2) Areas of failing paint/caulking at exterior trim. Improve as needed.

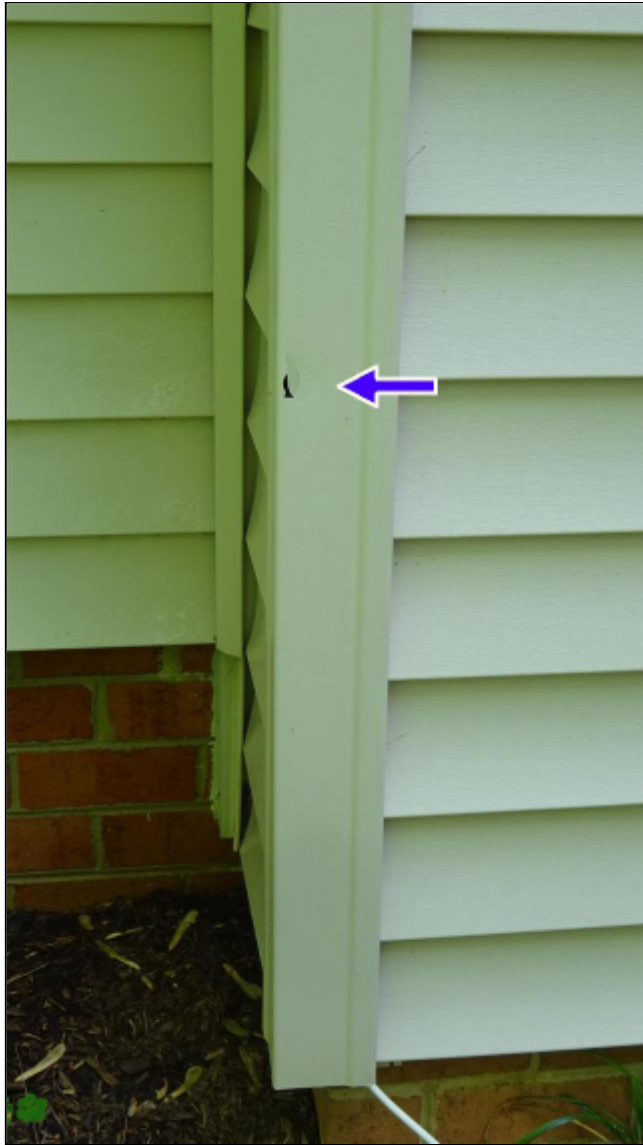
1.1 (Picture 1)

Minor damage to siding. Gap at siding above rear porch at gutter may allow moisture/insects to penetrate. Repair as needed.

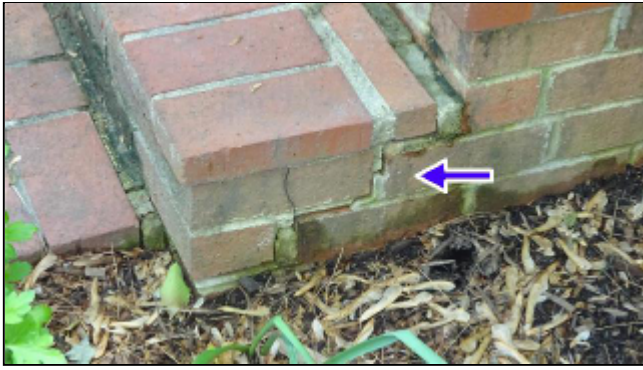
(1) Tuck point repairs needed at front brick stoop/steps.

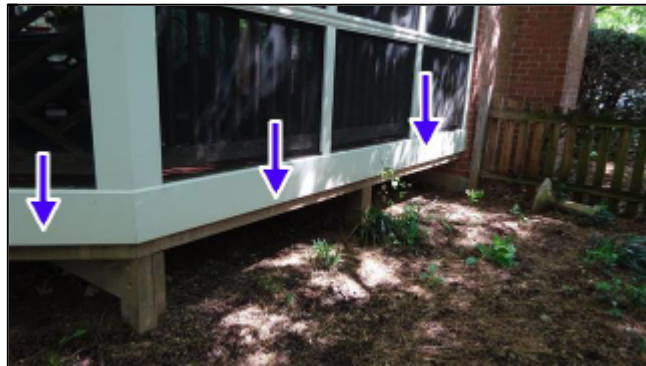
1.2 (Picture 4)

(2) Recommend installing lattice at base of back porch to prevent vermin entry.

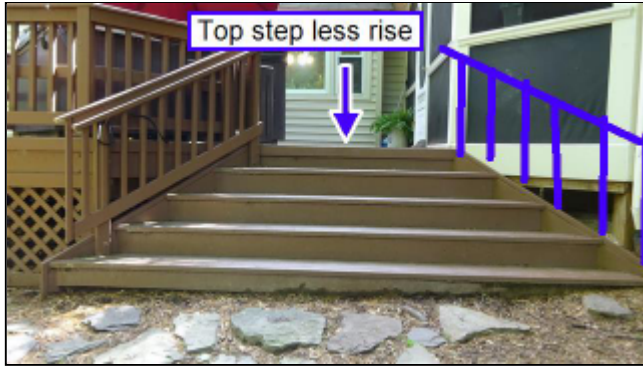
1.3 (Picture 1)

Potential trip hazard: Uneven riser heights at the front are rear steps. Recommend additional graspable handrails, or improve steps to be equal riser heights.

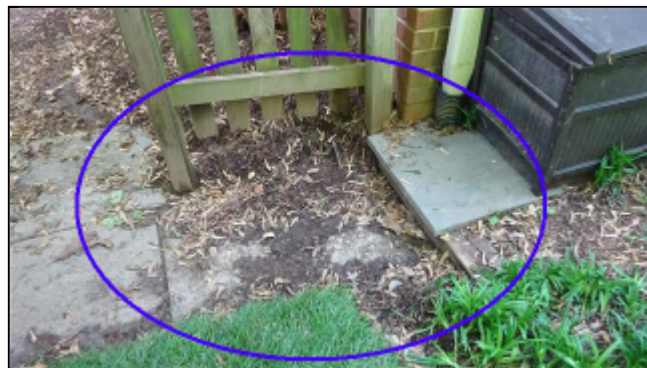
1.6 (Picture 1)

Low spot/negative grade along the left rear corner near the foundation. Recommend adding additional backfill to create the proper slope away from the house to allow for effective drainage.

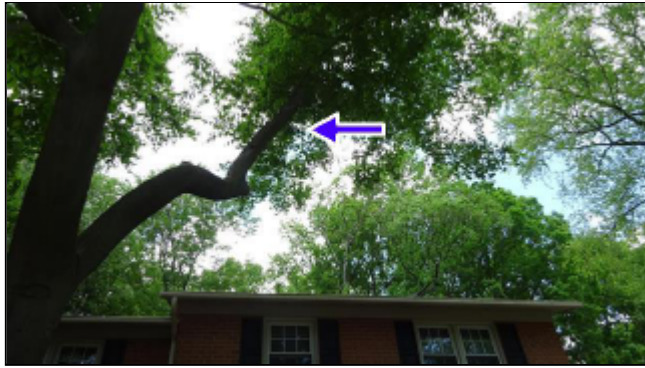
1.7 (Picture 1)

Large tree branches have grown over the structure. Significant damage to structure can result from storm/wind damage. Trim back all vegetation at least one foot from structure.

Large tree branches have grown over the structure. Significant damage to structure can result from storm/wind damage. Trim back all vegetation at least one foot from structure.

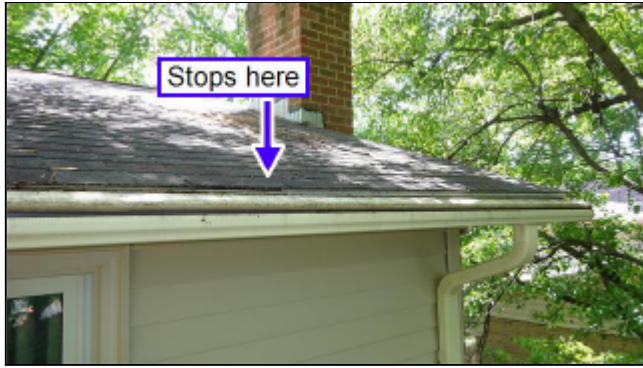
(1) Drip edge missing on portions of the roof. Recommend adding for leak prevention.

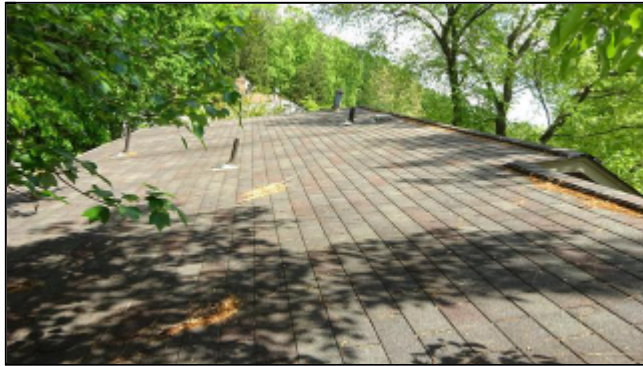
2.0 (Picture 3)

(2) FYI: Roof covering is in good condition with average wear and tear. Shade, overgrown tree branches and debris on roof covering will lessen the lifespan over time.

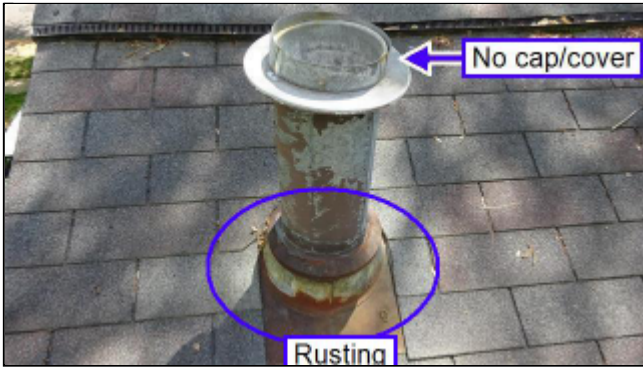
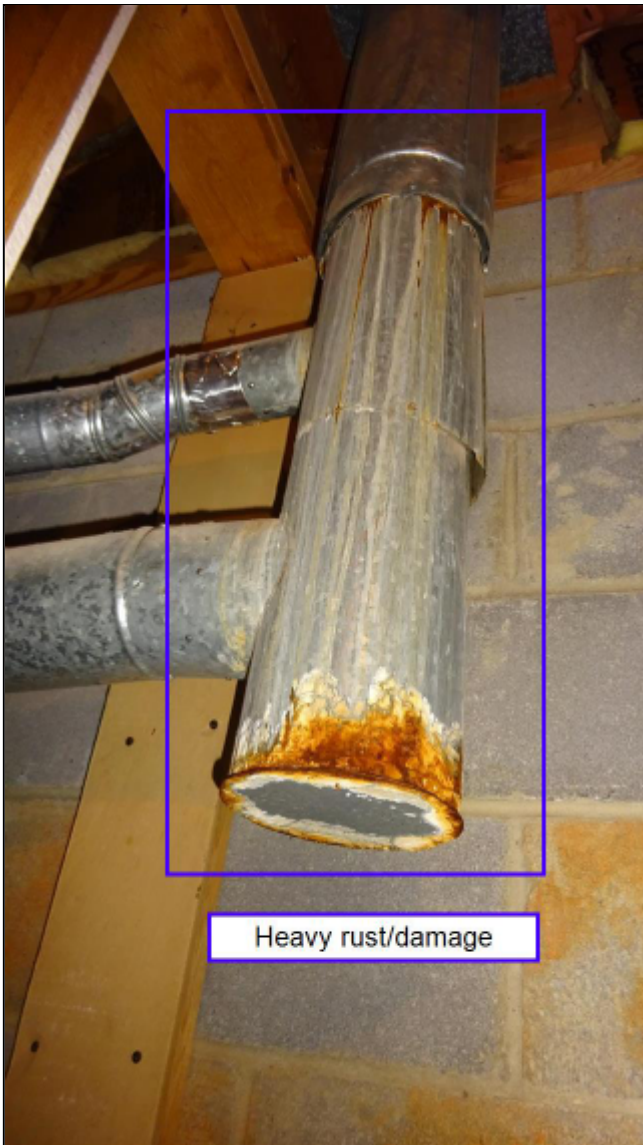
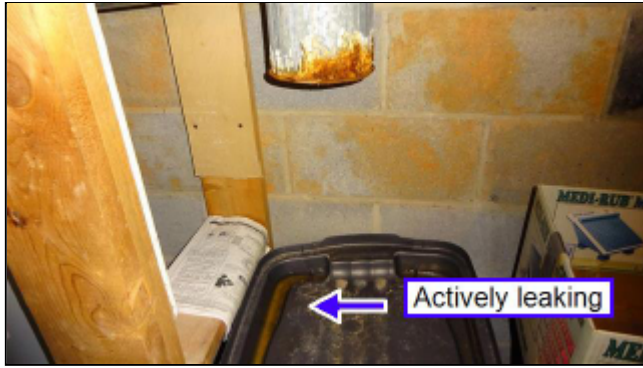
(1) Cover missing from metal chimney stack. Significant rusting and damage has occurred. Additional non visible damage may be present in the length of the stack.

(1) Cover missing from metal chimney stack. Significant rusting and damage has occurred. Additional non visible damage may be present in the length of the stack.

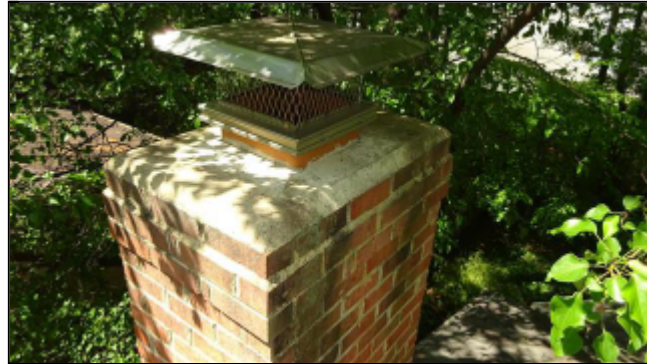
2.2 (Picture 4)

(2) FYI: Masonry chimney cap, bricks and mortar in good condition.

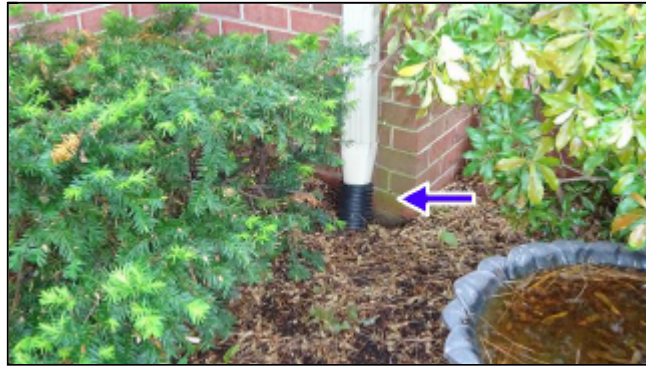
2.3 (Picture 4)

(3) FYI: Below ground drain lines for downspouts. Unable to determine if drains will function properly.

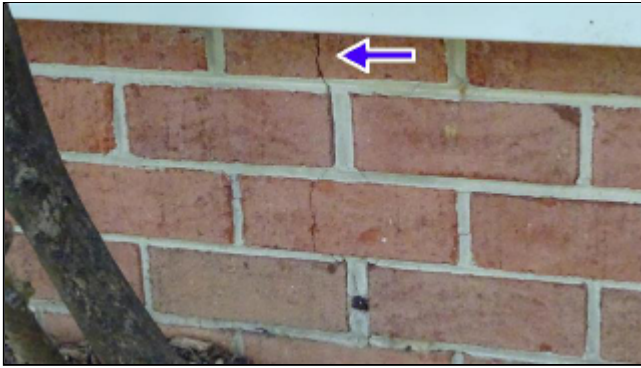
3.1 (Picture 1)

Minor settlement cracks on left rear corner at exterior bricks. Negative grading noted. Correct grading and seal all cracks with appropriate exterior sealant.

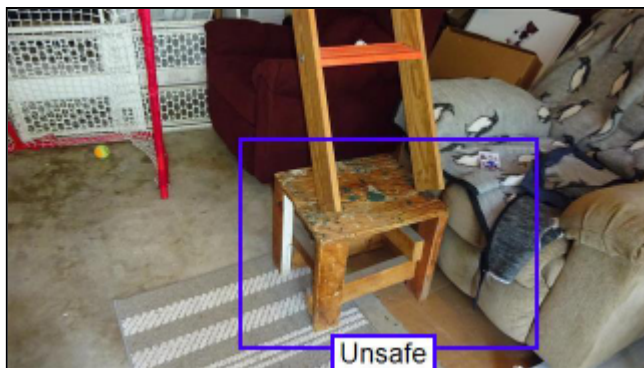
Garage attic access stairs improper length. Stairs must fully extend to floor. Ladder direction faces away from the center of the attic space and towards the narrow portion at the top of the ladder. Traversing these stairs is unsafe. Replace with proper length stairs and turn around to center.

Garage attic access stairs improper length. Stairs must fully extend to floor. Ladder direction faces away from the center of the attic space and towards the narrow portion at the top of the ladder. Traversing these stairs is unsafe. Replace with proper length stairs and turn around to center.

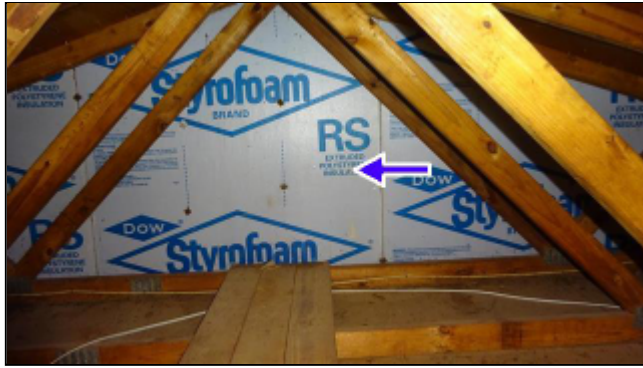
Styrofoam insulation in garage attic space is not fire rated and is combustible. Replace or cover with 5/8" fire rated drywall (gypsum board).

Styrofoam insulation in garage attic space is not fire rated and is combustible. Replace or cover with 5/8" fire rated drywall (gypsum board).

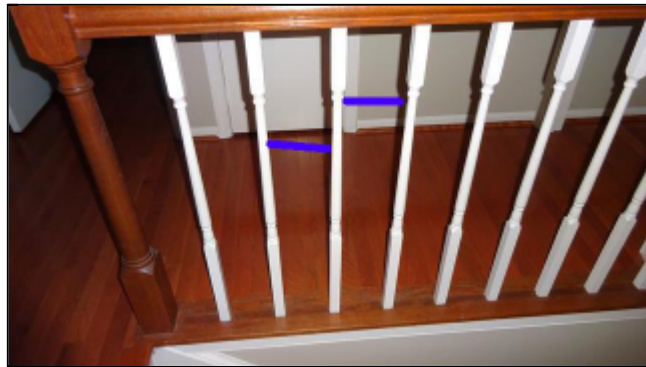
6.3 (Picture 2)

(2) FYI: Potential Safety concern: The opening between the stairwell Balusters (vertical posts comprising barrier in railings) is greater than 4" which can pose a threat to toddlers. Although wider spacing was adequate when home was built -- modern building safety standards is now a maximum of 4" between balusters. Consider installing appropriate safety guard as determined.

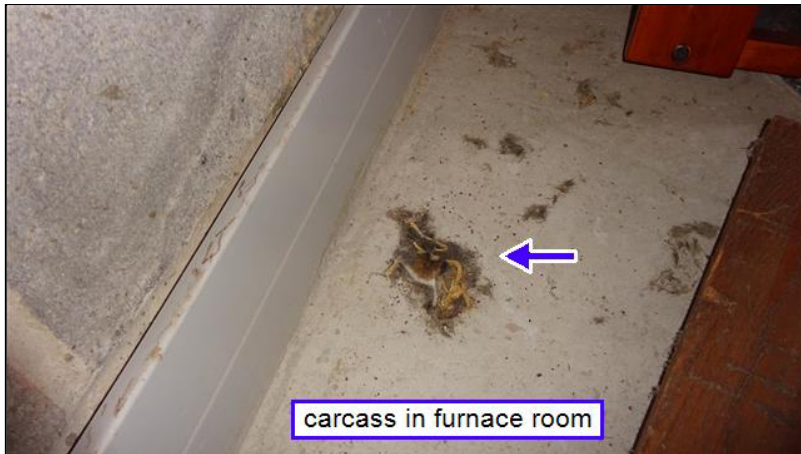
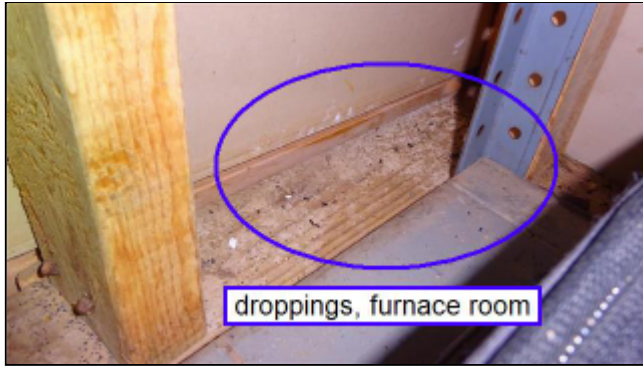
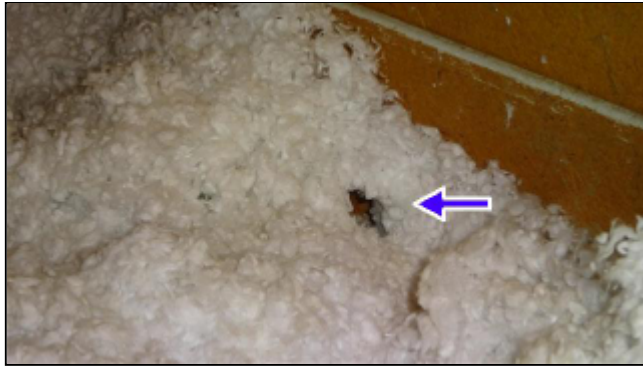
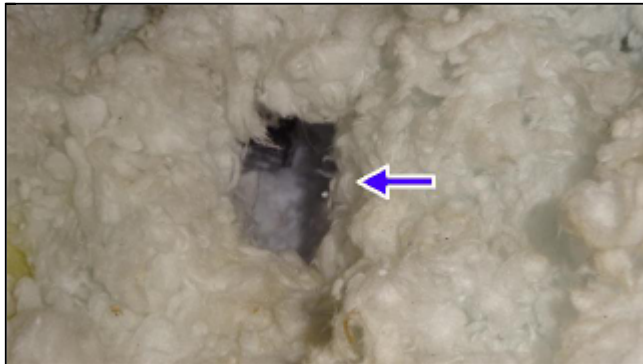
(1) Evidence of active rodent activity throughout the home as viewed in the kitchen sink cabinet, basement furnace room and attic. Have entire home evaluated and remediated by a pest control specialist.

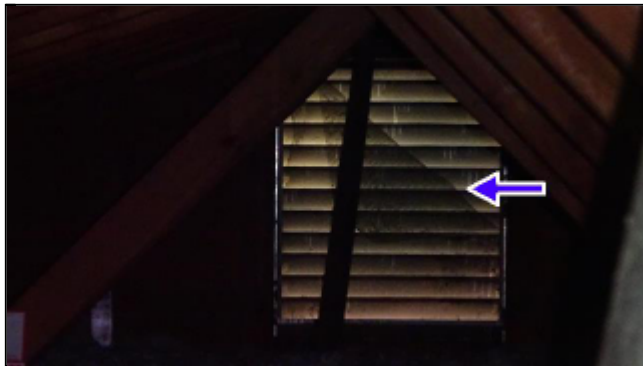
(2) Screen on attic gable vent is damaged/falling. Insect and possible vermin activity. Have remediated by a pest control specialist.

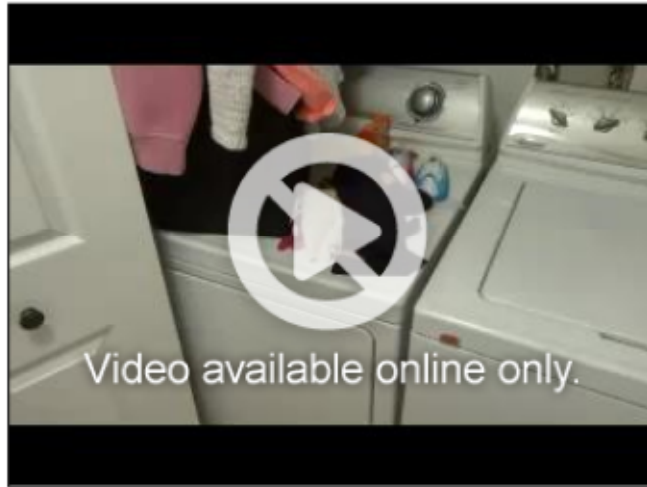
7.6 (Video 1) Click to play video

Clothes dryer makes loud grinding noise when operated. Service or replace as needed.

Clothes dryer makes loud grinding noise when operated. Service or replace as needed.

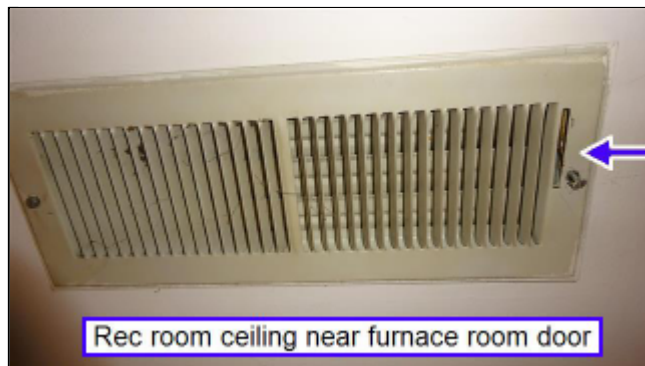
8.5 (Picture 2)

(2) Basement register cover adjustment mechanism is broken.

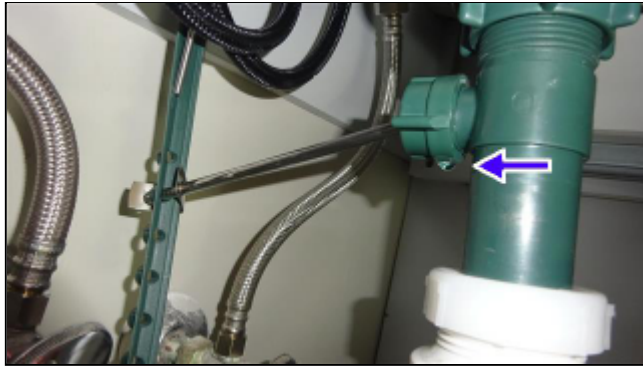
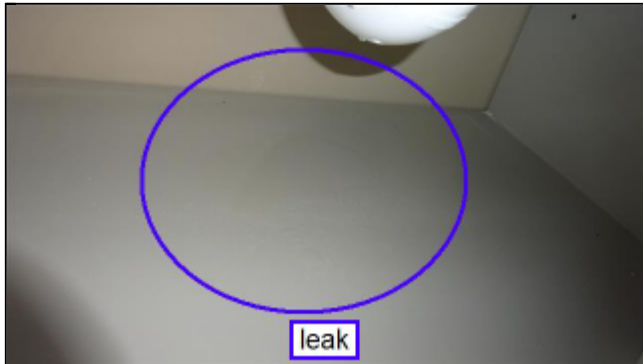
(1) Master bathroom sink stopper leaking at the connection to the drain pipe.

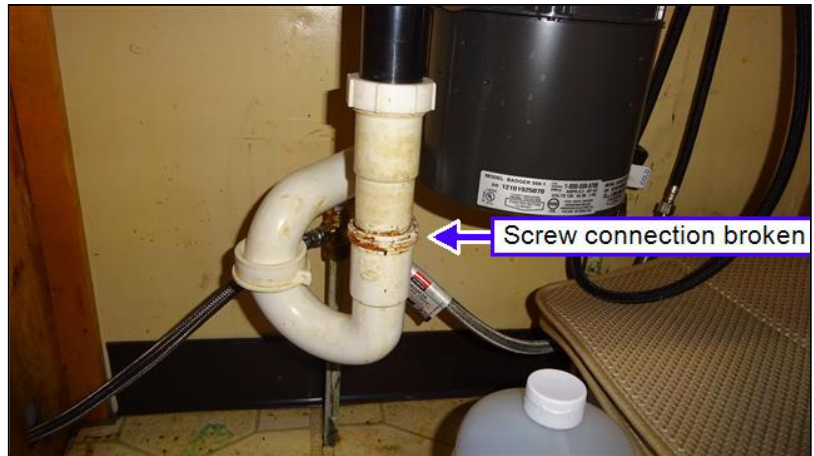
9.0 (Picture 3)

(2) Kitchen sink drain connection damaged. Drain has leaked and should be replaced.

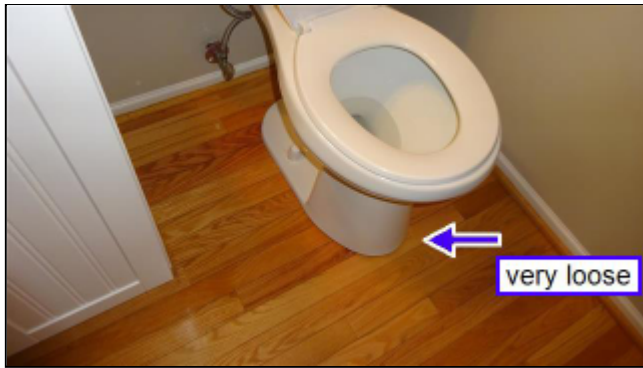
9.3 (Picture 1)

Multiple toilets are loose at floor anchor bolts. Repairs may involve re-setting the toilet on a new wax seal and or more extensive repairs to the flange or subfloor. Have a licensed plumber correct as needed.

Multiple toilets are loose at floor anchor bolts. Repairs may involve re-setting the toilet on a new wax seal and or more extensive repairs to the flange or subfloor. Have a licensed plumber correct as needed.

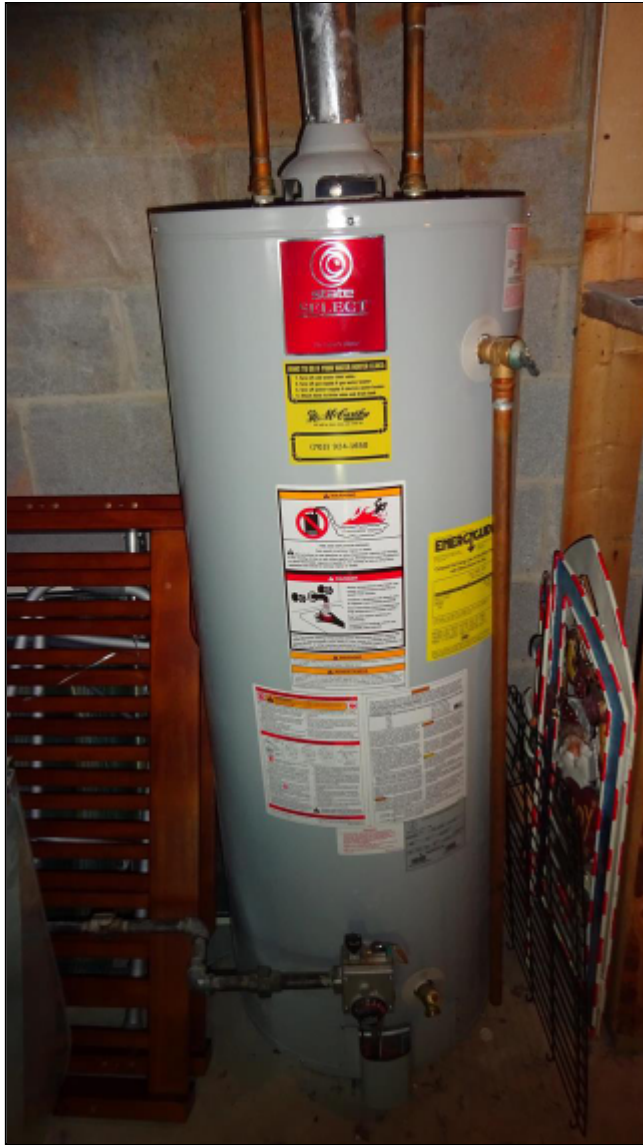
Deferred Cost: The water heater is beyond its useful life and may require replacement within the near term future. The average life span of a water heater is 8-12 years.

9.4 (Picture 2) Manufactured 2006

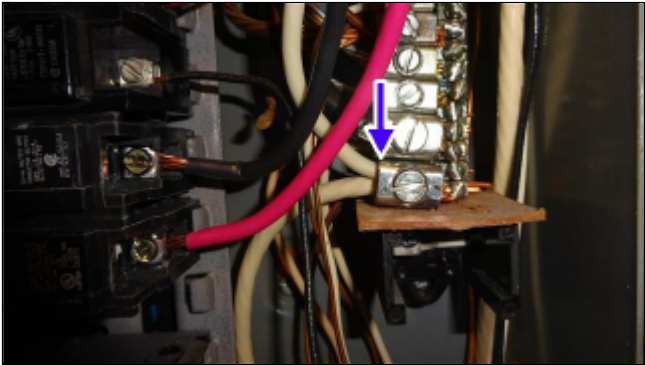
10.1 (Picture 1)

(1) Neutral wires are doubled together under single lug on the neutral bus bar. This is unsafe for circuit isolation and is a potential fire hazard if a loose connection develops. Qualified electrician should evaluate and repair as necessary.

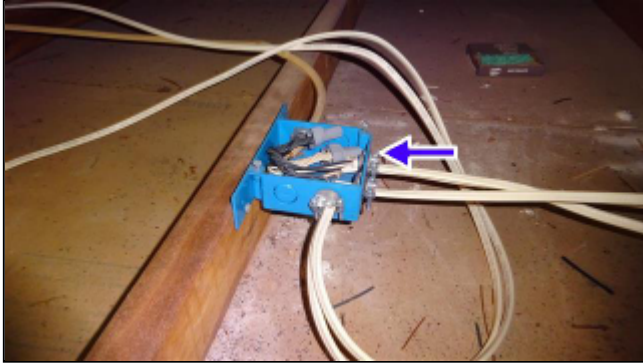
10.4 (Picture 1)

Open junction boxes observed in the garage attic. Repair as needed by a licensed electrician.

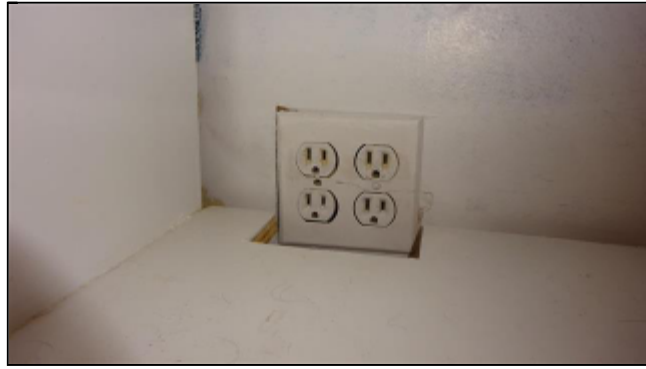
10.6 (Picture 1)

(1) Loose outlets in basement behind the built in shelf.

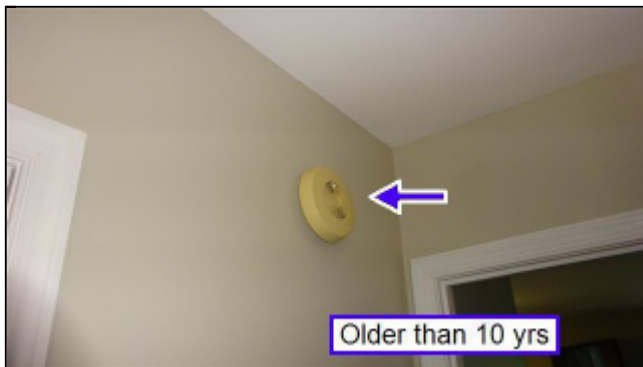
(1) Replace all smoke detectors which are greater than 10 years old with new dual sensor smoke alarms. Add dual sensor smoke alarms to every sleeping area.
