Inspection Report

Property Address:
6013 Somewhere Ln

Date: 4/12/2019	Time: 11:00 AM	Report ID: 6013Somewhere
Property: 6013 Somewhere Ln	Customer:	Real Estate Professional:

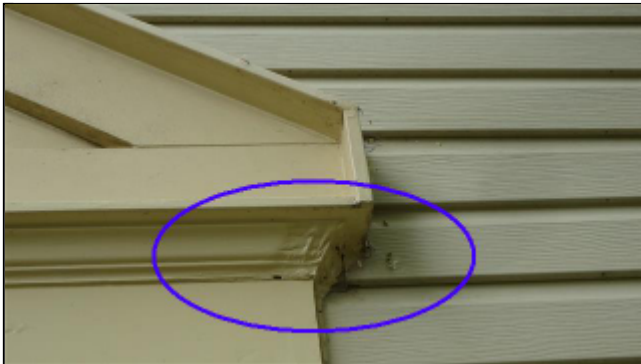
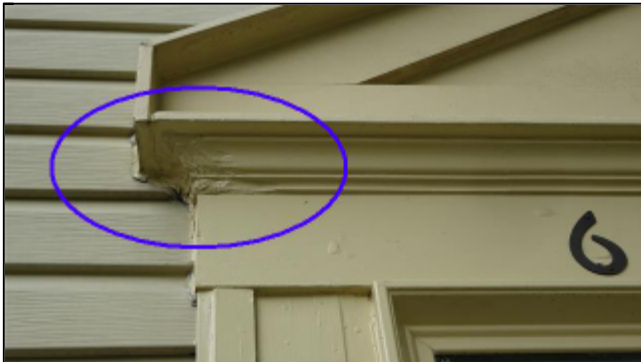
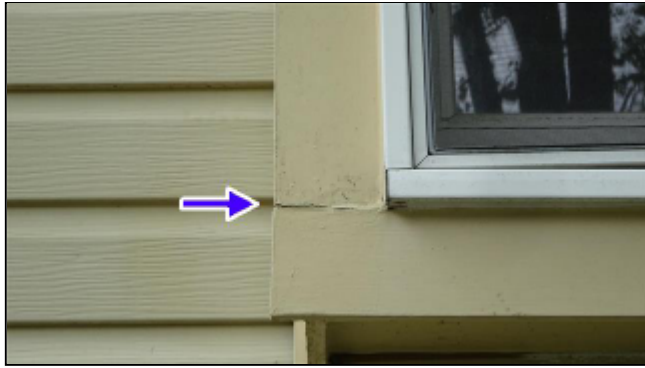
(1) Areas of failing/rotting exterior wood trim.

(1) Areas of failing/rotting exterior wood trim.

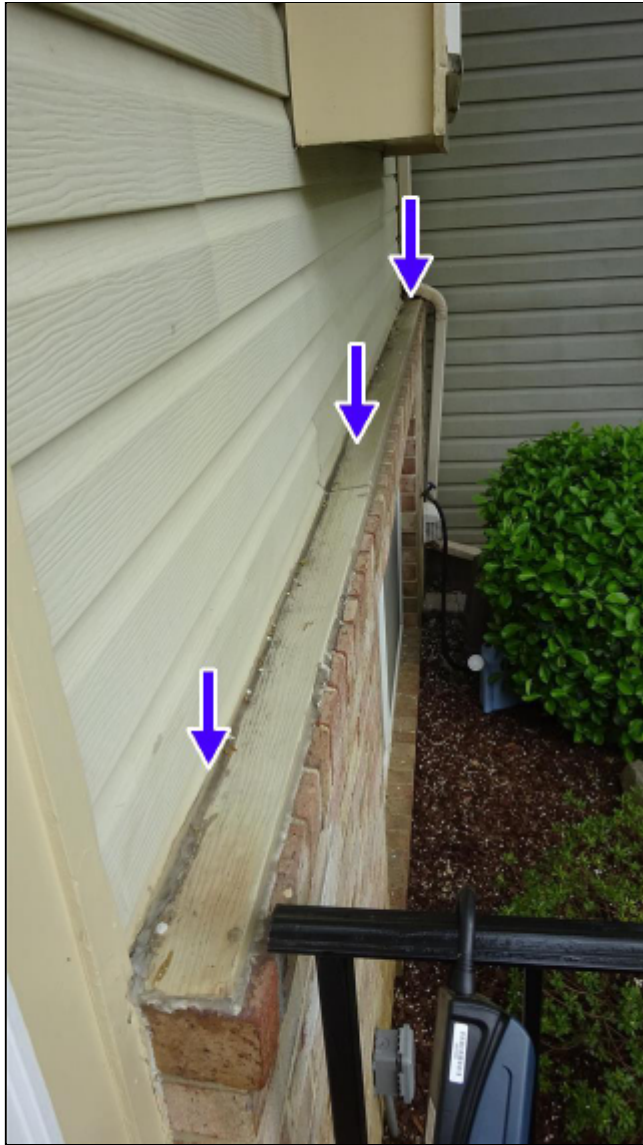
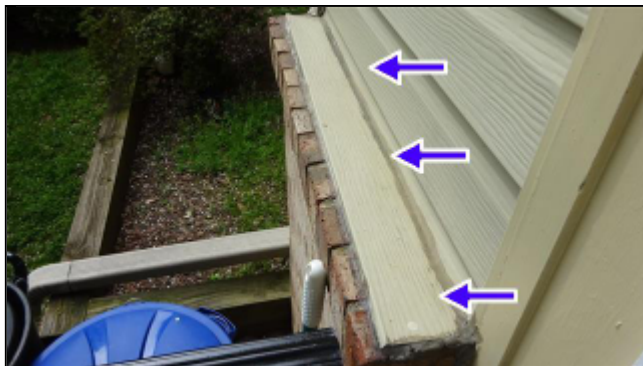
(2) Transition from aluminum siding to brick facade has negative grade, expect water to pool. Area has been heavily caulked from prior repairs. Recommend installing trim cap that slopes away from the home to allow water run off.

(2) Transition from aluminum siding to brick facade has negative grade, expect water to pool. Area has been heavily caulked from prior repairs. Recommend installing trim cap that slopes away from the home to allow water run off.

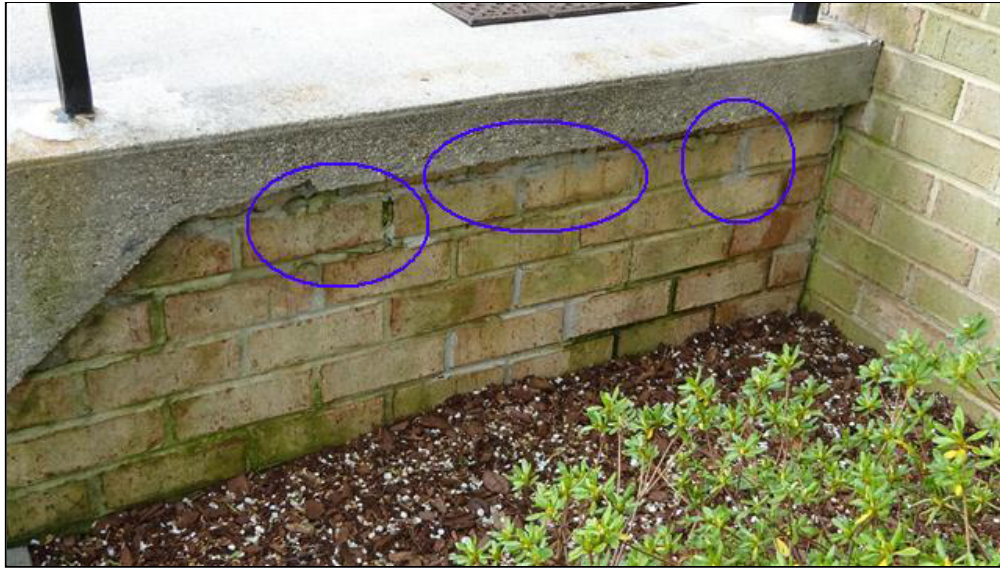
1.2 (Picture 1)

Areas of prior caulking repairs to mortar under front porch. Recommend professional tuck point repair as needed.

Areas of prior caulking repairs to mortar under front porch. Recommend professional tuck point repair as needed.

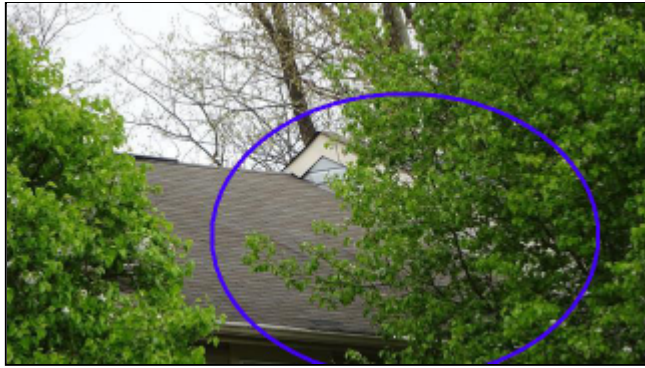
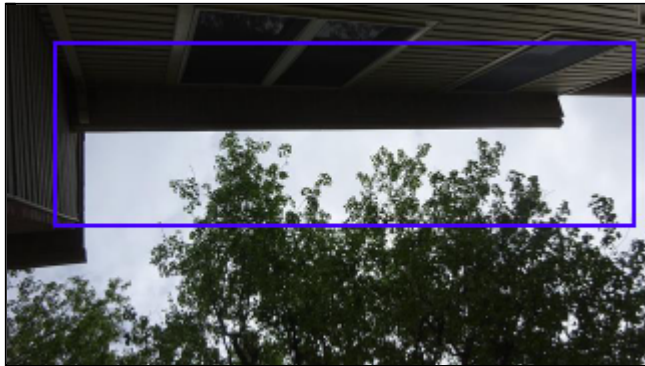
Overgrown vegetation in contact or growing over structure. Trim back all vegetation at least one foot from structure.

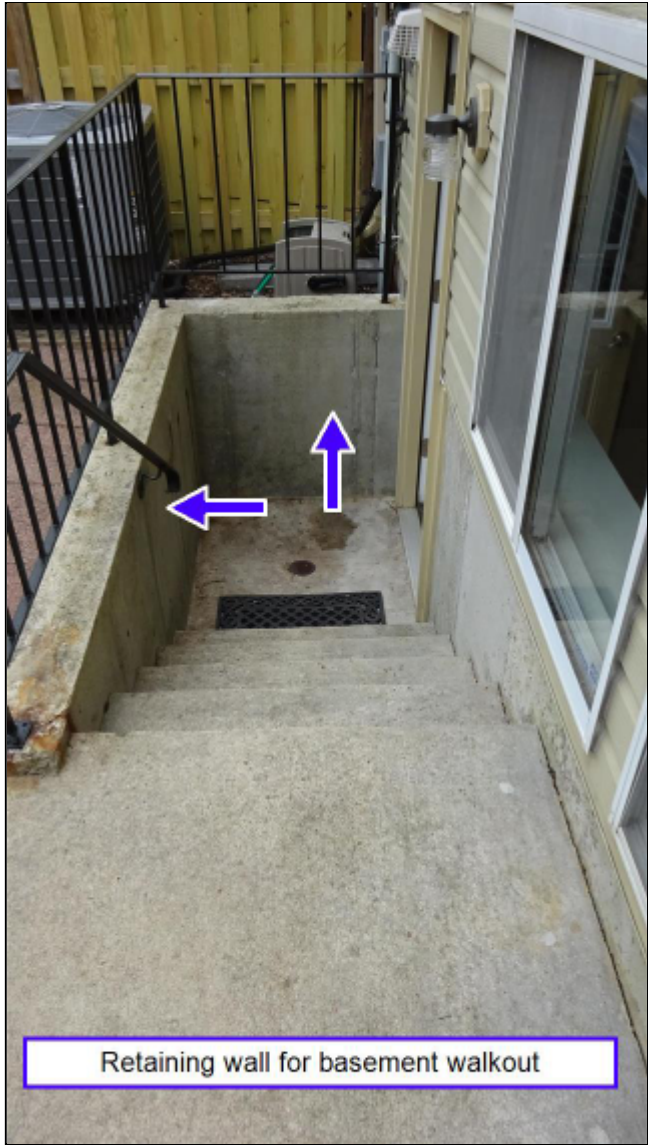
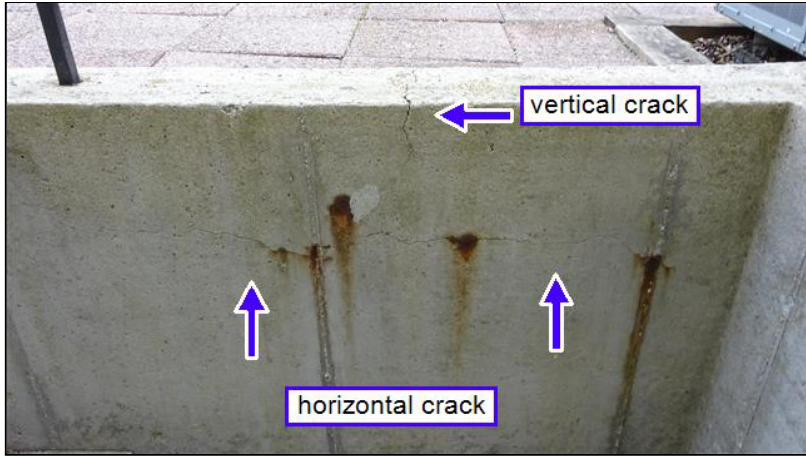
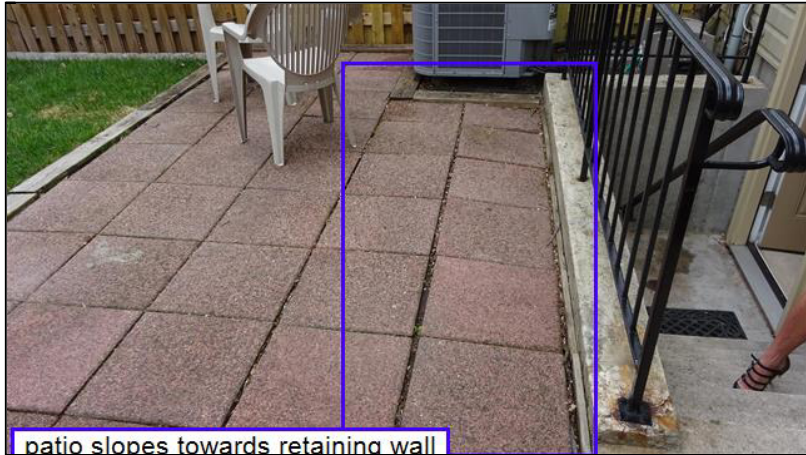
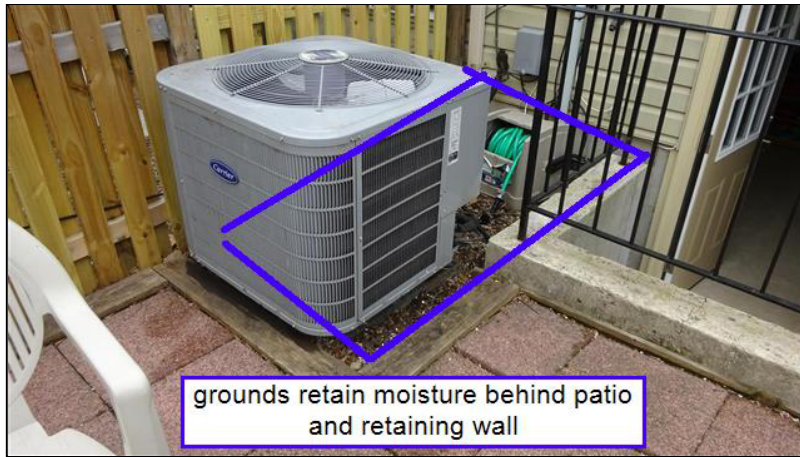
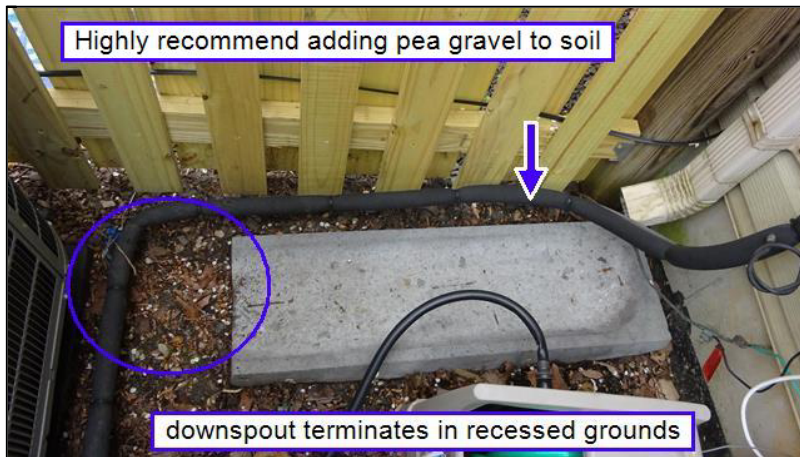
(1) Negative grading and poor drainage surrounding basement walkout retaining wall. Horizontal and vertical cracking on concrete retaining wall. Grading must be improved to prevent further structural damage. Repair existing cracks by a qualified contractor. Improve patio to encourage moisture to flow away from the retaining wall. Extend downspout beyond Heat pump condenser and add gravel to soil bed.

(1) Negative grading and poor drainage surrounding basement walkout retaining wall. Horizontal and vertical cracking on concrete retaining wall. Grading must be improved to prevent further structural damage. Repair existing cracks by a qualified contractor. Improve patio to encourage moisture to flow away from the retaining wall. Extend downspout beyond Heat pump condenser and add gravel to soil bed.

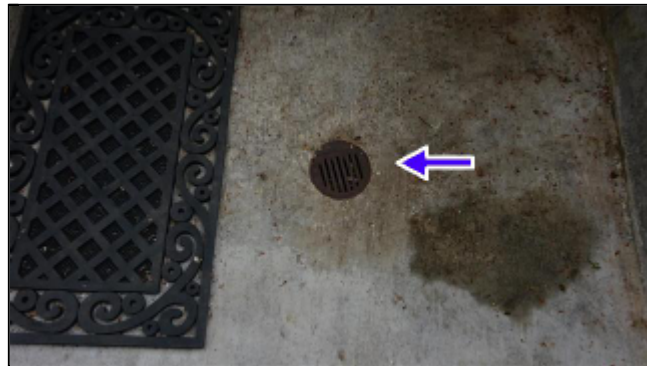
1.9 (Picture 6)

(2) FYI: Always keep this drain free of leaves and debris to prevent clogging.

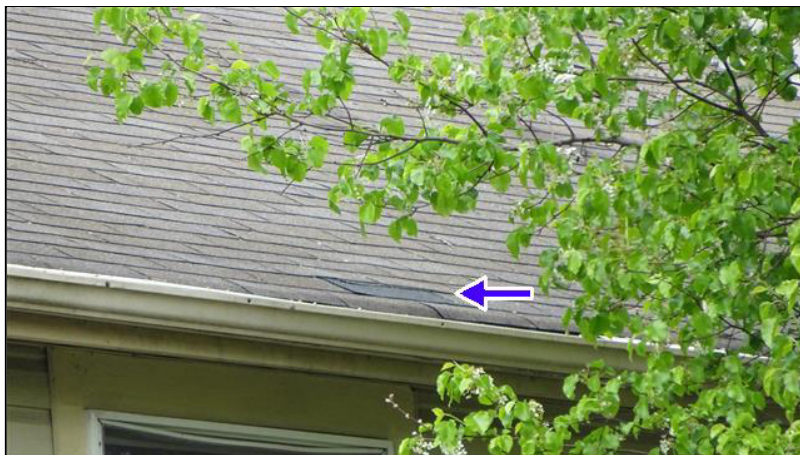
2.0 (Picture 1)

(1) Damaged/missing roofing tile.

(1) Damaged/missing roofing tile.

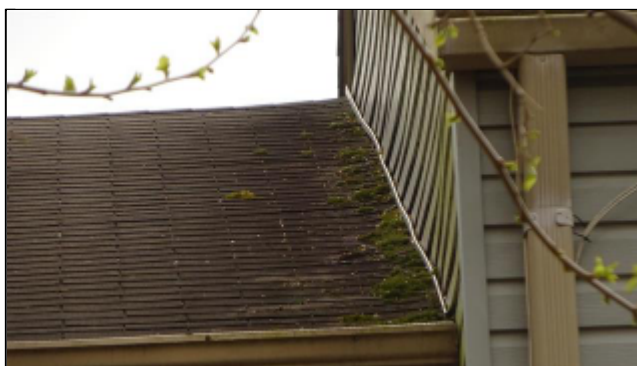
2.0 (Picture 2)

(2) Considerable amount of moss on the rear corner of roof. Moss can reduce the life span of the roof coverings and cause leaks in the attic. Recommend professional cleaning.

(2) Considerable amount of moss on the rear corner of roof. Moss can reduce the life span of the roof coverings and cause leaks in the attic. Recommend professional cleaning.

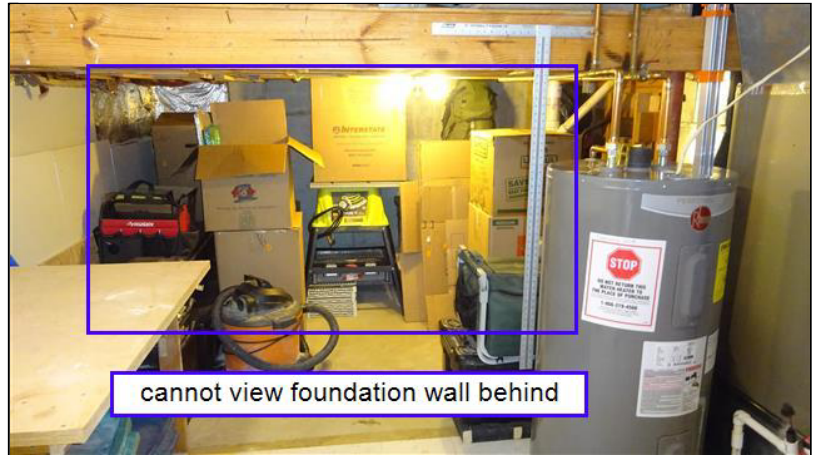
3.1 (Picture 1)

Inspected. Basement poured concrete foundation wall partially visible due to personal possessions.

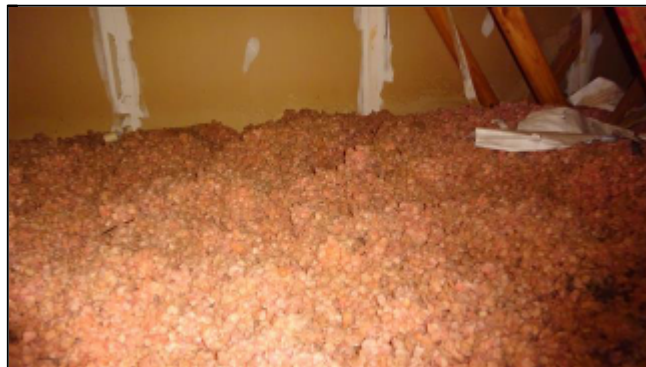
4.1 (Picture 1)

(1) Inspected. FYI Insulation is generally adequate.

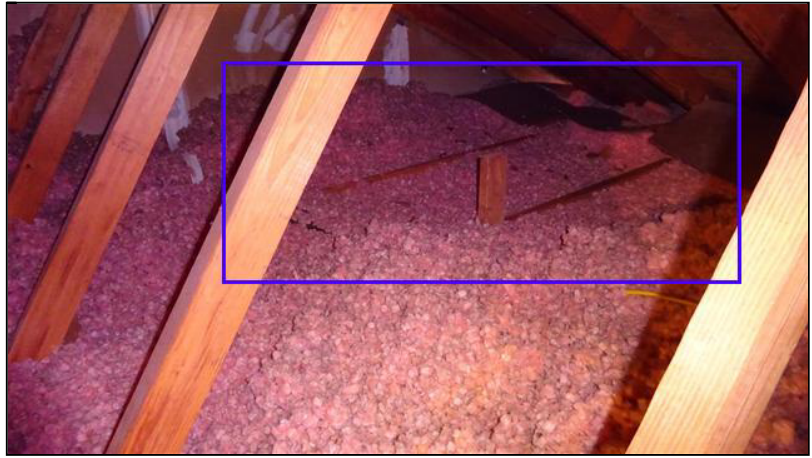
4.1 (Picture 2)

(2) Uneven areas of insulation in attic space. This will contribute to decreased energy efficiency.

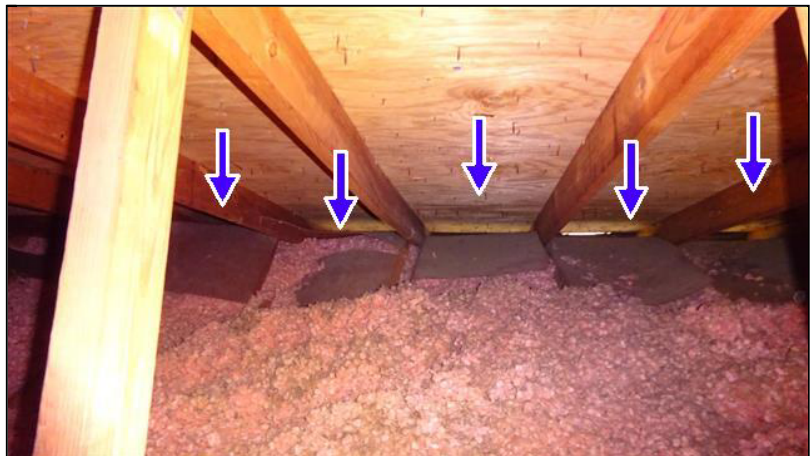
4.3 (Picture 1)

(1) Deteriorated baffles in the attic soffits. Replace.

- (1) Deteriorated baffles in the attic soffits. Replace.
- (2) Possible nest or vegetation in rear corner soffit. Appears inactive, recommend removal.

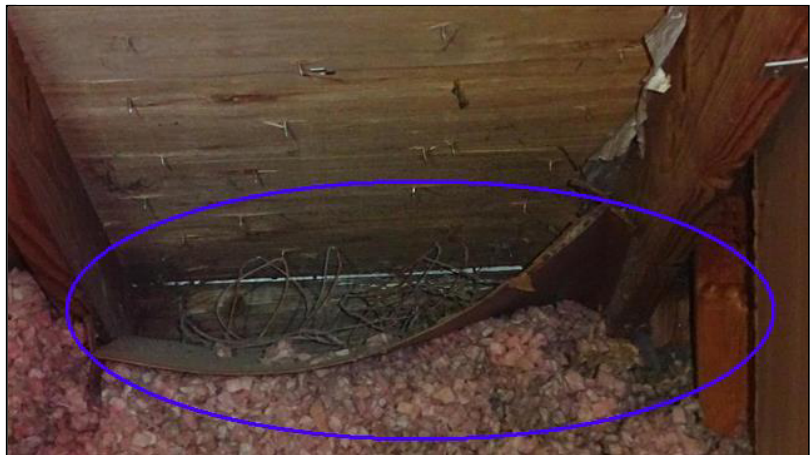
4.3 (Picture 2)

(2) Possible nest or vegetation in rear corner soffit. Appears inactive, recommend removal.

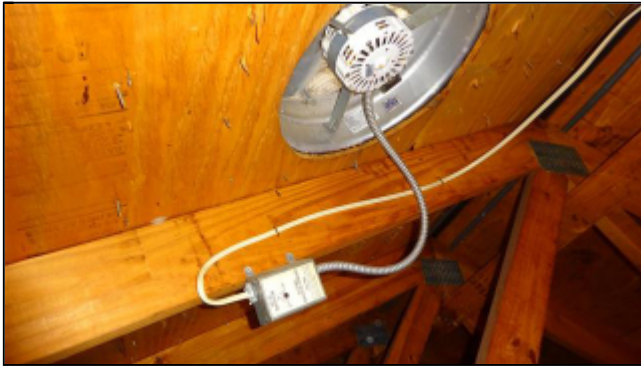
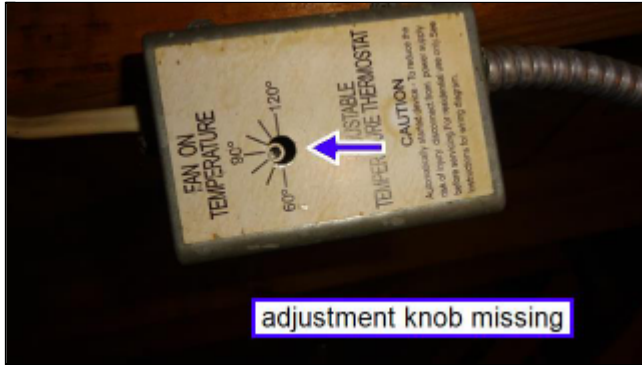
Attic power ventilator fan inoperable. Thermostat knob missing, could not be activated. Repair as needed.

Attic power ventilator fan inoperable. Thermostat knob missing, could not be activated. Repair as needed.

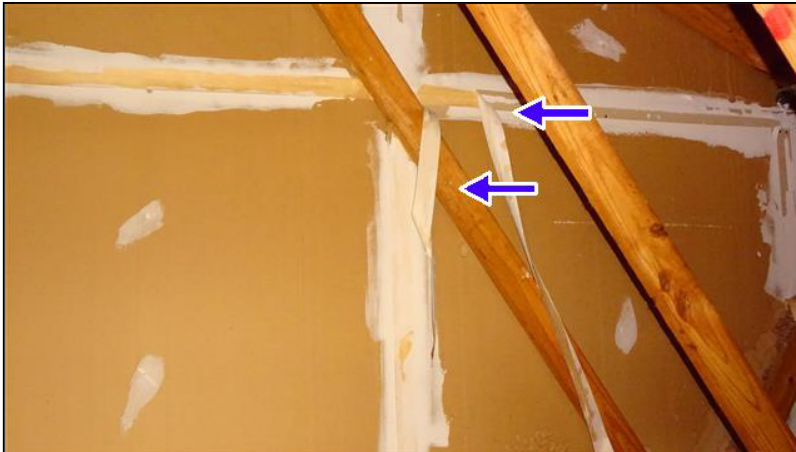
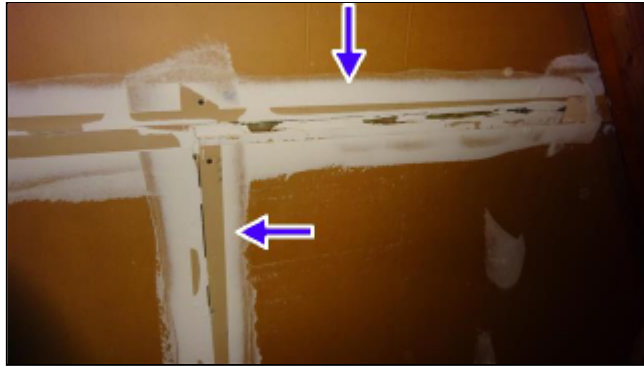
Firewall separation joints deteriorated. Repair all open joints to maintain firewall separation.

Firewall separation joints deteriorated. Repair all open joints to maintain firewall separation.

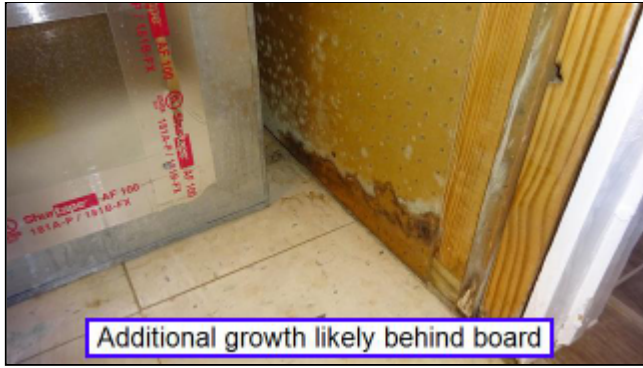
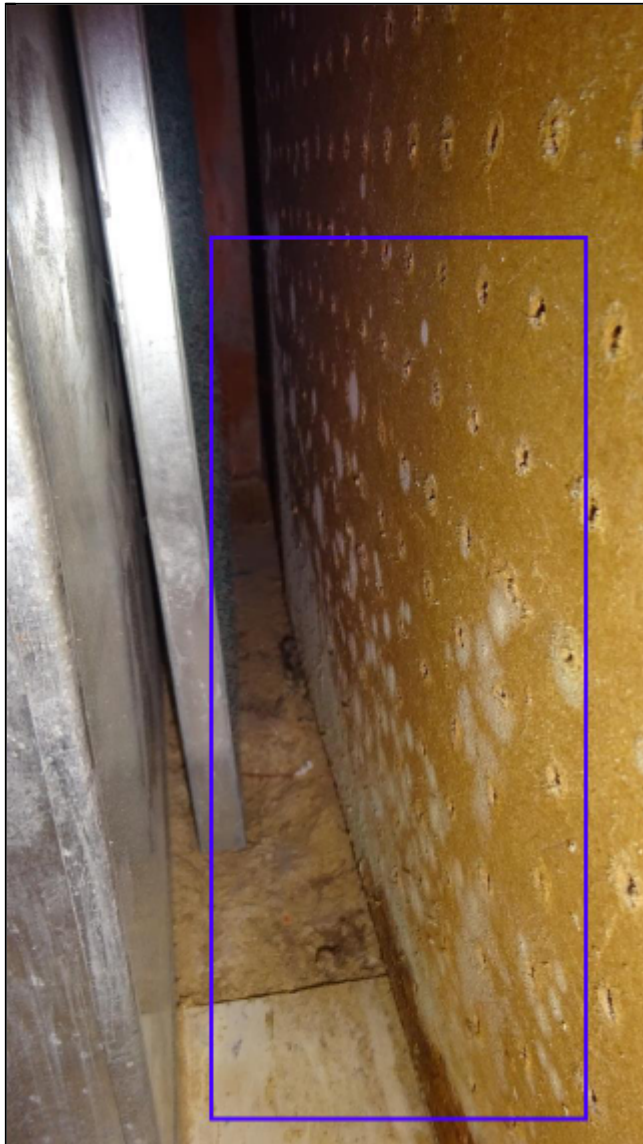
Fungal-like stains and moisture damage on peg board behind interior heat pump. Fungal-like stains adjacent to the HVAC. Have further evaluated/tested by a certified mold inspector. Correct any active sources of moisture and remediate as needed by a qualified specialist.

Fungal-like stains and moisture damage on peg board behind interior heat pump. Fungal-like stains adjacent to the HVAC. Have further evaluated/tested by a certified mold inspector. Correct any active sources of moisture and remediate as needed by a qualified specialist.

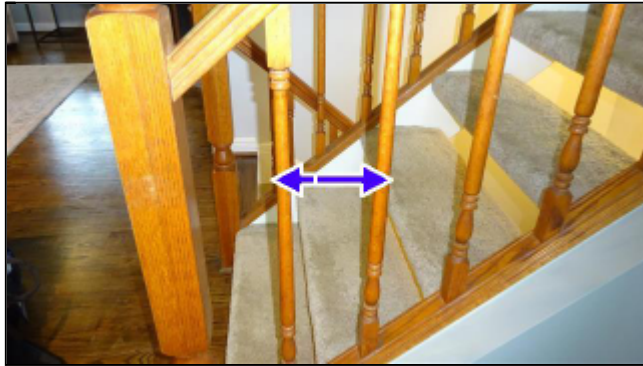
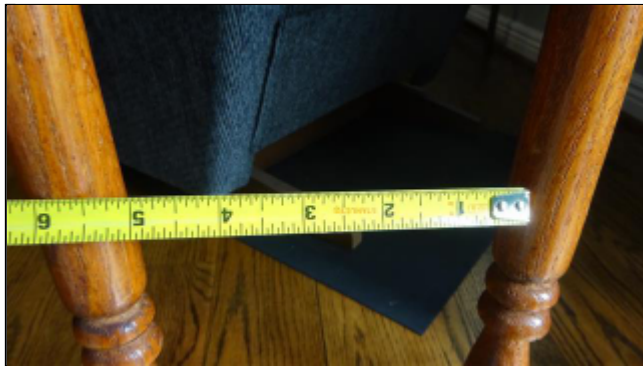
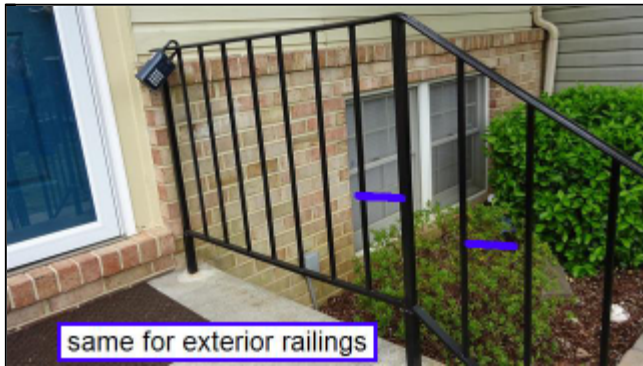
(1) Potential Safety concern: The opening between the stairwell Balusters (vertical posts comprising barrier in railings) is greater than 4" which can pose a threat to toddlers. Although wider spacing was adequate when home was built -- modern building safety standards is now a maximum of 4" between balusters. Consider installing appropriate safety guard as determined.

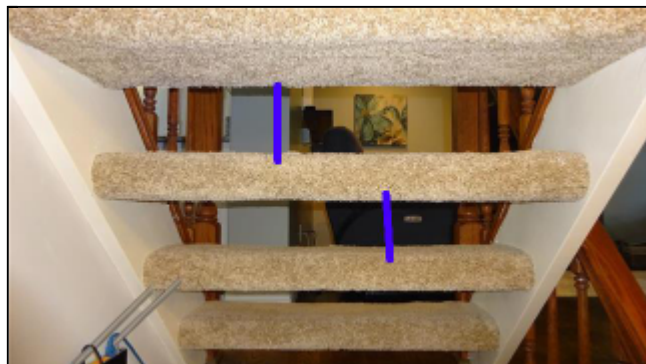
5.3 (Picture 4)

(2) Potential Safety Concern: Open risers on stairwell can present a safety concern to infants, children and small animals. Recommend closing risers.

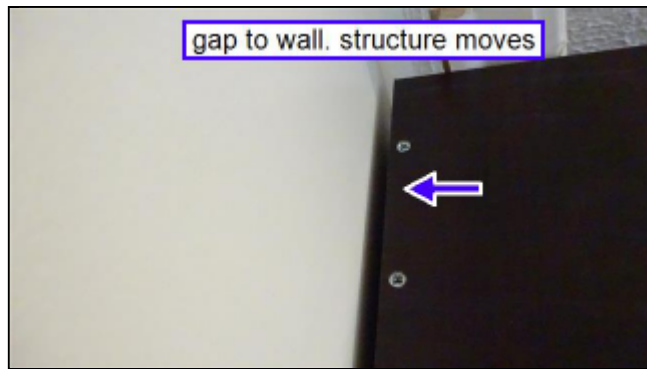
5.4 (Picture 1)

(1) Basement murphy bed is not fully secured to the wall. This could present a serious safety concern and must be corrected.

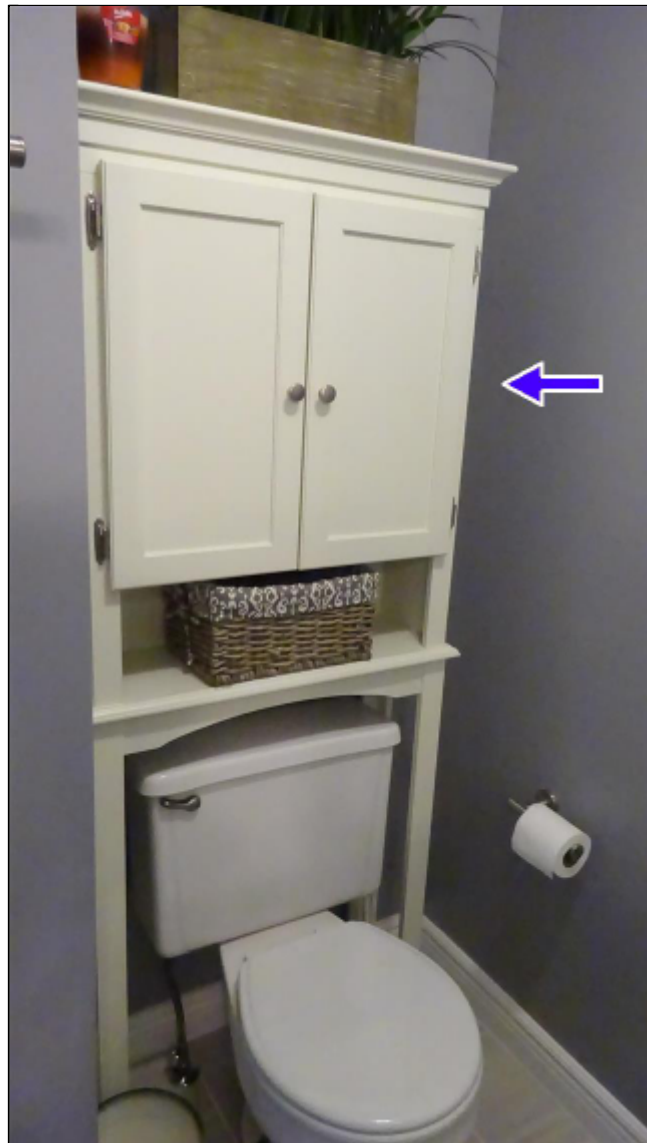
5.4 (Picture 2)

(2) Potential Safety Concern: Overhead toilet storage unit is not secure.

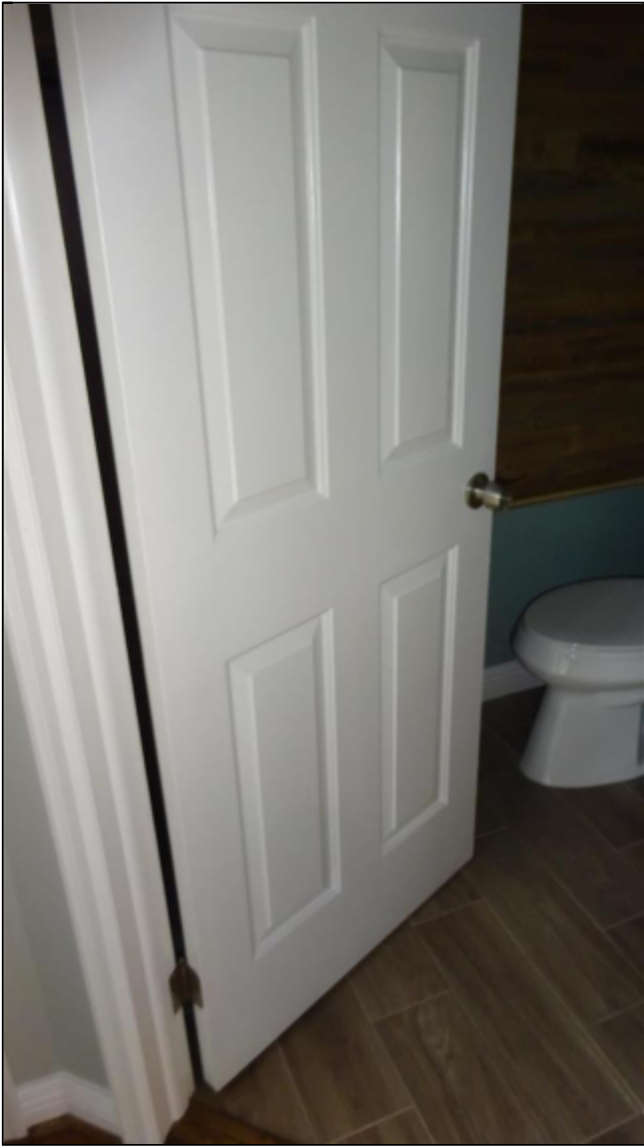
5.5 (Picture 1)

Main level powder room door is not level. Closes on its own.

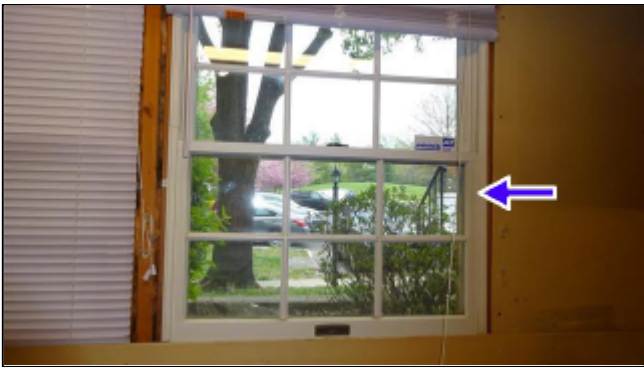
5.6 (Picture 1)

Unsafe: Basement furnace room window slams shut. Spring missing/broken.

Unsafe: Basement furnace room window slams shut. Spring missing/broken.

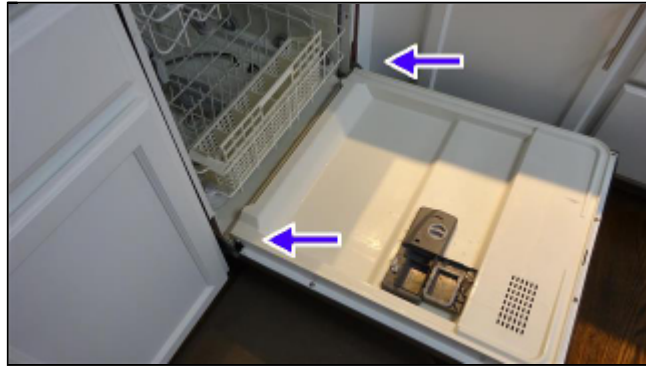
6.0 (Picture 1)

(1) Dishwasher door spring faulty.
Door falls open.

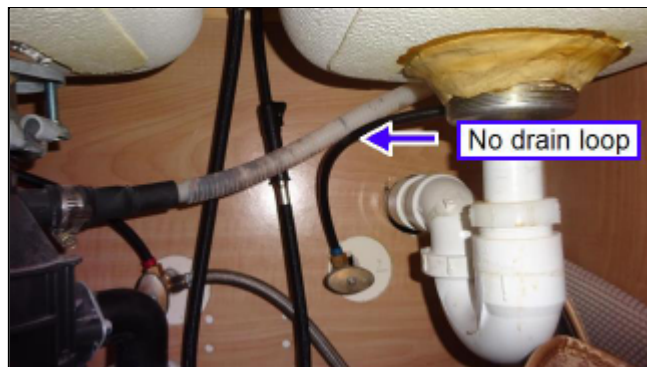
6.0 (Picture 2)

(2) The dishwasher drain line was not installed with an air gap or drain loop. This can allow the dishwasher to siphon dirty water back into the dishwasher.

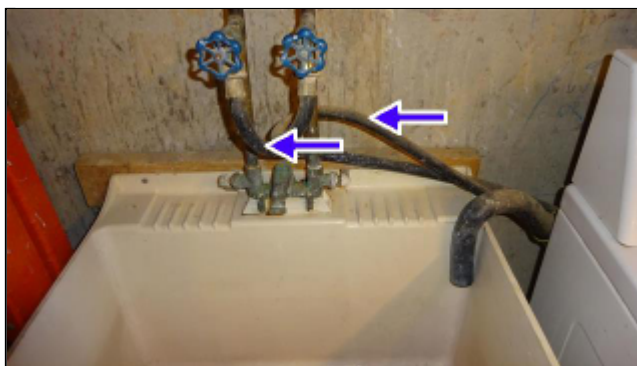
6.5 (Picture 1)

Highly recommend upgrading to the braided metal washing machine water supply hoses instead of the rubber ones--which are prone to burst.

- Highly recommend upgrading to the braided metal washing machine water supply hoses instead of the rubber ones--which are prone to burst.

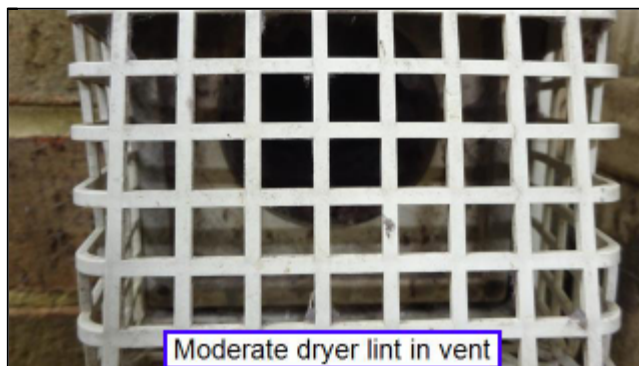
6.7 (Picture 1)

Moderate volume of lint in dryer vent and behind appliance. Have vent professional cleaned.

Moderate dryer lint in vent

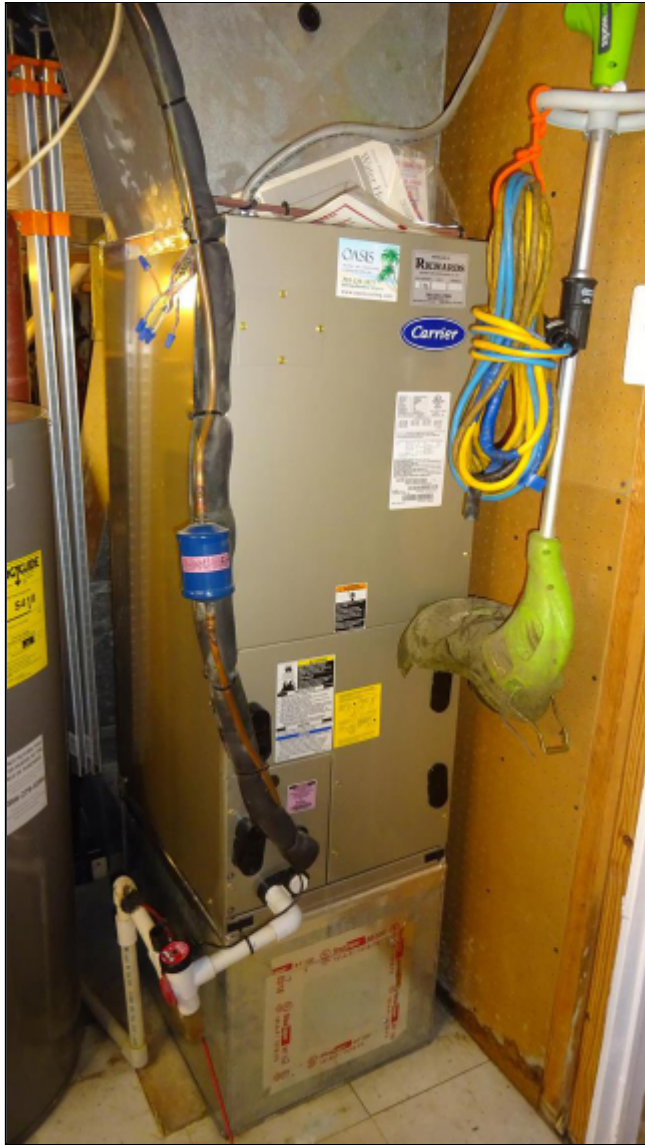
7.0 (Picture 1)

Inspected. Heat pump air handler Carrier 2013. Recommend yearly clean and service as maintenance.

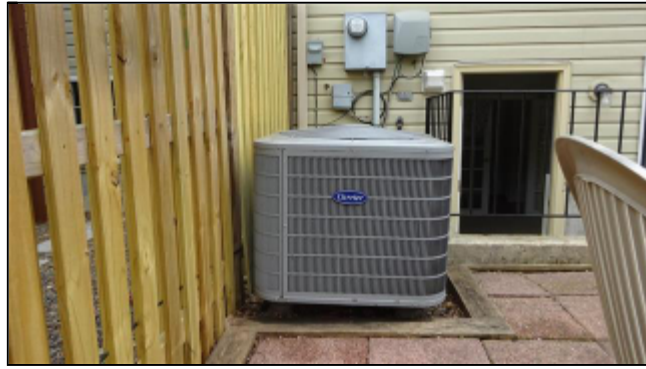
7.3 (Picture 1)

(1) The exterior heat pump compressor is not level. This can affect system performance and shorten service life. Level unit/pad and or ground underneath.

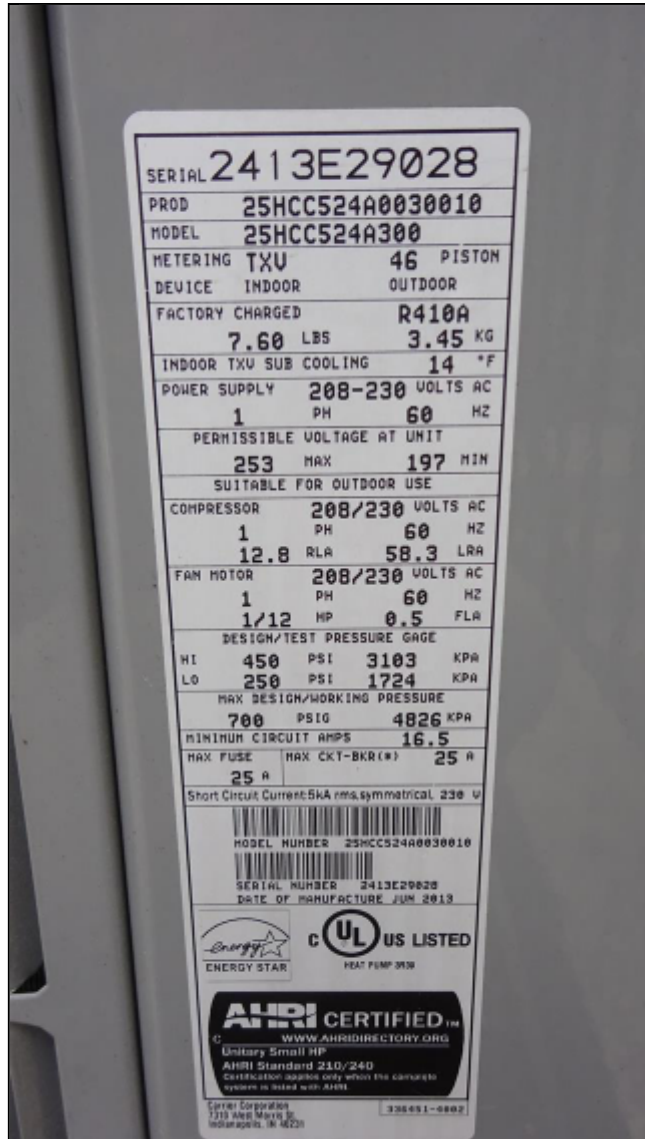
7.3 (Picture 2)

(2) Heat pump compressor data tag.
2013 Carrier

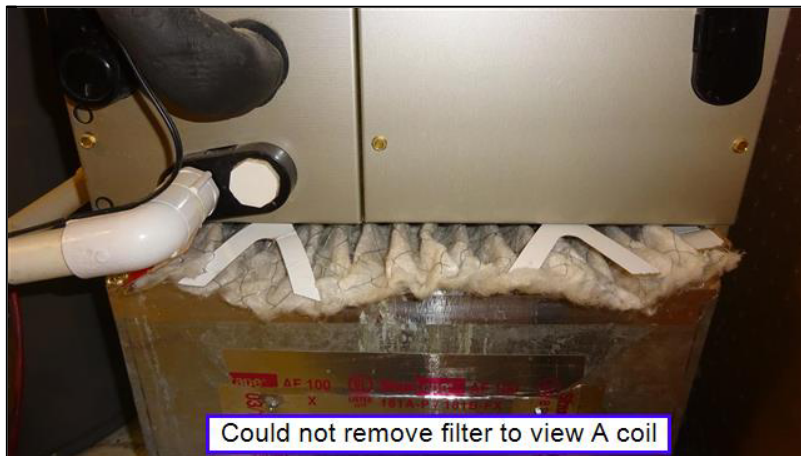
7.5 (Picture 1)

The heat pump filter is damaged and stuck inside the air handler.

- The heat pump filter is damaged and stuck inside the air handler.

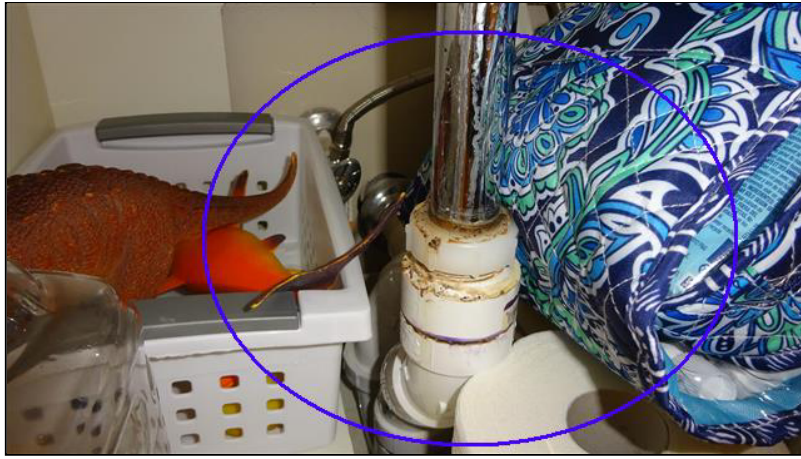
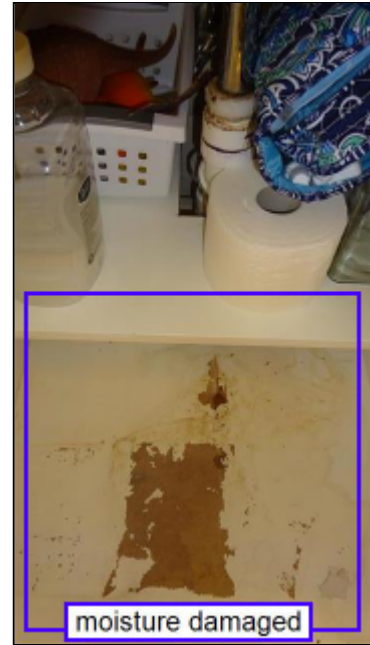
(1) Active drain leak and damage to the vanity drawer in upstairs hall bathroom. Drawer under drain also obstructed by drain preventing proper closure.

(1) Active drain leak and damage to the vanity drawer in upstairs hall bathroom. Drawer under drain also obstructed by drain preventing proper closure.

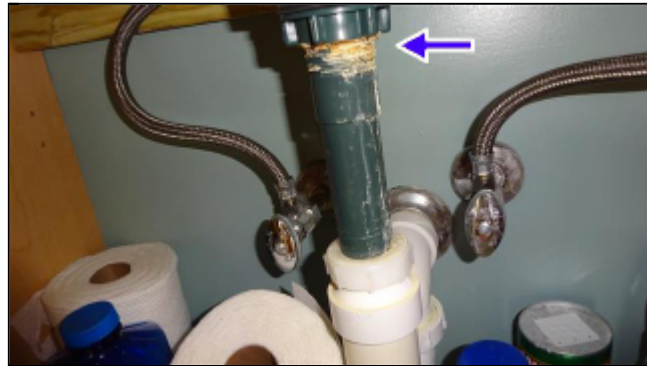
8.0 (Picture 3)

(2) Main level powder room drain has leaked. No current leak.

(2) Main level powder room drain has leaked. No current leak.

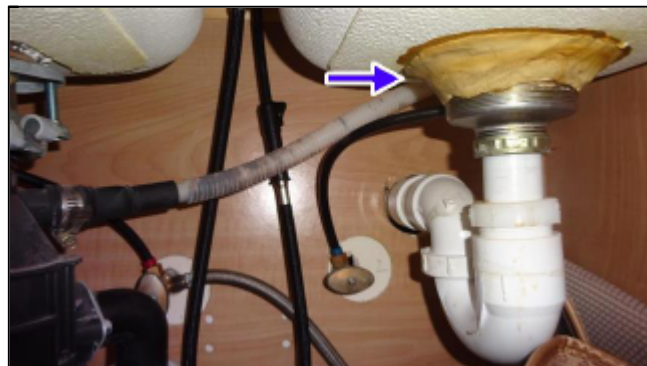
8.0 (Picture 4)

(3) Heavy amount of plumbers putty applied to kitchen sink drain. This usually indicates there has been a leak. No visible current leak.

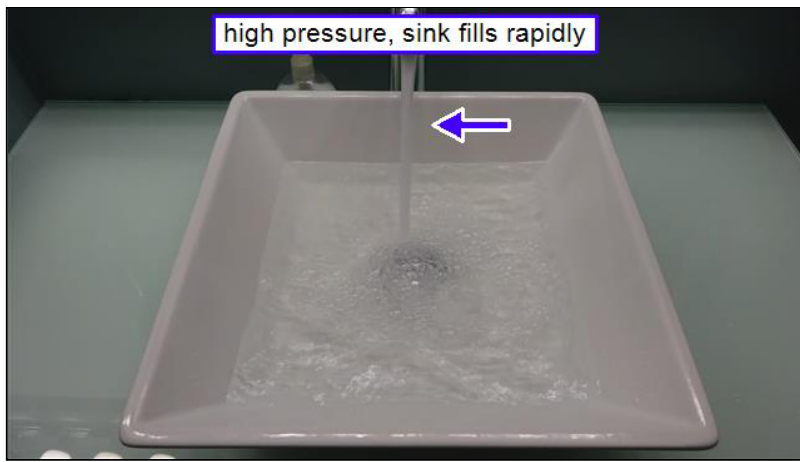
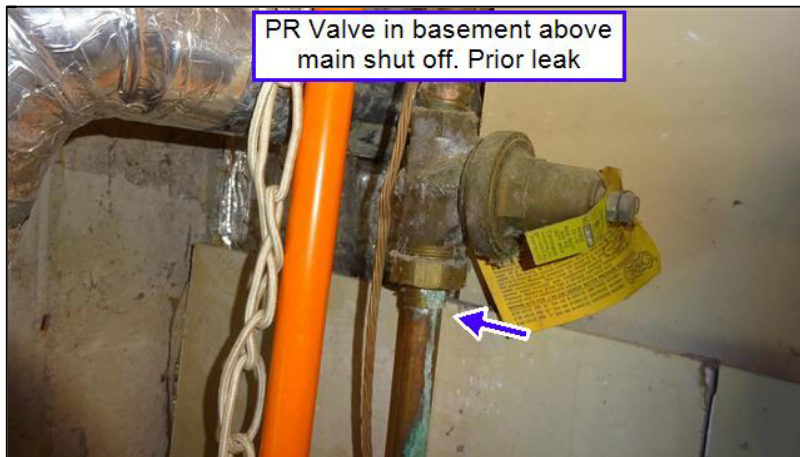
(1) Water pressure was generally high. The plumbing system may be prone to leaks in piping, fittings are other components. Recommend having a plumber measure the PSI and adjust the pressure regulator to reduce the pressure to under 80PSI. Note: Prior leak visible under the pressure regulator valve - have evaluated for replacement by plumber.

- (1) Water pressure was generally high. The plumbing system may be prone to leaks in piping, fittings are other components. Recommend having a plumber measure the PSI and adjust the pressure regulator to reduce the pressure to under 80PSI. Note: Prior leak visible under the pressure regulator valve - have evaluated for replacement by plumber.

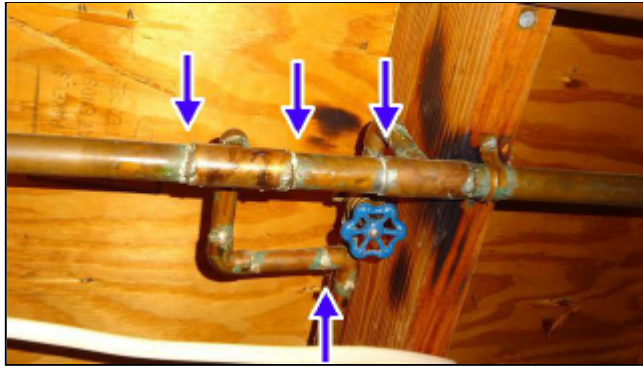
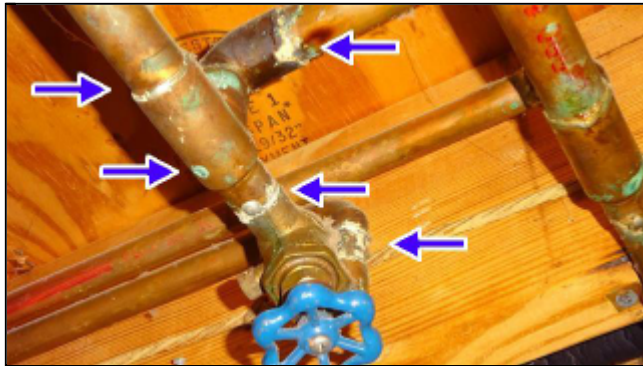
(2) Efflorescence observed on pipe joints in the furnace room ceiling suggests prior pin hole leaks. There were no visible active leaks in the copper branch piping at the time of inspection. Monitor for leakage or preemptively repair.

- (3) Efflorescence observed on pipe joints in the furnace room ceiling suggests prior pin hole leaks. There were no visible active leaks in the copper branch piping at the time of inspection. Monitor for leakage or preemptively repair.

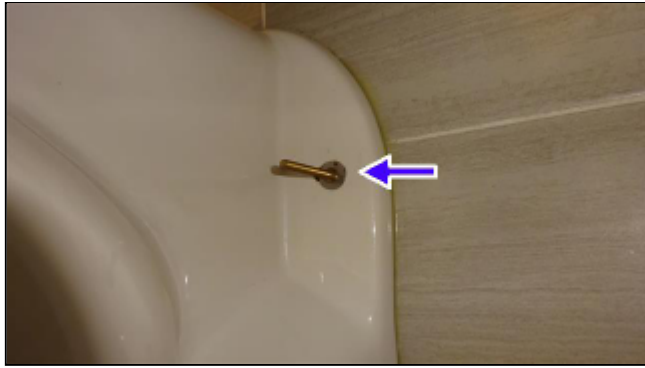
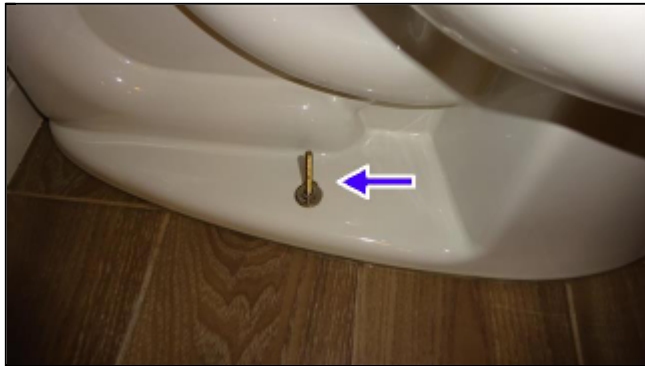
Toilet basin screws too long. Have cut to proper length by a plumber.

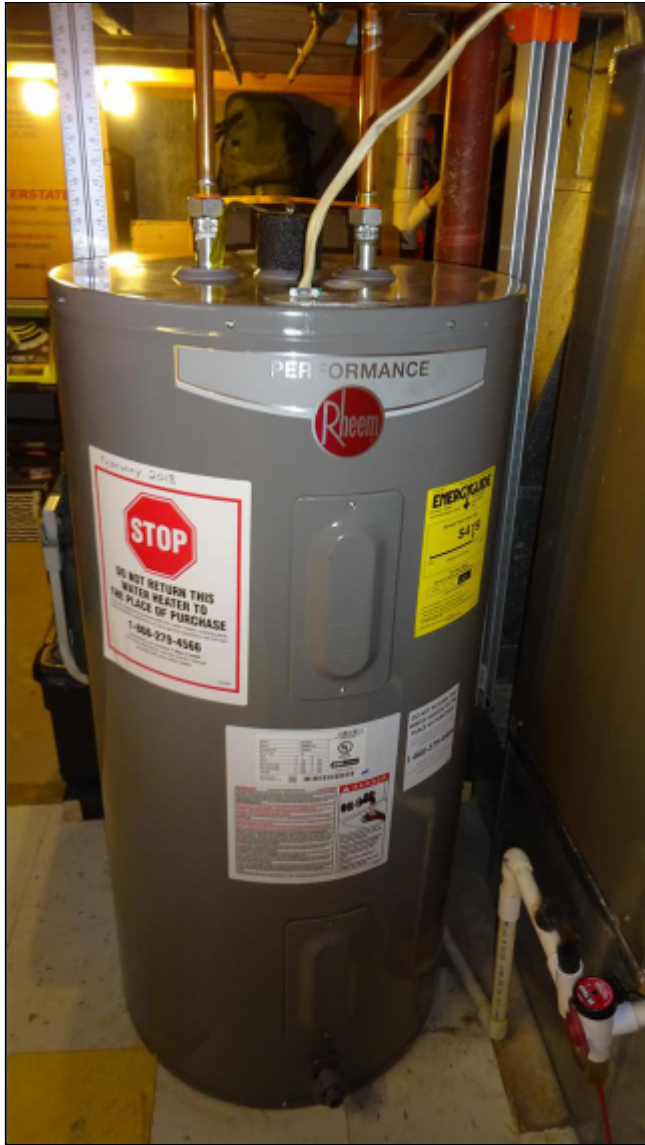
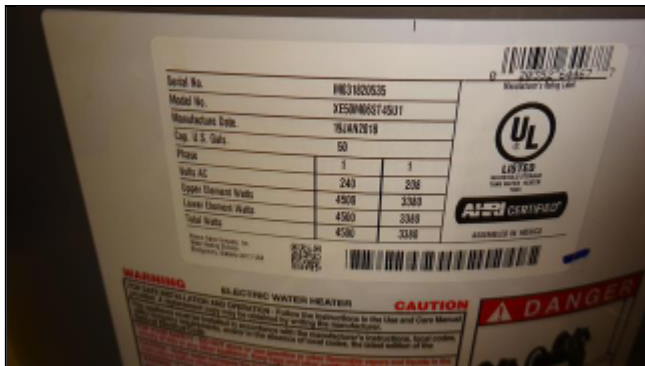
Inspected. Rheem hot water heater 2018

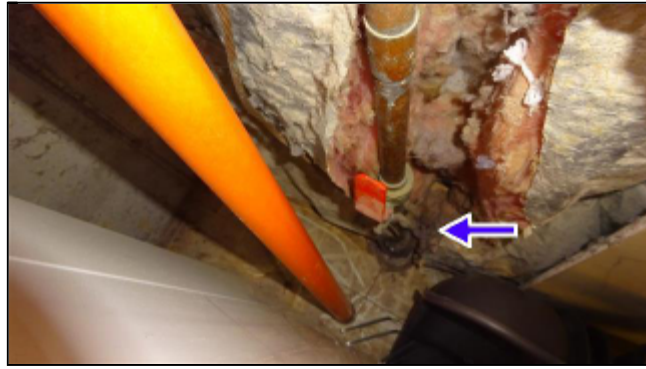
8.5 (Picture 1)

Inspected. Main shut off on front wall of furnace room to the side of the clothes dryer.

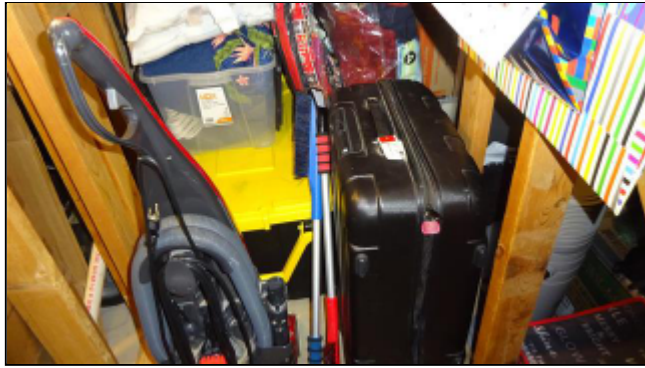
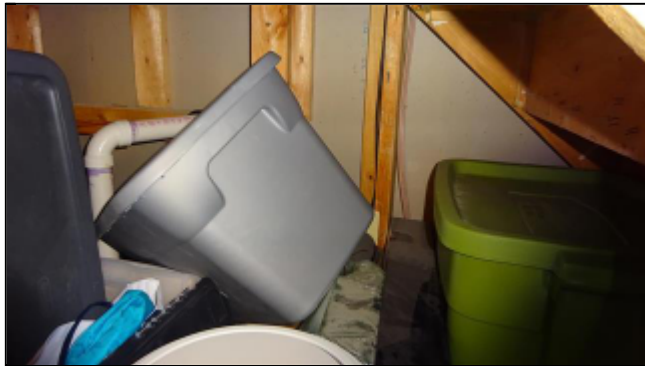
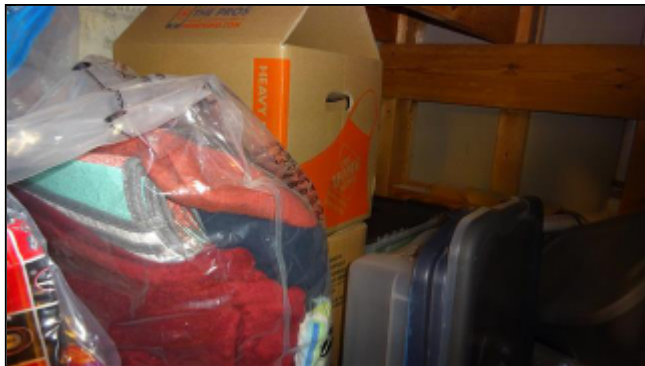
None visible. Furnace room and under stair storage occupied with heavy storage of personal items. Partial visibility.
