Inspection Report

Property Address:
6013 Somewhere Ln

Date: 4/12/2019	Time: 11:00 AM	Report ID: 6013Somewhere
Property: 6013 Somewhere Ln	Customer:	Real Estate Professional:

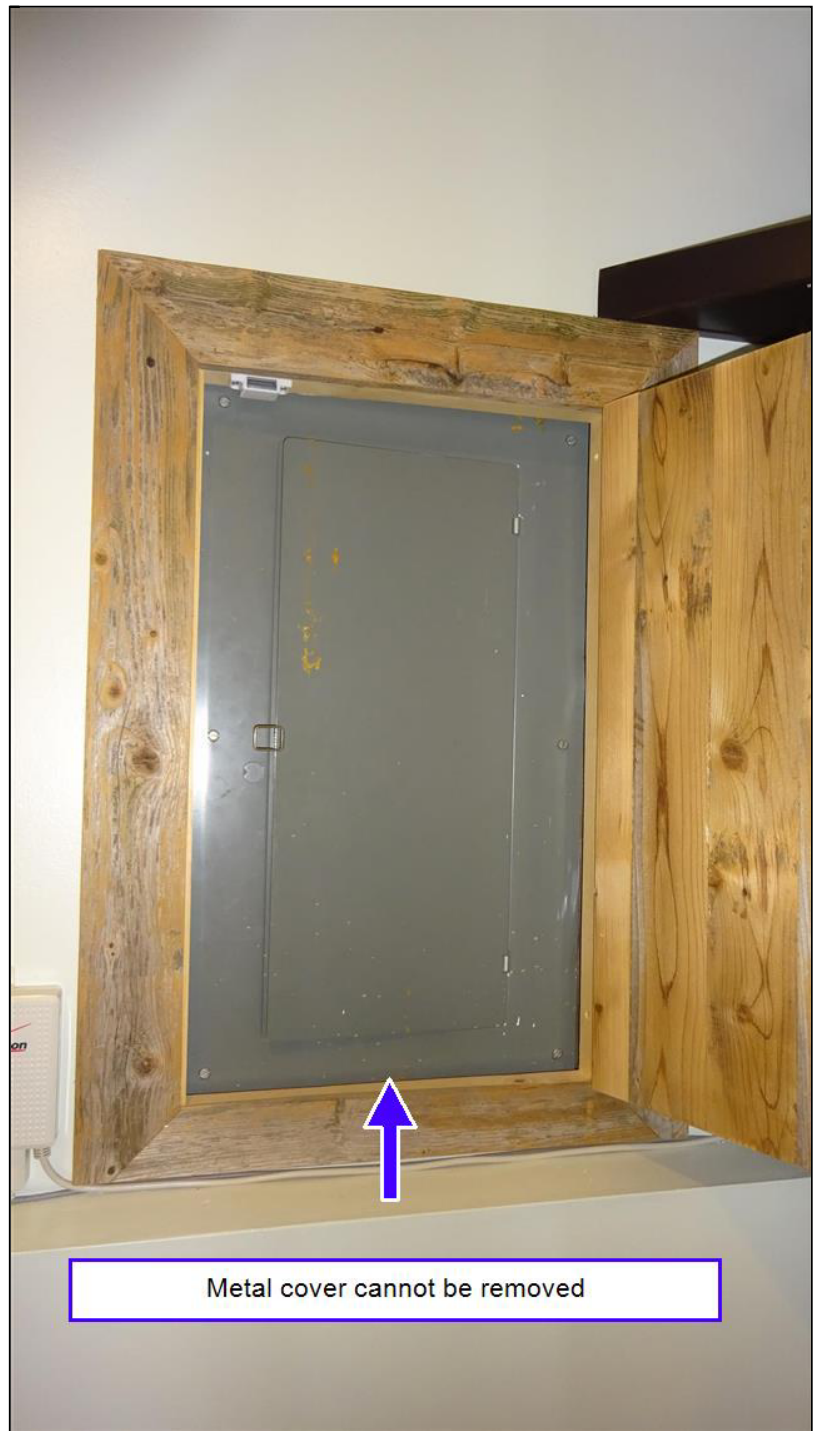
9.1 (Picture 1)

The main panel cover could not be removed. All components associated with main panel could not be inspected. Framed decorative wood door over the electrical panel is smaller dimension than the electrical panel and cover. Frame of wood decorative door will need to be fully removed in order to access electrical panel wiring behind the cover. Remove decorative door for panel inspection and re install decorative door as needed to allow full access to panel.

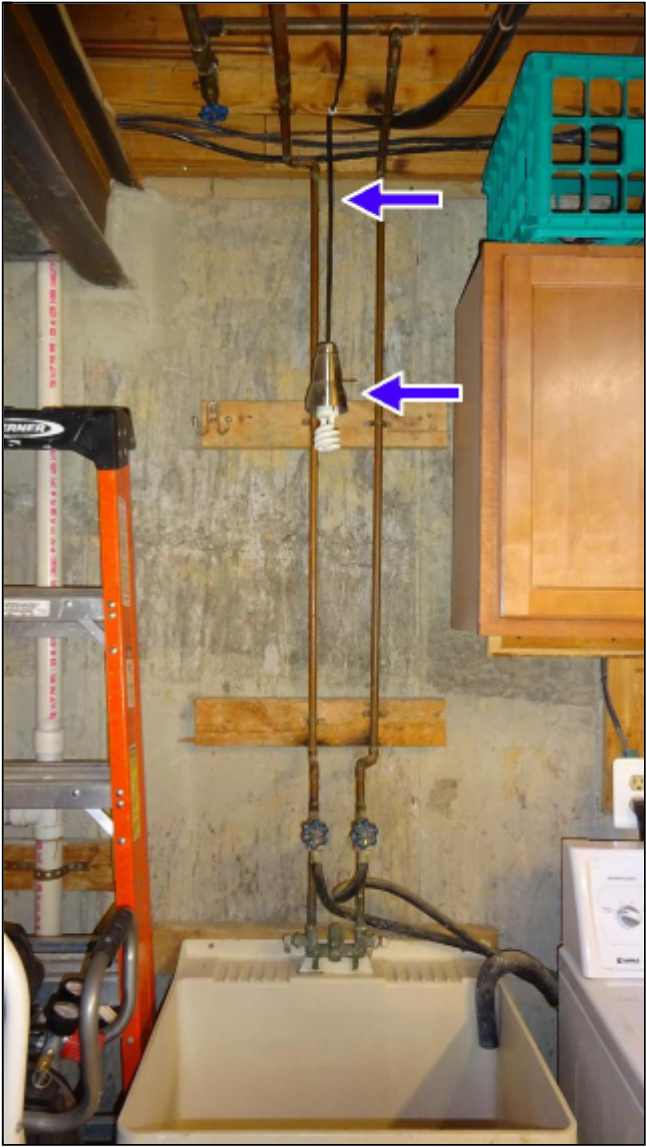
9.5 (Picture 1)

Unsafe: Fixture above utility sink is installed with ungrounded handyman extension wiring and is not a fixture suitable for wet locations. Replace fixture and wiring by a licensed electrician.

Unsafe: Fixture above utility sink is installed with ungrounded handyman extension wiring and is not a fixture suitable for wet locations. Replace fixture and wiring by a licensed electrician.

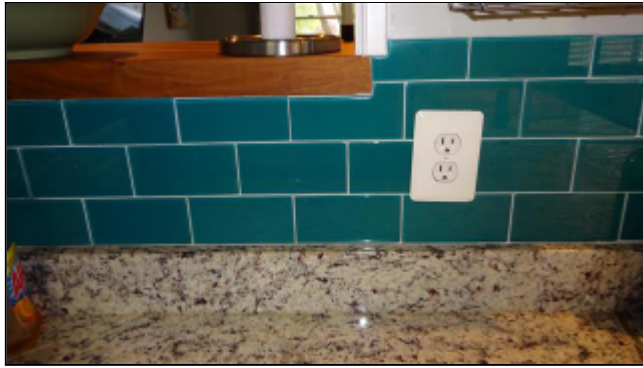
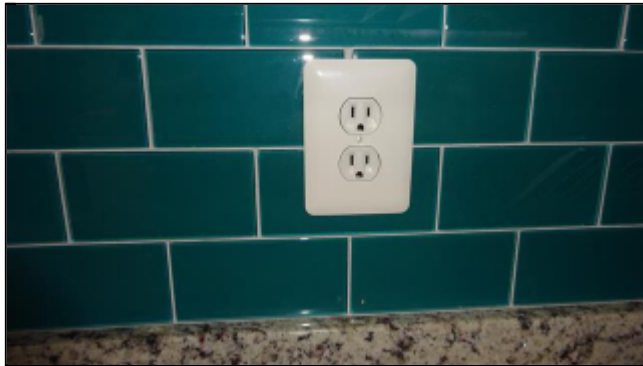
Unsafe: There is no GFCI protection for the kitchen outlets. Outlets are newly installed and not GFCI protected which suggests less than professional installation. Have licensed electrician install as needed.

Unsafe: There is no GFCI protection for the kitchen outlets. Outlets are newly installed and not GFCI protected which suggests less than professional installation. Have licensed electrician install as needed.

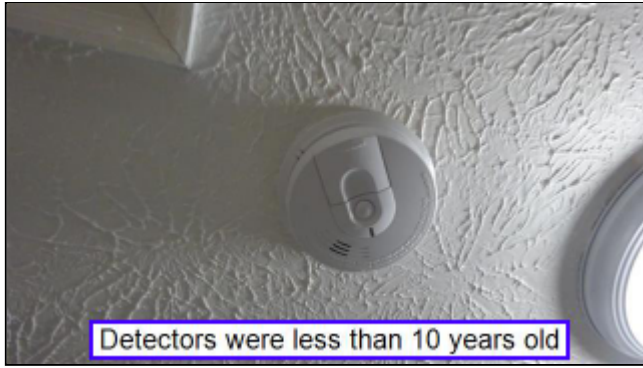
9.9 (Picture 1)

Present. Replace all smoke alarms when they are 10 years old. Current residential fire safety requires smoke alarms on every level in the home including basements; AND inside every bedroom. Also, all smoke alarms should be interconnected, so activation of ONE alarm sets off ALL other alarms. Power should be supplied from the house electrical wiring as well as a battery backup. Smoke alarms should NOT be installed in the kitchen to prevent false alarms--keep at least 10 feet from a cooking appliance. IONIZATION type smoke alarm is generally more responsive to flaming fires. PHOTOELECTRIC smoke alarm is more responsive to slow smoldering fires. For the best protection, I recommend the Photoelectric alarm OR the combination-type (also known as dual sensor alarms). Testing of smoke detectors is not included in this inspection. Pushing the "Test" button only verifies that there is power at the detector--either a battery or hard wired to the house power--and not the operational workings of the detector. The operational check is done by filling the sensor with smoke and or subjecting the detector to flame/heat and is beyond the scope of this inspection. Battery operated smoke alarms should be checked routinely and the batteries changed frequently.

Detectors were less than 10 years old

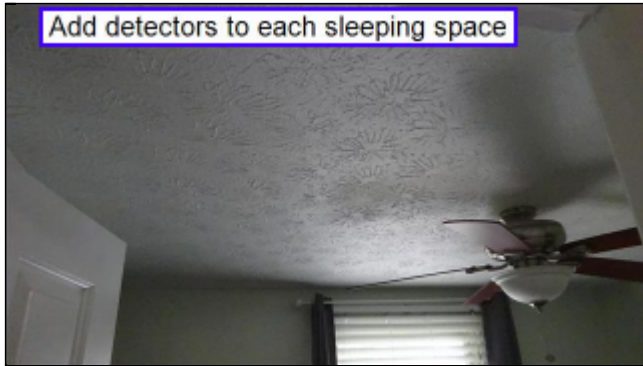
9.9 (Picture 2)

Add detectors to each sleeping space
