**Inspection Report**

**HomeBuyers Inspection**

33977 Stara Lane, Hendersonville, NC

3/30/2012

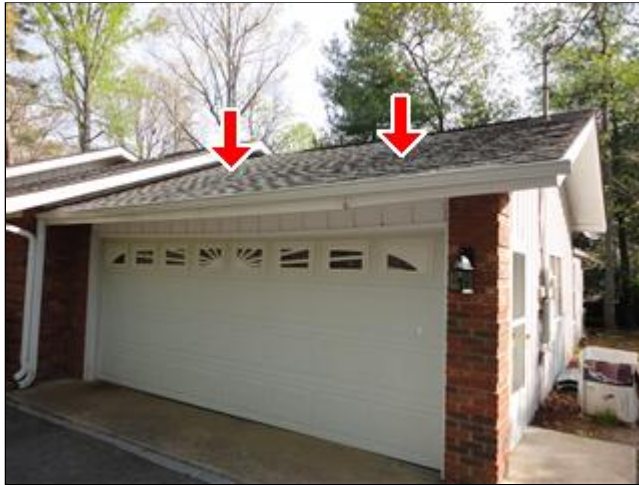
1.0 Picture 1

- 🔍 (1) Evidence of a leak in the Den below corresponds with the middle skylight roof and flashing area. Repairs are needed. Recommend a qualified contractor inspect further and repair as needed.
- 🔍 (2) The roof covering was installed improperly above garage. Roof sheathing needs to be replaced in this area. This will involve some shingle replacement. A qualified contractor should inspect and repair as needed.

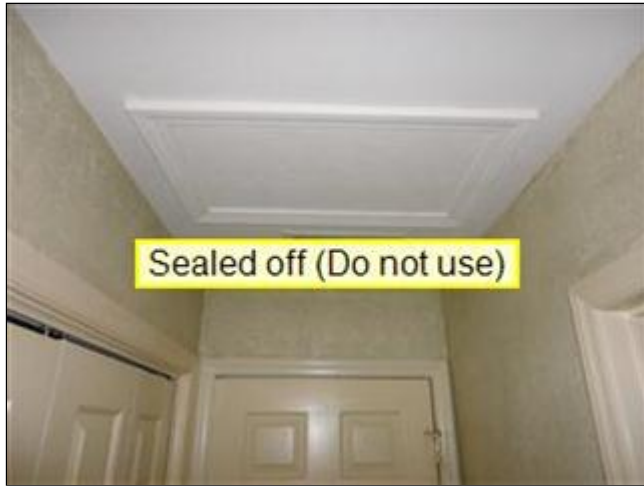
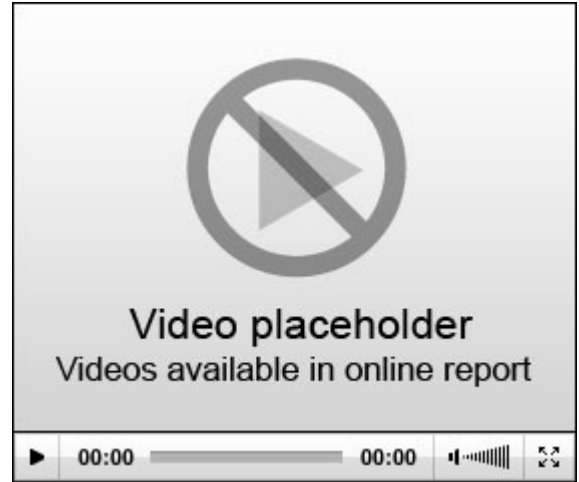
No longer an attic access. Use the pull down stairs at garage.

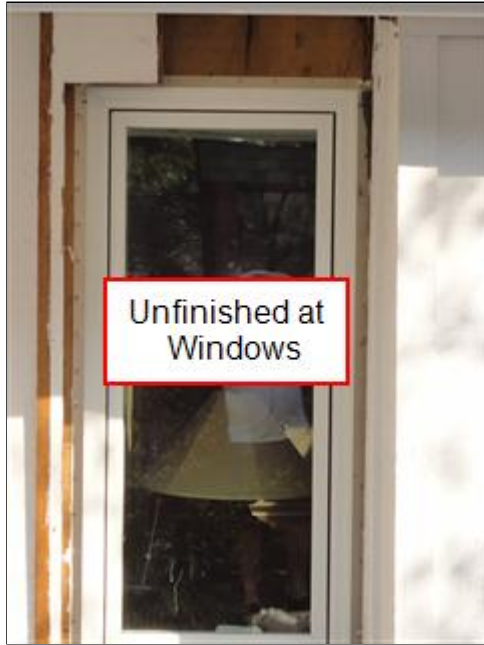
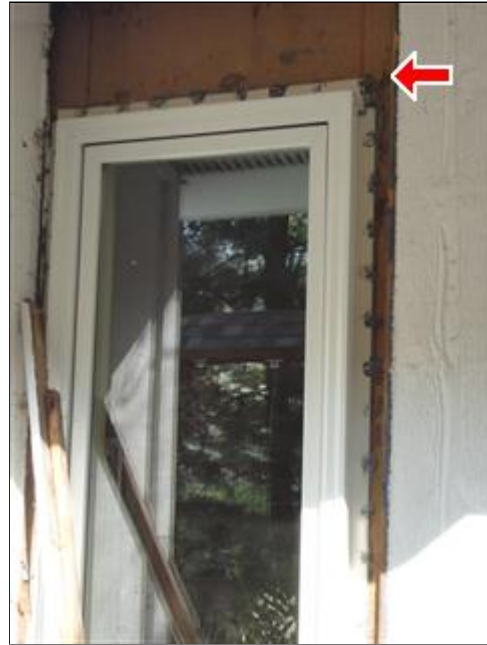
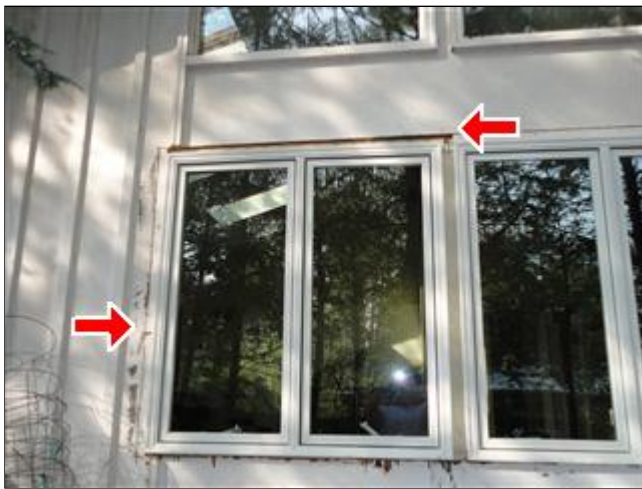
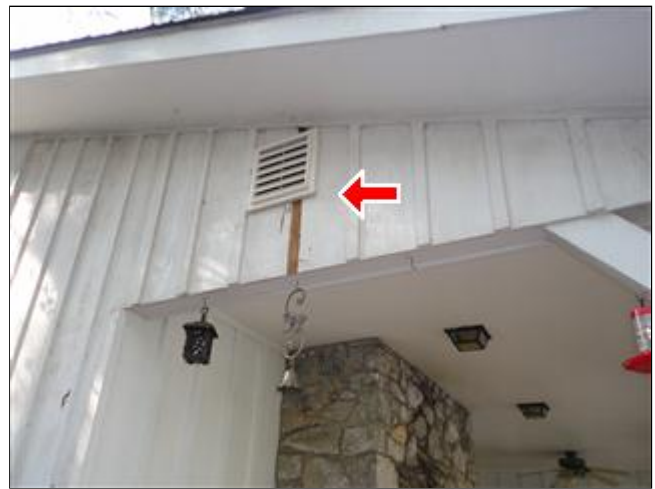
🔍 The Wood siding at the right side (facing front) and rear of home is missing or incomplete at time of inspection around new premium windows that have recently been installed. I did not inspect the installation of siding at this location. A qualified contractor should inspect and repair as needed. The siding will need prep and paint.

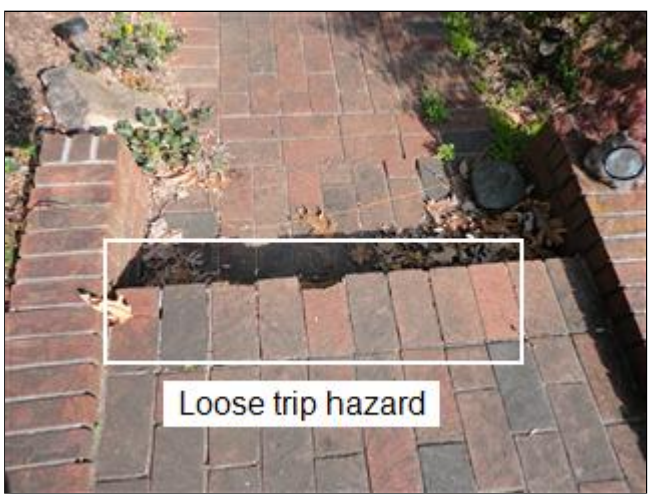
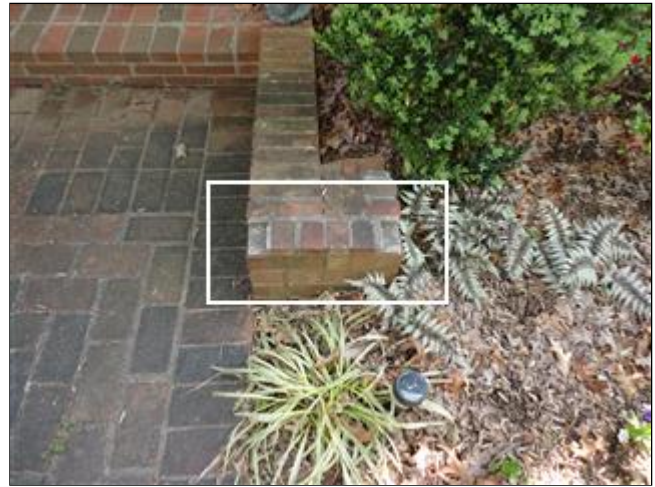
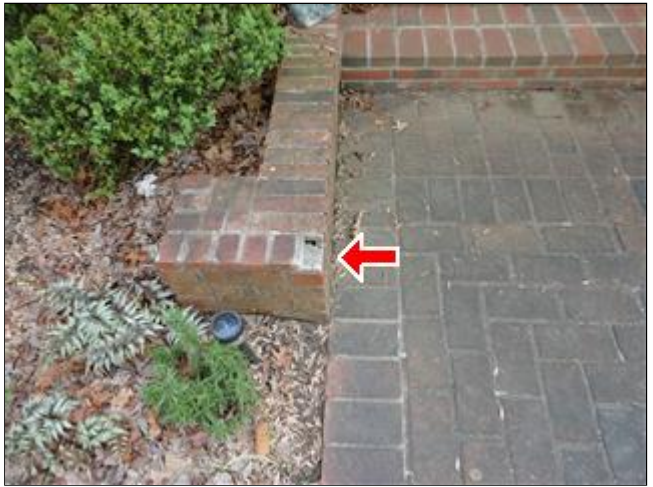
🔍 (2) The brick walkway at the front of home are deteriorated in areas. A general replacement is likely. A qualified contractor should inspect and repair as needed.

2.4 Picture 2 Water signs at front step

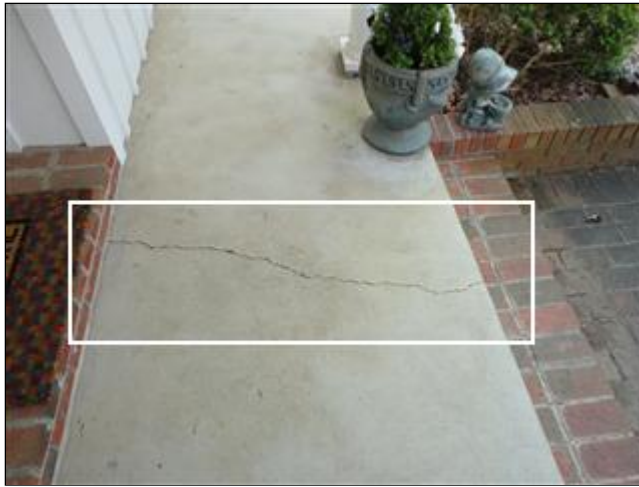
2.4 Picture 6

(3) Concrete is cracked at front entrance of home. Appears to only affect the slab itself and is more cosmetic.

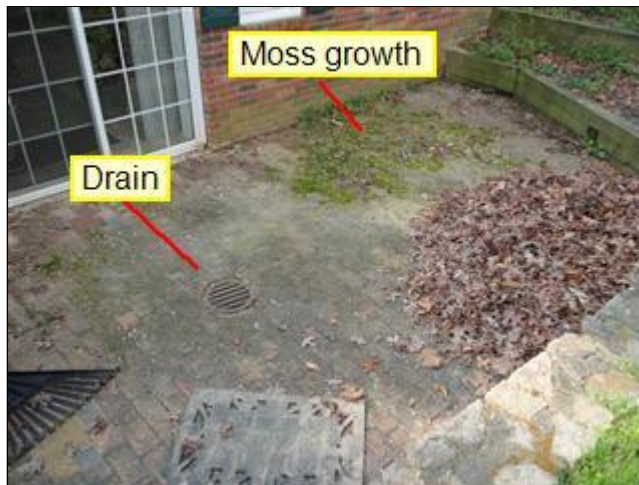
2.4 Picture 7

(4) The brick floor on the patio at the left side (facing front) has deteriorated mortar or grout, and is loose and uneven in areas. Water can cause further deterioration if not repaired and sealed properly. A qualified contractor should inspect and repair as needed.

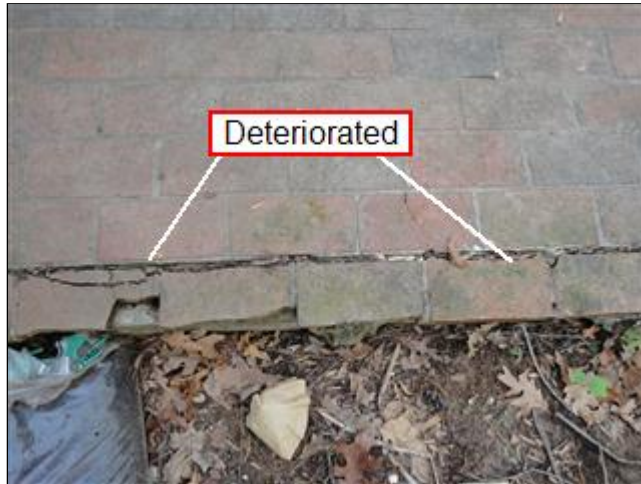
2.4 Picture 8

- 🔍 (5) The brick floor on the patio at the rear of home is old and deteriorated. A general replacement is likely. A qualified contractor should inspect and repair as needed.

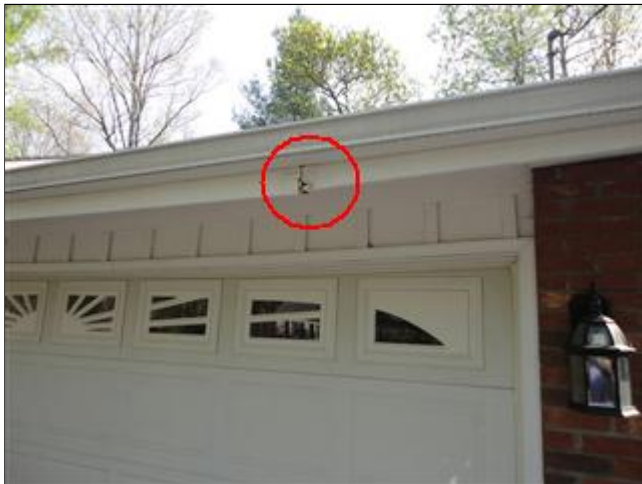
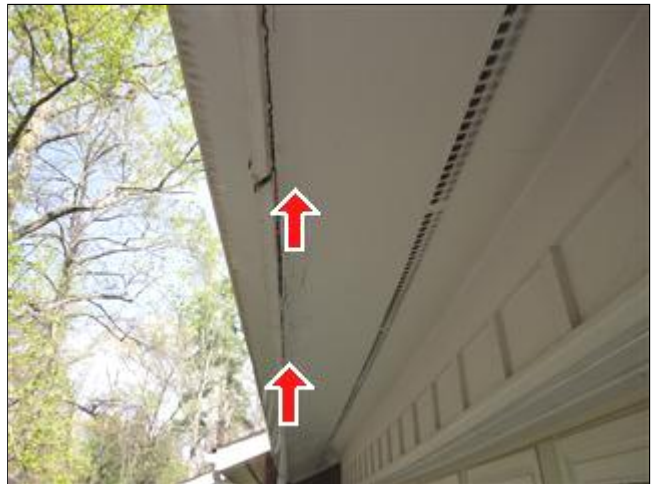
- 🔍 (1) The wood fascia and soffit panels at eave on the front of home above garage are deteriorated. Repairs are needed to roof covering as well. A qualified contractor should inspect and repair as needed.

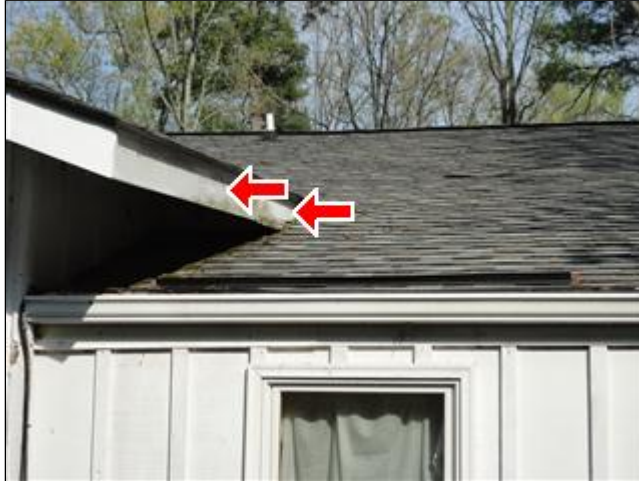
2.5 Picture 3

- 🔍 (2) The wood fascia at eave on the right side (facing front) is deteriorated. This is a small repair. A qualified contractor should inspect and repair as needed.

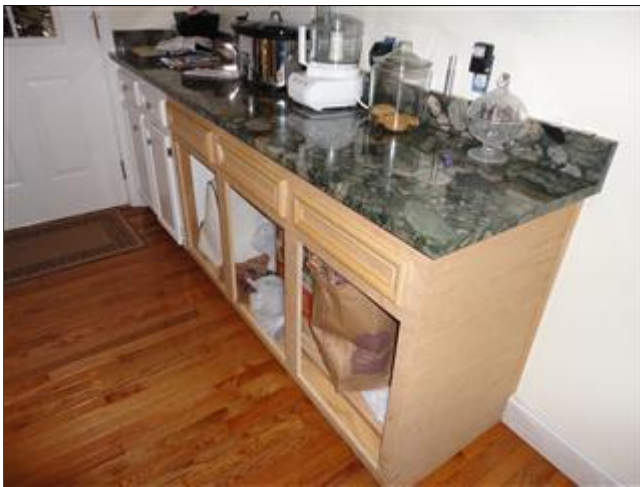
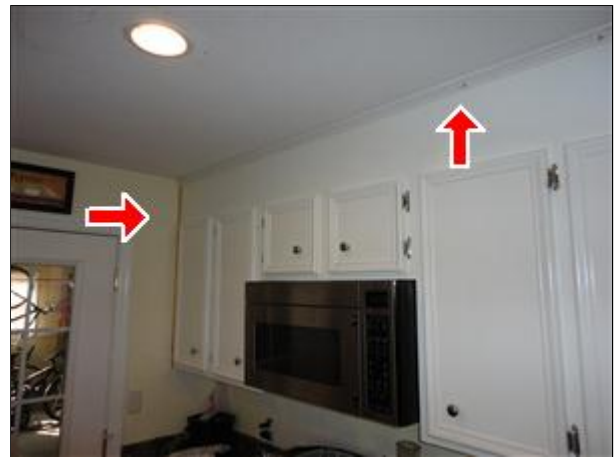
🔍 Base Cabinetry and trim at wall cabinet are unfinished at kitchen.

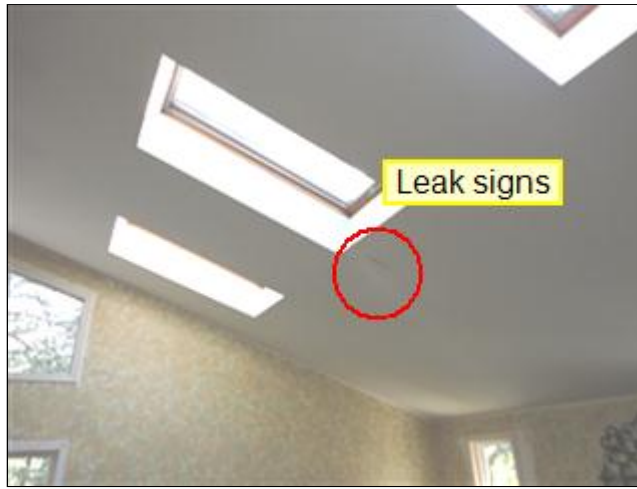
5.0 Picture 1

- 🔍 (1) The Sheetrock on the ceiling reveals a water stain indicating a leak did or still exists at the Den. Repairs are needed. A qualified contractor should inspect and repair as needed (See Roof Coverings).

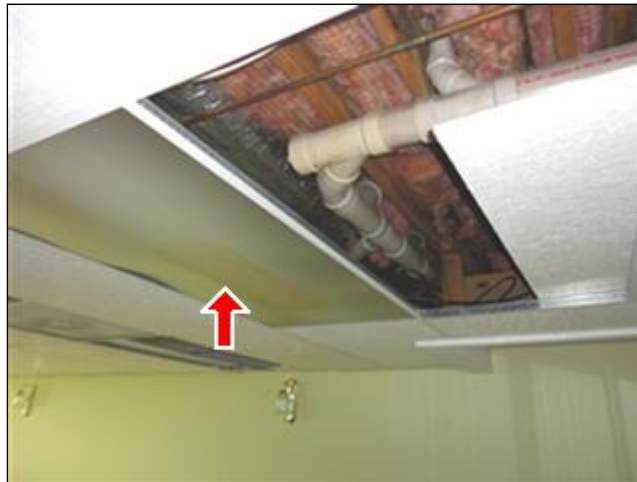
5.0 Picture 2

- 🔍 (2) Water stain on ceiling panel lower level indicates plumbing leak.

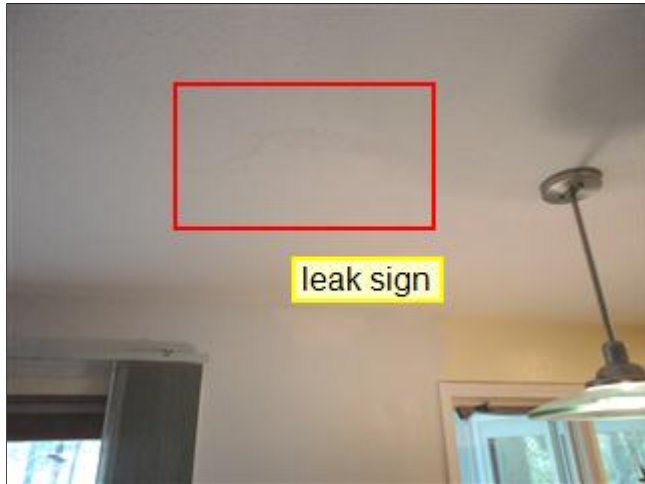
- 🔍 (3) The Drywall on the ceiling reveals a water stain indicating a leak did or still exists at the Dining Room. Repairs are needed. A qualified contractor should inspect and repair as needed.

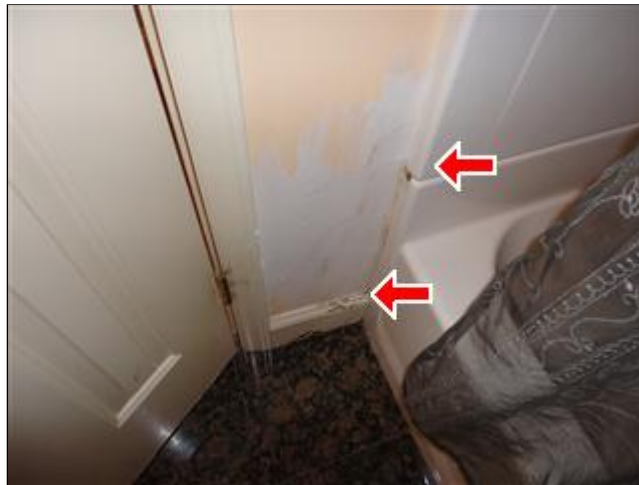
5.1 Picture 1

- 🔍 (1) Unfinished around windows in kitchen, and Den.
- 🔍 (2) The Wall at the bathtub is deteriorated and needs repair or replacement. The wall board and framing may need repair (not visible). I recommend repair or replace using a qualified contractor.

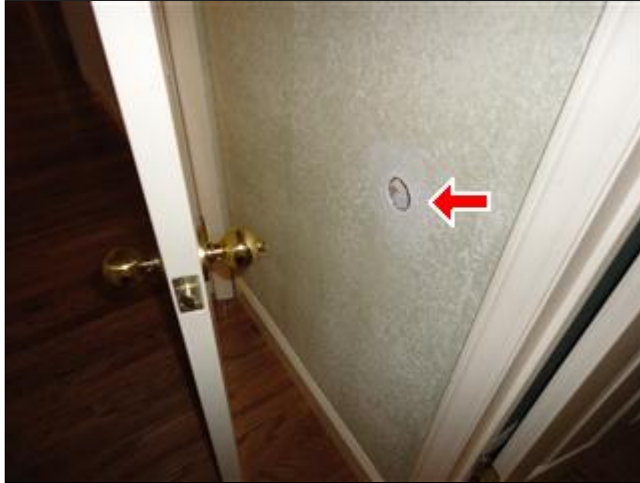
5.1 Picture 2

- 🔍 (3) The sheetrock on the wall is dented or damaged from door knob at the hallway. While this damage is cosmetic, it needs to be repaired. A qualified contractor should inspect and repair as needed.

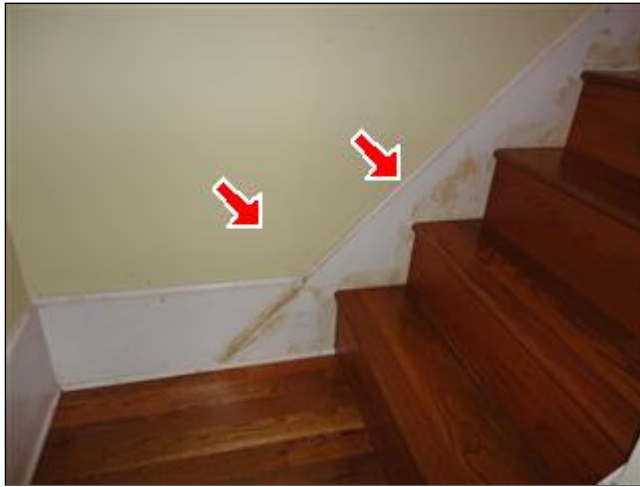
5.1 Picture 3

- 🔍 (4) Stair cover trim is unfinished needs prep and paint at stairs.

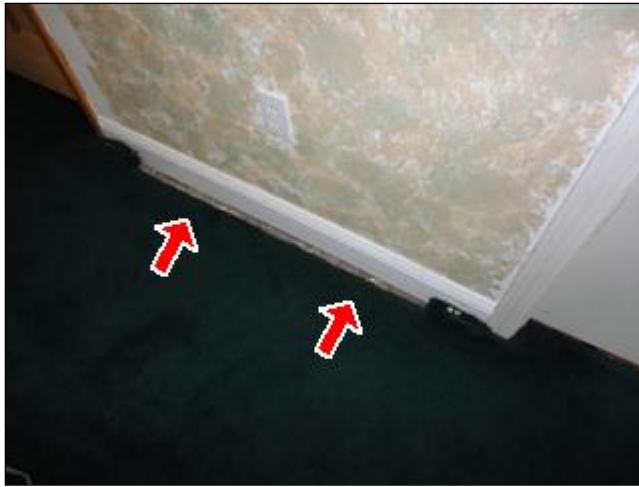
5.2 Picture 1

🔍 Carpet is loose or cut short from where electric baseboard use to be in areas around the perimeter of the Den.

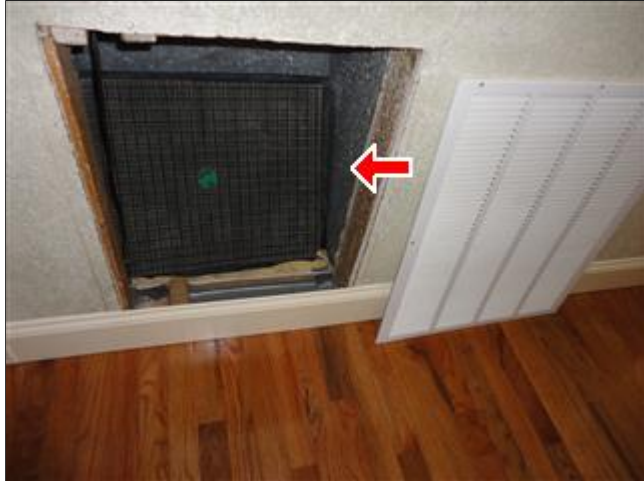
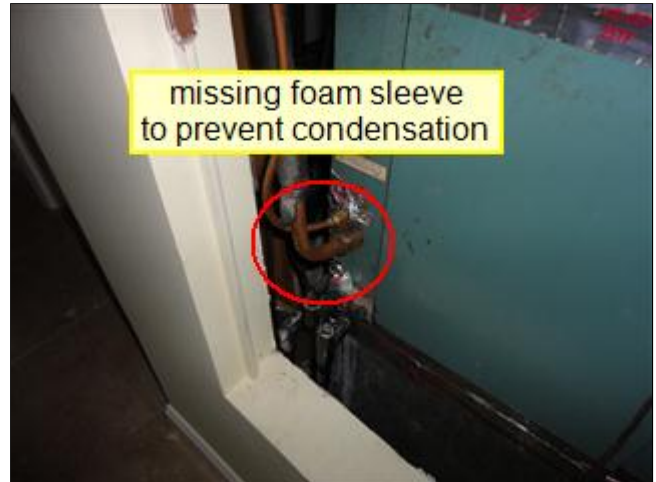
- 🔍 The washable filter is dirty. The filter needs to be cleaned. Recommend foil taping the filter for a better seal. See Video. Foam sleeve missing at suction line creates condensation and drips water.

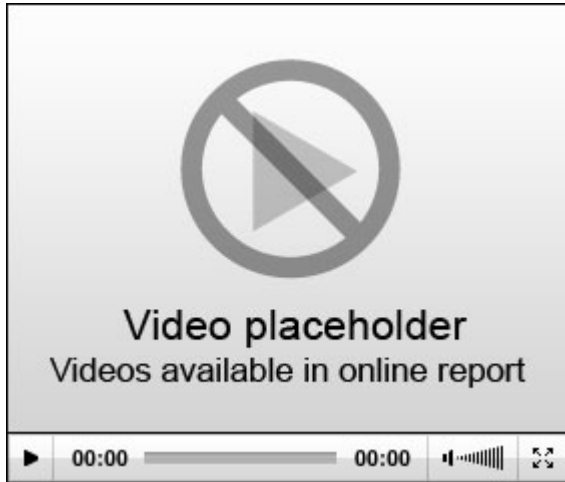
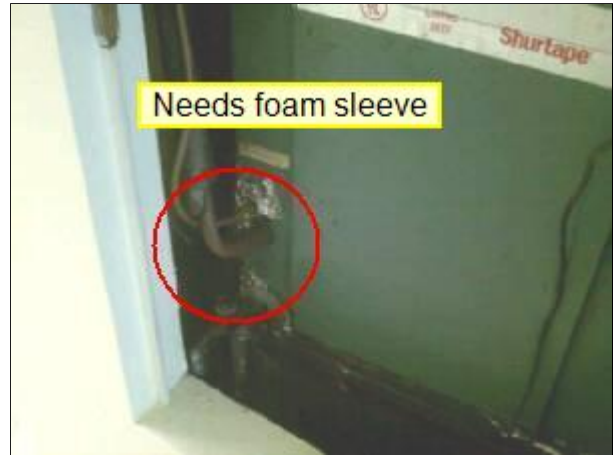
Air handler and heat pump is old but appears to be working properly. Foam sleeve on suction line is not covering copper line and condensation can drip.
