Inspect Before You Invest

SUMMARY REPORT

Client: MIKE FIMBREZ
Realtor: Steve Baker
Inspection Address: 3003 W BELLE AVE , QUEEN CREEK, AZ 85214
Inspection Date: 2/25/2021 Start: 12:00 pm End: 3:00 pm
Inspected by: Will Hanson

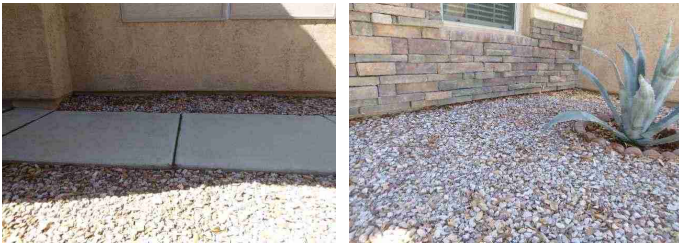
- 1.2 - Grading and drainage is either negative or neutral adjacent to the residence, and moisture intrusion will remain a possibility. The soil or the hard surfaces should slope away from the residence to a distance of

at least six feet, to keep moisture away from the footings. We can elaborate on this issue, but you should seek a second opinion from a geologist or grading and drainage contractor.

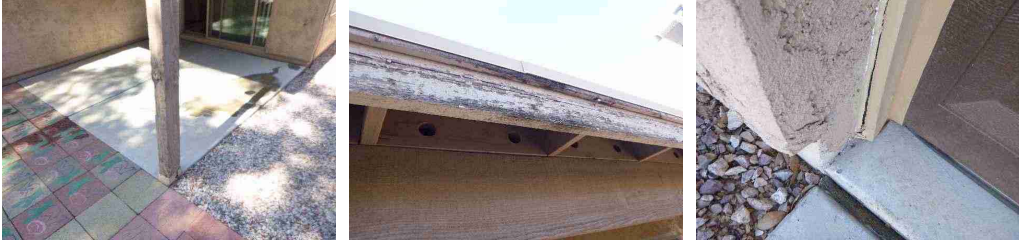
1.5 - The fascia board and trim, and particularly that on the south facing side that is exposed to the sun, are in poor condition and should be serviced.
Back patio area on the east side and the trim at the front garage door

The fascia board and trim are in poor condition and should be serviced - *Continued*

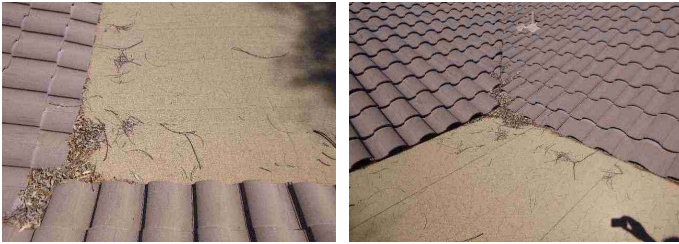
3.3 - Remove debris from roof surface. Debris on roof tiles can hold moisture longer and speed up deterioration of the roofing material. Also clean debris from roof wall transition flashing to prevent water from backing up under the roof tiles.

Remove debris from surface of roof - *Continued*

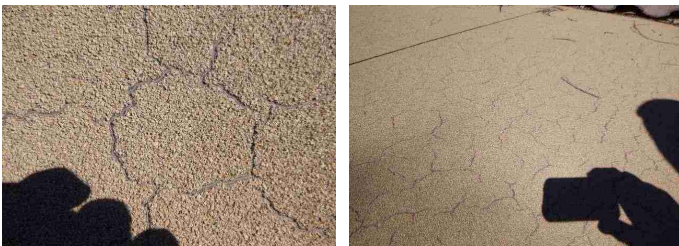
3.4 - The flat roof is in the primary stages of decomposition, which means that the roof will need to be maintained and closely monitored, You may wish to have a second opinion before the close of escrow. Consult a licensed roofing contractor.

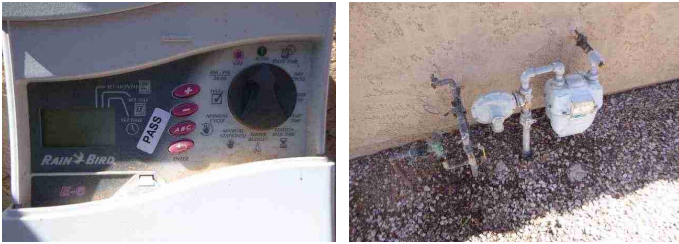
The backflow device at the main is leaking and the system was shut off when we arrived

The sprinkler system was not operational at the time of the inspection - *Continued*

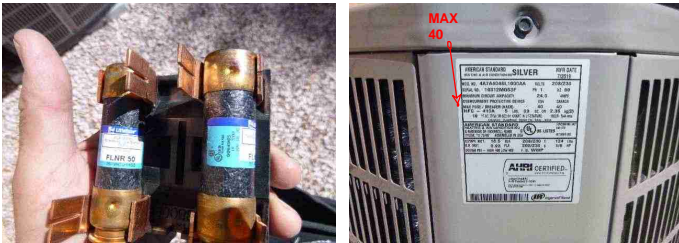
8.1 - The data panel on the A/C unit states that the breaker or fuse should be 40 amps maximum. The fuse at the disconnect panel is 50 amps, which may be too big for the A/C units. Consult a licensed electrical contractor.

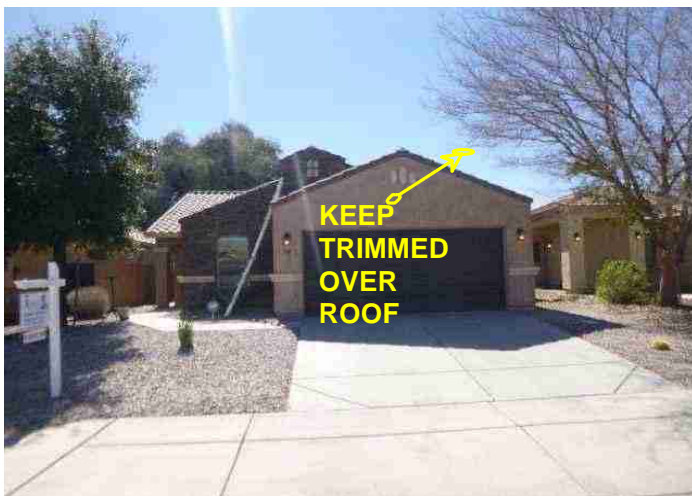
1.3 - There are tree limbs overgrowing the residence that should be trimmed or monitored, to insure that they do not impact of damage the roof or its components. Monitor or repair as required.

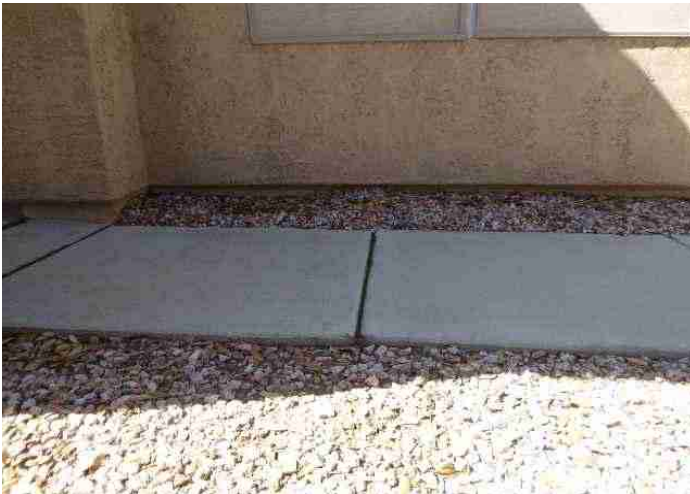
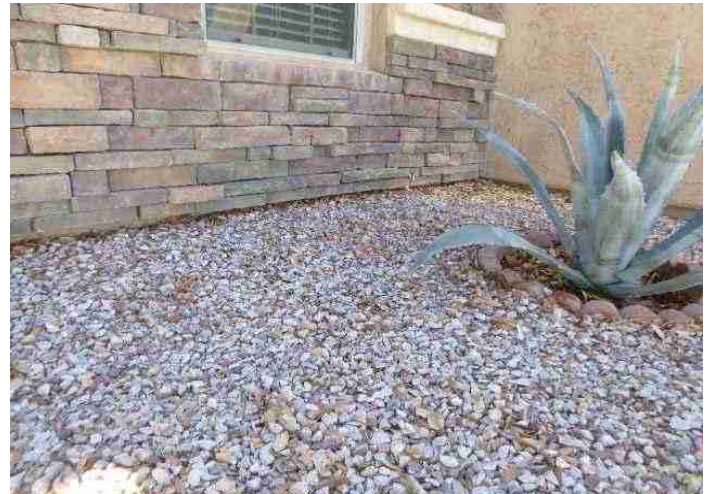
1.6 - Grading and drainage is either negative or neutral adjacent to the residence, and moisture intrusion will remain a possibility. The soil or the hard surfaces should slope away from the residence to a distance of at least six feet, to keep moisture away from the footings. We can elaborate on this issue, but you should seek a second opinion from a geologist or grading and drainage contractor.

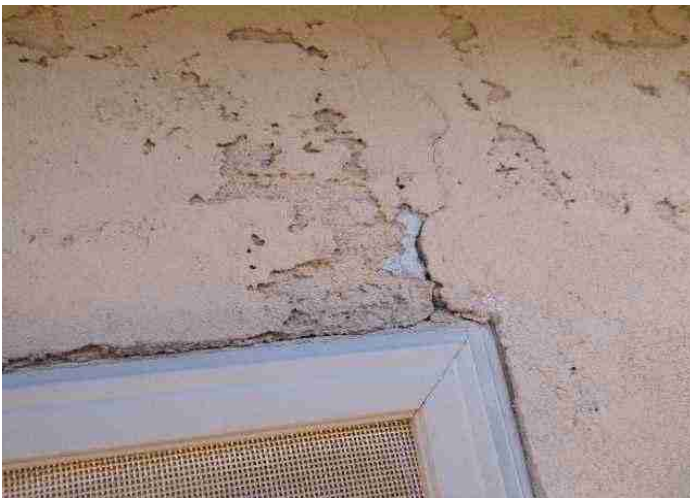
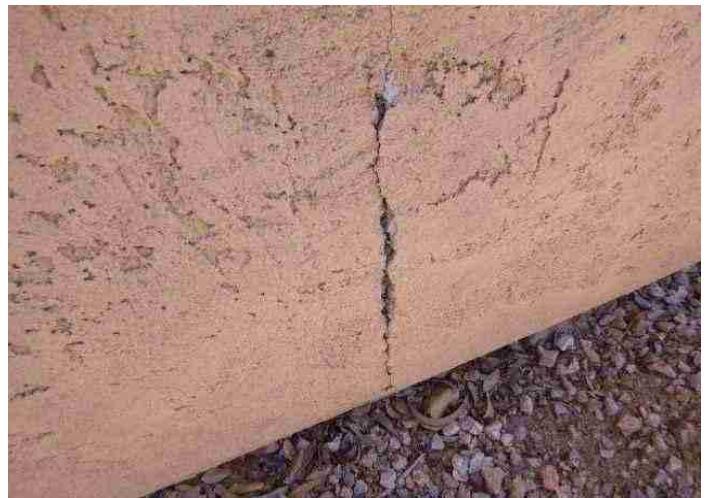
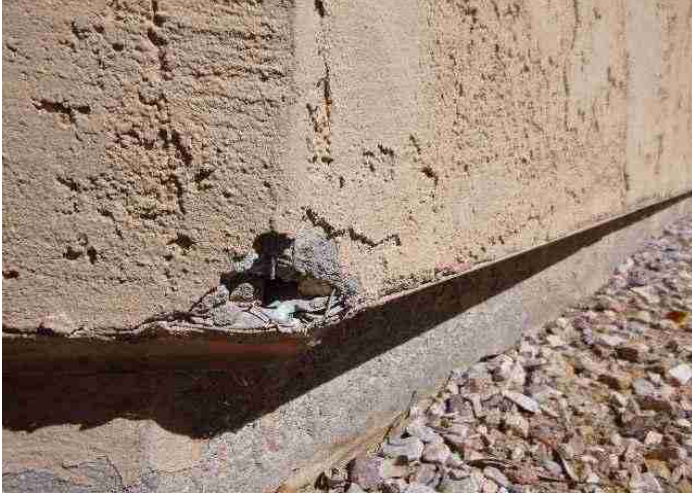
1.10 - There are small stress fractures in the stucco that result from movement, and are quite common. Most people do not realize that structures move, but they do and sometimes more or less continuously. Therefore, stress fractures can reappear after they have been repaired, and particularly if they have not been repaired correctly. Monitor or repair as required.

1.11 - Maintain all exterior finishes, caulking, and other sealants at any dissimilar material abutments and all penetrations to the walls and roof. This inexpensive task aids in the prevention of moisture intrusion and saves on costly repairs.

Caulk seal all gaps openings - *Continued*

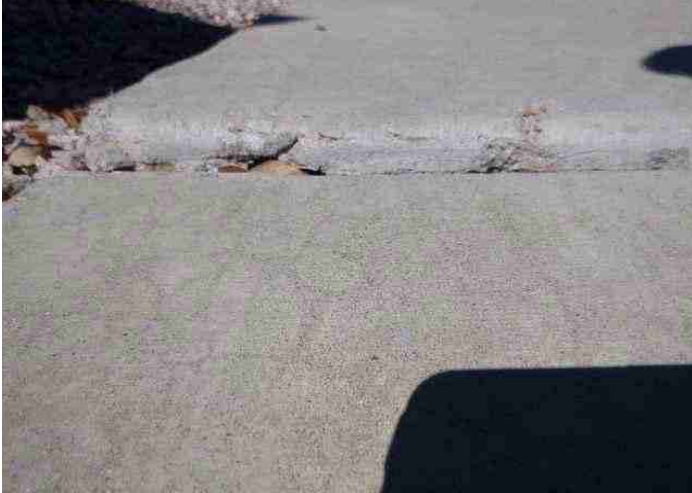
1.14 - There is an offset in a walkway that could prove to be a trip-hazard. Monitor or repair as required. Consult a licensed contractor.

There is an offset in a walkway that could prove to be a trip-hazard - *Continued*

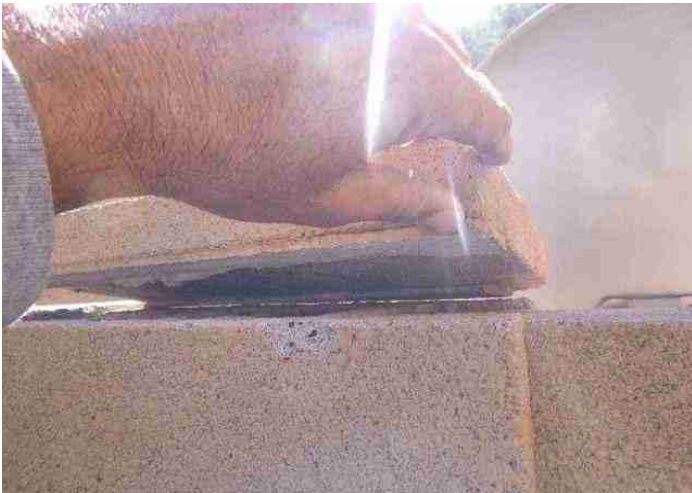
1.15 - There are loose or missing cap blocks on the cinder block yard wall, at various locations. Monitor or replaced as required. Consult a licensed contractor.
Near electrical panel in front

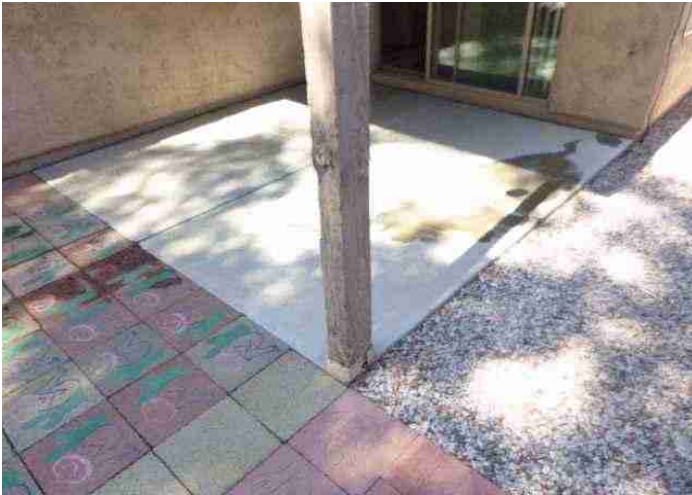
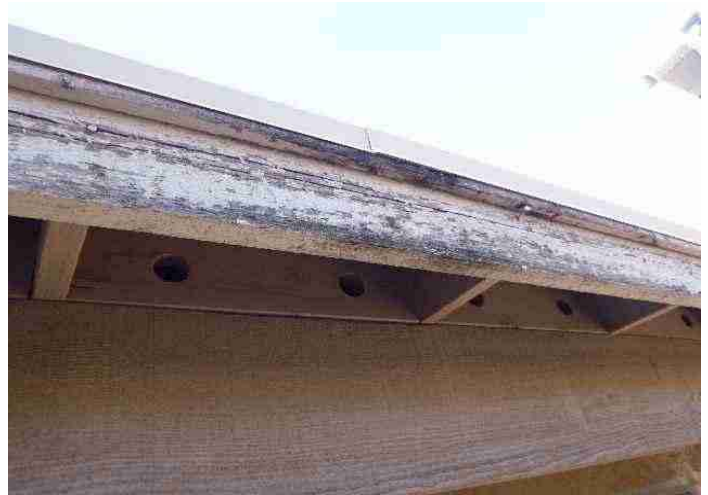
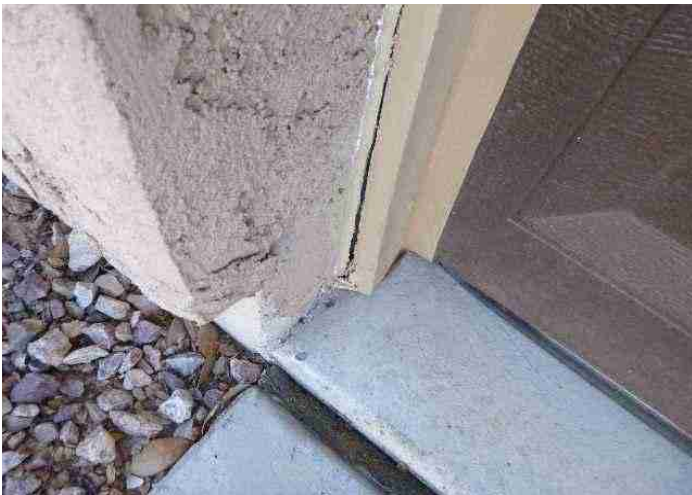
1.16 - The fascia board and trim, and particularly that on the south facing side that is exposed to the sun, are in poor condition and should be serviced.
Back patio area on the east side and the trim at the front garage door

The fascia board and trim are in poor condition and should be serviced - *Continued*

1.17 - Sections of the fascia and trim need maintenance type service, and particularly on the south facing side where they are exposed to direct sunlight. Monitor or repair as required. Consult a licensed contractor.

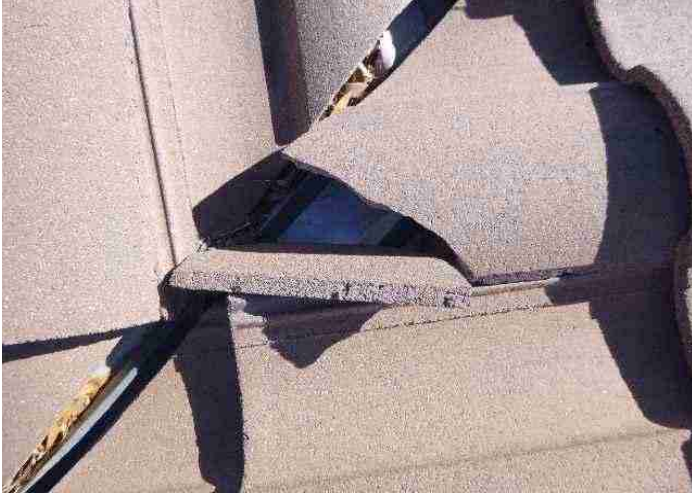
There are a number of cracked or broken tiles that should be serviced - *Continued*

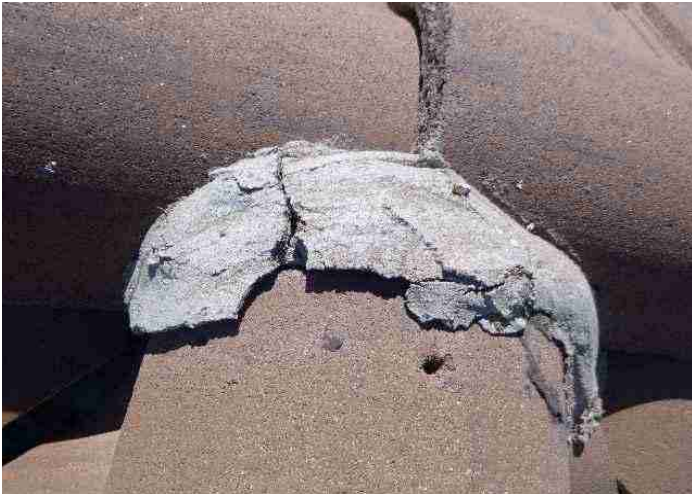
3.5 - There is a damaged mortar pack that needs to be sealed. Monitor or repair as required. Consult a licensed roofing contractor.

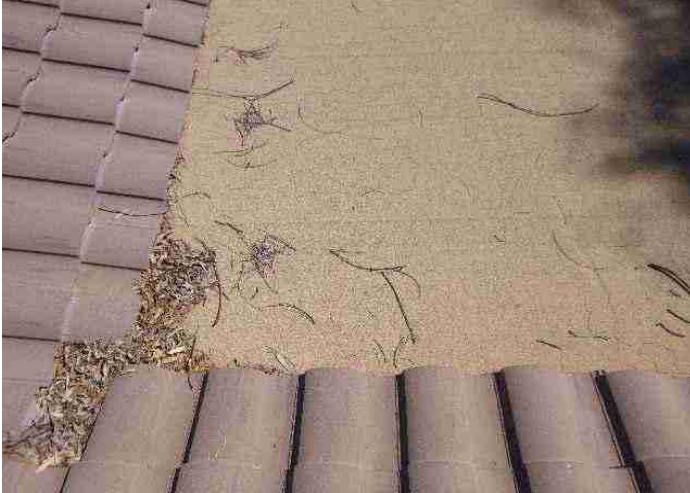
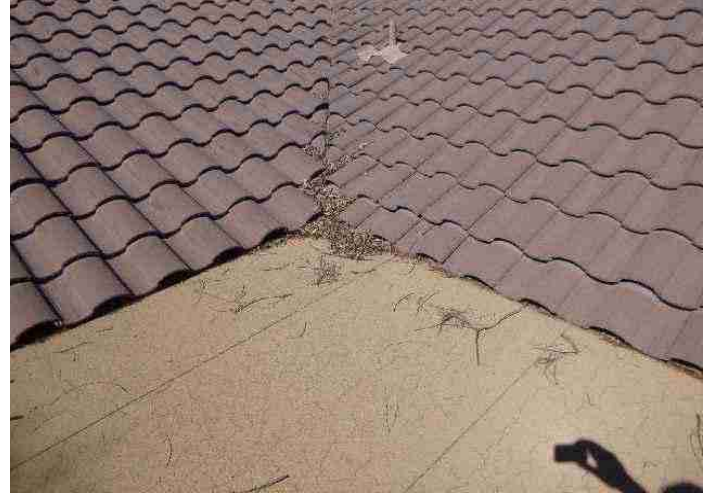
3.6 - Remove debris from roof surface. Debris on roof tiles can hold moisture longer and speed up deterioration of the roofing material. Also clean debris from roof wall transition flashing to prevent water from backing up under the roof tiles.

Remove debris from surface of roof - *Continued*

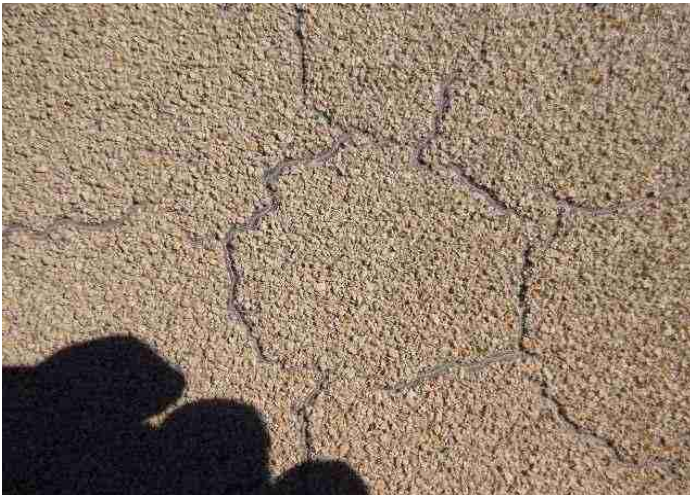
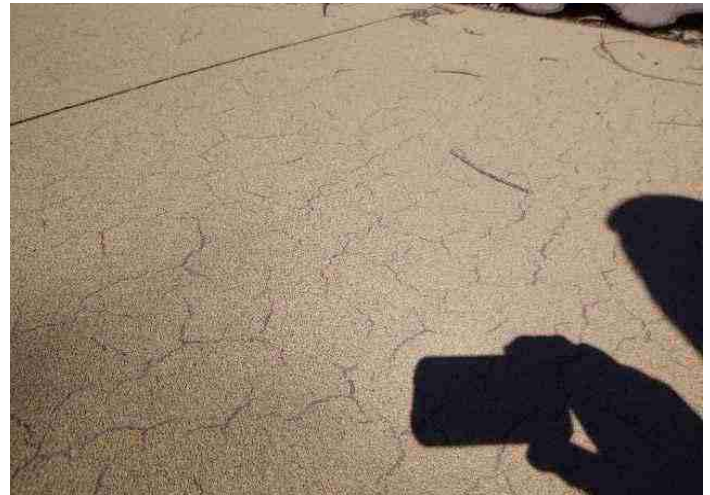
3.7 - The flat roof is in the primary stages of decomposition, which means that the roof will need to be maintained and closely monitored. You may wish to have a second opinion before the close of escrow. Consult a licensed roofing contractor.

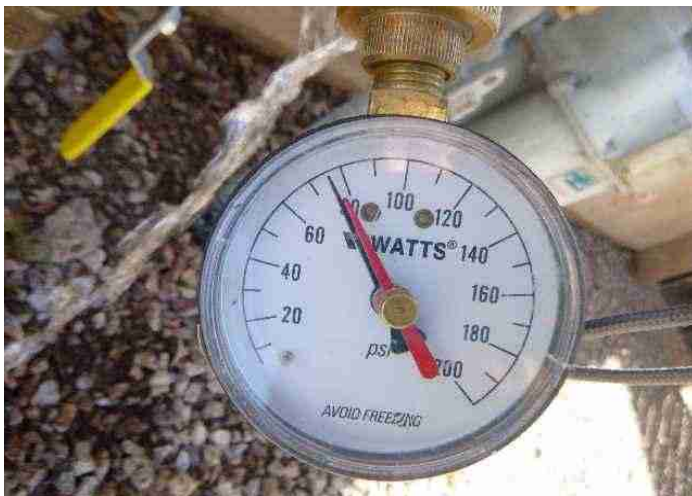
5.2 - The pressure at the street is under 80 psi and a regulator is not required on the plumbing system. The pressure is approximately 79 psi. If the pressure inside the residence exceeds 80 psi, which is too strong, it could stress components of the system.

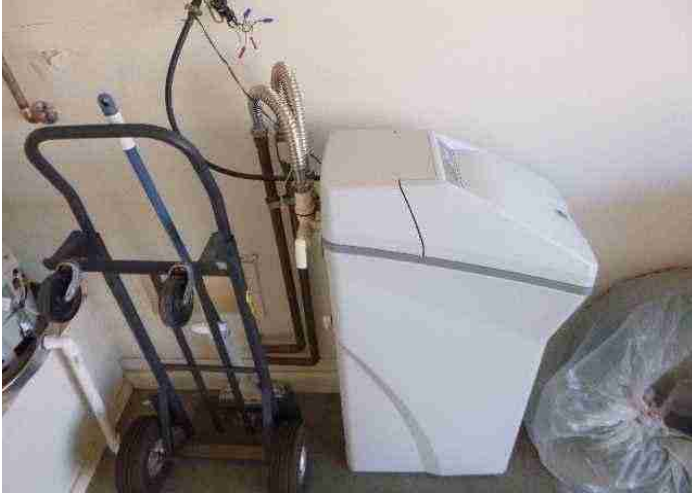
5.5 - We do not evaluate the water softener you may want to have a professional look at it for you

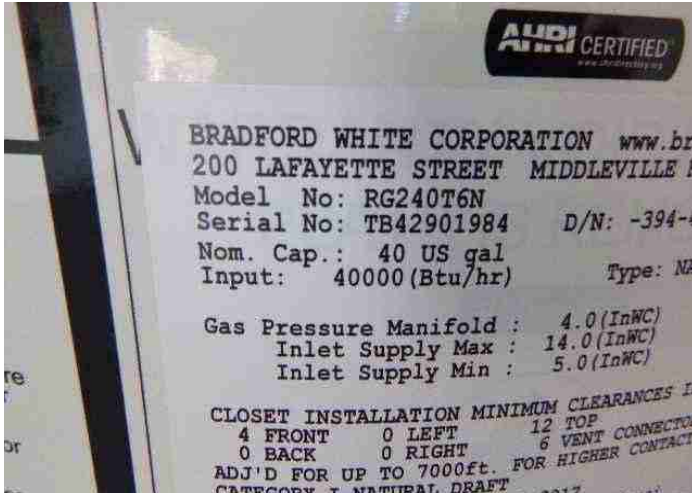
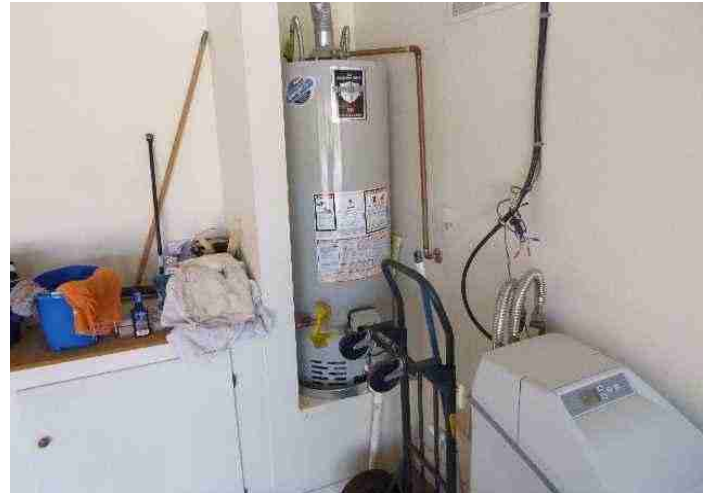
5.10 - Hot water is provided by a 2 year old (2019), 40 gallon water heater that is located in the garage. Water heaters last approximately eight to ten years.

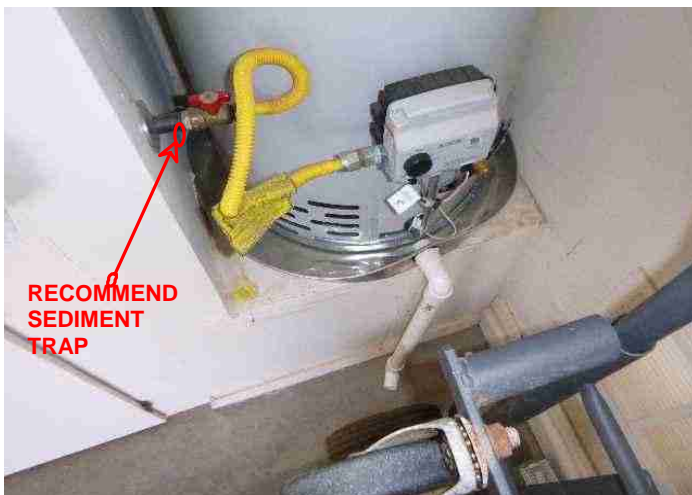
5.13 - There is no sediment trap installed at the gas line it is recommended to be installed consult with a licensed plumber

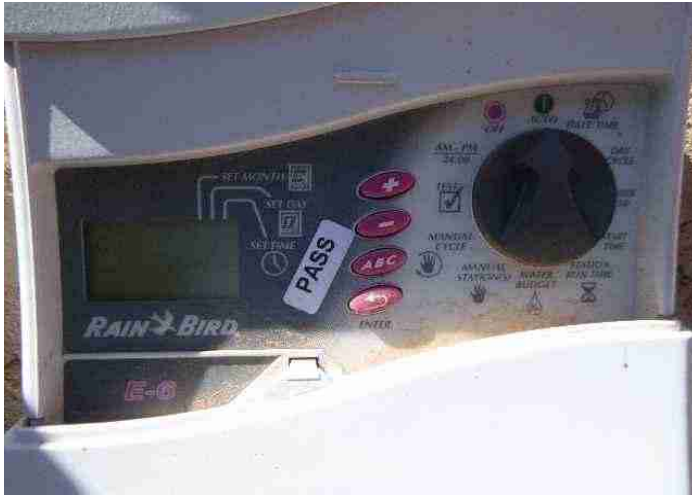
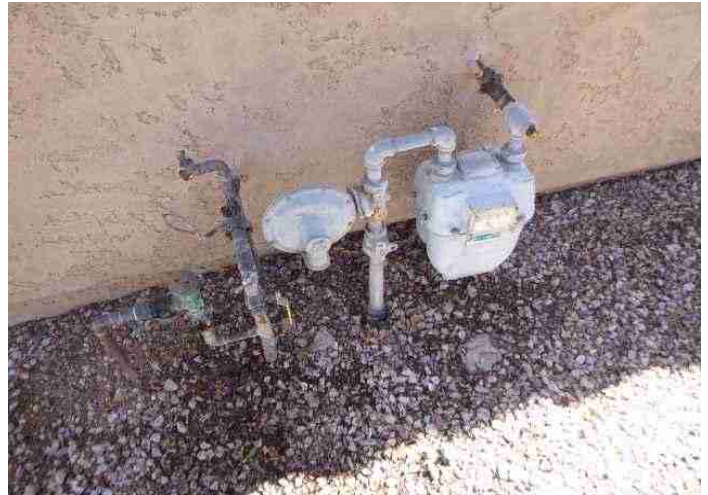
The sprinkler system was not operational at the time of the inspection - *Continued*

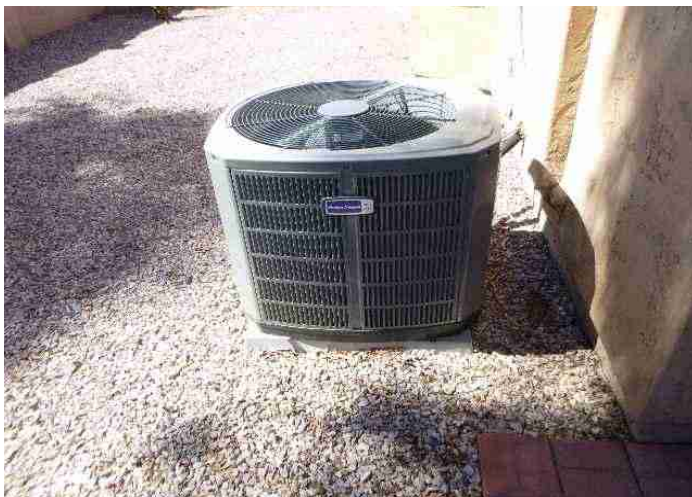
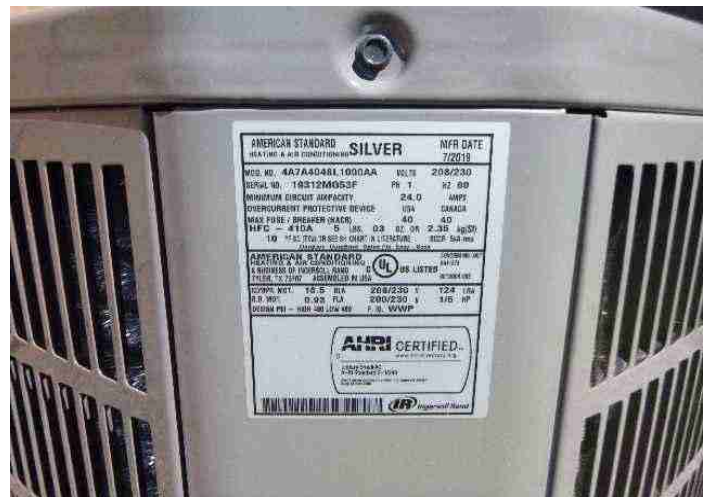
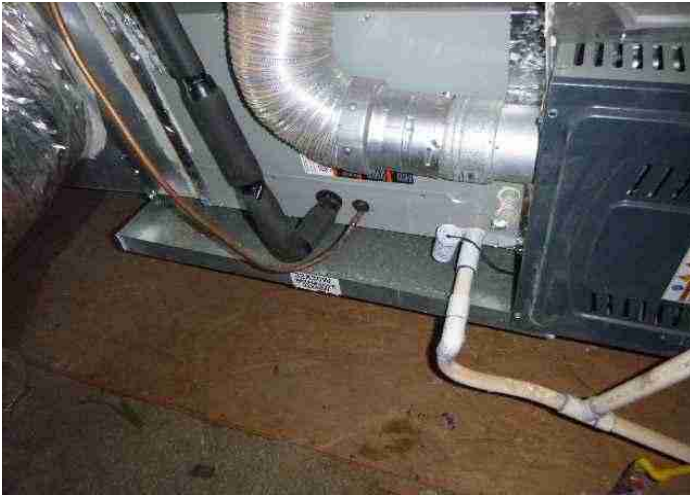
8.1 - Central heat and air-conditioning are provided by a single split-system, consisting of a 2 year old (2019), furnace that is located in the attic, and a 2 year old (2019), 5 ton, condensing coil located on the side yard

The residence is served by a single split system with the location indicated within the report - *Continued*

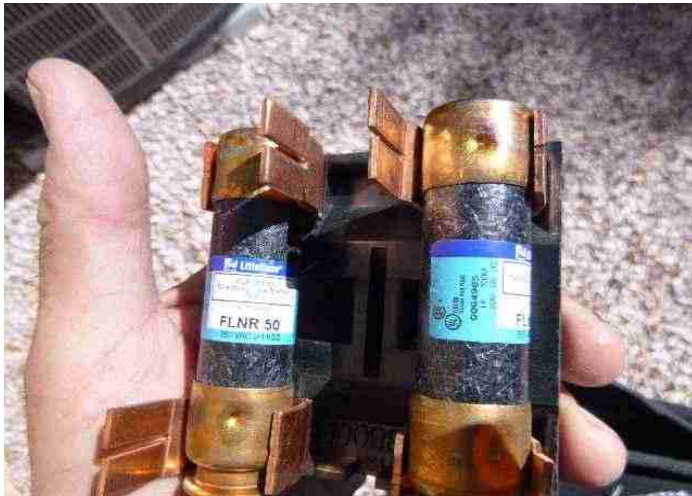
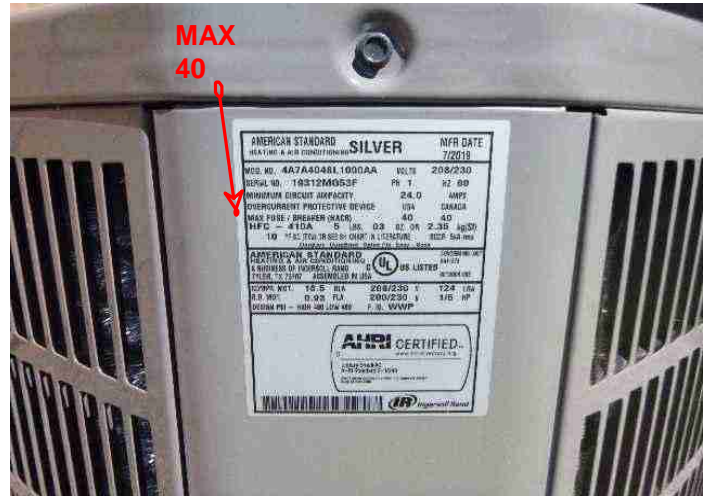
8.14 - The data panel on the A/C unit states that the breaker of fuse should be 40 amps maximum. The fuse at the disconnect panel is 50 amps, which may be too big for the A/C units. Consult a licensed electrical contractor.

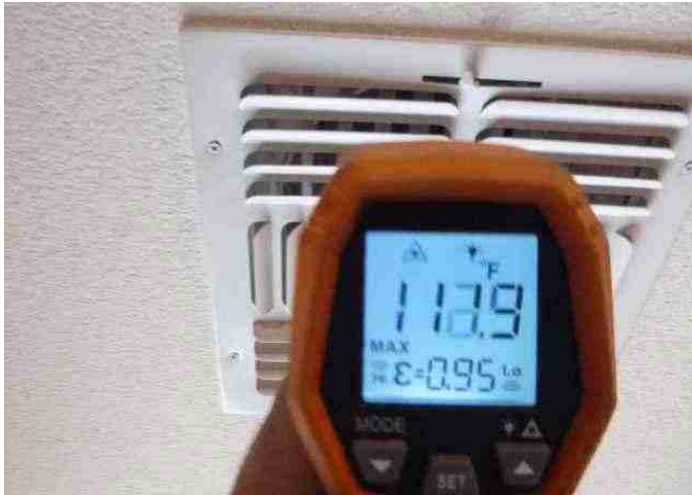
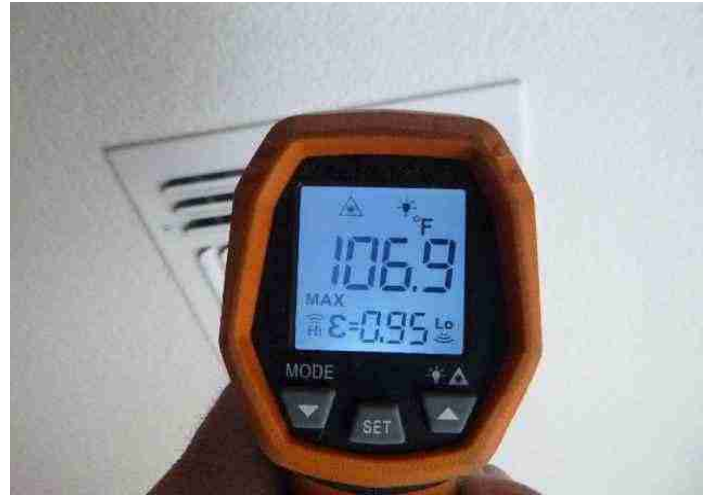
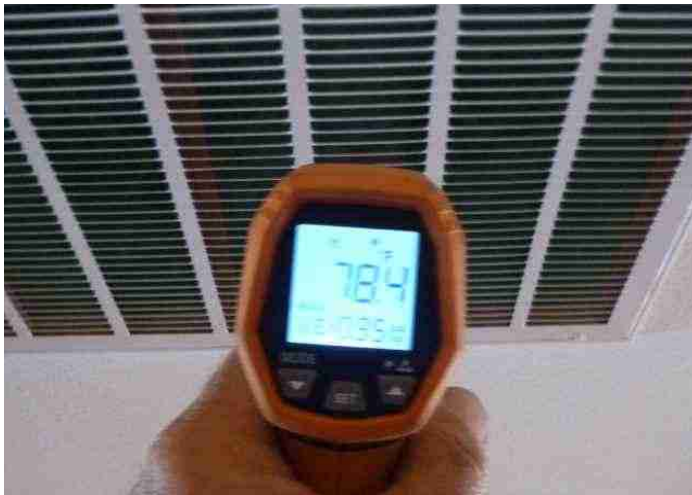
The units were only tested on heat. The units were not tested with air conditioning because of the cooler temps we did not want to damage the units have a licensed HVAC guy check the units

The air-conditioning achieved an acceptable differential temperature split as indicated within the report - *Continued*

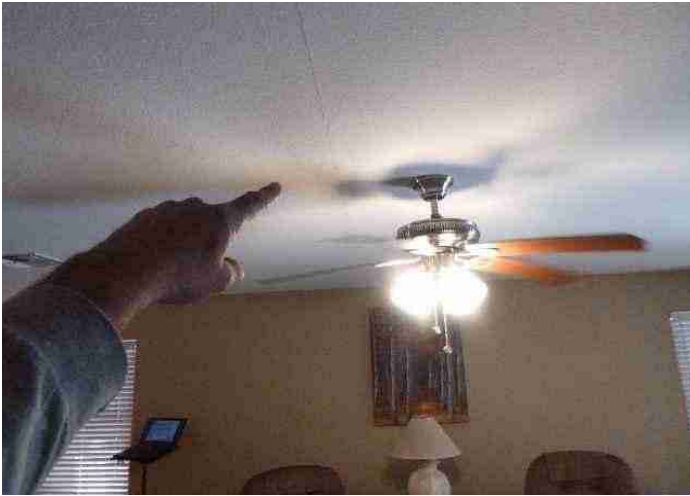
9.11 - The ceiling in the living room has a crack that looks to be a seam crack but you may want to have a licensed contractor evaluate to see if it is anything structural

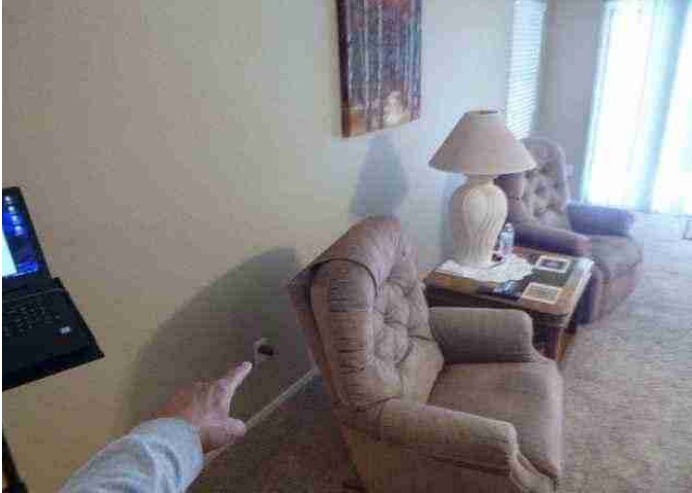
An outlet has an open neutral - *Continued*

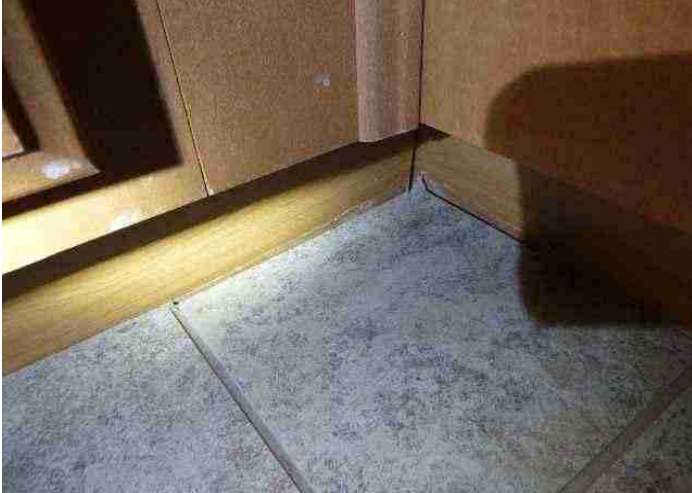
There are open grout-joints in the tiles that should be sealed to prevent moisture damage - *Continued*

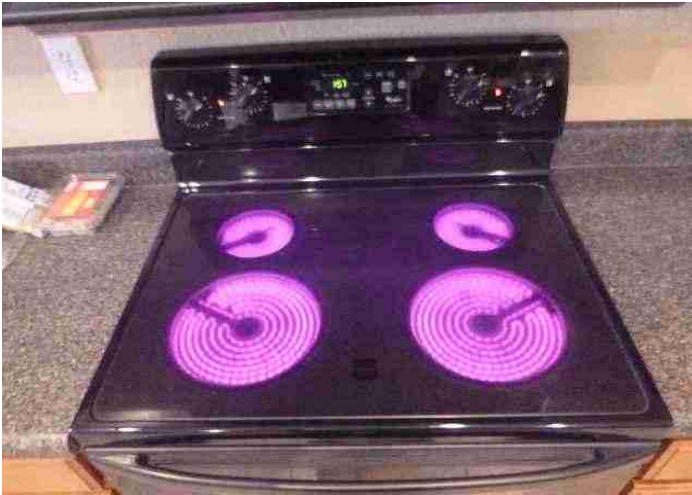
10.13 - The electric range is functional, but was neither calibrated nor tested for its performance.

The electric range is functional - *Continued*

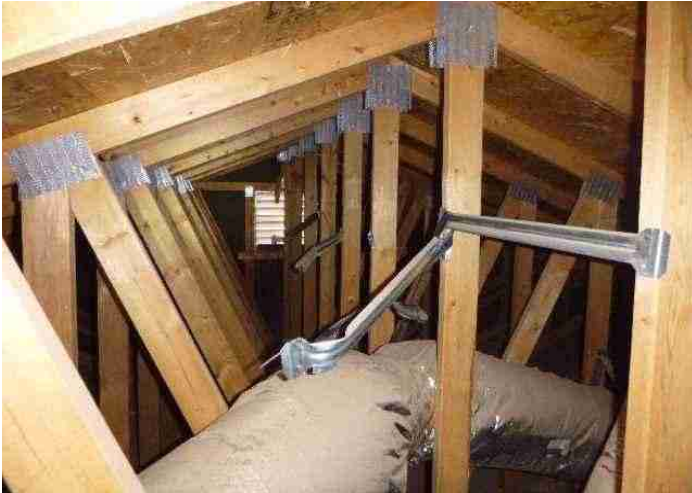
13.4 - Some of the collar-ties or sway braces are missing or damaged. This is not a serious structural deficiency, but one that should be reevaluated or serviced. Consult a licensed contractor. These may be used when setting the trusses but not structural after the sheathing is installed

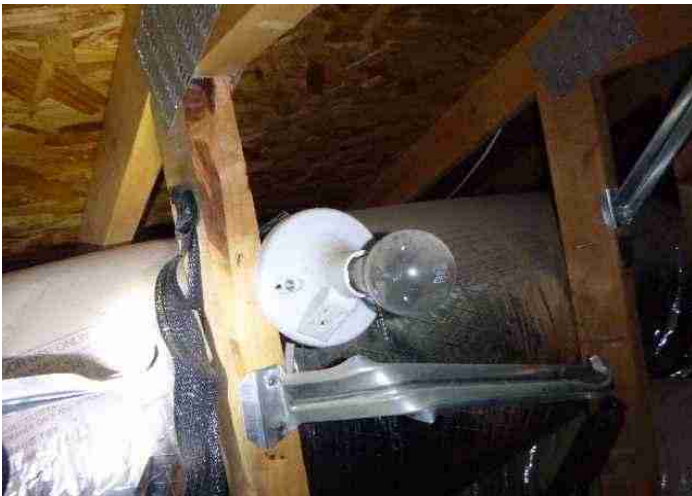
13.6 - The light did not respond most likely due to burned out bulb because the receptacle worked

13.2 - The light did not respond most likely due to burned out bulb because the receptacle worked

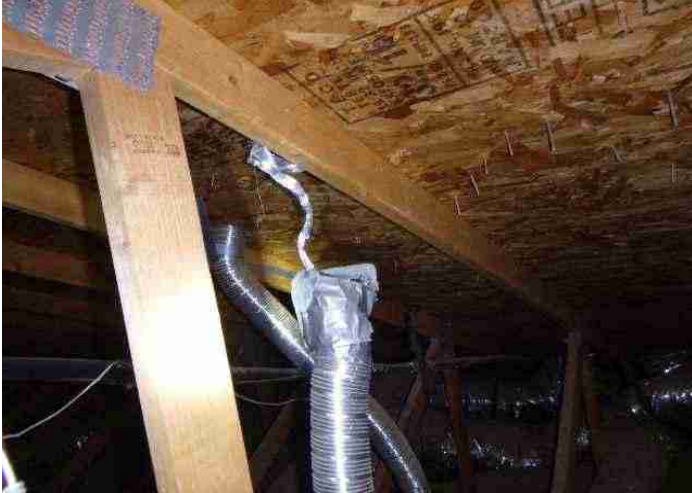
13.9 - An exhaust duct is separated within the attic, and should be repaired. Monitor or repair as required. Consult a licensed contractor.

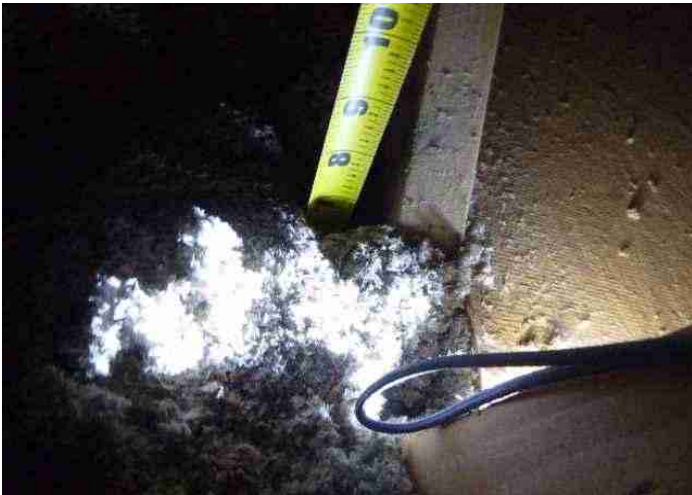
13.11 - The attic is insulated, with approximately eight to ten-inches of blown-in cellulose, which meets or is close to current standards. Some types of this insulation, which were manufactured and installed prior to 1979, consist of shredded paper and are flammable. However, we do not categorically recommend removing and replacing the insulation, because this is a personal decision that is best made by the owners or the occupants.

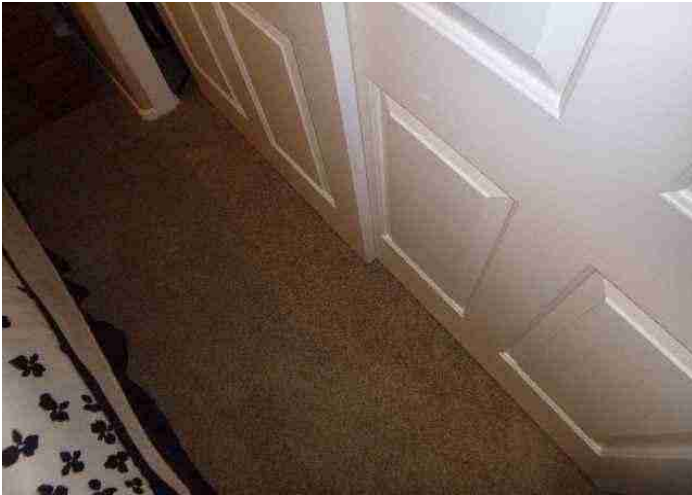
14.24 - The door guide is missing on bottom of door

door guide - *Continued*

14.1 - The door guide is missing on bottom of door

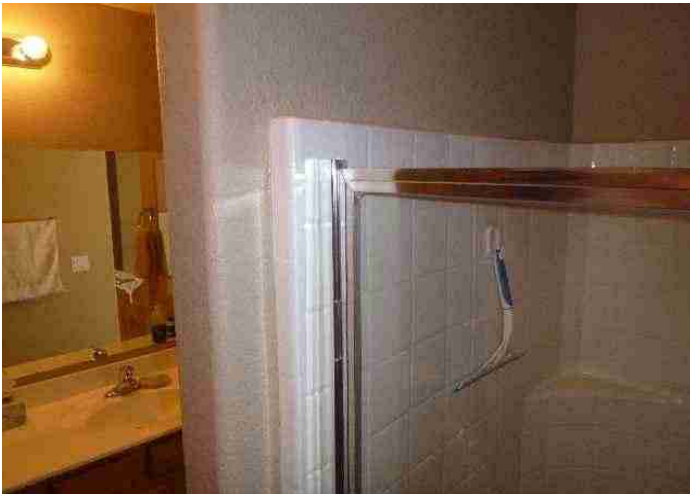
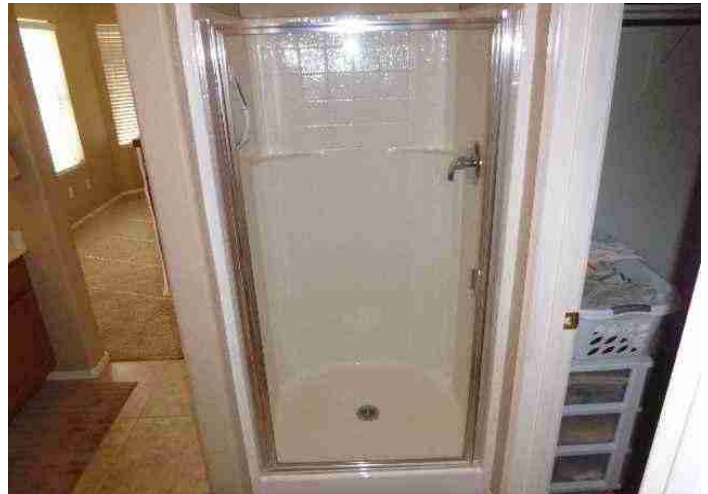
15.11 - The shower enclosure hardware will need to be serviced to work effectively. The door does not stay closed. Monitor or repair as required.
Sticks on bottom coming off wall not attached

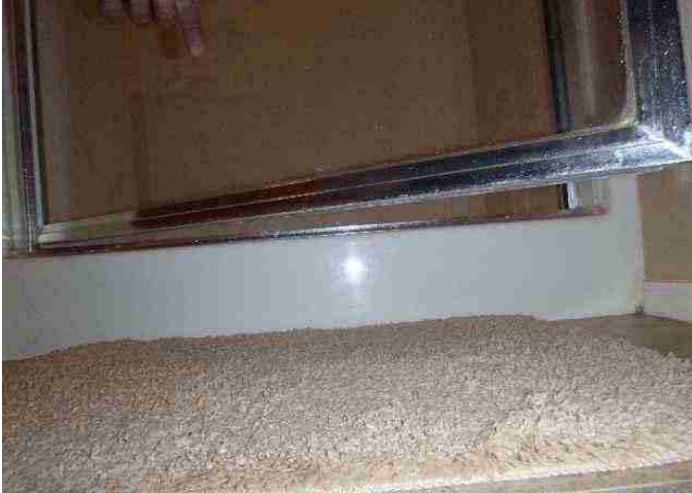
15.12 - The shower door seal is missing or damaged, and should be serviced. Monitor or repair as required.

The showerdoor seal is missing or damaged and should be serviced - *Continued*

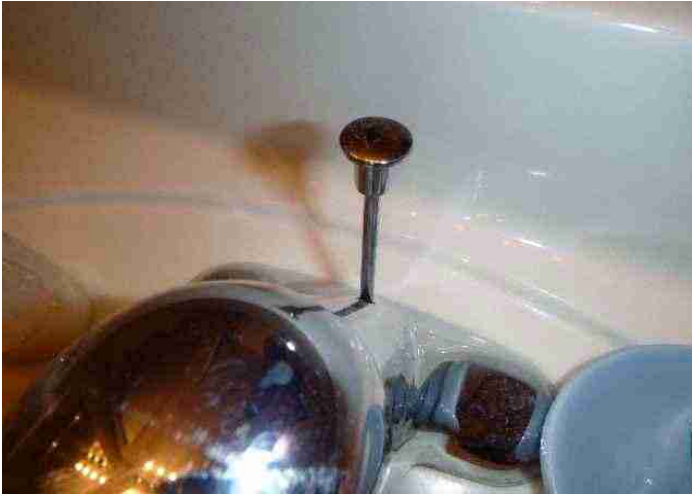
15.24 - The mechanical sink stopper will need to be adjusted to engage. Consult a licensed plumbing contractor.

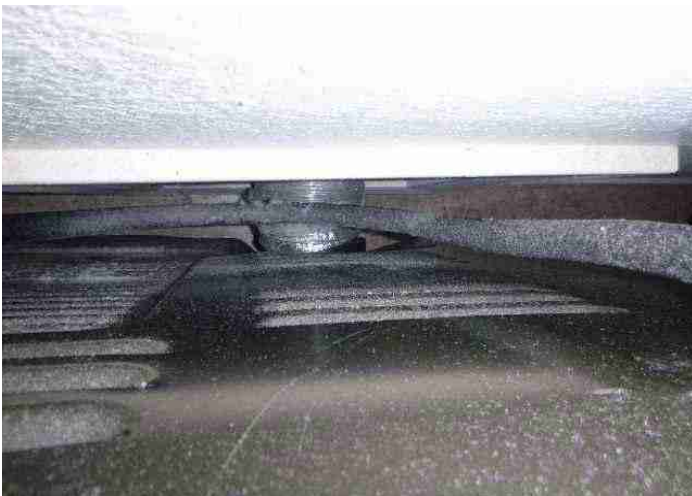
16.9 - The dryer vent is separated and should be repaired. Monitor or repair as required.
Just came off of the dryer behind the dryer

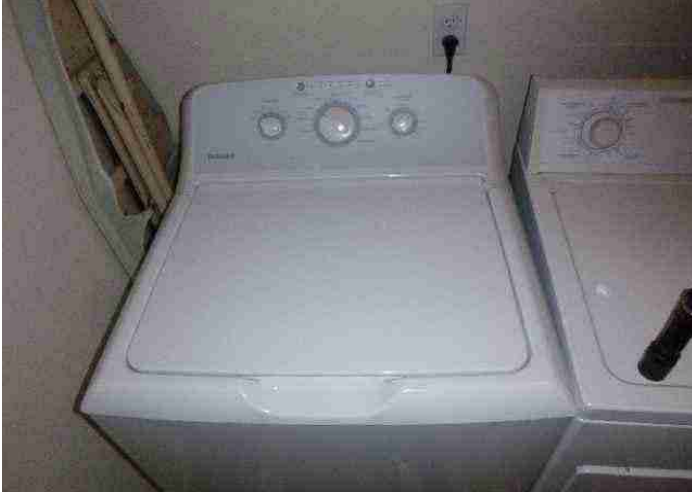
16.12 - The washer and dryer are functional, but were neither calibrated nor tested for their performance.
The washer was very noisy

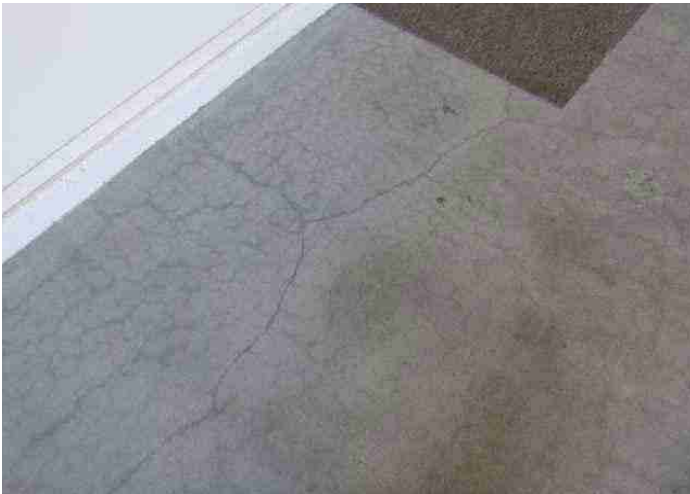
17.3 - There are small cracks in the slab floor of the garage that we do not regard as being structurally significant, which you may wish to view for yourself and decide whether or not you want a second opinion.

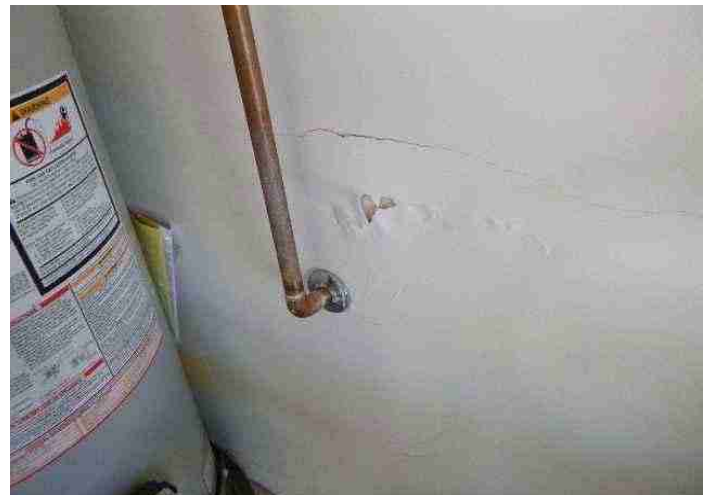
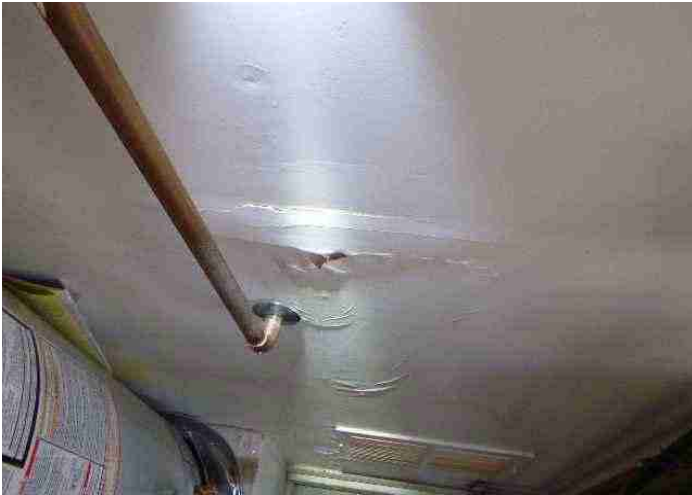
17.4 - The walls and/or ceiling has typical cosmetic damage. Monitor or repair as required. Consult a licensed contractor.

The walls and or ceiling has typical cosmetic damage - *Continued*

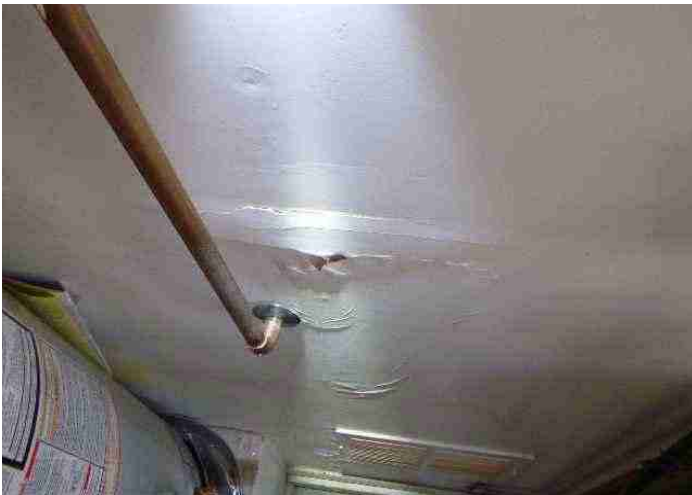
17.5 - There is moisture damage to the drywall, the cause of the moisture is unknown. The area was wet at the time of the inspection. Consult a licensed contractor.
Near the water heater

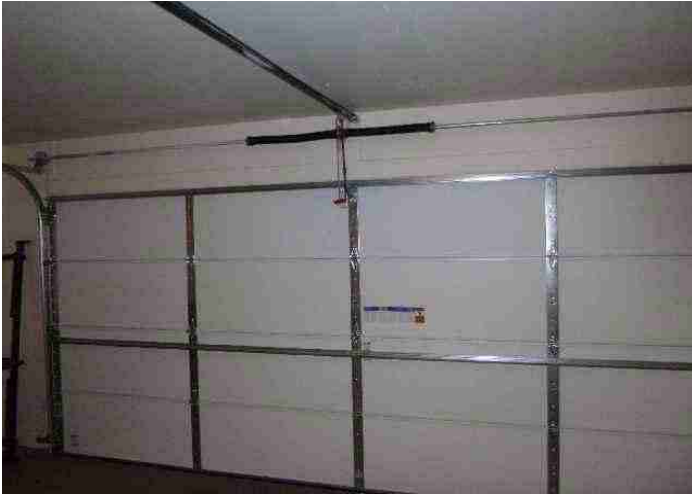
17.11 - The garage door opener is functional, but it takes too much force to auto-reverse and may need to be adjusted. Consult a garage door contractor. Monitor or repair as required.

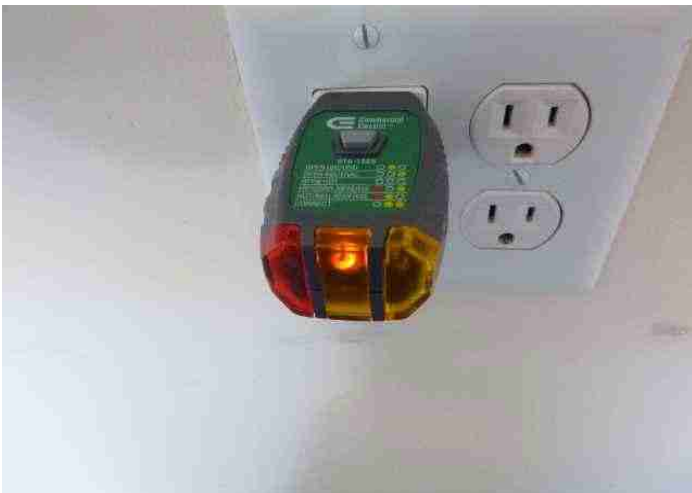
17.3 - An outlet has an open ground, and should be serviced to have ground fault protection, which is mandated by current standards and is an important safety feature. Consult a licensed electrical contractor.
GFCI on wall
