Concrete Cloth™

CASE STUDY:

Florence, SC
Paved Drainage Swale

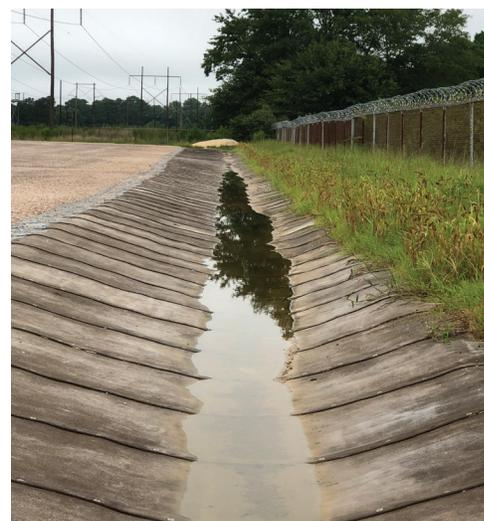
Newly covered swale using Concrete Cloth GCCM

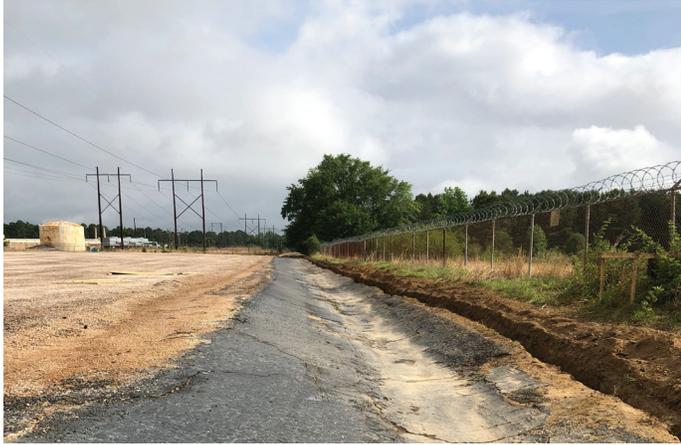
Asphalt swale before rehabilitation

A decommissioned manufacturing facility owned by ESAB was being monitored by Roux Associates, Inc. to ensure the property would be kept up to designated standards and proper condition. There is an on-site landfill surrounded by drainage swales at the facility that needed to be relined. The asphalt-paved swales had deteriorated over the years and there was no concern of project disruption since the facility was closed. The site had limited access, however, which also limited the type of material that would be easy to maneuver through the small gate for the swale repair.

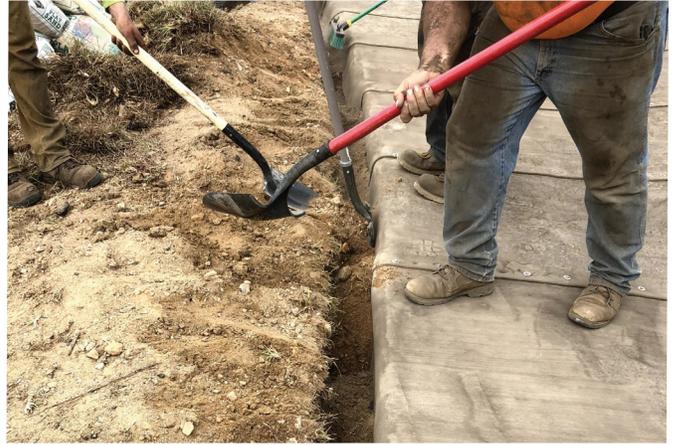
The team digs a trench to help anchor the Concrete Cloth GCCM into the ground

The team of about five crew members dug a trench to anchor the GCCM the first day, and then installed the material for the next two and a half days due to weather conditions. Because Concrete Cloth GCCM cannot be over-hydrated, the material was not affected by the storm. The south and east sides of the swale were lined for 650 linear feet.

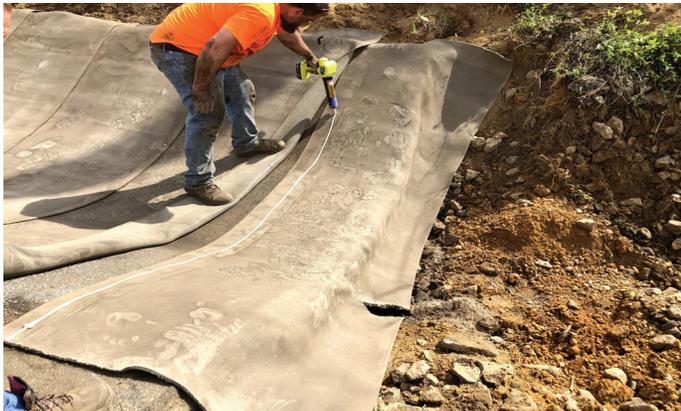
The material is adhered together using water-resistant caulking

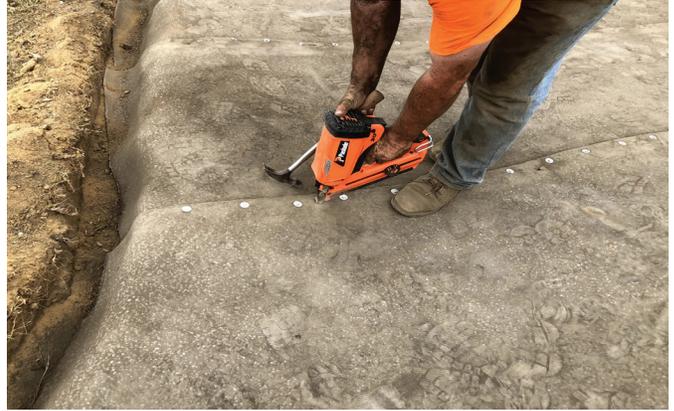
The material is anchored to the existing asphalt channel using four-inch nails

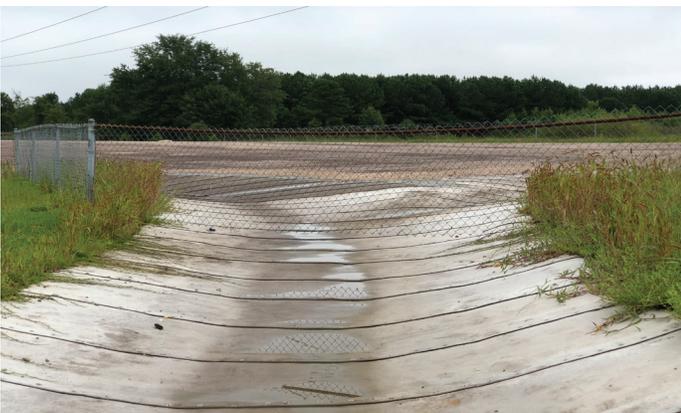
Newly covered swale using Concrete Cloth GCCM

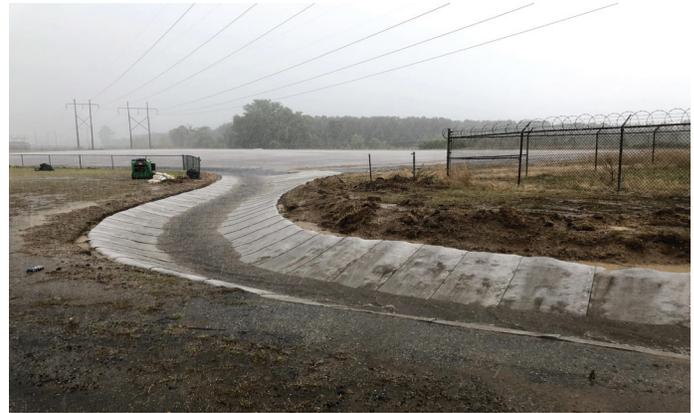
The contractor used the weather conditions to his advantage to hydrate the Concrete Cloth GCCM because it cannot be over-hydrated
